SUBJECT: Operational Report - Lessons Learned, Headquarters, 520th Transportation Battalion, Period Ending 31 January 1970

DEPARTMENT OF THE ARMY
HEADQUARTERS, 520TH TRANSPORTATION BATTALION (AM&S) (GS)
APO 96289

SUBJECT: Operational Report - Lessons Learned, 520th Transportation Battalion
(AM&S) (GS), Period Ending 31 January 1970, RCS CSFOR-65 (R2)

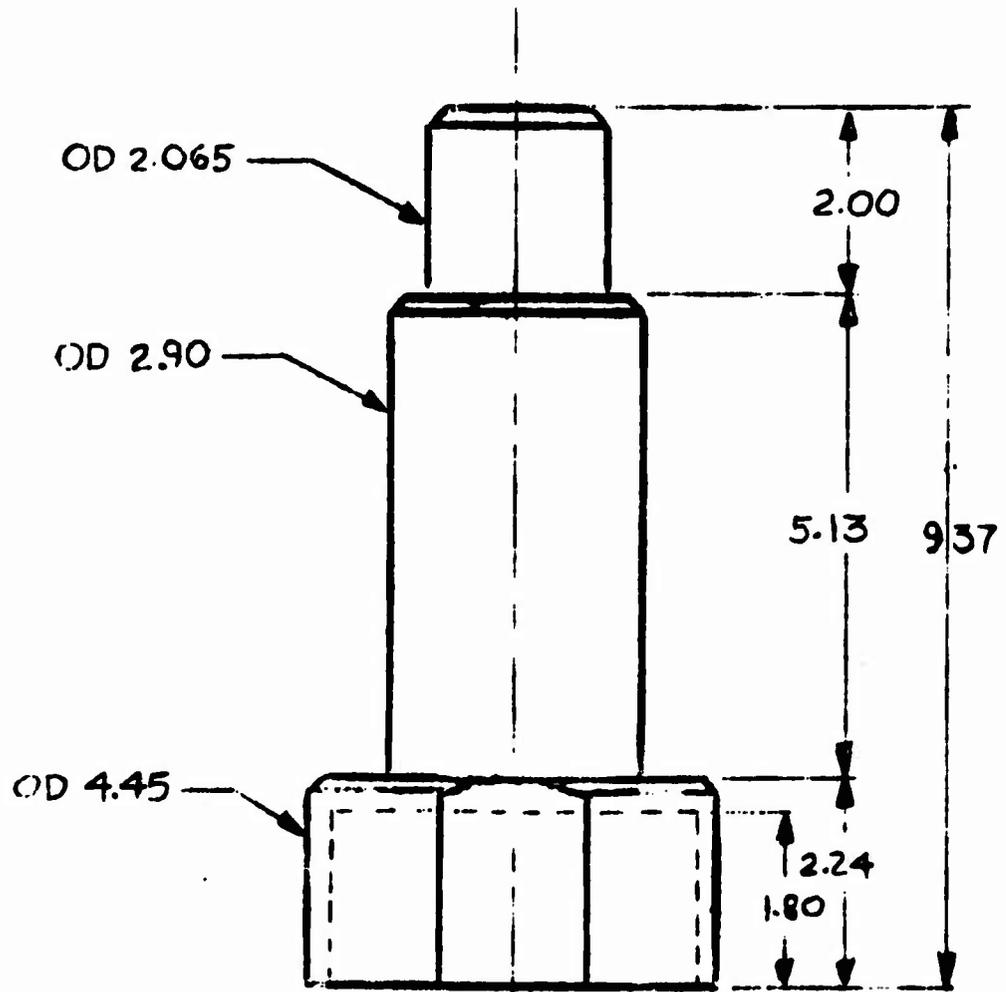
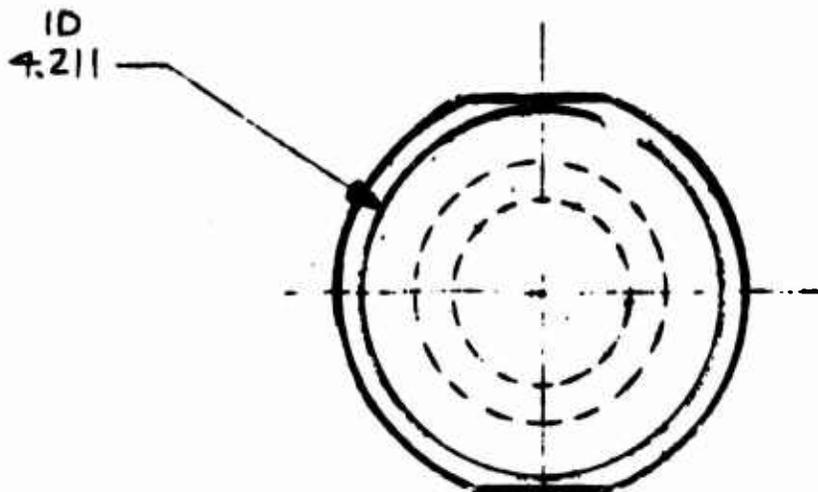
Incl 1

(a) Observation: The rotor head stand issued with the OH-58 special tool set for use on a balance stand has not proven practicable in the field. A locally manufactured stand, designed to adapt to the UH-1 rotor stand (FSN 4920-678-5431), is more suitable.

(b) Evaluation: The stand, as designed and illustrated (see Incl 1), can be easily manufactured in any DS machine shop from 7075 T6 aluminum bar stock. The base portion is machined within the inner base diameter to fit snugly over the UH-1 rotor stand and secured with a set screw (not illustrated). To adapt the hub holding portion to a table or other type stand, a larger diameter of bar stock must be used. By reducing the length of the resulting wider base portion, a butt plate with four bolt holes is fabricated to allow for a stable mounting of the stand on any flat surface.

b. Reference item concerning "Rotor Head Stand, OH-58A Helicopter", page 4, paragraph 2c(2); nonconcur. The observation cites no reason as to why the issued rotor head stand is impracticable. The evaluation describes a rotor head stand which does not incorporate the rotor head balancing features presently found in the issued item. Unit has been advised that an EIR should be submitted if the issued item is impracticable. No action by higher headquarters is recommended.

(c) Recommendation: That design specifications for this OH-58 rotor head stand be distributed by AVSCOM, especially to maintenance units supporting both the UH-1 and OH-58A helicopters.

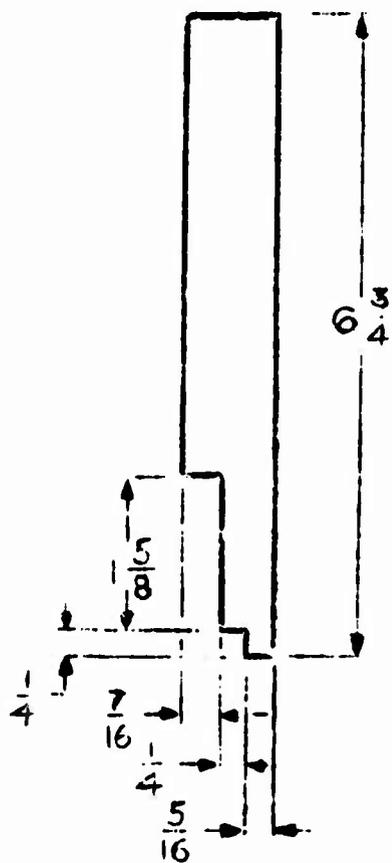
Incl 2

(a) Observation: Redistribution and removal of excess grease while packing a UH-1 or AH-1 short shaft cannot be done effectively by hand.

(b) Evaluation: The packing of a UH-1 or AH-1 short shaft, in accordance with TM 55-1520-210-35-2 and TM 55-1520-210-20, requires a .020 - .030 inch grease wall above the top of the splines. To accomplish this accurately and efficiently, a field expedient tool has been developed (see Incl 2). This tool is cut from standard .054 sheet aluminum or similar soft metal. The step design of the tool follows the inside contour of the short shaft and its spline teeth. After coating the splines with an excessive amount of grease, the tool is inserted so that the first step of the tool rests on the smooth wall portion of the short shaft's inner coupling. By using the smooth wall as a guide and rotating the tool around the shaft, the excess grease is removed.

(c) Recommendation: That the design of this tool be disseminated for local fabrication and use to all aviation maintenance units as an interim measure until a standard tool is developed and distributed.
