NOLTR 70-136

DEVELOPMENT, TEST AND EVALUATION OF
THE ROCKET LAUNCHER SAFETY AND ARMING
DEVICE (MLU-53/B)

1 SEPTEMBER 1970

UNITED STATES NAVAL ORDNANCE LABORATORY, WHITE OAK, MARYLAND

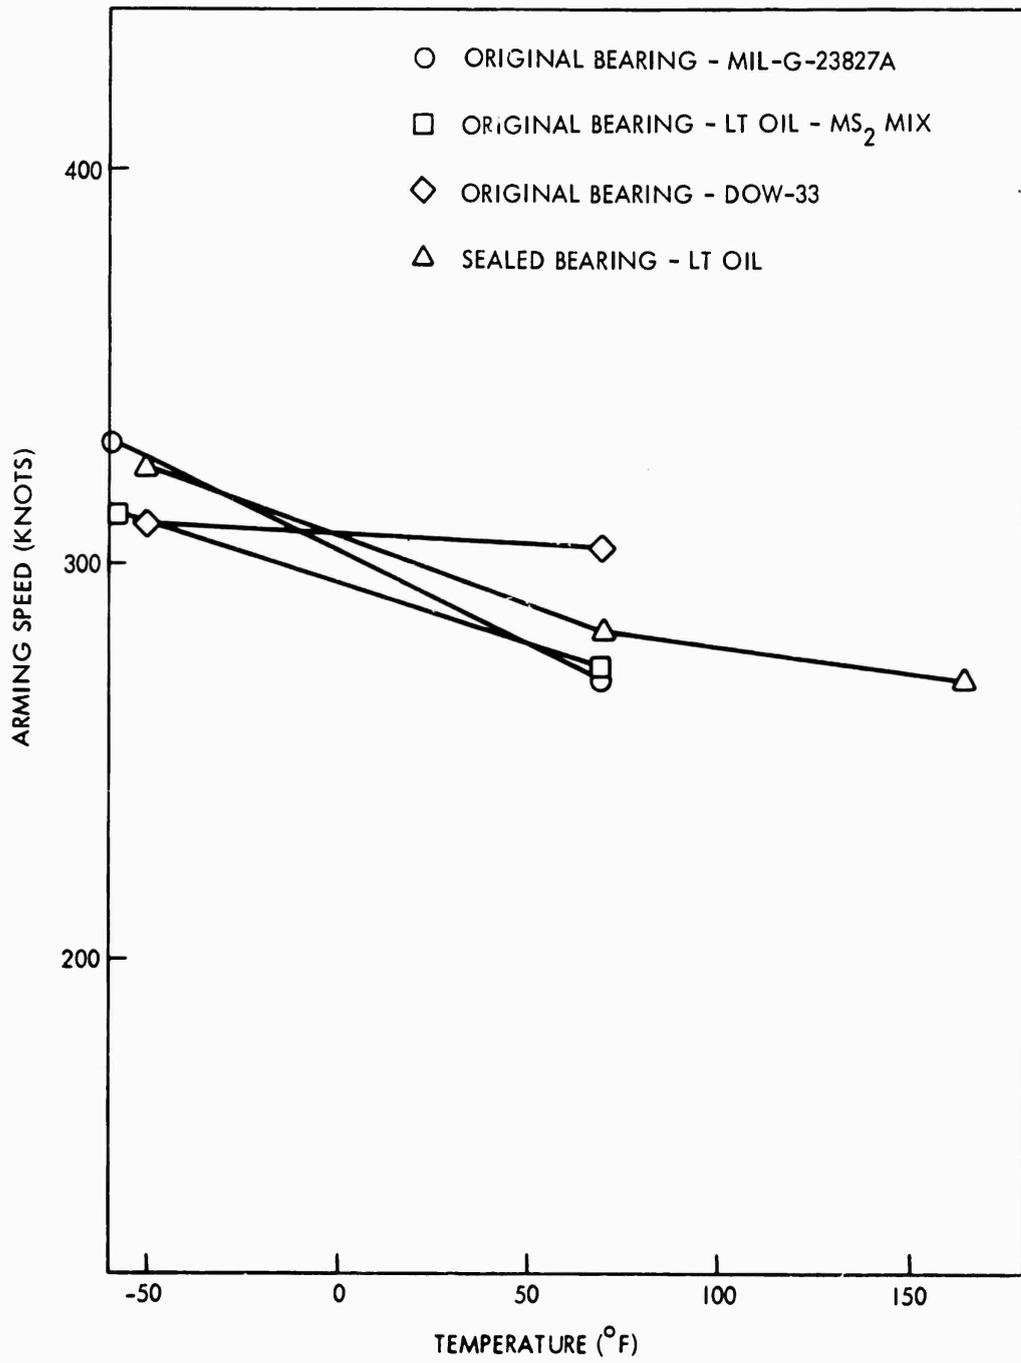
FIG. 7 EFFECT OF TEMPERATURE ON ARMING POINT OF PHASE I S&A

7. TU-1 was soaked at -65°F , and then tested at sea level wind tunnel conditions. The cold soak resulted in an increase in the arming speed of about 60 knots. This was considered to be a result of viscosity changes in the bearing lubricant. Two silicone base lubricants were tested at room temperature and -55°F . Dow-33 silicone grease showed a shift of only six knots while Dow FS-1292 shifted the arm point by 30 knots. These lubricants were tested only to determine the minimum amount of shift that could be expected. A third test was run using sealed bearings lubricated with light instrument oil. The test data showed a shift of about 50 knots between 70° and -55°F which seems to be a normal shift for most lubricants regardless of their initial viscosity. The test data for various lubricants, shown in Figure 7, indicate that temperature will change the initial arming point by about 50 knots/ 100°F . It should be noted that the silicone base lubricants have a limiting upper speed which for this unit was 15,000 rpm (about 350 knots). Beyond this point, lubricating value deteriorates rapidly, and bearing life is in jeopardy.

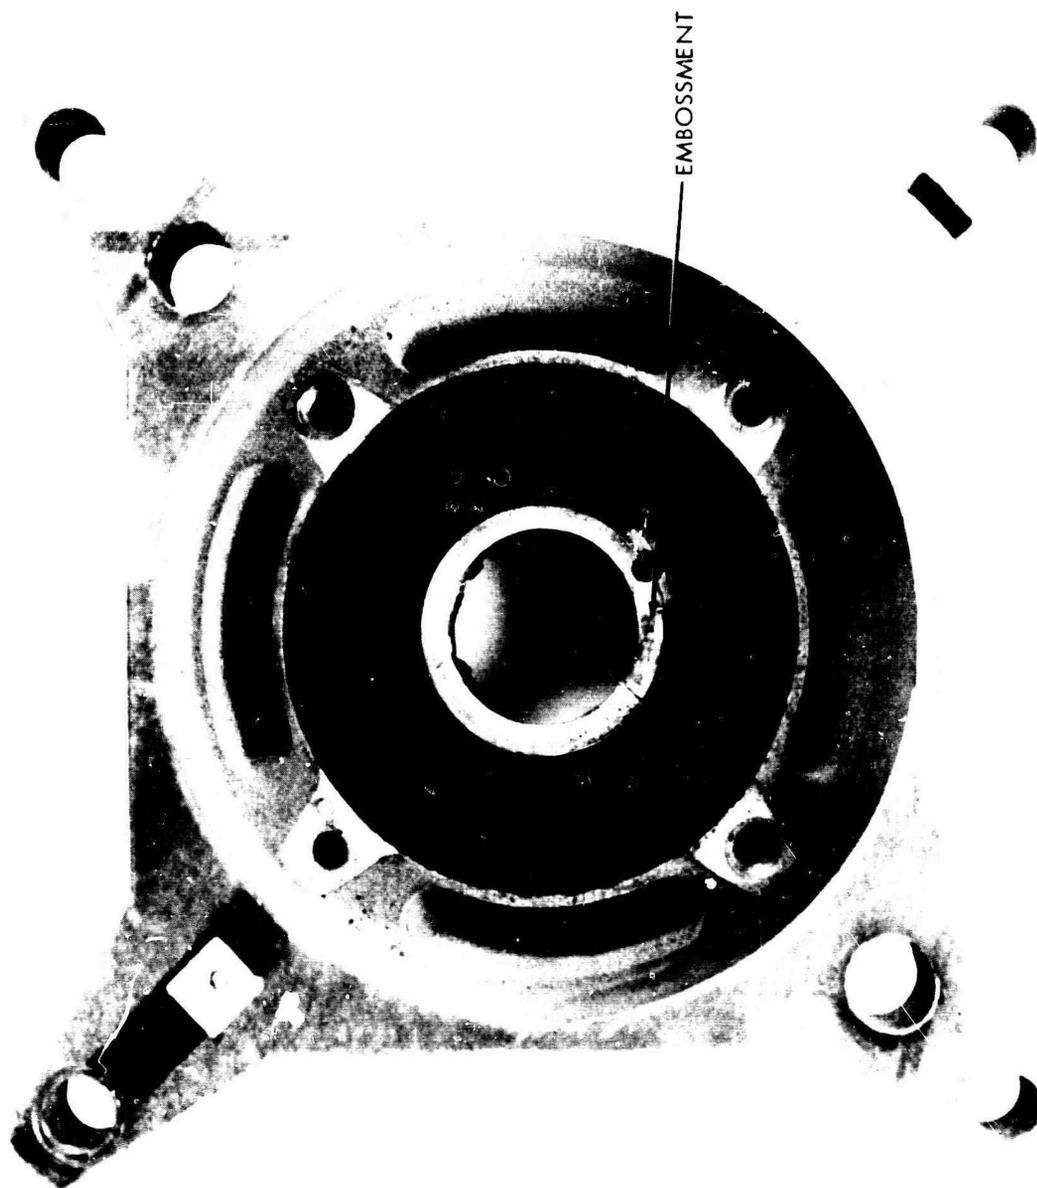
FIG. 23 VIEW OF ROTOR CAVITY SHOWING
EMBOSSMENT OF THRUST FACE

c. Embossing of the thrust face in a cast rotor housing by a counterbore in the rotor thrust face caused rough bearing surfaces which tend to hang up (see Fig. 23).

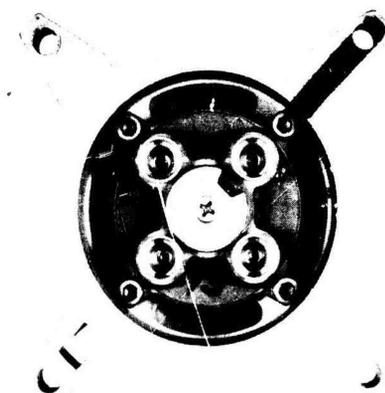
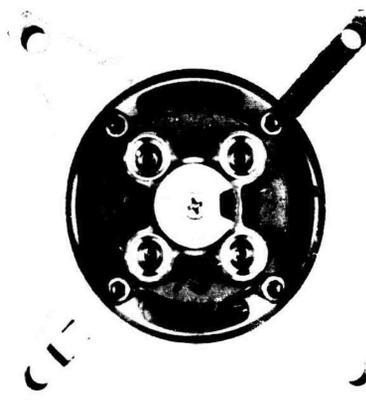
FIG. 25 S&A MODE INDICATOR

42. Figure 25 shows the S&A mode indicator. The disk rotates 45 degrees with the rotor so that the slot exposes either a red background or a green background to indicate armed or safe mode respectively. After firing a rocket, the background was found to be burned too badly to be read. The problems encountered with this indicator prompted the suggestion from NWEF, Albuquerque, New Mexico, that a safe/arm indicator be devised that could be seen from the exterior of the pod and would not be damaged by the rocket blast. However, in view of the disarm problems encountered during field tests, there was reluctance to "hanging" an indicator fix on the S&A that could decrease the available disarm-return force. It was thought that any "quick fix" would create more problems than it would solve and only a long range solution was considered practical.
