**COATINGS FOR LIGHTING PROTECTION OF  
STRUCTURAL REINFORCED PLASTICS**

**TECHNICAL REPORT AFML-TR-70-303 Pt. I**

March 1971

Air Force Materials Laboratory  
Nonmetallic Materials Division  
Air Force System Command  
Wright-Patterson Air Force Base, Ohio

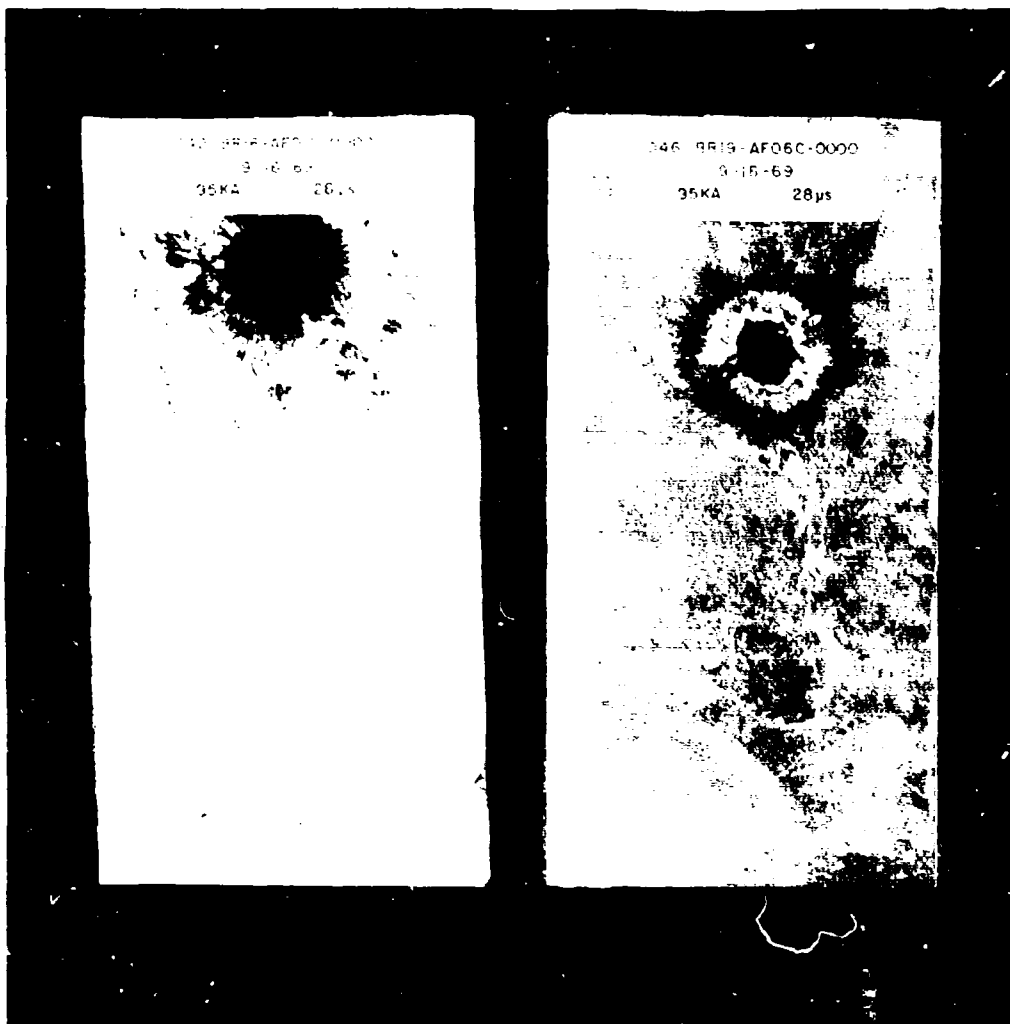
At the discharge level, i.e., 100 KA, the epoxy glass scrim cloth layer offers no additional protection to the composite. This result was also observed in the tests involving a Kapton dielectric layer between the composite and the aluminum foil. Visible damage to the Kapton film undercoat was minimal or nonexistent. The metal foil was able to dissipate the energy of these discharges and prevent current penetration into the boron or graphite fibers.

Figure 16 LIGHTNING DAMAGE TO ALUMINUM FOIL COATED BORON EPOXY COMPOSITES

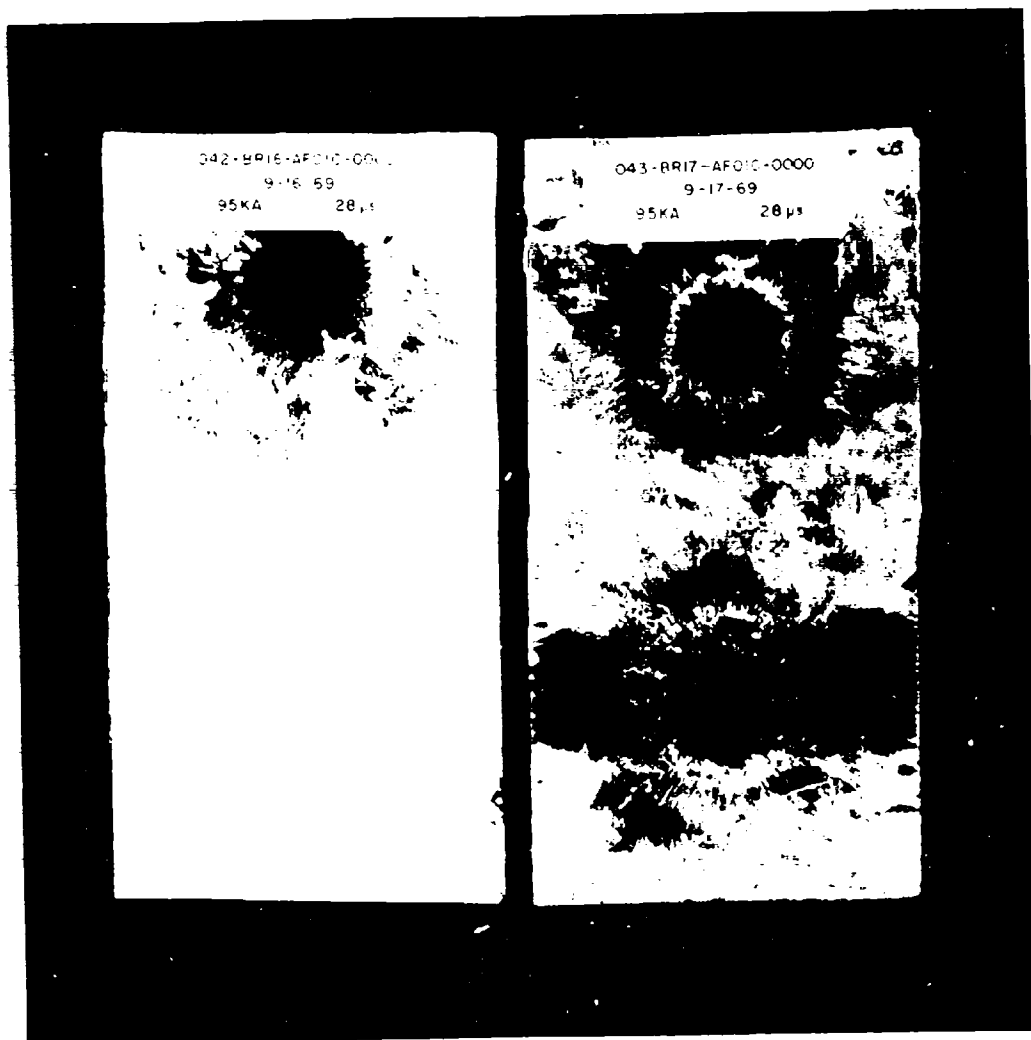
Figure 18: RESTRIKE DAMAGE TO ALUMINUM FOIL COATED BORON EPOXY LAMINATE

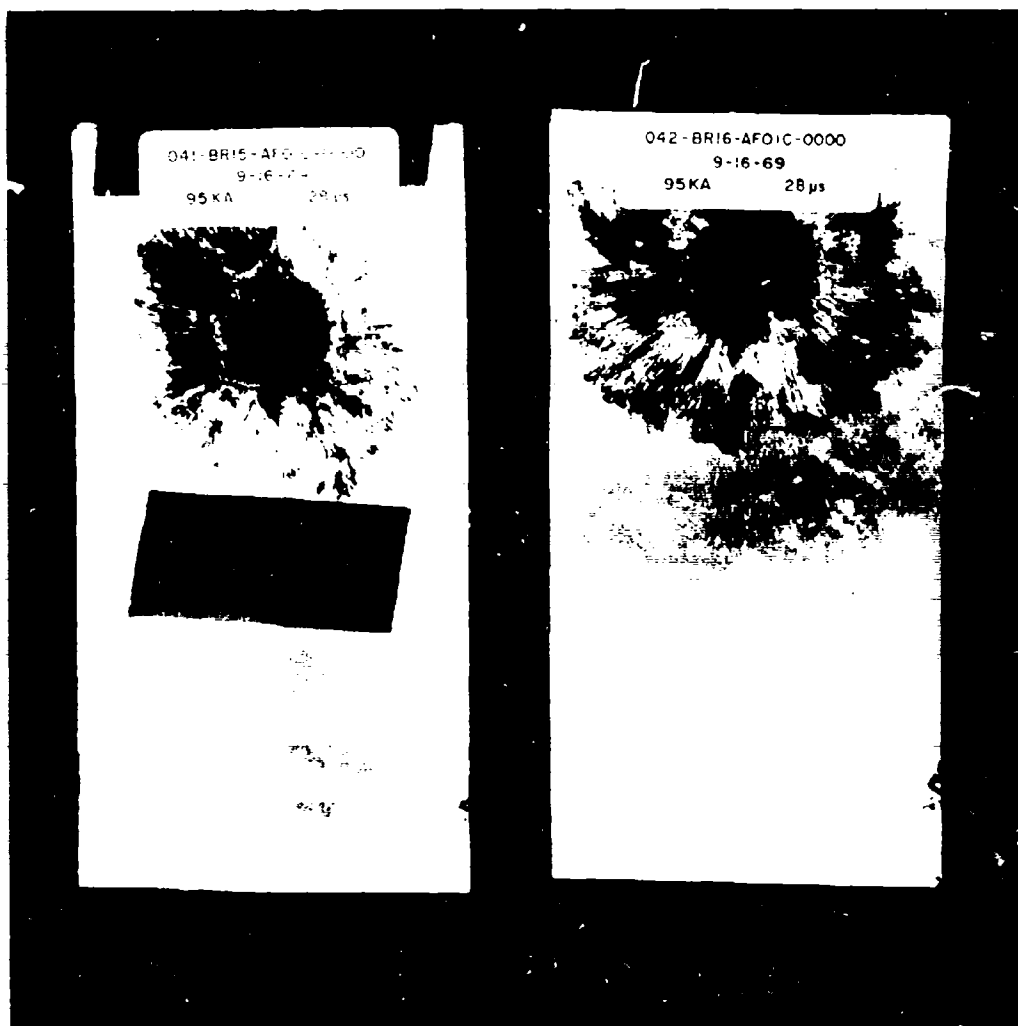
Figure 20 EFFECT OF FILAMENT ORIENTATION ON LIGHTNING DAMAGE TO FOIL COATED BORON EPOXY LAMINATES

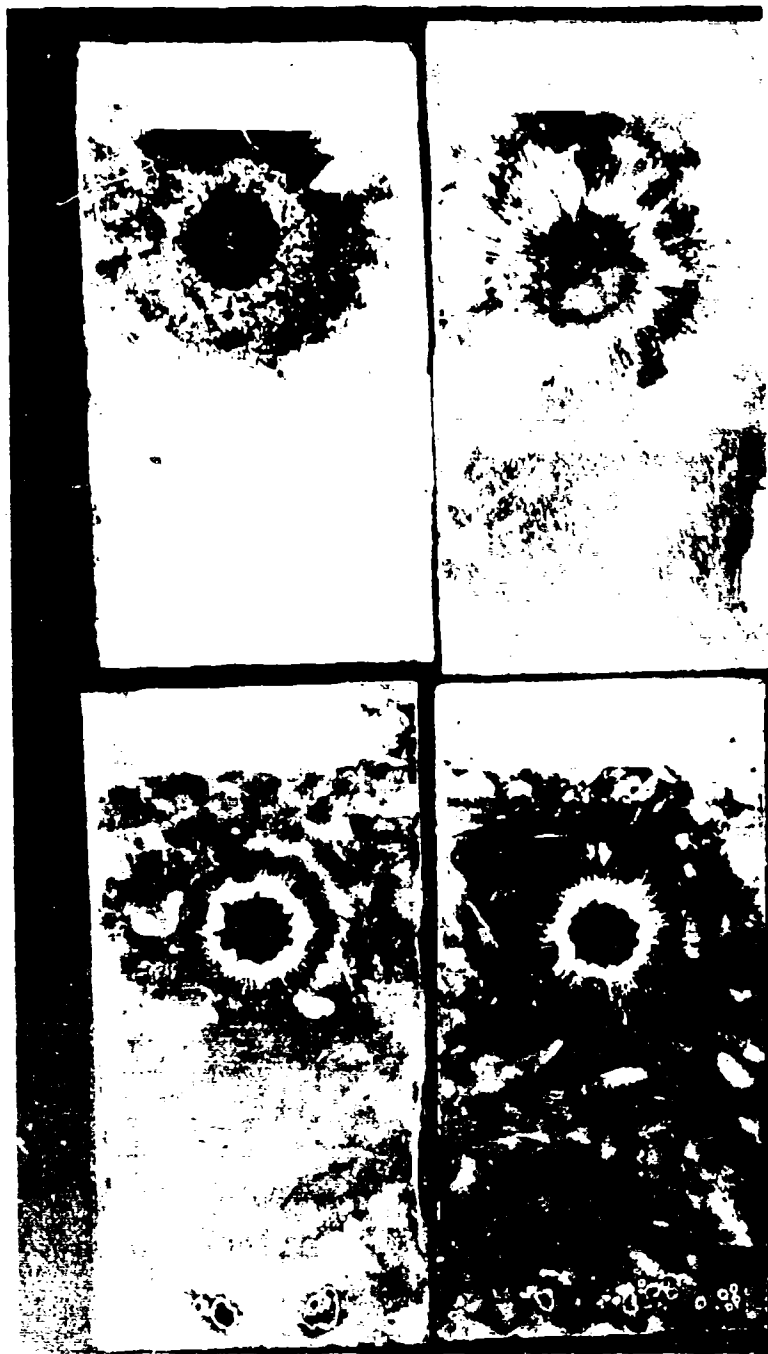
Figure 24. LIGHTNING DAMAGE TO ALUMINUM AND COPPER FOIL COATED COMPOSITES

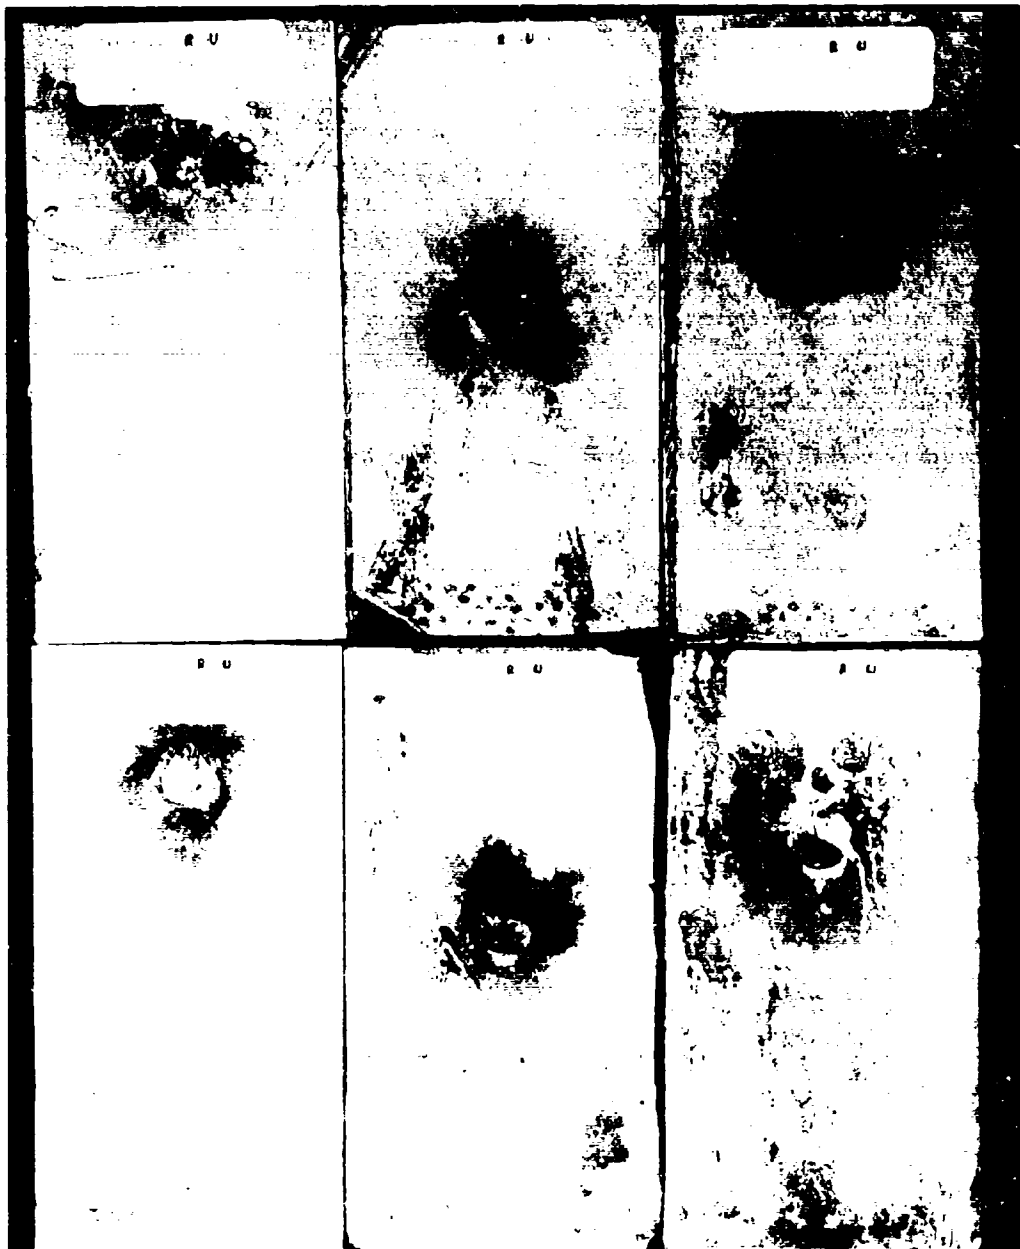
Figure 36 SIMULATED LIGHTNING DISCHARGE TO BRONZE WIRE FABRIC COATED COMPOSITES

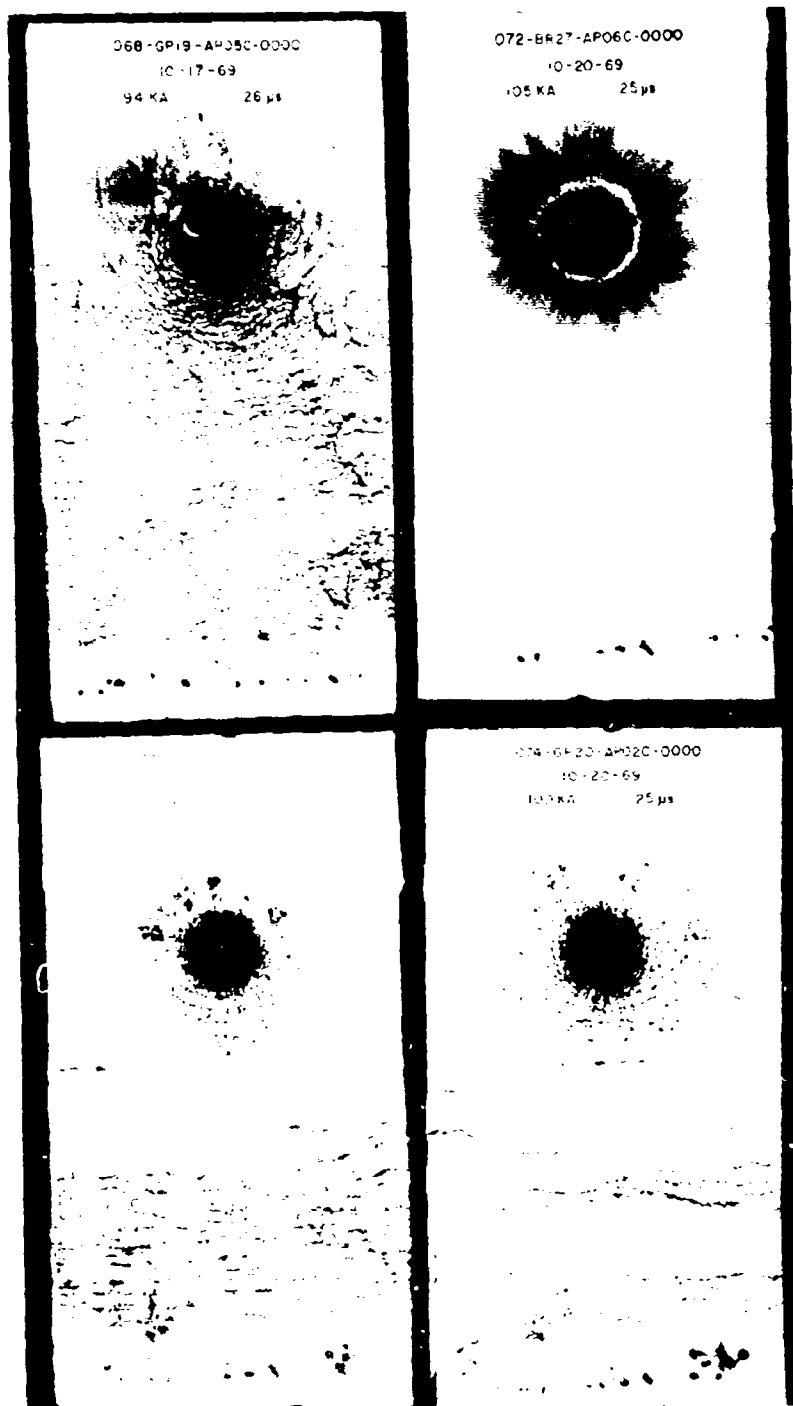
Figure 46: DAMAGE TO PLASMA-SPRAYED ALUMINUM COATED BORON EPOXY AND GRAPHITE EPOXY COMPOSITES
