**COATINGS FOR LIGHTNING PROTECTION OF
STRUCTURAL REINFORCED PLASTICS**

TECHNICAL REPORT AFML TR-70-303 PART II

Air Force Materials Laboratory
Nonmetallic Materials Division
Air Force System Command
Wright-Patterson Air Force Base, Ohio

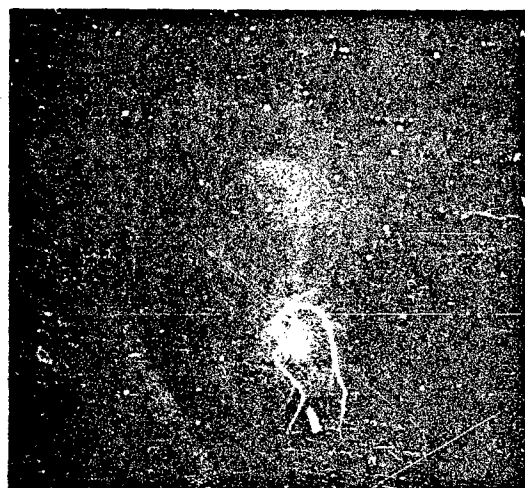
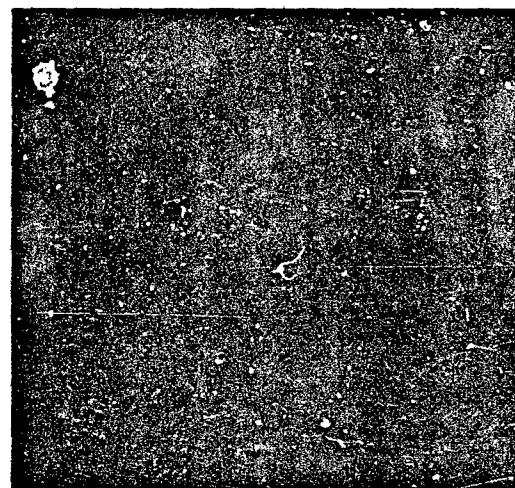
Figure 12 illustrates the maximum waveforms obtained for these panels. Figure 13 shows the streamers produced on panels with nonconductive surface coatings of nylon-fabric-impregnated epoxy (a) and Kapton film (b).

Figure 13. Streamer Discharges Produced on Panels 298 and 364

The triboelectric charging measurements indicated that it is inadvisable to use thin films of dielectric materials over conductive composites. This is especially true for areas where particle impact would be prevalent (nose radomes, leading edges, etc.). Streamers across dielectric films are not only a possible source of radio interference, but also puncture the film allowing possible coating degradation.

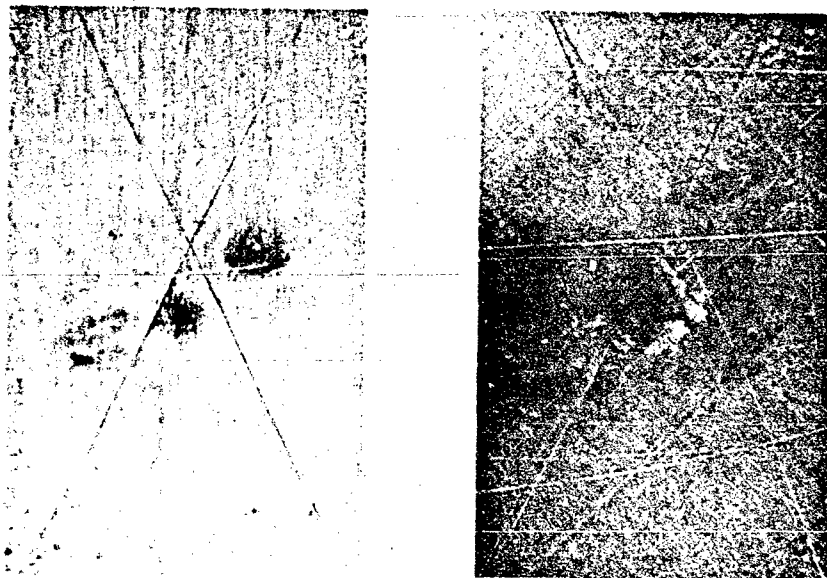
Aluminized glass filaments provide excellent high-current protection for boron-filament-reinforced plastics. Coating area weights of 0.040 lb/sq ft (including resin) are easily prepared and handled. This coating is less satisfactory for graphite-fiber-reinforced plastics since a heavier (0.080 lb/sq ft) coating weight appears to be required. Corrosion may be a problem with this aluminum-carbon galvanic couple since panels exposed to a 3% salt spray for 30 days underwent severe corrosion especially about the edges. Coatings applied to boron-fiber-reinforced laminates did not undergo corrosion when exposed to similar conditions. These differences are illustrated in Figure 24.

Figure 24. Aluminized, Glass-Coated, Graphite-Epoxy (left) and Boron-Epoxy (right) Laminates After Exposure to 3% Salt Spray for 30 Days; Graphite-Epoxy Laminate Displays Coating Corrosion

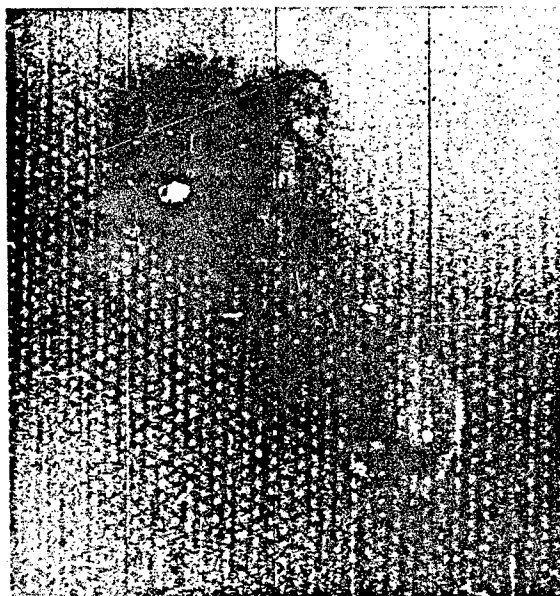
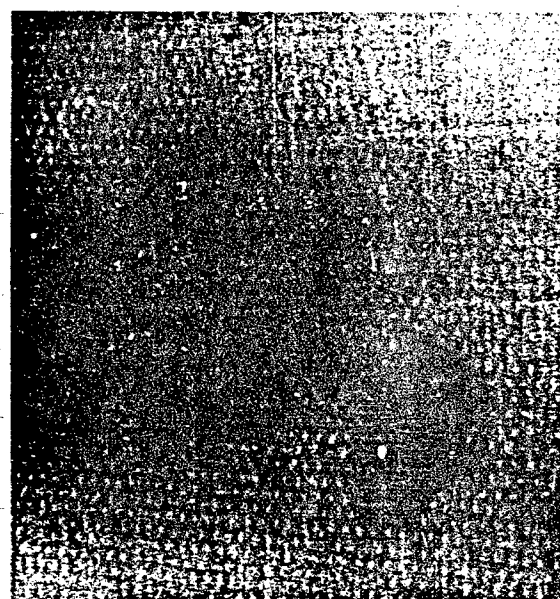
Figure 29. Backside Damage to Panels BR 14 (Left) and BR 14C (Right)

Backside damage to these panels is shown in Figure 29. It can be seen that the hot-spot zones were considerably larger than the holes. Additionally, the repeated testing of the laminates appeared to enhance the damage in the already weakened areas.
