RESISTANCE OF DIFFUSION-BONDED ELECTROLESS NICKEL-  
PLATED Ti-5Al-2.5Sn ALLOY TO HOT SALT STRESS CORROSION  
CRACKING

AMMRC TR 75-26

December 1975

**ARMY MATERIALS AND MECHANICS RESEARCH CENTER**  
Watertown, Massachusetts 02172

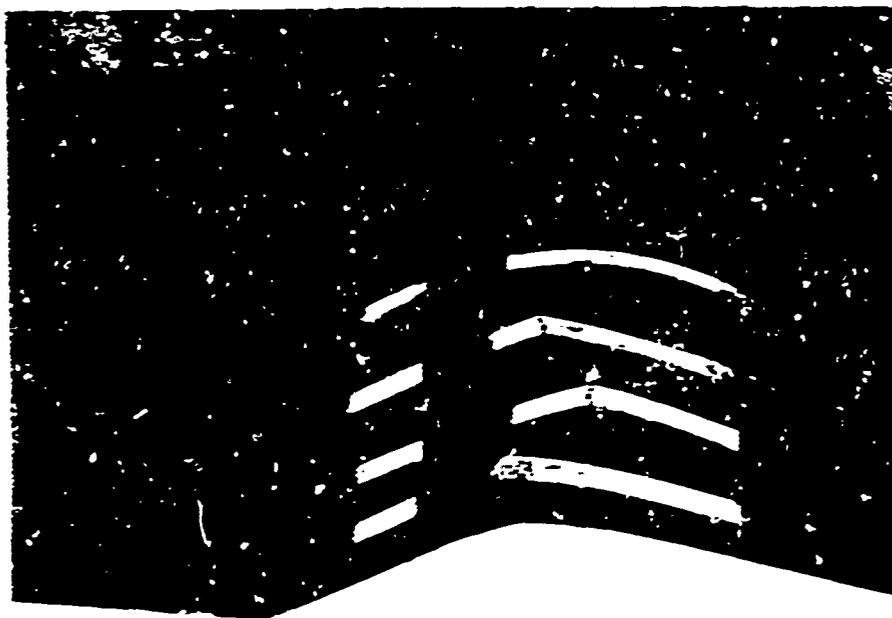
Figure 5. Plated and nonplated specimens in test fixture after heating at 900 F for 100 hours.

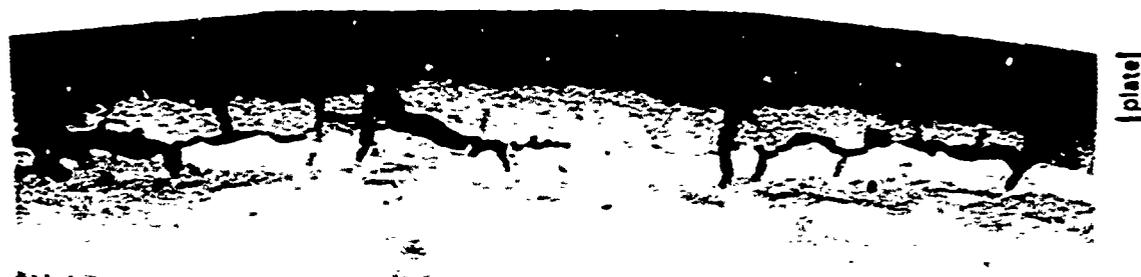
Despite the existence of stress raisers at the base of the corrosion troughs, the inward intrusion of corrosive activity was generally arrested at the substrate level. Figure 13 shows a representative damaged cross-section of the electroless nickel plate of specimen N5 after exposure at 960 F for 1000 hours. Apparently, the combination of temperature, corrosive media, and stress in the segments shown were not sufficient to initiate or propagate into the substrate. Although delamination also occurred between diffusion layers of the nickel plate, the base of the diffusion-bonded plate remained firmly attached to the titanium substrate.

Figure 13. 1000-hour test at 960 F - cross-section of salt-treated electroless nickel plate, specimen N5, showing troughs and delaminations. Mag. 1000X

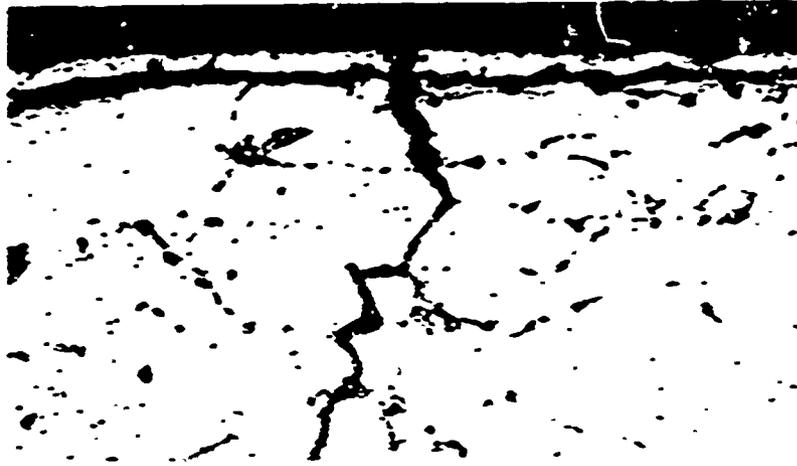
One significant characteristic of the surface cracks in the electroless nickel plating was their continuity into the titanium substrate. Figure 14 shows a cross-section of such a crack. The primary cause of crack initiation in the plated surface was not identified, but embrittlement may be a source. A crack in the plating combined with other reactions, may then encourage the diffusion of harmful chemical species to the substrate forming a crevice where surface embrittlement and cracking of the titanium surface commences to occur. Yet, it is generally recognized that the presence of cracks or stress raisers alone have only a minimal effect on hot salt stress cracking to the extent that precracked test specimens are not useful in these HSSCC experiments. Also, as described earlier, the existence of scratches and indentations in the surface of the plating did not enhance stress corrosion of the exposed areas. Moreover, the pits, troughs, and mechanically induced indentations and scratches did not appear to act as preferential sites for crack initiations.

Figure 14. Cross-section of crack through electroless nickel plate layer and Ti-5Al-2.5Sn substrate, specimen E5. Mag. 1000X

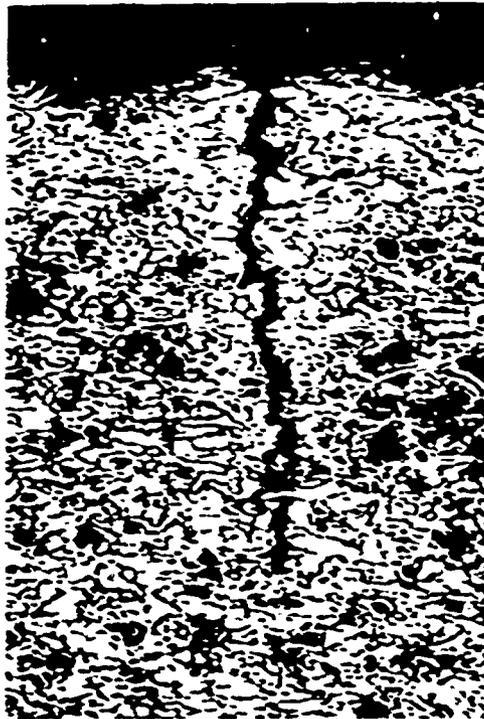
A representative corrosion crack penetration into the titanium alloy substrate is shown in Figure 15. Propagation of this type of crack has been attributed by Garfinkle<sup>11</sup> to the reaction of titanium with chlorine ions to form a chlorotitanate which hydrolyzes with H<sub>2</sub>O to release chlorine ions and TiO<sub>2</sub> along with nascent hydrogen (H<sup>+</sup>) which serves as the source of embrittlement in anodic regions such as grain boundaries:

Figure 15. Cross-section view of SC crack penetrating into titanium substrate, specimen E5. Mag. 200X
