TECHNICAL REPORT HL-79-20

MODEL STUDY OF HARRY S. TRUMAN SPILLWAY, OSAGE RIVER, MISSOURI

Hydraulic Model Investigation

November 1979

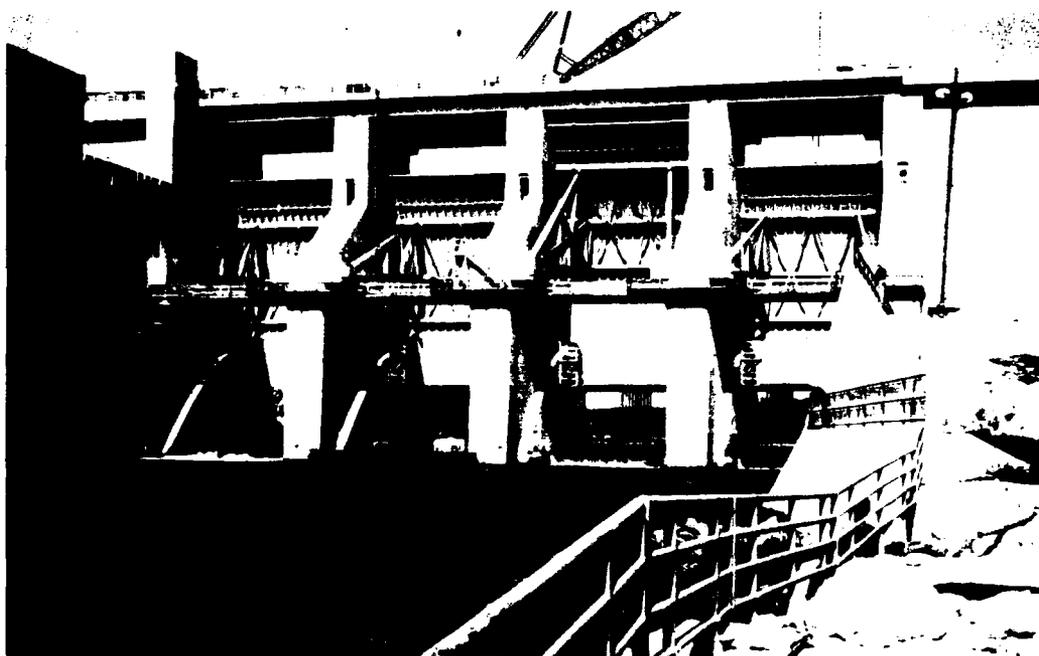
Figure 2. The prototype with spillway completed to el 660.0

4. The four-bay spillway was constructed to el 660.0 (Figure 2, Plate 2) when the last cofferdam of the earth fill was placed to seal

5. A fish kill was experienced during the spring of 1978 downstream of the partially completed spillway. The cause of the fish kill was attributed to gas embolism due to excessive supersaturation of total dissolved gases in the water downstream of the dam. Flow passing the partially completed spillway (constructed to el 660.0, Figure 3 and Plate 2) became aerated and then plunged to the bottom of the stilling basin. The relatively deep tailwater of approximately 45 ft induced pressures of about 1.3 atmospheres. This pressure forced the air into solution and yielded dissolved gas concentrations equal to about 125 to 130 percent of the saturated level at the surface of the water. These levels were excessive during a period when certain fish were spawning in near surface waters.

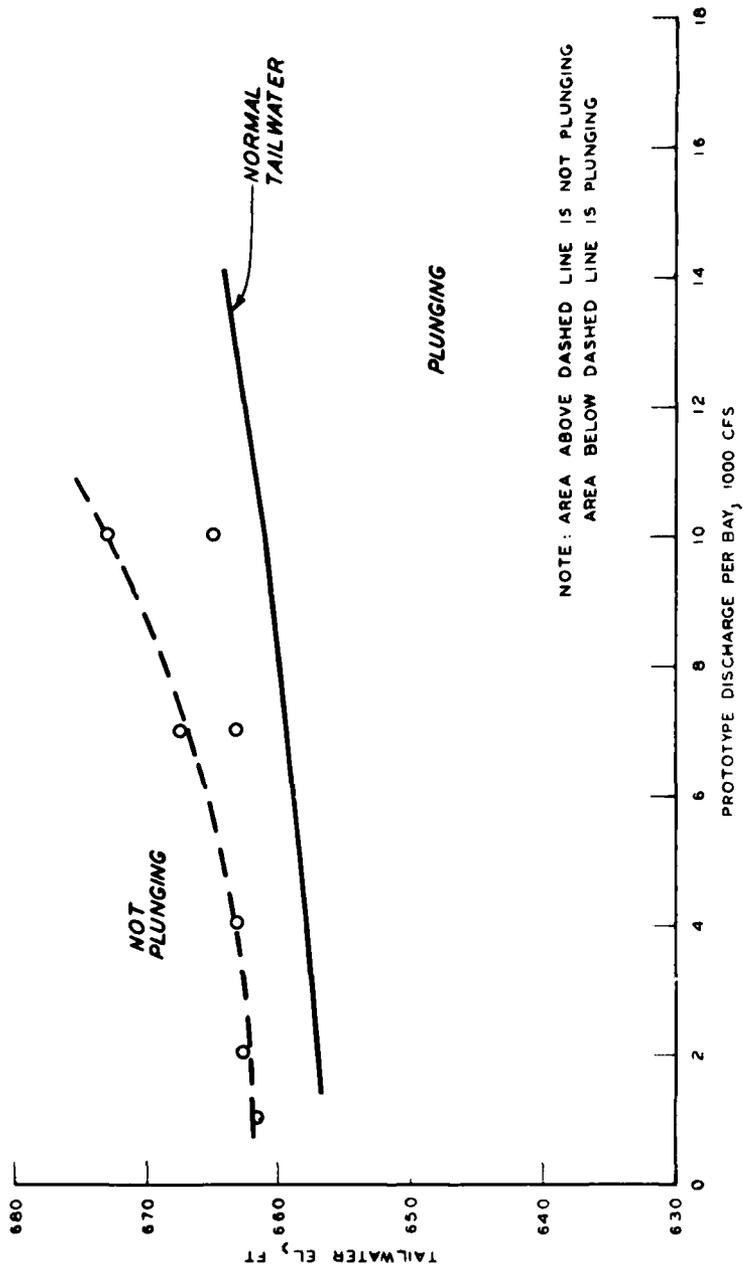
ORIGINAL DESIGN-SPILLWAY INVERT
COMPLETED TO EL 660.0

11. Initial tests were conducted with the spillway crest partially completed to el 660.0 as shown in Plate 2. Flow passing over the spillway plunged through the tailwater to the stilling basin apron for all discharges with normal tailwater elevations as was experienced in the prototype (Photos 1a-8a). As the tailwater was raised for each of the various discharges, there was an elevation at which flow began to ride the surface. A plot showing this tailwater elevation for various discharges up to 10,000 cfs per bay is shown in Plate 7.
