AMMRC MOBILE ACCELERATOR NEUTRON RADIOGRAPHY SYSTEM
OPERATIONS AT U.S. ARMY YUMA PROVING GROUND

Interim Technical Report
Report No. 3-41000/4R-110

15 April 1984

LTV AEROSPACE AND DEFENSE COMPANY
Vought Missiles and Advanced Programs Division
P.O. Box 225907
Dallas, Texas 75265

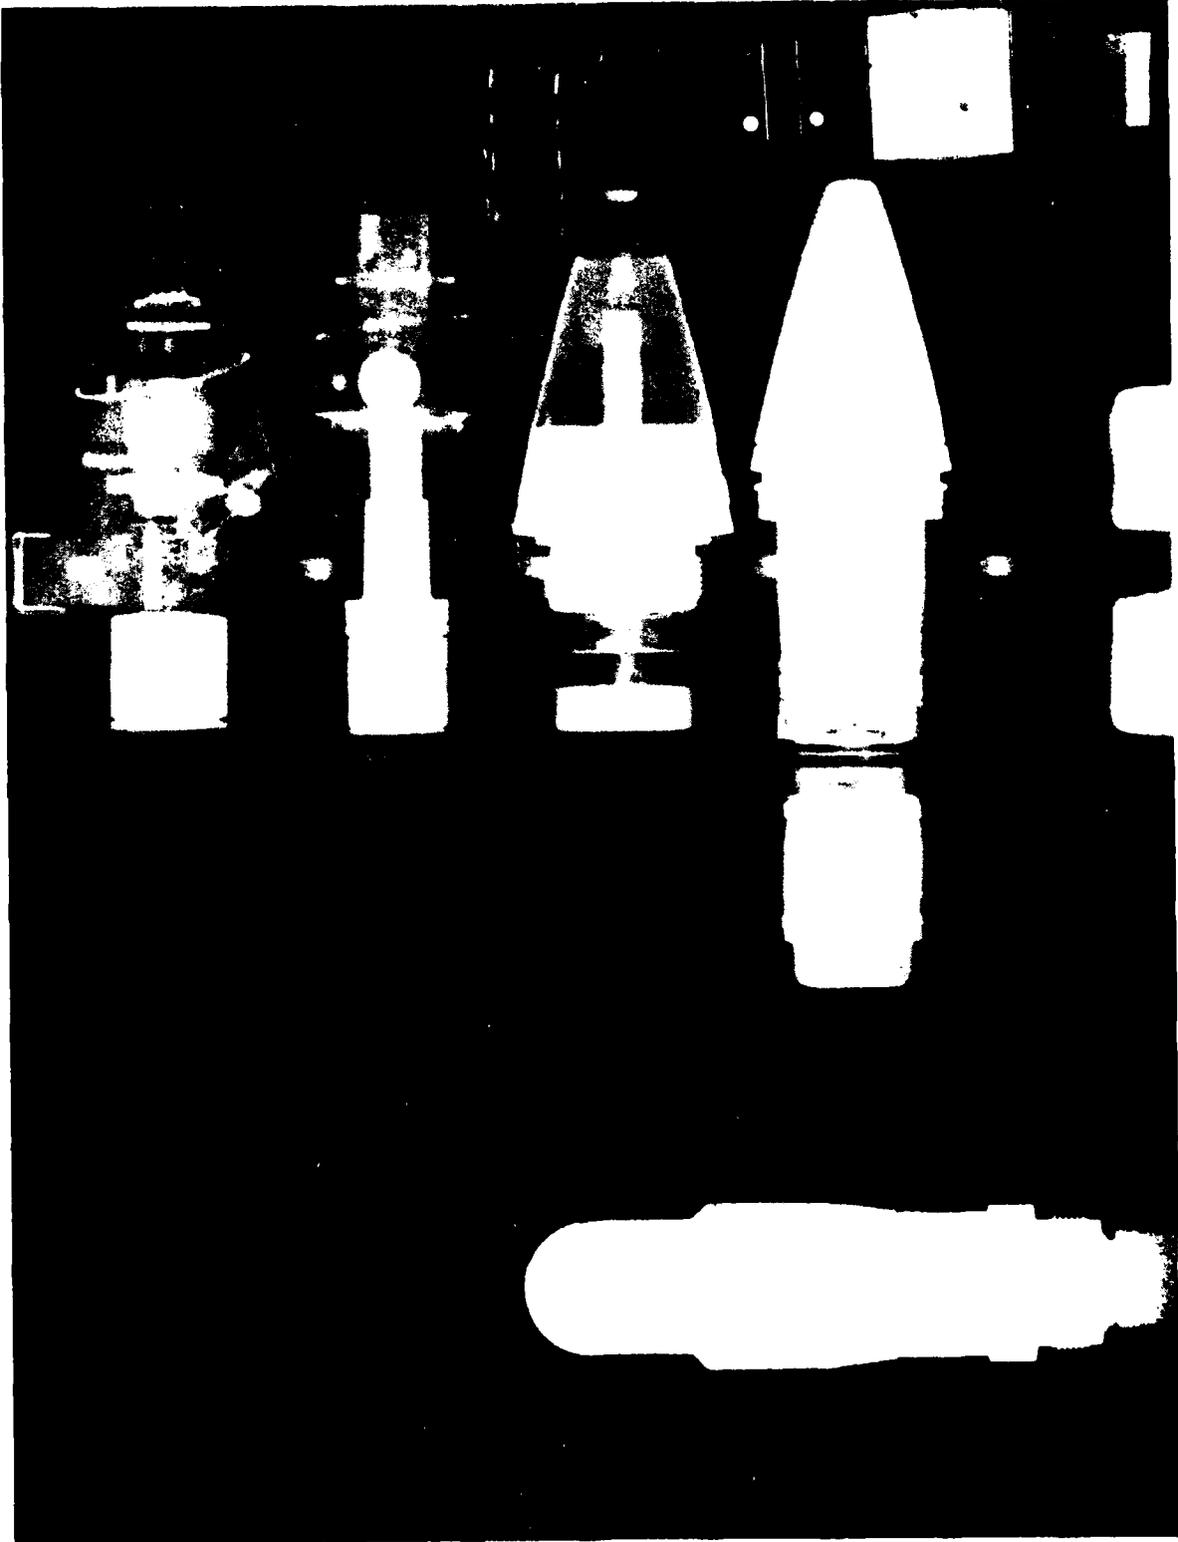
Figure 10N. Neutron Radiograph of M524 Fuze (Top, Right), M567 Fuze (2nd from top on right), M557 Fuze (3rd from top, right), M728 Proximity Fuze (Bottom, right), M432 Rocket Fuze (Bottom, left)

The neutron radiograph (Figure 10N) on the other hand, clearly images, reading from right to left on the M524 fuze (which is the first device beginning at top right in the radiograph), the primer, the M63 detonator, the M2 delay element, the detonator lead charge, the M80 detonator, the booster lead charge and booster assembly. On the M567 fuze (second from top, on right) the metal parts and arming mechanism are not imaged well with neutrons, as would be expected; however, the auxiliary booster assembly, the O-Ring, and booster charge and felt pad are clearly imaged. The M557 fuze, (third from top, on right) had a high attenuation for thermal neutrons throughout the fuze body, and hence details within the body are not imaged. However, the booster charge at the base of the fuze is clearly imaged. The other two devices, the M728 fuze and M432 rocket fuze, do not lend themselves to inspection by thermal neutrons because of the synthetic materials used in the windshield, the plastic material encasing the electronics in the nose cones, and the cadmium plating over most of the metal casing. Exposure parameters used in this neutron radiograph were: Film Kodak SB; converter-Lanex Fine; L/D = 36; Exposure-80 minutes (20 to 30 min. with normal output).

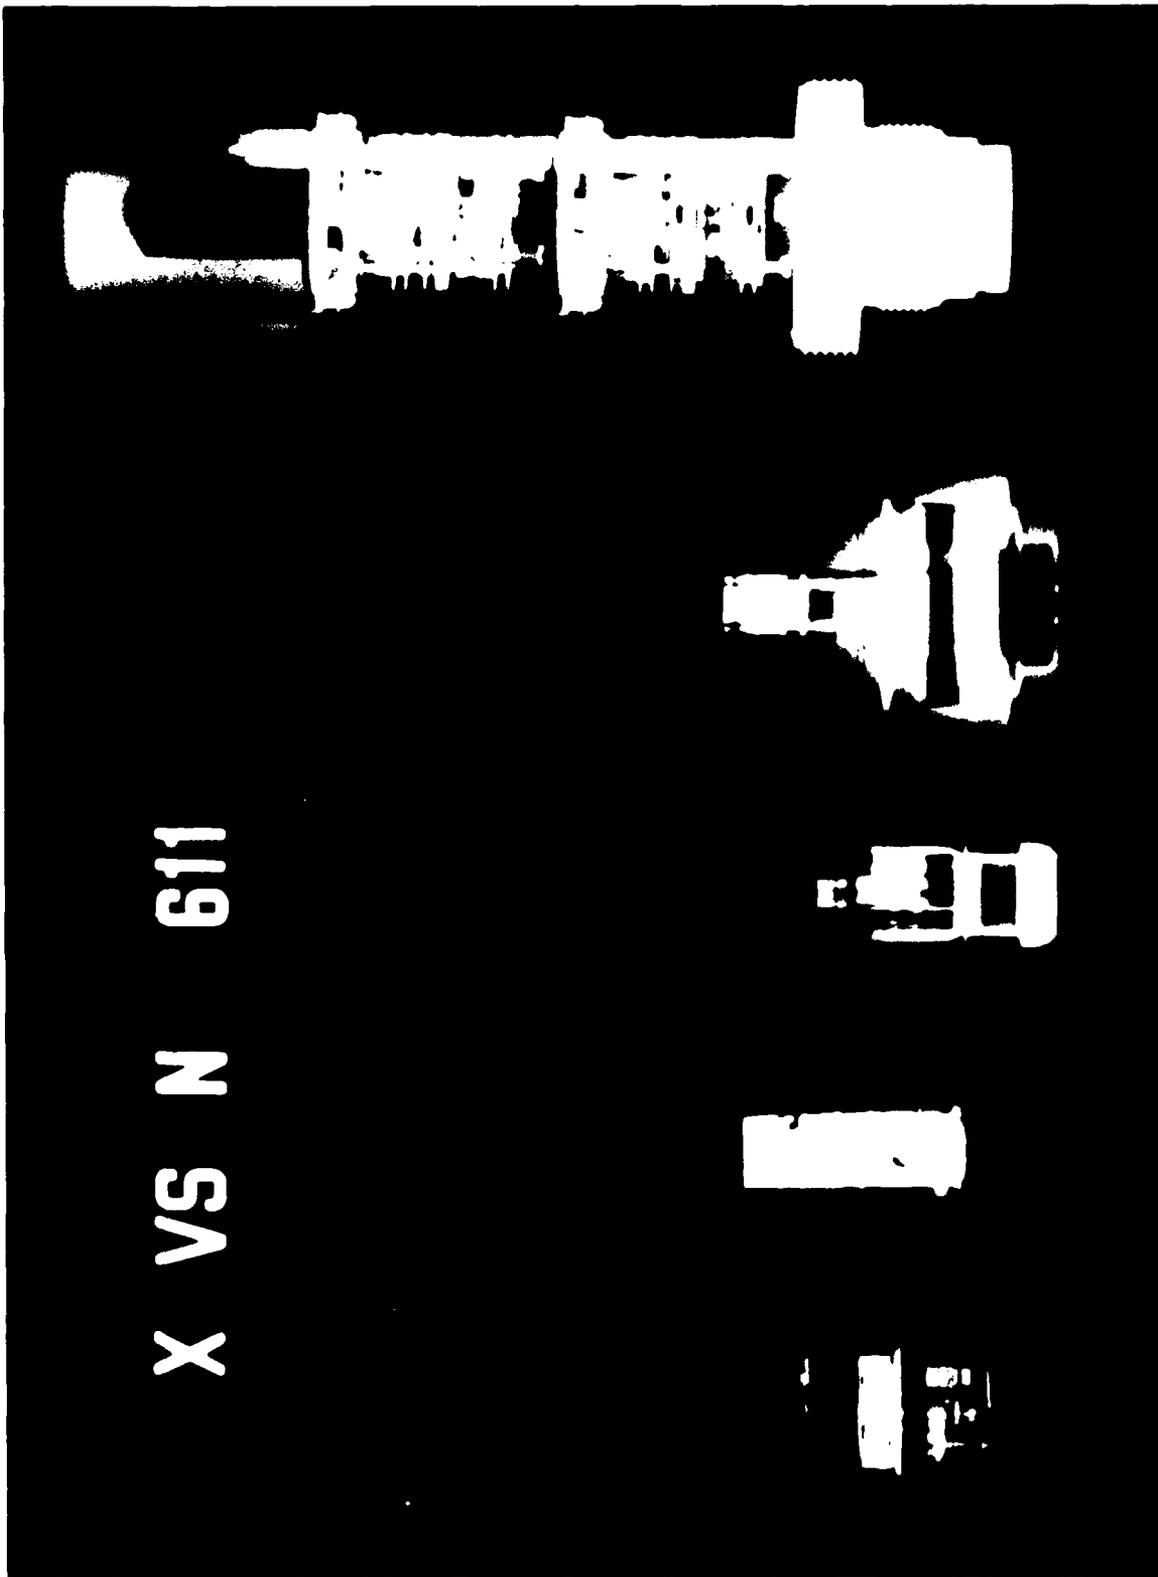
Figure 11X. X-Ray Radiograph of (Left to right) M734 Fuze, M567 Fuze, 2.75 Rocket Fuze, M84 Fuze, and a Special Three-Fuze Assembly

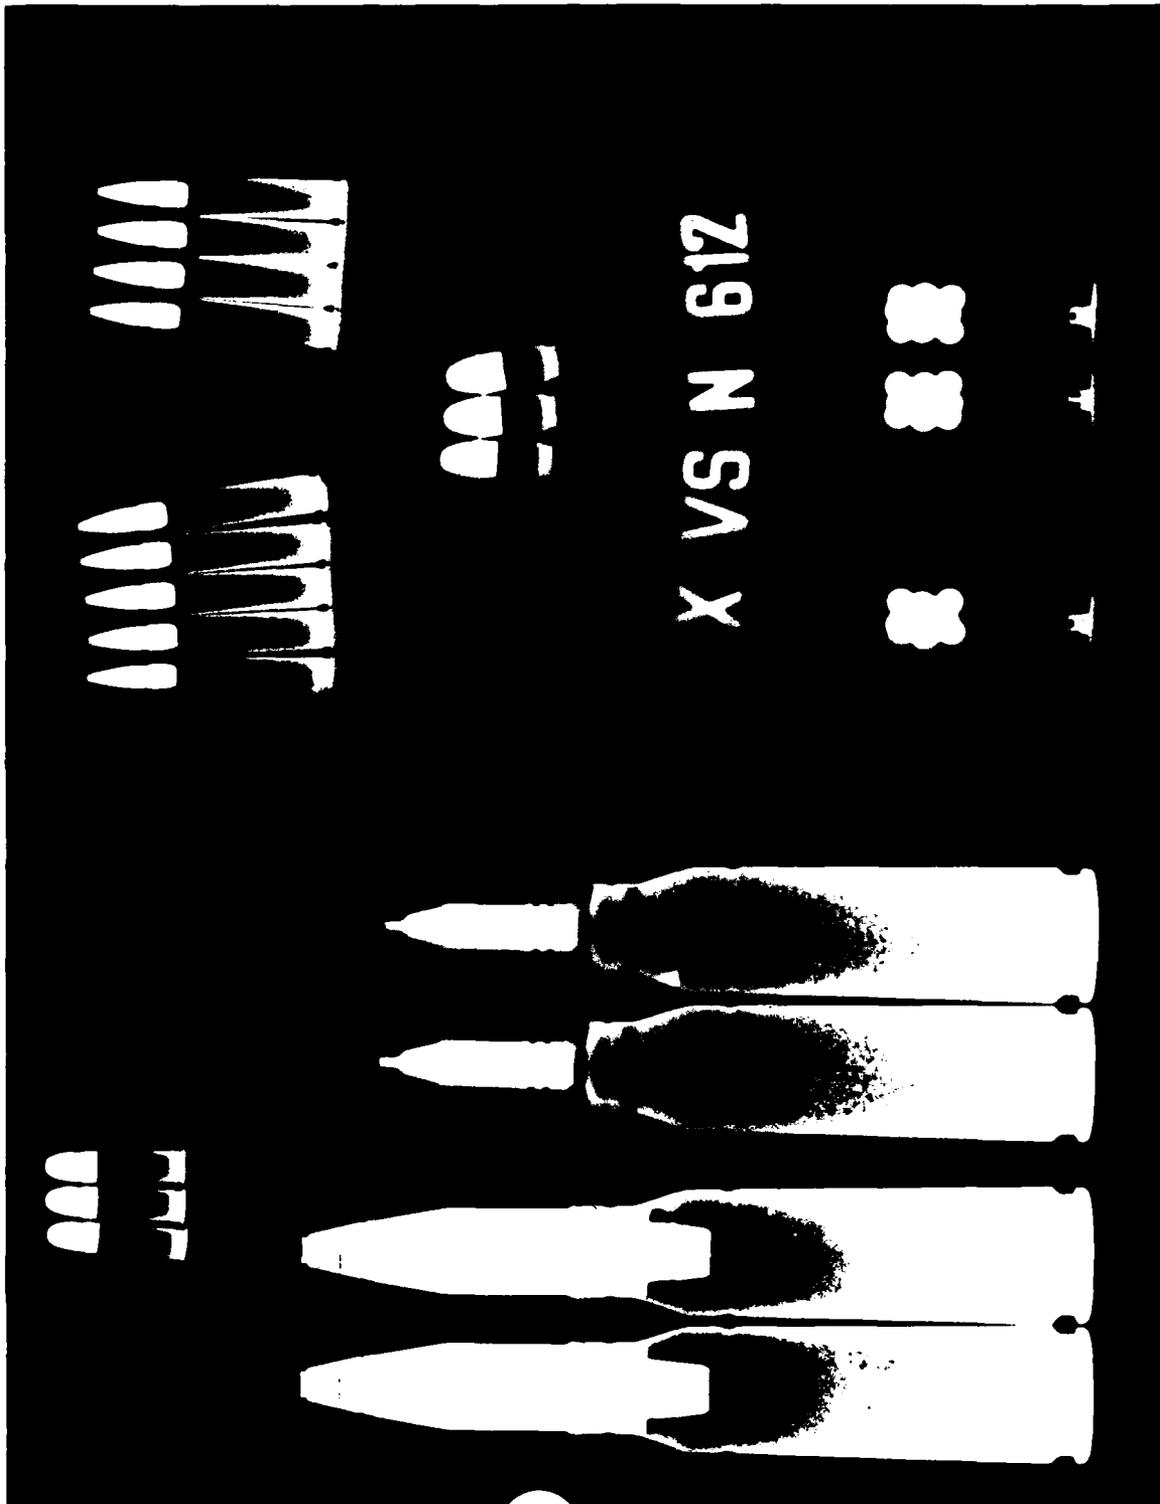
The X-ray images the fuzes in the 30 mm APDS-T projectiles but shows little definition of the case charges, the projectile body charges, and the fuze detonators. In the 25 mm 792 projectiles the X-ray images the projectile body and provides a good image of the case charge except at the lower end of the case, where the firing pin/detonator, which also is not imaged, is located. The X-ray image of the 12-gauge shells show good definition of the cartridge base and minimal detail in the shell area. Similarly, the other small ammunition show little or no definition of the case charges.

Figure 12X. X-Ray Radiograph, Reading from left to right, bottom, 30 mm APDS-T Projectiles (2 ea); 25 mm 792 Projectiles (2 ea), 12-Gauge Shotgun Shells (3 ea); from left to right top, 38 Caliber Specials (3 ea) and 7.62 Tracer Ammunition (5 ea and 4 ea)

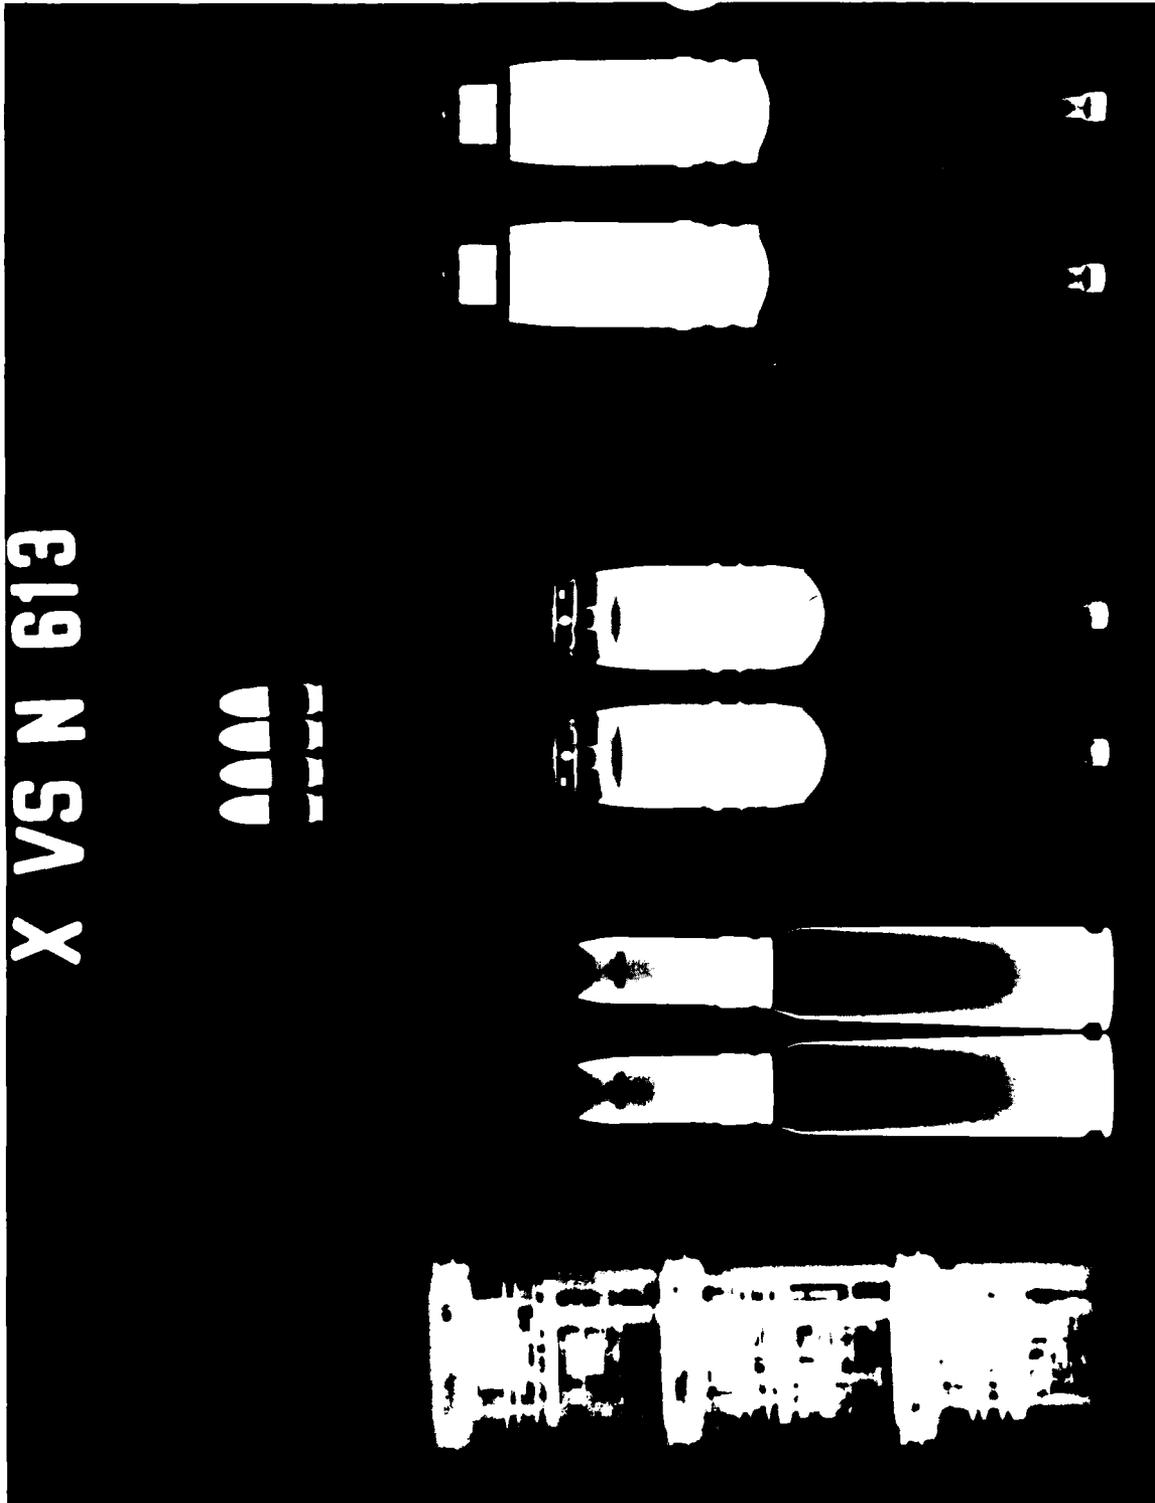
In the three element fuze assembly the X-ray, Figure 13X shows good detail of the metal parts and S&A device but no image of the detonators. The X-ray image of the 20 mm M56A4 HEI projectile shows some detail of both the case charge and the HE body charge. The 30 mm M552 projectile with XM579E2 fuze and 25 mm HEI-T, XM792 w/PD M71435 fuze images show fair definition of the case charge flash element, good body definition and good definition of fuze metal parts but no image of fuze detonators and very little case charge definition. Likewise, the X-ray images show no image of the case charge in the 9 mm projectile shells.

Figure 13X. X-Ray Radiograph, Left to Right, of Three-Element Fuze Assembly, 20 mm M56A4 HEI Projectile (2 ea), 30 mm M552 Projectile with XM579E2 Fuze (2 ea), 25 mm HEI-T XM 792 Projectile with a PDM714E5 Fuze, Top Center: 9 mm Ball Projectile (4 ea)

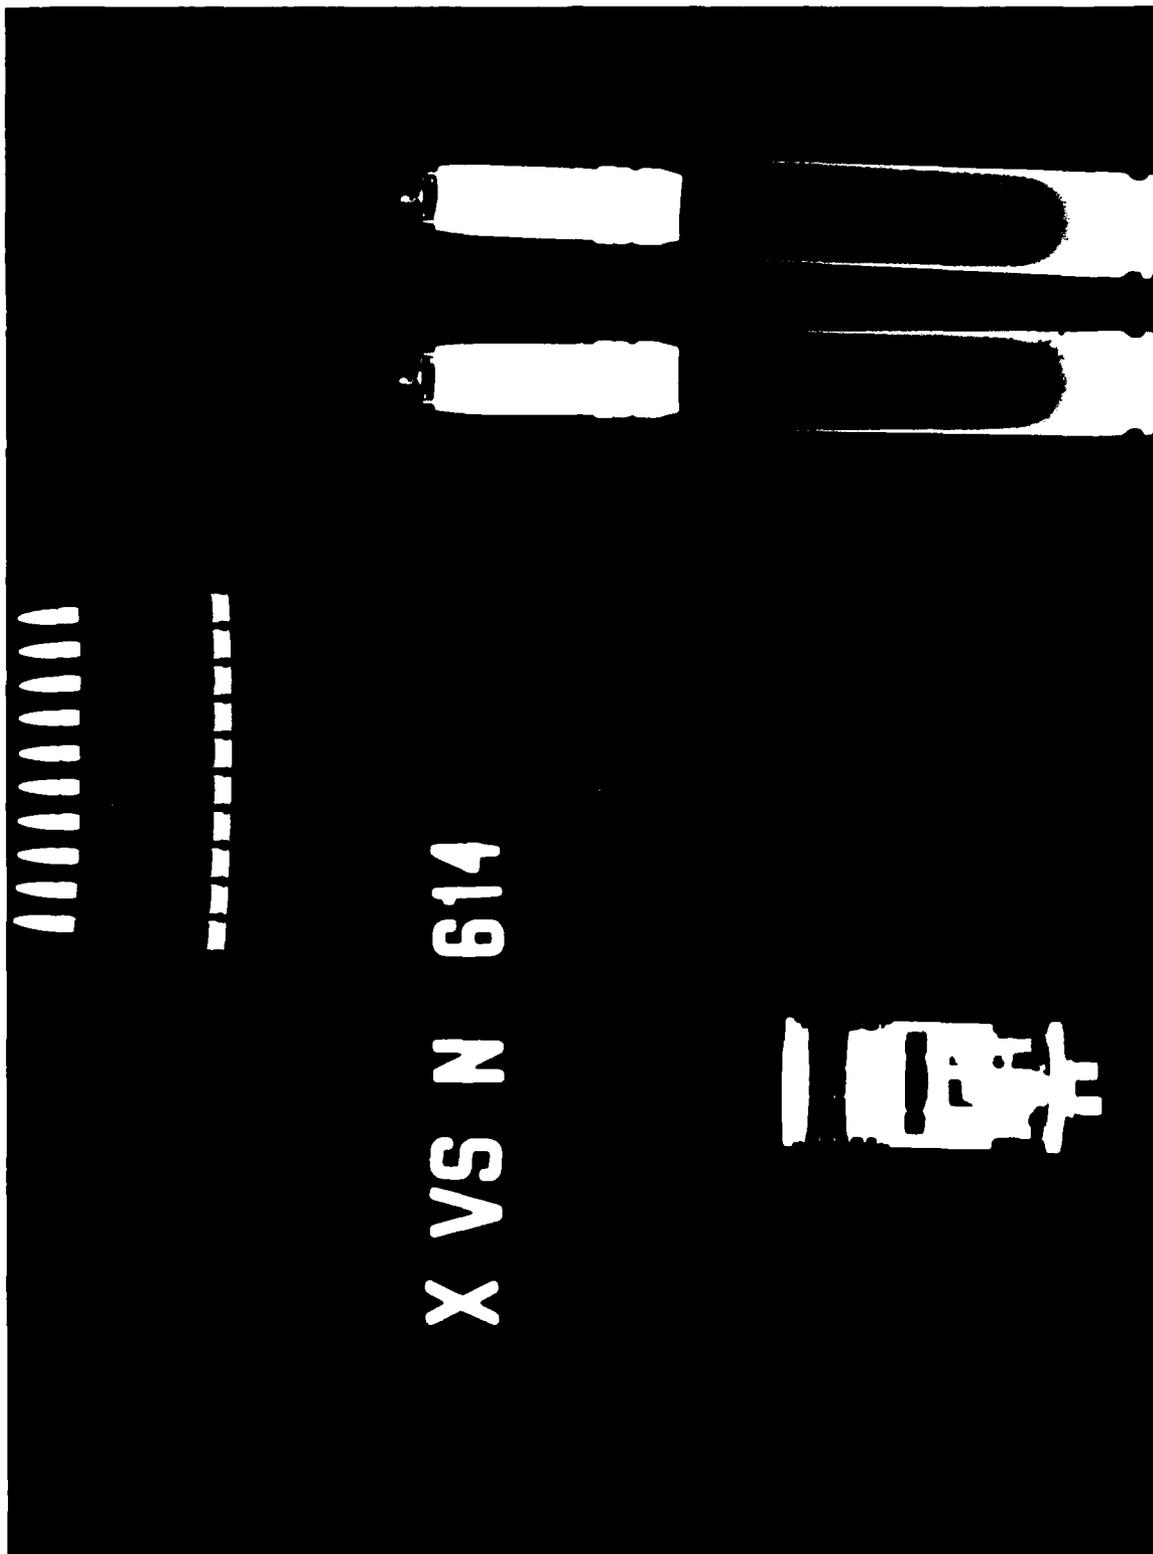
Figure 14X. X-Ray Radiograph of, Left to Right, 2.75 Rocket Fuze, 20 mm XM 599 Projectile (2 ea), and, at top, 7.62 mm Projectile (10 ea)

On the X-ray, Figure 14X, in addition to the usually good definition of the metal parts and S&A device, it is seen that two fuze detonators below the fuze base ring of the 2.75 rocket fuze also are imaged. On the 20 mm XM 599 the X-ray does not image the case detonator. The projectile body and metal fuze parts show the usual good definition, and the usual lack of good definition of the case charge is apparent. The 7.62 projectile image shows only the case and shell projectile body.
