SOILING, CLEANING, AND WEATHERING EFFECTS ON AIRCRAFT POLYURETHANE TOPCOATS

Donald J. Hirst and Charles R. Hegedus

Air Vehicle and Crew Systems Technology Directorate
Naval Air Development Center
Warminster, PA 18974-5000

PHASE REPORT
PROJECT NO. R534A52
WORK UNIT ZM 540

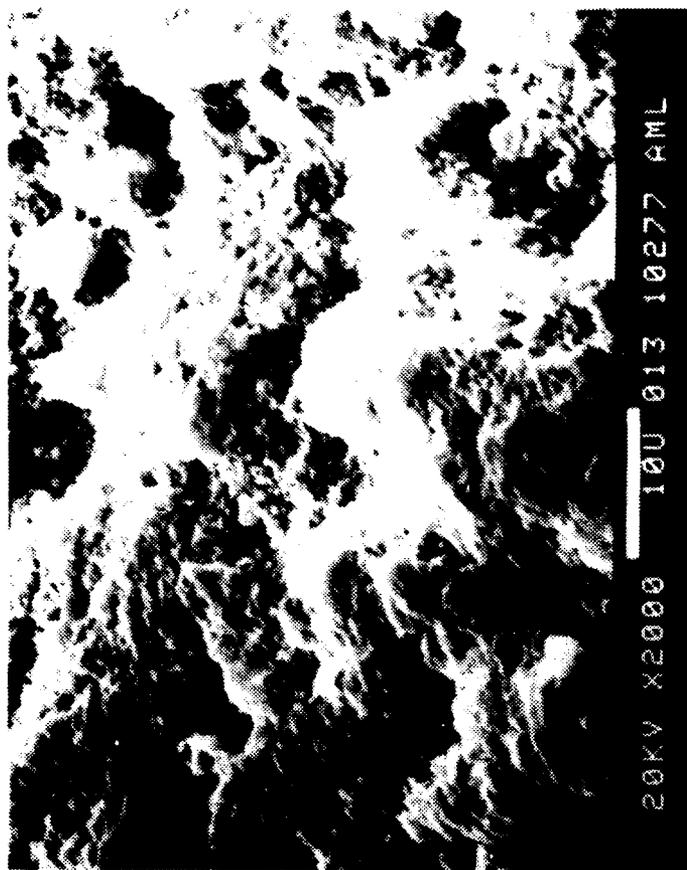
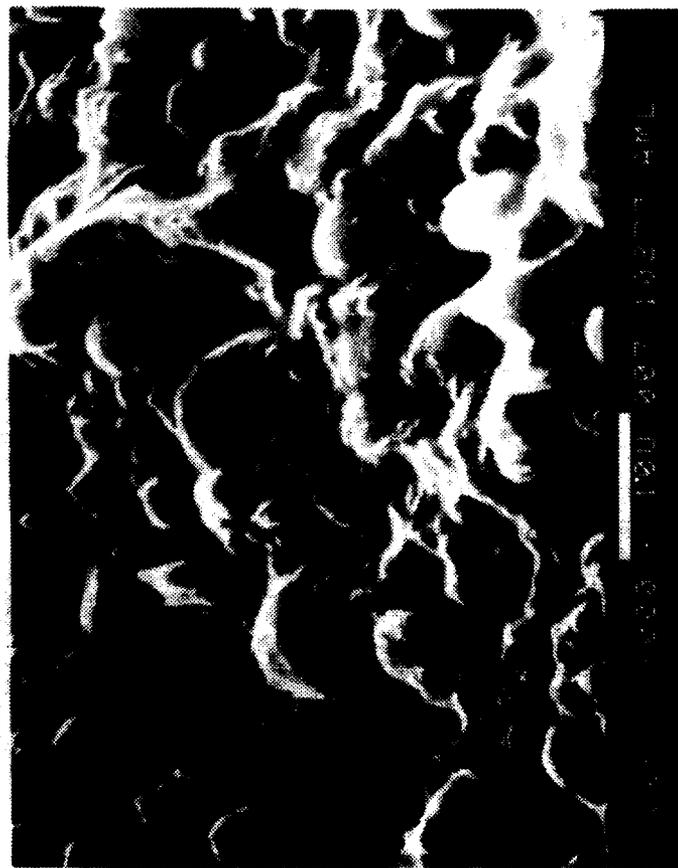
FIGURE 1. SCANNING ELECTRON MICROGRAPHS (2000X) OF POLYURETHANE AIRCRAFT TOPCOATS

The higher dE is, the greater the color change and the poorer the coating cleanability.) The effect observed in Figure 1 is caused by the surface roughness required for low gloss coatings, allowing carbonaceous soil particles to become entrapped in the coating surface. A second trend was found with the hydrophilic nature of the coating surface and cleanability. As suggested in Figure 2, coatings which were more hydrophilic (lower contact angle) were more cleanable than those which were hydrophobic. This effect is attributed to the smoother surface of the hydrophilic coatings and the ability of the cleaner to wet these surfaces more efficiently. Reference (1) also discusses the improved cleanability of low gloss (<3) coatings which contain polymer bead pigments. The bead coatings have a thin layer of resin which coats the surface, and rounded surface protrusions while conventionally pigmented topcoats of equivalent gloss (1.0) were resin starved at the surface and had jagged surface protrusions. This effect is illustrated in the scanning electron micrographs in Figure 3. The surface exhibited by the polymer bead coatings was far less

likely to entrap and retain soil particulates.

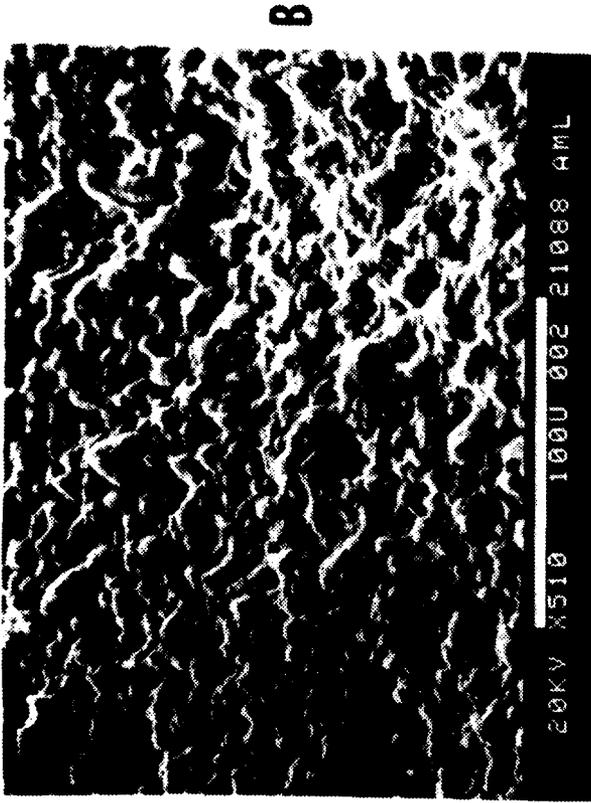
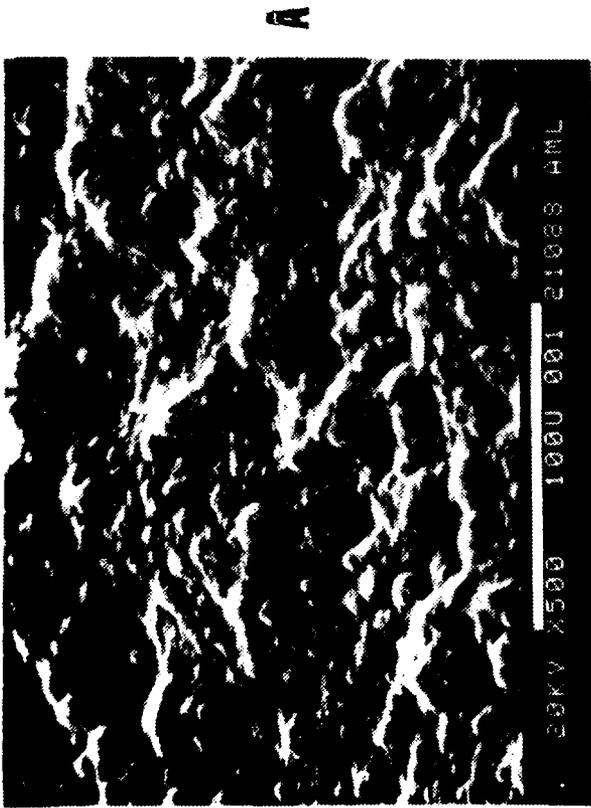
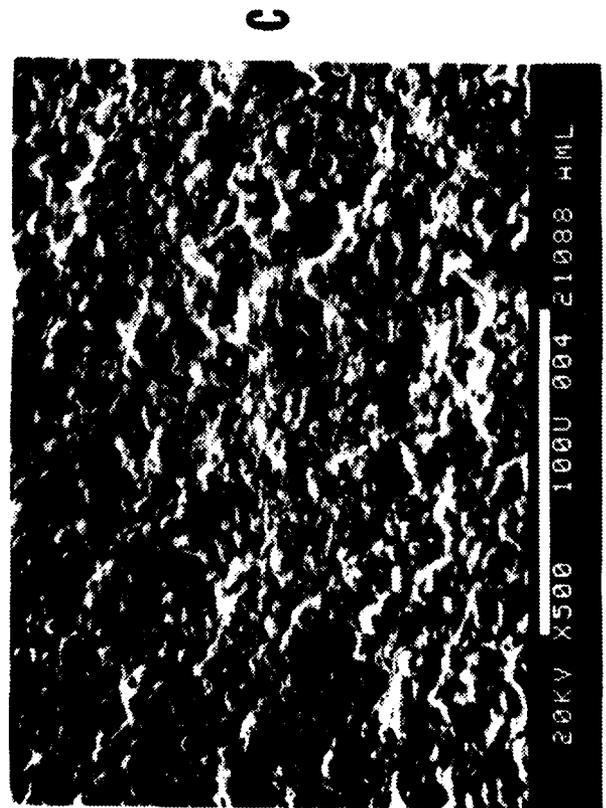
FIGURE 7. SEMs (500X) OF WEATHERED SPECIMENS

Figures 7 through 10 show obvious cracking of Deft and DeSoto MIL-C-83296 polyurethane topcoats upon accelerated weathering in a xenon arc weatherometer. This was unexpected since MIL-C-83286 has an accelerated weathering exposure

requirement of 500 hours with minimal reduction in flexibility. It is suspected that these cracks are caused by internal stresses arising from chemical and surface changes in the coatings during weathering. Although the 1600 hour exposure period of this study significantly exceeds the specification exposure period, it may be a reasonable duration for evaluation of coatings for Navy aircraft which are repainted approximately every 4 to 6 years. During that service time, they are exposed to extremely harsh environmental conditions: sunlight, wide temperature ranges in flight (-65° to 350°F) and on ground ($<0^{\circ}$ to $>100^{\circ}\text{F}$), high humidity, salt spray, and carbonaceous oily soils. In order to further understand cracking and other aircraft polyurethane coating responses to weathering, an extensive study has been initiated which will examine chemical, physical, optical, and surface property changes of the coating during exposure in Florida, a xenon arc weatherometer and a QUV chamber (ASTM G-53).

The third significant observation from the SEMs is the effect of weathering on the polymer bead coating, Camolite. Although it did not crack, the coating appears to be eroded across the entire surface but more dramatically around the polymer bead particles. This also was unexpected. Previous reports on polymer bead coatings specifically discuss the weather and chemical resistance of aircraft polyurethane coatings containing these pigments (2-6). Other references discuss gloss uniformity, scrub resistance, opacity, application characteristics (7), and light scattering effects (8) imparted by polymer beads when incorporated into a paint binder. It should be noted that although the method of bead preparation was similar in these studies (9), the bead manufactureres were different. Nonetheless, the effect of weathering on the Camolite coating in this study is obvious. One explanation of the degradation mechanism is that the beads, which are normally produced from a styrenated polyester, are susceptible to ultraviolet degradation due to the small concentration of the aromatic segment in the copolymer. Further evaluation of this effect is ongoing.

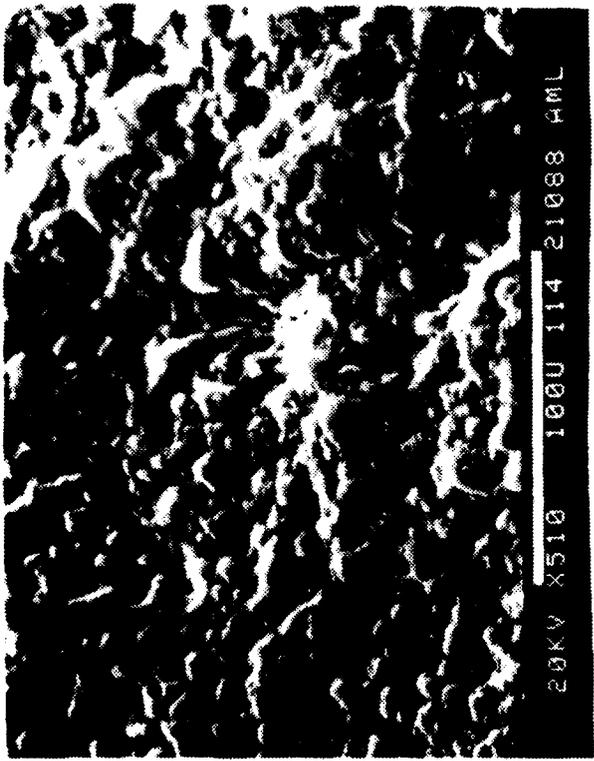
FIGURE 9. SEMs (500X) OF WEATHERED/SOILED/
CLEANED SPECIMENS

The SEMs of unexposed, weathered, and weathered/soiled/cleaned topcoat specimens indicate that the Deft coating undergoes no drastic changes in topography (with the exception of cracking which will be discussed below). However, weathered and weathered/soiled/cleaned coatings appear to be slightly rougher than the unexposed specimens. This suggests some minor erosion/chalking has occurred which effects the thin layer of resin on the surface, exposing more pigment.

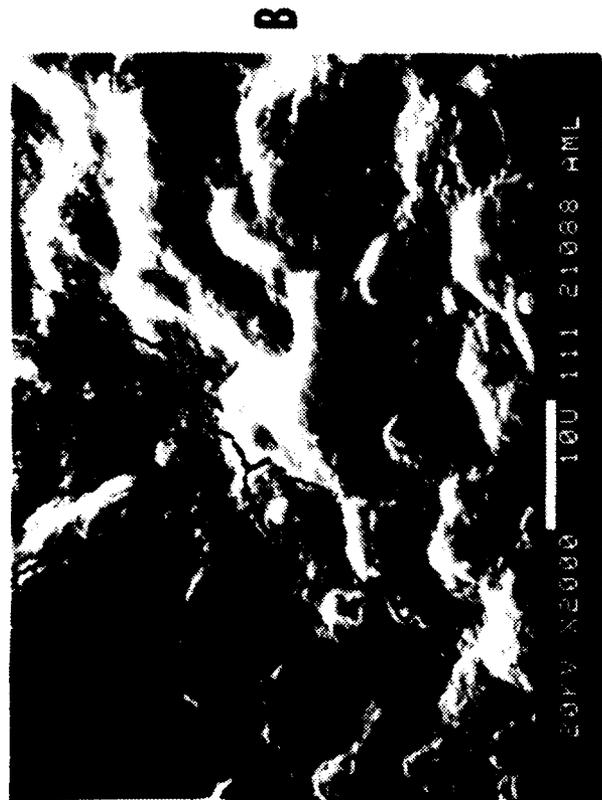
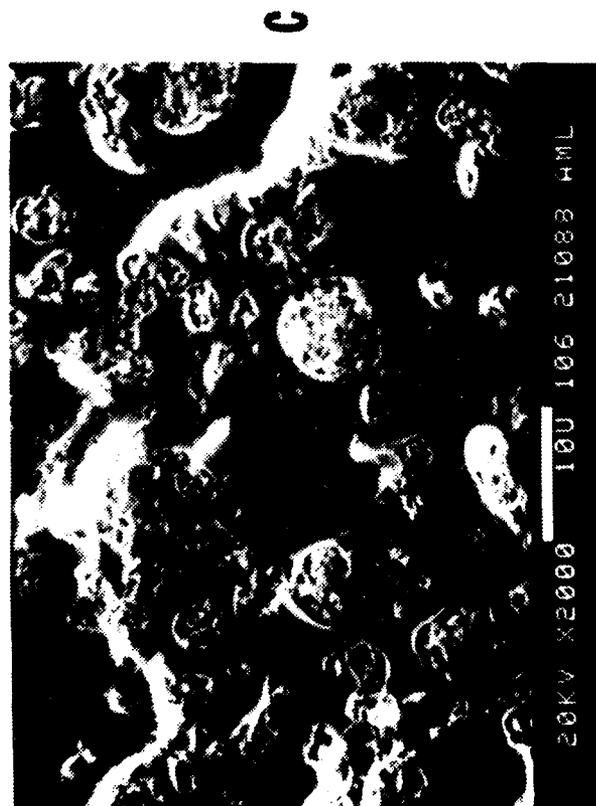
FIGURE 10. SEMs (2000X) OF WEATHERED/SOILED/
CLEANED SPECIMENS

SEMs at 2000X of the DeSoto coating show some differences between the unexposed and weathered/soiled/cleaned specimens. The unexposed specimen is extremely rough with a resin starved surface, exposing pigment. It has a surface roughness on the magnitude of 5 to 10 microns, but also a microroughness at the sub-micron level. The weathered specimen exhibits very little of the sub-micron irregularities. This is probably caused by the "rinsing" action in the weathering cycle which removed any loose debris from the surface. The weathered/soiled/cleaned specimen appears slightly smoother than the weathered specimen, caused by the burnishing action of the cleaning cycle.
