US Army Corps
of Engineers
Construction Engineering
Research Laboratory

USA-CERL TECHNICAL REPORT N-88/21
August 1988

An Economic Assessment of Renovating Temporary Wood Frame Buildings

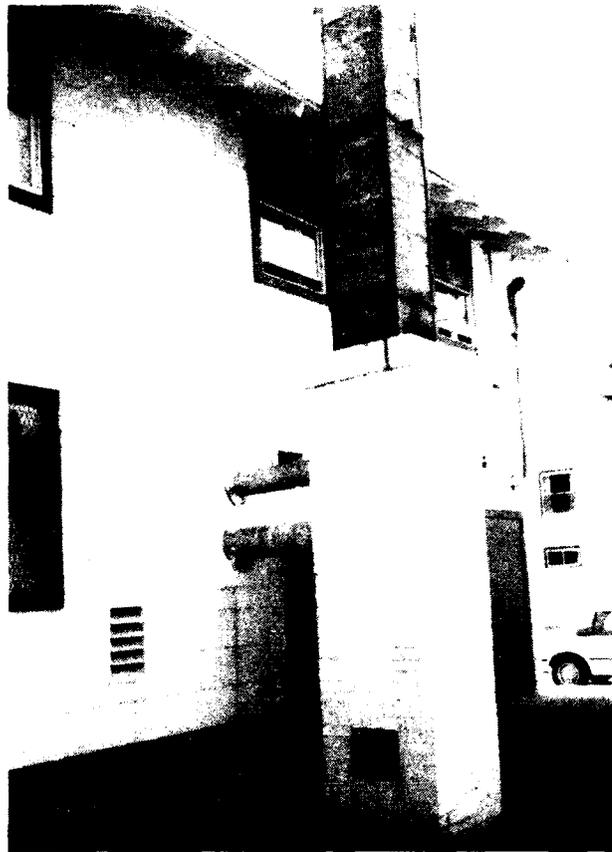
Figure 3. Free-standing chimney of a barracks at Fort Lewis.

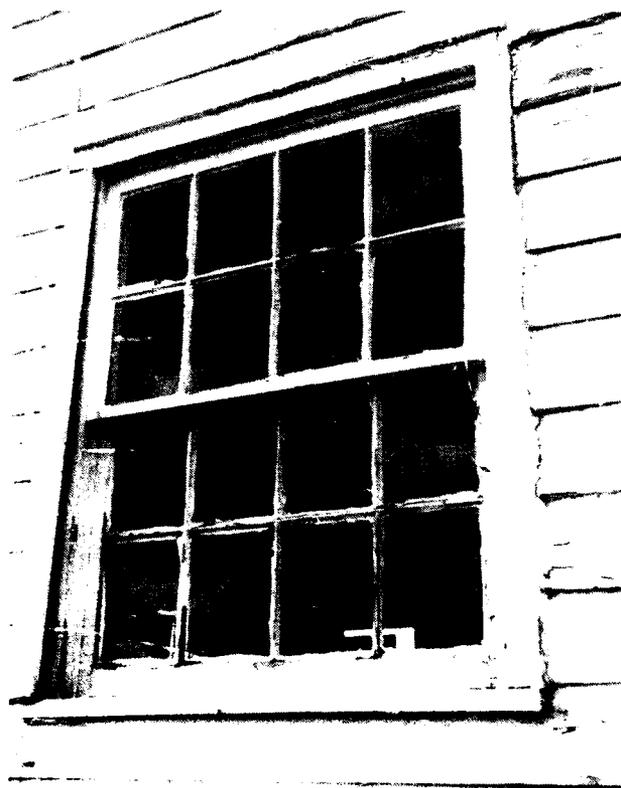
Exterior windows were frequently in poor condition (Figure 11). In 14 buildings (half of the sample) windows were clearly inadequate. Exterior doors were in much better condition. In only four structures were they judged to be poor. In general they were rated average to good.

Figure 11. A window in poor condition.

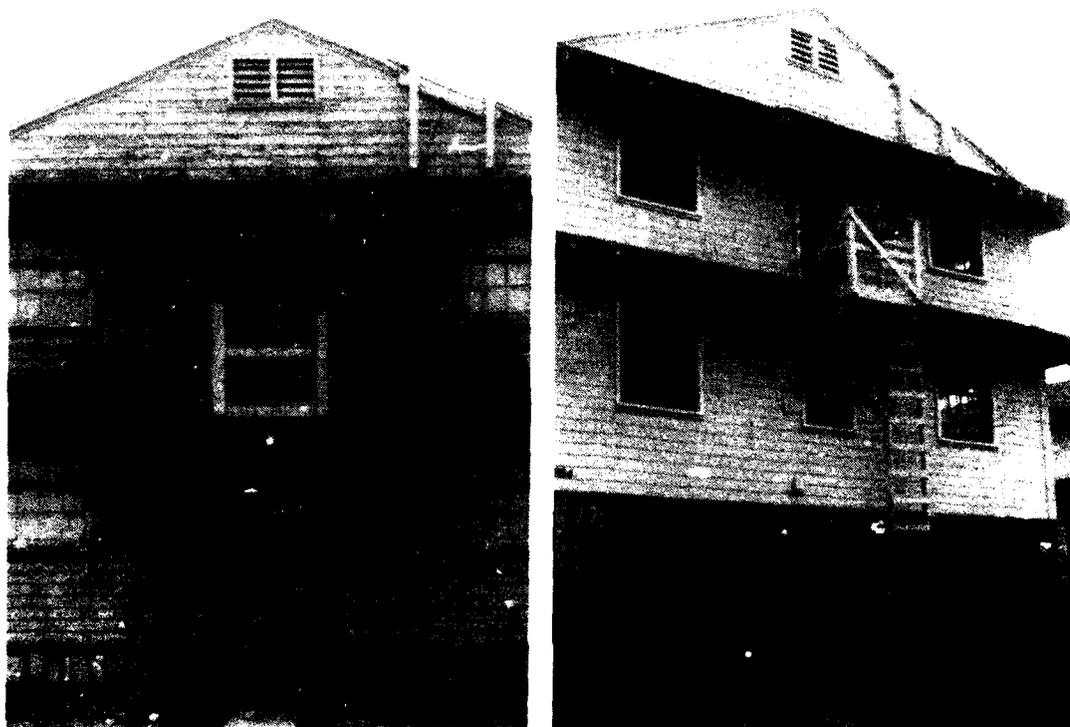
A third observation concerns fire safety. In cases where the duct system was not replaced, smoke in the corridor may prevent users from safely reaching the fire escape at the end of the corridor. Also, the wooden ladder fire escapes are often in need of repair or replacement (Figure 13). In judging the fire safety of wood buildings in general, however, it should be noted that building contents are at least as important a source of fire hazard as the structure itself.⁷

Figure 13. Fire escapes.
