# E-3 AWACS CORROSION PREVENTION ADVISORY BOARD (CPAB)

12 JULY 1990  
TINKER AFB, OK

**E-3 CORROSION PREVENTION ADVISORY BOARD MINUTES  
12 JULY 1990**

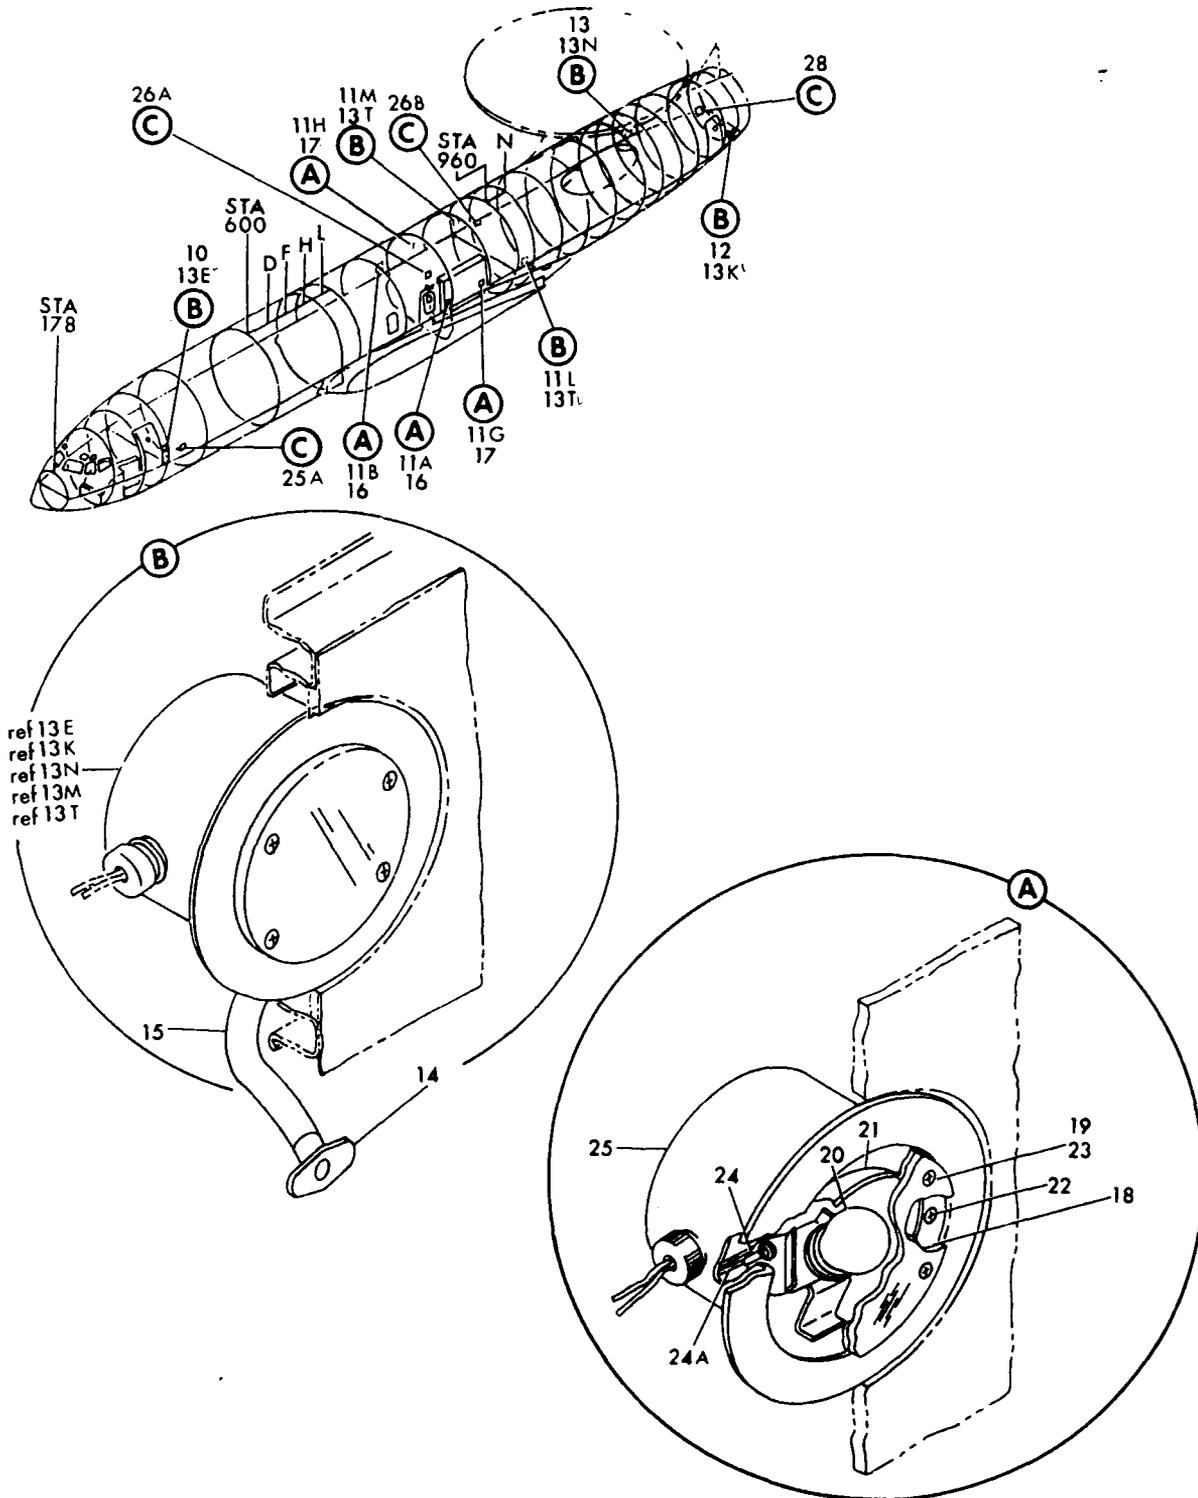
FIGURE 7. LIGHT INSTL, EXTERIOR EMERGENCY EXIT  
POWER SUPPLY INSTL, EXTERIOR EMERGENCY EXIT (SHEET 1)

TCTO has already been written by MMKRTA but currently on hold for parts. Kitproof is also on hold. Reflector assy, P/N 31-1560-1 is unavailable at this time.

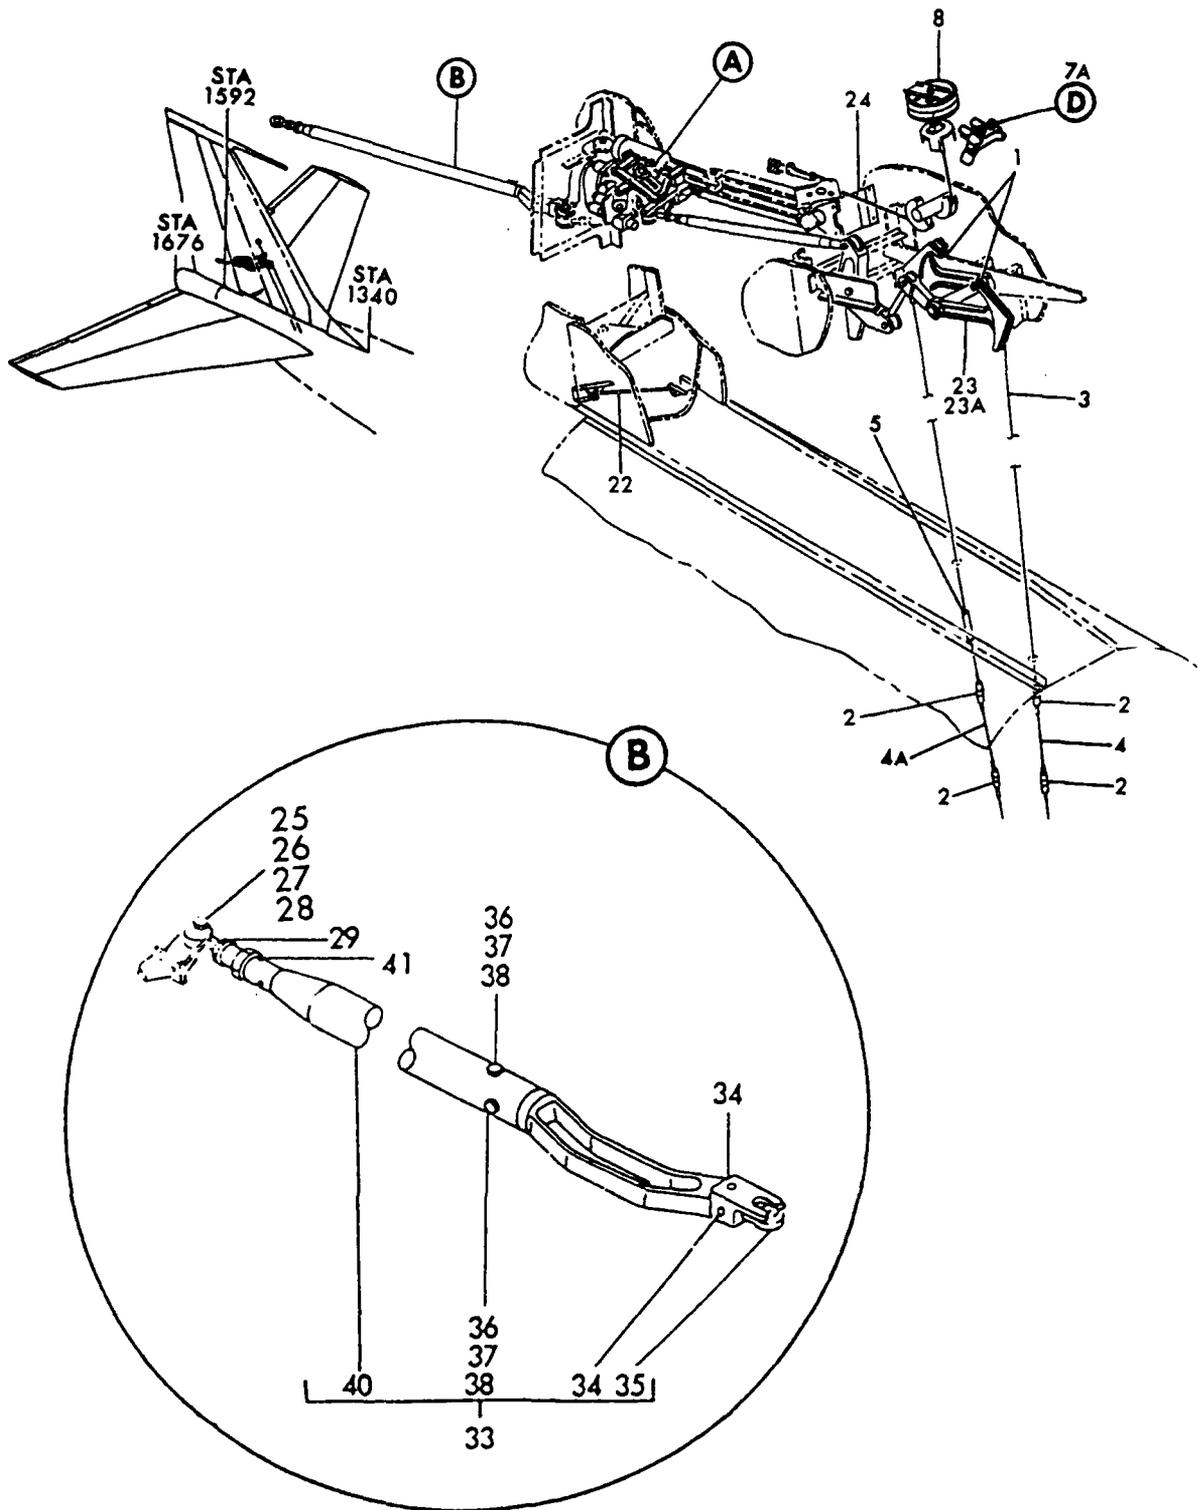
SEE NOTE ON PARTS LIST PAGES  
 FIGURE 14A. CONTROL INSTL, RUDDER (SHEET 1)

TCTO has been completed and will be published soon. During kit proof, hole was too large and drilled completely through part. TCTO revised to reduce hole diameter to 3/16" and only drill lower side of rod. It was also discovered that attach hardware was loose, corroded, or missing. MMKRA will request all users initiate a one time inspection at O/I for corroded, missing, or loose hardware, and replace if necessary.

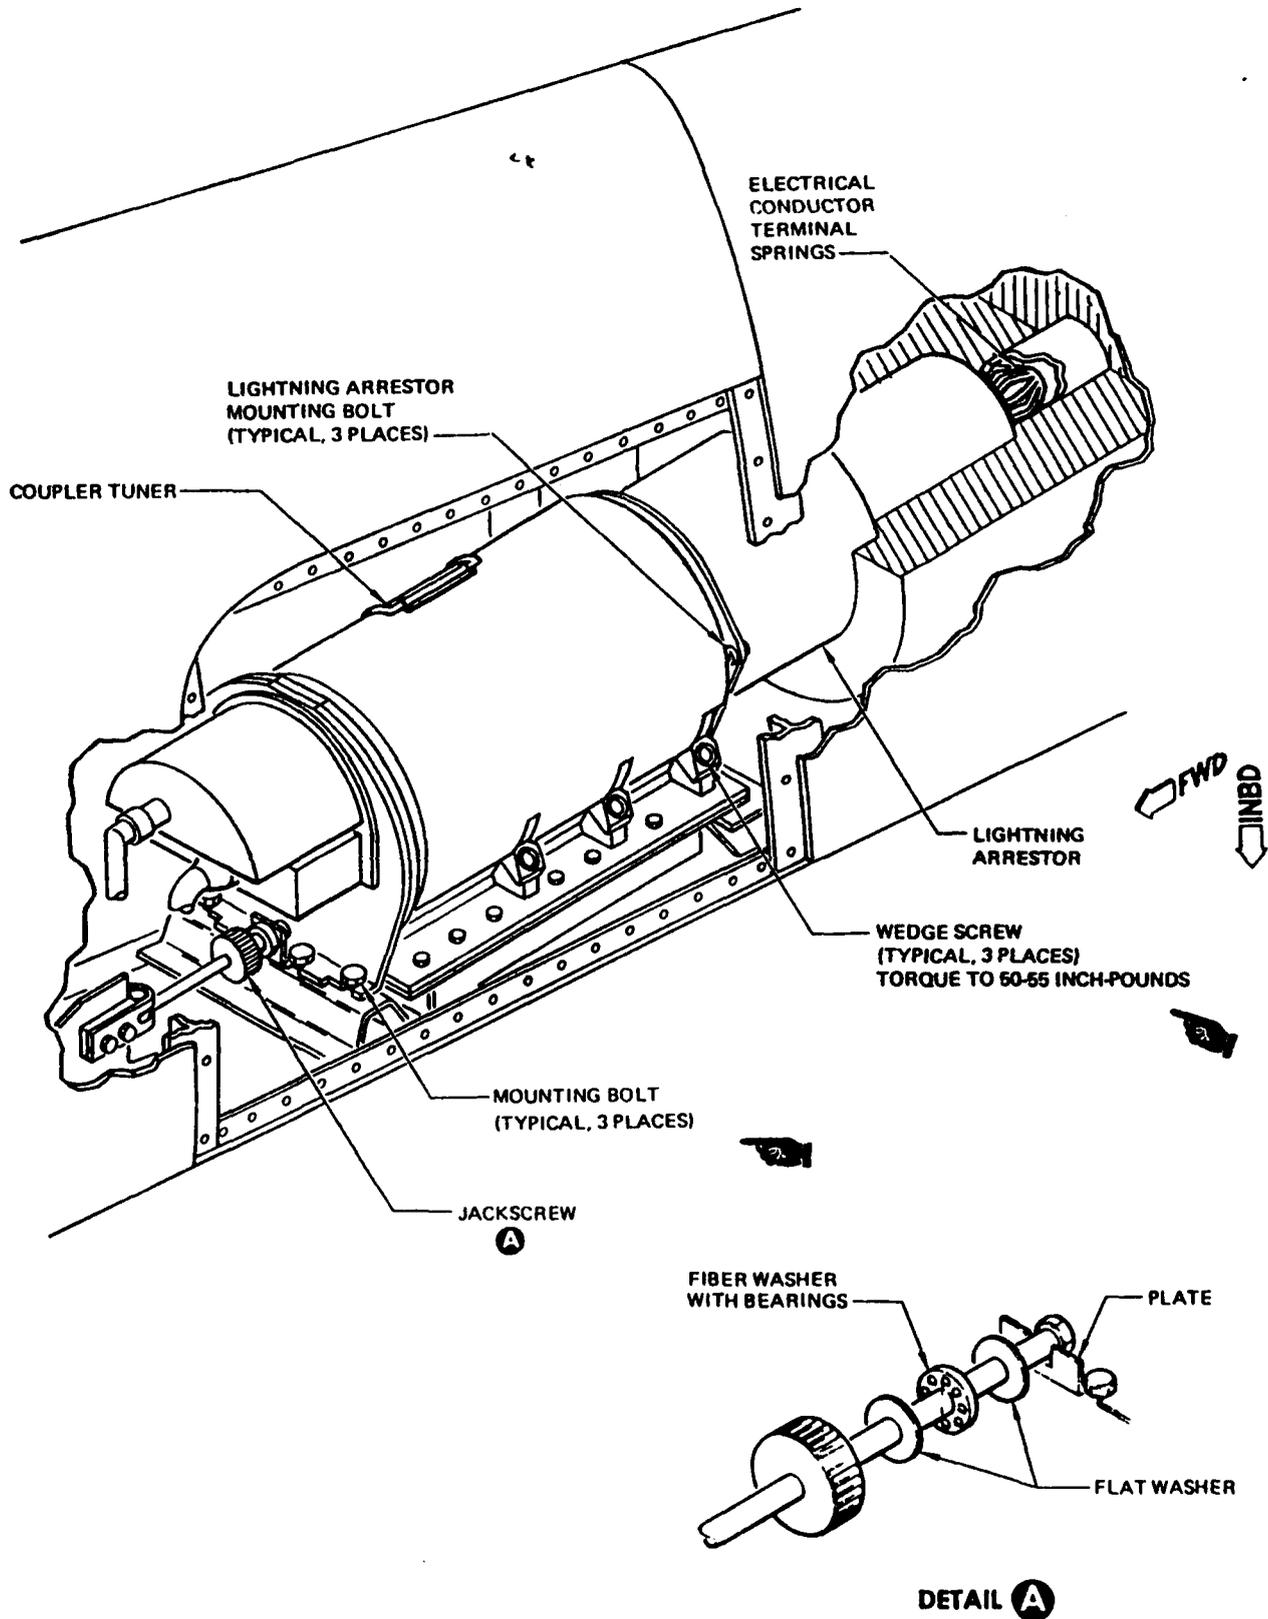
Figure 10-21. HF Transmit Components Installation, Wing Tip

E-3	CORROSION PREVENTION ADVISORY BOARD	ACTION ITEM #: 88-16
O R I G I N A L T O R	<b>SUBJECT:</b> E-3 Wingtip and HF Antenna Corrosion	<b>BACKGROUND DATA:</b>  <b>PART NUMBER:</b>  <b>NSN:</b> <b>DRAWING(S):</b>  <b>TO(S):</b> <b>FIGURE:</b> <b>INDEX:</b> <b>WORK UNIT CODE:</b>
	<b>NAME:</b> Hfw Franz-Josef Deckers <b>ORGANIZATION:</b> NAEWF E-3 Comp. <b>TELEPHONE:</b> 01-49-2451-63-6215 <b>DATE SUBMITTED:</b> May 1988	<b>PROBLEM:</b> NATO discovered severe corrosion on HF antennas located in the E-3 wingtips as well as corrosion on wingtip structure. Water remains trapped in the wingtips after washing. Adding more drain holes in this area may help.
	<b>RECOMMENDED ACTION:</b> Identify manufacturing processes and materials and configuration of HF antennas located in E-3 wingtips. Identify possible solutions to inhibit corrosion.  <p style="text-align: center;">(USE CONTINUATION SHEET IF NECESSARY)</p>

Mr. Richard Elmslie from Boeing reported that EST 90-E3B2-13 has been started. Boeing will take action to investigate the need of foam surrounding HF antenna.

Reported foam cracking was investigated by MMKRA and found not to be a significant problem. EST would require an exhibit, which is unavailable. No EST will be pursued, and any future problems will be corrected on a case-by-case basis.

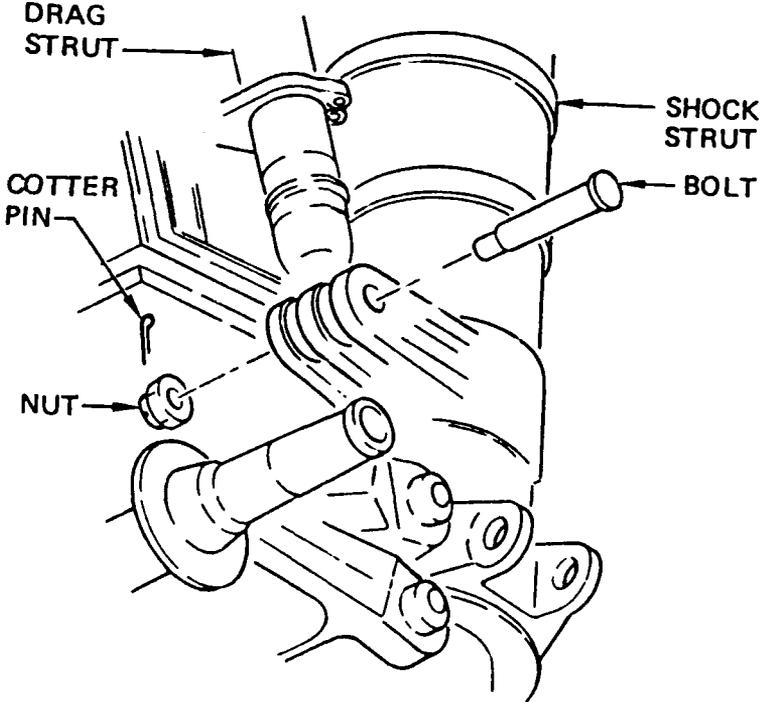
# E-3 LANDING GEAR DRAG STRUT / SHOCK STRUT BOLT

E-3	CORROSION PREVENTION ADVISORY BOARD		ACTION ITEM #: 88-18
O R I G I N A T O R	<b>SUBJECT:</b> Main Landing Gear Drag Strut/Shock Strut Bolt Corrosion.		<b>BACKGROUND DATA:</b> <b>PART NUMBER:</b> 66-03943 <b>NSN:</b> <b>DRAWING(S):</b>
	<b>NAME:</b> John Zylkowski <b>ORGANIZATION:</b> NAEWF/FCL-TCD <b>TELEPHONE:</b> 01-32-6544-4694 <b>DATE SUBMITTED:</b> May 1988		<b>TO(S):</b> 1E-3A-23 <b>FIGURE:</b> 5-3 <b>INDEX:</b> 10 <b>WORK UNIT CODE:</b> 13DD0
	<b>PROBLEM:</b> The bolt connecting the MLG drag strut and shock strut corrodes. It is in a critical area and must be protected.		
	<b>RECOMMENDED ACTION:</b> Identify and implement solutions to inhibit corrosion in this area.  <p style="text-align: center;">(USE CONTINUATION SHEET IF NECESSARY)</p>		
C P A B A C T I O N	<b>STATUS:</b> 1 Jun 1988: NATO is removing corrosion and installing new bolts with MIL-S-81733 sealant.  Sept 1988: Removing corrosion and installing bolts with sealant should solve the problem, provided bolt removal does not require excessive force during future inspections. After procedure verification, T.O. 1E-3A-2-32-1 will be updated to reflect the use of sealant instead of grease.  15 NOV 1988: NATO will apply DINOL AV-5 penetrating CPC to some bolts and compare them with the bolts installed wet with MIL-S-81733. Sealant is wiped off of the bolts during installation due to the tight fit. NATO will report results at the next CPAB meeting.  <p style="text-align: right;">(continued)</p>

NAEWF E-3A Component has no results because it only has been approximately one year since the application of MASTINOX to landing gear bolts.

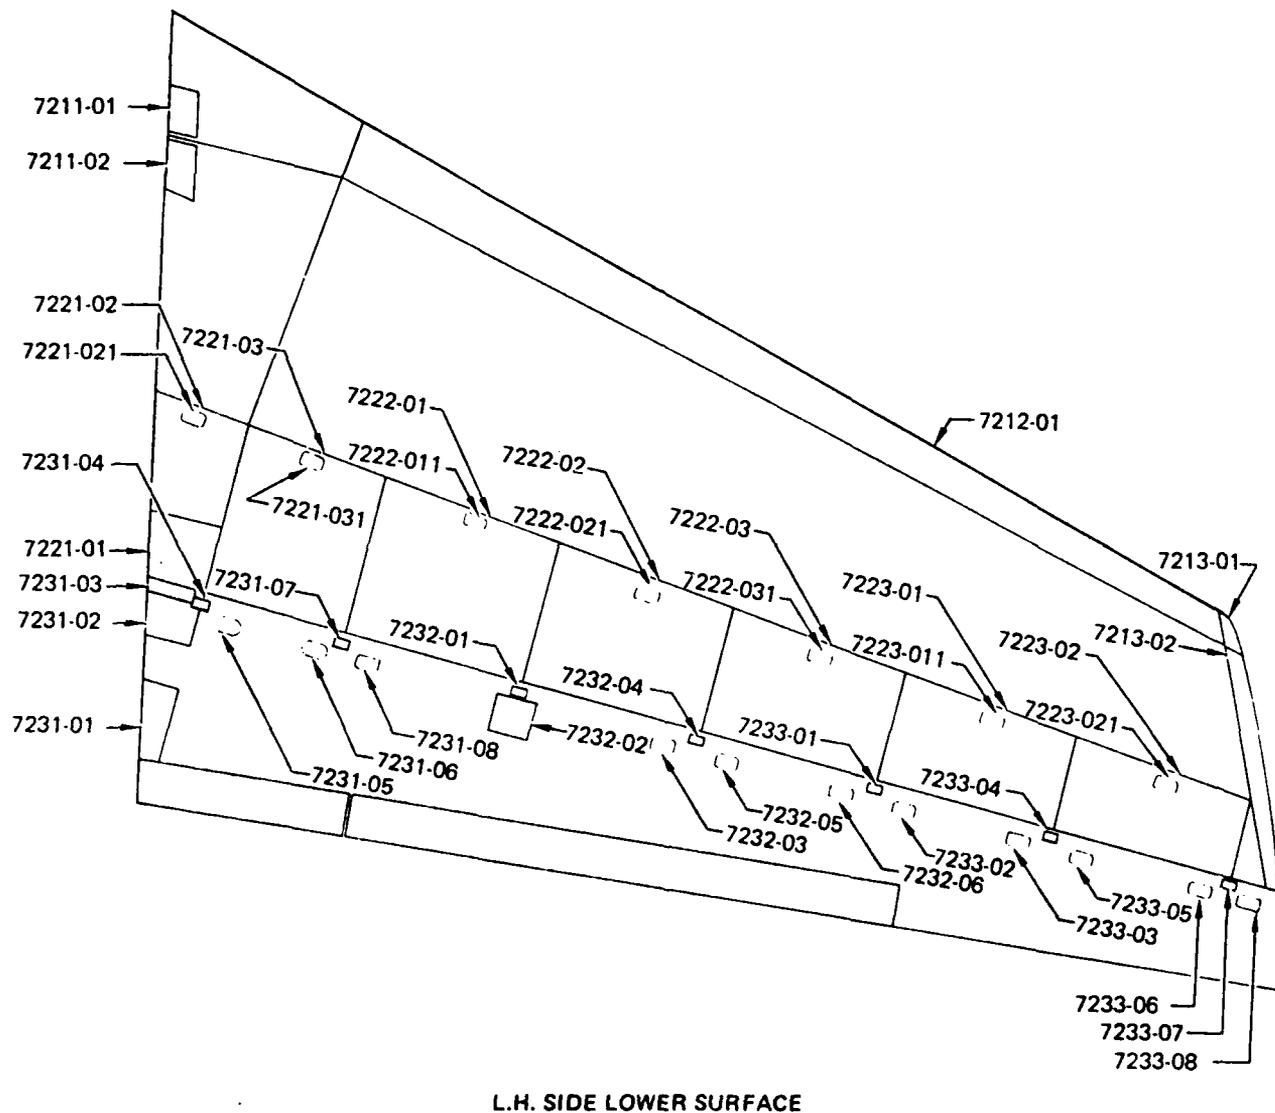
Figure 3-6 Stabilizer and Elevator Access Panels (Sheet 1 of 8)

E-3	CORROSION PREVENTION ADVISORY BOARD	ACTION ITEM #: 88-25
O R I G I N A L T O R	<b>SUBJECT:</b> Elevator Thrust Hinge Access Panel	<b>BACKGROUND DATA:</b> <b>PART NUMBER:</b> Panels 7231-03, 8231-03 <b>NSN:</b> <b>DRAWING(S):</b>
	<b>NAME:</b> HFw Franz-Josef Deckers <b>ORGANIZATION:</b> NAEWF E-3A Comp <b>TELEPHONE:</b> 01-49-2451-63-6215 <b>DATE SUBMITTED:</b> May 1988	<b>TO(S):</b> 1E-3A-23 <b>FIGURE:</b> 3-6 <b>INDEX:</b> <b>WORK UNIT CODE:</b> 11FDL, 11FGN
	<b>PROBLEM:</b> Standing water in this panel is a problem.	
<b>RECOMMENDED ACTION:</b> Initiate action to provide drain holes in the elevator thrust hinge access panels.  (USE CONTINUATION SHEET IF NECESSARY)		
C P A B  A C T I O N	<b>STATUS:</b> 2 Sept 1988: A TCTO is being issued to drill a 0.30 inch diameter drain hole on the lower surface access panels (7231-03 and 8231-03) 3 inches inboard of the existing inboard drain hole and on the same centerline of both existing drain holes. MIL-S-81733 is then applied to channel water toward the new drain hole. ECO being issued to change configuration on drawings.  12 March 1990: Action Item originally closed Sept 1988 after ECO prepared and MMKRTA tasked to draft TCTO. No action has been taken regarding issue of TCTO. Action Item reopened at March 1990 CPAB due to lack of TCTO. OC-ALC/MMKRA/MMKRTA will ensure TCTO is completed as necessary.  July 1990: TCTO will not be generated due to the forging of the material. MMKRTA will develop ACI procedures to apply CPC, and add a leveling compound. Fasteners prohibit drilling of drain hole.

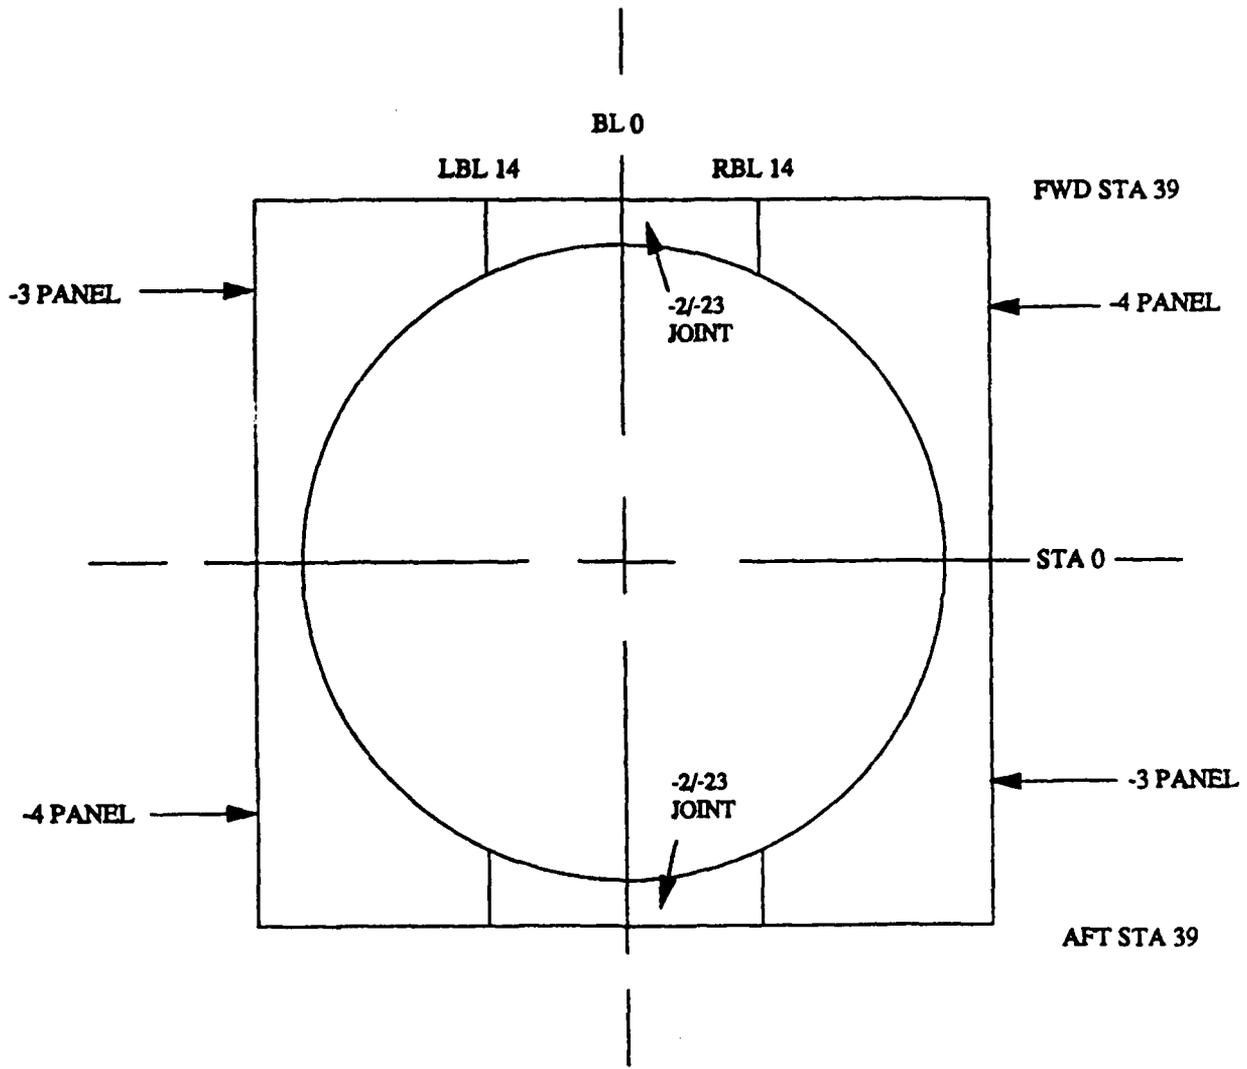
**FIGURE 5: JOINT LOCATIONS**

E-3	CORROSION PREVENTION ADVISORY BOARD		ACTION ITEM #: 88-30
O R I G I N A L T O R	<b>SUBJECT:</b> Antenna Pedestal Closure Panels/Splice Plates	<b>BACKGROUND DATA:</b>  <b>PART NUMBER:</b> 204-20133  <b>NSN:</b> <b>DRAWING(S):</b>	
	<b>NAME:</b> Josef Deckers <b>ORGANIZATION:</b> NAEWF/Comp/LWMQ <b>TELEPHONE:</b> 49 2451-63-363 <b>DATE SUBMITTED:</b> 15 NOV 1988	<b>TO(S):</b> 1E-3A-18; 1E-3A-4-93-3 <b>FIGURE:</b> 4-9 ; 7D <b>INDEX:</b> ; 12 - 17 <b>WORK UNIT CODE:</b>	
	<b>PROBLEM:</b> Extensive corrosion is found on the tin plated closure panels and splice plates. Moisture migrates into the area and the tin plated parts corrode.		
	<b>RECOMMENDED ACTION:</b> Evaluate the original design and recommend alternative materials. Determine if problem exists in USAF fleet. Recommend solutions.  <p style="text-align: center;">(USE CONTINUATION SHEET IF NECESSARY)</p>		
C P A B A C T I O N	<b>STATUS:</b> May 1989: Boeing evaluated the problem and found the following: 1. Review of Design: a. Corners: The four corners consist of bonded aluminum honeycomb panels (204-20133-3, and -4, two each) which are tin plated on the upper surface of the outboard flange (7075 aluminum). These tin plated surfaces are attached to chemically treated 7075 clad aluminum plates. These plates are attached to primed 7075 aluminum fittings (204-20136). See Figures 5 and 6. b. Sides: The sides are tin plated 7075 bare aluminum panels (204-20133-2) which are wash primed, primed, and enamelled. These panels are attached to tin plated clad 7075 aluminum fillers (204-20133-23). These fillers are also attached to the primed strongback extrusions at STA 39. See Figures 5 and 6. 2. Repair: See T.O. 1E-3A-3-1, Section VII, Figure 7-3, Detail V for damage allowances after corrosion removal and refinishing. 3. Recommended Solutions: a. Corners: Fillers (204-20133-19, -22, -25 and -26)  <p style="text-align: right;">(continued)</p>

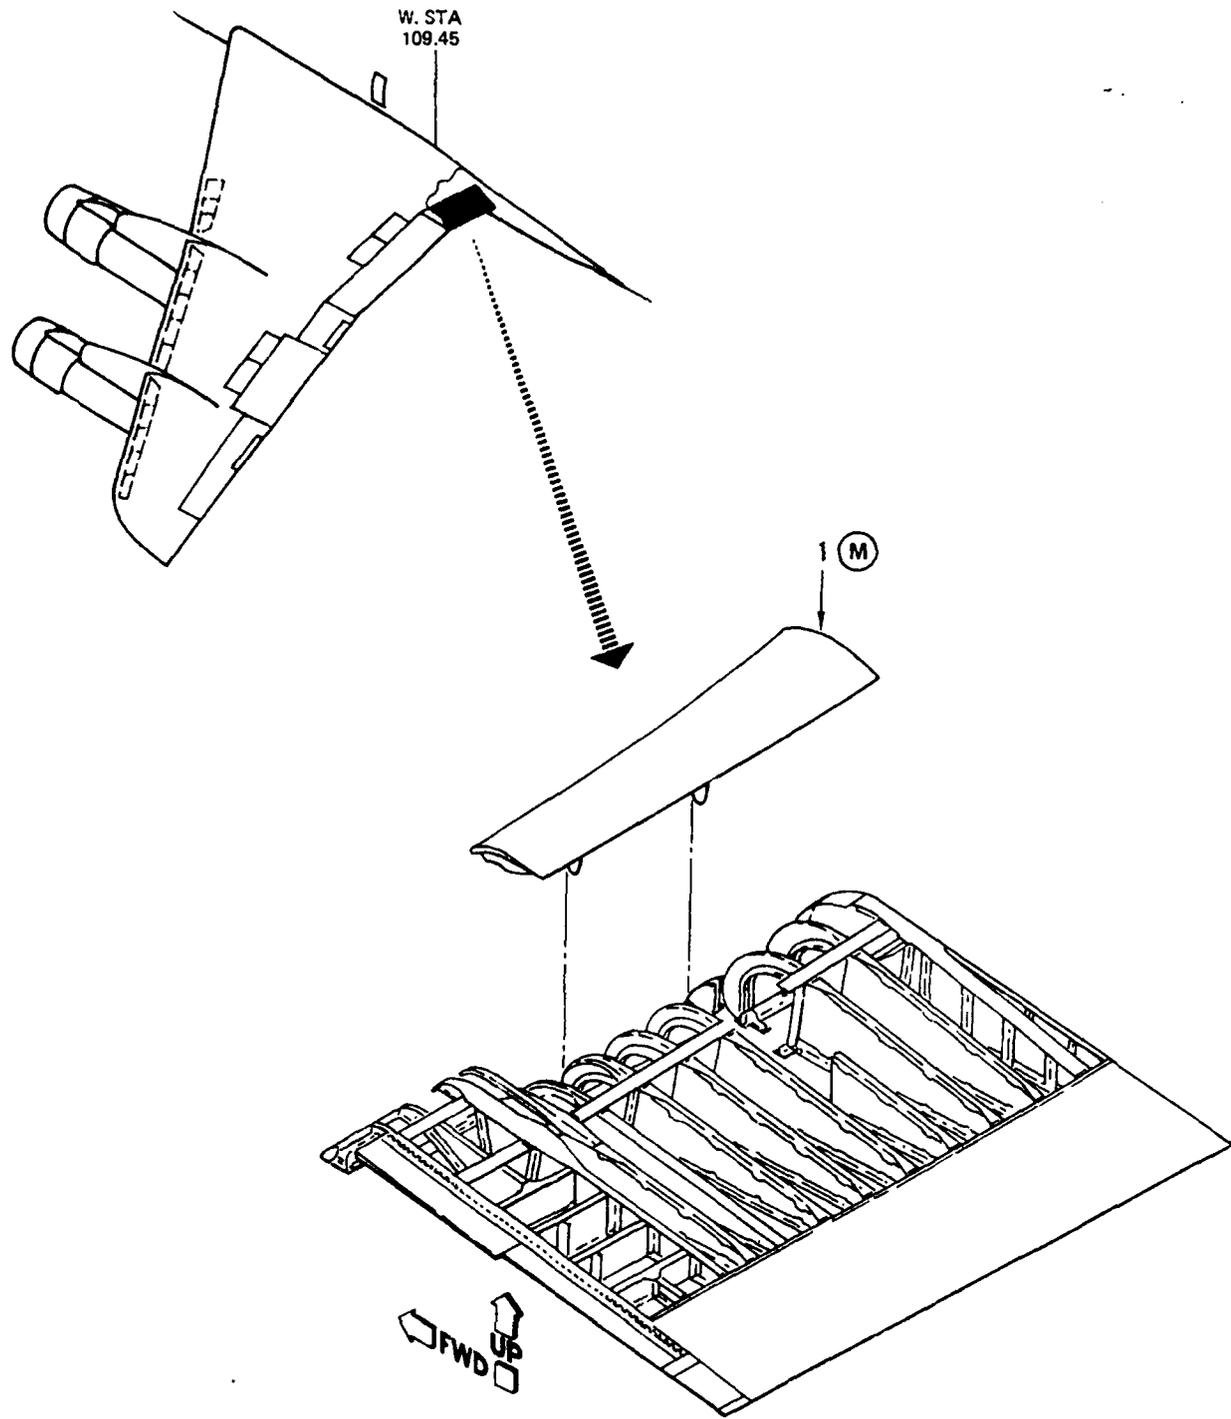
Figure 2-5. Fillet Flap Flaperette Corrosion Inspection Guide (Sheet 1 of 2)

NAEWF E-3A Comp. reported that A/C -0456, treated with Lixton compound with teflon coating on 30 Nov., is in good condition when inspect on 30 June. Another aircraft treated the same way on 30 Dec. is also currently in good condition. So far, the coating is adhering to the surface with Lixton. A/C -0457 will be similarly treated soon.

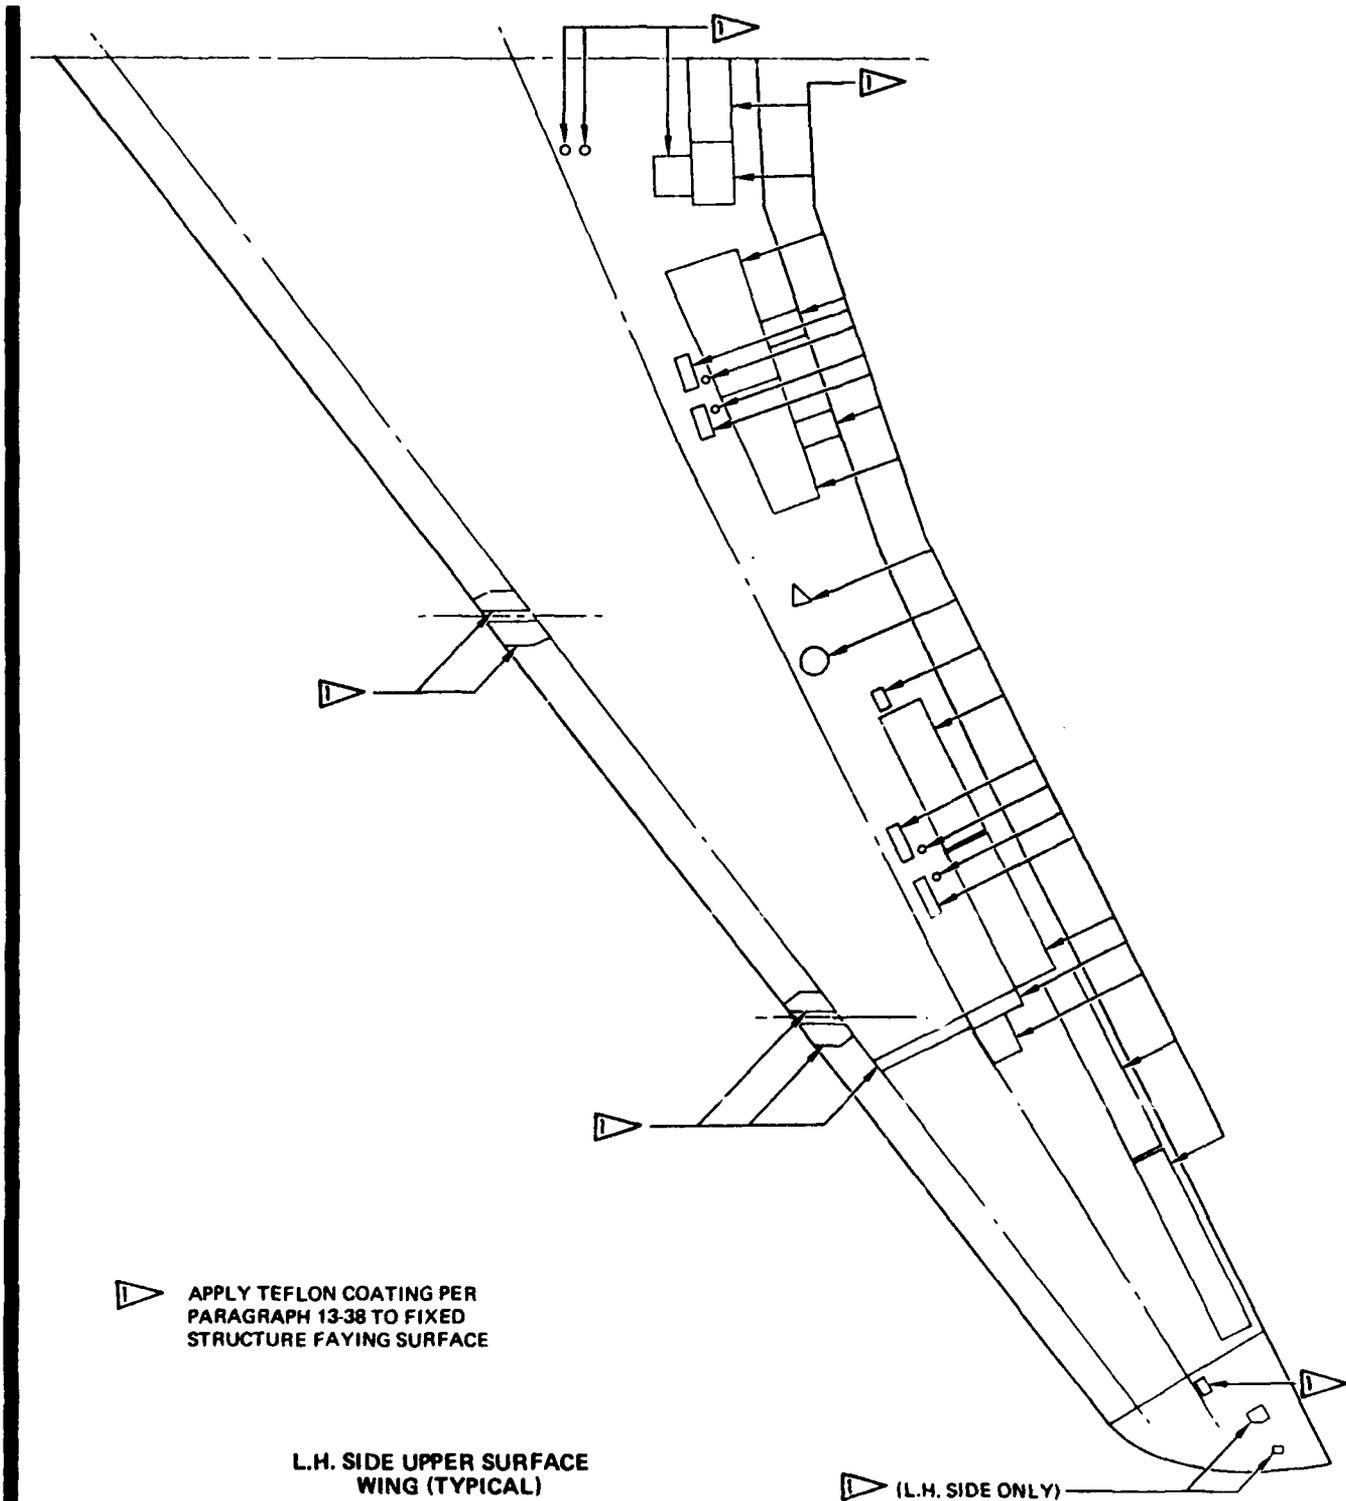
Figure 13-16. Abrasion-Resistant Teflon Coating Locations (Sheet 5 of 6)

E-3	CORROSION PREVENTION ADVISORY BOARD	ACTION ITEM #: 88-32
O R I G I N A L T O R	<b>SUBJECT:</b> Abrasion Resistant Teflon Coating on Faying Surfaces	<b>BACKGROUND DATA:</b> <b>PART NUMBER:</b> 7-W-27 or 7-X-74 <b>NSN:</b> <b>DRAWING(S):</b>
	<b>NAME:</b> HFW Franz-Josef Deckers <b>ORGANIZATION:</b> NAEWF E-3 Comp. <b>TELEPHONE:</b> 01-49-2451-63-6215 <b>DATE SUBMITTED:</b> 15 NOV 1988	<b>TO(S):</b> 1E-3A-23 <b>FIGURE:</b> 13-16 ; para. 13-38 <b>INDEX:</b> entire figure <b>WORK UNIT CODE:</b>
	<b>PROBLEM:</b> Teflon coating is applied on faying surfaces during manufacture to prevent fretting. The areas of application listed in T.O. 1E-3A-23 fig. 13-16 are incomplete. Requirements for inspection and replacement of the teflon coating are non-existent.	
	<b>RECOMMENDED ACTION:</b> Ensure reapplication requirements are included in tech data, and ensure figure 13-16 is updated to include areas in engine cowlings, nacelles, and fuselage that require teflon coating reapplication.  (USE CONTINUATION SHEET IF NECESSARY)

Statement of work for a Boeing EST has already been submitted by MMKRA. Procedures for application are available in T.O. -23.

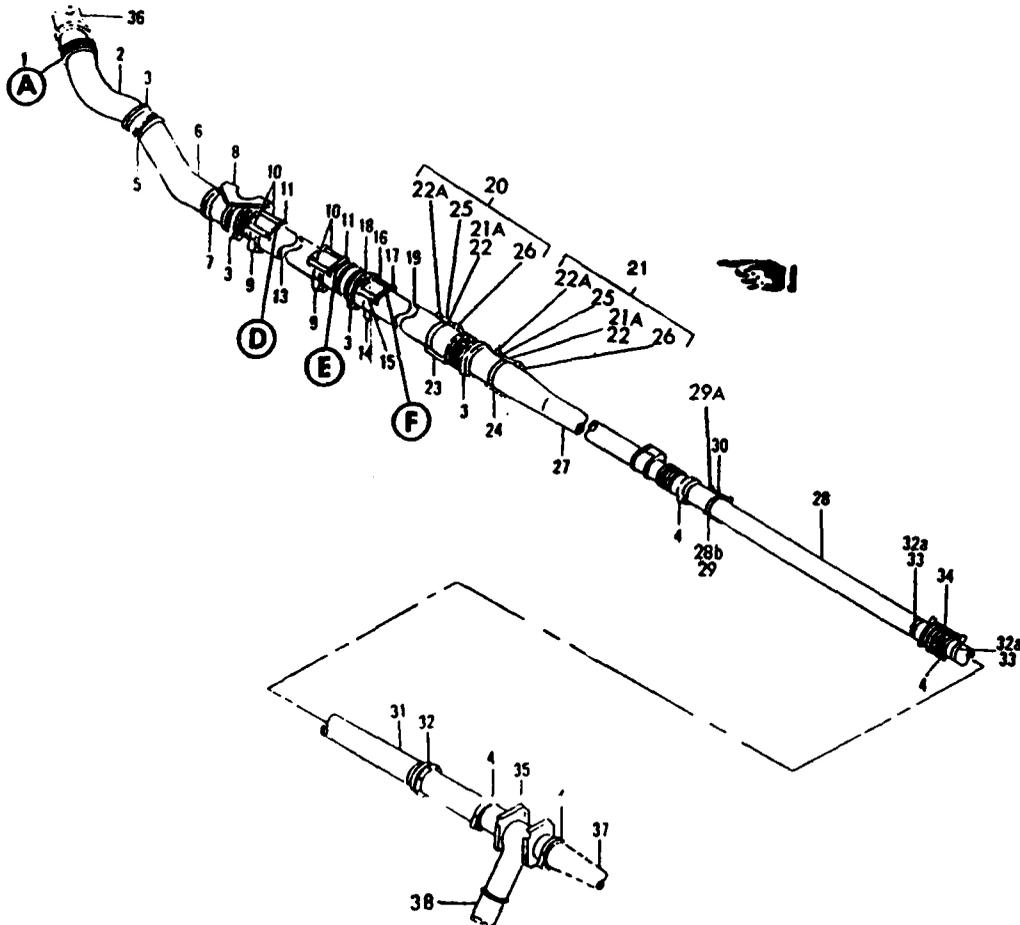
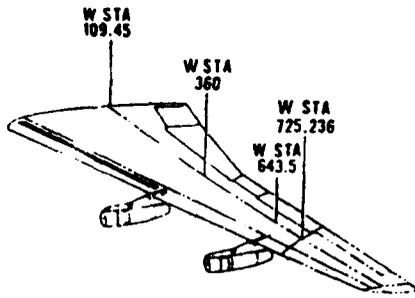
SEE NOTE ON PARTS LIST PAGES  
FIGURE 17. DUCT INSTL, WING LEADING EDGE CABIN AIR (SHEET 1)

Statement of work for L.E. skin will require removal of bleed air ducts. MMKRA will look again at bleed air ducts and replace it as necessary. The diameter for the out-board ducts are .016" and for the in-board ducts are 050". Maximum allowable pitting for out-board and in-board are .002" and .003" respectively. If replacement ducts are not available, MMKRA will generate repair procedures.

NAEWF E-3 Component reported no corrosion found on ducts.

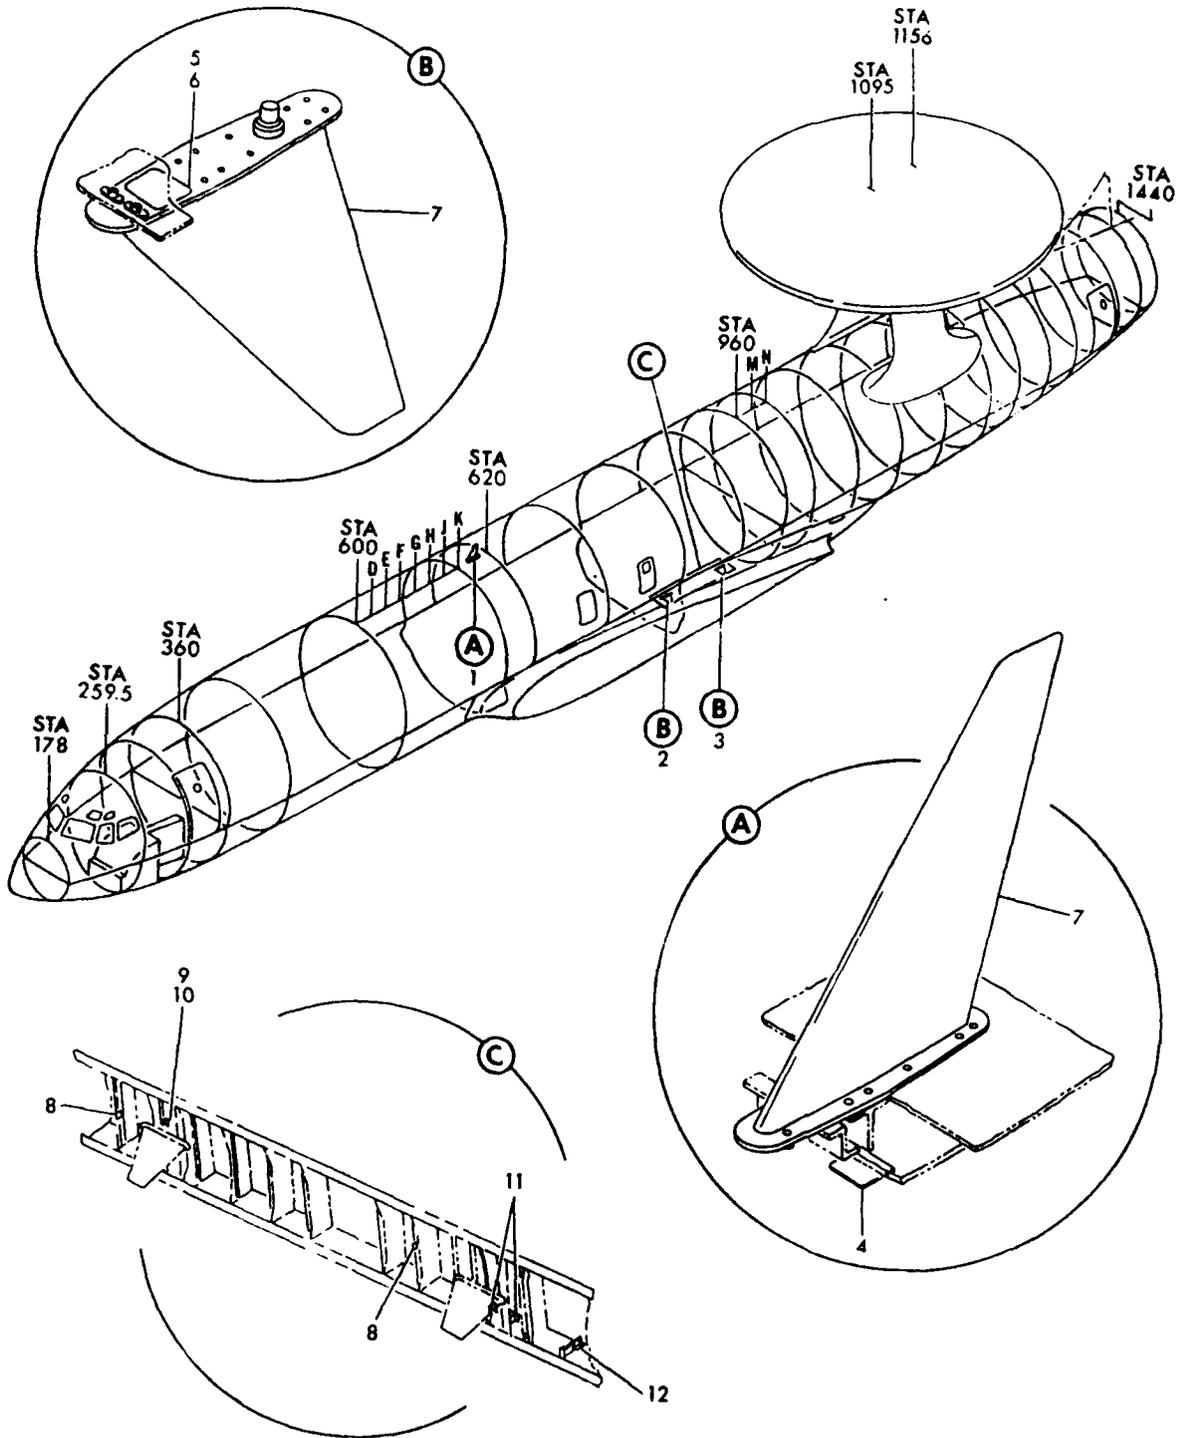
SEE NOTE ON PARTS LIST PAGES  
 FIGURE 13 ANTENNA INSTL, VHF/UHF STATION 600L, 844 AND 930 BLAD

E-3	CORROSION PREVENTION ADVISORY BOARD		ACTION ITEM #: 89-07
O R I G I N A L T O R	<b>SUBJECT:</b> VHF Antenna (#1 & 2) Corrosion	<b>BACKGROUND DATA:</b>  <b>PART NUMBER:</b> 204-14994  <b>NSN:</b> <b>DRAWING(S):</b> 204-14994	
	<b>NAME:</b> TSgt. Charles Faircloth <b>ORGANIZATION:</b> 961 AWACS/MACM <b>TELEPHONE:</b> <b>DATE SUBMITTED:</b> 23 May 1989	<b>TO(S):</b> 1E-3A-4-23-01 <b>FIGURE:</b> 13 <b>INDEX:</b> 7 <b>WORK UNIT CODE:</b>	
	<b>PROBLEM:</b> The #1 and #2 VHF Antennas located on the keel beam between the main landing gear doors are corroding. Corrosion is more severe at the antenna/fuselage interface.		
<b>RECOMMENDED ACTION:</b>  <p style="text-align: center;">(USE CONTINUATION SHEET IF NECESSARY)</p>			
C P A B A C T I O N	<b>STATUS:</b> May 1989: OC-ALC Depot Maintenance also identified corrosion on these antennas. Rework procedures are being developed and MMKRA will determine what action is necessary to prevent future corrosion on the antennas and on the fuselage skin.  Nov 1989: SOW developed to repair antennas. Corrosion found on LE and mating surfaces between fuselage and antenna base. Rework requires refinishing, with conductive alodine. MMKRA is investigating the use of conductive sealant as a faying surface seal during rework.  LE corrosion due to paint erosion/lack of erosion tape. Frequent touch-up and application of erosion tape will eliminate LE corrosion problems.  16 Nov 1989: OC-ALC/MMKRA will investigate changing Tech Order to paint leading edge and applying erosion tape.

MMKRA is working on statement of work for MMKRTA to generate TCTO. 552 AWACW requested form 252 be issued if SOW is not necessary. MMKRA took action to change T.O. rather than issue TCTO.

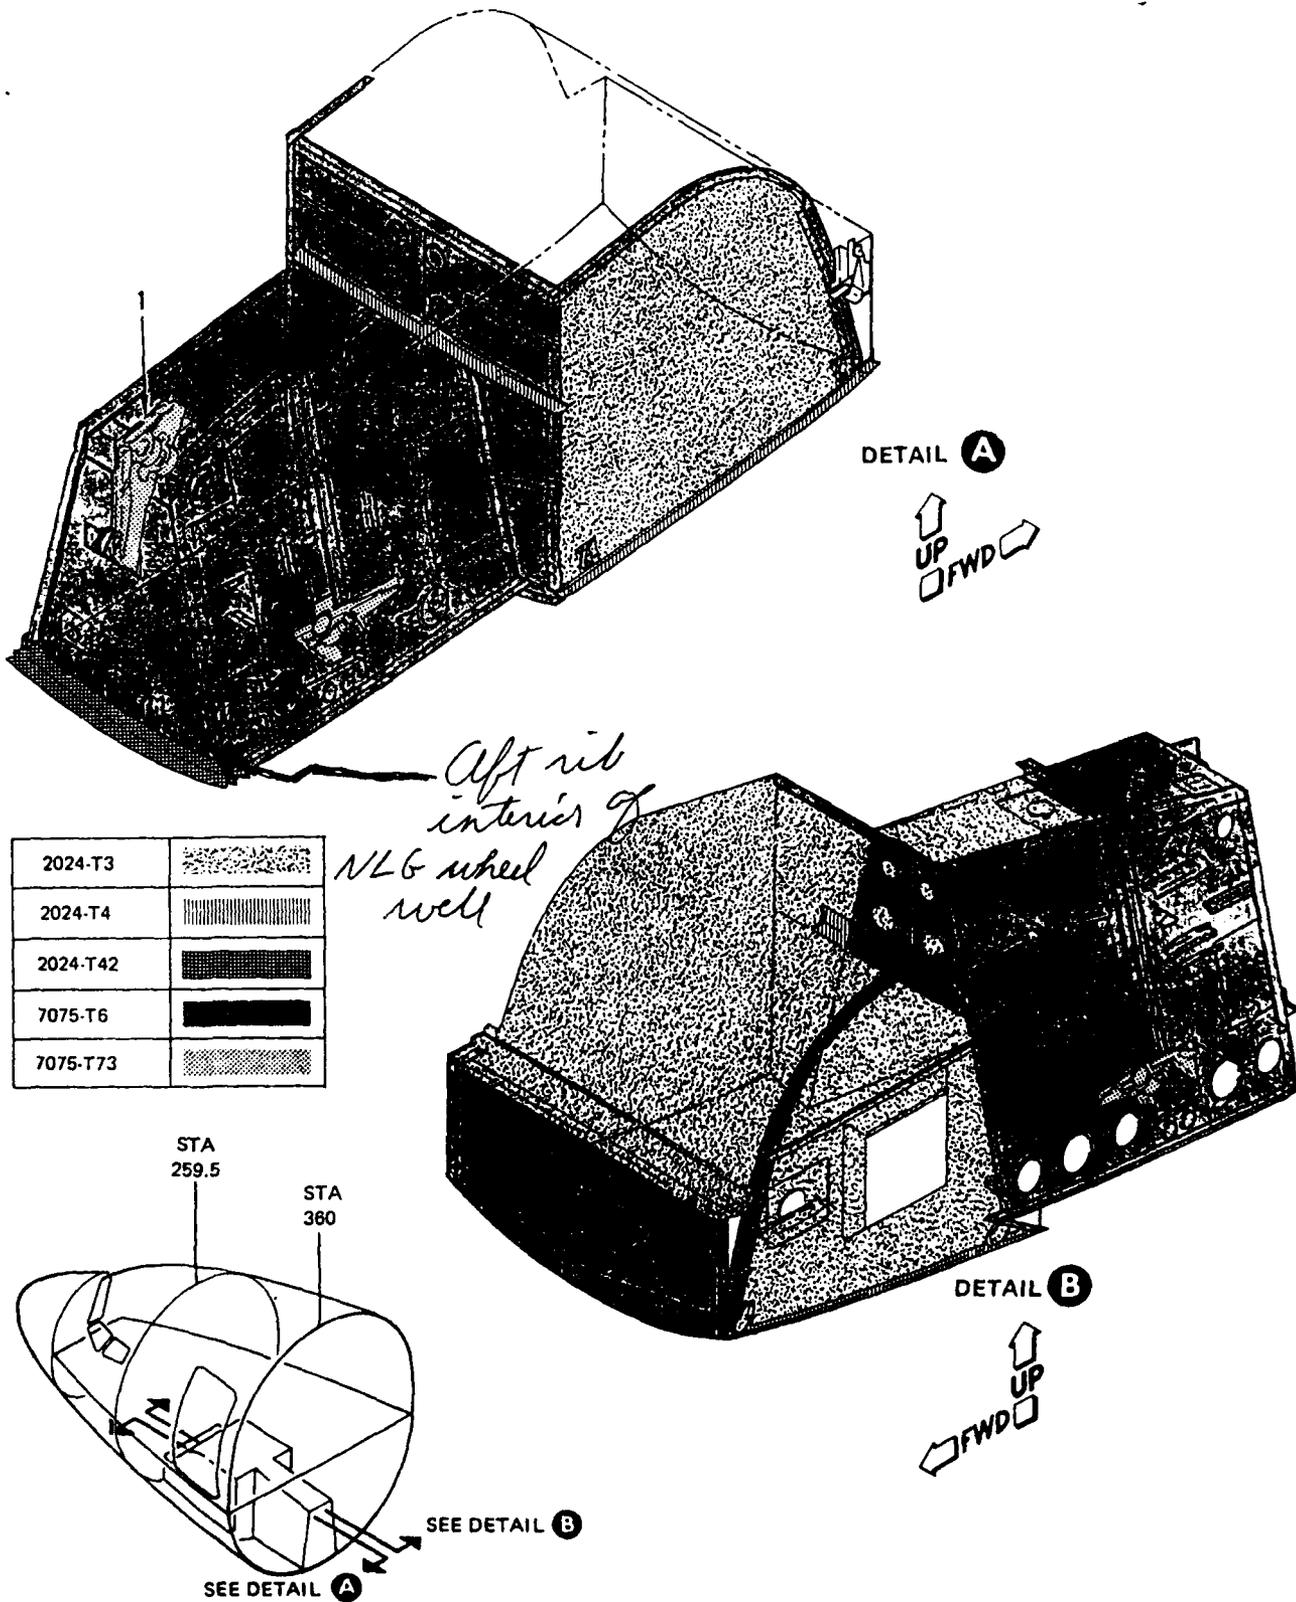
Figure 4-9. First Body Section Nose Gear Wheel Well Corrosion Inspection Guide (Sheet 1 of 2)

E-3	CORROSION PREVENTION ADVISORY BOARD		ACTION ITEM #: 89-09
O R I G I N A T O R	<b>SUBJECT:</b> Nose Landing Gear Door Aft Rib Corrosion	<b>BACKGROUND DATA:</b>  <b>PART NUMBER:</b>  <b>NSN:</b> <b>DRAWING(S):</b>	
	<b>NAME:</b> TSgt Charles Faircloth <b>ORGANIZATION:</b> 961st AWACS <b>TELEPHONE:</b> <b>DATE SUBMITTED:</b> May 1989	<b>TO(S):</b> <b>FIGURE:</b> <b>INDEX:</b> <b>WORK UNIT CODE:</b>	
	<b>PROBLEM:</b> The aft rib in the nose landing gear (NLG) wheel well is collecting water and beginning to corrode.		
	<b>RECOMMENDED ACTION:</b> Drill a drain hole in the lowest spot and ensure an adequate drain path.  <p style="text-align: center;">(USE CONTINUATION SHEET IF NECESSARY)</p>		
C P A B  A C T I O N	<b>STATUS:</b> May 1989: MMKRA will include procedures for drilling the drain hole in a field level TCTO.  Nov 1989: MMKRA preparing ECO to document drain hole installation. Once ECO is submitted, MMKRTA will prepare TCTO to add drain hole and leveling compound.  16 Nov 1989: OC-ALC/MMKRA will submit document(s) to NAEWF E-3 Component illustrating location of rib.  12 March 1990: Investigation of drawings still being undertaken by MMKRA. TCTO will be prepared once investigation is complete. Location in question will be relayed to E-3A Component as soon as possible.  <p style="text-align: right;">(continued)</p>

NAEWF E-3A Comp. reported that A/C 0442 through 0453 has no drain hole but sealant. A/C 0454 through 0459 has drain hole but no sealant. MMKRA/552 AWACW will take action to inspect USAF aircraft.
