# E-3 AWACS CORROSION PREVENTION ADVISORY BOARD (CPAB)

12 JULY 1990  
TINKER AFB, OK

**E-3 CORROSION PREVENTION ADVISORY BOARD MINUTES  
12 JULY 1990**

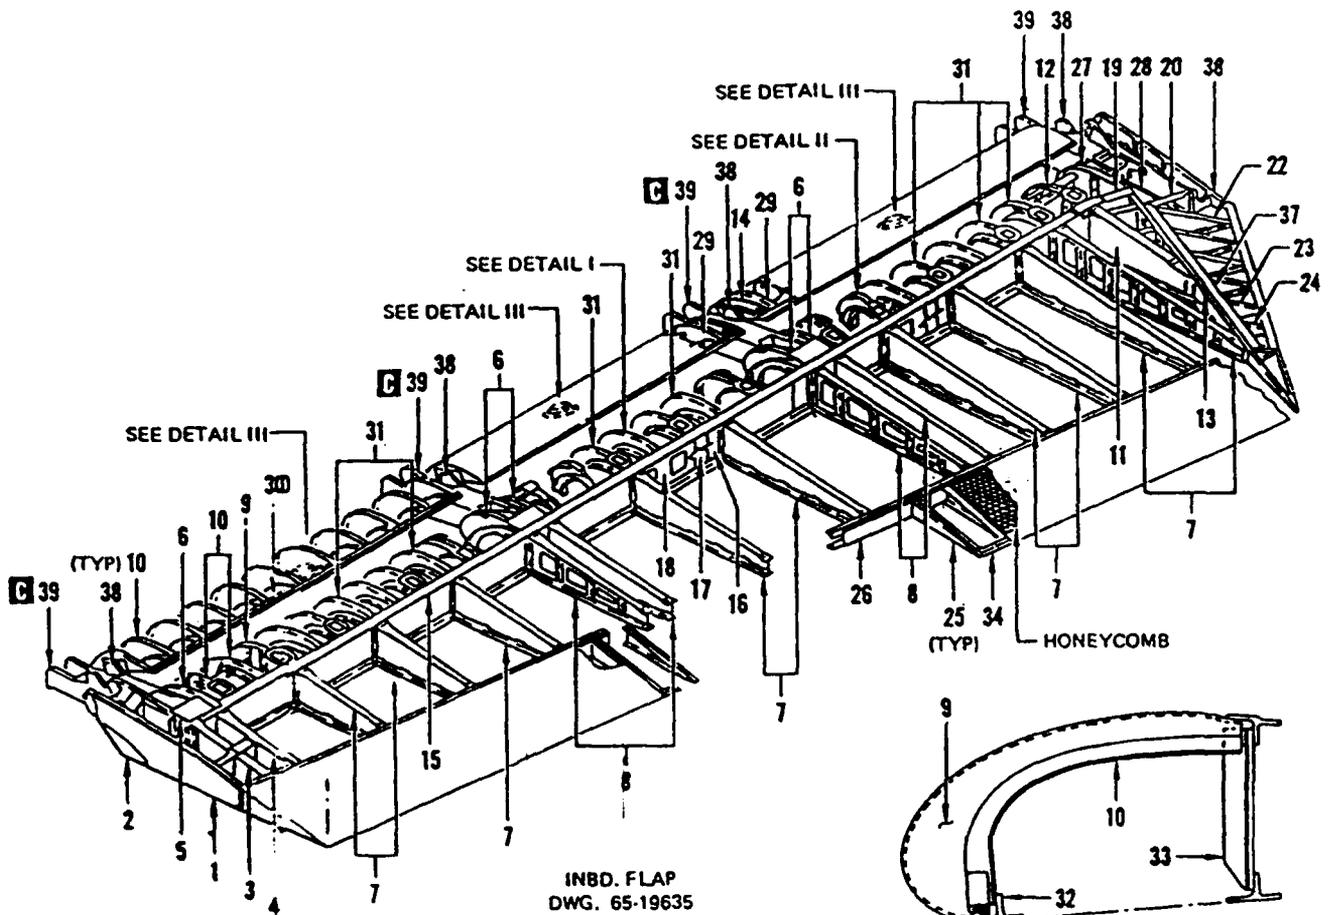
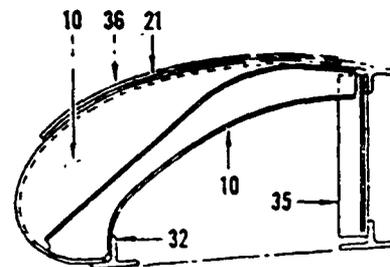
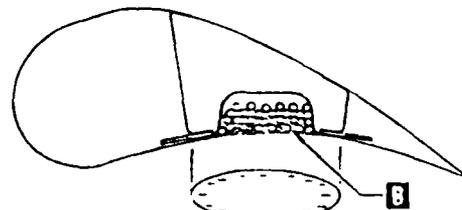
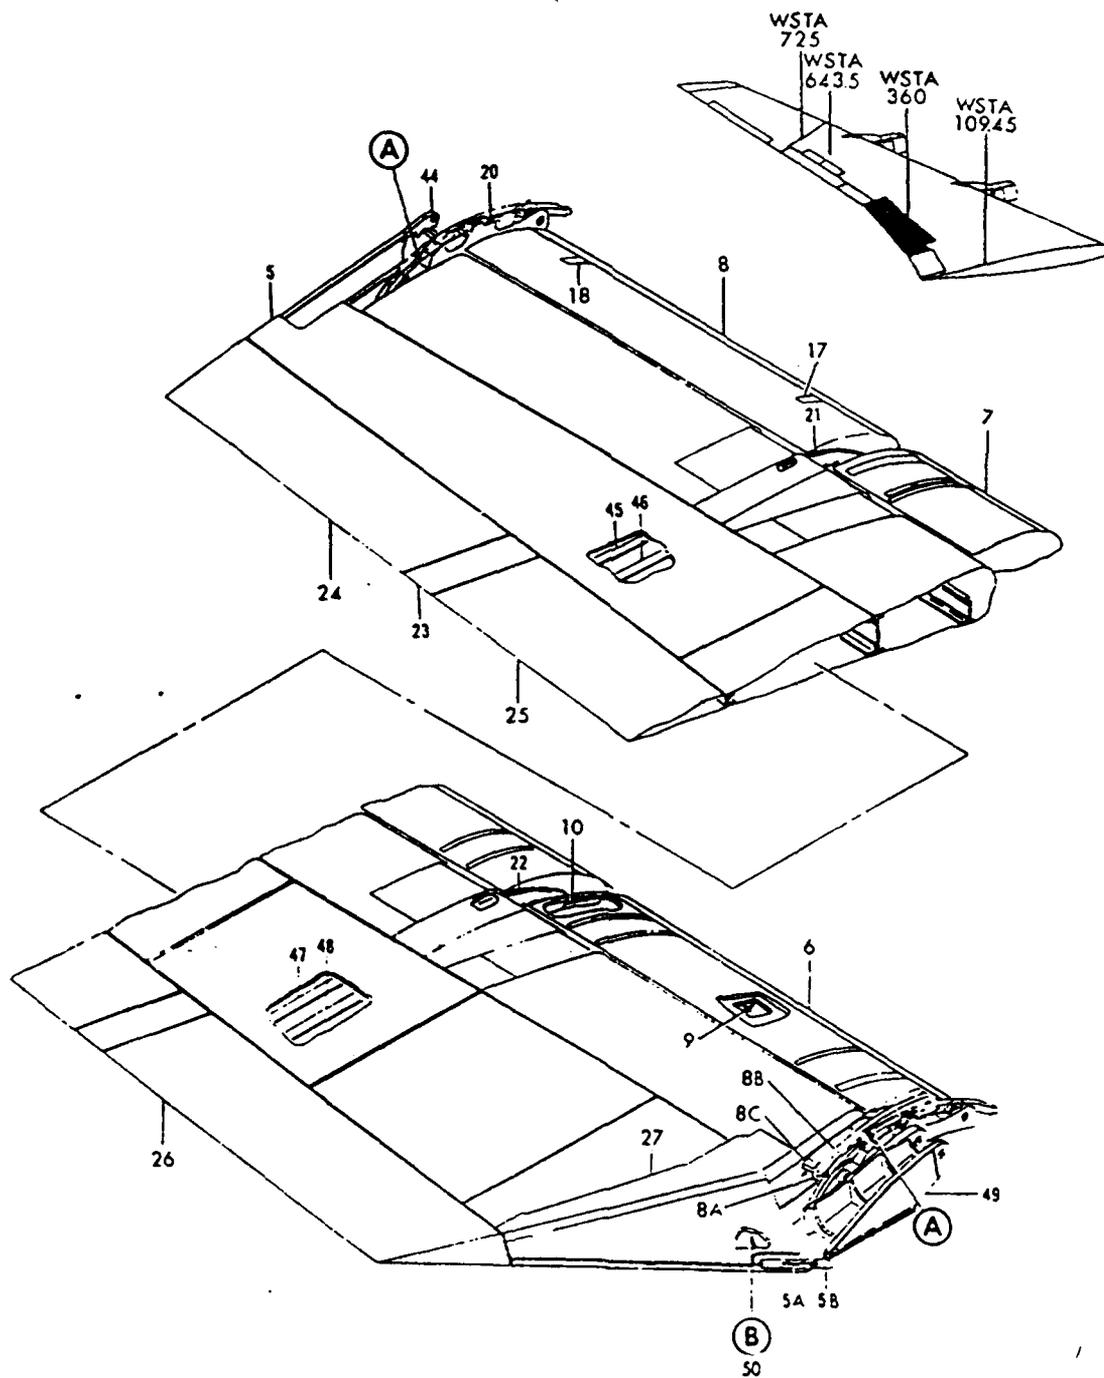
Figure 2-27. Wing Inboard Flap Structure Identification and Repair Index (Sheet 1 of 3)

E-3	CORROSION PREVENTION ADVISORY BOARD	ACTION ITEM #: 89-11
O R I G I N A L T O R	<b>SUBJECT:</b> Inboard Trailing Edge Flap	<b>BACKGROUND DATA:</b> <b>PART NUMBER:</b> 65-18441-61/-62 <b>NSN:</b> <b>DRAWING(S):</b>
	<b>NAME:</b> HFw Franz-Josef Deckers <b>ORGANIZATION:</b> NAEWF E-3 Comp. <b>TELEPHONE:</b> 01-49-2451-63-6215 <b>DATE SUBMITTED:</b> 16 NOV 1989	<b>TO(S):</b> 1E-3A-4-27-1 <b>FIGURE:</b> 27-06-12 <b>INDEX:</b> 23 <b>WORK UNIT CODE:</b>
	<b>PROBLEM:</b> Water is collecting in the inboard flap cavity. After removal of cover assy, 65-18441-33, excessive corrosion was found on the rivet nuts on bolt heads, as well as light corrosion on the flap structure. A/C 79-0454 and 79-0449 were inspected and the same condition was discovered.	
<b>RECOMMENDED ACTION:</b> Install drain holes in the inboard edge of the lower cover assembly  <p style="text-align: center;">(USE CONTINUATION SHEET IF NECESSARY)</p>

C P A B  A C T I O N	<b>STATUS:</b> 16 Nov 1989: OC-ALC/MMKRA will investigate, prepare ECO, and coordinate TCTO with OC-ALC/MMKRTA to install drain hole(s) as necessary to correct problem.  12 March 1990: No action has been taken yet by OC-ALC/MMKRA.  July 1990: OC-ALC/MMKRTA is generating a TCTO to inspect and install drain hole(s) as necessary. Kitproof/publication scheduled for late Sept 90.	
	<b>ACTION OPR(S):</b> OC-ALC/MMKRA	<b>POINT(S) OF CONTACT:</b> Lt. Jim Kihle
<b>STATUS:</b> OPEN <b>DATE CLOSED:</b> <b>FINAL DISPOSITION:</b>

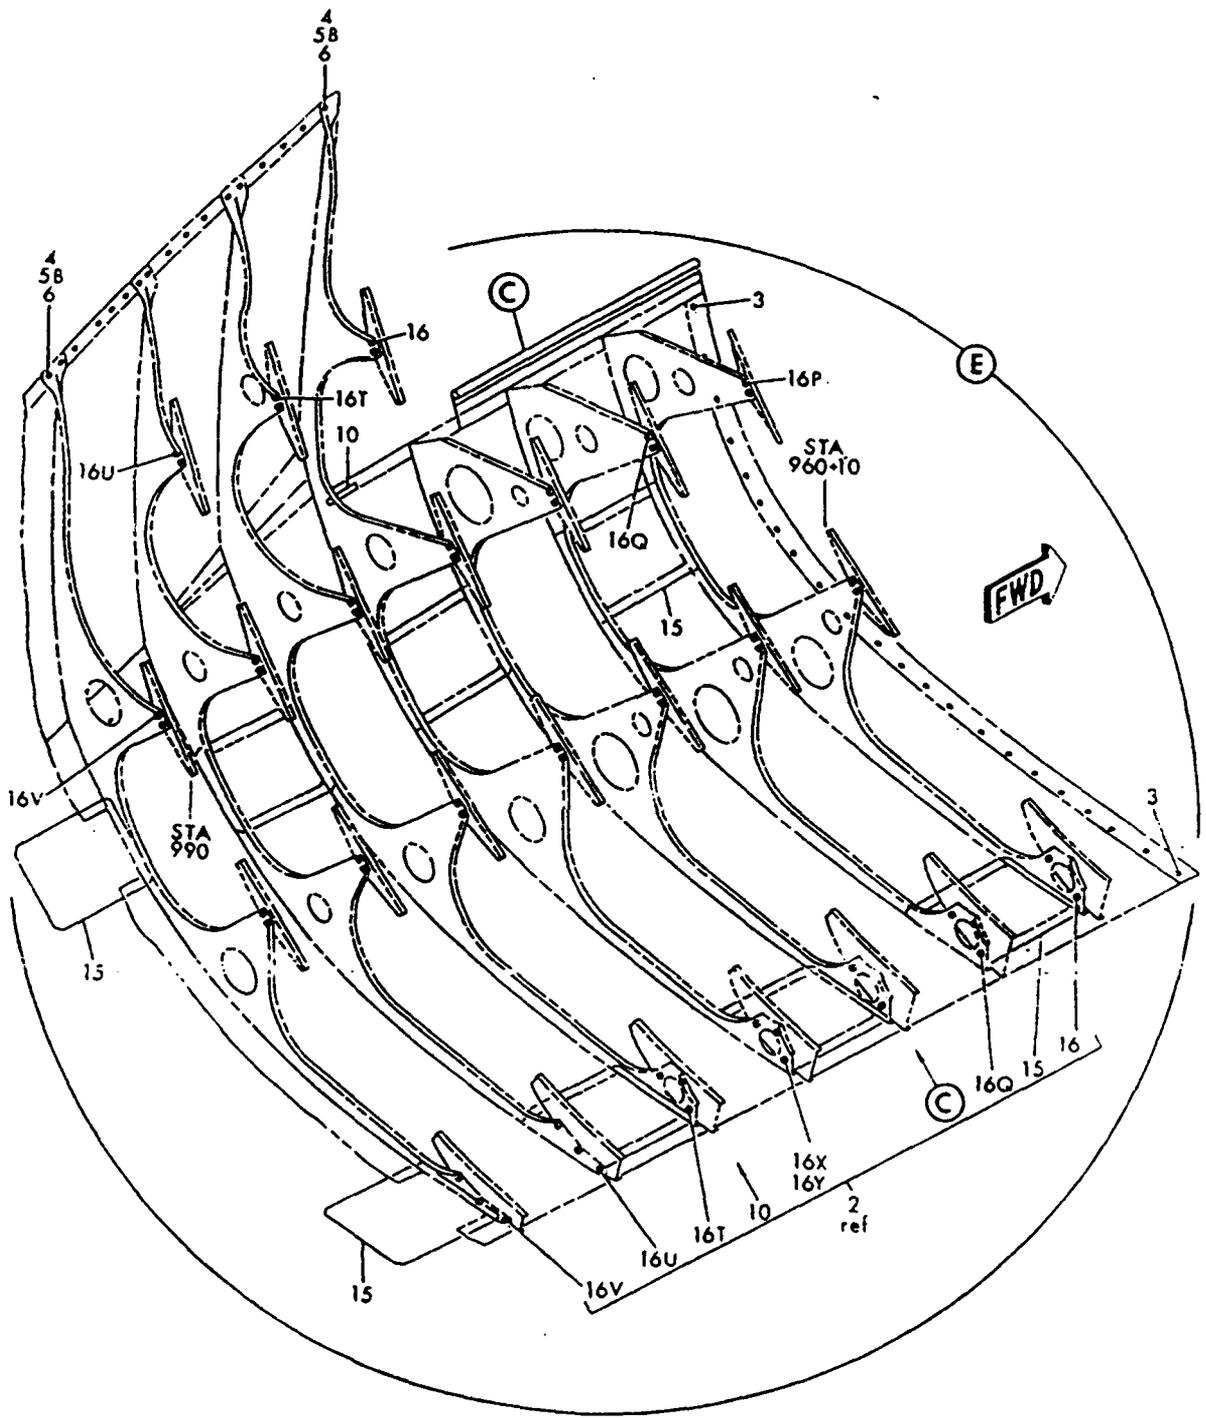
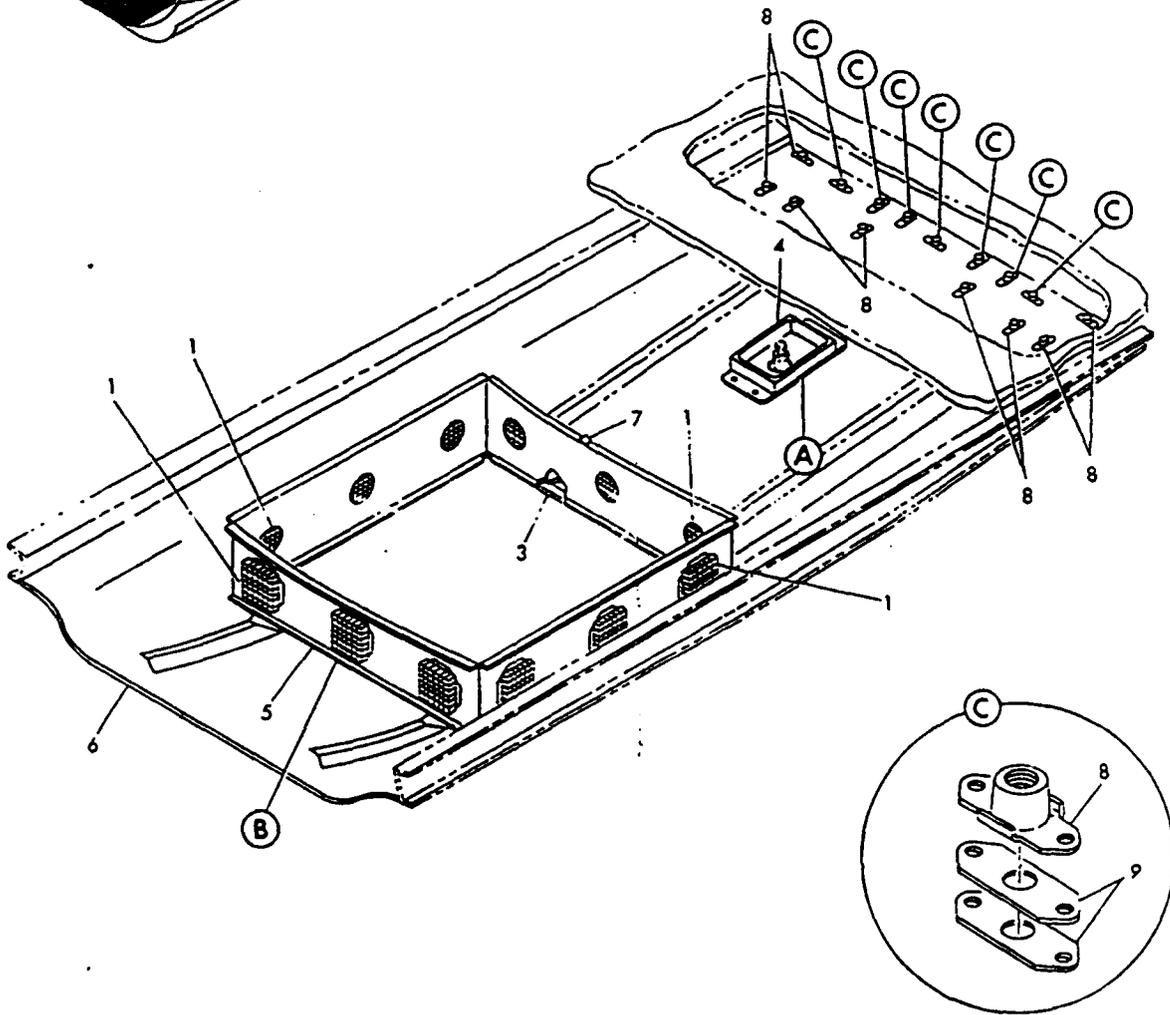
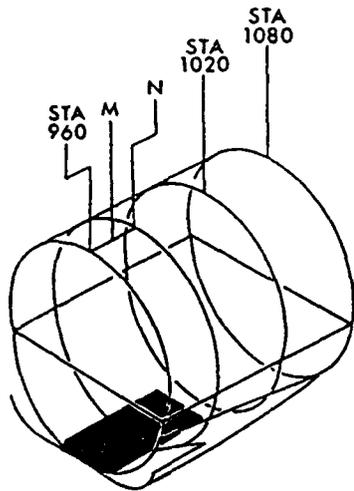
SEE NOTE ON PARTS LIST PAGES  
 FIGURE 17. FAIRING INSTL. STA 990 TO 1060 WING TO BODY (SHEET 3)

E-3	CORROSION PREVENTION ADVISORY BOARD	ACTION ITEM #: 89-12
O R I G I N A L T O R	<b>SUBJECT:</b> Fairing Installation STA 960 to 1020, Wing to Body	<b>BACKGROUND DATA:</b>  <b>PART NUMBER:</b> 65-22871-31  <b>NSN:</b> <b>DRAWING(S):</b>
	<b>NAME:</b> HFw Franz-Josef Deckers <b>ORGANIZATION:</b> NAEWF E-3 Comp. <b>TELEPHONE:</b> 01-49-2451-63-6215 <b>DATE SUBMITTED:</b> 16 NOV 1989	<b>TO(S):</b> 1E-3A-4-53-1 <b>FIGURE:</b> 53-02-7A <b>INDEX:</b> 48 <b>WORK UNIT CODE:</b>
	<b>PROBLEM:</b> Water is collecting in the wing to body fairing. Existing drain holes in the lower frame are too high, resulting in water level being 1/2" high before draining.	
<b>RECOMMENDED ACTION:</b> Install drain holes in the lowest spot of both wing to body fairings.  (USE CONTINUATION SHEET IF NECESSARY)		
C P A B  A C T I O N	<b>STATUS:</b> 16 Nov 1989: OC-ALC/MMKRA will investigate problem, prepare ECO, and coordinate TCTO with OC-ALC/MMKRTA to install drain hole(s) to correct problem.  OC-ALC/MMKRA will also investigate related water collection problem with the doppler velocity sensor cavity aft of the MLG wheel wells.  12 March 1990: ECO's documenting additional drain holes have been submitted by MMKRA. OC-ALC/MMKRTA is preparing a TCTO to install the drain holes. Once installed, drainage should be sufficient to correct water retention problems in the fairings and the doppler velocity sensor cavity.  July 1990: TCTO is being written by MMKRTA and will be finished by next CPAB. 552 AWACW/MAQ is setting up kitproofing.

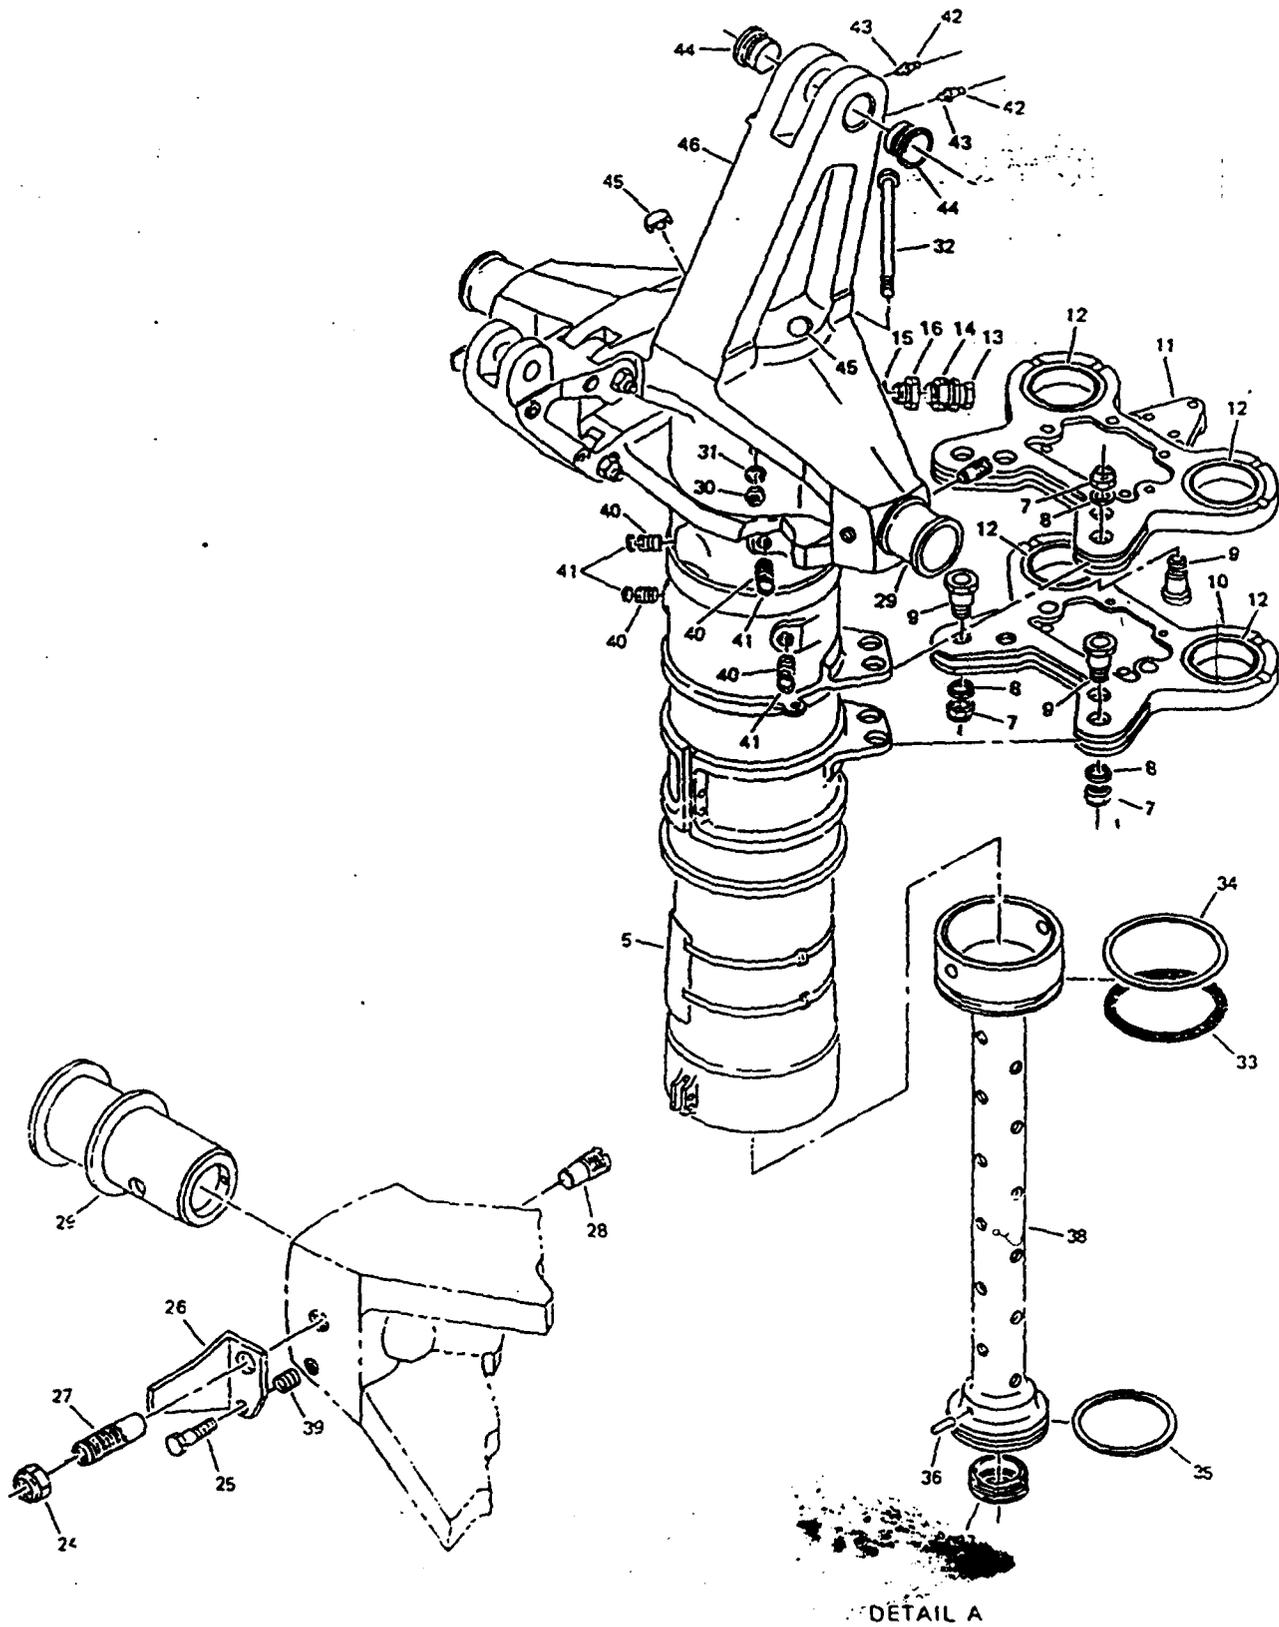
E-3	CORROSION PREVENTION ADVISORY BOARD		ACTION ITEM #: 89-14
O R I G I N A L T O R	<b>SUBJECT:</b> Nose Landing Gear Trunnion and Bearing Assembly	<b>BACKGROUND DATA:</b>  <b>PART NUMBER:</b>  <b>NSN:</b> <b>DRAWING(S):</b>	
	<b>NAME:</b> HFw Franz-Josef Deckers <b>ORGANIZATION:</b> NAEWF E-3 Comp. <b>TELEPHONE:</b> 01-49-2451-63-6215 <b>DATE SUBMITTED:</b> 16 NOV 1989	<b>TO(S):</b> 1E-3A-4-32-1 <b>FIGURE:</b> 32-03-23 <b>INDEX:</b> 18/19 <b>WORK UNIT CODE:</b>	
	<b>PROBLEM:</b> During lubrication of NLG trunnion, it was noted that no grease could be applied. After removal of lower NLG trunnion fitting caps and bearing halves, it was discovered that the grease channel of the lower bearing halves were clogged. Trunnions had slight surface corrosion.		
	<b>RECOMMENDED ACTION:</b> 1) Add to phase every 1380 hours to remove lower trunnion fitting caps and inspect bearing and trunnion, 2) Accomplish lubrication more frequently, and 3) Change grease from present MIL-C-21165 to MIL-G-23827 for all grease locations on landing gear. (USE CONTINUATION SHEET IF NECESSARY)

C P A B  A C T I O N	<b>STATUS:</b> Nov 1989: Based on findings, E-3A Component has initiated a one time inspection (OTI).  16 Nov 1989: OC-ALC/MMKRA will investigate problem and make Tech Order changes as necessary.  12 March 1990: A cost estimate of an EST is being developed by Boeing to investigate applying a dry film lubricant to the surfaces of the bearing. If this is feasible, existing grease holes will be plugged and frequent lubrication will no longer be required.  July 1990: MMKRA will pursue testing locally before submitting an EST to Boeing.		
	<b>ACTION OPR(S):</b> OC-ALC/MMKRA	<b>POINT(S) OF CONTACT:</b> Jon Kimmel	<b>EST. COMPLETION DATE:</b>
<b>STATUS:</b> OPEN <b>DATE CLOSED:</b> <b>FINAL DISPOSITION:</b>
