# The Chemical Resistance of Epoxy Adhesive Joints Exposed to Aviation Fuel and its Additives

**Air Vehicles Division**  
**Platforms Sciences Laboratory**

DSTO-TR-1650

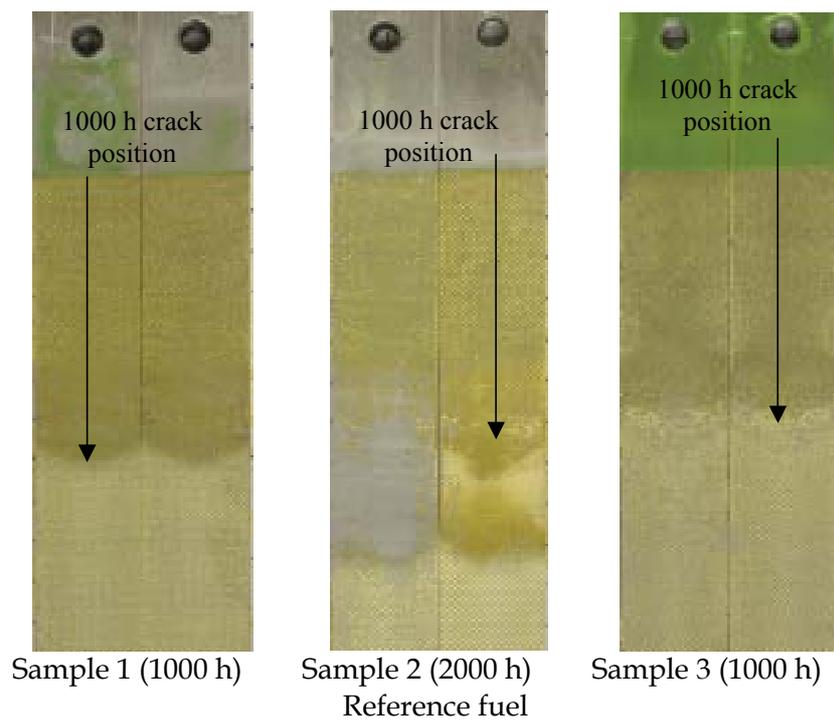
Figure 10 shows the failure surfaces resulting from the three samples exposed to the reference fuel for 1000 and 2000 hours exposures. Whilst samples 1 and 3 exhibit predominantly cohesive failure within the FM73 layer, sample 2 shows that exposure for an additional 1000 hours actually results in extended crack growth. The extended crack growth in sample 2 also appears to propagate interfacially, between the adhesive and metal, as indicated by the metallic appearance of the left hand side sample.

Figure 10 Failure surfaces of LCE samples exposed to the reference fuel for 1000 and 2000 hours indicating the crack length after 1000 hours.

Failure surface inspection of the LCE samples (Figure 10 to Figure 15) also revealed a correlation between the level of degradation in joint fracture toughness and the level of interfacial failure between the adhesive and metallic layers. The DGME/water exposed samples (Figure 13) showed high levels of adhesion failure in the samples which exhibited the highest levels of crack growth. The cumene hydroperoxide samples (Figure 15) showed areas where corrosion of the underlying aluminium has progressed to a greater extent on the sample with the greater crack growth. Interestingly, the reference fuel sample (Figure 10) that was exposed for 2000 hours showed a substantial region of apparent interfacial failure that had occurred during the second two thousand hours. Similarly, the DCI-4A and fuel exposed sample (Figure 11) also showed an increase in interfacial failure during the second two

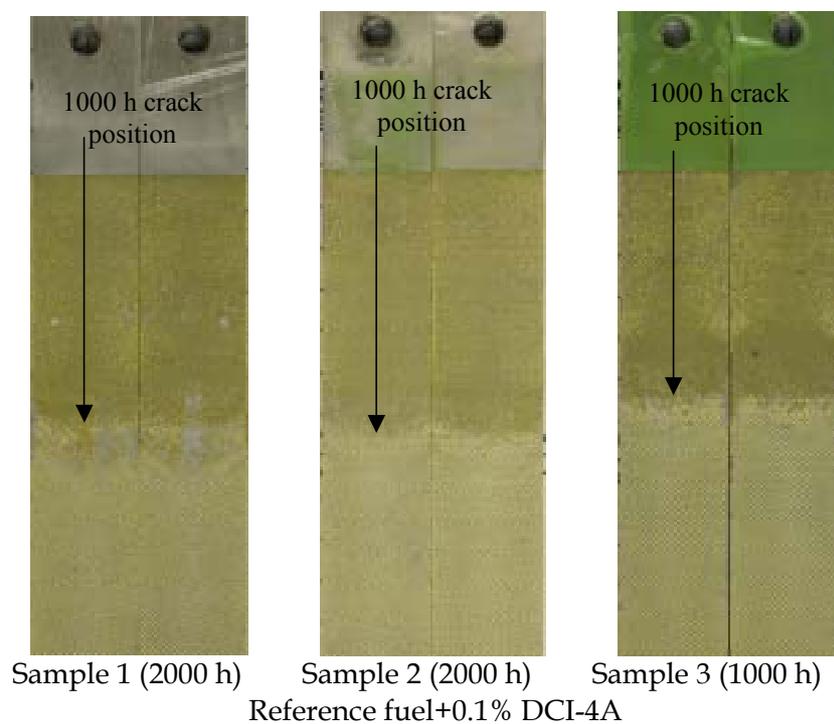
Figure 11 shows the failure surfaces for the LCE samples exposed to the reference fuel + 0.1% DCI-4A for 1000 and 2000 hours indicating the crack length after 1000 hours. Generally, there appears to be less "adhesion" failure on these samples, although sample 1 shows some interfacial failure particularly in the area where cracking has occurred in the second 1000 hours, similar to the trend observed with the reference fuel.

Figure 11 Failure surfaces of LCE samples exposed to the reference fuel + 0.1% DCI-4A for 1000 and 2000 hours indicating the crack length after 1000 hours.

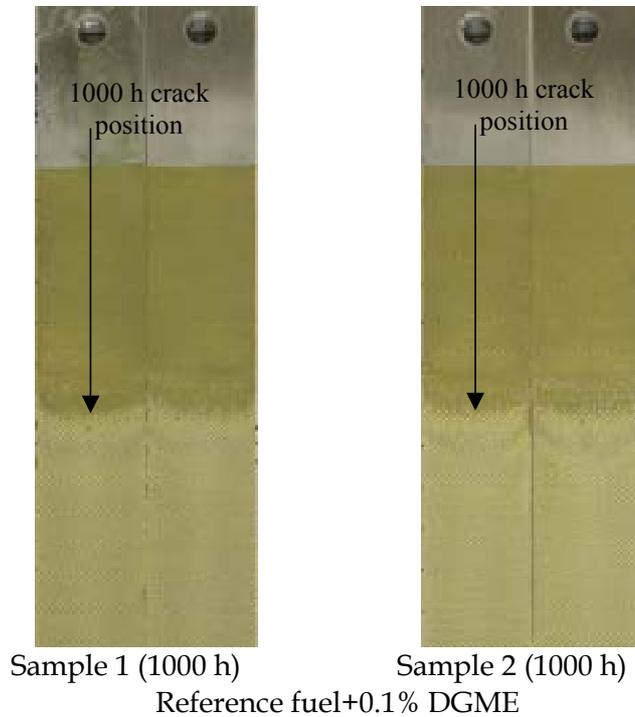
Figure 12 shows the failure surfaces for the LCE samples exposed to the reference fuel + 0.1% DGME for 1000 hours, indicating the crack length after 1000 hours. Generally, there appears to be cohesive failure within the FM73 layer for these samples.

Figure 12 Failure surfaces of LCE samples exposed to the reference fuel + 0.1% DGME for 1000 hours, indicating the crack length after 1000 hours.

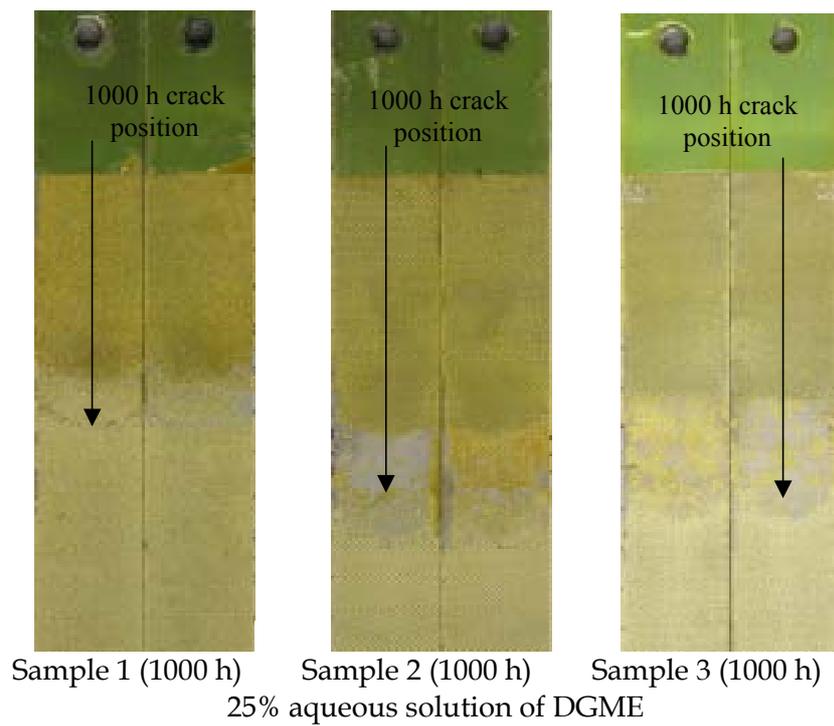
Figure 13 shows the failure surfaces of LCE samples exposed to a 25% aqueous solution of DGME for 1000 hours, indicating the crack length after 1000 hours. Samples 2 and 3 show obvious regions of failure at the adhesive and metal interface, suggesting that cracking has proceeded in this region due to degradation of the adhesive bonds. The first sample contains less evidence of the interfacial failure in the cracking region, although some adhesion failure has occurred.

Figure 13 Failure surfaces of LCE samples exposed to the 25% aqueous solution of DGME for 1000 hours, indicating the crack length after 1000 hours.

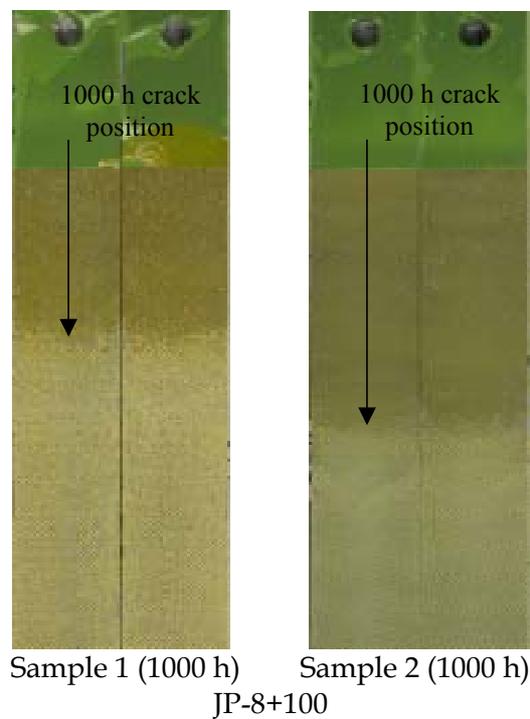
Figure 14 shows the failure surfaces of LCE samples exposed to the JP-8+100 for 1000 hours, indicating the crack length after 1000 hours. Neither sample indicates any substantial regions of adhesion failure, however, the crack length of the two samples is substantially different. As discussed in section 3.2 there appears to be no obvious reason for the differences in crack length of the two specimens.

Figure 14 Failure surfaces of LCE samples exposed to the JP-8+100 for 1000 hours, indicating the crack length after 1000 hours.

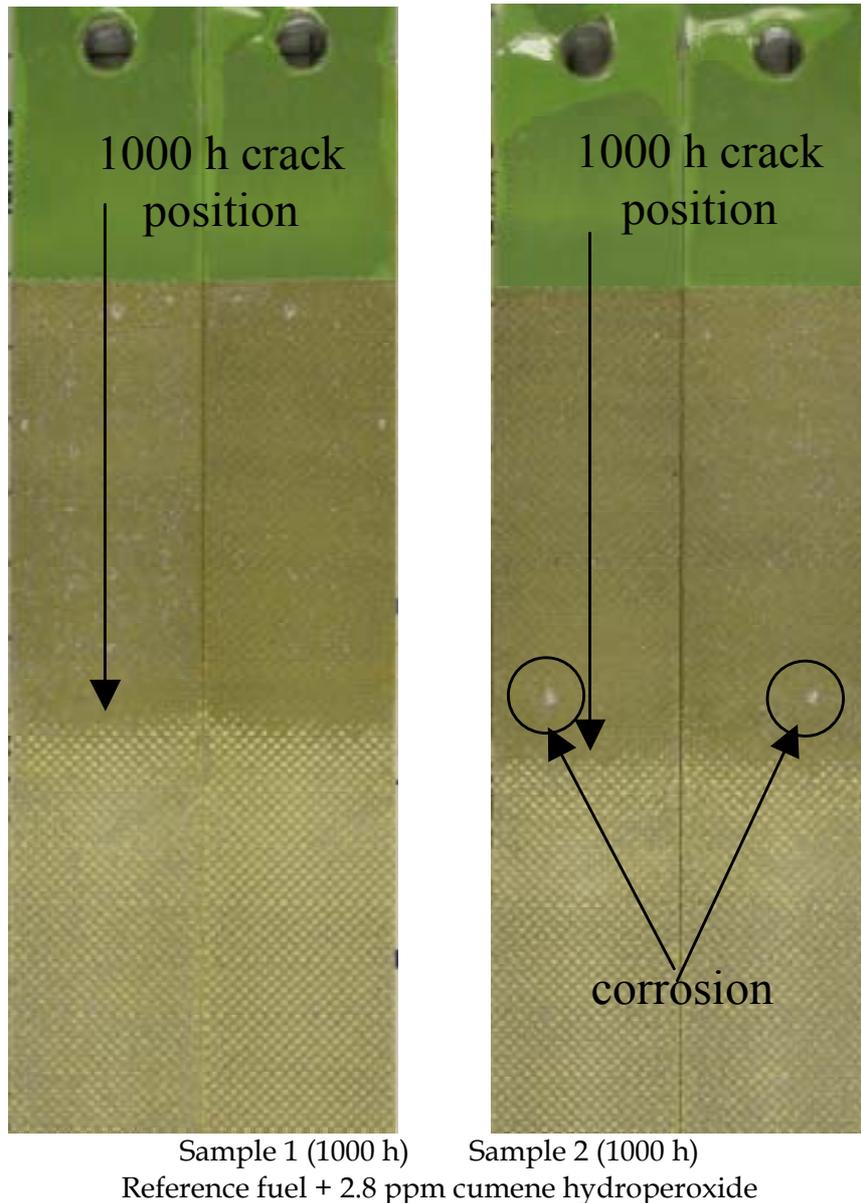
Figure 15 shows the failure surfaces of LCE samples exposed to the reference fuel + 2.8ppm cumene hydroperoxide for 1000 hours, indicating the crack length after 1000 hours. Neither sample indicates any substantial regions of adhesion failure, although there appear to be a number of smaller regions where the metal has been attacked and pulled out during fracture. A higher magnification area of such an area is shown in Figure 16. Whilst similar areas of corrosion were observed in some of the other samples, the samples exposed to the reference fuel + 2.8ppm cumene hydroperoxide appeared to have a greater number of such regions.

Figure 15 Failure surfaces of LCE samples exposed to the reference fuel + 2.8ppm cumene hydroperoxide for 1000 hours, indicating the crack length after 1000 hours.

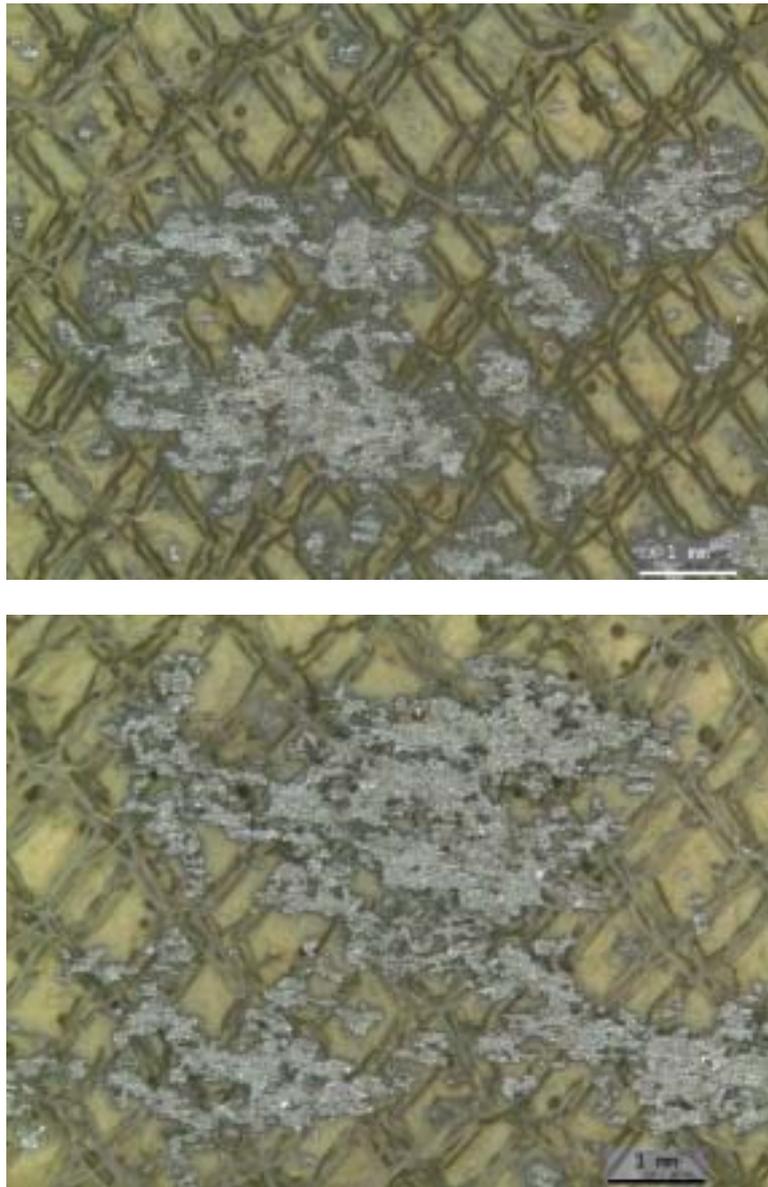
Figure 16 High magnification image of the corrosion region highlighted in Figure 15 for the LCE samples exposed to the reference fuel + 2.8ppm cumene hydroperoxide.

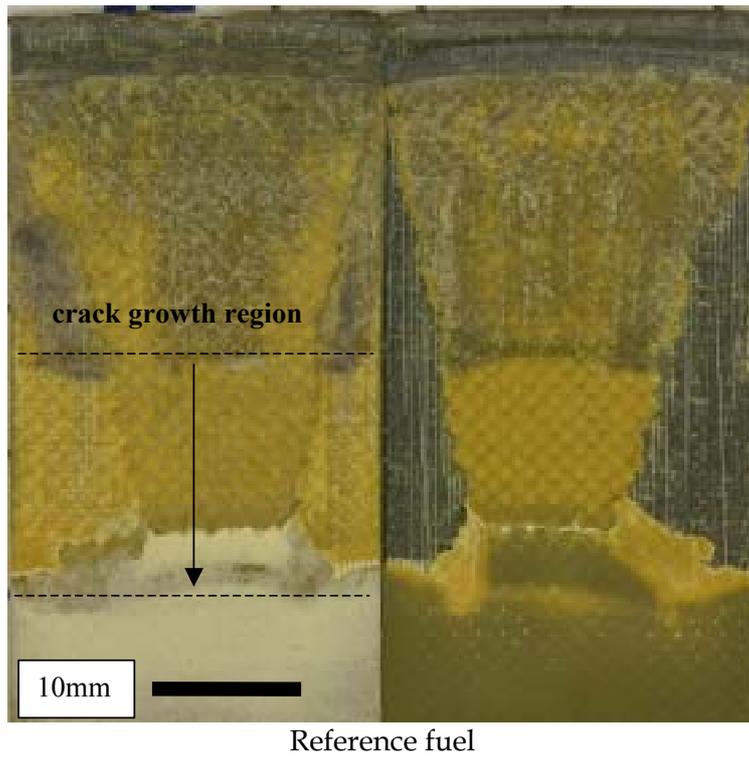
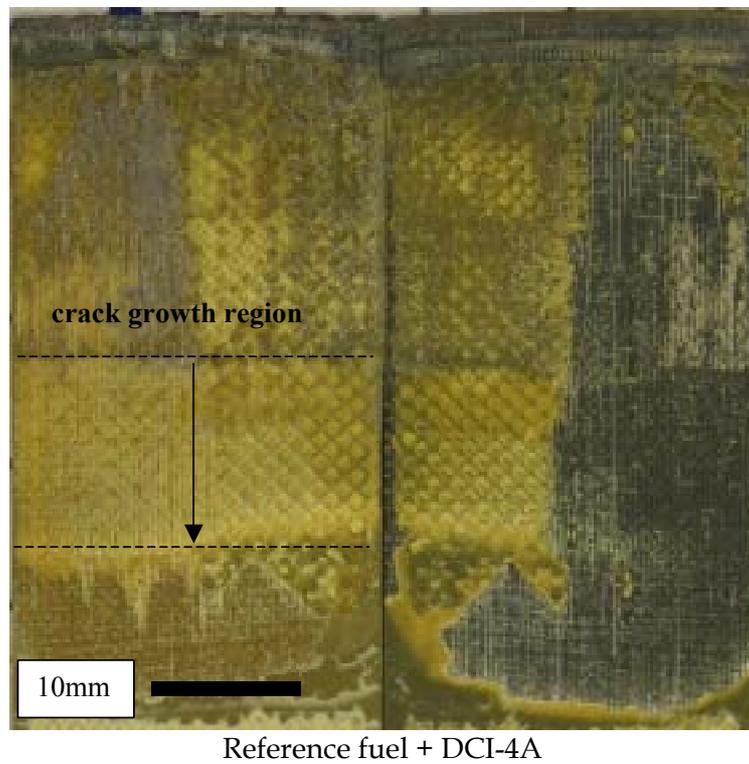
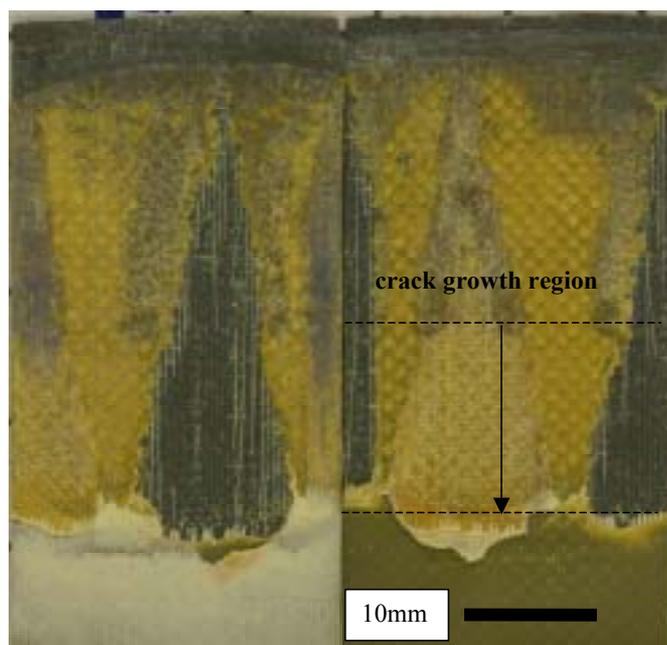
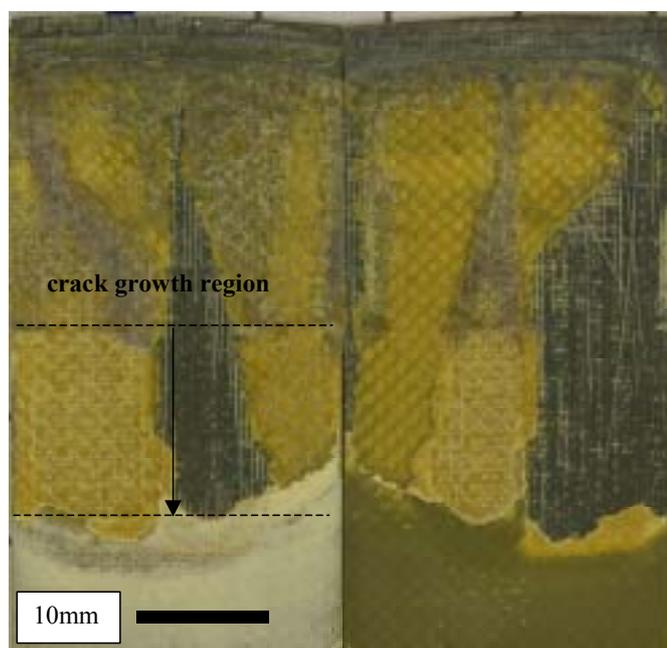
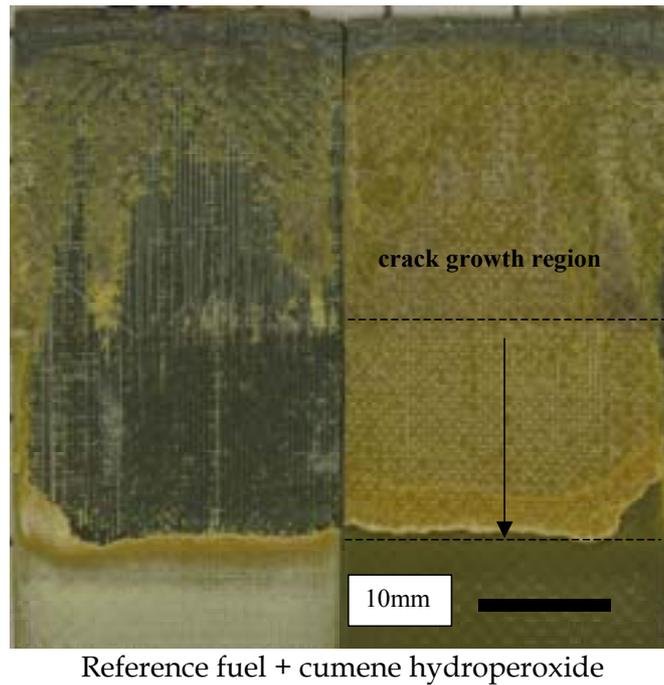
Figure 18 to Figure 22 show the failure surfaces for the boron double cantilever beam specimens exposed to the reference fuel and additives for 1000 hours. In all samples the fracture appears to propagate either between the FM73 layers or within the boron composite resin layer adjacent to the FM73 layers. The support scrim in the 5521/4 resin has been exposed during fracture supporting the conclusion that fracture has propagated through the composite resin. The relative percentage of failure in the resin appears to increase from Figure 18 to Figure 22, with the cumene hydroperoxide sample showing almost 100% failure through the 5521/4 layer.

The BDCB samples fracture analysis was complicated by mixed modes of fracture observed for all samples. Failure appeared to propagate either within the FM73 layers or within the 5521/4 layer adjacent to the FM73 layer. The brittle 5521/4 resin matrix is susceptible to fracture when cleavage stresses are induced during the wedge style test and it is difficult to correlate failure modes with fracture toughness values calculated in Table 4. The fracture toughness calculation is also dependent on the adhesive modulus and as fracture propagates into the resin layer this value clearly changes from that used for FM73 [15]. Visual examination of the failure surfaces (section 3.6) suggests that the DGME/water and cumene hydroperoxide/ reference fuel samples have the highest amount of failure within the resin layer. However, the fracture toughness of the BDCB specimens, in general, does not appear to be directly related to percentage of failure within the 5521/4 layer.

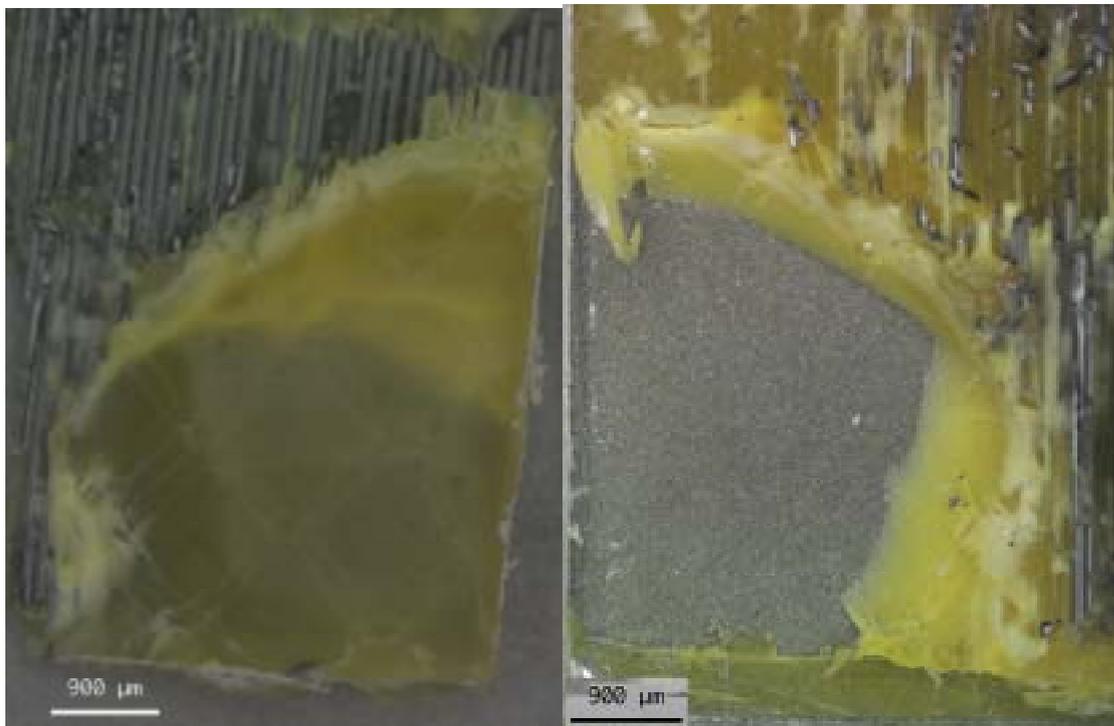
Figure 24 shows the failed surfaces produced by the fatigued boron-aluminium sample immersed in the reference fuel for 283 days prior to testing. The fracture has propagated from the corner and close to the FM73 and metal interface. This locus of failure was also observed for similar specimens that were unconditioned. However, the unconditioned samples also failed at a lower load, around 26kN[16].

Figure 24 Failure surfaces of the fatigued boron-epoxy SDS immersed in the reference fuel for 283 days prior to testing.

Previous work on SDS specimens manufactured using metallic patches[17] provided a similar failure mode to that observed for the boron SDS specimens (Figure 24). In the metallic patched SDS samples, theoretical modelling indicated that peel stresses played a significant role in influencing the fatigue resistance of the adhesive joints loaded in tension. Substantial improvements in fatigue resistance could be achieved by reducing the peel stresses of the SDS specimens by decreasing the taper angle of the patch. In the case of boron SDS specimens, an increase in the fracture toughness of the adhesive, caused by fuel uptake, may lead to a similar effect in helping to reduce peel stresses.
