1. REPORT DATE (DD-MM-YYYY) 19-05-2010		2. REPORT TYPE Technical Paper & Briefing Charts		3. DATES COVERED (From - To)	
4. TITLE AND SUBTITLE AFRL Solid Propellant Laboratory Explosive Siting and Renovation Lessons Learned				5a. CONTRACT NUMBER	
				5b. GRANT NUMBER	
				5c. PROGRAM ELEMENT NUMBER

6. AUTHOR(S) Daniel F. Schwartz (AFRL/RZSP)				5d. PROJECT NUMBER	
				5e. TASK NUMBER	
				5f. WORK UNIT NUMBER 50260541	
7. PERFORMING ORGANIZATION NAME(S) AND ADDRESS(ES) Air Force Research Laboratory (AFMC) AFRL/RZSP 10 E. Saturn Blvd. Edwards AFB CA 93524-7680				8. PERFORMING ORGANIZATION REPORT NUMBER AFRL-RZ-ED-TP-2010-258

AFRL Solid Propellant Laboratory Explosive Siting and Renovation Lessons Learned

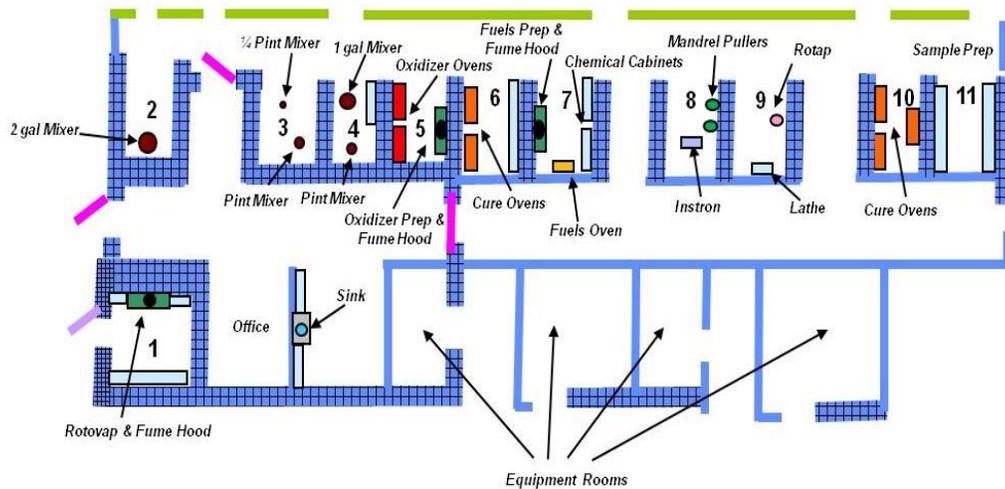
Figure 1. Bldg 8473 Pre-Renovation Layout

Before the renovation, Bldg 8473 consisted of eleven reinforced concrete cells with blow-out rear walls, explosion resistant windows and remote manipulators (Cells: 1-4, 8, 9 and 11). The basic operations consisted of: mixing, casting and curing of high energy solid propellants. Remote operations were performed behind blast walls in the hallways while looking through explosion resistant glass windows. The basic layout is shown in Figure 1.

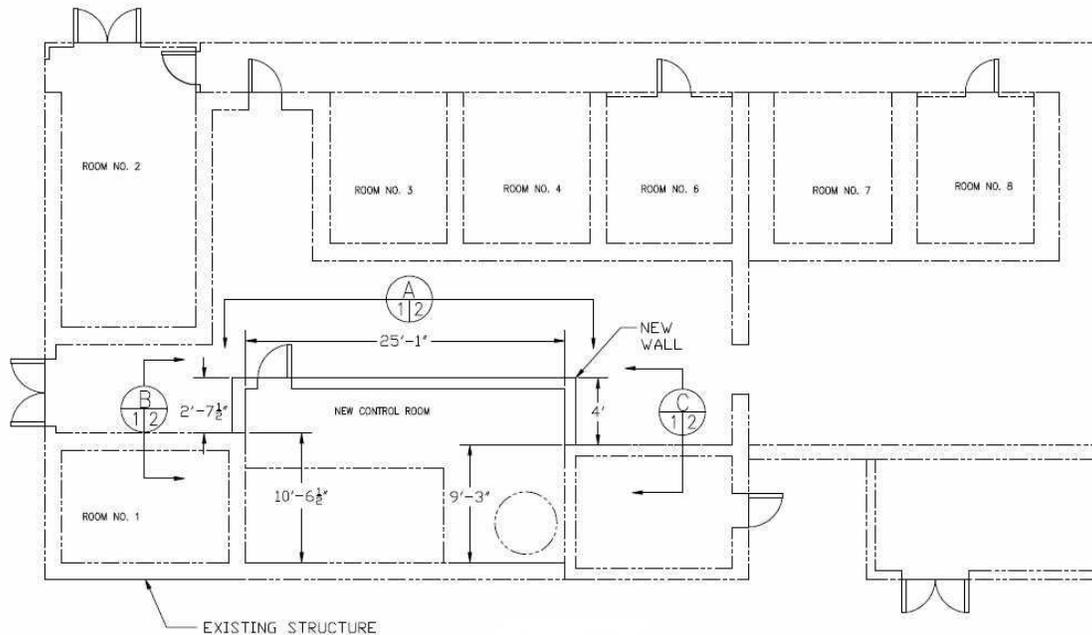
Figure 1. Proposed layout of the new hardened control room

The final AES design of the hardened control room and blast door were reviewed and endorsed by NAVFAC ESC “The hardened control room walls and blast door are designed to sufficiently resist any fragments and residual leakage blast pressure generated by an accidental explosion from one of the test cells. The blast door is the DB-200 Model from Protective Door Industries, has a minimum ultimate unit resistance of 3 psi and large ductility capabilities to attain large deflections, would be loaded in the seated direction, and has a custom door frame and anchors designed specifically to resist the blast loads and develop the full resistance of the door.”

The scope of the NAVFAC ESC contract was expanded to include a preliminary design of a hardened control room to protect personnel from blast and fragment hazards. The NAVFAC ESC design was for an 8-inch reinforced concrete wall composed of 4 ksi concrete with #4 bars spaced at 12 inches on center each way for each face, anchored into the existing reinforced concrete walls and a 3 psi rated blast door. The general layout of the control room proposed by NAVFAC ESC is shown in Figure 1. AES was tasked to provide a detailed design with inputs from NAVFAC ESC.

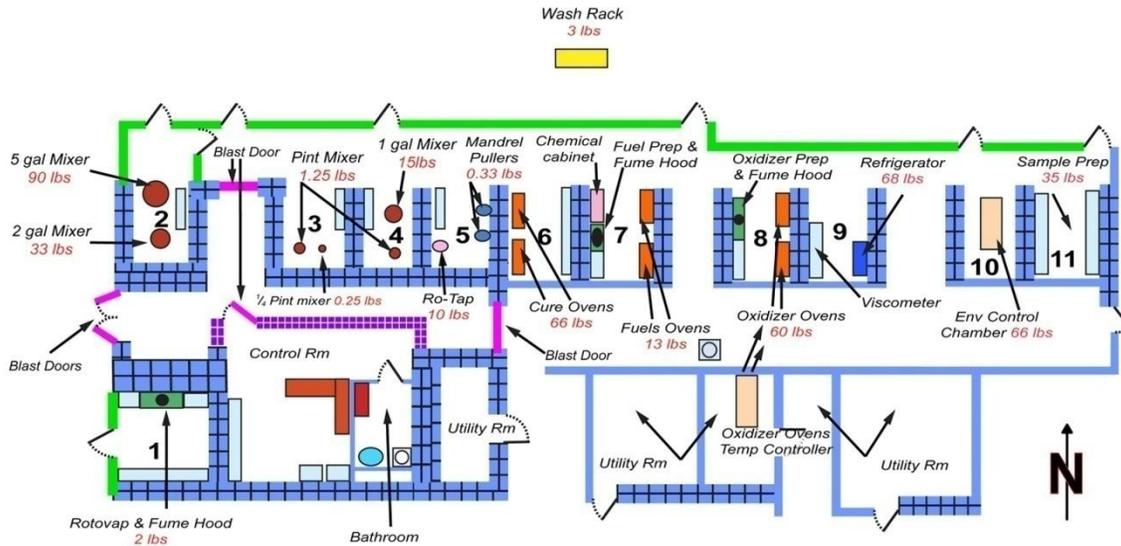
Figure 3. Bldg 8473 Post-Renovation Layout

After the renovations, the remote operations (cells 2-5) will be controlled from the hardened control room using an Allen-Bradley programmable logic controller (PLC) system. The post-renovation layout showing the operations and HD 1.1 quantities for all cells is shown in figure 3.
