COMPARISON OF BULLET RESISTANCE OF NEW AND AGED POLY-CARBONATE

J. B. R. Heath, R. W. Gould, and  
E. B. Stimson, National Research  
Council of Canada

ABSTRACT

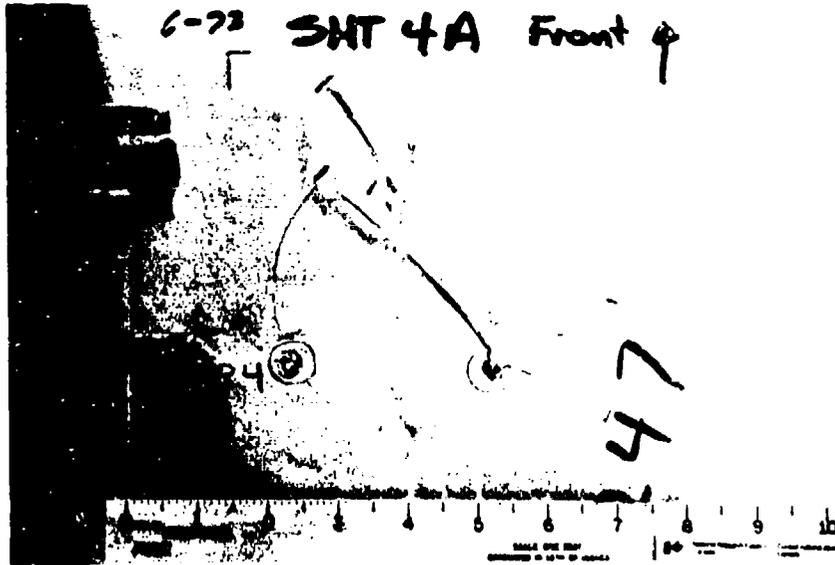
FIG. 28 TESTS 23 TO 25 - PANEL P1 - PART II

In tests 23 to 25, with impact spacing similar to that on new material 8 x 8 panels, fracturing occurred in the naturally aged (8 year) material on the second impact, with major damage occurring on the third as shown in Figures 28 and 29. As a result of the damage from the third impact, a fourth would obviously result in bullet penetration of both panels. The aged panels suffered major damage on the third impact compared to the new material, where major damage occurred on the fourth impact in two cases and on the sixth in one case.

Signs of material degradation occurred with the 8 year old 8 x 8 panels (Tests 23, 24 and 25). Fracturing of the outer panel resulted on the second impact, while with the new material 8 x 8 panels the outer panel did not fracture until the third impact in two cases and on the fifth impact in one case.

(a) DAMAGE AS A RESULT OF TEST 24

(b) DAMAGE AS A RESULT OF TEST 25

Obviously more work should be undertaken with naturally aged material, preferably with 12 x 12 panels to minimize possible panel size effects.

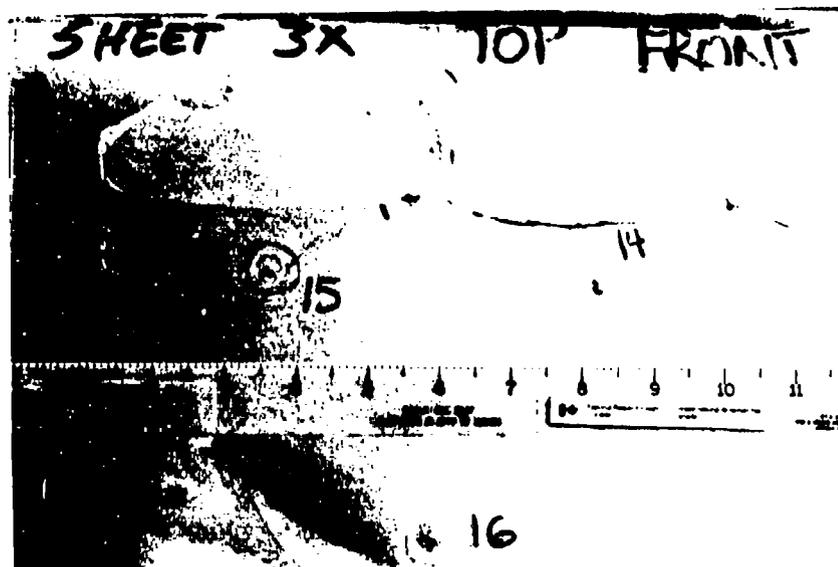
FIG. 31 TESTS 14 TO 16 - PANEL P1 - PART II

The results of the impacts carried out on these panels were very inconsistent. New material that had been heat aged six months prior to the ballistic tests suffered major damage after just one or two impacts. In Test 3 a large section of panel 2 separated as a result of the single impact. The damage is shown in Figure 30. Fracturing occurred in panel 1 (Test 14, 15 and 16) on the second impact and major damage occurred on the third (Test 16) as shown in Figure 3.

The results from the tests carried out on this material were inconsistent. Material that had been heat aged six months prior to ballistic testing showed degradation as major damage occurred to test panels on only the first or second impact (Tests 14, 15 and 16). However, material that had been heat aged days prior to testing showed no signs of degradation (Tests 40 to 49). This material should be tested at some future date to see if degradation continues after the heat aging process.

(a) DAMAGE AS A RESULT OF TEST 15

(b) DAMAGE AS A RESULT OF TEST 16
