TITLE: Minutes of the Explosives Safety Seminar (22nd) Held in Anaheim,
California on 26-28 August 1986. Volume 2.

SUPPRESSION OF PROPAGATION BETWEEN STACKS OF BOMBS

KENNETH R. SHOPHER

EXPLOSIVES SAFETY BRANCH
AIR FORCE INSPECTION AND SAFETY CENTER
NORTON AIR FORCE BASE, CALIFORNIA

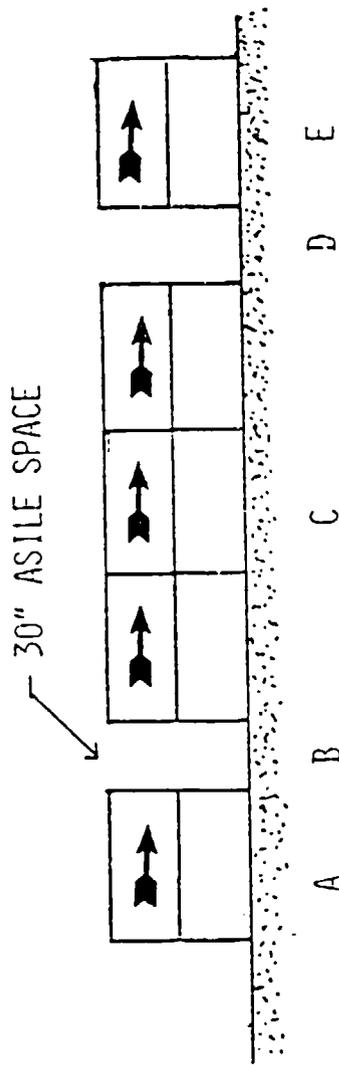
TEST NUMBER: 1

RESULTS: All bombs detonate.

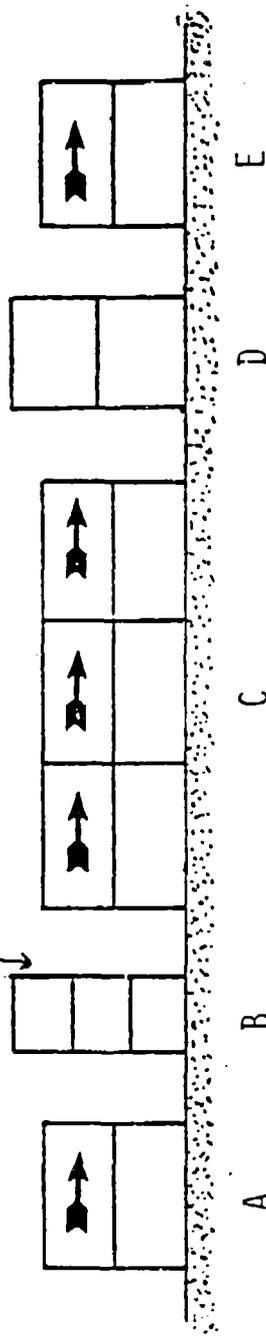
RESULTS: One bomb on CBU side functioned low order, all others survive.

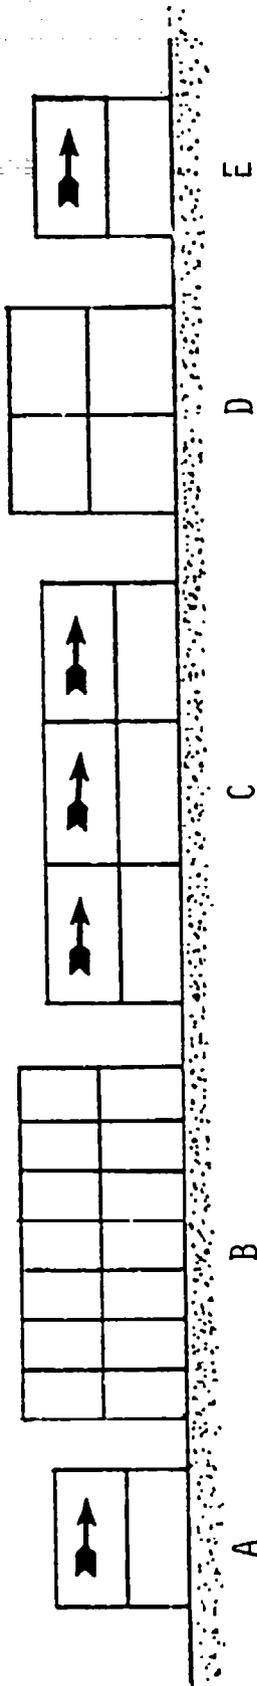
TEST NUMBER: 3

RESULTS: Bombs on fin side survive, bombs on 20 MM side detonate.

CONCLUSIONS: None. Why did less sensitive bombs fail when more of the same buffer was used? Did the change from 24 acceptors to 36 increase the probability of a lethal fragment? Continue testing with 36 acceptors. Stagger the rows of buffer horizontally so no line of sight exists between columns of acceptors.

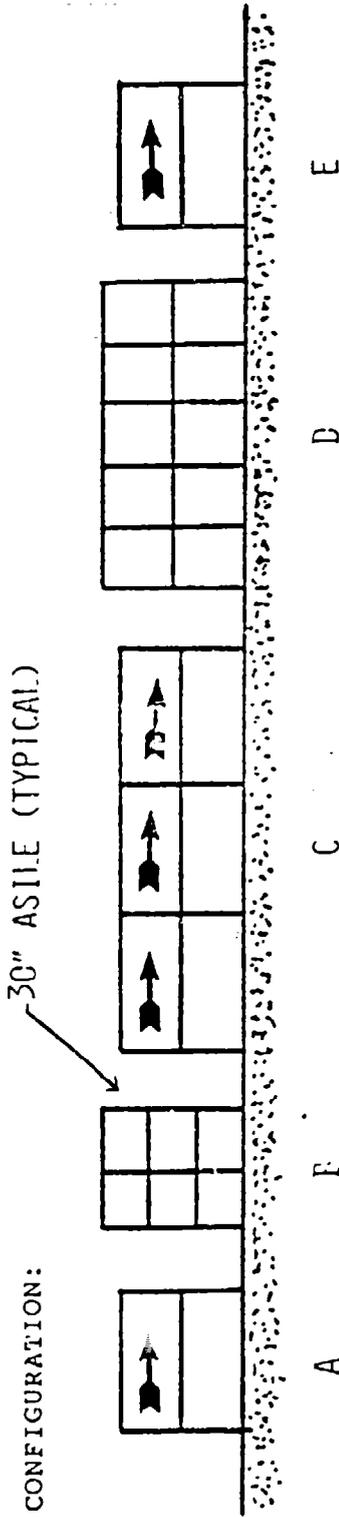
TEST NUMBER: 4

RESULTS: Bombs on CBU side detonate, bombs on fin side survive.

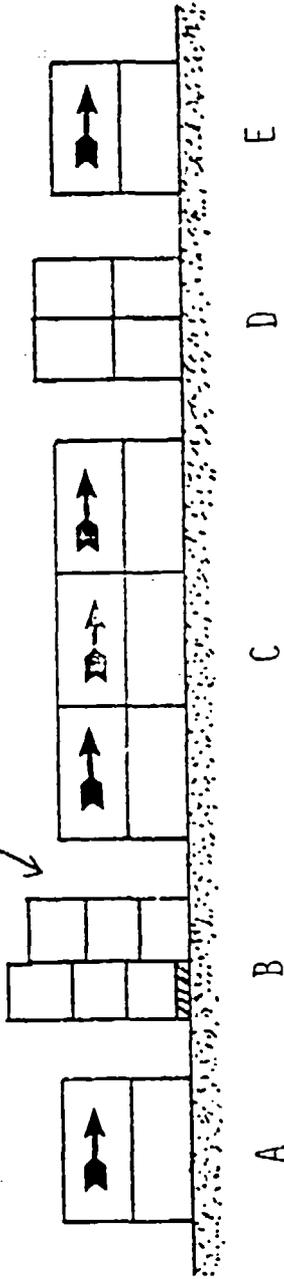
RESULTS: All bombs functioned high order.

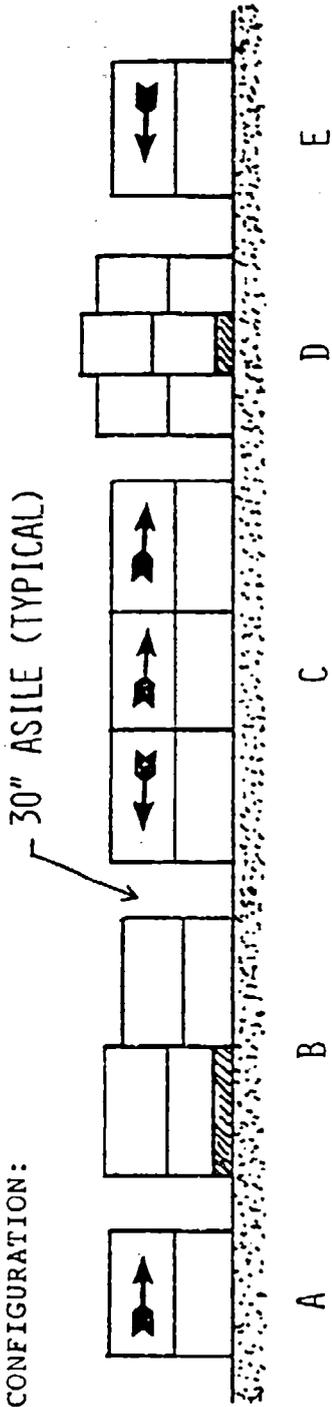
TEST NUMBER: 6

RESULTS: All bombs survive.

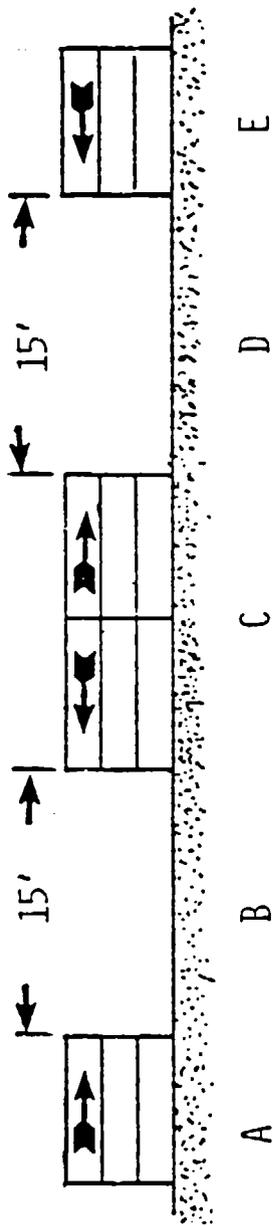
RESULTS: All acceptors survive. Noses of bombs show erosion from fragments and jets.

CONCLUSIONS: MK 84 bombs can survive attack by 24 MK 84 bombs without buffers at a distance of 15 feet, when oriented nose to nose and steel nose plugs are inserted in the nose fuze wells.
Try nose to tail and tail to nose exposures.

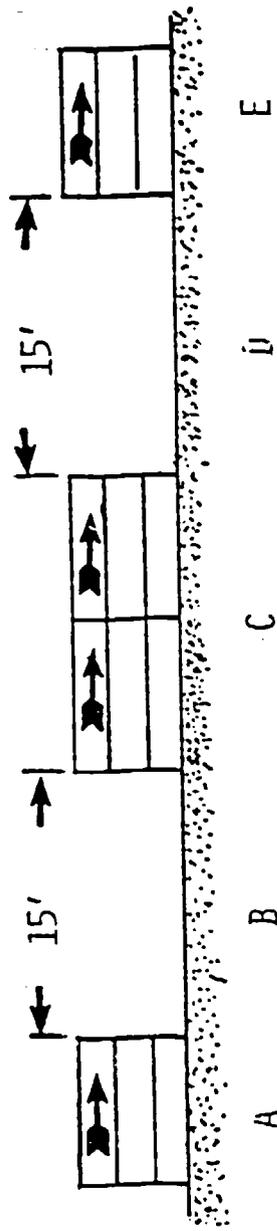
RESULTS: All acceptors detonate.

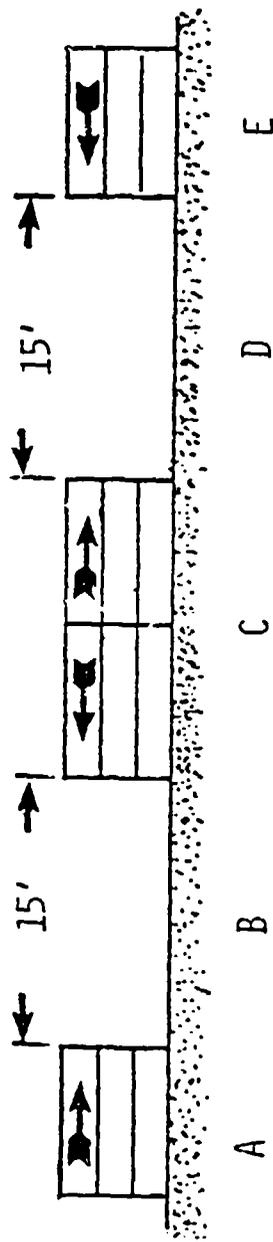
RESULTS: All acceptors survive. Nose plugs show erosion from fragment attack.

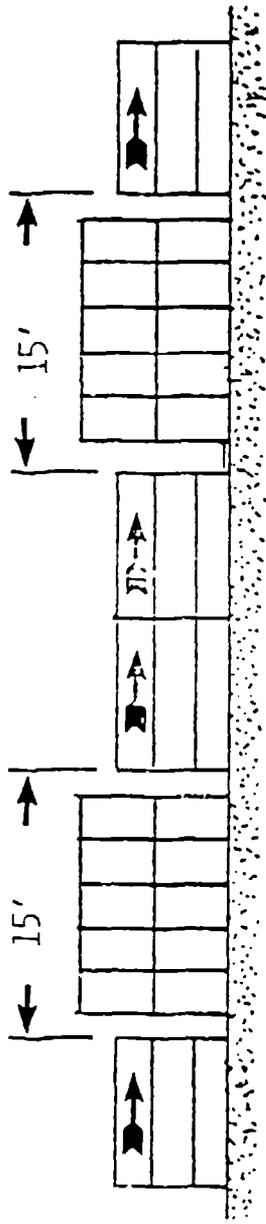
RESULTS: One low order explosion in each acceptor stack. Many acceptor bombs show severe fragment damage.

CONCLUSION: This configuration could be successful with more buffer material. Try again with more buffer.

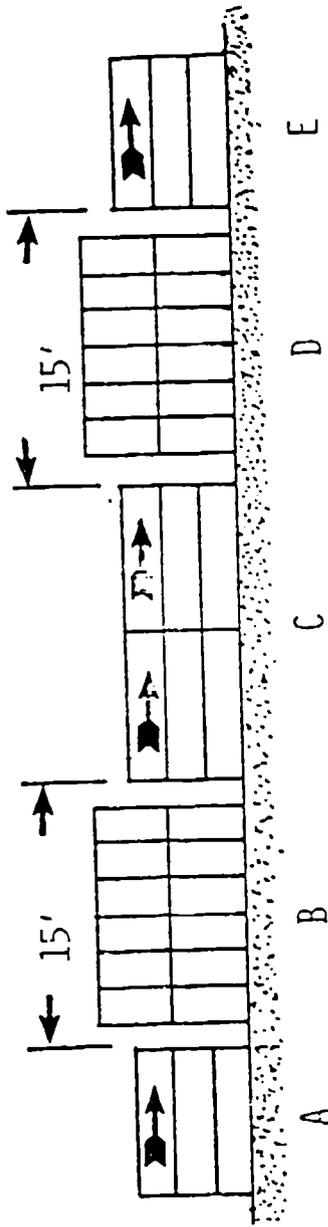
RESULTS: One low order in each acceptor stack. Severe fragment damage to many survivors.

CONCLUSIONS: Since bombs oriented nose to nose survive with very little damage and no low orders abandon this configuration and continue the tests with nose to nose orientation and 15' separation.

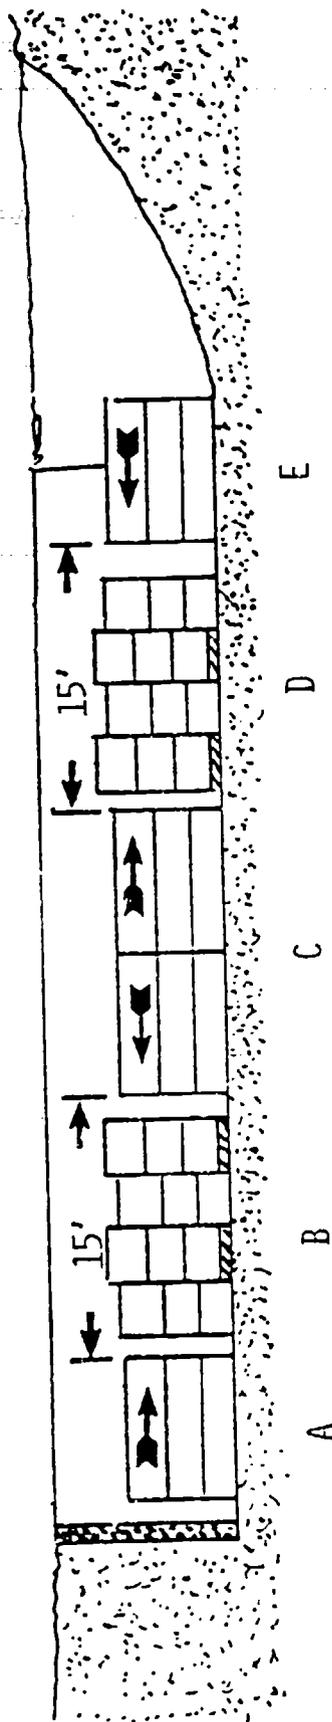
RESULTS: Acceptors at closed end detonated. Acceptors at open end survived in very good condition. MK 20s appear to have mass detonated, there were a few intact metal components of the M118 bomblets but no unreacted explosives.

CONCLUSION: Acceptor bombs at closed end reacted due to pressures created by the combined MK 84 donor and the MK 20 acceptor. This pressure was not allowed to relieve due to the construction of the igloo. The lack of fragment damage to surviving bombs tends to rule out fragment attack as a mechanism. Try next test in a simulated igloo built above ground.

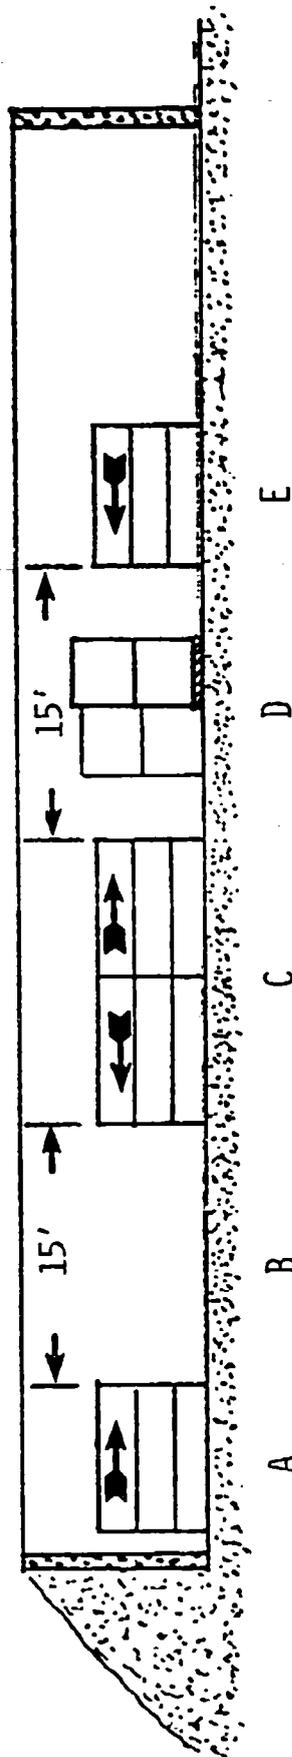
RESULTS: All acceptor bombs survive. Bombs which were protected by 30 mm buffer suffer very little damage. Bombs on closed end are damaged much like those in tests 1 and 3. Some 30 mm rounds survived intact. Most cartridge cases and propellant were consumed. Many projectiles appear to have reacted low order and only split the projectile case and consumed most or all of the explosives inside.

CONCLUSIONS: Pressure is not a problem with 24 MK 84 bombs. 30 mm HEI is an effective buffer. Continue to test in above ground igloo and start increasing donor toward a goal of 64 MK 84.

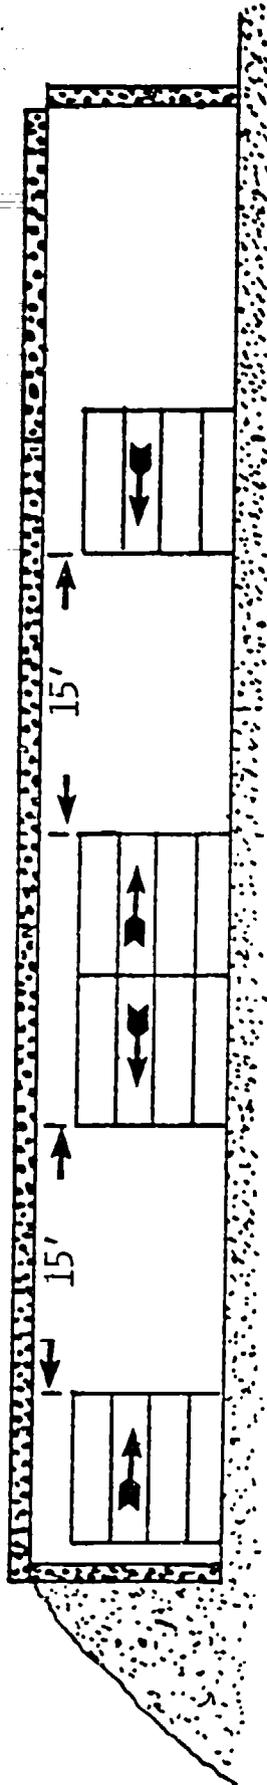
RESULTS. All acceptors survive, numerous large dents in sides of bombs which appear to be caused by interaction of bombs with the steel structure in the igloo or with other bombs. Many bombs have severe fragment damage similar to that seen in tests 4 and 5.

CONCLUSIONS: Most of the large dents were caused by bombs colliding with other bombs, very few sharp edged dents that one would expect from collisions with the steel structure. The severe fragment damage leads us to believe that we are near propagation caused by high energy fragments and must now use buffer. Pressure created by the donor bombs is not yet a problem. Continue tests in above ground igloo with roof, increase donor to 64 bombs, and use buffer material.

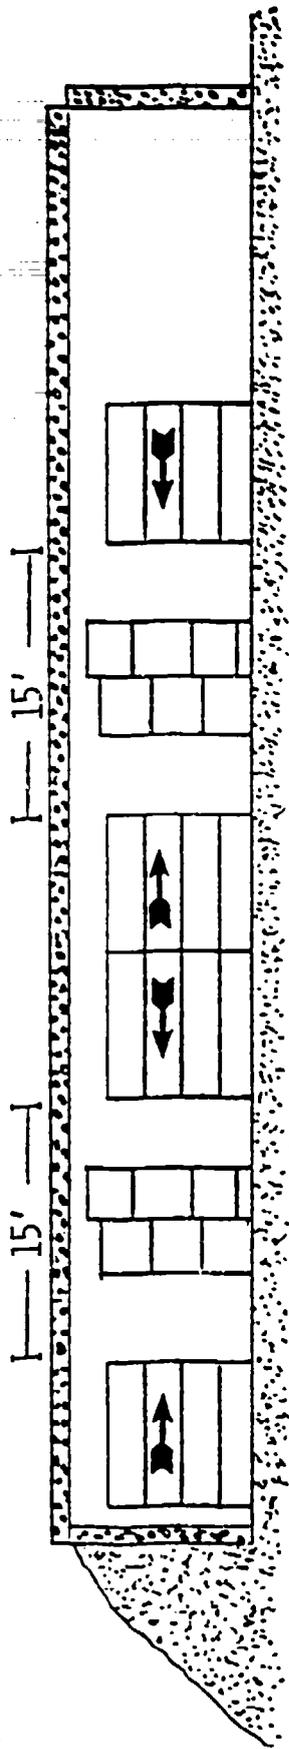
RESULTS: Acceptor bombs on the door end detonate. 7 bombs on the closed end sustain low order detonations (5 of which are on top row), 7 bombs have large dents in sides, still have fragment damage.

CONCLUSION: The large quantity of fragments generated by 64 MK 84 bombs overcame the buffer. Pressure was not a factor or we would have expected the donor at the closed end to mass detonate. Repeat the test using more substantial buffer.

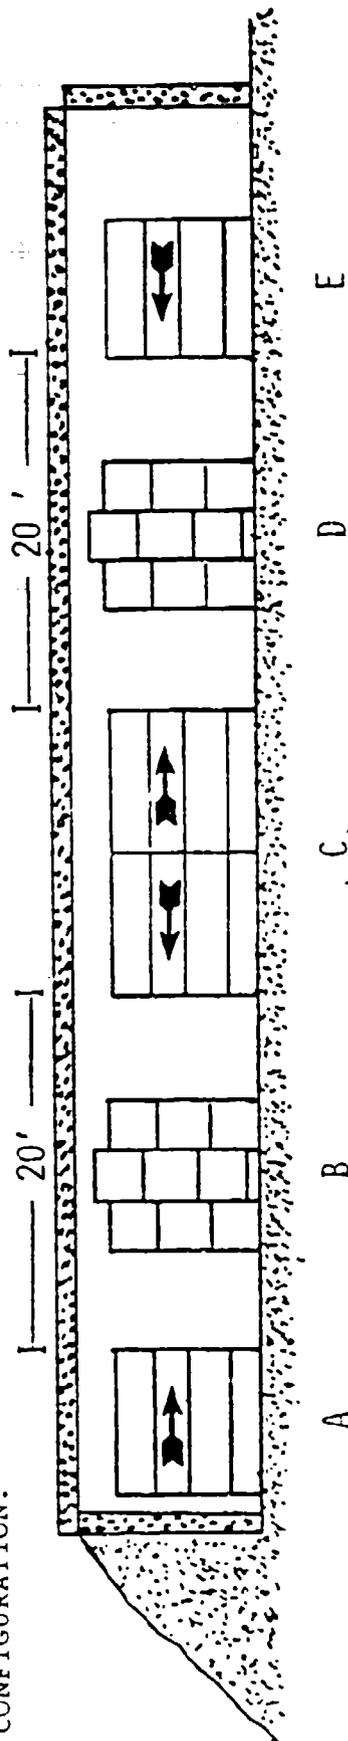
A clear impression of a bomb base plate on the side of a bomb gave credence to our belief that many dents were caused by bomb to bomb collisions. We felt strongly that the failure was caused by fragment attack rather than pressure because the acceptor at the rear of the igloo had survived a 64 MK 84 attack with less buffer and less distance to the donor.

RESULTS: Acceptors at closed end of igloo detonated. Acceptors at door end were in relatively good condition, 4 had dents in the side, 2 had fragment damage on noses, one had a fragment hole in the side, and one had the base plate knocked off by impact with another bomb or with the steel roof beams. Evidence of bomb to bomb interaction was indicated by the clear impression of a base plate on the side of one of the surviving bombs. A considerable amount of the 20 mm ammunition was unreacted. A few cans, with contents, survived virtually intact and were crushed by the pressure.

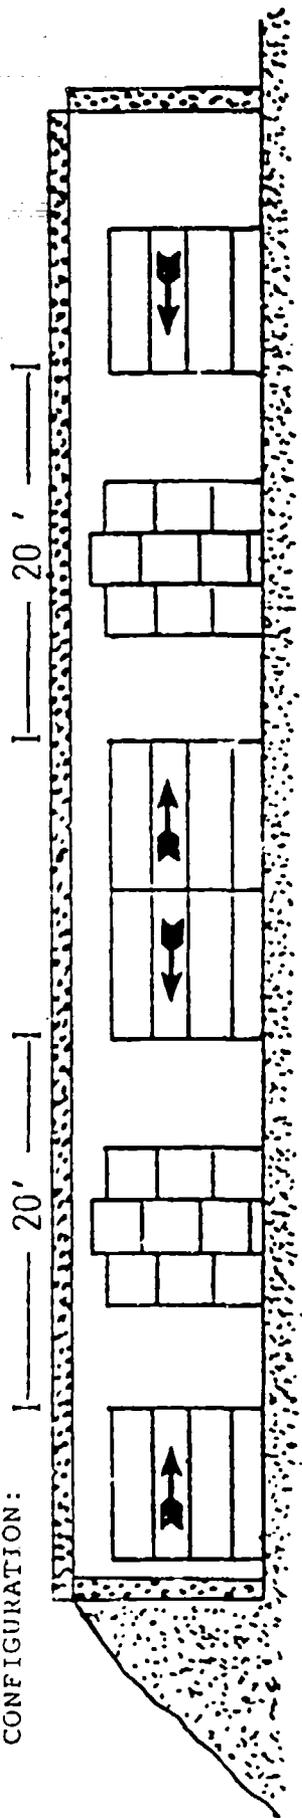
RESULTS: All acceptors survive. Very little fragment damage occurred but several bombs sustained dents in the sides.

CONCLUSIONS: Substantial buffers will prevent propagation and also prevent fragment damage to bombs.
Since the 1.2 CBU 58 worked try the 1.1 MK 20

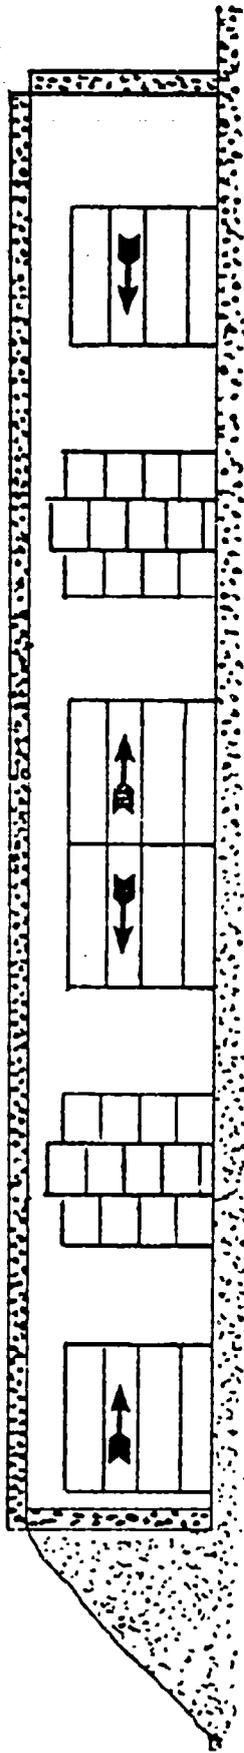
RESULTS: One bomb from the top row of each acceptor detonated low order. All other bombs survive with very little fragment damage. Several acceptors have dents in sides.

CONCLUSIONS: Three rows of MK 20s are an effective buffer. In this test the tops of the donor, buffer, and acceptor stacks were at virtually the same height. Only one row of buffer material(the one staggered vertically) was at the same height as the acceptors. We feel the low order was caused by a fragment that passed through the one stack of buffer material.
