# ON THE MECHANISM OF CAVITATION DAMAGE

M. S. Plesset and A. T. Ellis

Hydrodynamics Laboratory  
CALIFORNIA INSTITUTE OF TECHNOLOGY  
Pasadena, California

Report No. 21-15

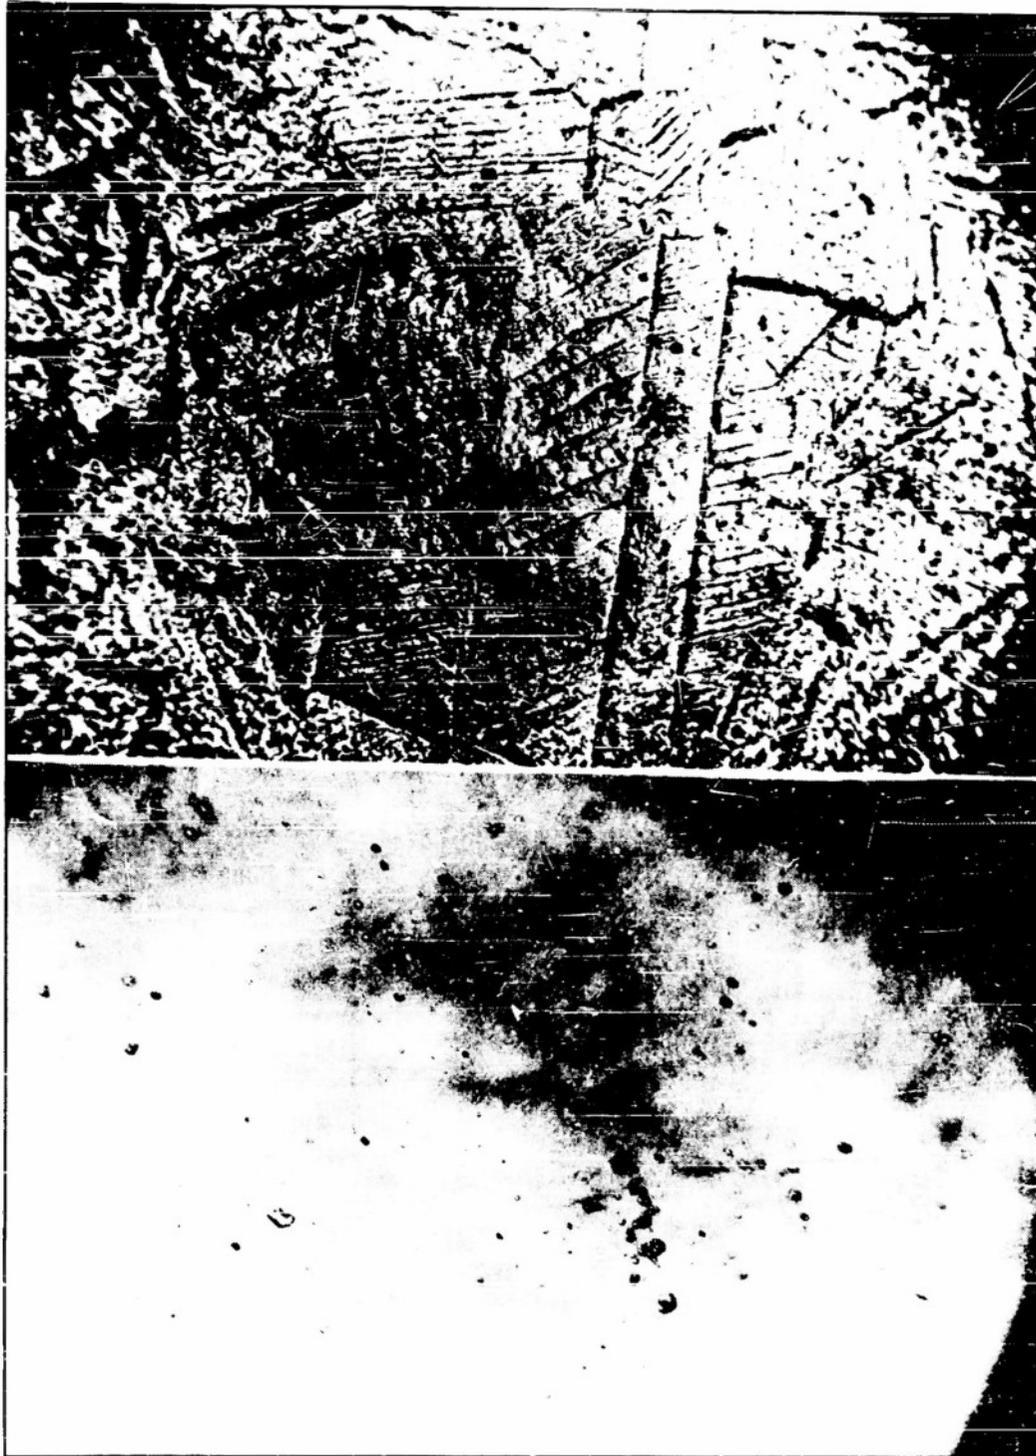
Before exposure to cavitation.

After 5 min. exposure to cavitation.

Fig. 7 - Photomicrograph of stainless steel specimen. Magnification 560X.

A series of experiments were made to observe the optical changes in the surface of a specimen under cavitation damage. Figure 6 shows the surface of a nickel specimen after a 5 minute exposure to the cavitation cloud. It is of interest to note the unevenness of the damaged surface. This appearance of microscopic "hills and valleys" is characteristic of the behavior of very soft materials. Figure 7 shows a stainless steel specimen which is of somewhat greater interest, metallurgically, since slip lines are clearly in evidence. These results may be compared with the photomicrographs of a harder material, an example of which is titanium 130-A (Fig. 8). No optical alteration in the surface of this material is evident even after prolonged exposure to the cavitation cloud.

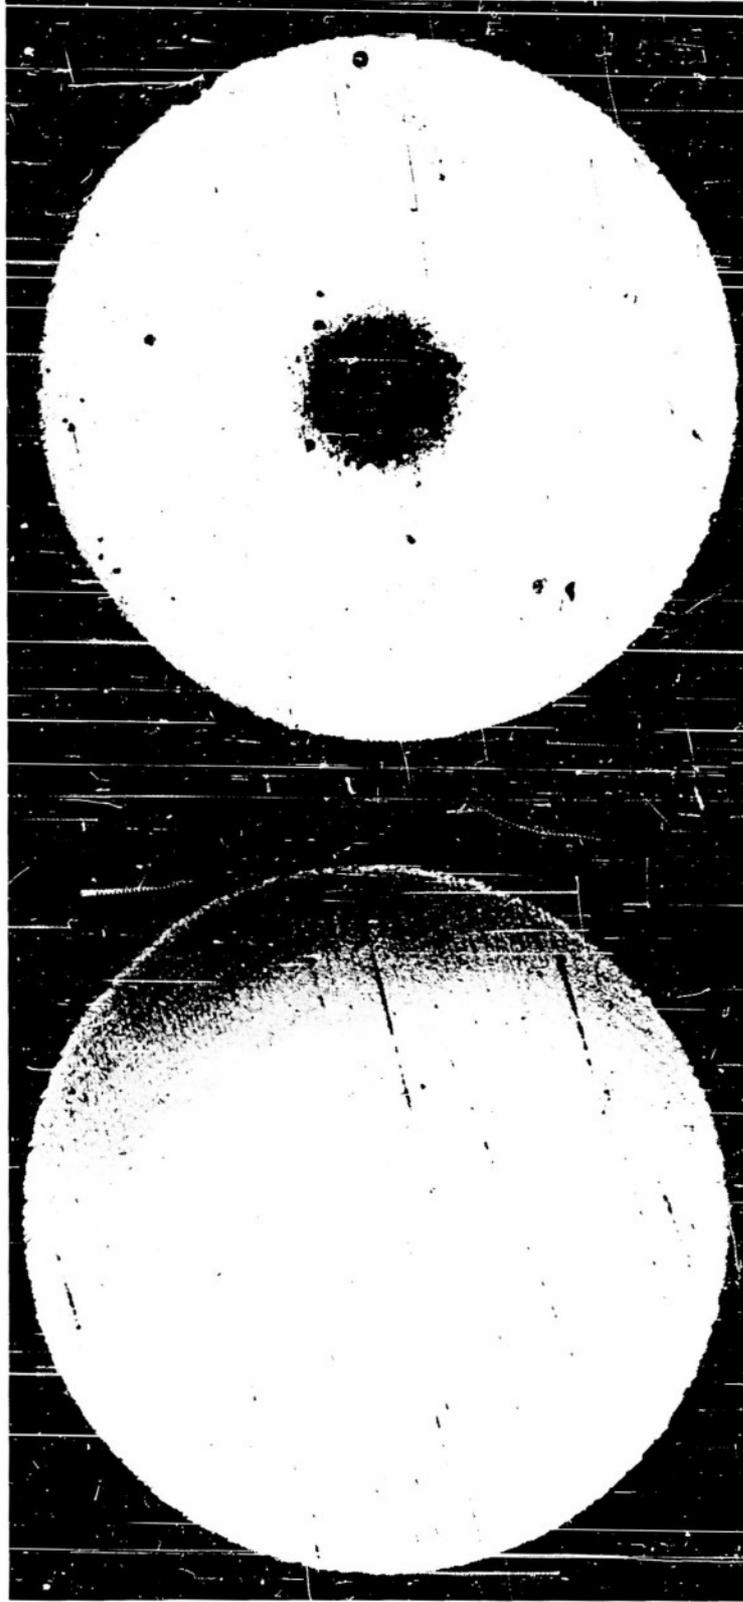
Fig. 9

Stellite.  
Undamaged.  
Magnification 40X.

Stellite.  
Damaged 1 hour.  
Magnification 40X.

A series of experiments were undertaken to secure a rough measure of resistance to cavitation damage in a series of polycrystalline substances. This series has definite engineering interest. To get significant damage quickly, the specimens were made with a small tip protruding above the level of the bottom flat plate. By this means the cavitation cloud was concentrated over the end of the tip and did not appear elsewhere. The area concentration so obtained gave an intensity increase by a factor of 25 over the conditions shown in Figs. 6, 7, and 8. With this configuration, the cavitation damage effectively drilled nearly cylindrical cavities in the specimens. The depth of these cylindrical holes for given exposure time is a measure of the resistance to damage. Measurements of this kind are summarized in Table I. A photograph of a stellite specimen exposed to this concentrated cloud is shown in Fig. 9, and a corresponding photograph of a titanium 150-A specimen is shown in Fig. 10.

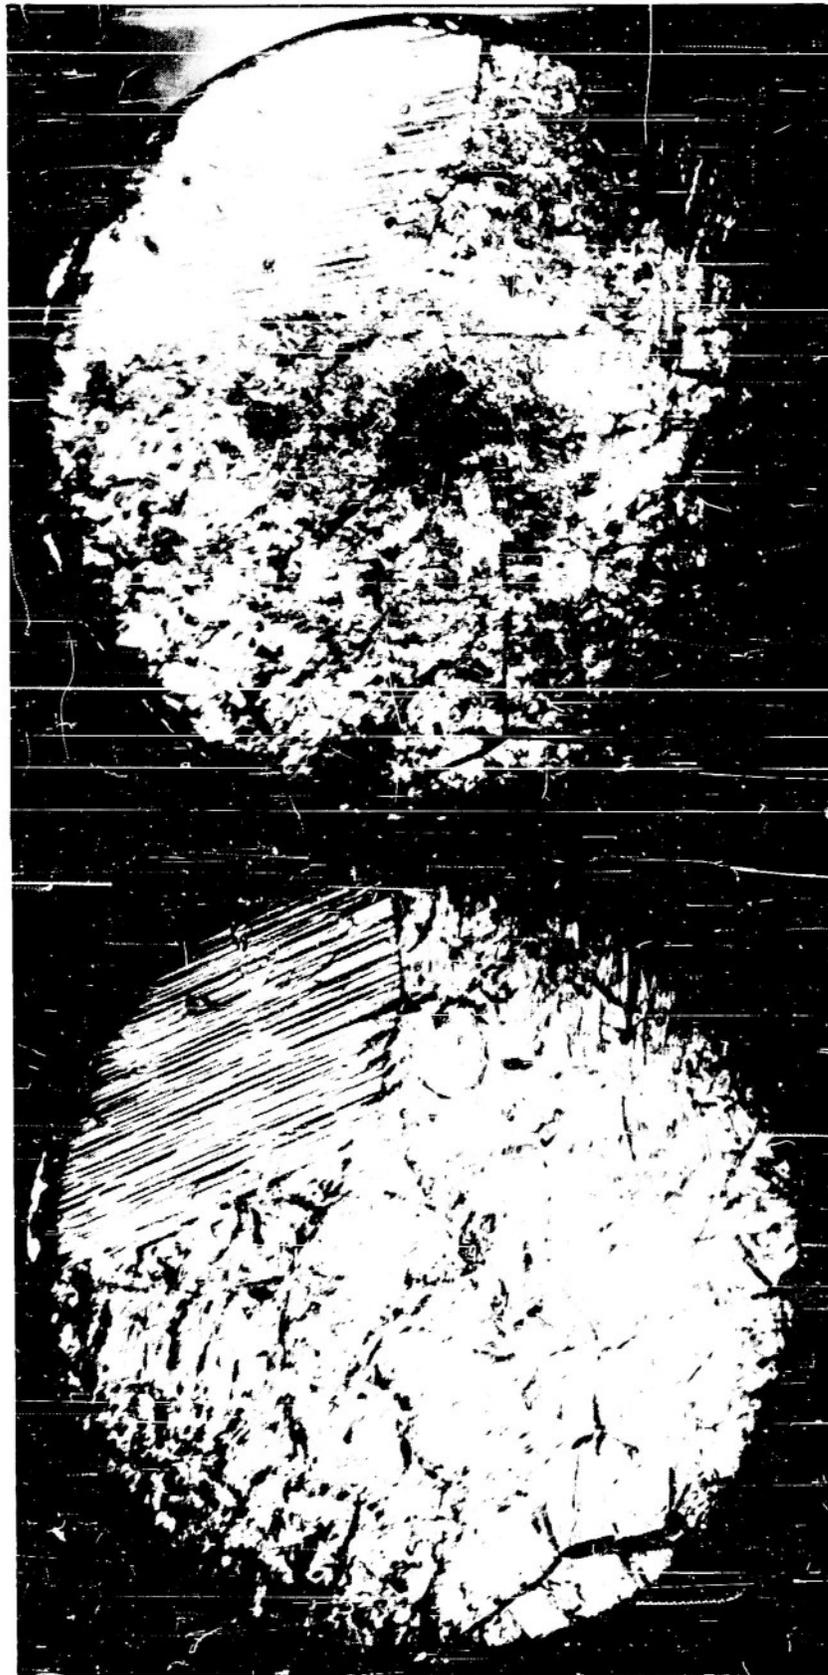
Fig. 10

Titanium 150-A.  
Undamaged.  
Magnification 40X.

Titanium 150-A.  
Damaged 1 hour.  
Magnification 40X.

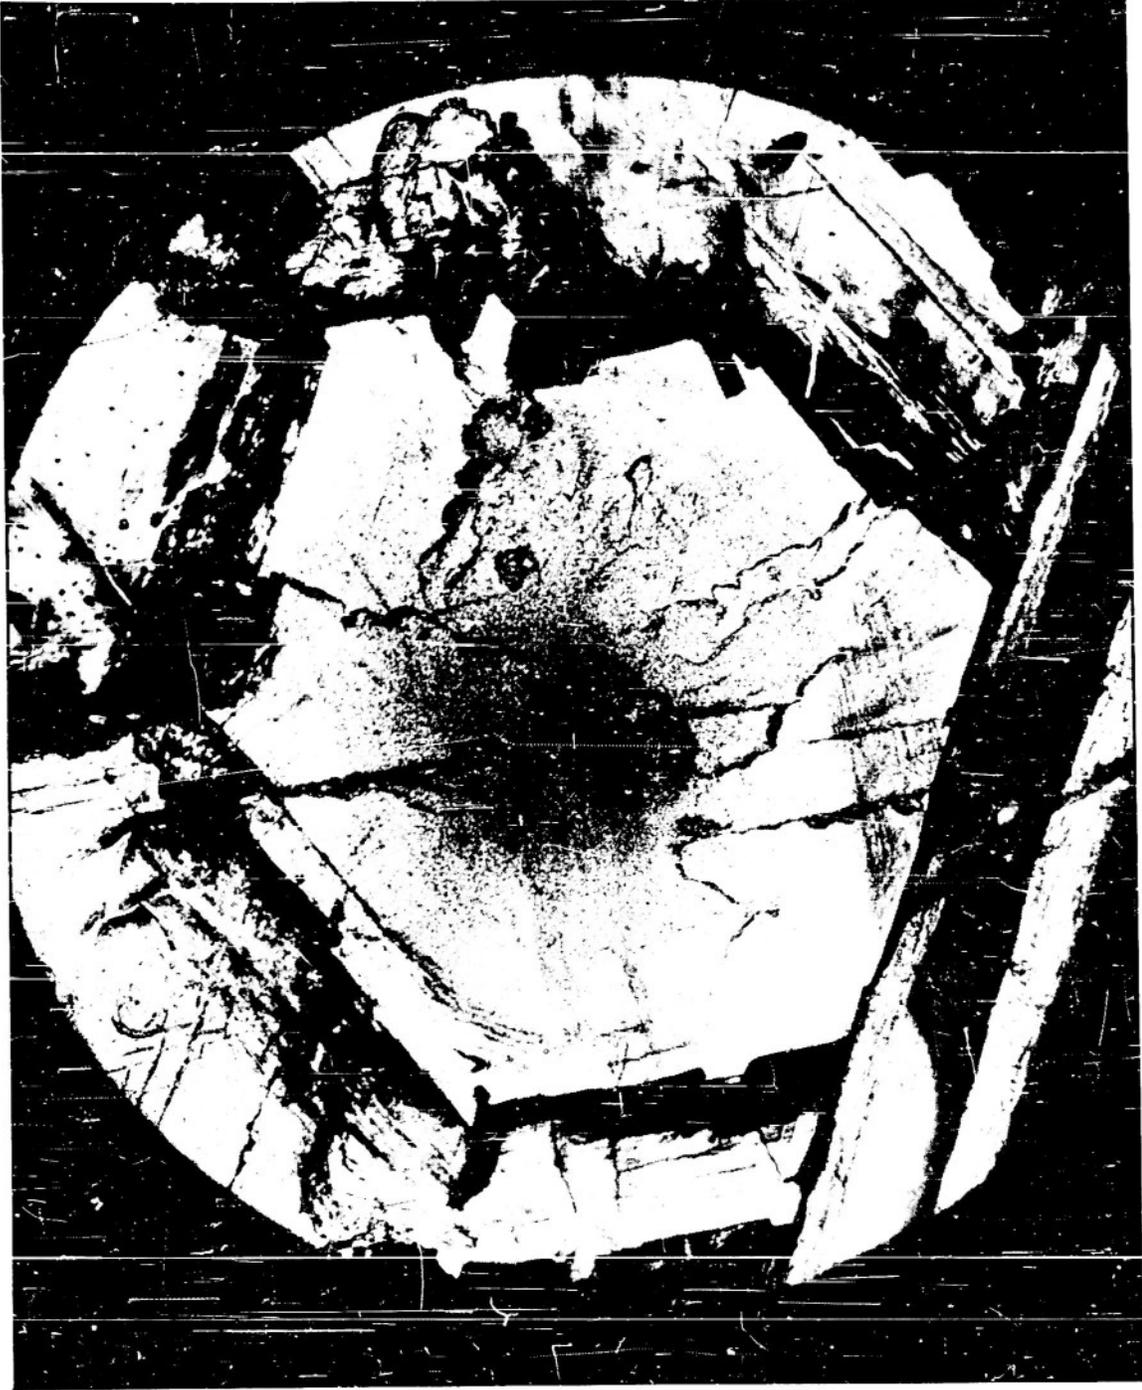
Fig. 11 - Center of damaged area on (0001) plane of a single zinc crystal after 10 min. exposure to 1/16 in. diameter cavitation bubble cloud. Magnification 38X.

Photomicrography can be a powerful tool in revealing alterations in crystal structure if the specimen is a single crystal. A zinc monocrystal was made available to the authors through the kindness of Dr. Thad Vreeland, Jr., of the Engineering Division, California Institute of Technology. A basal plane (0001 plane) was obtained for exposure to cavitation by cleavage in liquid nitrogen. When this surface is stressed by the cavitation field, the hexagonal structure of the exposed plane becomes evident. Figure 11 shows this effect when the surface is exposed to a cloud of extent small compared with the exposed area. The nearly point application of the cavitation stress brings out the hexagonal structure very readily. Figure 12 shows a basal plane in a zinc crystal before exposure to cavitation. Figures 13, 14, and 15 show this same specimen after exposure to a broad cloud of cavitation covering the specimen. Similar observations have been made on a zinc crystal cut parallel to a twinning plane and the results are shown in Figs. 16, 17, and 18. The geometry of the zinc crystal is sketched in Fig. 19.

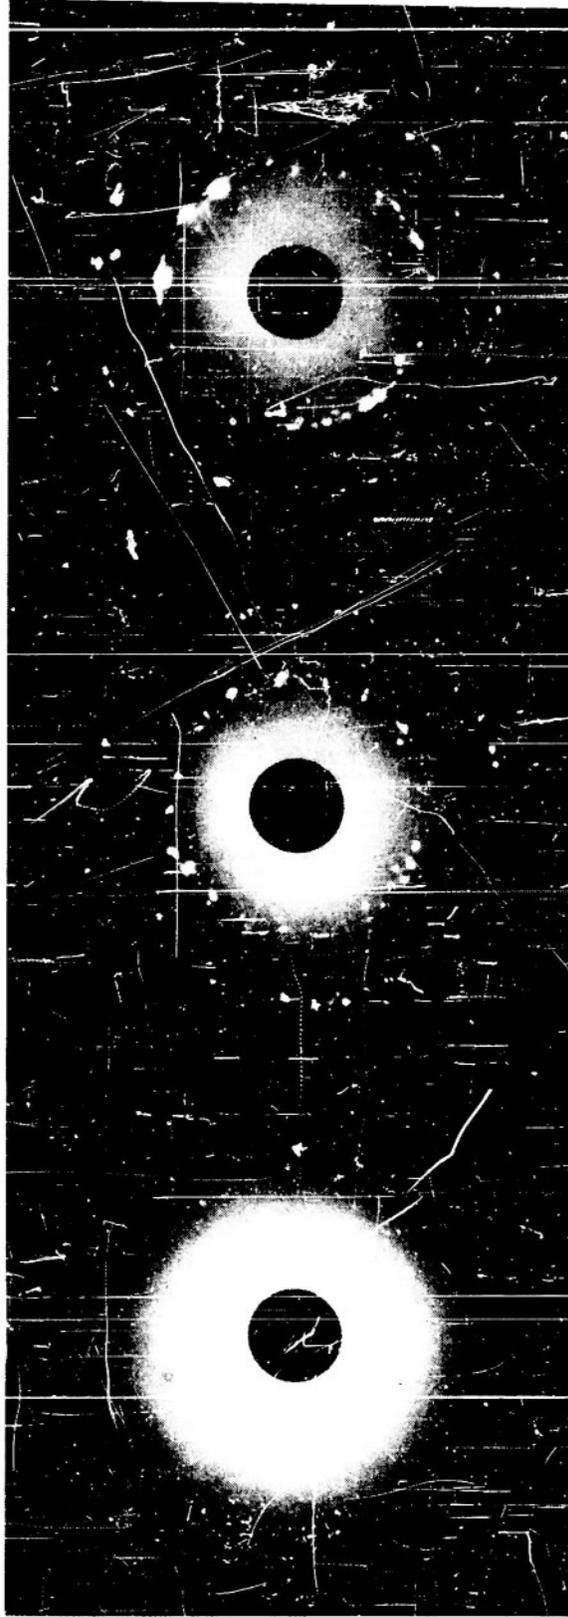
Before exposure to cavitation

After 2 seconds exposure.

After 10 seconds exposure.

Fig. 20 - X-ray diffraction pattern of nickel specimen showing rapid onset of cold work on exposure to cavitation.

Changes in structure can be observed readily in a polycrystalline specimen by the use of X-rays. For this reason, a series of observations were made on ordinary specimens exposed to cavitation damage. Figure 20 shows X-ray diffraction patterns from a nickel specimen before exposure to cavitation, after 2 seconds exposure to a broad cavitation cloud, and after 10 seconds exposure. The blurring of the patterns, which is quite marked after only 2 seconds exposure, shows that plastic deformation of the nickel microcrystals starts almost immediately upon exposure to cavitation. Figure 21 shows entirely similar results in brass. These specimens showed no significant optical change or weight loss; yet the alteration in structure is very evident from the X-ray observations.

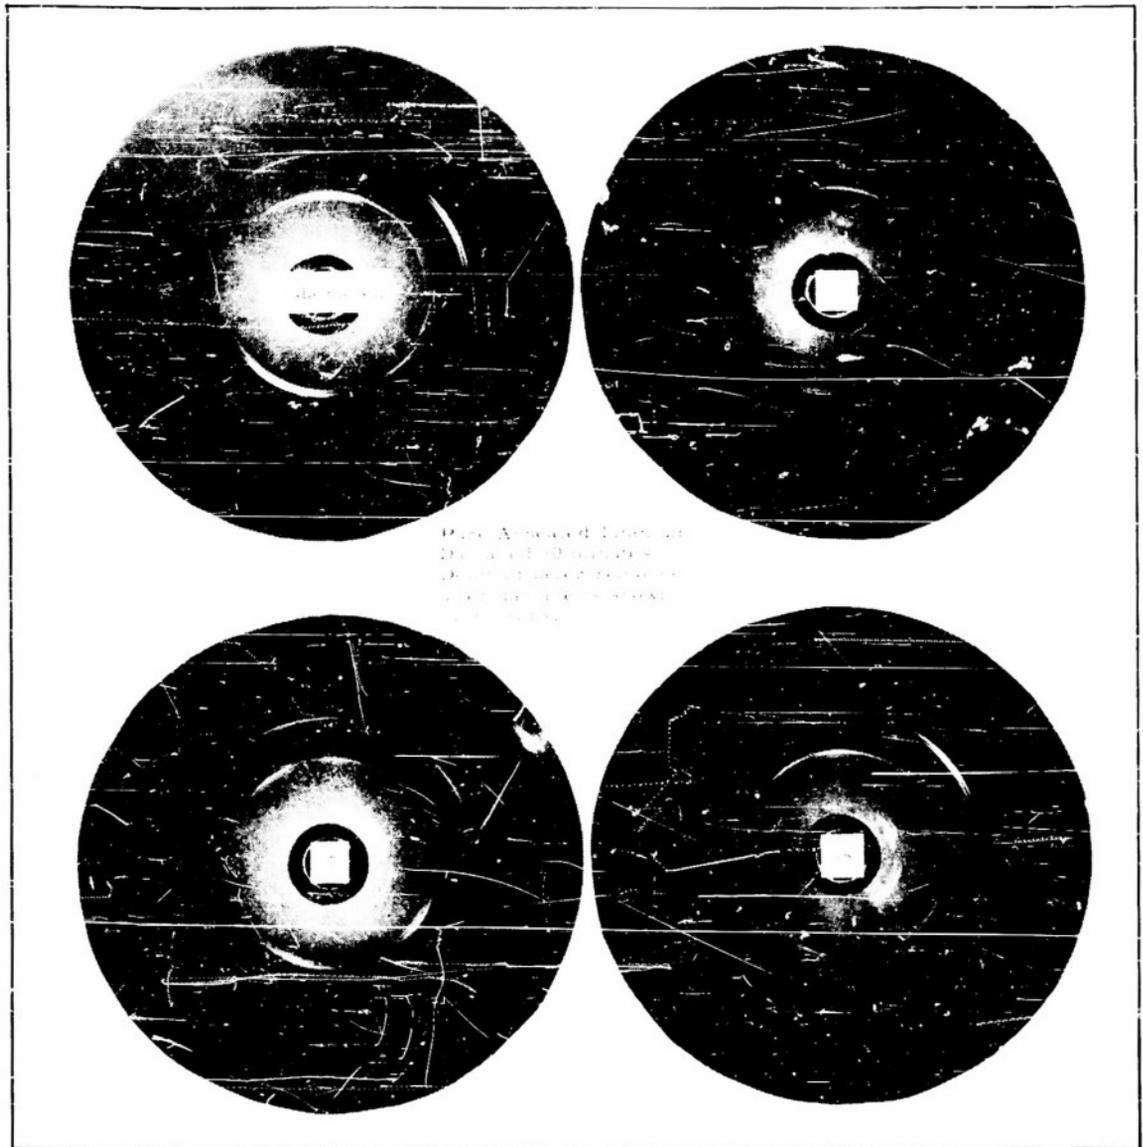
Fig. 25 - Pure annealed titanium. Damaged 30 min. Depth of layer removed after damage is shown in microns.

To determine the depth of the region of plastic deformation, thin layers were removed from the surface until the X-ray pattern returned approximately to its original configuration. Layers were "peeled off" uniformly by the process of electrolytic polishing. These results are illustrated in Figs. 22 and 23 for nickel, and in Fig. 24 for brass. A similar study was made of a pure titanium specimen and is illustrated in Fig. 25. Here the X-ray diffraction spots are replaced by circular lines since the specimen was rotated while being exposed to the X-ray beam. The broadening of the circular lines shows again the plastic deformation which takes place on exposure to cavitation. To determine the depth of penetration of the region of plastic deformation in titanium, layers were removed in steps by etching until the lines returned approximately to their original sharpness.
