ARL-MR-0919 • FEB 2016

Remote-Controlled Rotorcraft Blade Vibration and Modal Analysis at Low Frequencies

by **Natasha C Bradley**
Vehicle Technology Directorate, ARL

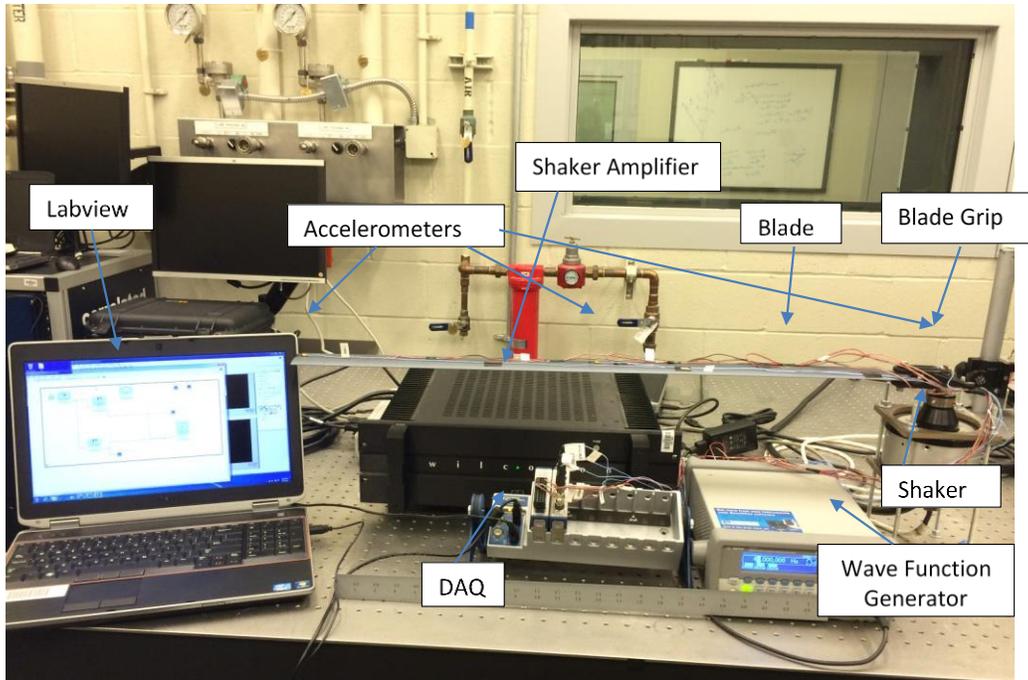
In this experiment, the rotor blade was attached to a mechanical shaker using a blade grip (Fig. 1). The blade was oriented horizontally (x-y plane), and the shaker was pulsing in the vertical direction (z axis). The exact composition of the blade material, an aluminum alloy, was unknown because the manufacturer considers that information proprietary. The blade was in the shape of an airfoil 2.5 inches wide, 34.5 inches long, and 0.224 inch thick at the leading edge.

Fig. 1 Laboratory Virtual Instrument Engineering Workbench (LabVIEW) test setup

Accelerometers and strain gages were attached to the surface of the blade, transmitting vibration and strain information to the data acquisition unit (DAQ, National Instruments) (Fig. 1). The vibration and strain data were used to capture exactly what would happen to the rotor blade over different frequencies. This information would allow us to assign a health value (health index) to the rotor blade over time and thus be able to assign baseline and threshold usage values that could later be used to establish guidelines for normal and extreme usages. Once the normal and extreme usage threshold values were identified, we could begin to test flawed rotor blades in the same manner that the unflawed rotor blade was tested.

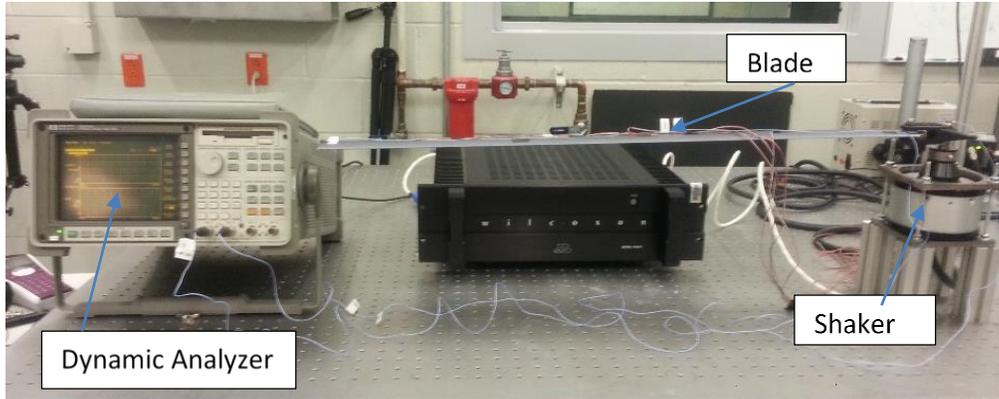
The equipment used in this experiment was a Wilcoxon Megget F4/F7 electromagnetic and piezoelectric shaker system including an F4 electromagnetic shaker, F7 piezoelectric shaker with an integral impedance head, and Wilcoxon power amplifier. An Agilent wave-function generator provided the signal to the power amplifier. In addition, a laptop equipped with LabVIEW software was attached to the specimen and used to record accelerometer and strain gage data over time. Single-axis accelerometers were used to measure vibration data. The reason for using single-axis accelerometers instead of triaxis accelerometers was that the

test specimen could only be moved in the z direction, so the vibration data collected in the other directions would be small and irrelevant (at least this was the assumption; if invalid, it might explain some of the discrepancies in the measured versus predicted results). To collect the modal data, a Hewlett-Packard dynamic signal analyzer replaced the wave-function generator, DAQ, and LabVIEW (Fig. 2). A PCB piezotronics miniature instrumented impact hammer was used as an excitation source to collect modal data (Fig. 3). The Table shows the test type and accelerometer locations.

Fig. 2 Shaker test setup for model analysis

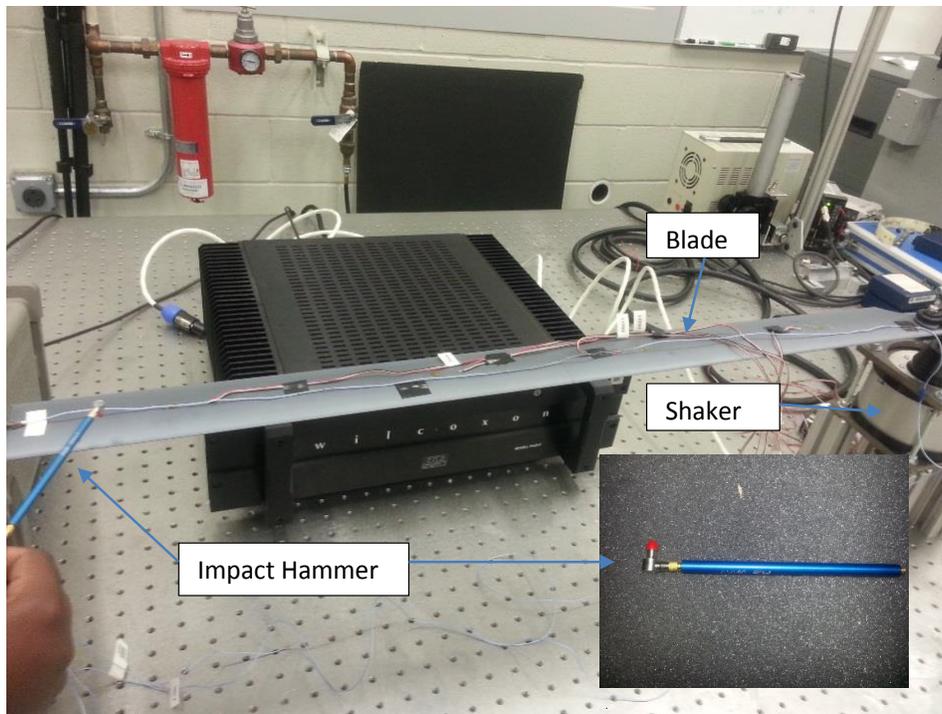
Fig. 3 Impact hammer test setup

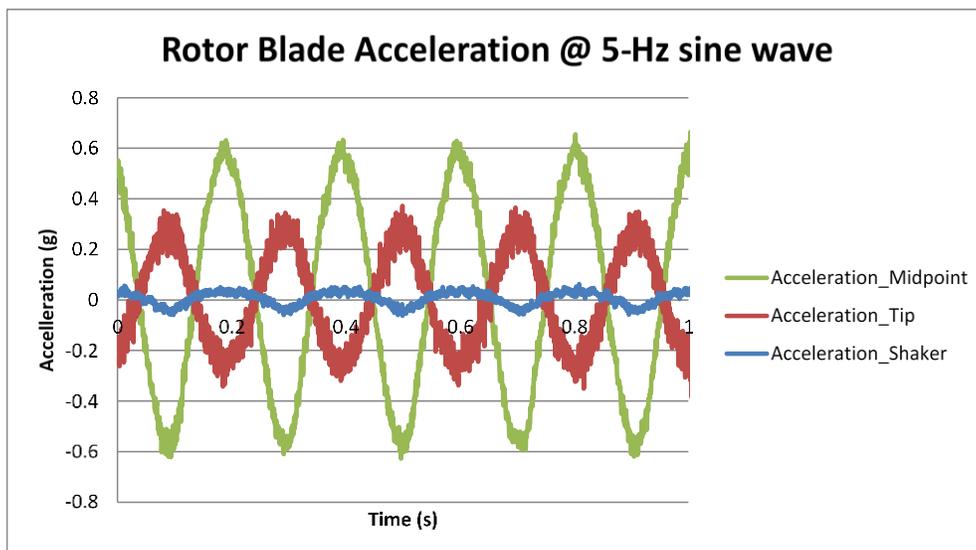
The baseline data was collected by both accelerometers and strain gauges. This memorandum report will focus on the accelerometer results. In Fig. 4, a 5-Hz sine wave was input to the blade by the shaker. The blade itself showed a response where the tip was out of phase with the excitation point. As will be discussed later in this report, this result is puzzling because at such a low frequency (under the predicted first mode natural frequency) the tip and midpoint of the blade should have been in phase with the shaker. The midpoint of the blade was also reaching a much higher acceleration than the tip, which was only true after you passed the first mode natural frequency.

Fig. 4 Blade response to shaker outputting 1-V sine wave at 5 Hz

A modal analysis was performed to locate the first 3 modes within the blade so that when testing occurred the frequencies chosen were not natural frequencies. This is important because when an object is vibrated at the same frequency as its natural frequency, the object can be seriously damaged or even cause damage to any object near it. On the other hand, if a modal analysis indicated that the natural frequency had changed from the baseline, it could be an indication of blade damage. Testing was performed with the dynamic analyzer and the impact hammer. The analyzed data were input into a MATLAB program to calculate mode shapes; mode 1 was found at 31 Hz; mode 2 was found at 95 Hz; and mode 3 was found at 183 Hz, as seen in Fig. 8. Although this blade was not a simple cantilever beam, Fig. 9 shows the approximate mode shapes. As stated earlier, the results of Figs. 4 and 5 indicated that the first mode shape was lower than 20 Hz and the third mode shape was lower than 100 Hz. Thus, the data from Figs. 4 and 5 are inconsistent with the data in Fig. 8, and the analysis was revised accordingly.

A complete dynamic response was graphed for the results from the impact hammer test (Fig. 10) as well as the results from a dynamic response test with the shaker (Fig. 11). The impact hammer involved an initial hit. Originally, this event was assumed to be the origin of the peak at 4 Hz in Fig. 10 and for this reason was not entered in to the MATLAB modal analysis algorithm. However, in hindsight, a small-amplitude bump (previously ignored as “noise”) also appeared near 4 Hz in the shaker driven amplitude response of Fig. 11 (no impact hammer involved). If the amplitude at 4 Hz was indeed the first-mode response, that would shift the second mode to 31 Hz and the third mode to 95 Hz (and the fourth mode to 183 Hz), removing the previous inconsistency among Figs. 4, 5, and 8.

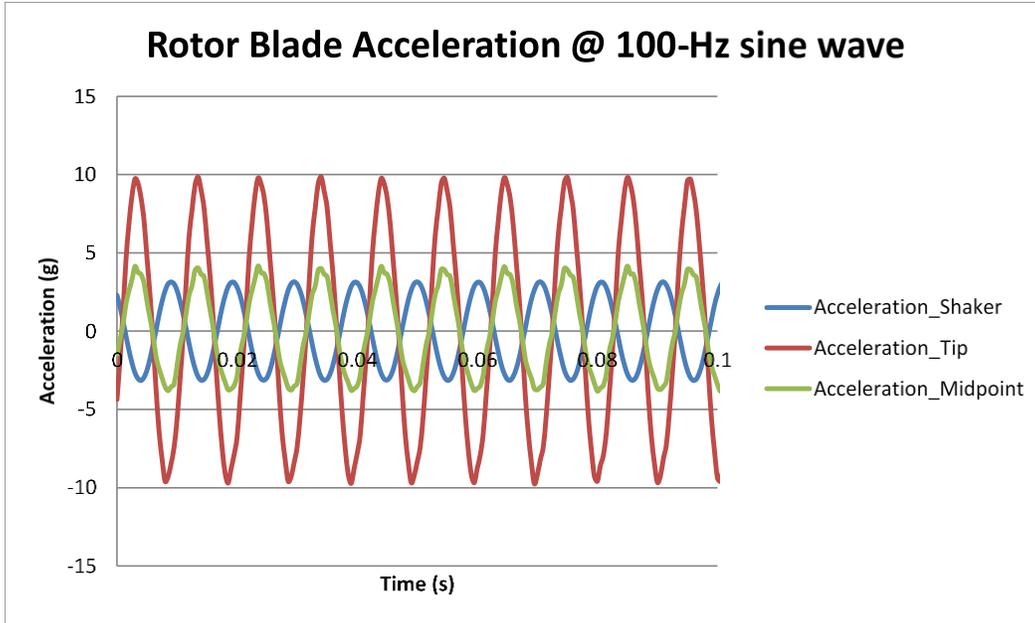
Figure 5 depicts a 100-Hz sine wave where the tip excitation was clearly larger than the acceleration recorded at the midpoint. The tip and the midpoint were also out of phase with the shaker acceleration. These observations make a case for the blade to be above the third mode.

Fig. 5 Rotor blade response to shaker outputting 1-V sine wave at 100 Hz

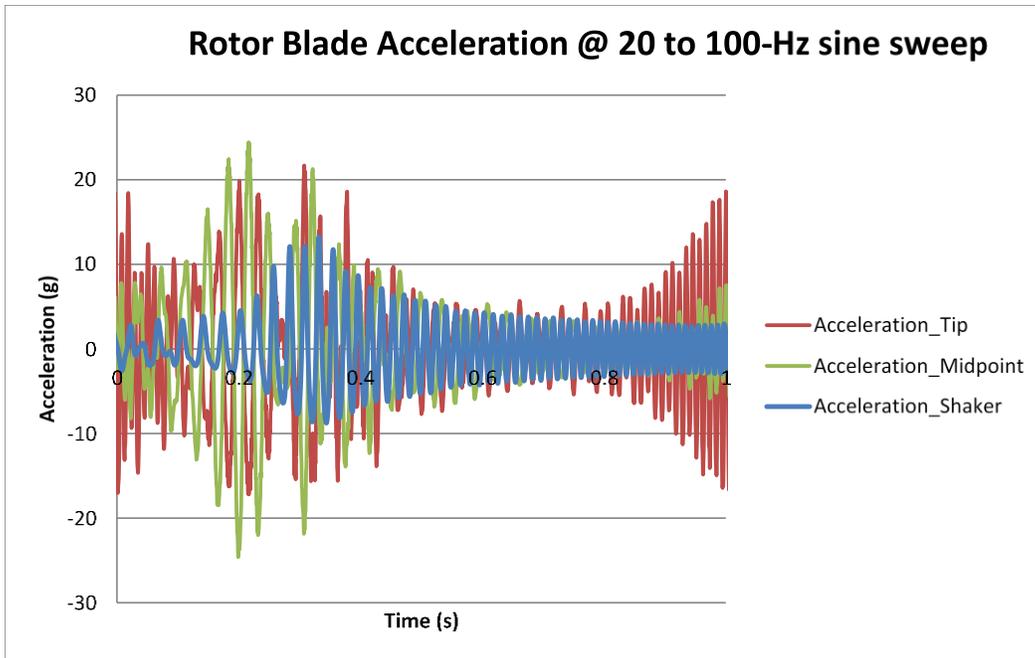
Figure 6, depicting the 20- to 100-Hz sine sweep, shows an interesting pattern with the acceleration of the shaker. The shaker was showing a change in amplitude as it was swept from 20–100 Hz in 1 s; at approximately 0.3 s or approximately 40 Hz (assuming a constant sweep rate) the shaker amplitude peaks. To investigate this peaking phenomenon, the output of the shaker itself (without blade) was tested.

Fig. 6 Rotor blade response to shaker outputting 1-V sine sweep from 20- to 100-Hz duration of 1 s

Figure 7 shows the shaker output at different frequencies between 5 and 100 Hz. The shaker shook much harder around 40 Hz, which indicated the possibility of a natural frequency of the shaker occurring around 40 Hz, and thus explained the point of maximum shaker amplitude in Fig. 6.

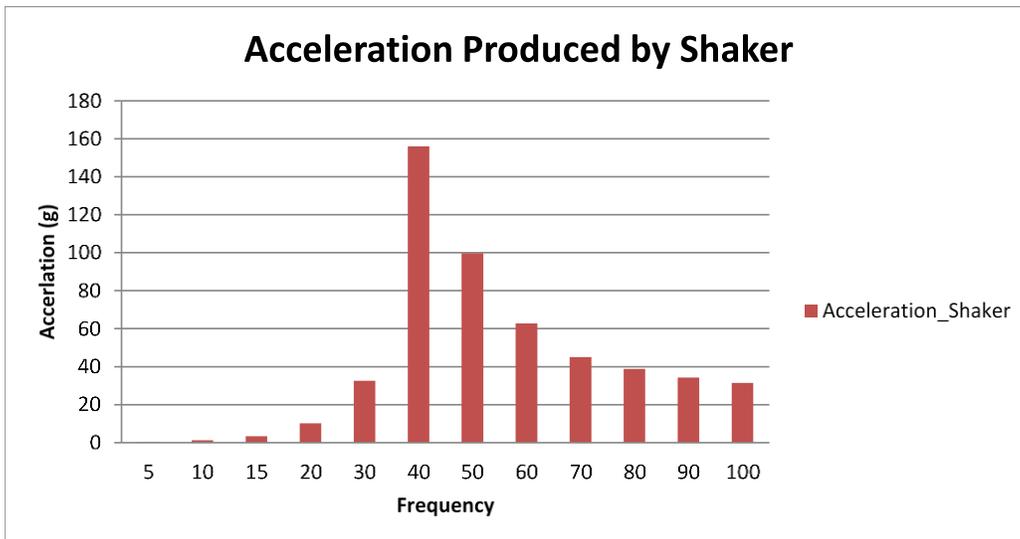
Fig. 7 Acceleration produced by shaker with no attachment

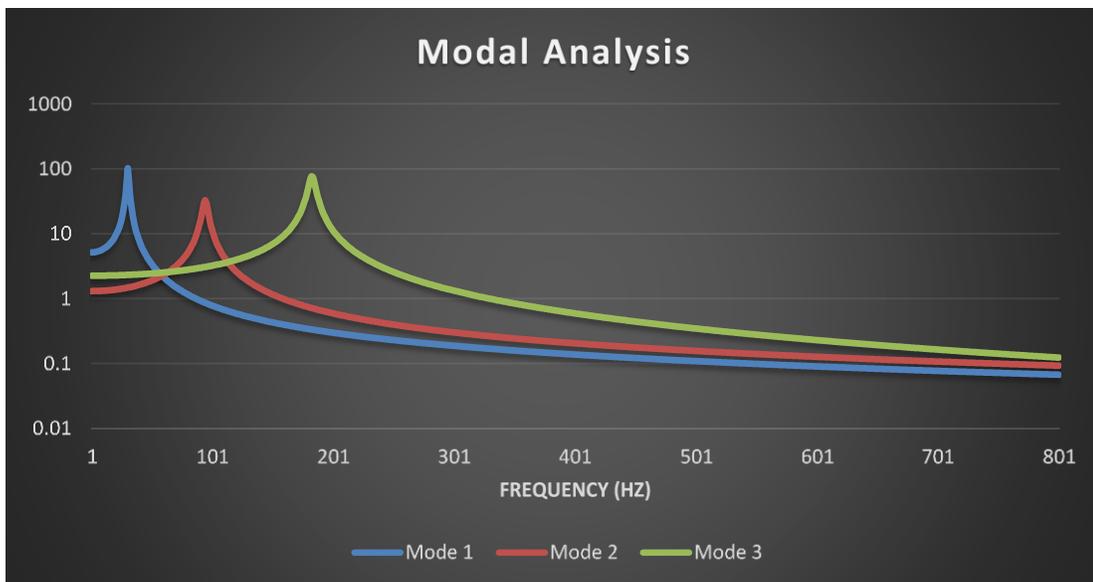
Fig. 8 First 3 modes observed using force caused by impact hammer

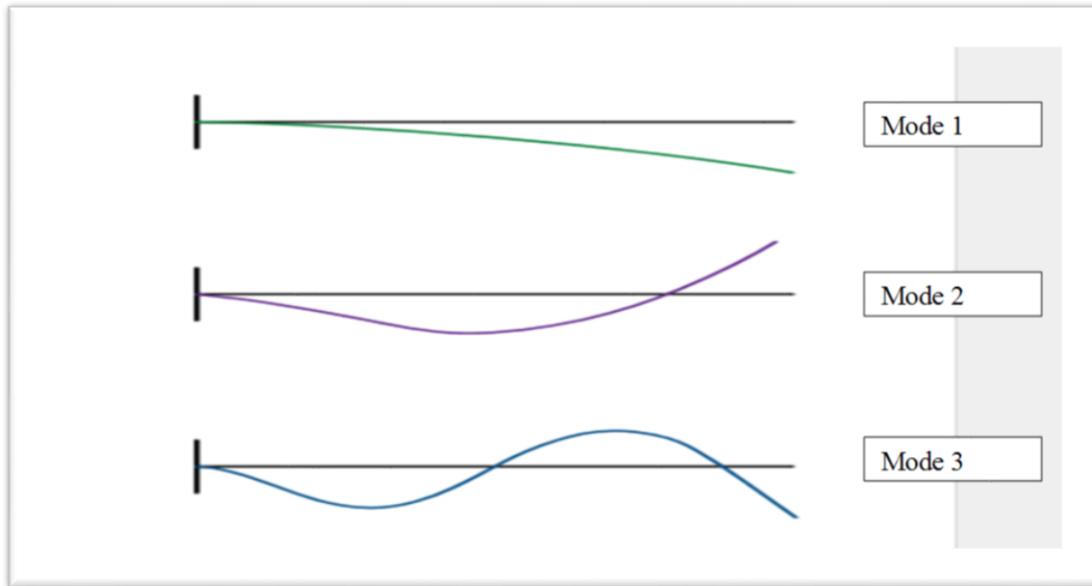
Fig. 9 Standard mode shapes for cantilever beam

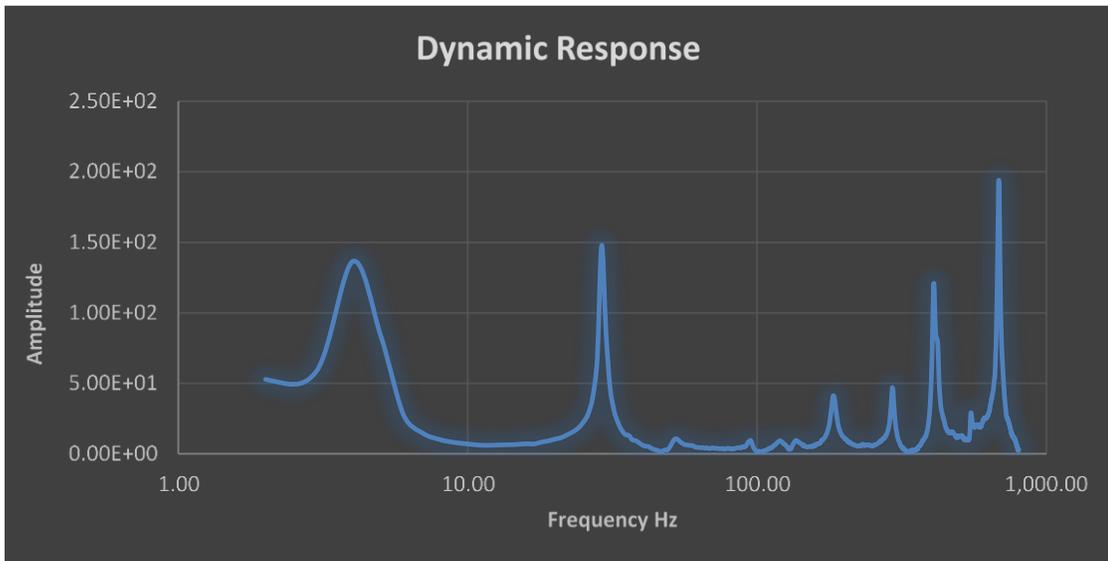
Fig. 10 Dynamic frequency response using impact hammer

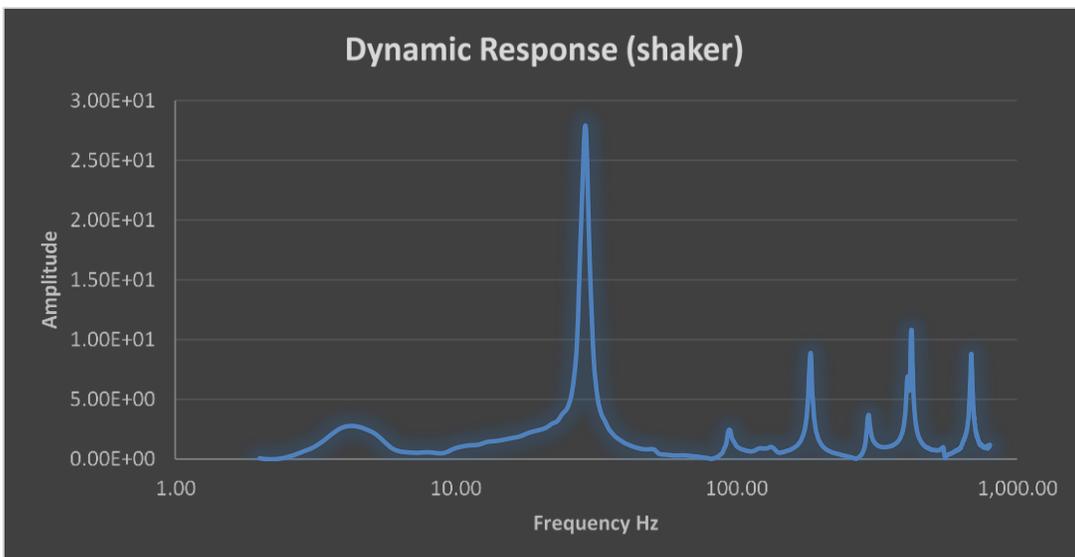
Fig. 11 Dynamic frequency response using shaker
