AFTER OPERATIONS REPORT

1ST ENGINEER ARCTIC TASK FORCE

RESEARCH AND DEVELOPMENT PROGRAM

GREENLAND 1955

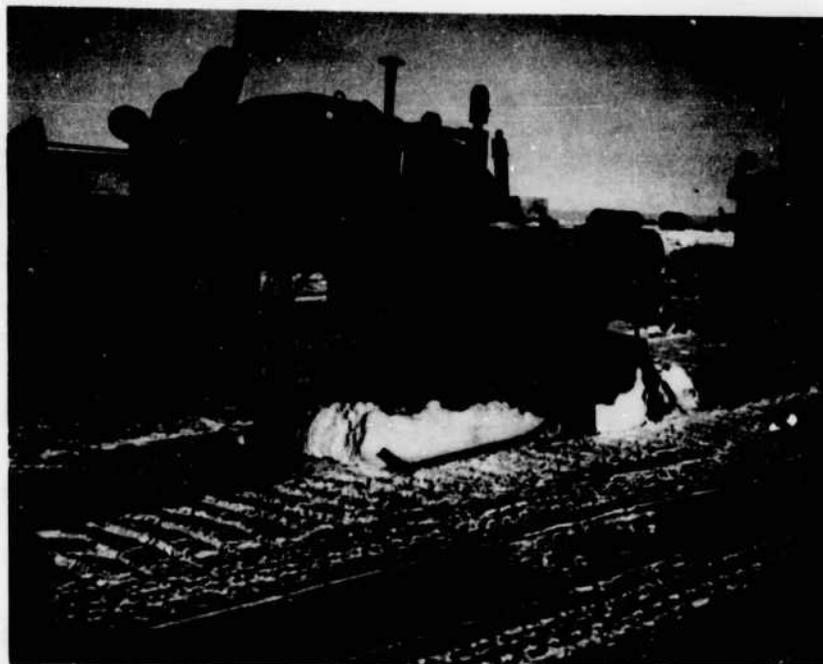
Fig. 3 Pulvimixer and Operator

(c) Considerable difficulties were experienced in maintaining pulvimixers and low ground pressure D-8 tractors due to a lack of sufficient spare parts and an acute shortage of qualified maintenance personnel. This situation was further aggravated by a lack of sufficient low ground pressure tractors to permit snow compaction equipment to be used in the most efficient manner. (Fig. 3)

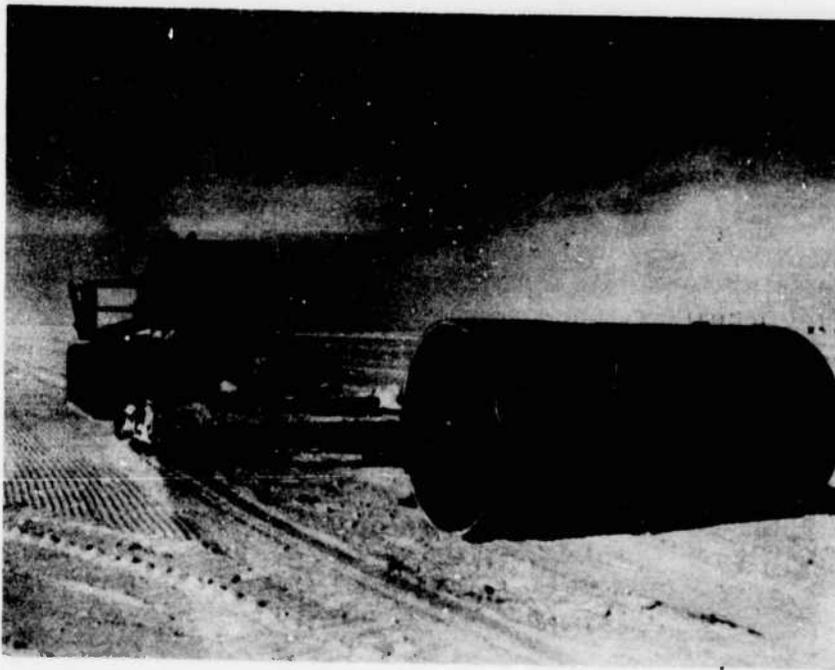
Fig. 4 Rear View of D-7, LGP, pulling Drag Unit and Corrugated Steel Roller

(d) Despite maintenance difficulties, shortage of personnel and equipment, compaction of the first strip was completed on or about the 20th of September, and although densities and hardness achieved were not uniform throughout the entire 10,000 foot length of the strip, the project engineer considered it ready for operational testing of wheel-type aircraft. (Figs. 4 and 5)

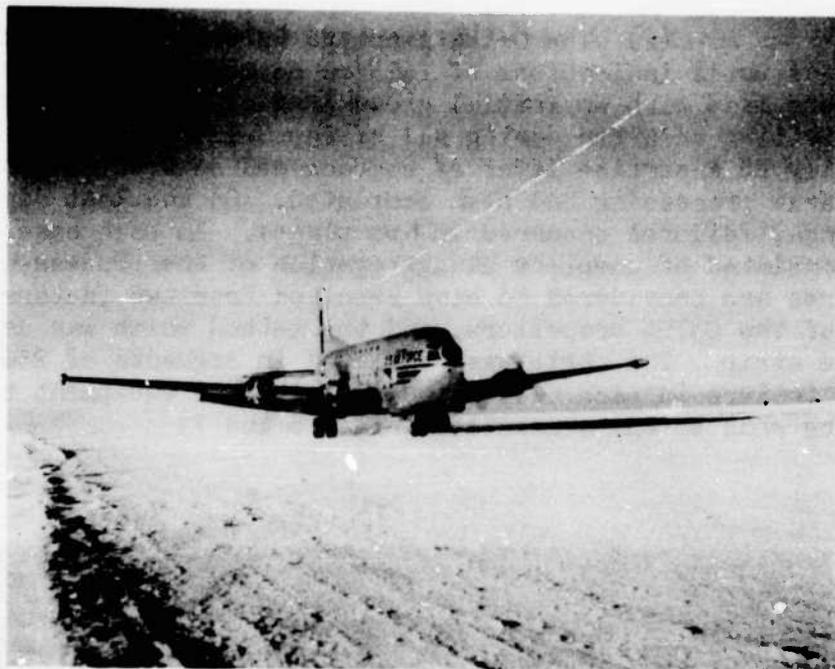
Fig. 7 C-124 Taking Off From Snow Compacted Air Strip

(f) The C-124 landings were made with increasingly heavier loads until indications of failure occurred. The last two landings were made with an initial gross load of 168,000 pounds. Considerable rutting occurred during all of the C-124 tests, but this was due primarily to a surface layer of unprocessed snow which had fallen after the next processing had been completed. On the last day of the test landings, failures occurred in two places. In each case these failures consisted of complete disaggregation of the processed layer. Both failures are considered to have resulted from two factors, the reversing of the C-124 propellers, and the method which was used to compact the strip. The strip was compacted in segments of 2500 feet each. The failure in each case coincided with the equipment turn-around areas at the ends of the segments. (Figs. 6 and 7)

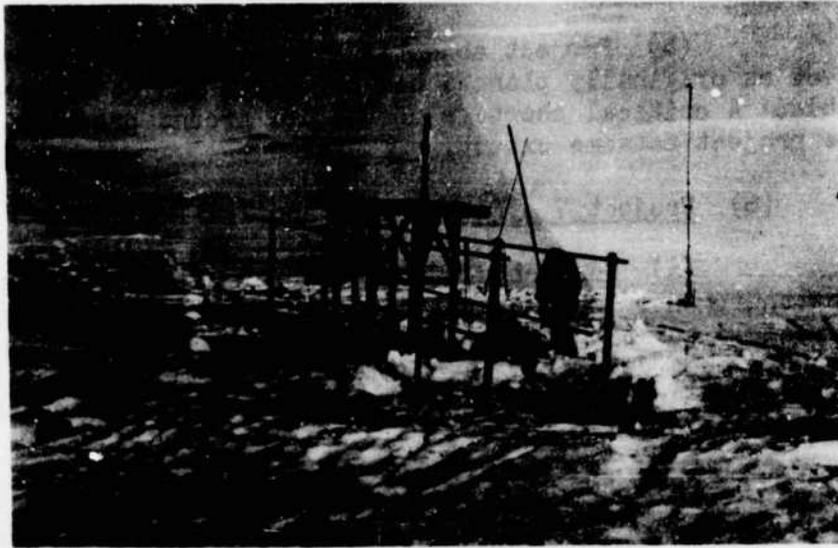
Fig. 8 Bridgework Erected Across Crevasse to Facilitate Entrance and Exit

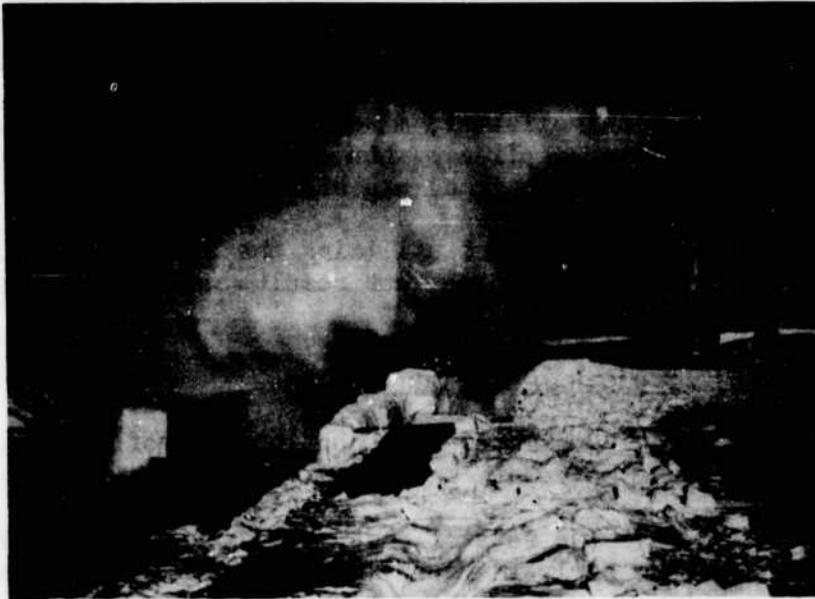
Fig. 11 Peter Senior Blowing Snow on Plywood Arches

(c) The tunnel and pit constructed and instrumented in 1954 were observed to measure deformation, loads and stresses. (Figs. 11, 12 and 13)

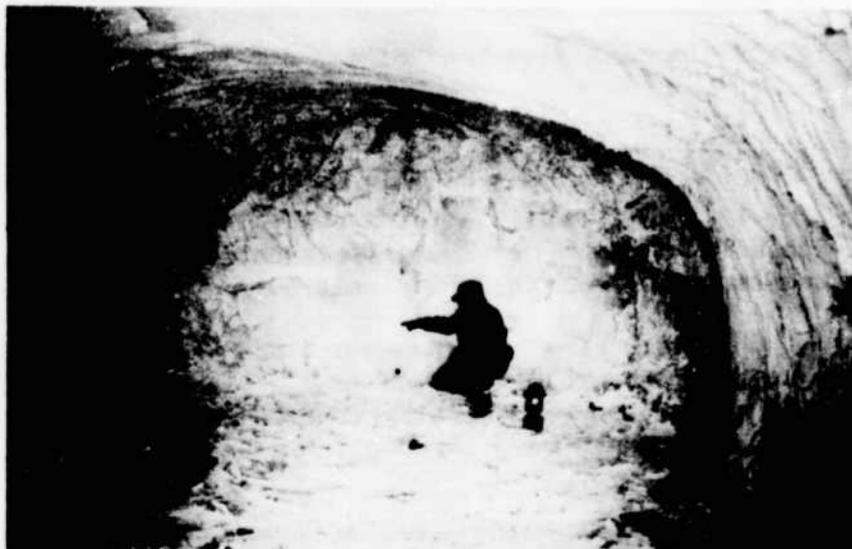
Fig. 17 Rear Wall of Jamesway Size Room Cut for NEAC

(a) Consisted of the excavation of a 500 foot tunnel in glacial ice to study tunneling techniques and the characteristic behavior of unsupported ice arches, corners, and fillets. (Fig. 17)

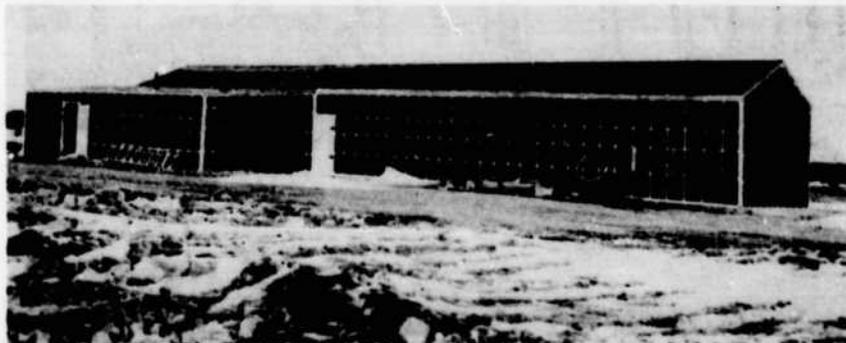
Fig. 24 Completed Kitchen-Warehouse at Engineer Camp TUTO

(2) It was designed to serve the dual purpose of a warehouse during the winter and a kitchen and mess hall during the summer after the supplies and equipment have been removed. (Fig. 24)

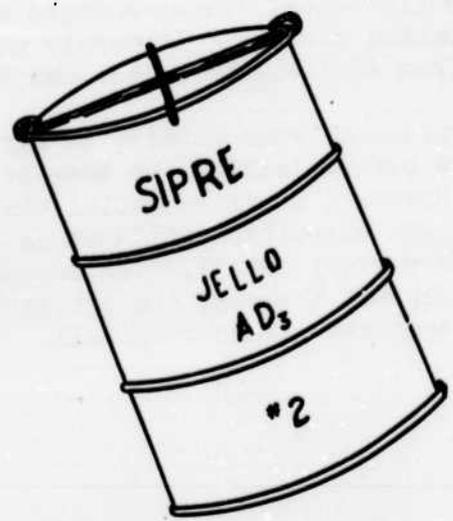
PLATE 10: Sketch of Barrel for Air Drop

b. Each barrel was numbered and labeled as shown. The AD₃#2 indicates that this is barrel #2 on air drop 3. An itemized list was prepared for each barrel. A complete breakdown of the supplies which were on each air drop was prepared prior to departure. This made it possible to adjust any shortage or over-supply as it arose in the field. Since the initial delay in departure cut 78 man days of food from the program it was necessary to eliminate some of the food from AD 3 and AD 4. The change in course caused by diplomatic clearance also changed some of the re-supply requirements. These changes were easily made with the system of pre-packed barrels. It merely meant cancellation of barrels 3, 4, and 7 from AD 3 and barrels 1 and 3 from AD 4.
