WADC TECHNICAL REPORT 59-744  
VOLUME VII

# INVESTIGATION OF FEASIBILITY OF UTILIZING AVAILABLE HEAT RESISTANT MATERIALS FOR HYPERSONIC LEADING EDGE APPLICATIONS

Volume VII—Oxidation Resistance of Bare and Coated Molybdenum Alloy and Graphite

*Bell Aerosystems Company*

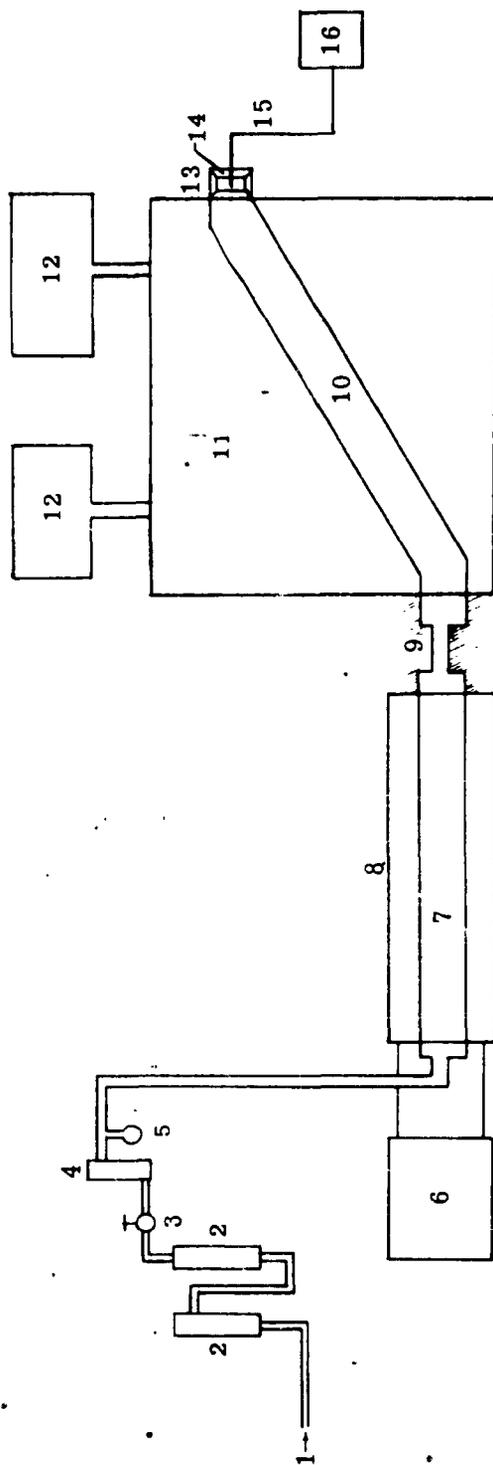
FIGURE 1. SCHEMATIC OF OXIDATION TEST EQUIPMENT

The regulating and measurement equipment, such as the flow meter, pressure gage, and flow regulator were positioned downstream of the preheater furnace, so that room temperature air was being metered and measured. Flow conditions were essentially the same as those employed previously, Section G of Volume III. However, during the present test series a higher mass velocity was employed as the upper limit of this variable, 5000 #/ft<sup>2</sup>hr rather than 4000 #/ft<sup>2</sup>hr. Reasons for the flow conditions are discussed in Appendix I of Volume III which also presents test Reynold's numbers. Platinum-platinum 10% rhodium thermocouples were used with the Brown potentiometer pyrometer to measure specimen temperatures.

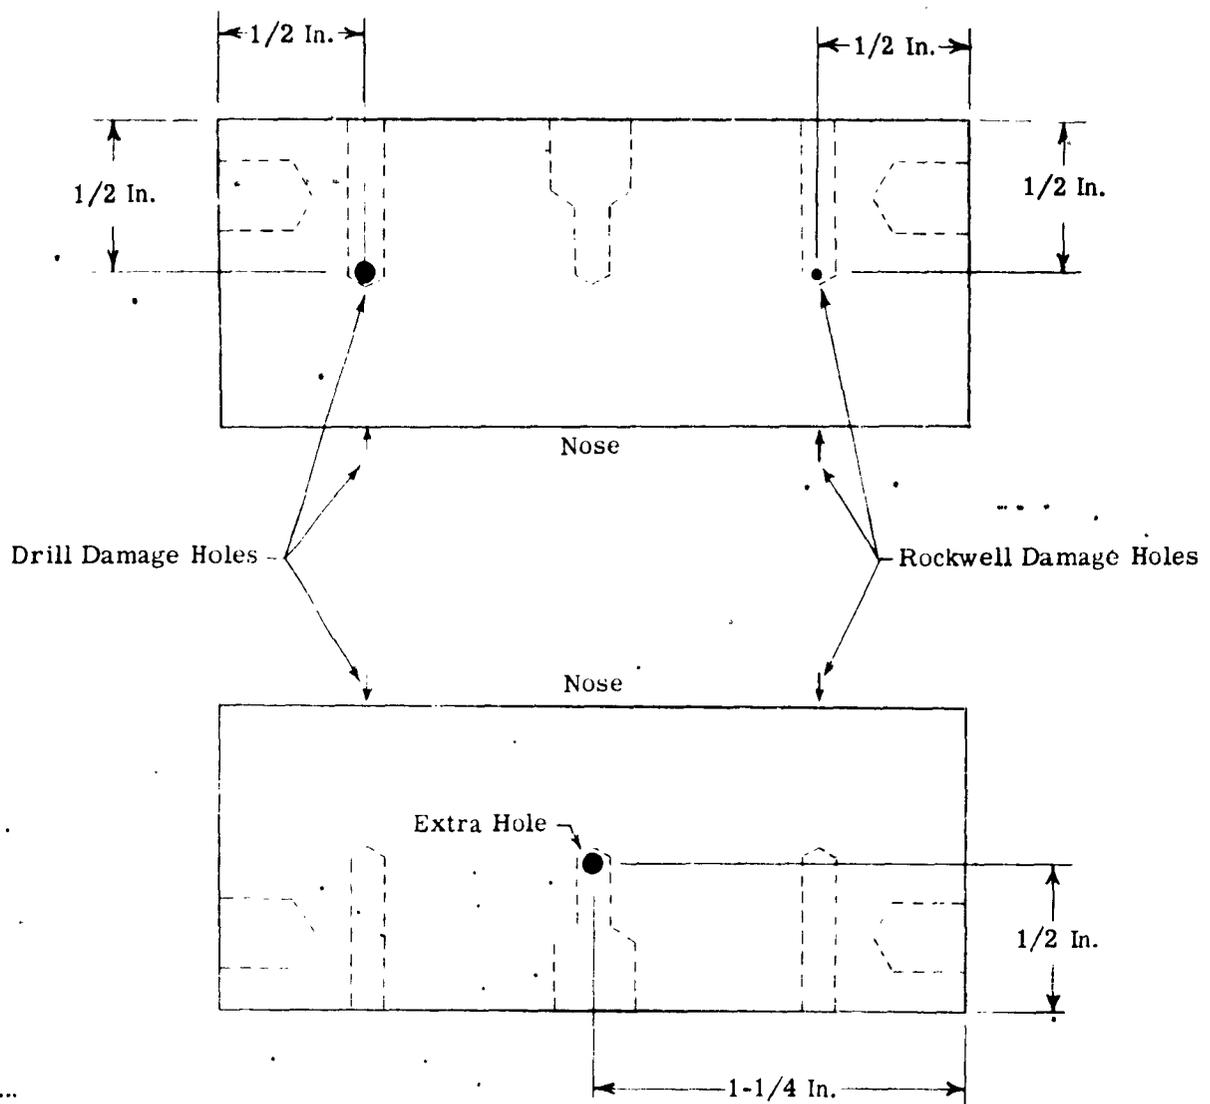
Note: Location Dimensions are Approximations

FIGURE 5. DIAGRAM OF DAMAGED COATED SPECIMENS SHOWING LOCATION OF REGULAR AND EXTRA HOLES

The artificially damaged specimens were tested in accordance with the schedule shown in Table 3. Siliconized ATJ graphite, W-2 coated 0.5% Ti molybdenum alloy, and Durak M3 coated 0.5% Ti molybdenum alloy specimens were intentionally damaged and were then tested to determine the extent to which the failure points would deteriorate when exposed to flowing air at high temperatures. The types of damage were designed to artificially simulate the effect of meteoroid impacts. Two hole sizes were selected on the basis of the discussions of Appendix II of Volume II. One was 0.07 inch in diameter and 0.04 inch deep, and the other was 0.01 inch in diameter and 0.007 inch deep. The 0.07 inch diameter hole was made with a #50 drill, while a standard Rockwell machine using a Braille tip with the 150 Kg load was used for the 0.01 inch diameter indentation. A crater of each size was made in the nose and one of each size on the skirt of each specimen. The craters were spaced so that the failure areas would not join during four hours of testing. Since the oxidation products from the nose areas would pass over the holes in the side of the specimen, an extra crater, either 0.07 inch diameter or 0.01 inch diameter, was made in the undamaged skirt of several specimens to ascertain the effects of these oxidation products. It might be expected that the gaseous products flowing over the skirt holes could either accelerate deterioration of the hole by their corrosiveness or furnish oxidation protection to the holes by displacement of the air flow. Figure 5 shows the location of the damaged areas on the test specimens including the location of the extra holes. Temperature measurements were taken at 15-minute intervals. The specimens were removed for visual examination at one-hour intervals. X-ray inspections were made before testing and at the completion of four hours of testing. No probing of the oxidized areas was performed until after the final X-ray inspection on the tested specimens. Measurements were taken of the hole diameter and hole depth for the damaged areas of all specimens after testing.

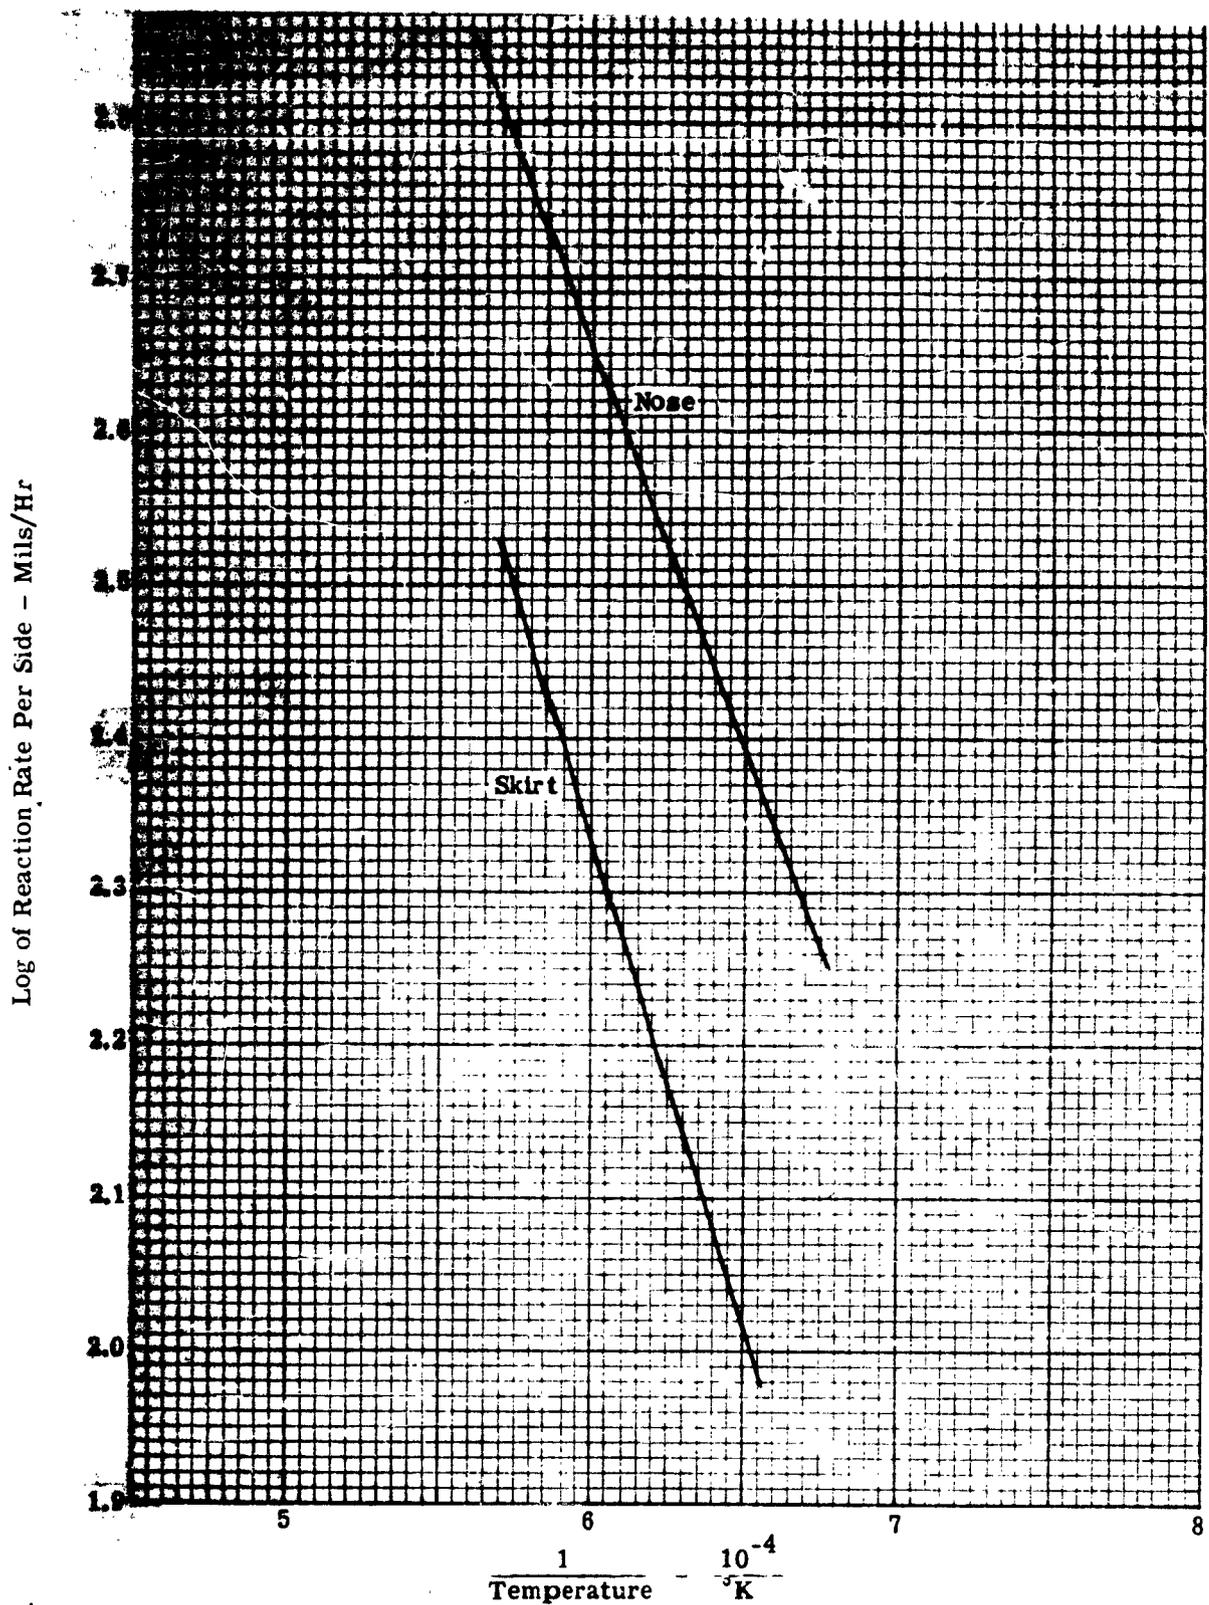
FIGURE 8. LOG OF SURFACE LOSS VS RECIPROCAL OF ABSOLUTE TEMPERATURE FOR UNCOATED 0.5% TITANIUM MOLYBDENUM ALLOY IN FLOWING AIR

Table 4 presents weight loss data, thickness change data, and test condition data for the uncoated 0.5% Ti molybdenum alloy. The thickness loss rate is given in mils per hour per side. The loss rate data was determined in three ways: (1) derivation from weight loss data, (2) measurements at a line across the specimen midway between the nose and the back, (3) measurement from the support pins to the nose and to the back edges. The data from each method is given in the table. Figure 6 shows the uncoated 0.5% Ti molybdenum alloy specimens before testing and after testing at 2000F in flowing air. Figure 7 shows the uncoated specimens before testing and after testing at 2450F in flowing air. During oxidation the metal loss was greatest at the nose and varied somewhat over the remainder of the specimen; however, the specimens retained their original wedge configuration. The oxidation reaction of molybdenum is exothermic; therefore, the specimen temperature during exposure is considerably higher than the initial test zone temperature (see Table 4). The actual specimen temperature was used for all computations.

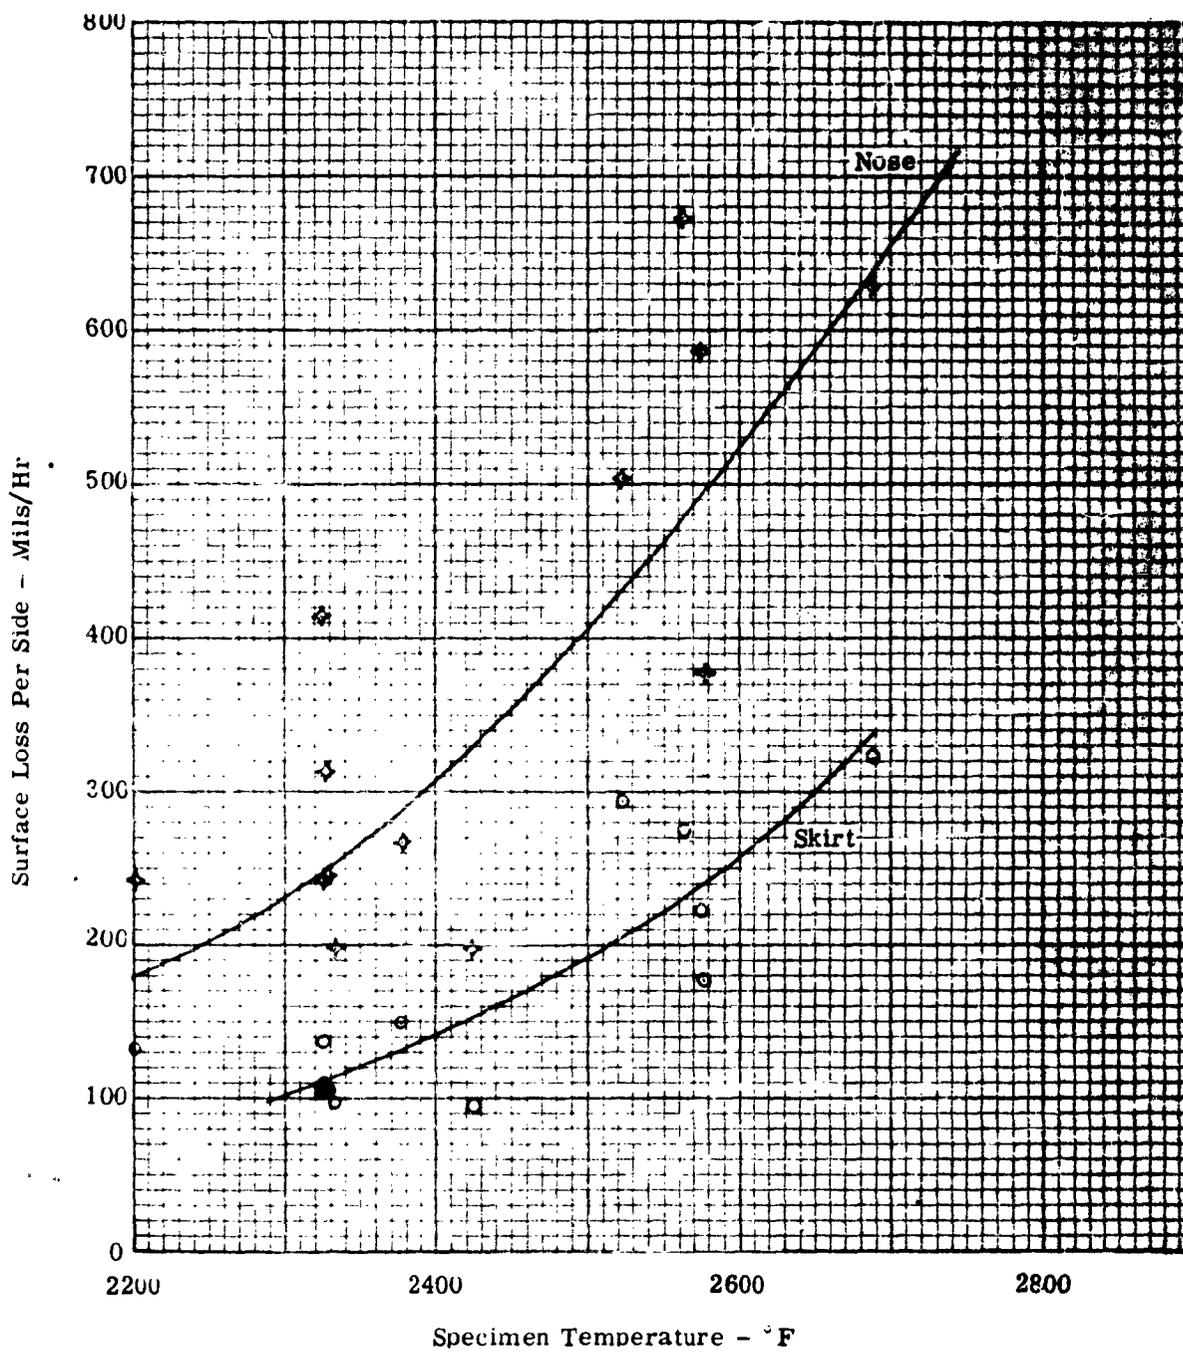
FIGURE 9. SURFACE LOSS FOR UNCOATED 0.5% TITANIUM MOLYBDENUM ALLOY IN FLOWING AIR

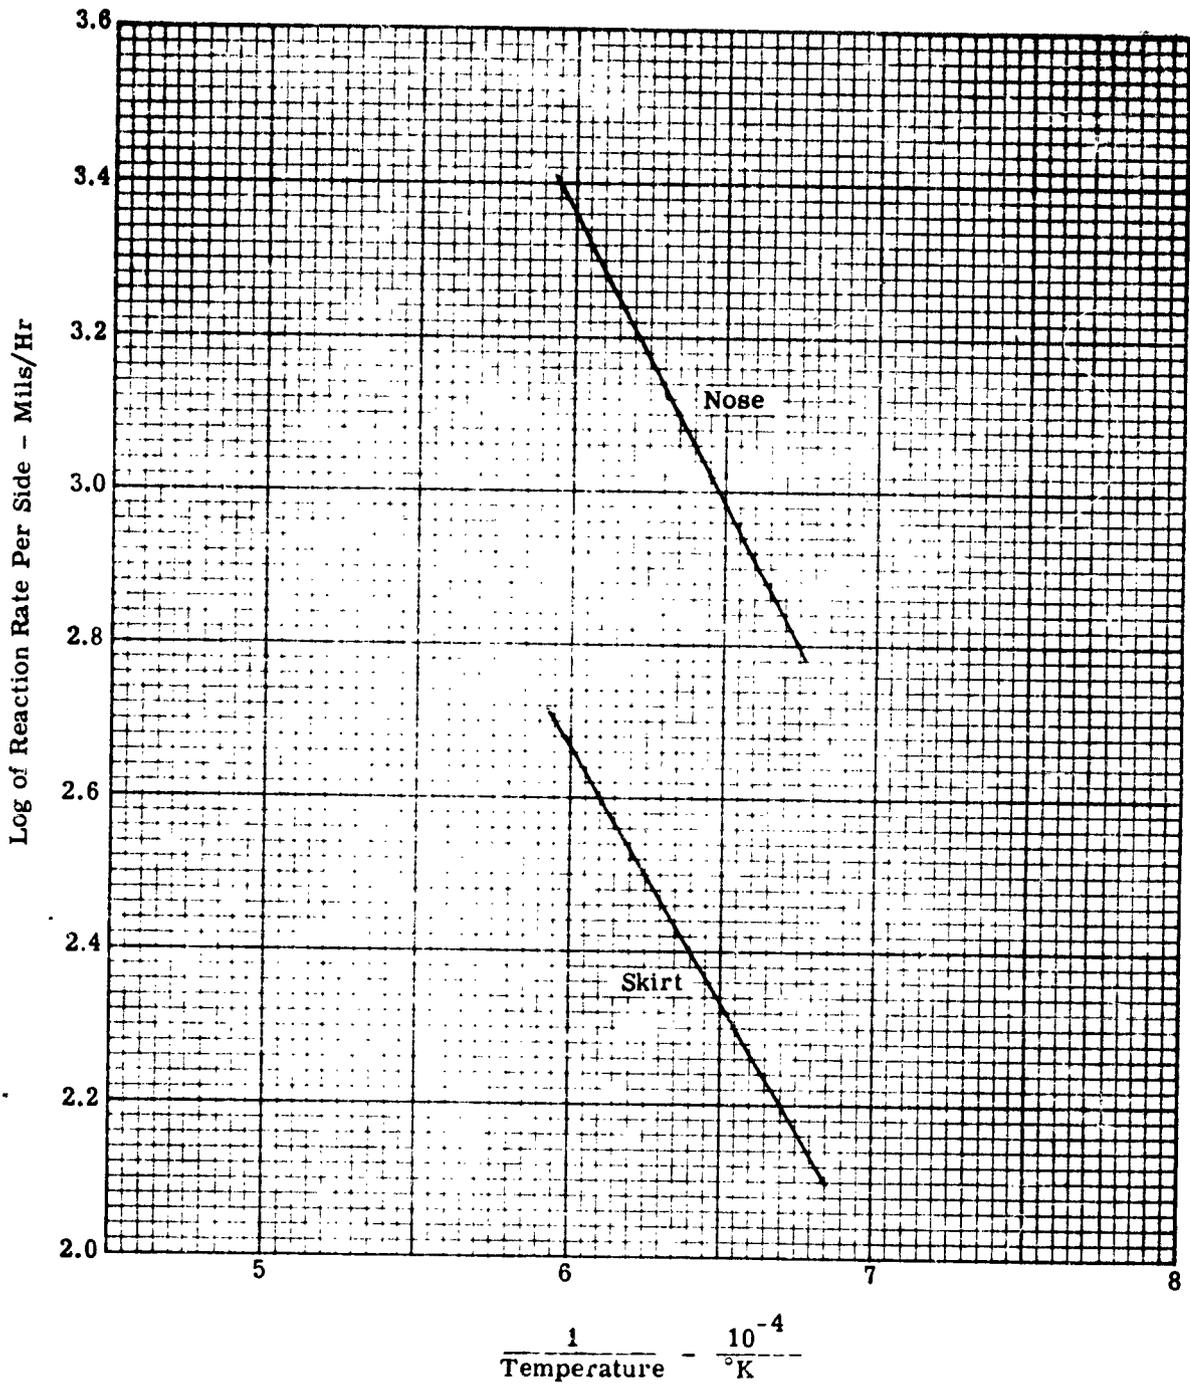
FIGURE 12. LOG OF SURFACE LOSS VS RECIPROCAL OF ABSOLUTE TEMPERATURE FOR UNCOATED ATJ GRAPHITE IN FLOWING AIR

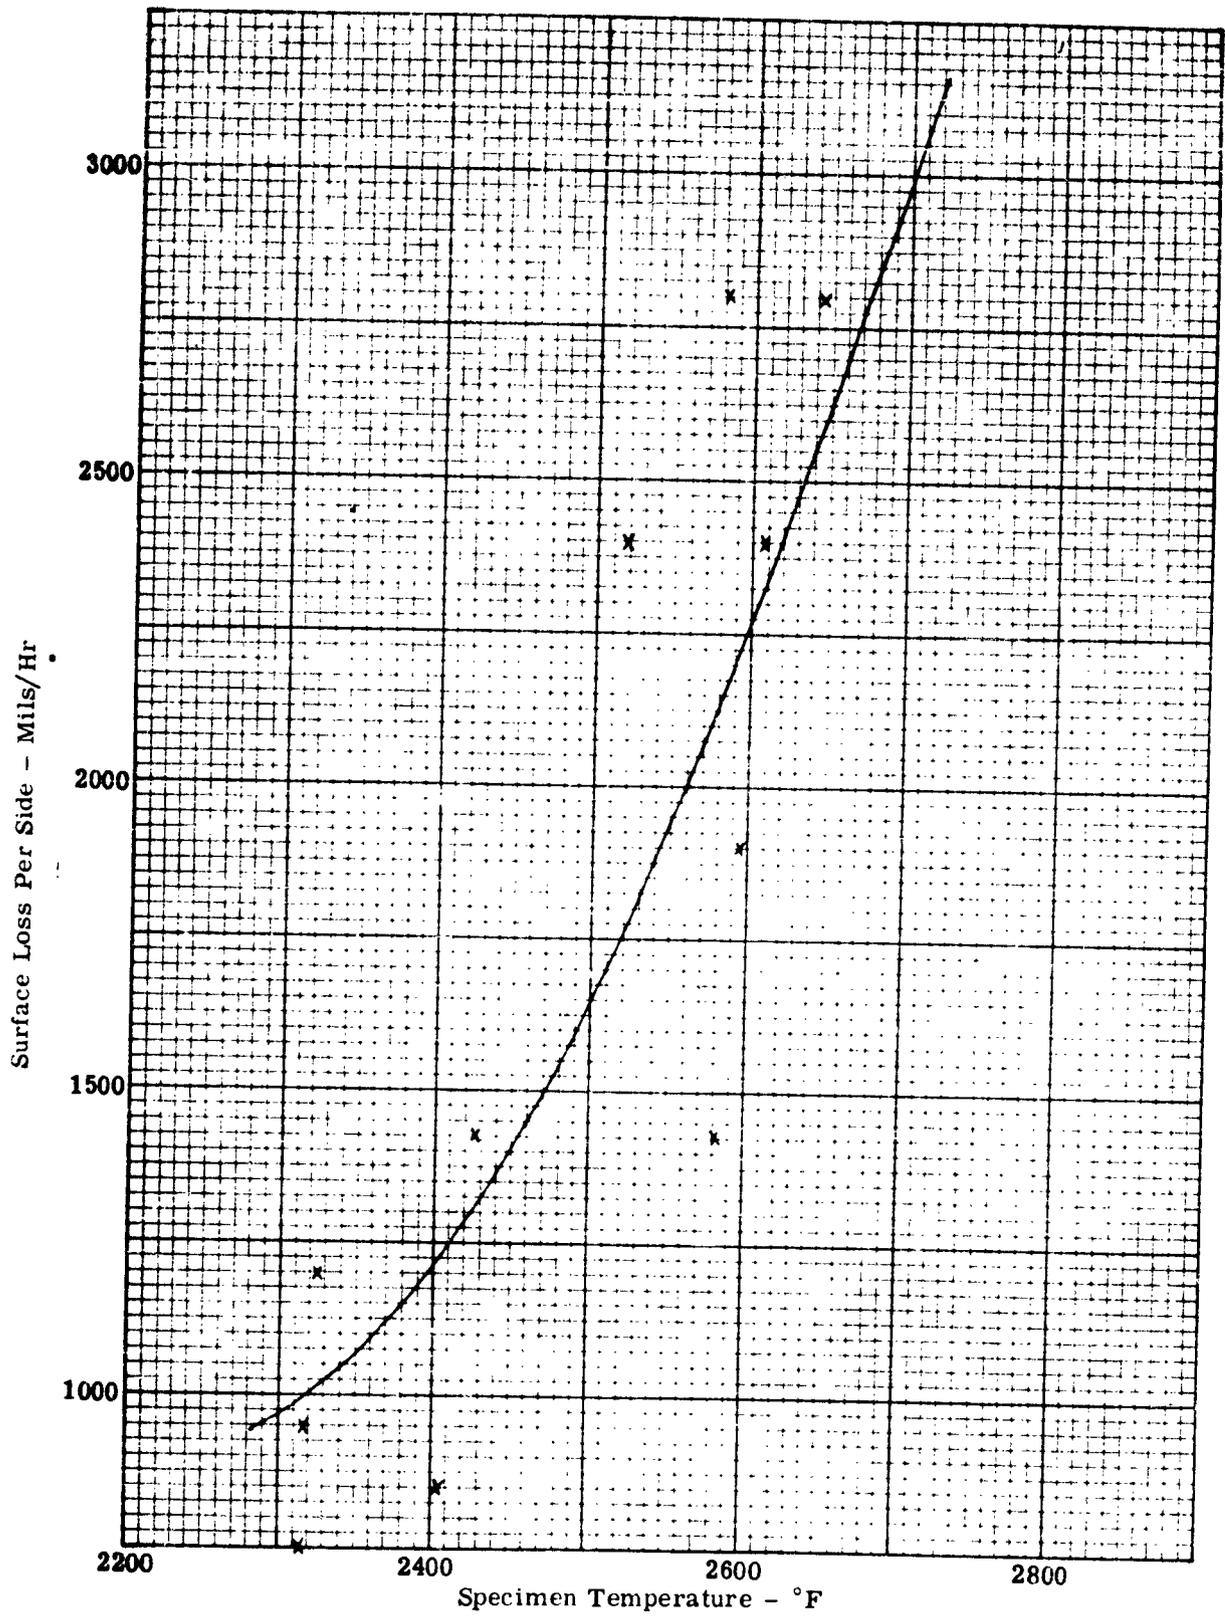
FIGURE 15. SURFACE LOSS AT NOSE FOR UNCOATED ATJ GRAPHITE IN FLOWING AIR

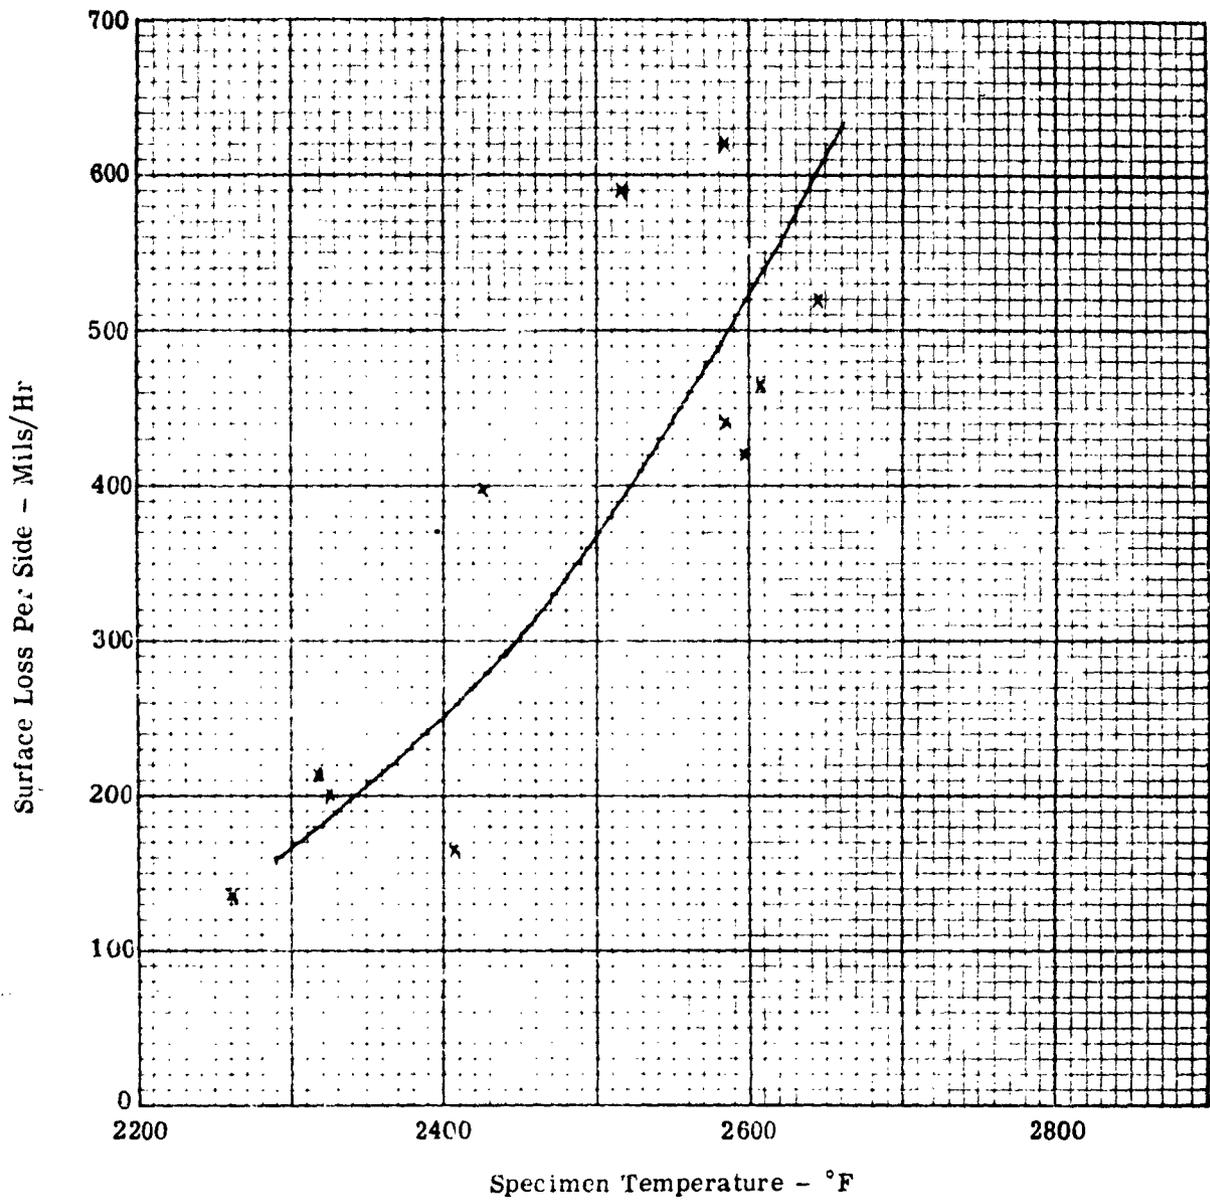
FIGURE 14. SURFACE LOSS AT SKIRT FOR UNCOATED ATJ GRAPHITE IN FLOWING AIR

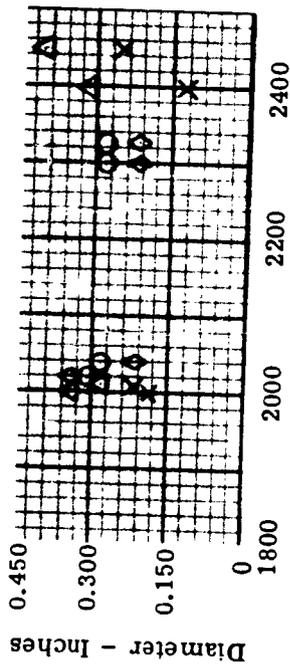
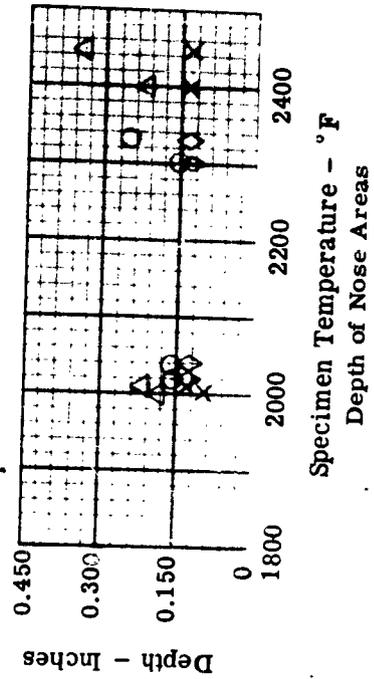
FIGURE 22. DIMENSIONS OF DAMAGED AREAS IN W-2 COATED 0.5% TITANIUM MOLYBDENUM ALLOY SPECIMENS AFTER TESTING

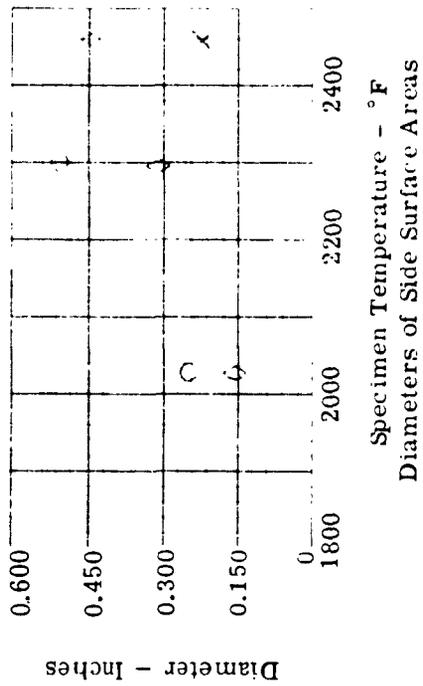
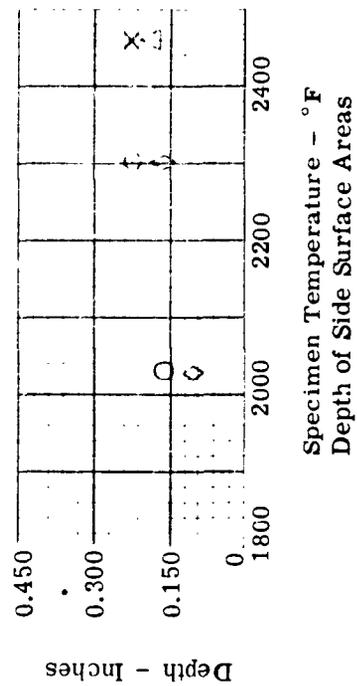
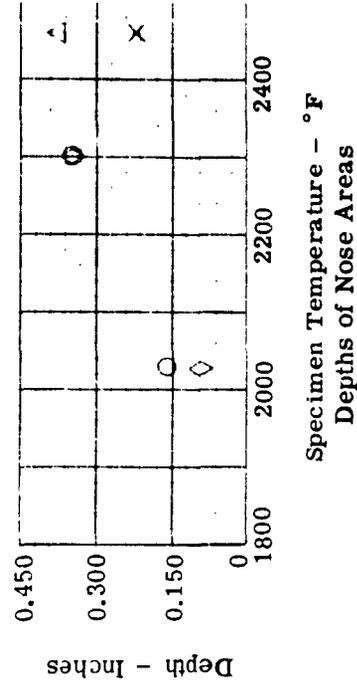
FIGURE 26. DIMENSIONS OF DAMAGED AREAS IN DURAK MG COATED 0.5% TITANIUM MOLYBDENUM ALLOY SPECIMENS AFTER TESTING

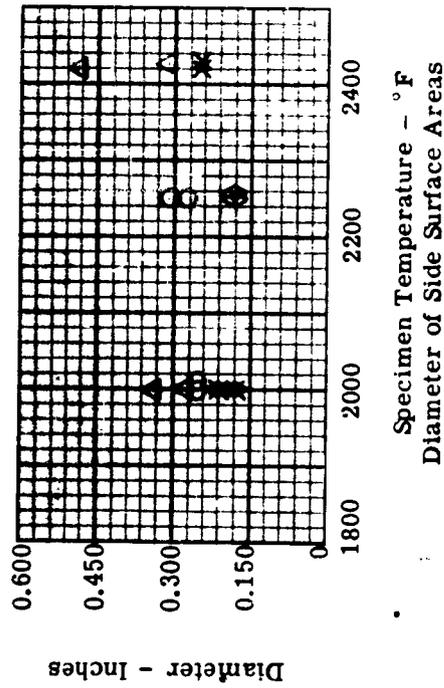
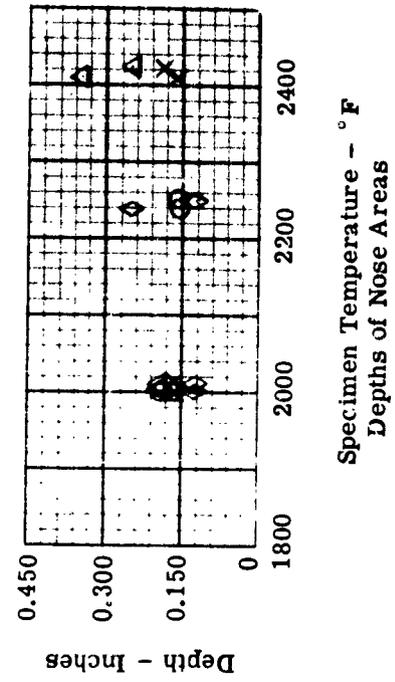
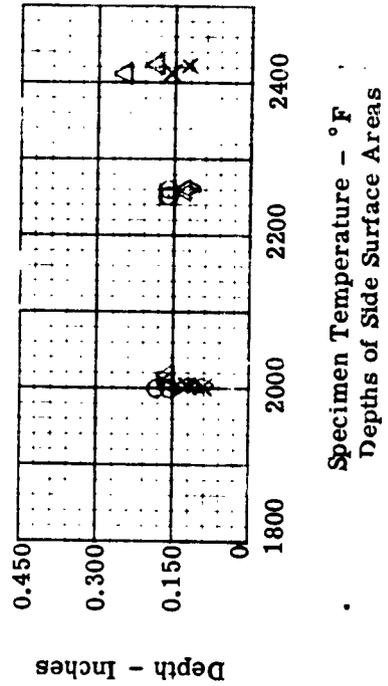
FIGURE 28. DIMENSIONS OF DAMAGED AREAS IN SILICONIZED ATJ GRAPHITE SPECIMENS AFTER TESTING

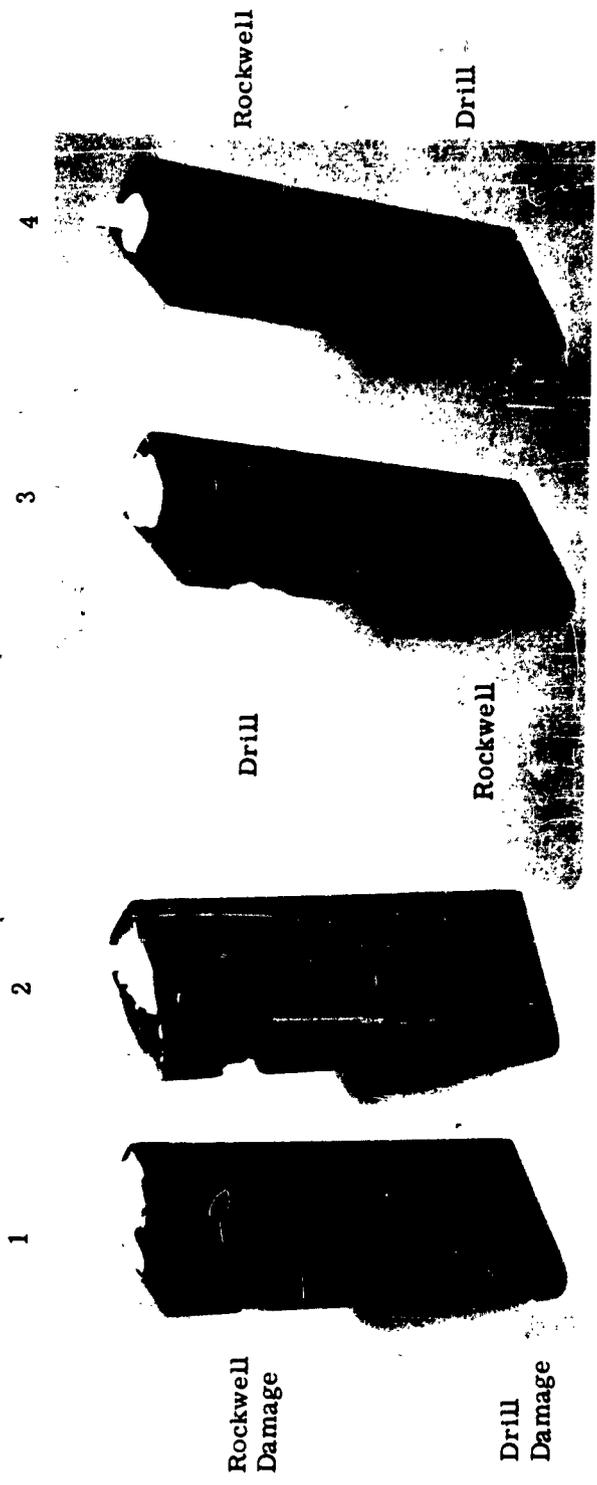
FIGURE 31. DAMAGED SILICONIZED ATJ GRAPHITE OXIDATION SPECIMENS  
AFTER TESTING AT 2450 °F IN FLOWING AIR

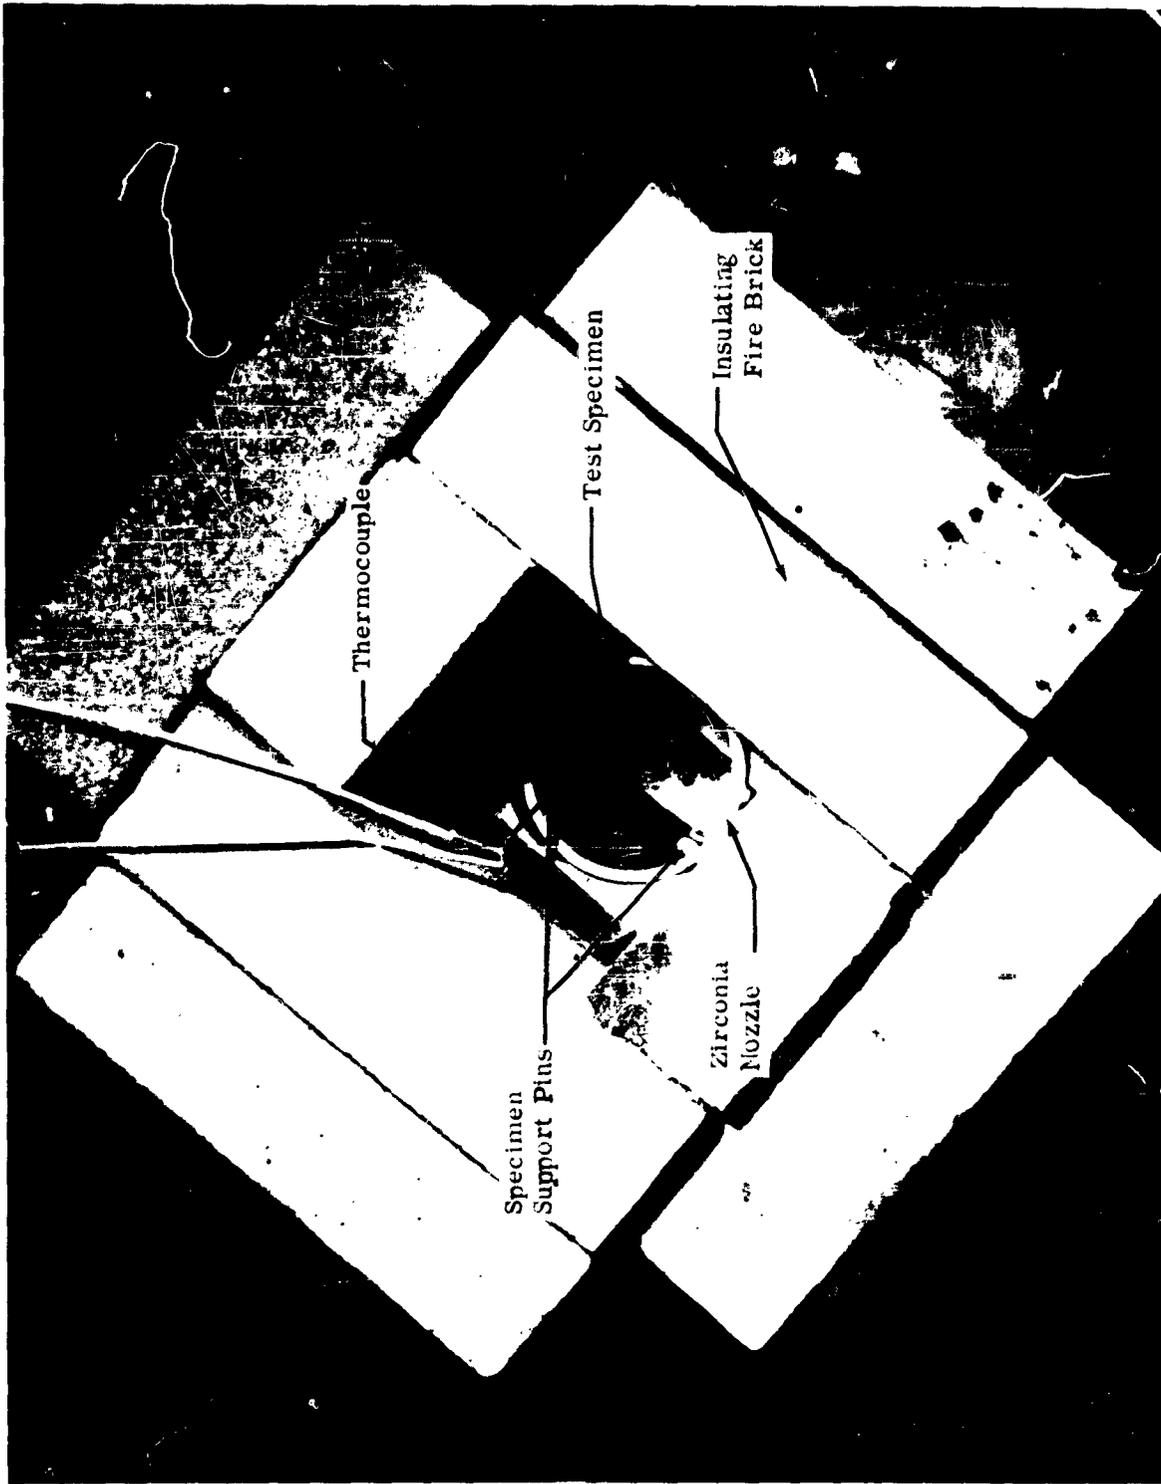
FIGURE 35. INTERIOR VIEW OF OXY-ACETYLENE TEST FURNACE  
WITH ONE SPECIMEN IN PLACE

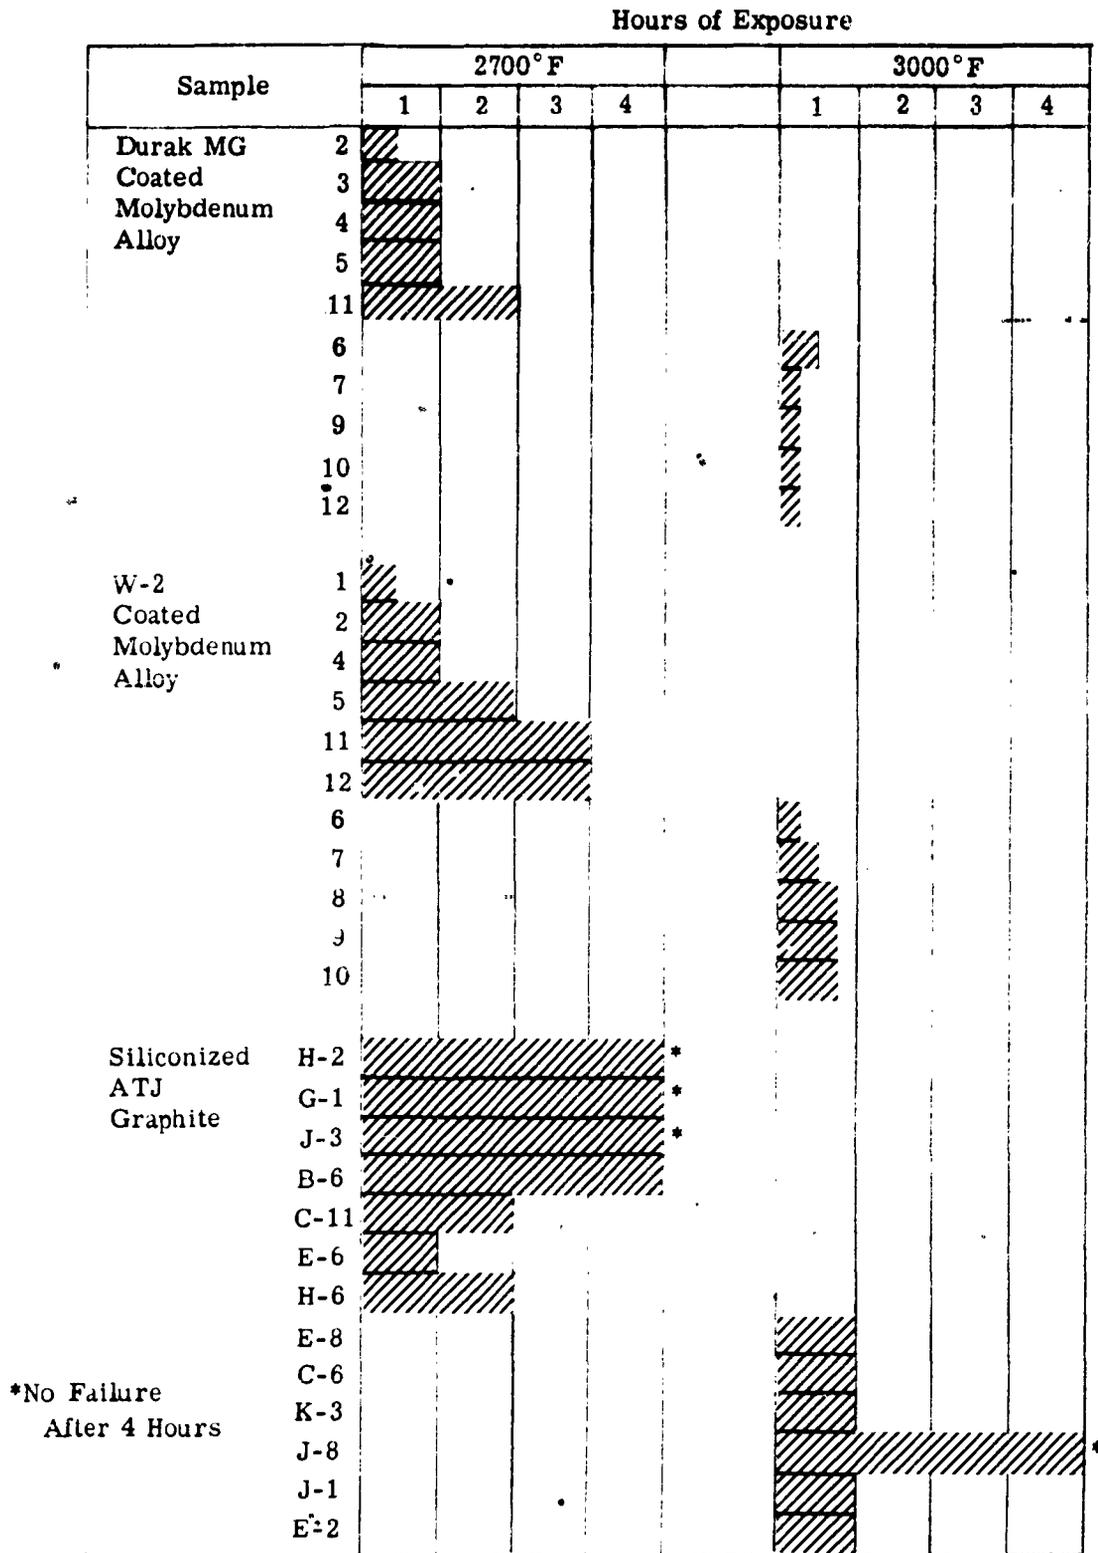
FIGURE 36. GRAPHIC PRESENTATION OF TEST RESULTS ON COATED SPECIMENS

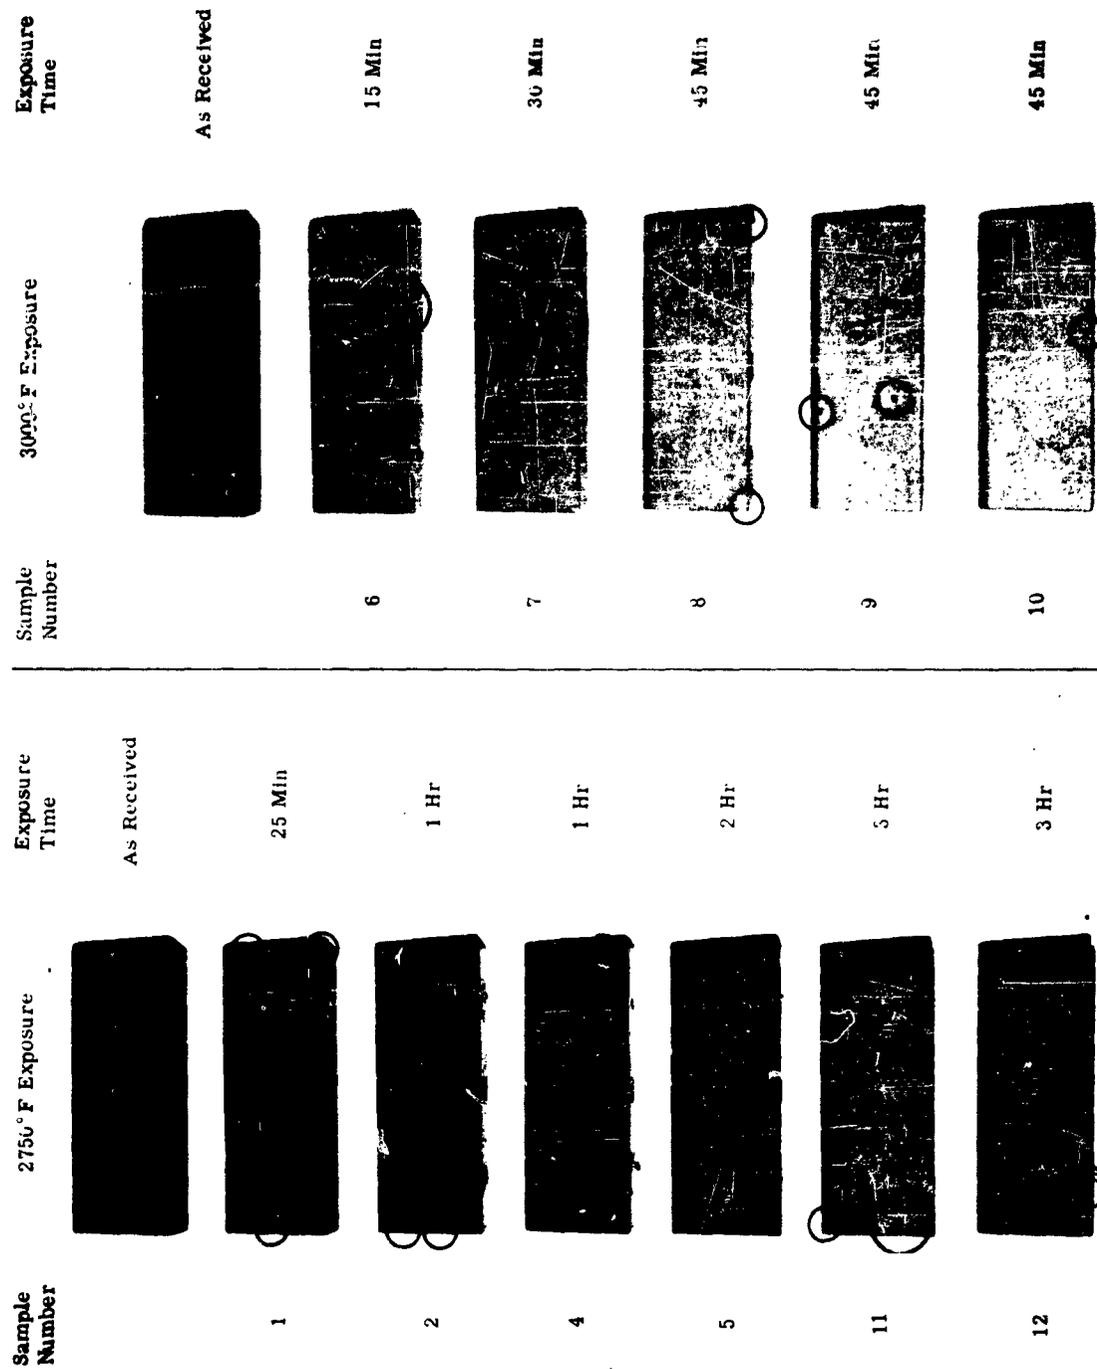
FIGURE 40. W-2 COATED MOLYBDENUM EXPOSED TO AN OXIDIZING ATMOSPHERE  
(FAILURES ENCIRCLED)

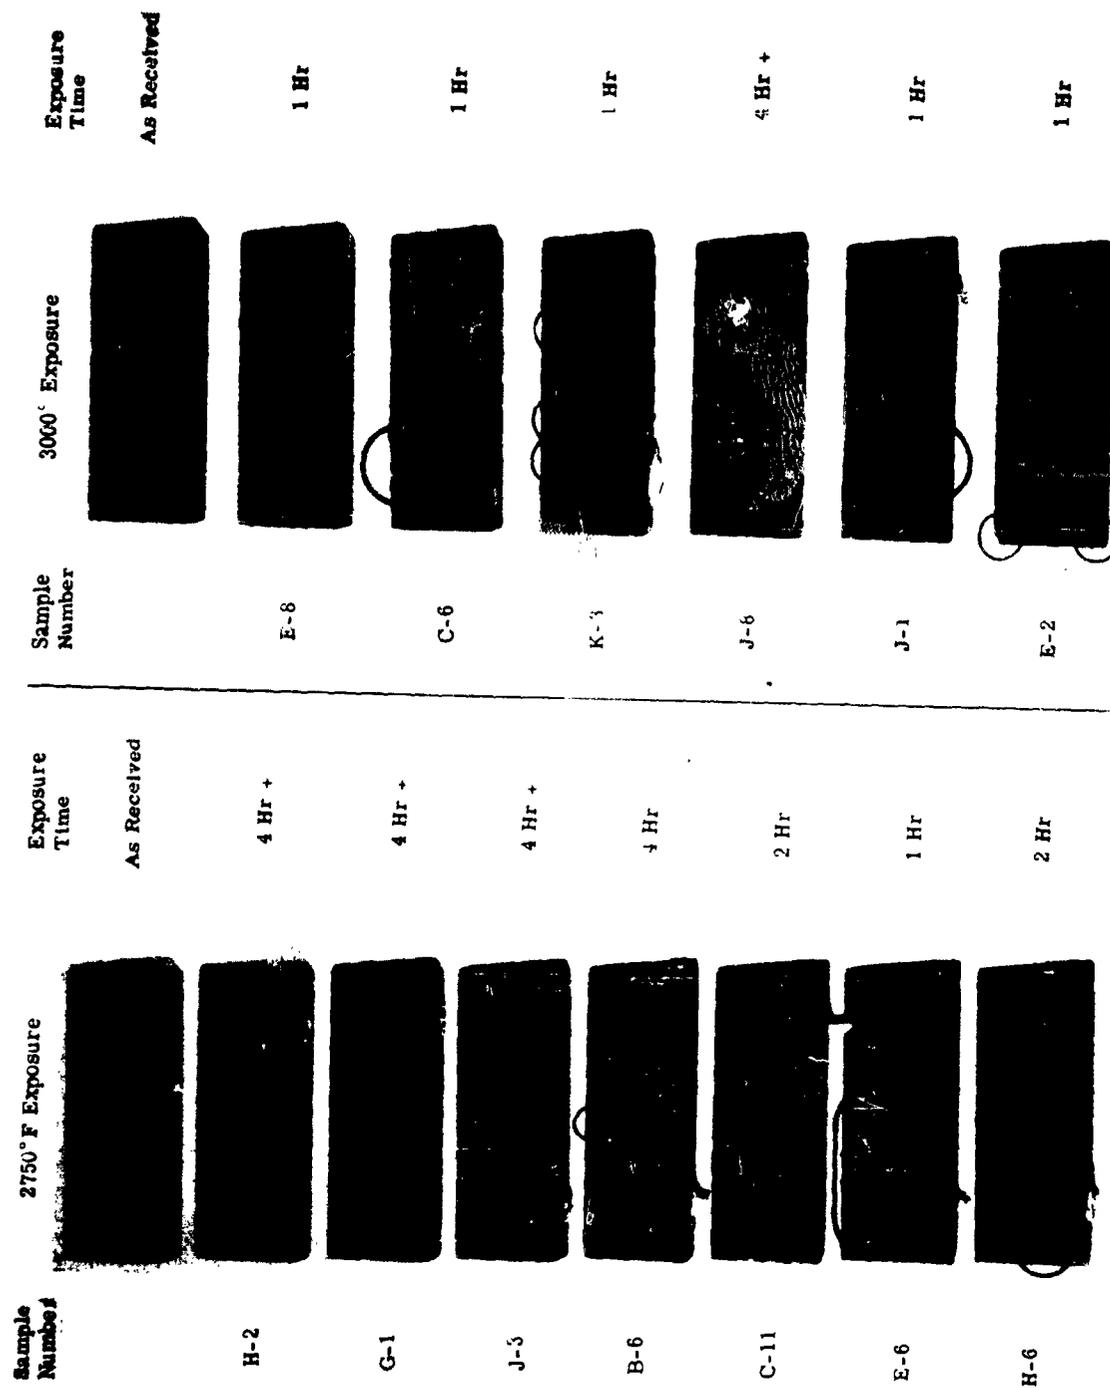
FIGURE 41. SILICONIZED ATJ COATED GRAPHITE EXPOSED TO OXIDIZING ATMOSPHERE  
(FAILURES ENCIRCLED)
