WADC TECHNICAL REPORT 59-744  
VOLUME VII

# INVESTIGATION OF FEASIBILITY OF UTILIZING AVAILABLE HEAT RESISTANT MATERIALS FOR HYPERSONIC LEADING EDGE APPLICATIONS

Volume VII—Oxidation Resistance of Bare and Coated Molybdenum Alloy and Graphite

*Bell Aerosystems Company*

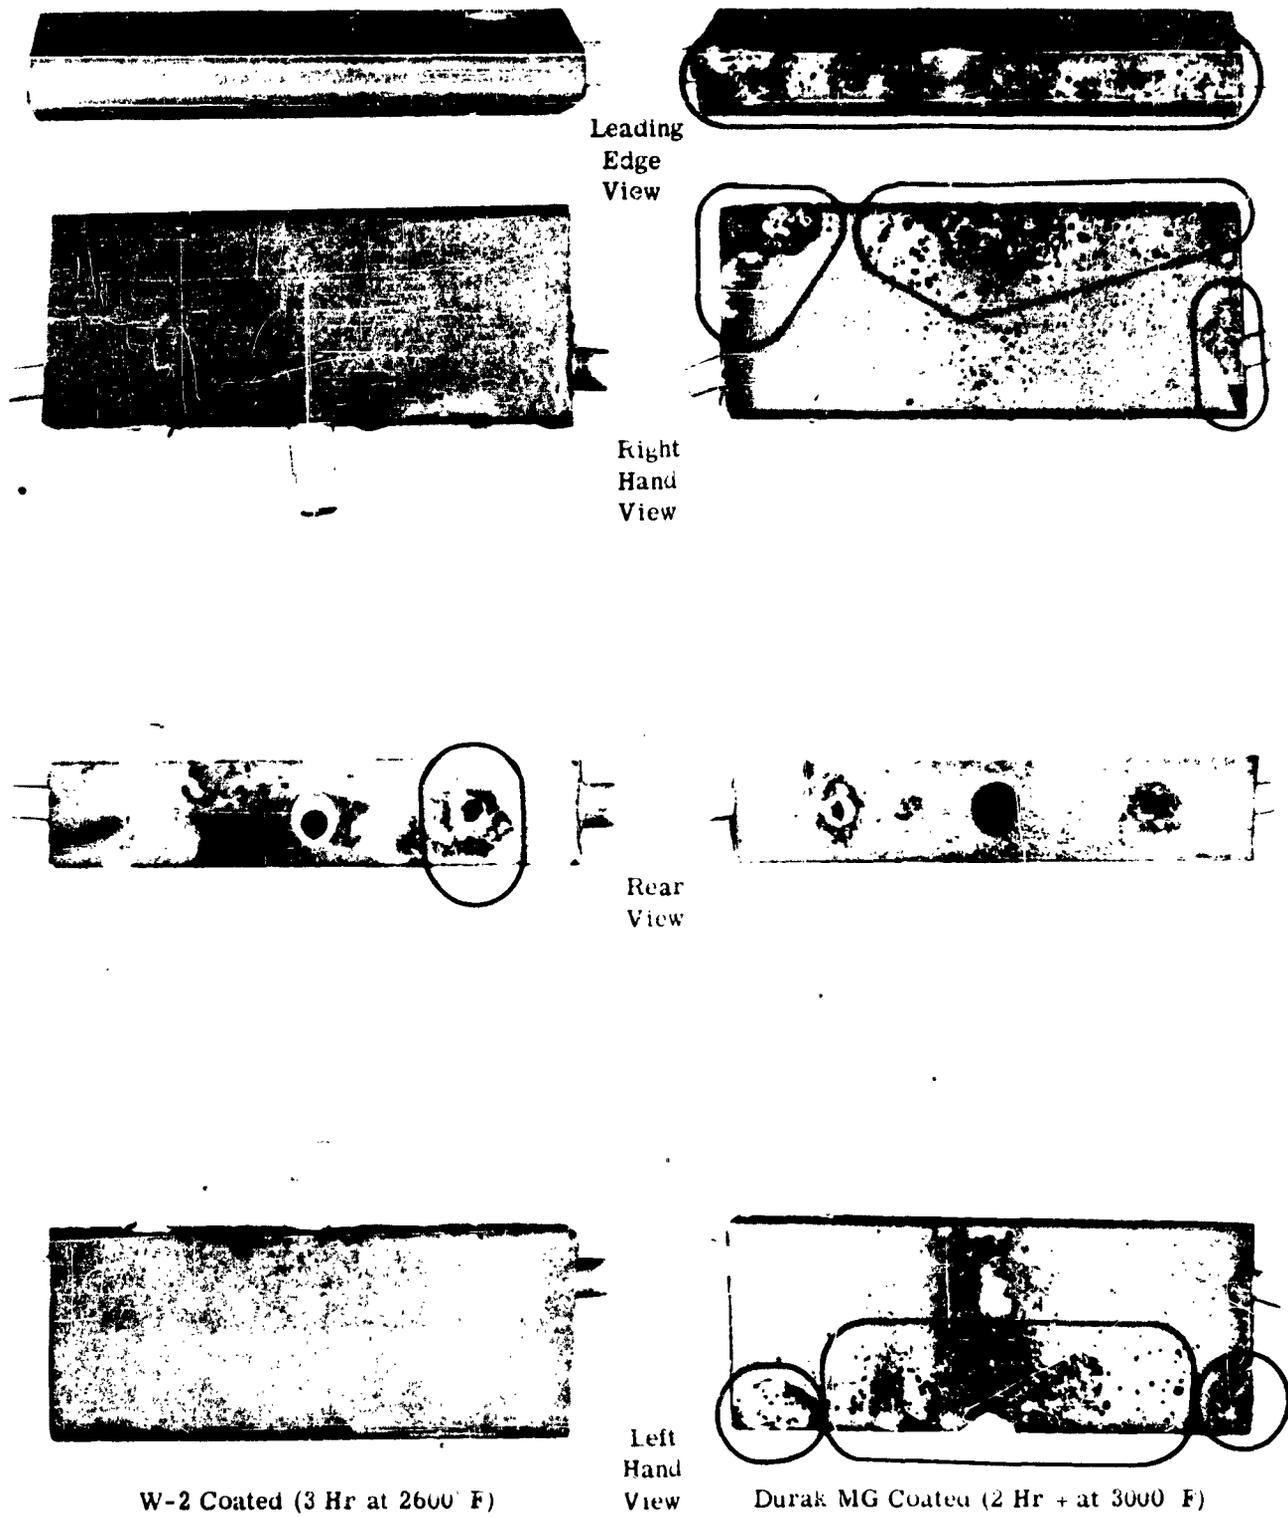
FIGURE 42. COATED MOLYBDENUM SPECIMENS AFTER TEST (FAILURES ENCIRCLED)

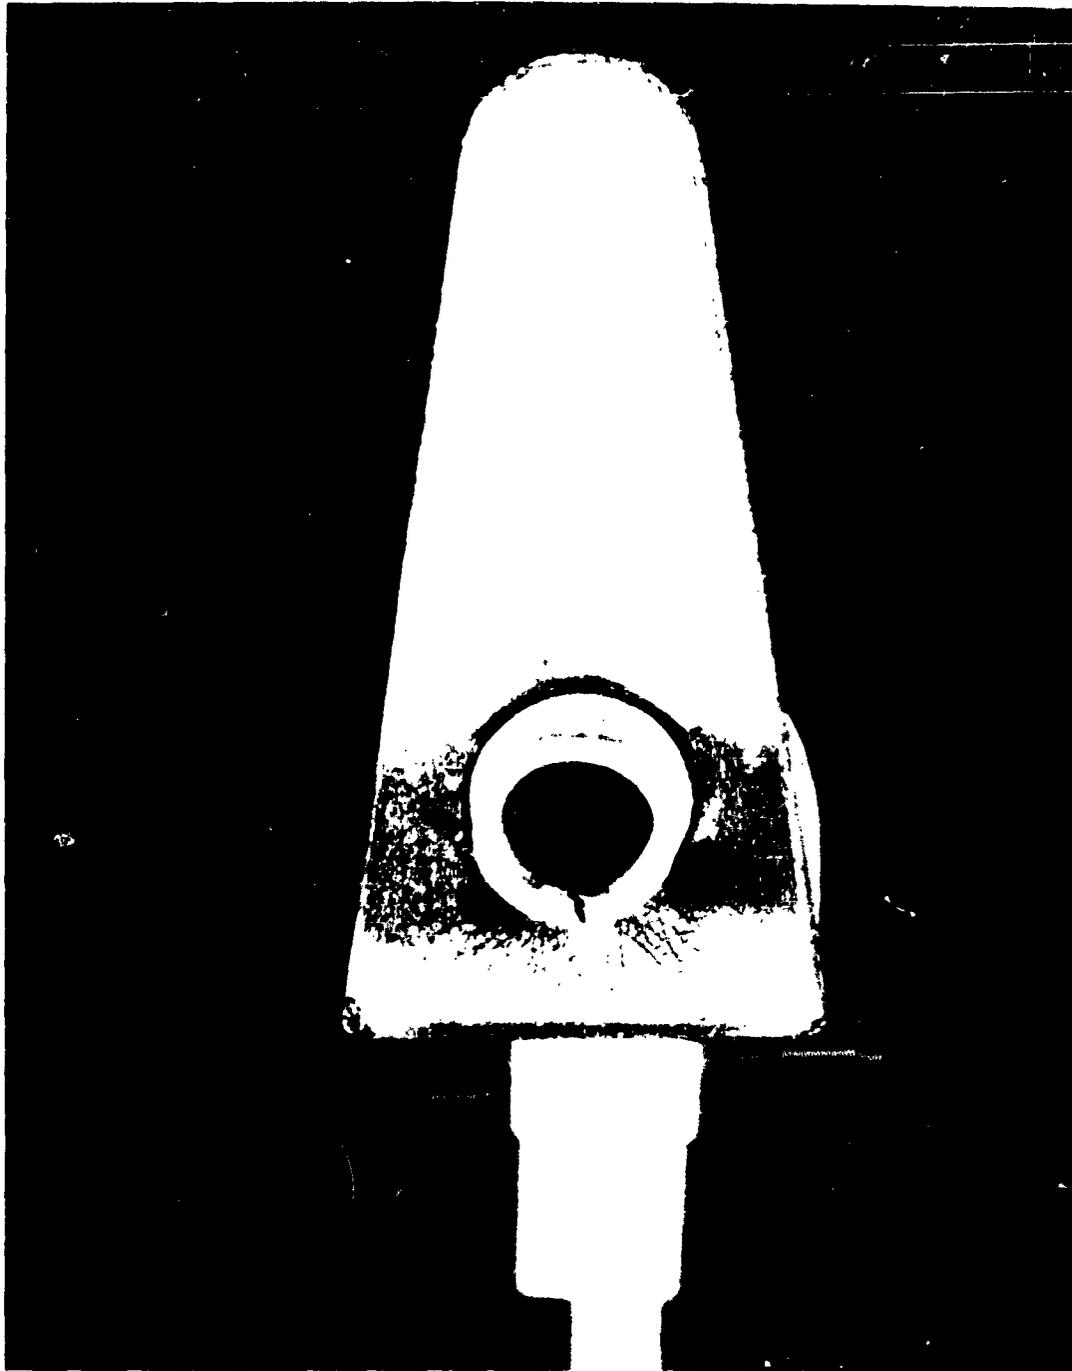
FIGURE 43. SIDE VIEW OF W-2 COATED MOLYBDENUM SPECIMEN SHOWING ZIRCONIA SUPPORTING ROD (AFTER 3 HOURS AT 2600° F)

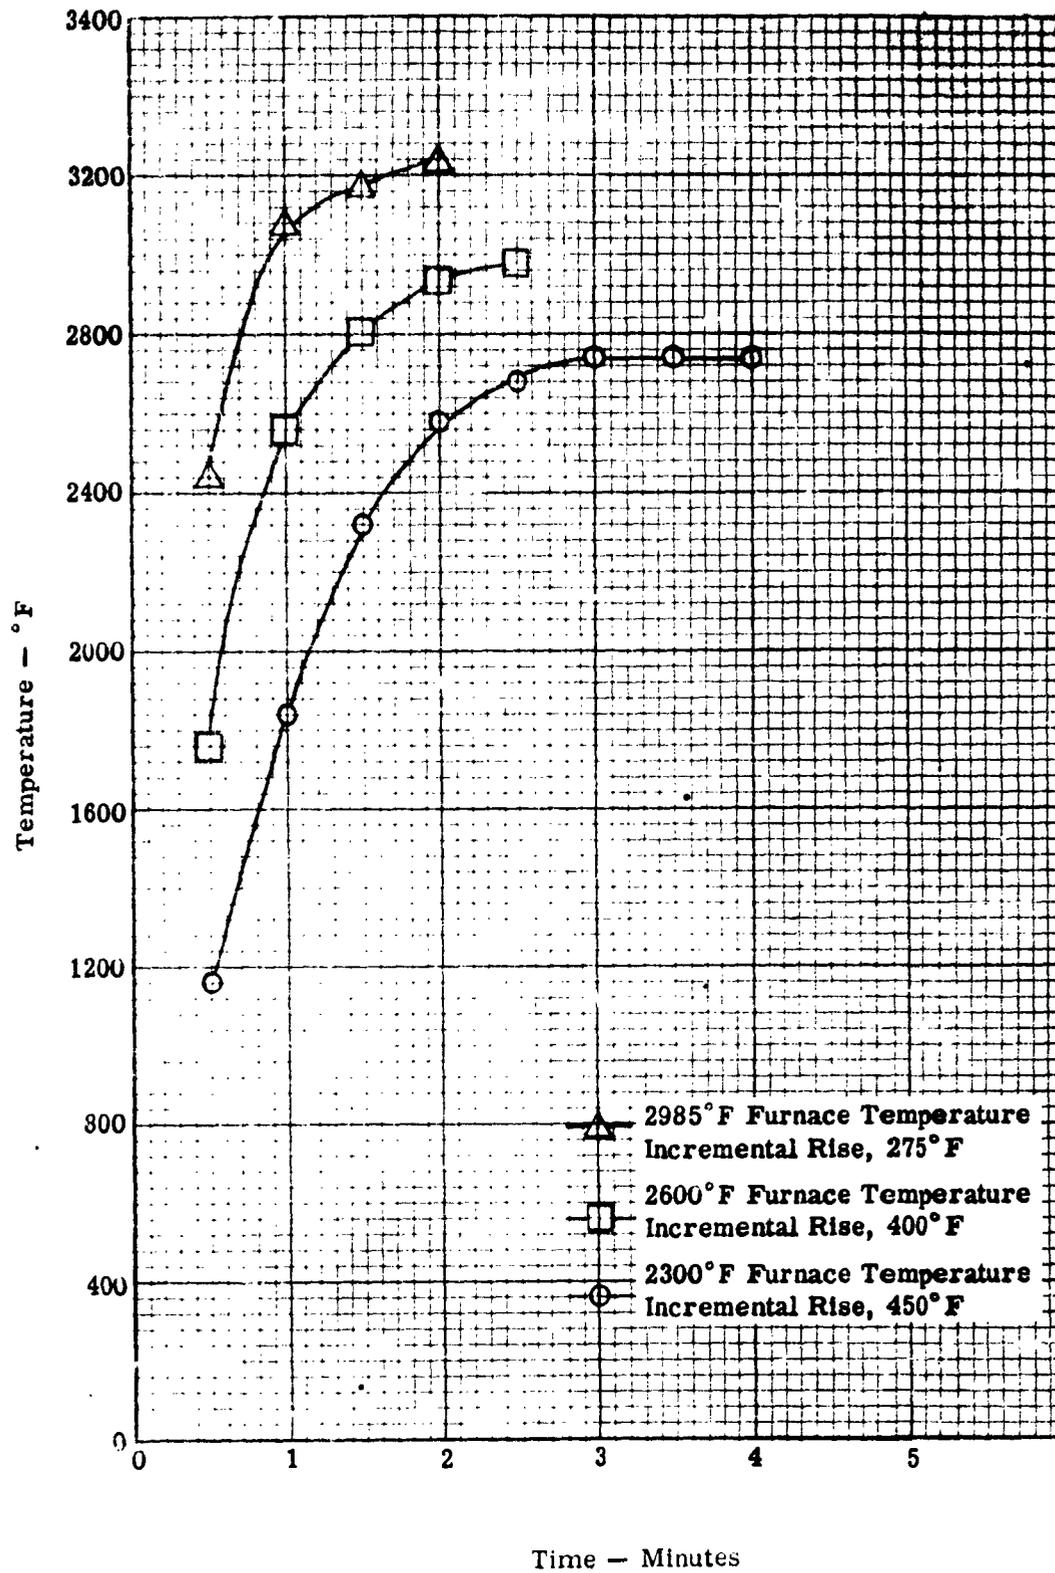
FIGURE 44. UNCOATED MOLYBDENUM SPECIMEN TEMPERATURE VS TIME OF EXPOSURE IN FURNACE

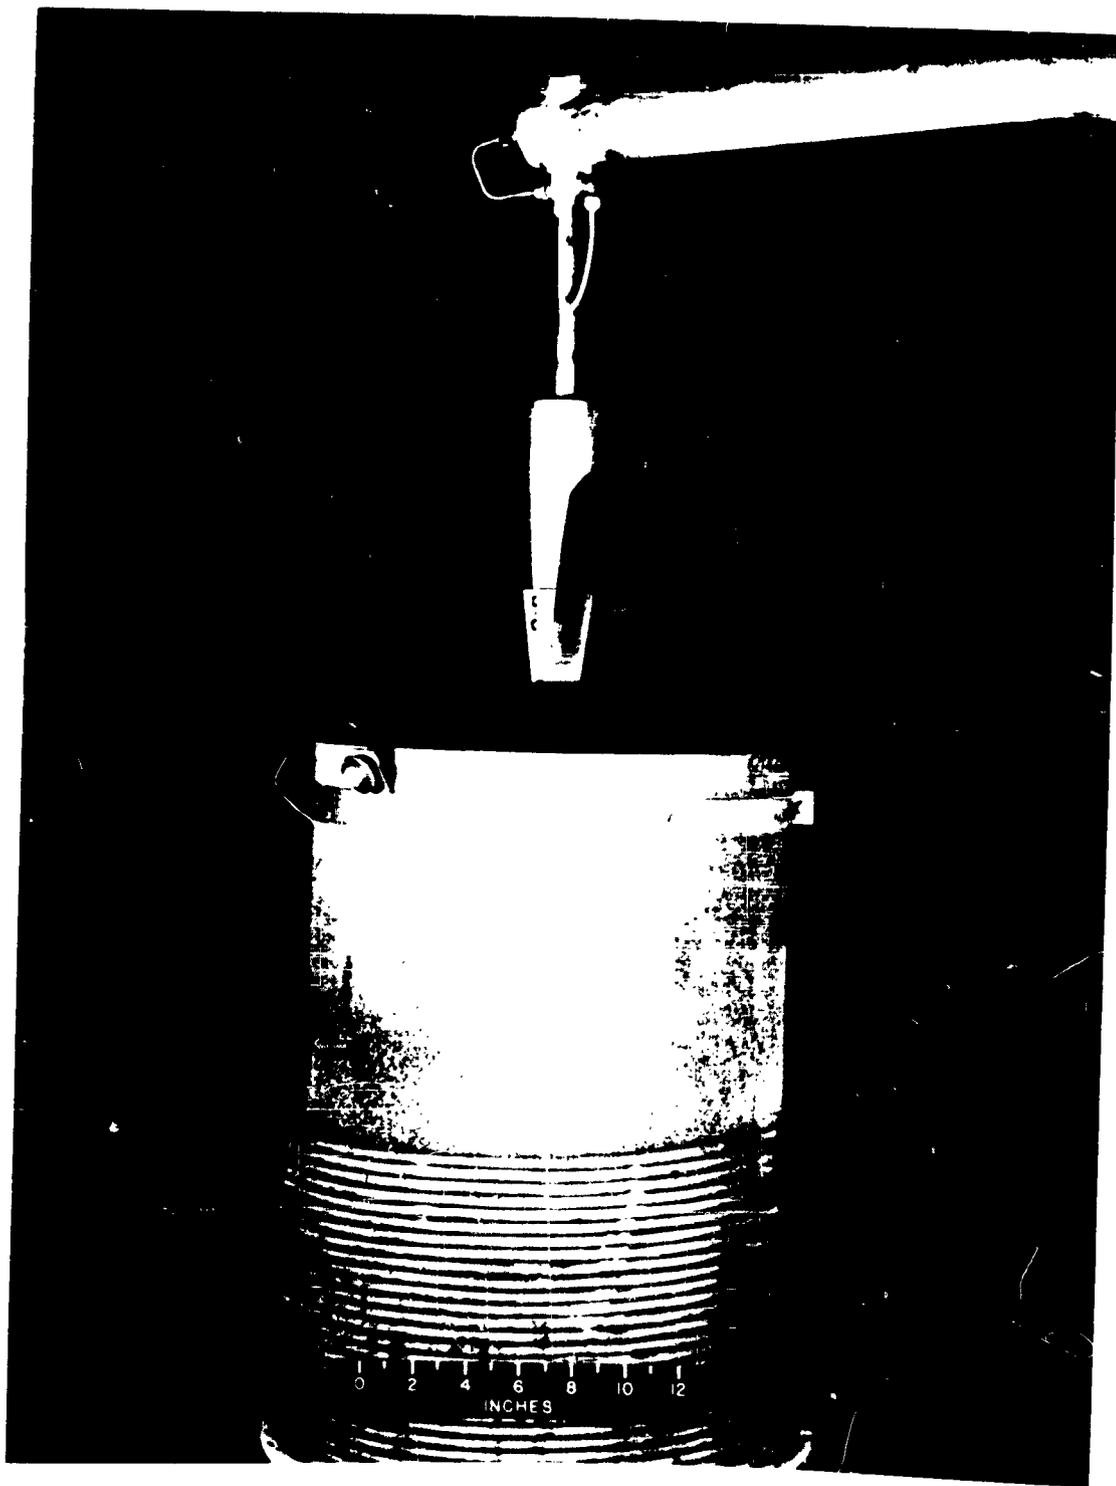
FIGURE 45. A LEADING EDGE SPECIMEN POSITIONED OVER NASA LANGLEY RESEARCH CENTER ARC JET NO. 20

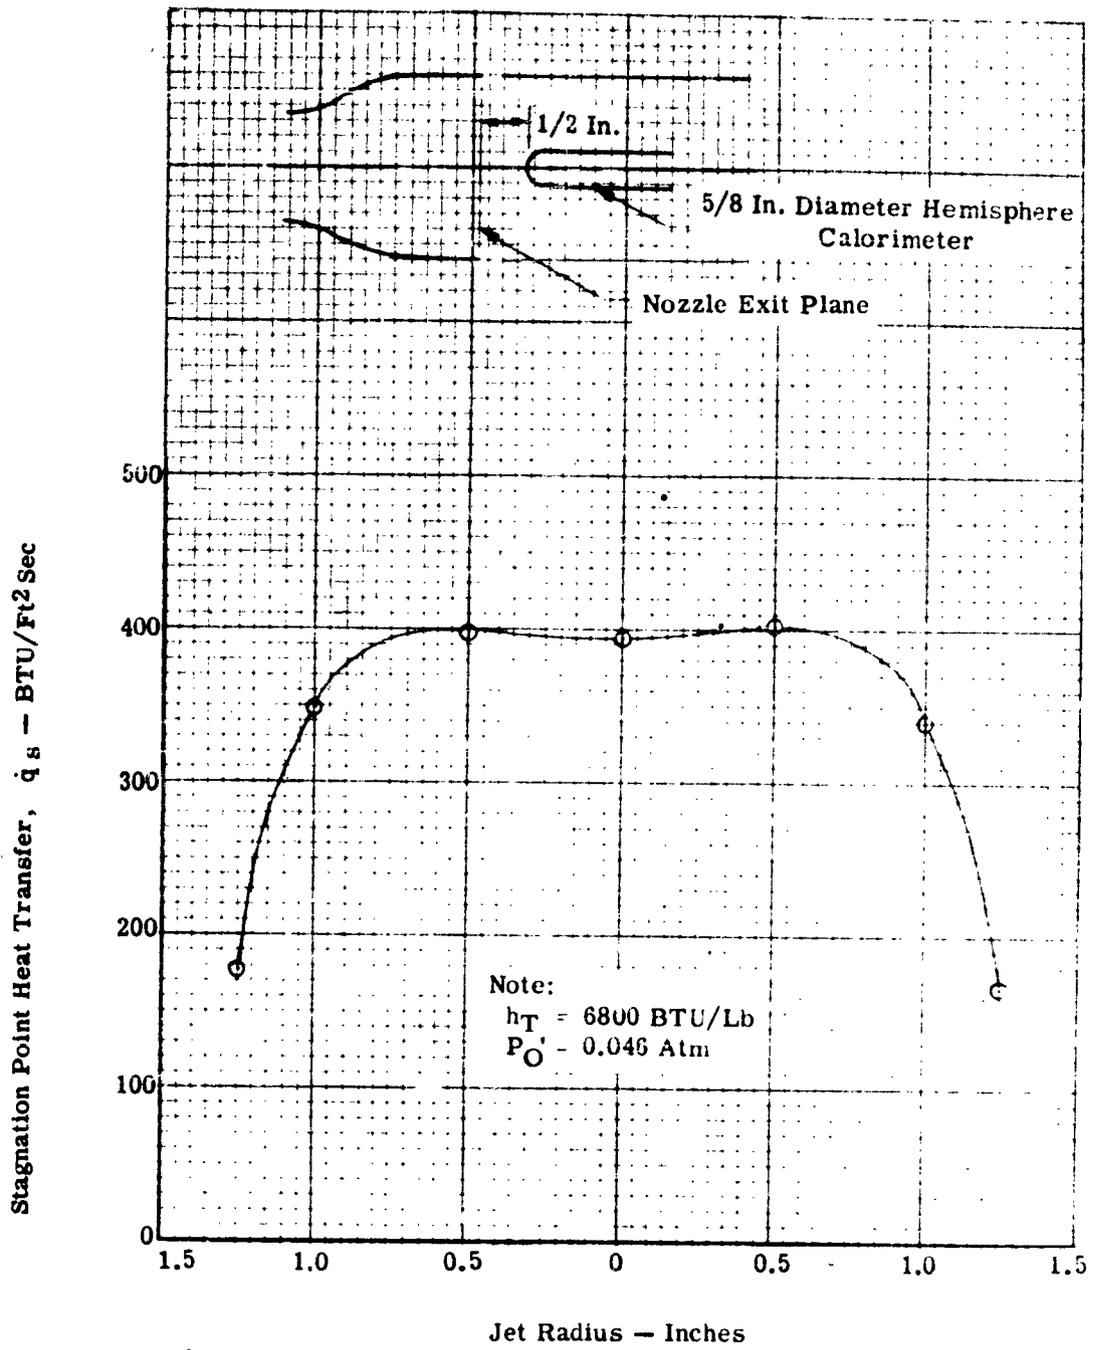
FIGURE 53. RADIAL SURVEY OF STAGNATION POINT HEAT TRANSFER RATE, PLASMADYNE CORPORATION

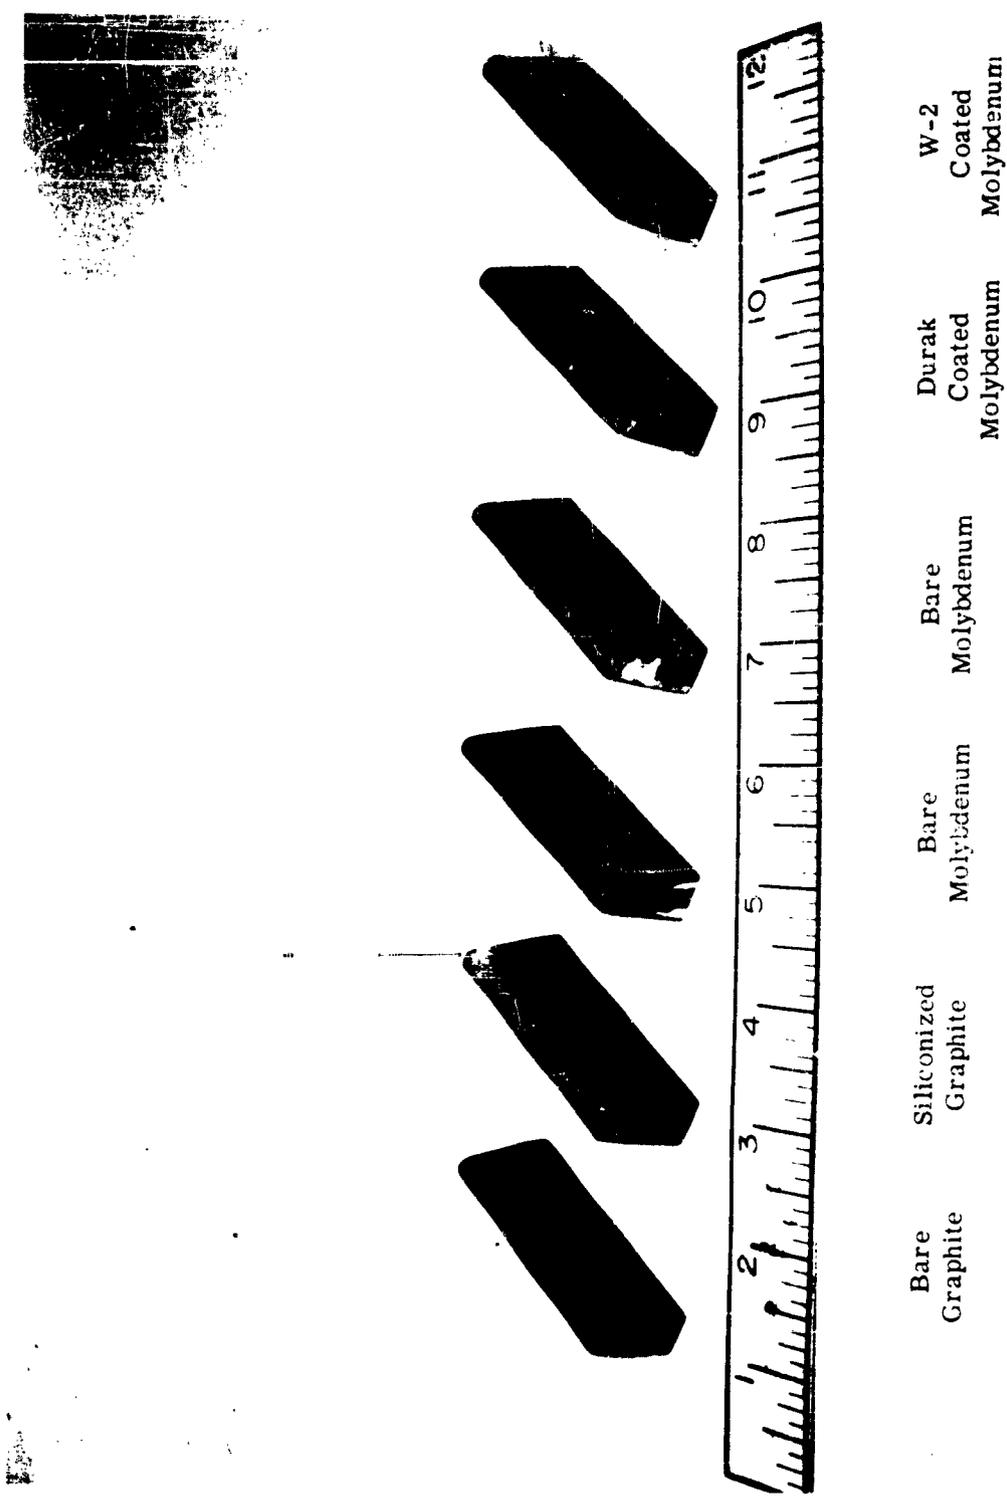
FIGURE 57. TYPICAL LEADING EDGE SPECIMENS AFTER NOMINAL 1-MINUTE TESTS IN NASA LANGLEY RESEARCH CENTER ARC TUNNEL (ARC JET NO. 10)

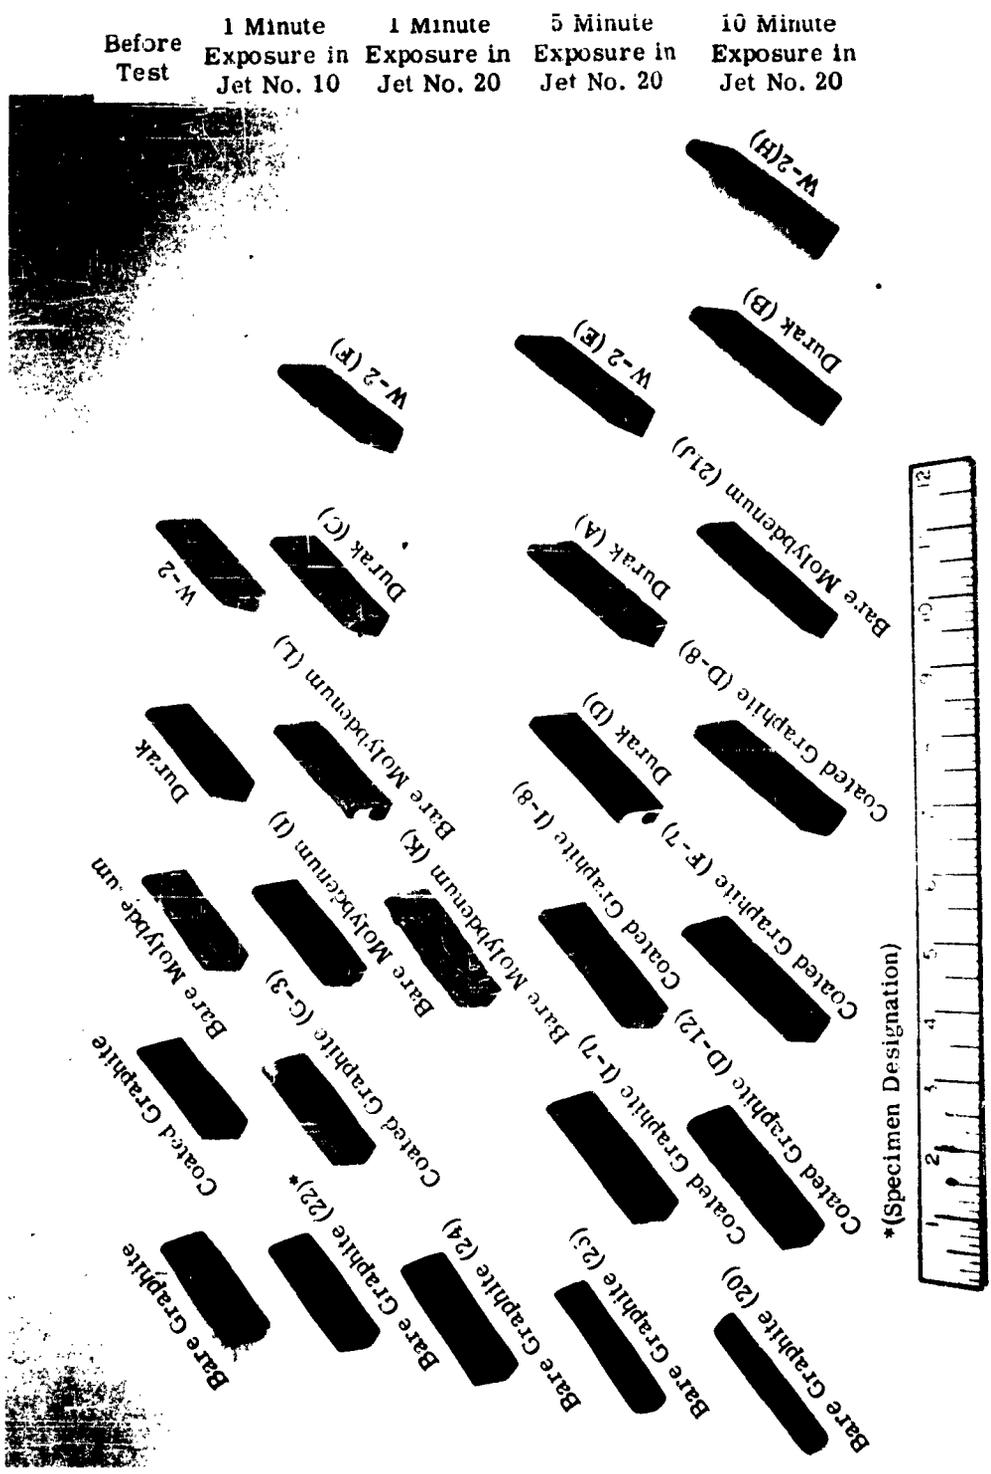
FIGURE 58. ALL SPECIMENS TESTED IN NASA LANGLEY RESEARCH CENTER ARC JETS

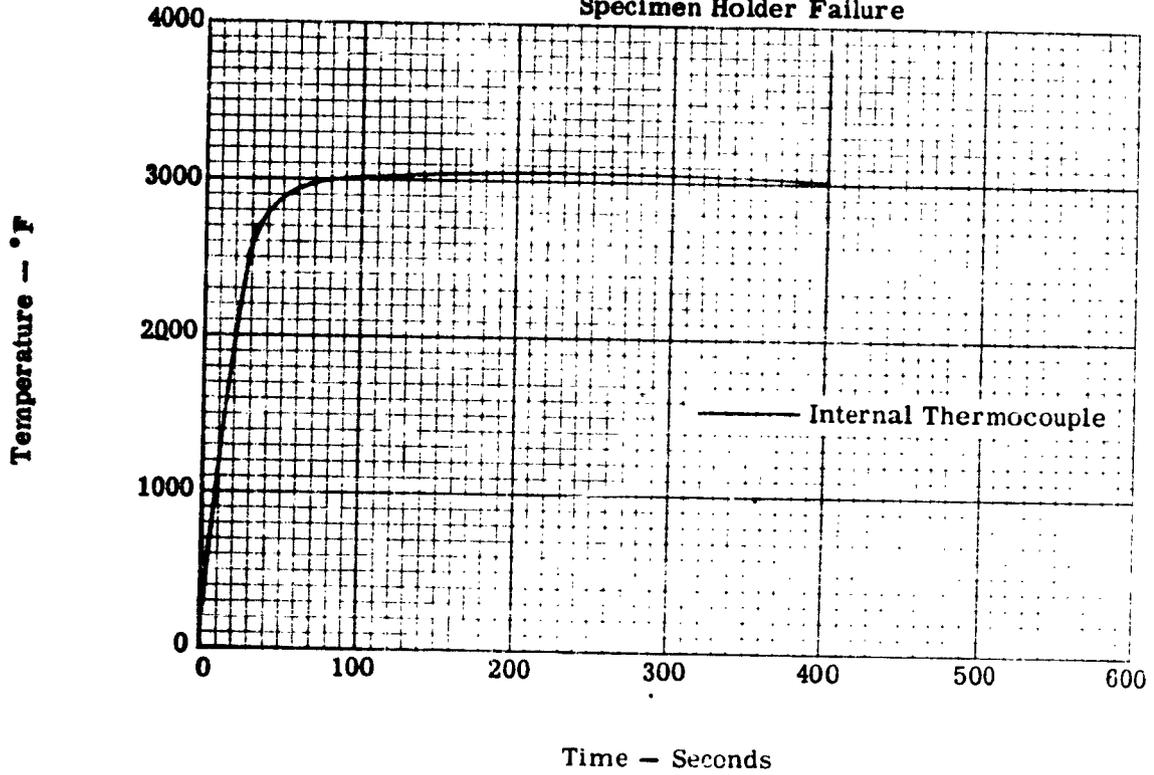
Specimen 29  
Bare ATJ Graphite  
Arc Jet 20

Test Terminated at 519 Seconds Because of  
Specimen Holder Failure

FIGURE 61. SPECIMEN 29 TEMPERATURE VS TIME, NASA LANGLEY RESEARCH CENTER.

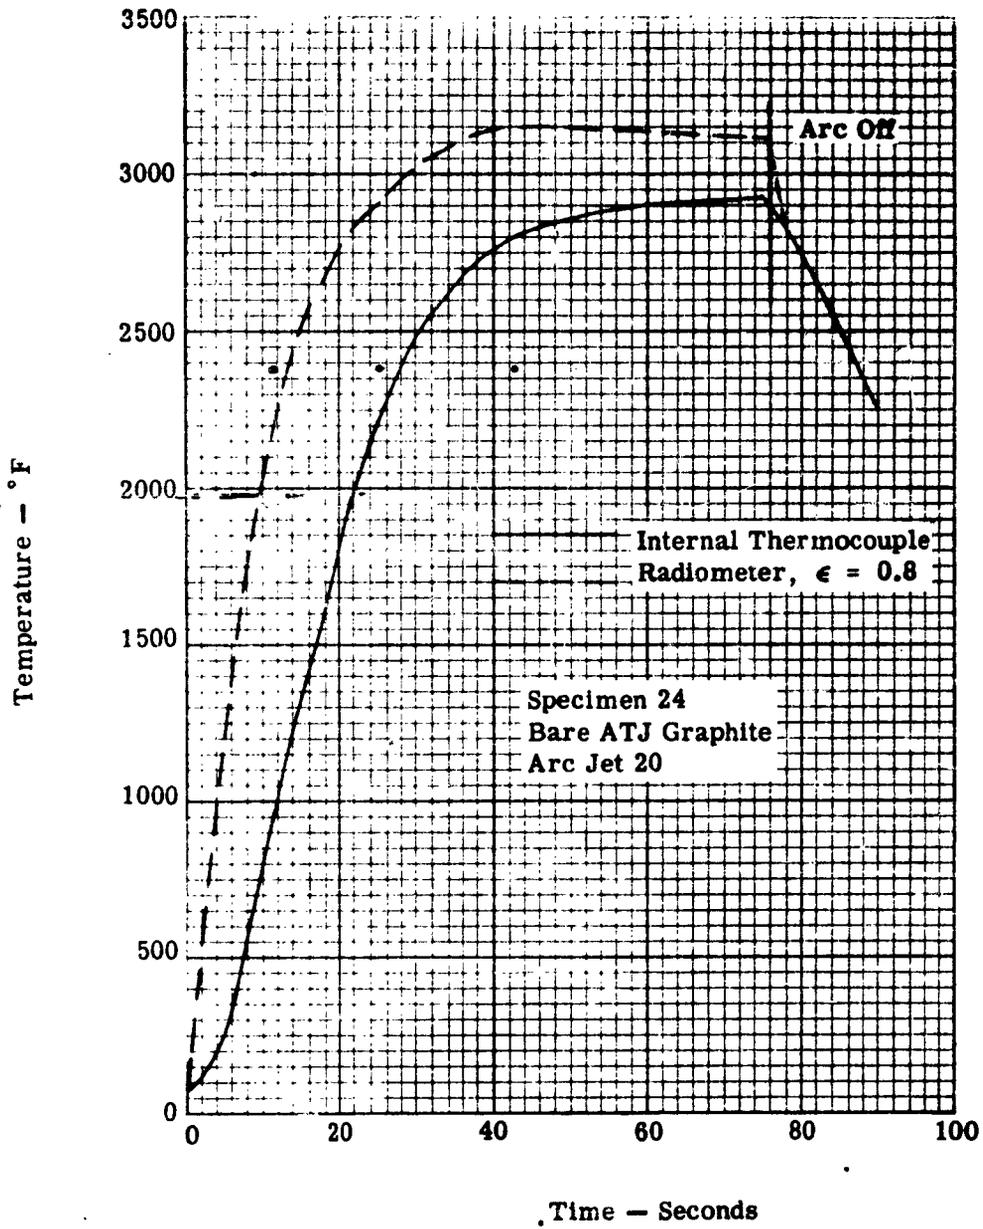
FIGURE 62. SPECIMEN 24 TEMPERATURE VS TIME, NASA LANGLEY RESEARCH CENTER

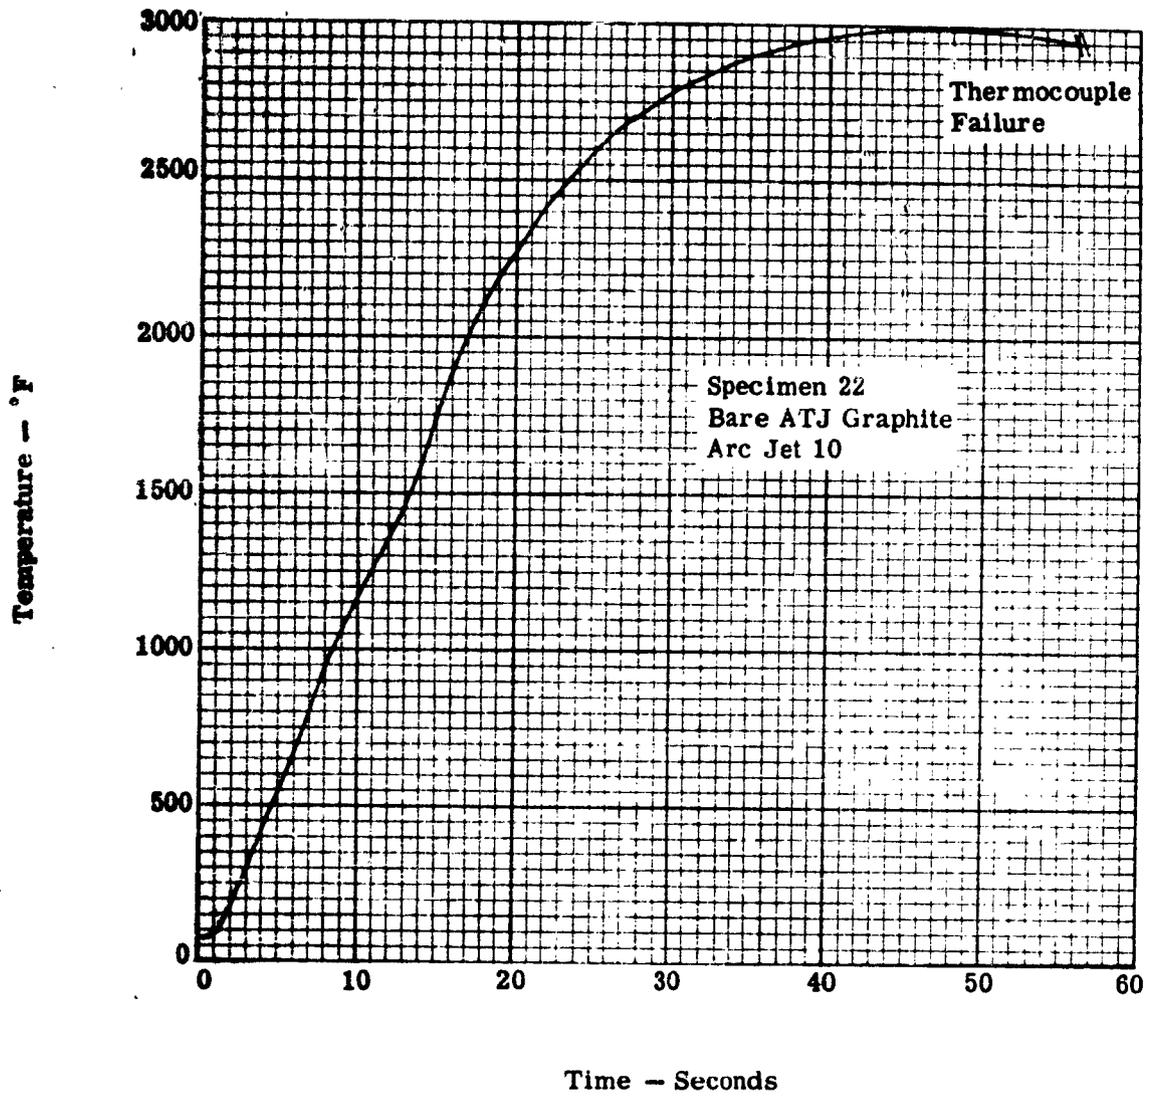
FIGURE 63. SPECIMEN 22 INTERNAL TEMPERATURE VS TIME; NASA LANGLEY RESEARCH CENTER

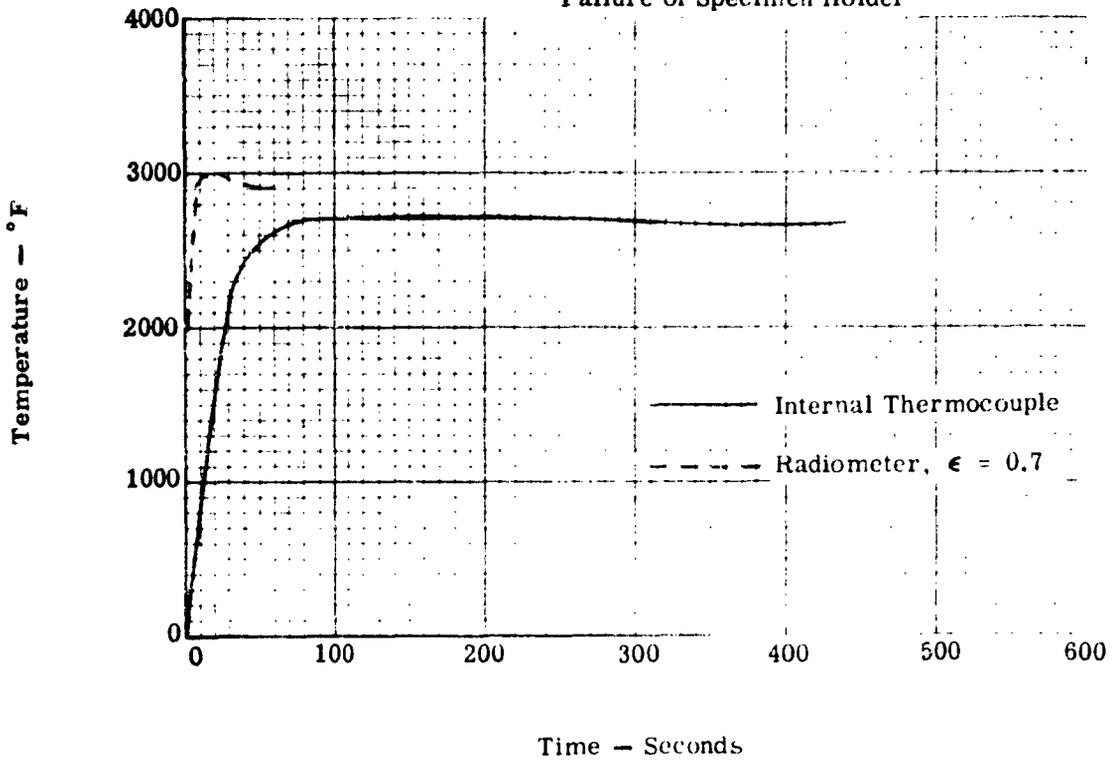
Test Terminated at 520 Seconds Because of  
Failure of Specimen Holder

FIGURE 68. SPECIMEN F-7 TEMPERATURE VS TIME, NASA LANGLEY RESEARCH CENTER

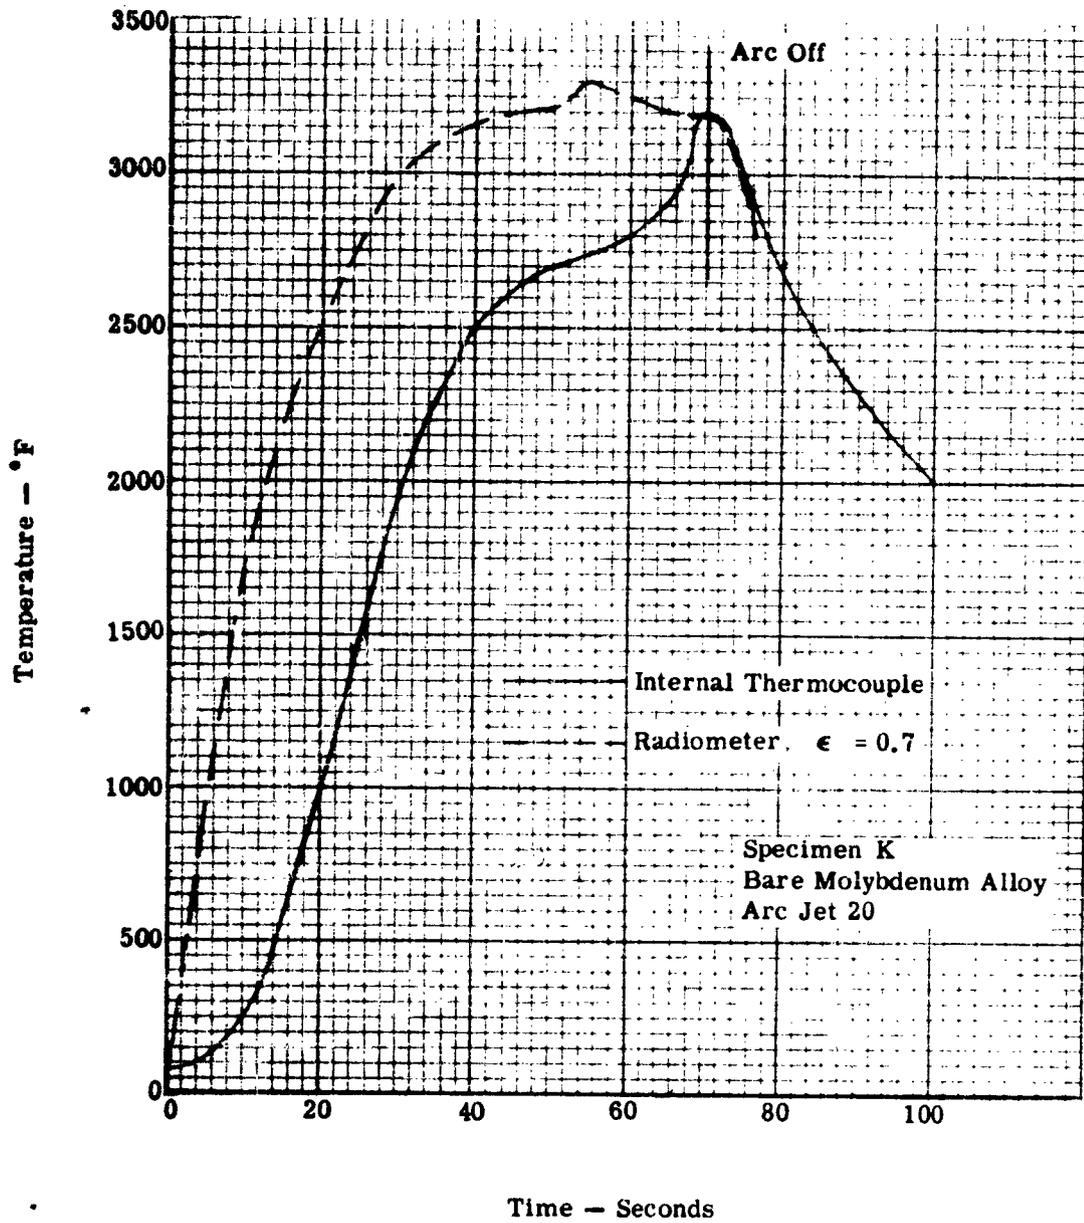
FIGURE 76. SPECIMEN K TEMPERATURE VS TIME, NASA LANGLEY RESEARCH CENTER

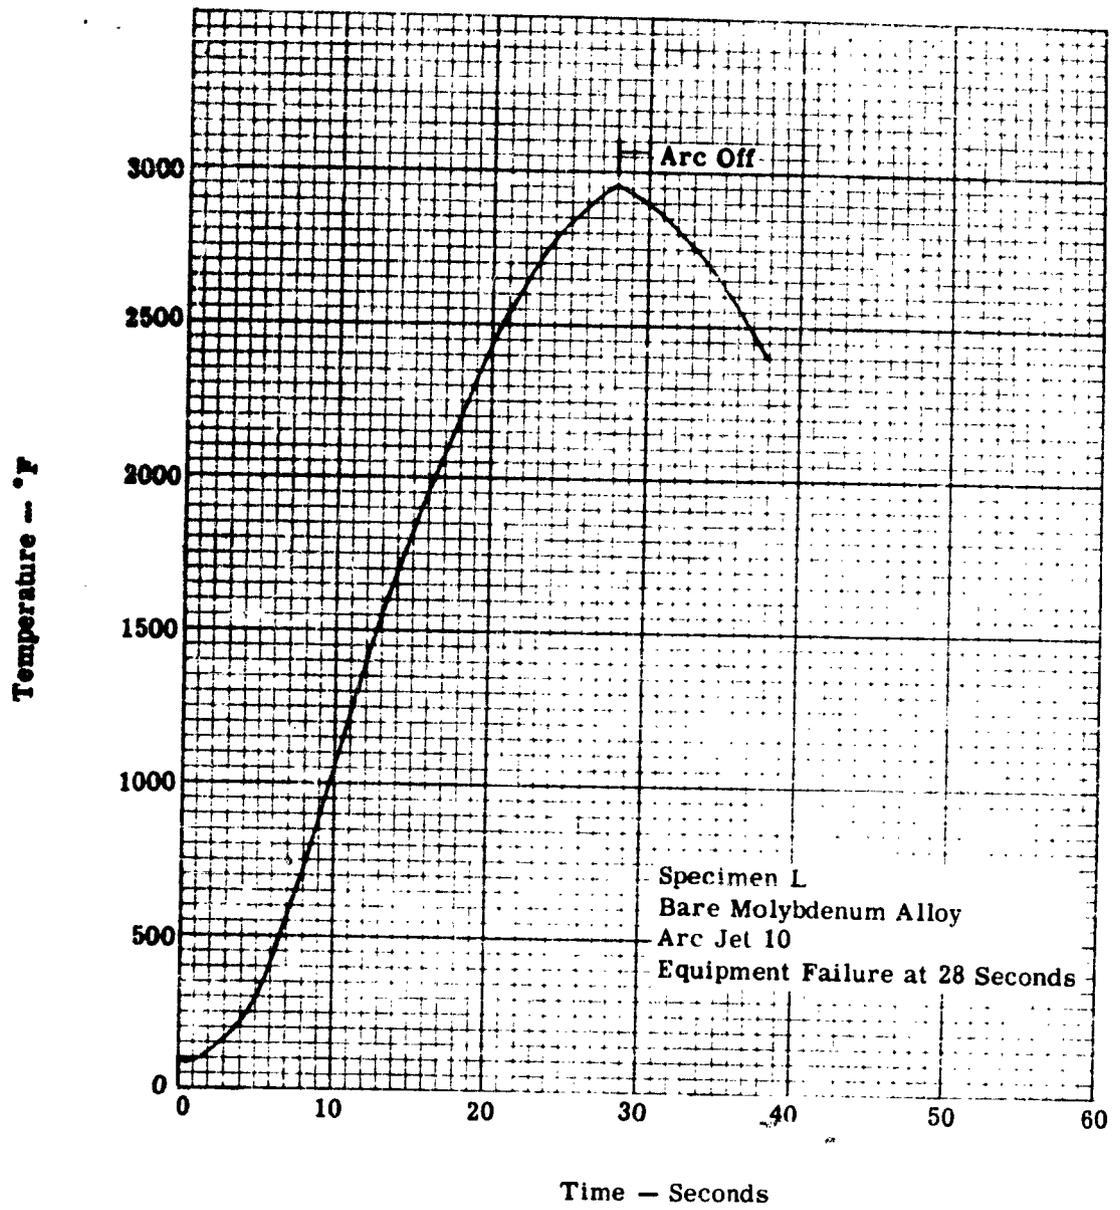
FIGURE 77. SPECIMEN L INTERNAL TEMPERATURE VS TIME, NASA LANGLEY RESEARCH CENTER

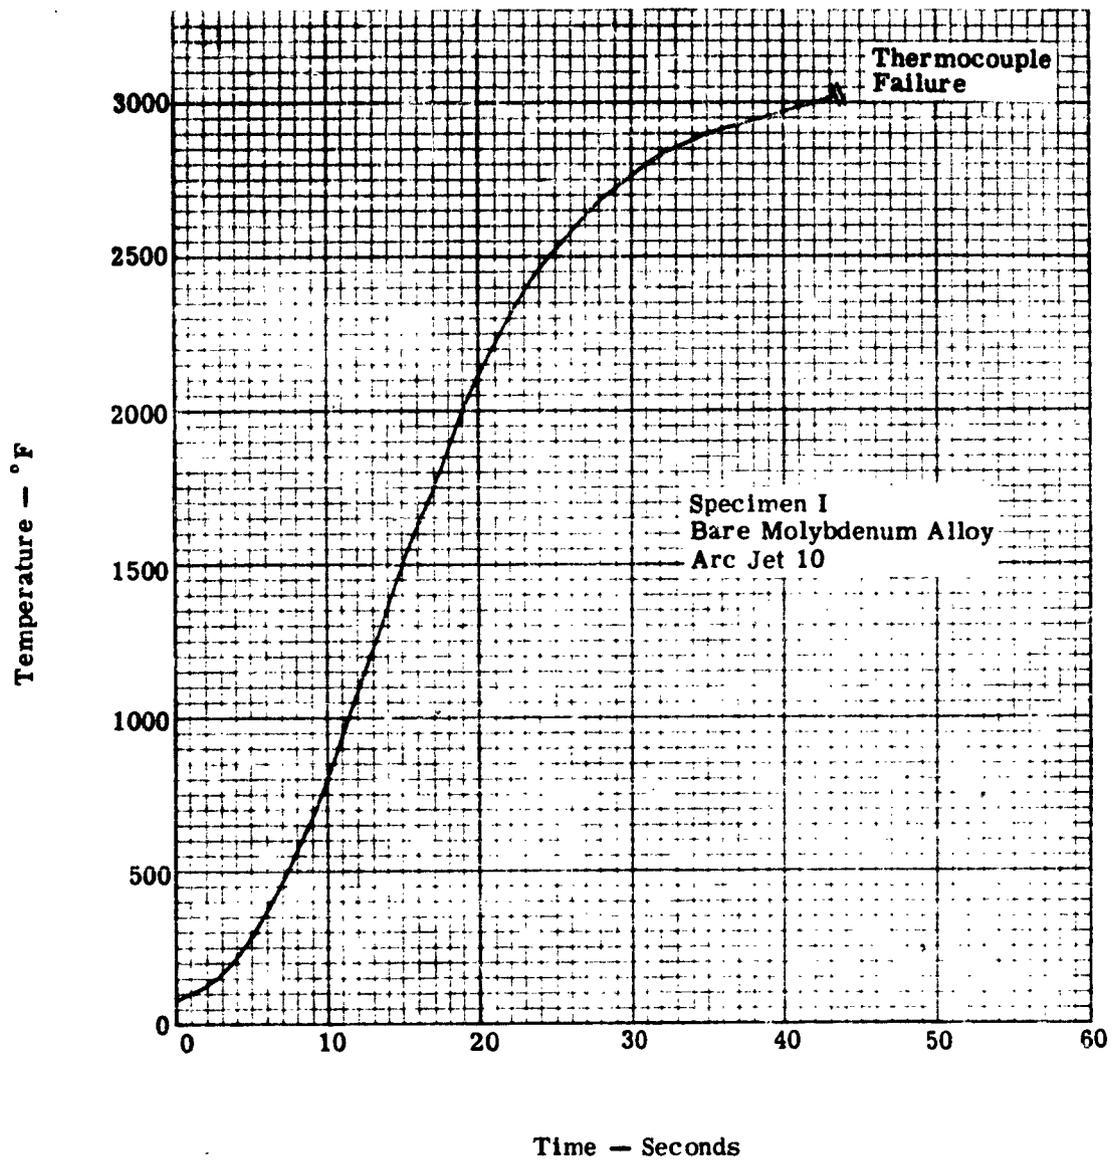
FIGURE 78. SPECIMEN I INTERNAL TEMPERATURE VS TIME, NASA LANGLEY RESEARCH CENTER

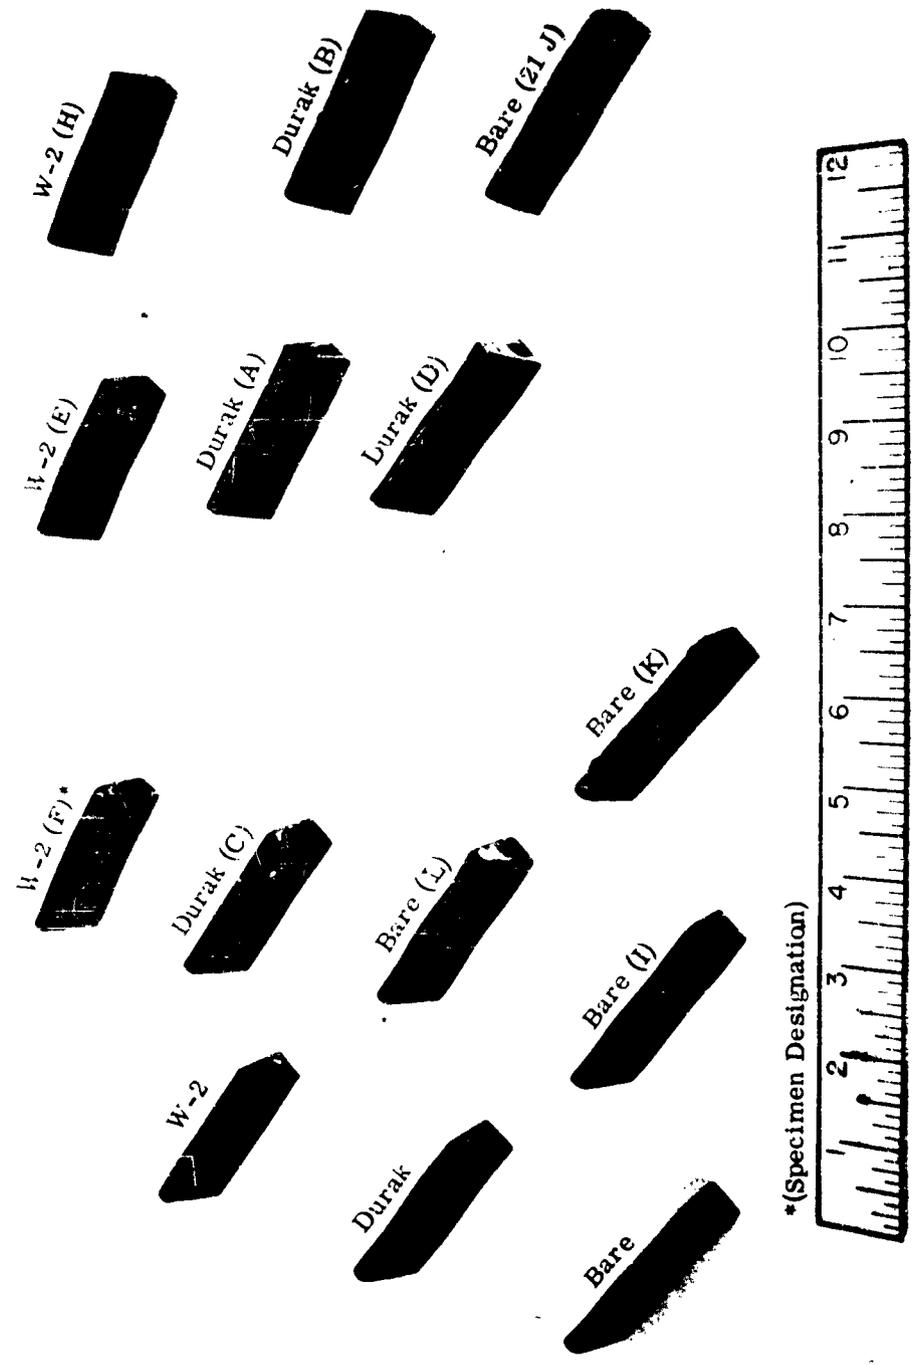
FIGURE 79. ALL BARE, W-2 COATED, AND DURAK MG COATED MOLYBDENUM ALLOY LEADING EDGE SPECIMENS TESTED IN NASA LANGLEY RESEARCH CENTER ARC JETS

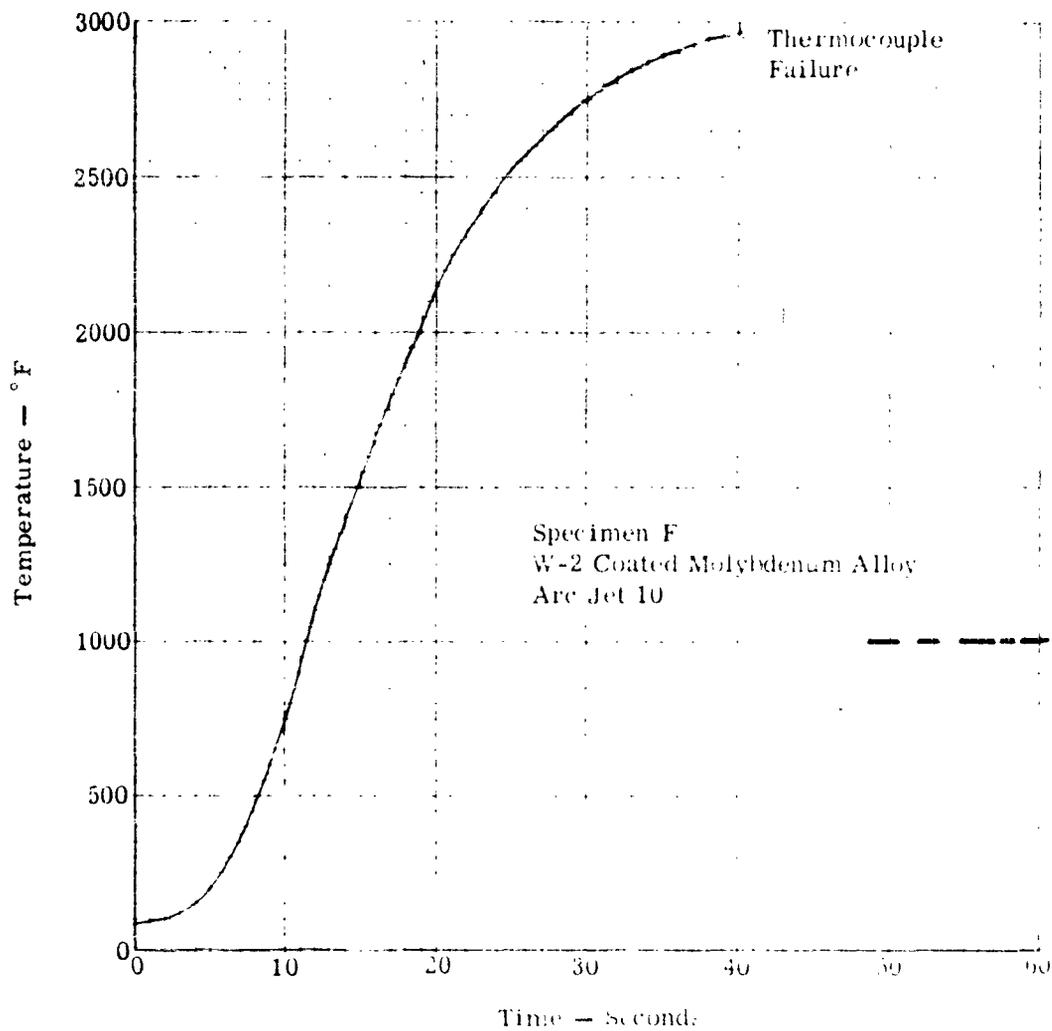
FIGURE 82. SPECIMEN F INTERNAL TEMPERATURE VS TIME, NASA LANGLEY RESEARCH CENTER

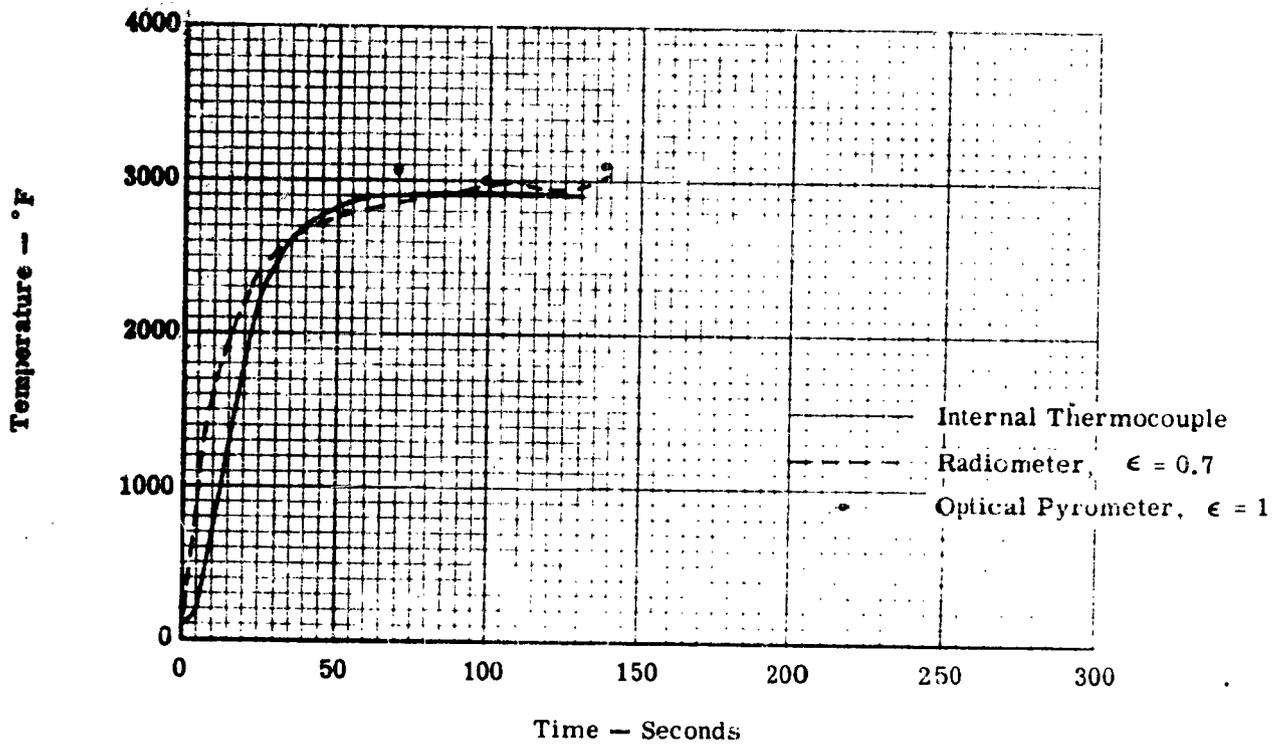
Specimen D  
Durak MG Coated Molybdenum Alloy  
Arc Jet 20  
Test Terminated at 142 Seconds Because of  
Failure of Specimen Holder

FIGURE 83. SPECIMEN D TEMPERATURE VS TIME, NASA LANGLEY RESEARCH CENTER
