WADC TECHNICAL REPORT 59-744  
VOLUME VII

# INVESTIGATION OF FEASIBILITY OF UTILIZING AVAILABLE HEAT RESISTANT MATERIALS FOR HYPERSONIC LEADING EDGE APPLICATIONS

Volume VII—Oxidation Resistance of Bare and Coated Molybdenum Alloy and Graphite

*Bell Aerosystems Company*

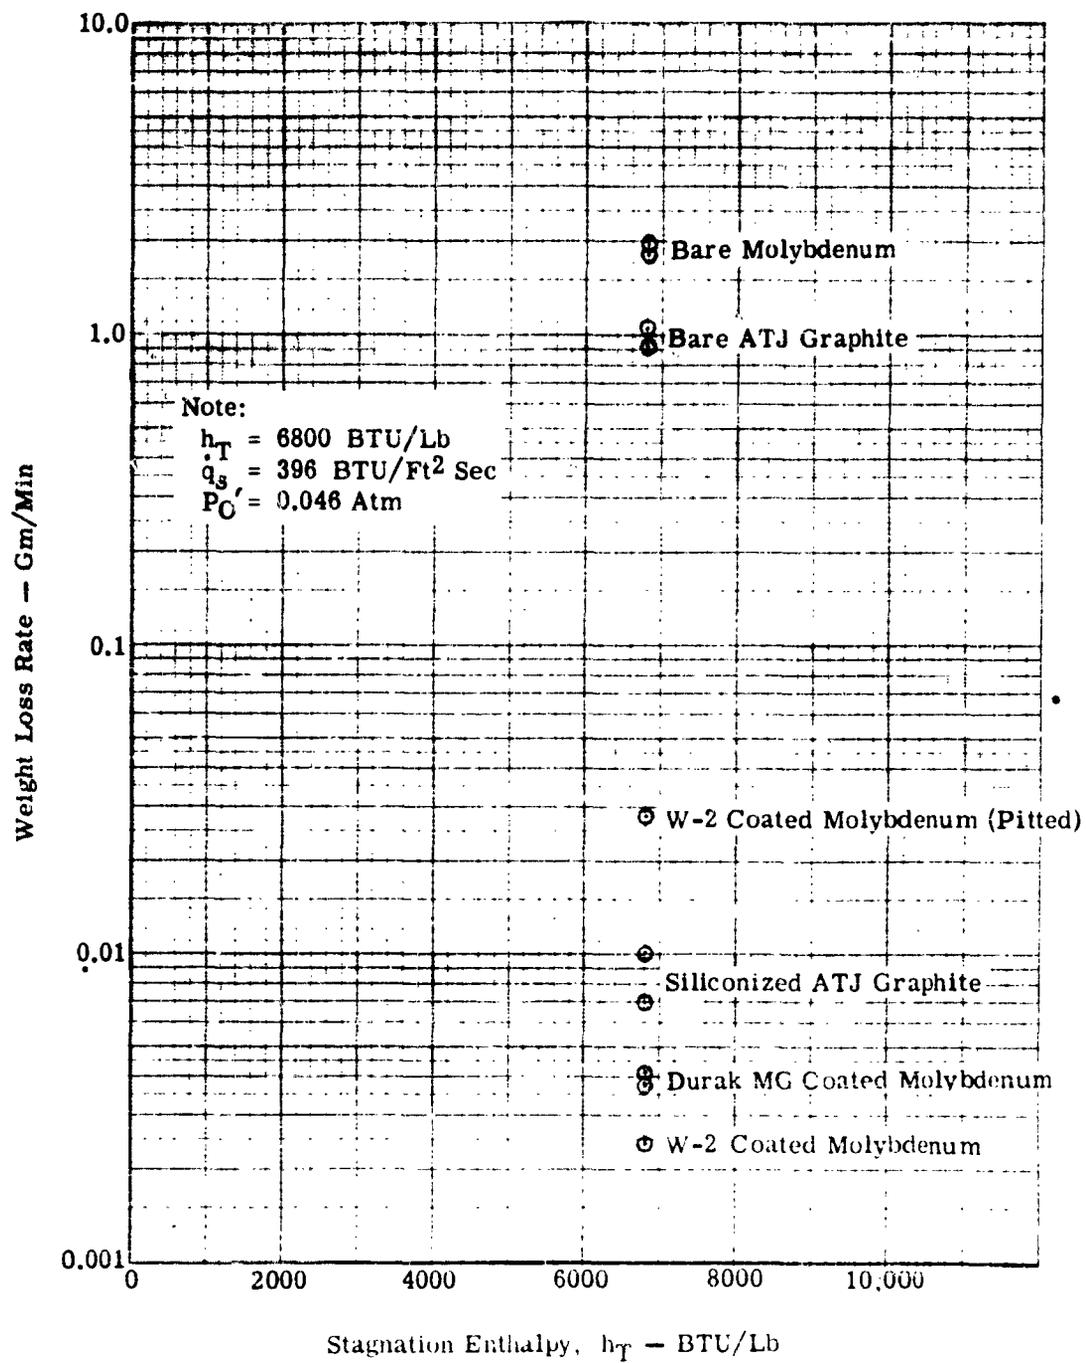
FIGURE 89. WEIGHT LOSS RATE VS STAGNATION ENTHALPY, PLASMADYNE CORPORATION

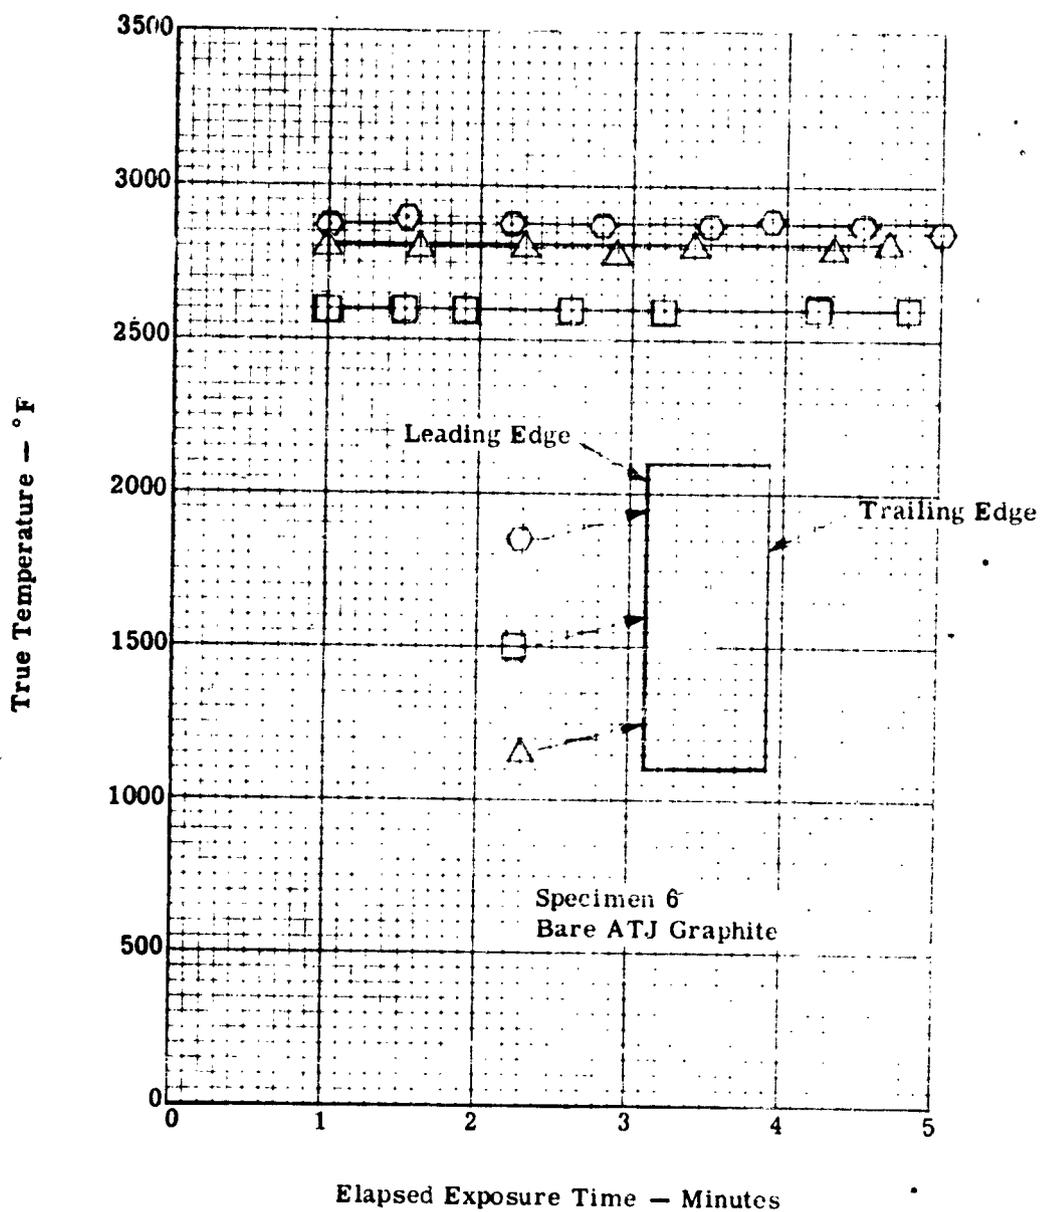
FIGURE 91. SPECIMEN 6 SURFACE TEMPERATURE VS TIME, PLASMADYNE CORPORATION

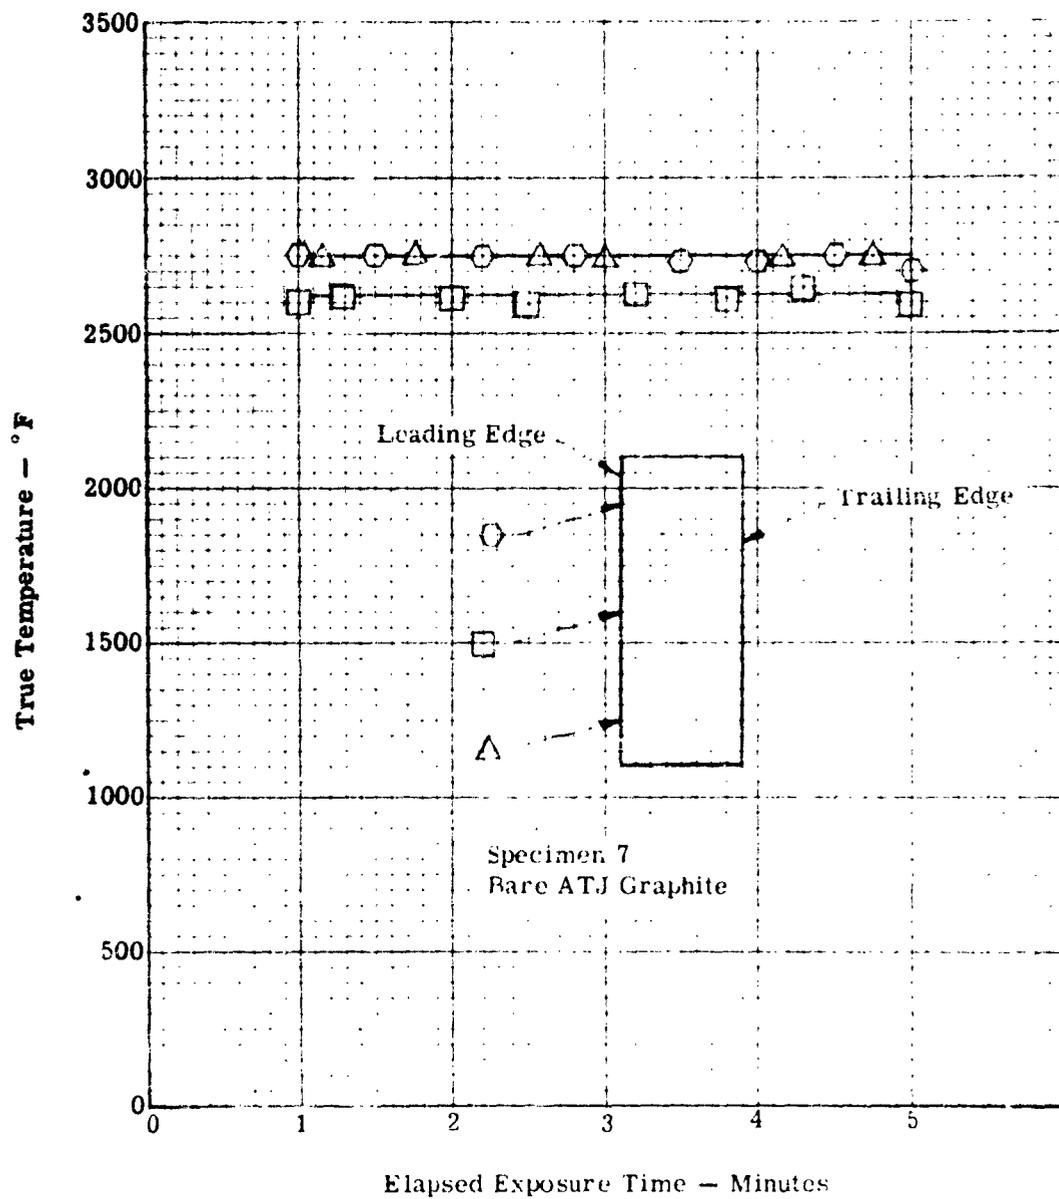
FIGURE 92. SPECIMEN 7 SURFACE TEMPERATURE VS TIME, PLASMADYNE CORPORATION

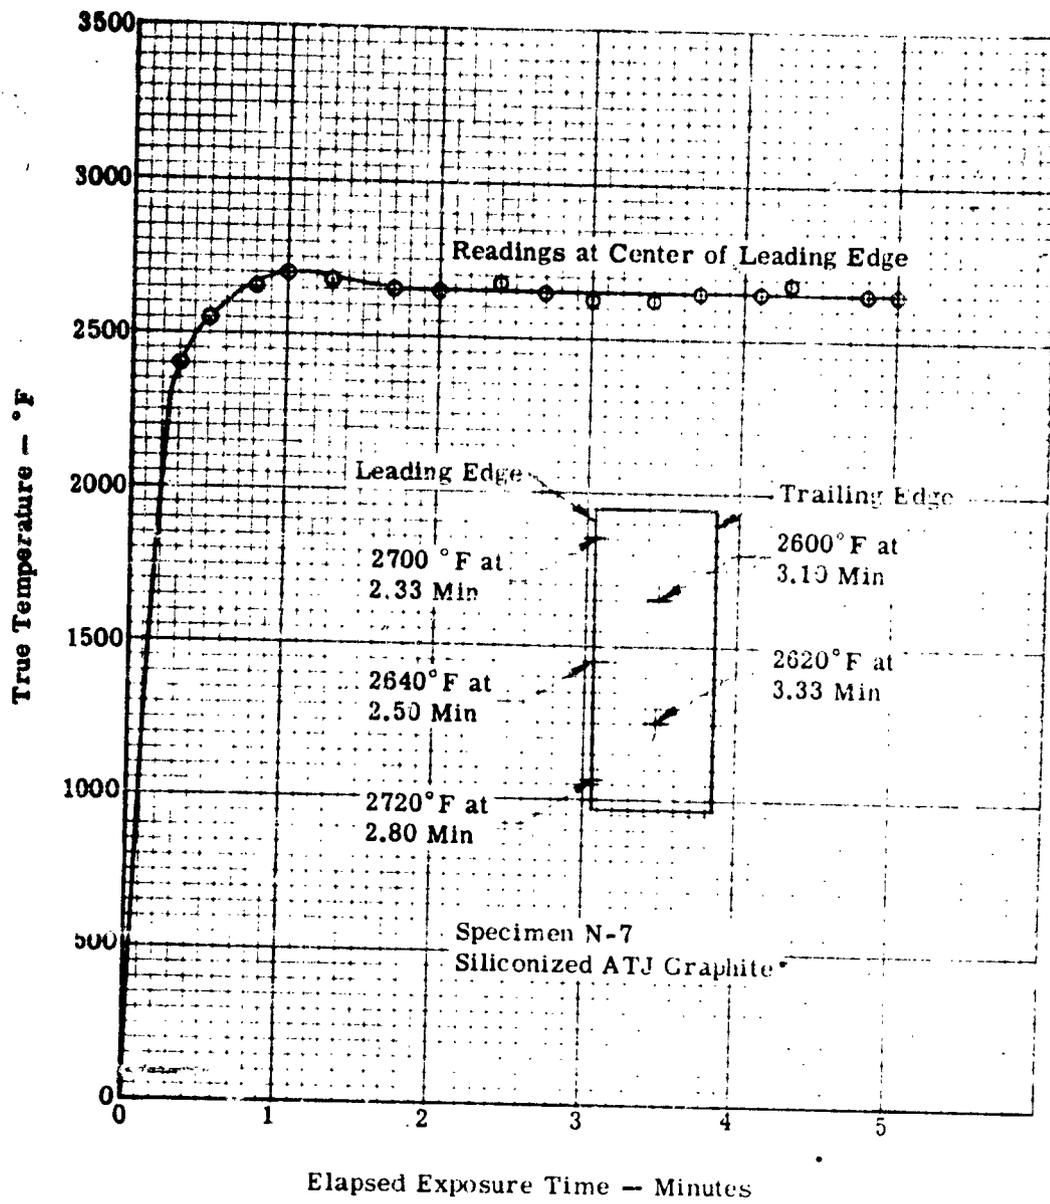
FIGURE 94. SPECIMEN N-7 SURFACE TEMPERATURE VS TIME, PLASMADYNE CORPORATION

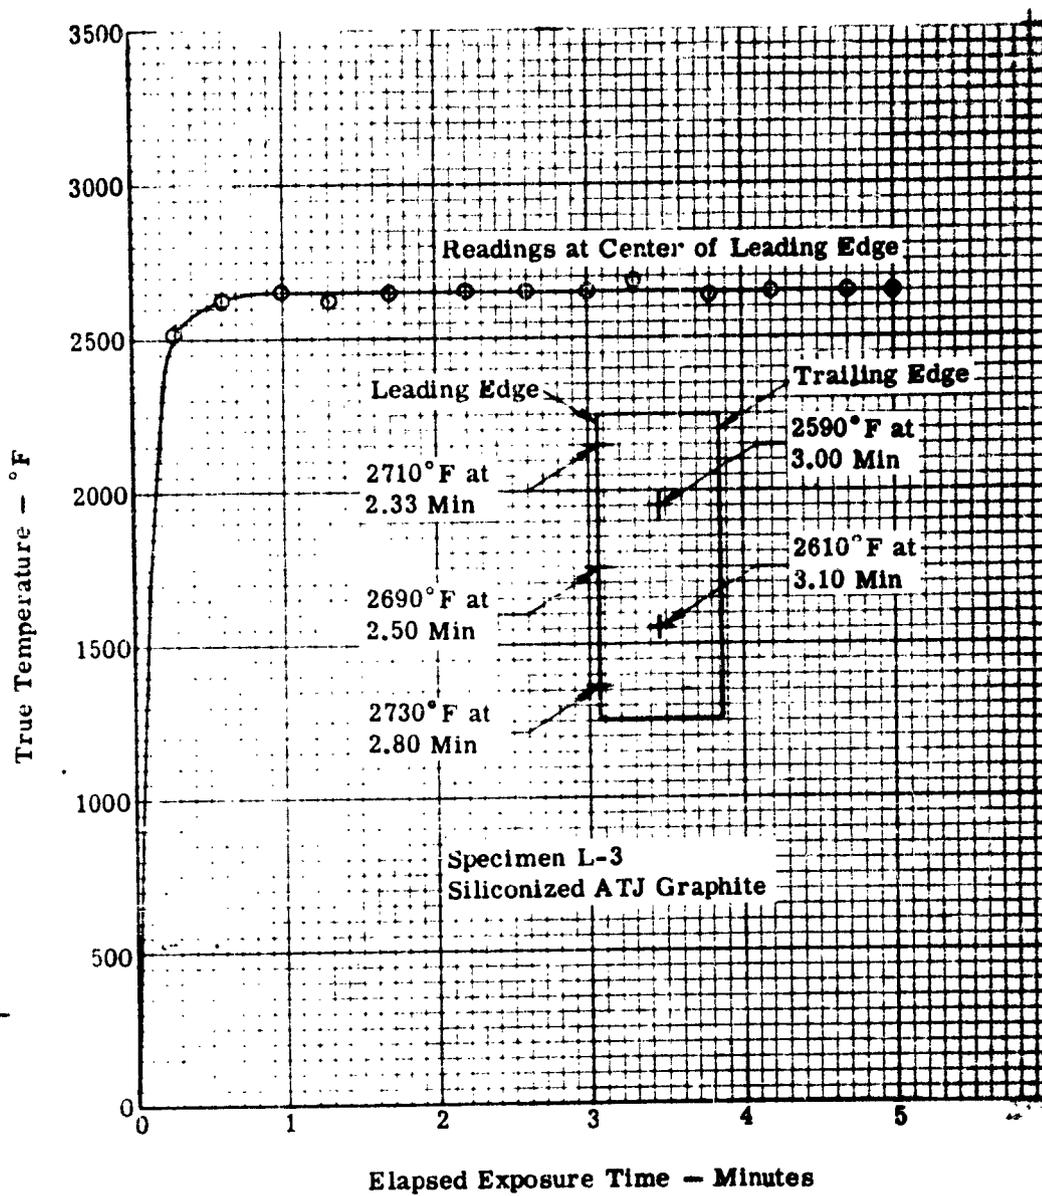
FIGURE 95. SPECIMEN L-3 SURFACE TEMPERATURE VS TIME, PLASMADYNE CORPORATION

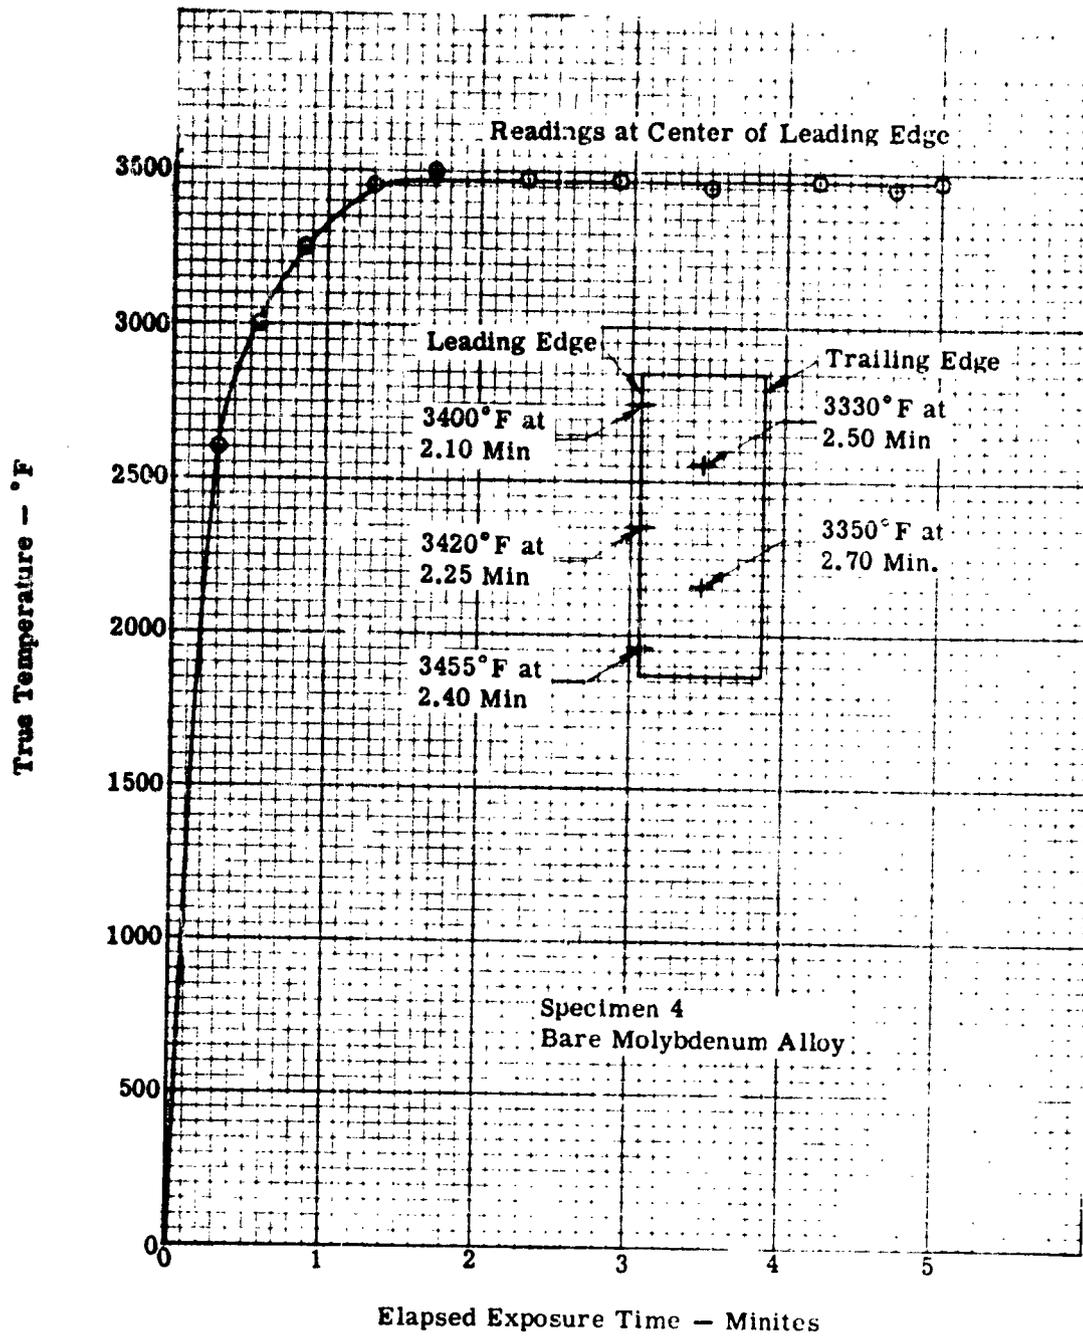
FIGURE 96. SPECIMEN 4 SURFACE TEMPERATURE VS TIME, PLASMADYNE CORPORATION

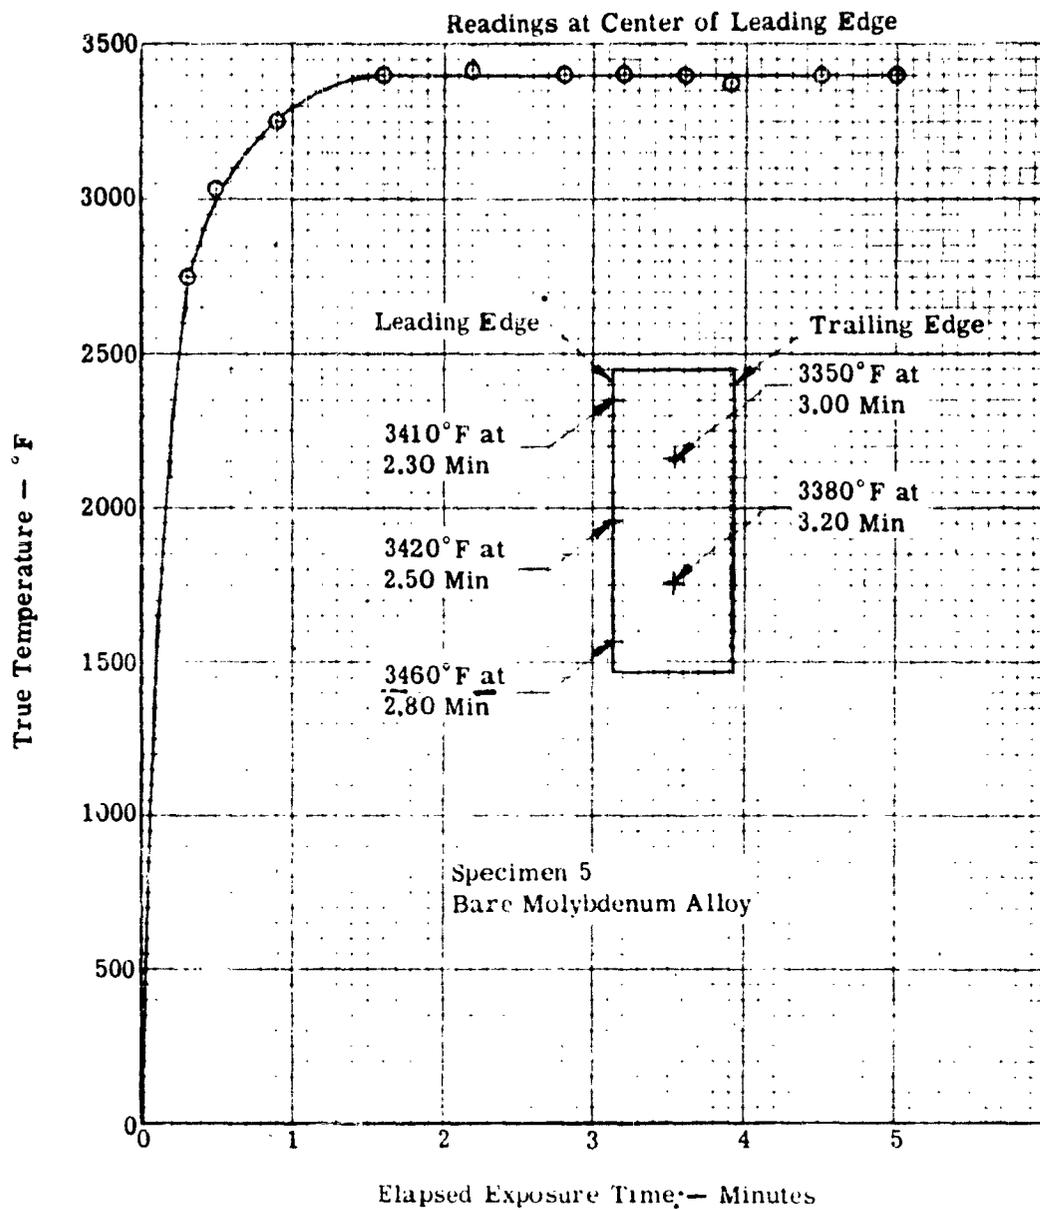
FIGURE 97. SPECIMEN 5 SURFACE TEMPERATURE VS TIME, PLASMADYNE CORPORATION

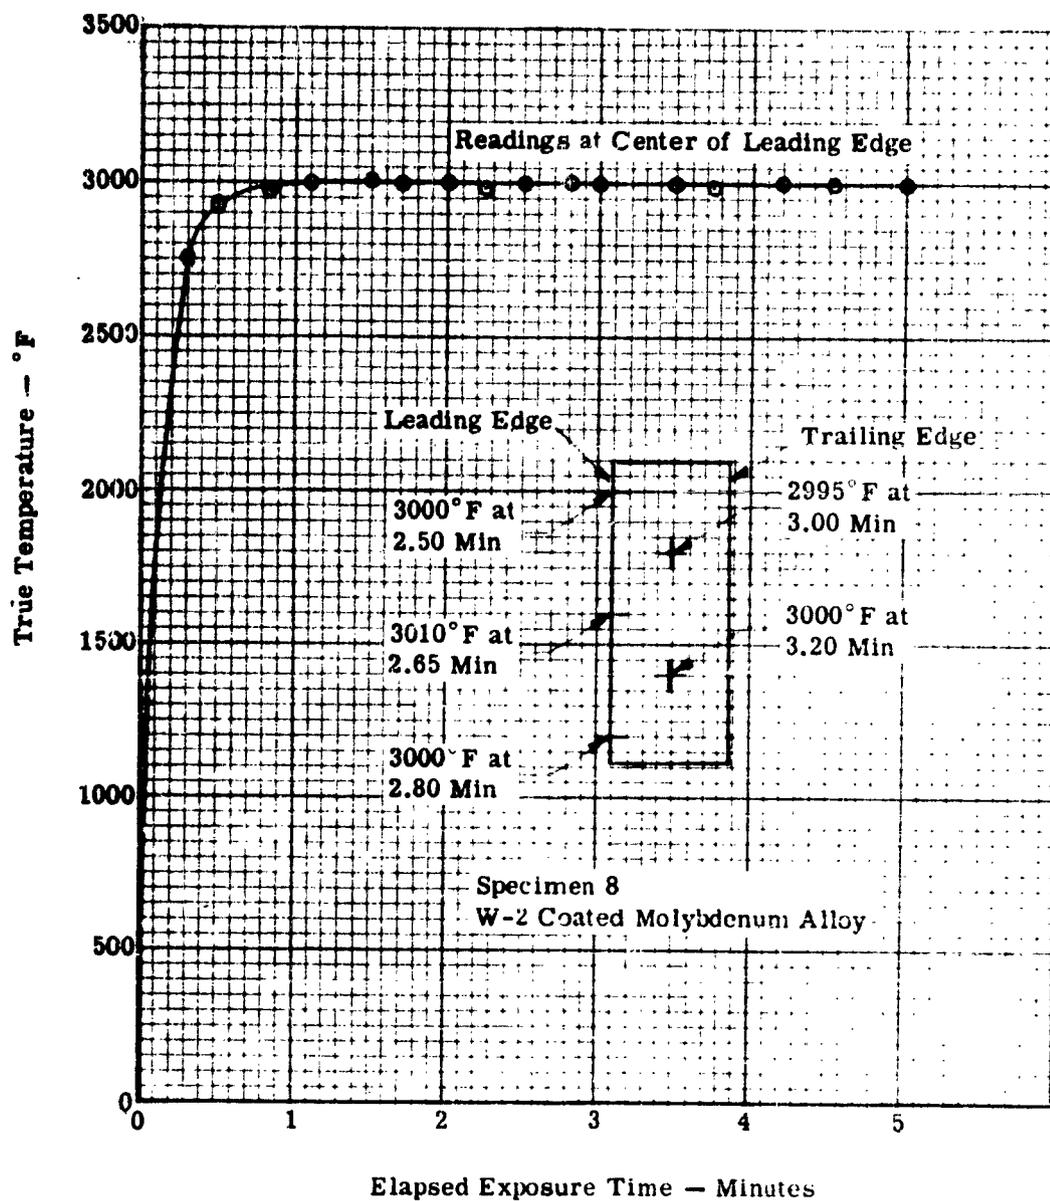
FIGURE 100. SPECIMEN 8 SURFACE TEMPERATURE VS TIME, PLASMADYNE CORPORATION

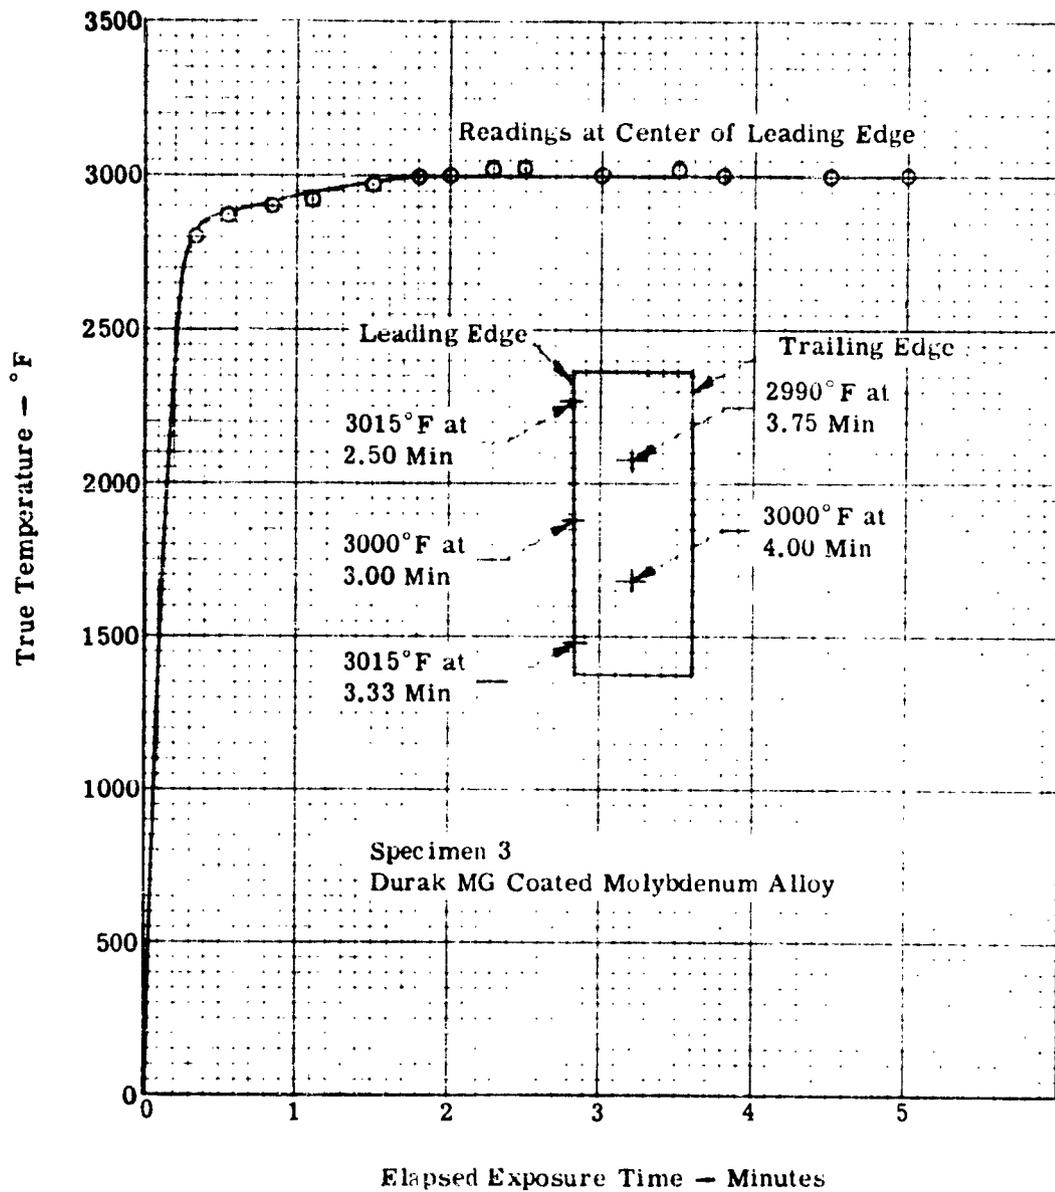
FIGURE 102. SPECIMEN 3 SURFACE TEMPERATURE VS TIME, PLASMADYNE CORPORATION

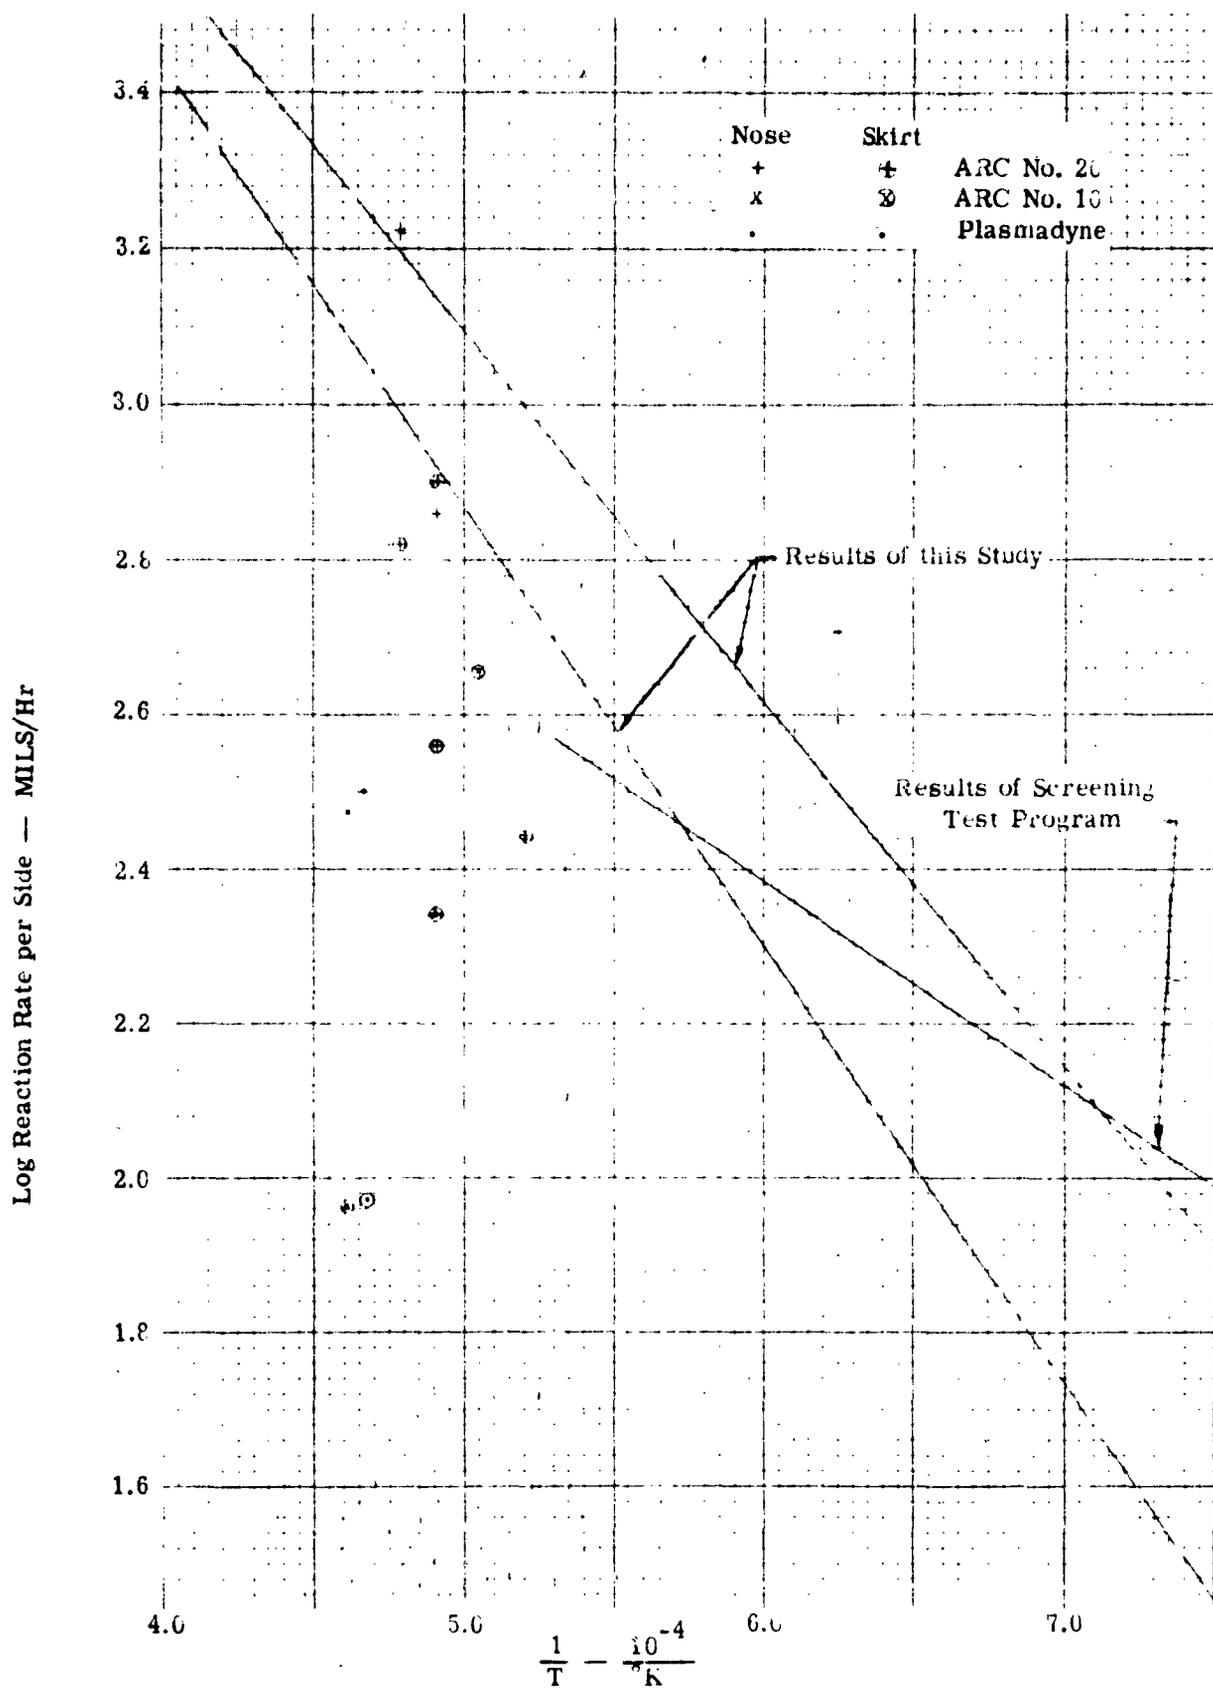
FIGURE 105. COMPARISON OF DATA FROM VARIOUS TEST FACILITIES, UNCOATED 0.5% TITANIUM MOLYBDENUM ALLOY

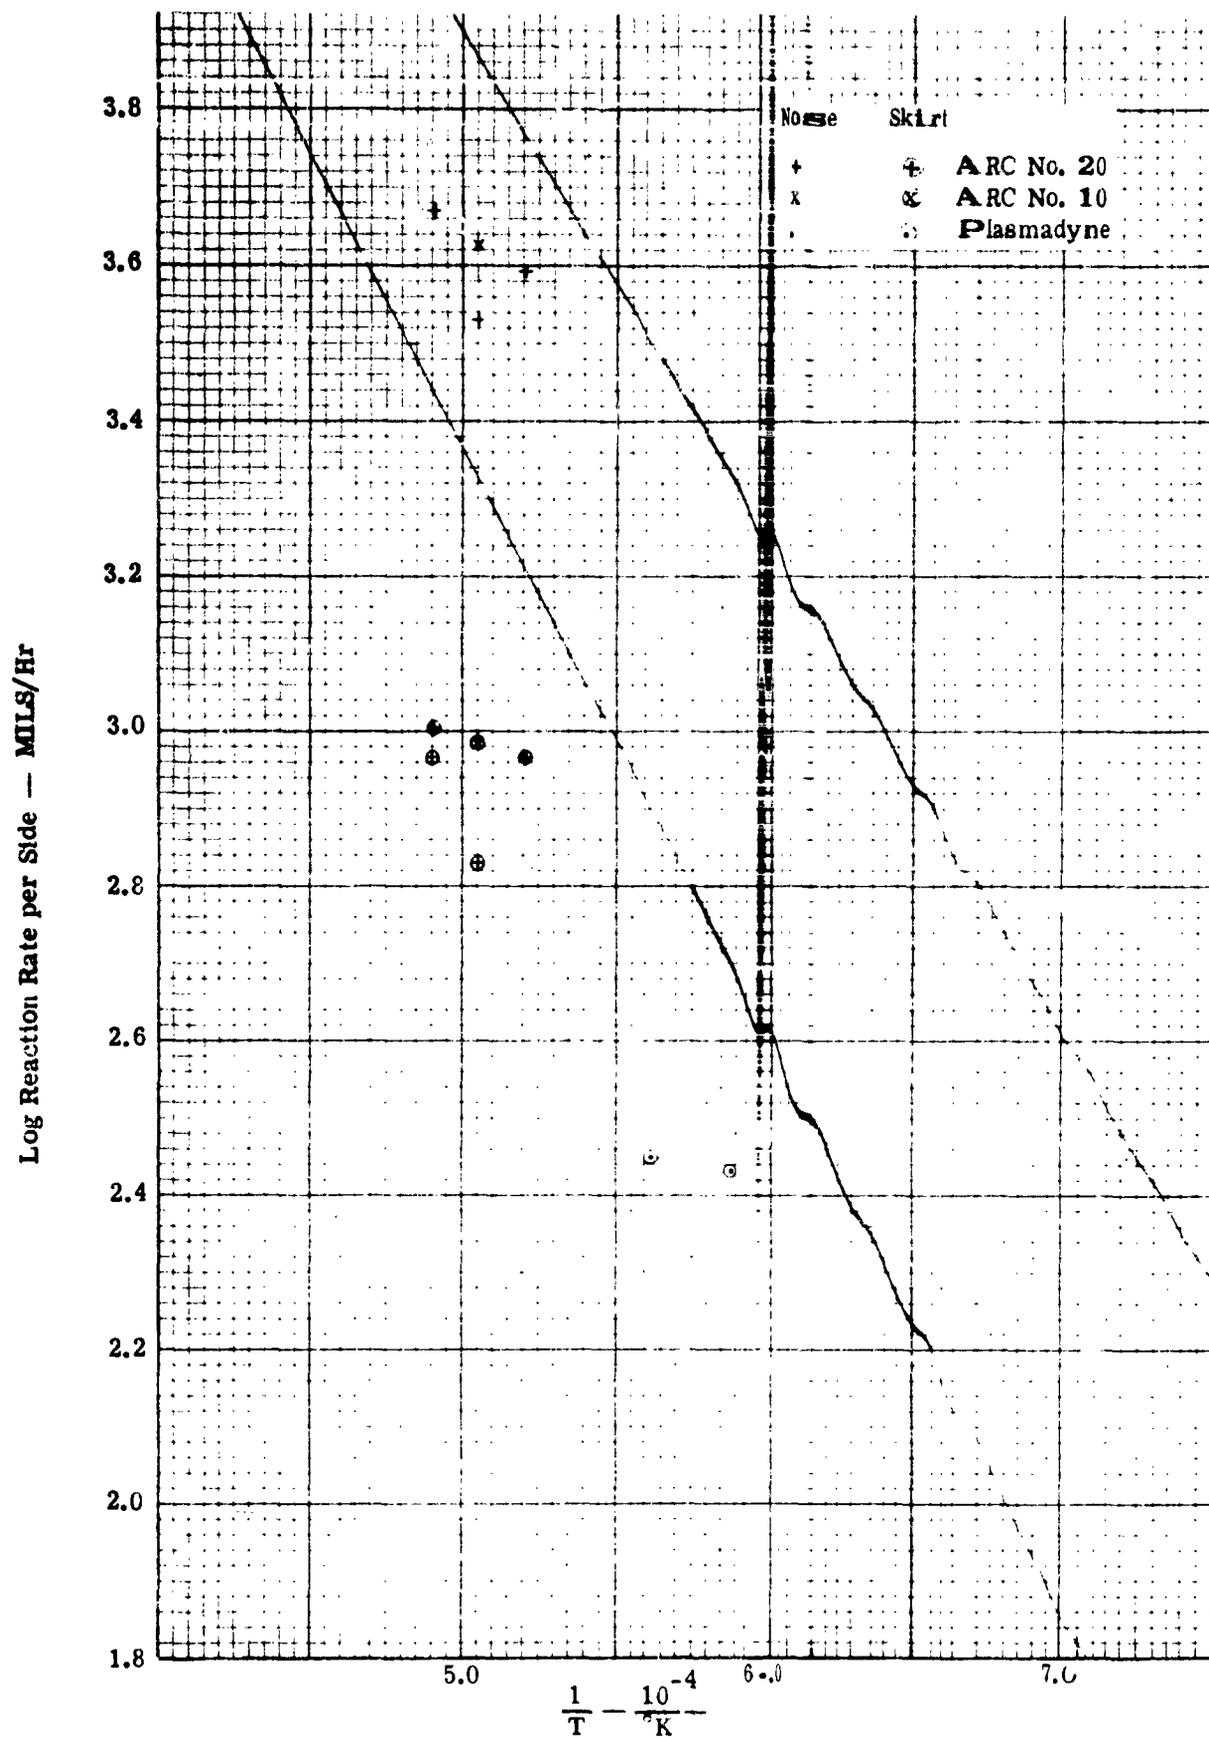
FIGURE 108. COMPARISON OF DATA FROM VARIOUS TEST FACILITIES, UNCOATED ATJ GRAPHITE

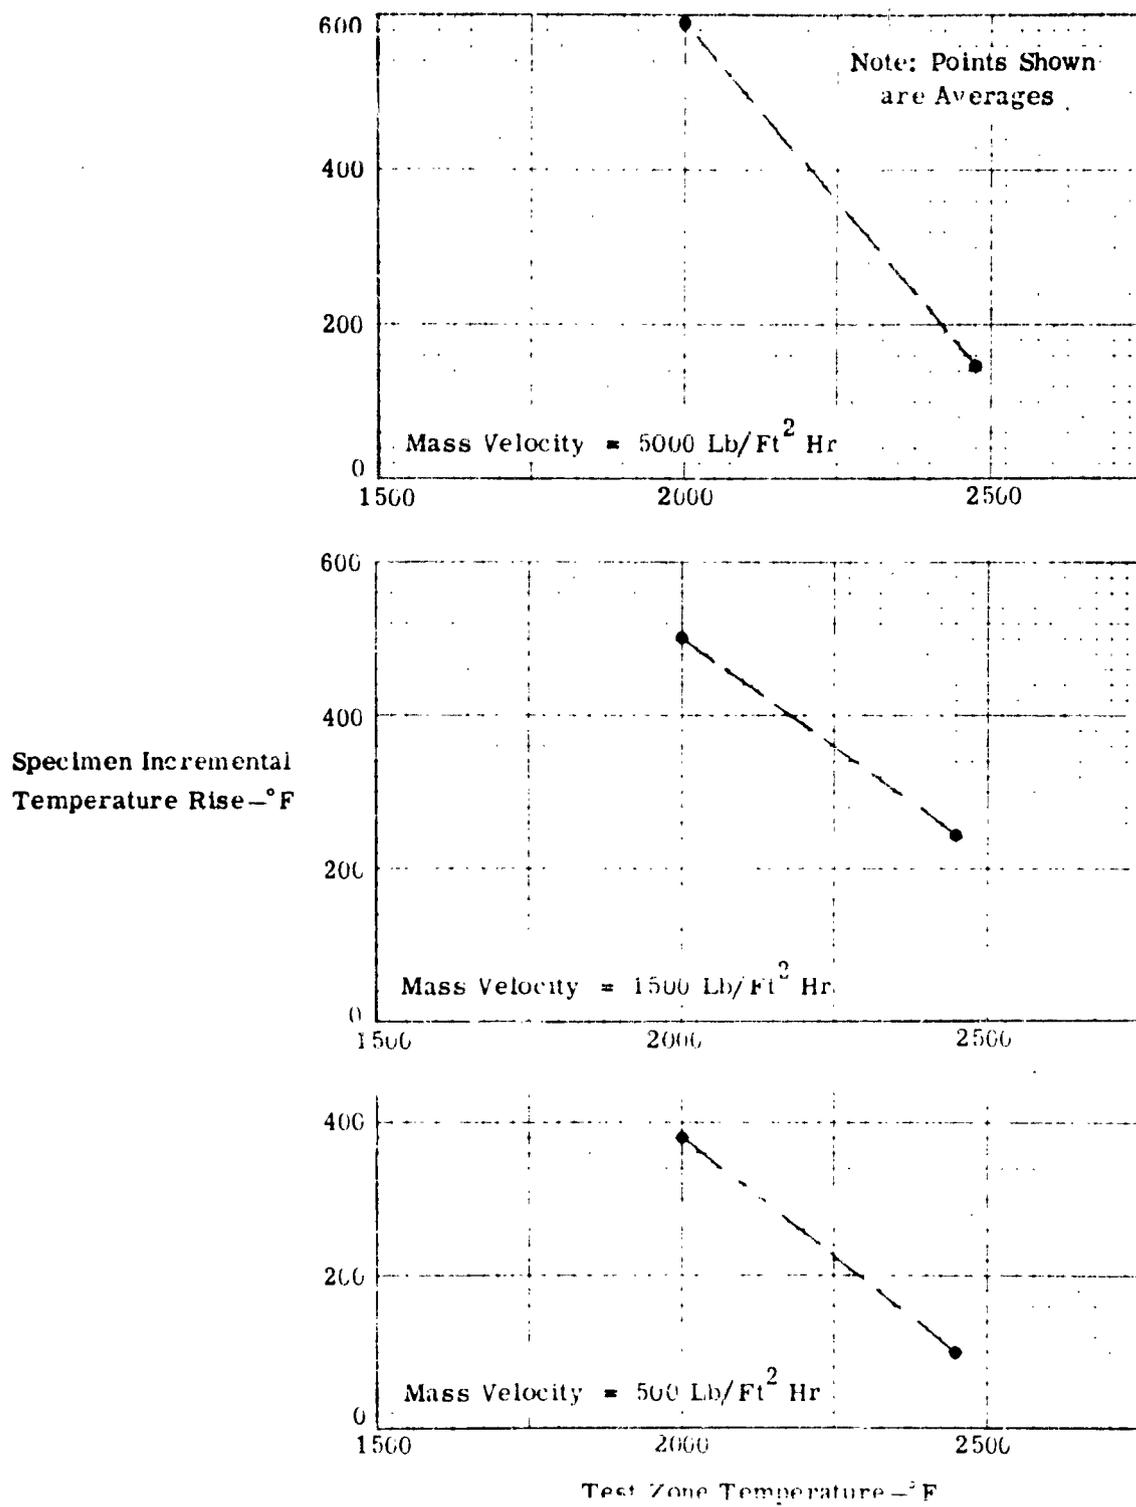
FIGURE 109. INCREMENTAL TEMPERATURE RISE DUE TO EXOTHERMIC REACTION, ATJ GRAPHITE

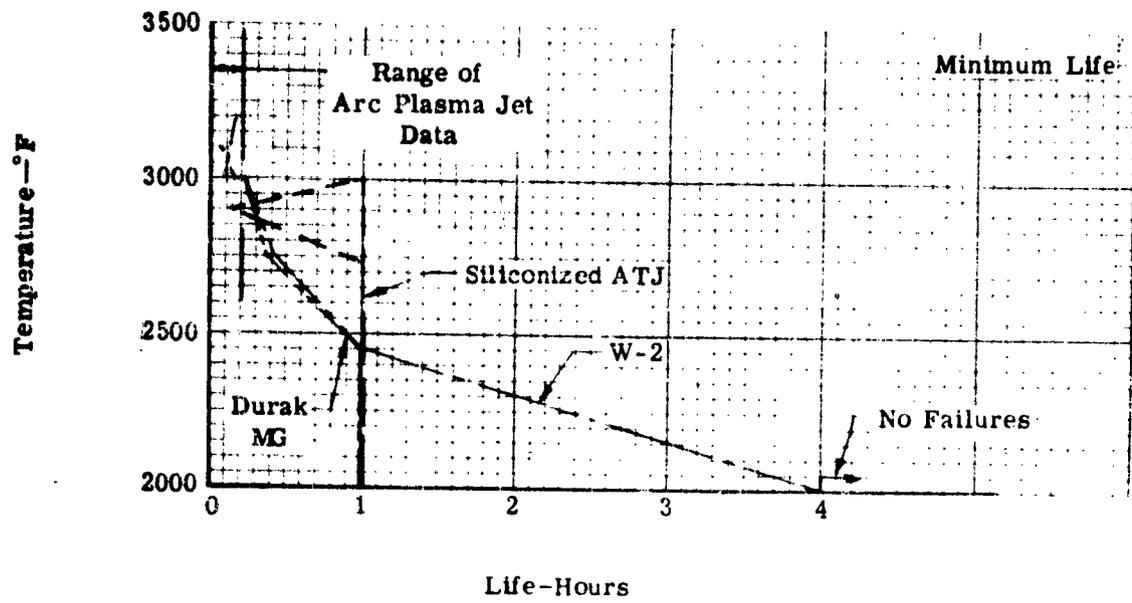
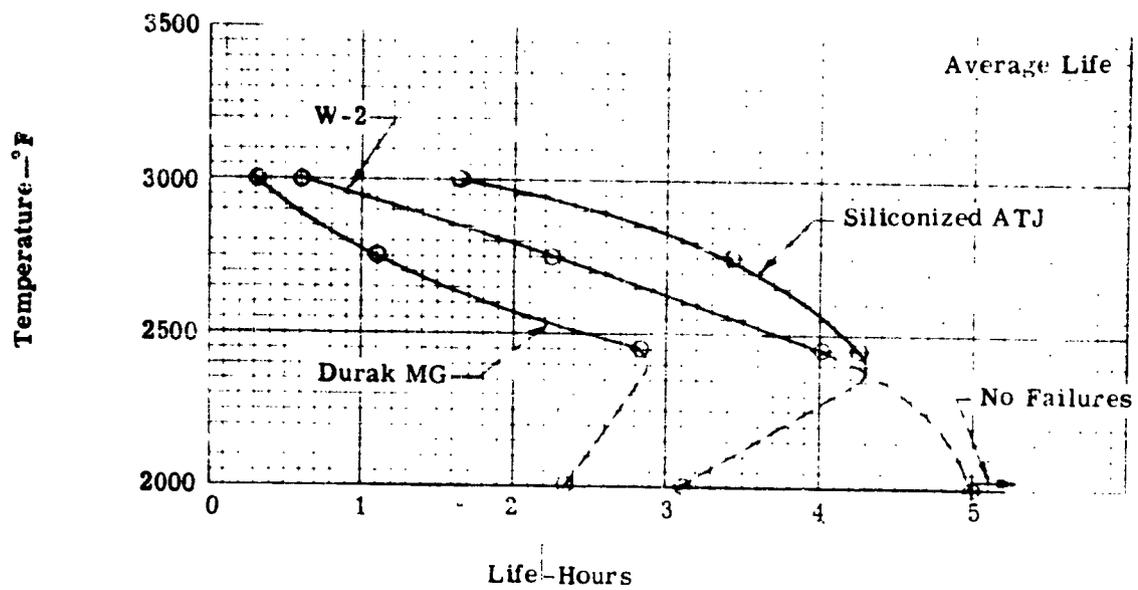
FIGURE 110. APPROXIMATE LIFE OF COATED MATERIALS

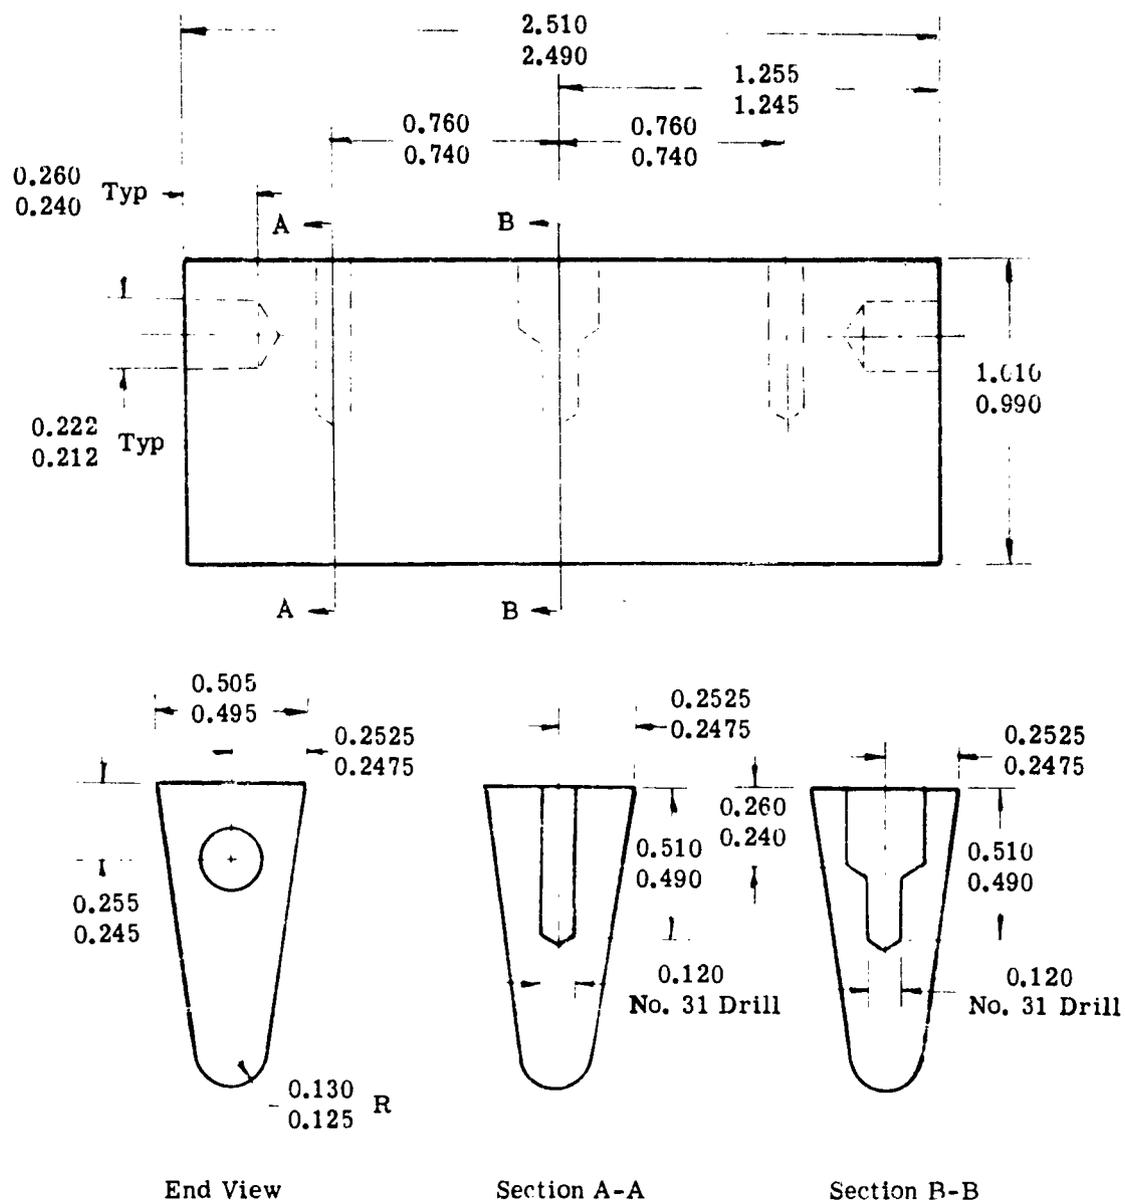
Notes: Surface Finish  $63\sqrt{\text{ }}$   
 Break all Edges and Holes  
 0.020-0.030

FIGURE 111. OXIDATION TEST SPECIMEN
