DEVELOPMENT OF HIGH PERFORMANCE ROCKET MOTOR CASE

QUARTERLY REPORT NUMBER 12

PRODUCT DEVELOPMENT DEPARTMENT
THE BUDD COMPANY
Philadelphia 32, Pennsylvania

ENGINEERING QUARTERLY PROGRESS REPORT NUMBER 12

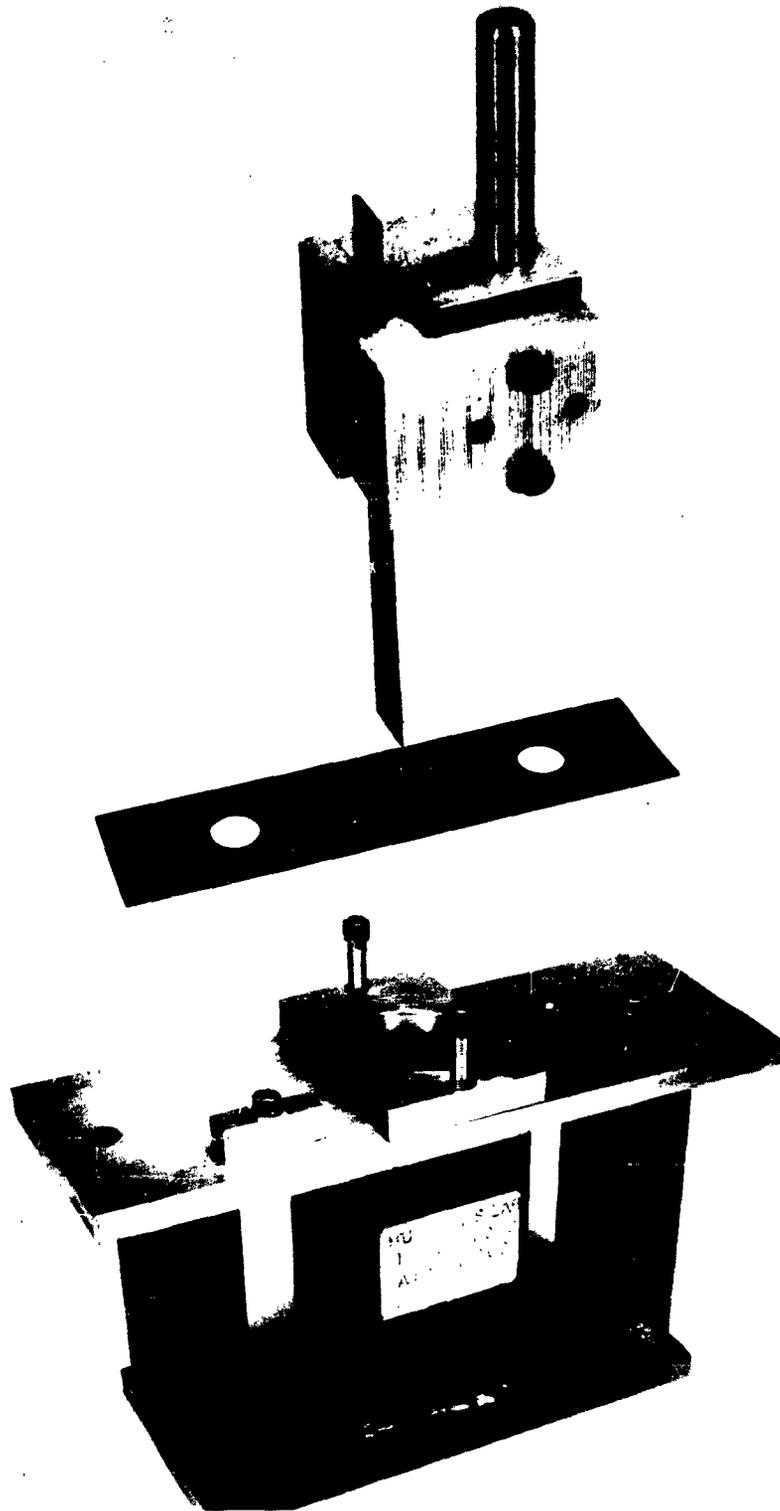
FIG. 3

Electrode and holder, Fracture Energy Specimen and Holding fixture for electrode discharge Spark Machining of Center Notch.

1. Square shear, oversize blank from sheet. Dye penetrant inspect to assure that edge flaws will clean up on subsequent processing.
2. Shape to outline dimensions required by Figure 1, and deburr.
3. Clean
4. Heat treat, where required.
5. Drill pin holes using the jig shown in Figure 2, deburr and clean.
6. Machine the center notch using the electric spark discharge process and the fixturing shown in Figure 3.
7. Clean, debur and inspect the notch at 50X, using a Kodak Optical Comparator.
8. Fatigue crack using high stress low cycle tension fatigue as shown in Figure 4.

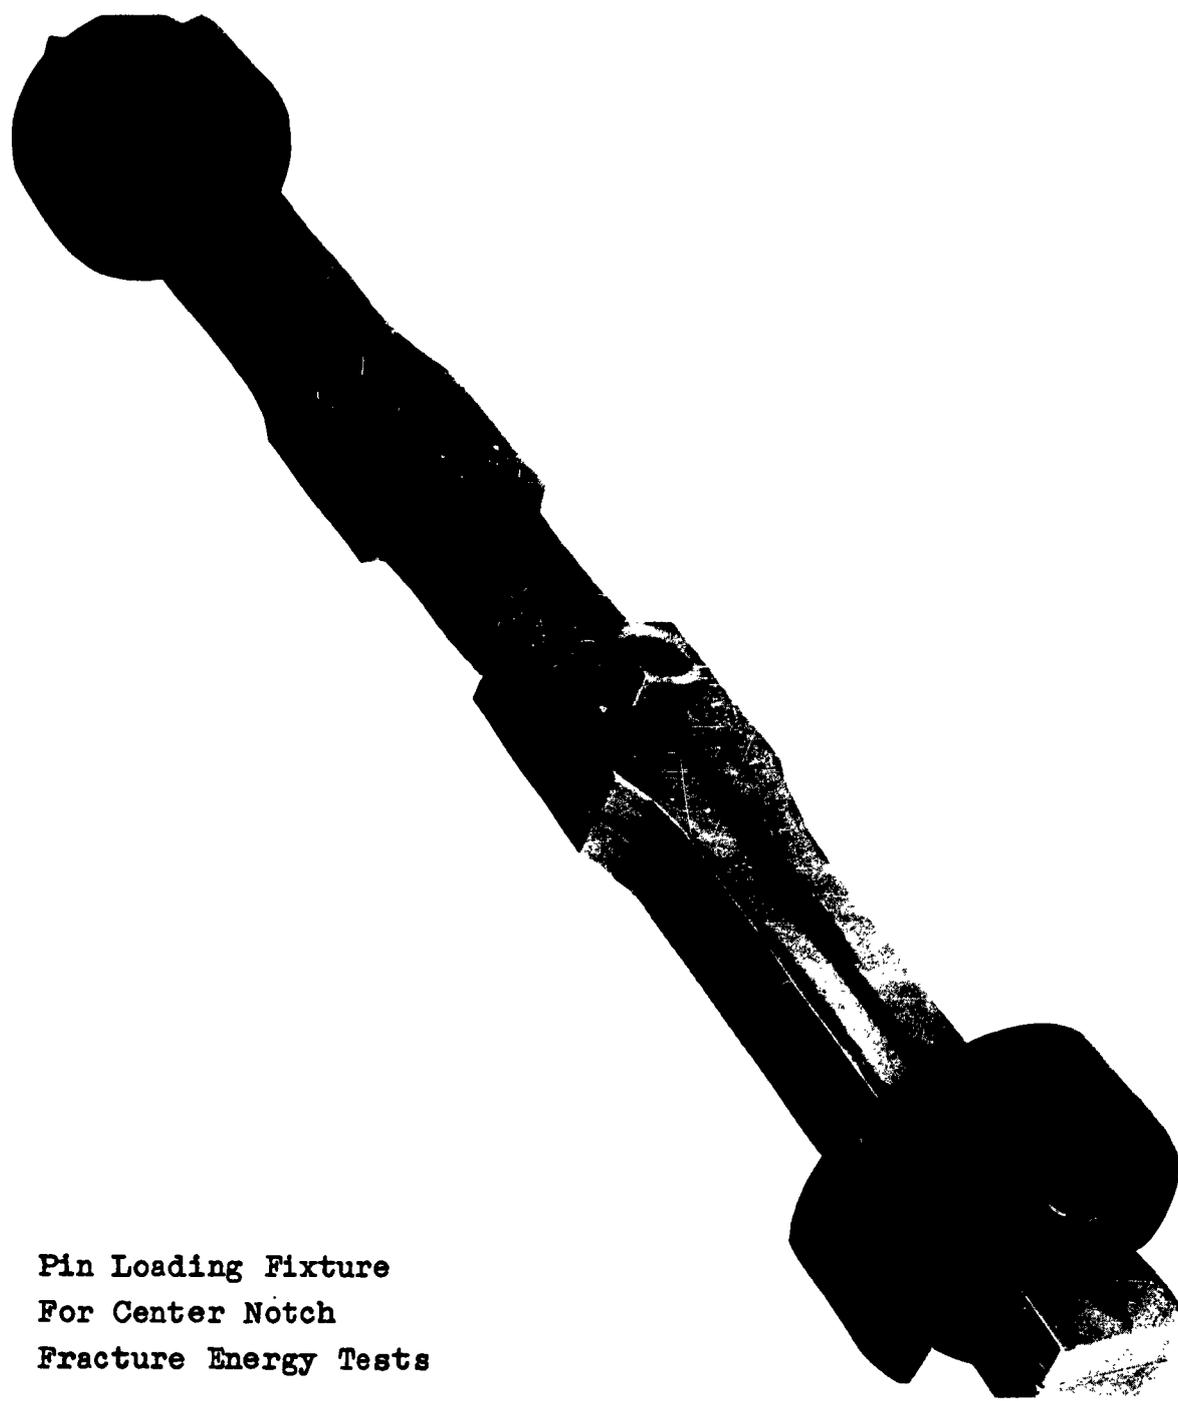
FIG. 5

Pin Loading Fixture
For Center Notch
Fracture Energy Tests

alignment of the specimen, sufficient but not excess ink, and controlled application of the tension load. Axial alignment is obtained through use of the pin grips shown in Figure 5. The amount of ink required is determined by experience. The specimen is strained using approximately a 0.010 inches per minute cross head speed, until fracture occurs.

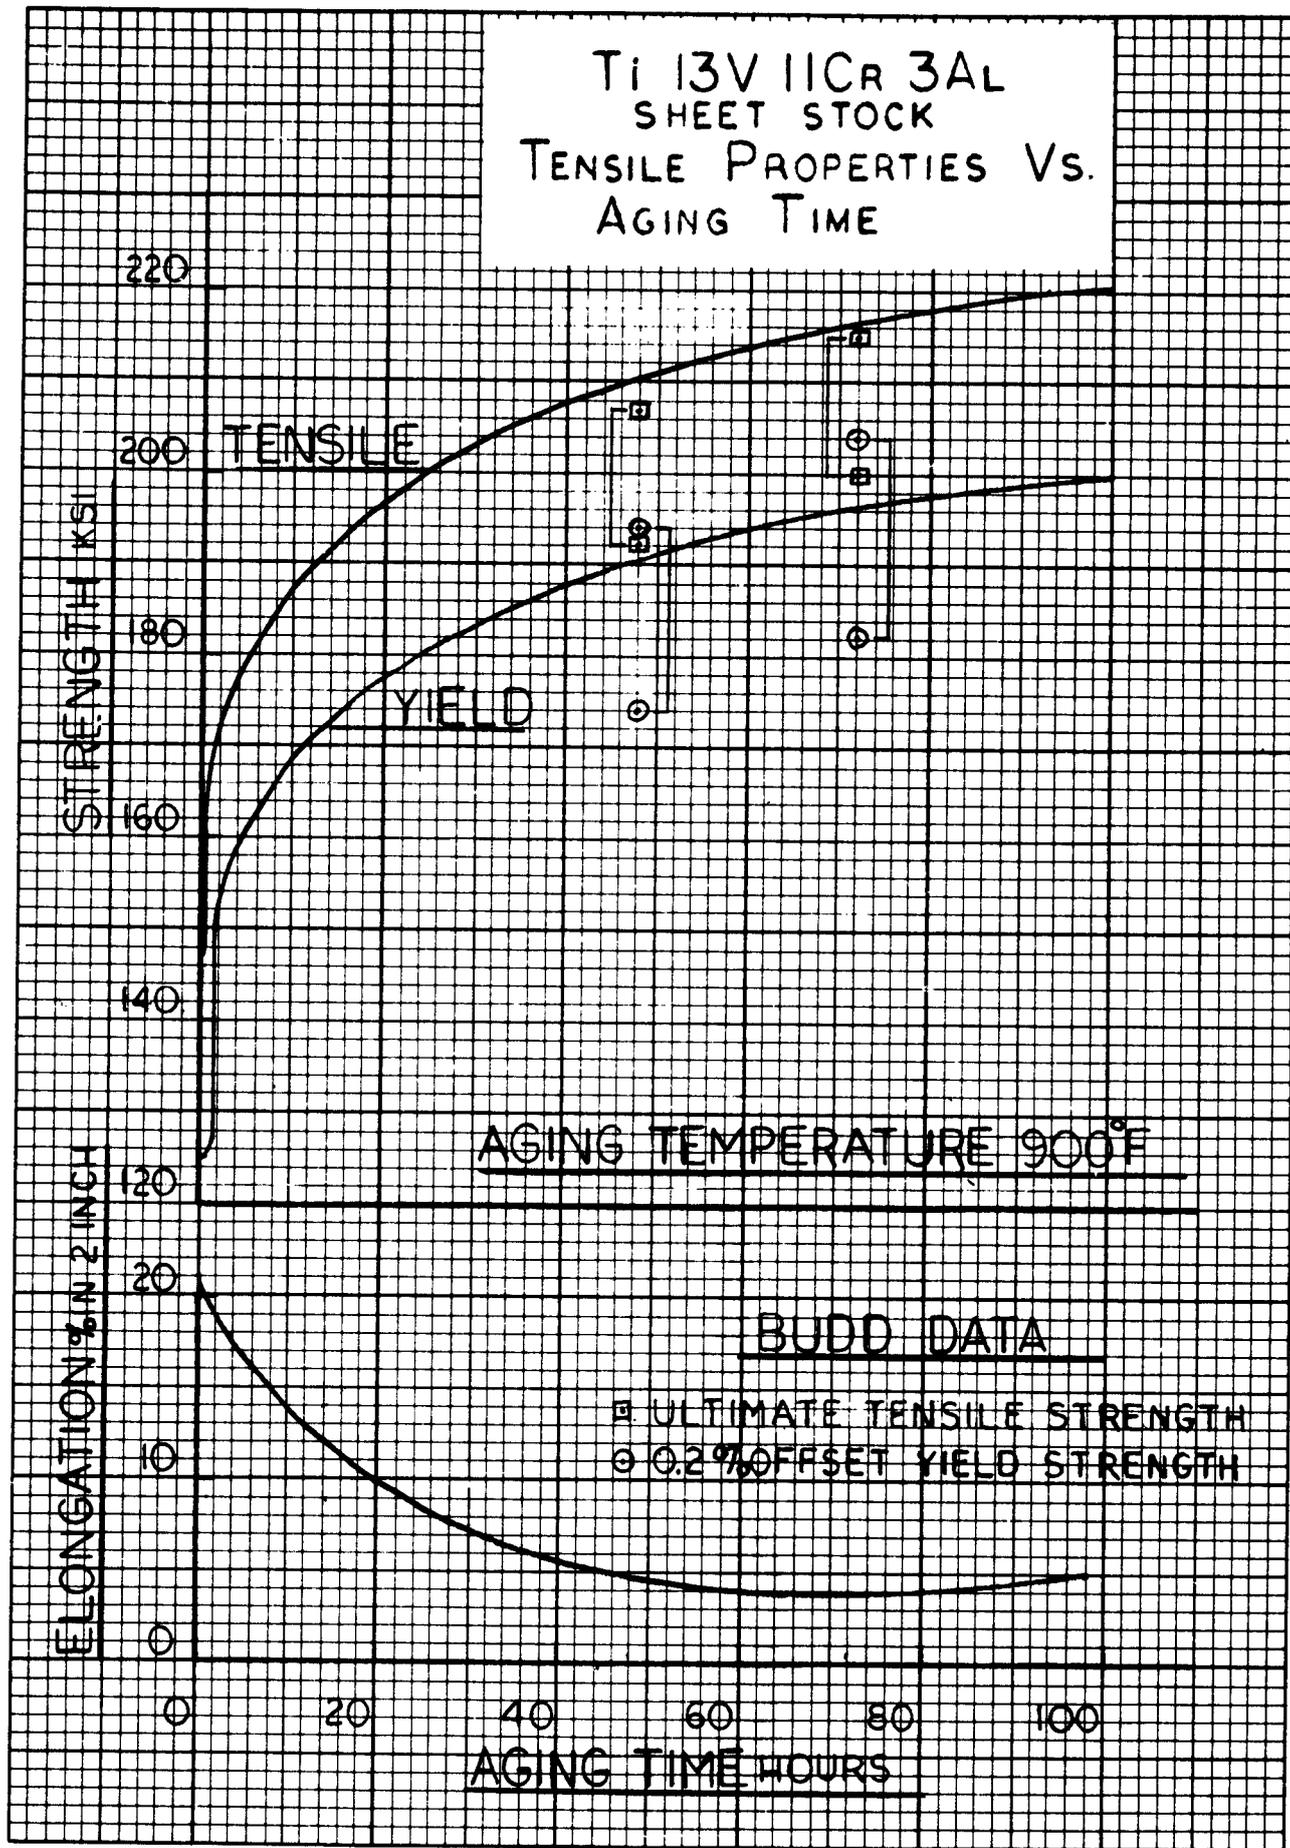
FIG. 6

Ti 13V 11Cr 3Al
 SHEET STOCK
 TENSILE PROPERTIES VS.
 AGING TIME

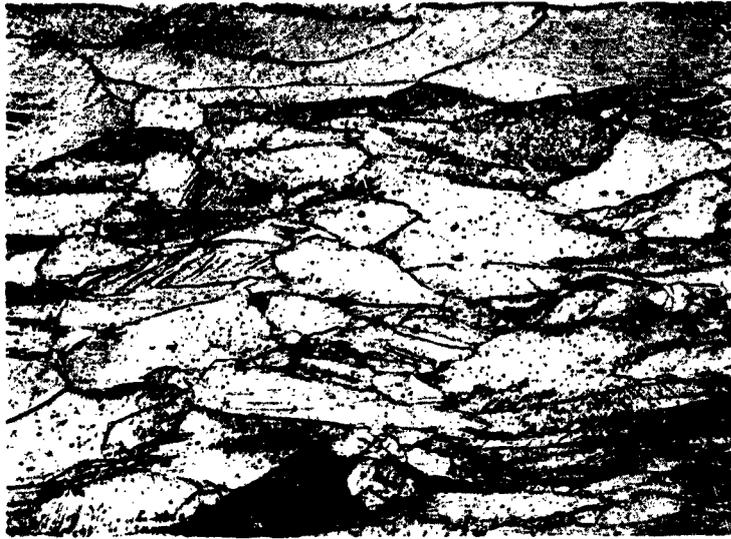
Longitudinal

100X Mag.

Specimen EANL - 1

Solution Annealed

The microstructures of material in various conditions are shown in Figures 7 through 11. The annealed material shown in Figure 7 exhibits elongated grains in the longitudinal direction despite the recrystallization of annealing. The very fine secondary phase which is only slightly visible in the annealed specimen EANL-1, Figure 6 is considerably more pronounced in the aged condition, as shown in Figure 8. Specimen EGNL-2 is a 2000X magnification of this structure. This secondary phase is most likely accicular alpha Ti forming in the otherwise all beta grains.

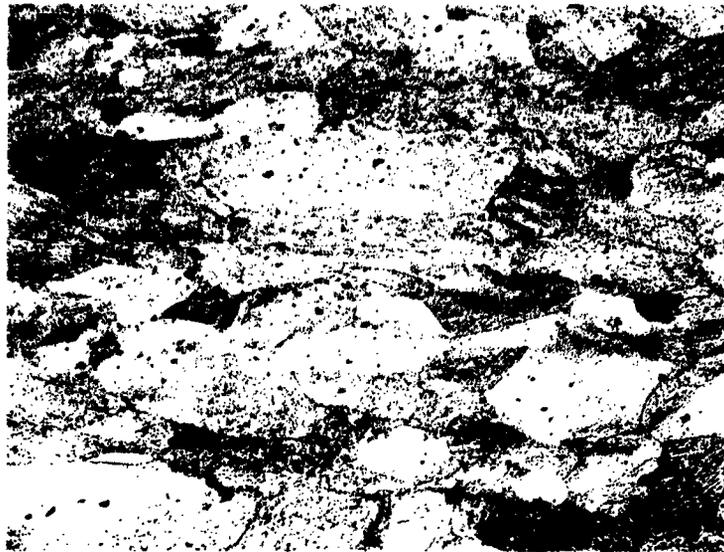
FIGURE 8

Longitudinal 100X Mag.
Specimen EGNL - 1

Longitudinal 2000X Mag.
Specimen EGNL - 2

Ti 13V-11Cr-3Al 0.060" Gage
Ht. No. D31 Solution Annealed + Aged 900°F, 72Hrs.
Etchant: 2% HF + HNO₃ + H₂O

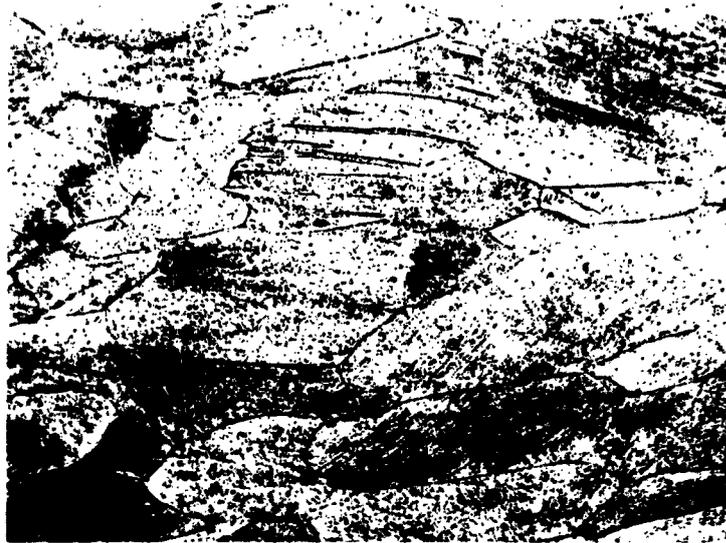
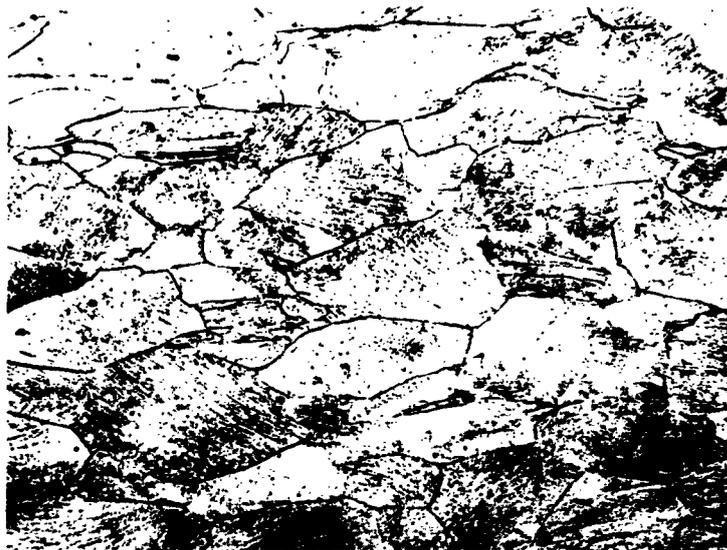
FIGURE 9

Longitudinal

250X Mag.

Specimen ETNL - 1

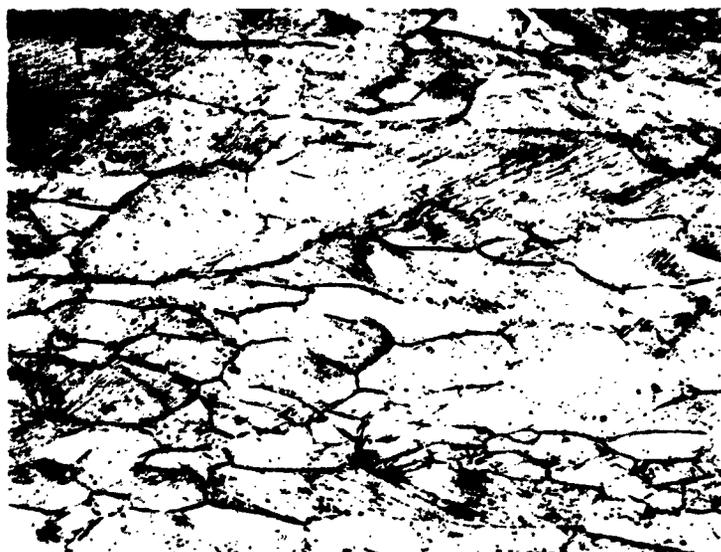
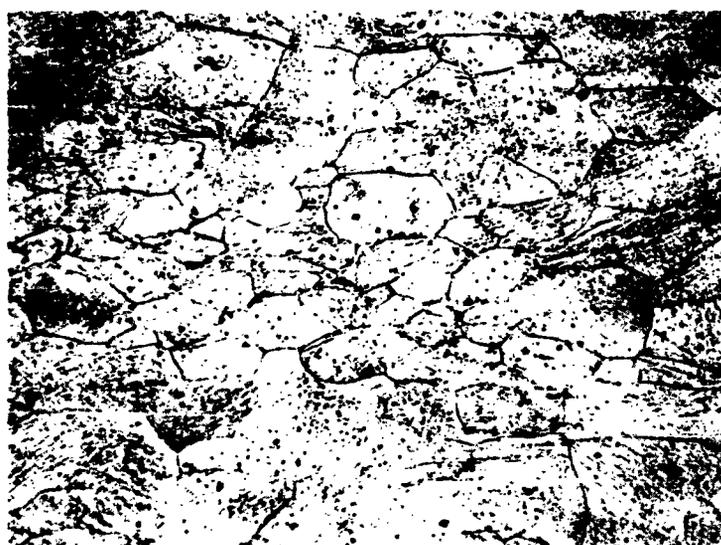
FIGURE 10

Longitudinal 250X Mag.
Specimen ENNL - 6

Transverse 250X Mag.
Specimen ENNT - 6

Ti 13V-11Cr-3Al 0.034" Gage
Ht.No. D260 Cold Rolled + Aged 900°F, 16Hrs.
Etchant: 2% HF + 40% HNO₃ + H₂O

Cold rolling and aging for 16 hours produced the structures shown in Figure 10. The elongated beta grains showing strain markings are typical. Not resolved in this photomicrograph is the accicular alpha phase that would be expected in the same manner as experienced with annealed and aged only material.

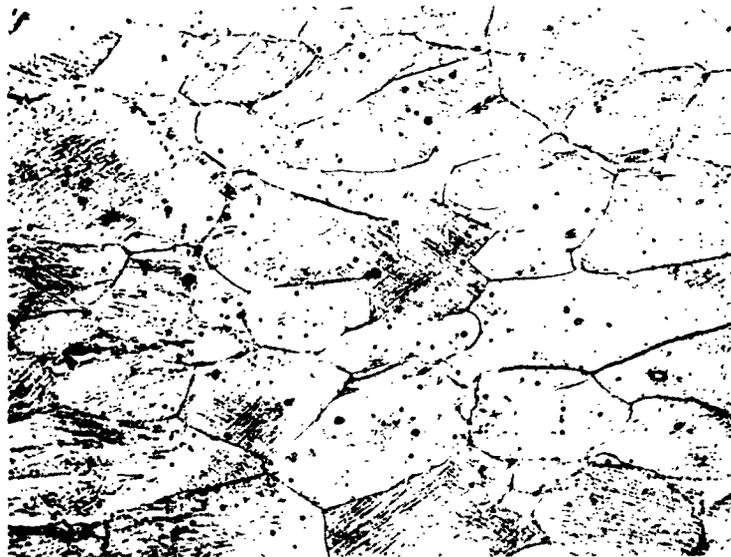
Longitudinal

250X Mag.

Specimen ENNL - 1

Material aged to 48 hours at 900°F after cold rolling as seen in Figure 11 shows the same general grain structure. However, the secondary alpha phase appears to be more nodular in form and there is little

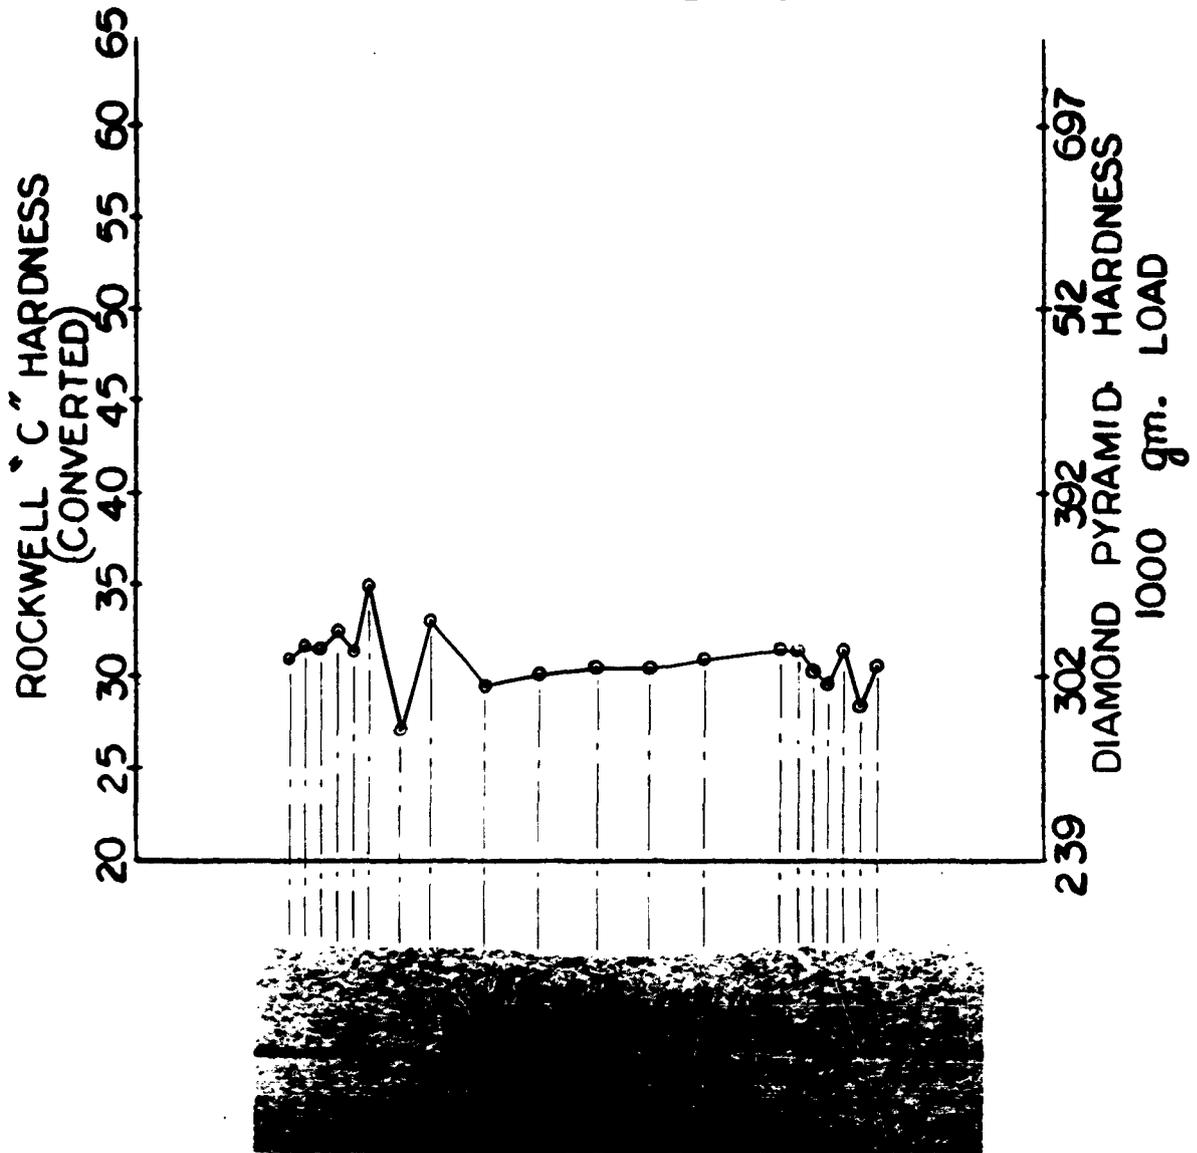
FIG. 13

WELD CROSS SECTION
KENTRON MICRO HARDNESS TESTER
DIAMOND PYRAMID PENETRATOR

SPEC. NO. EA0-1 WELD TYPE Resistance Spot MAG. 10X
 ETCHANT 2% HF + 10% HNO₃ + H₂O

MATERIAL Ti 13V-11Cr-3Al GAGE .060"

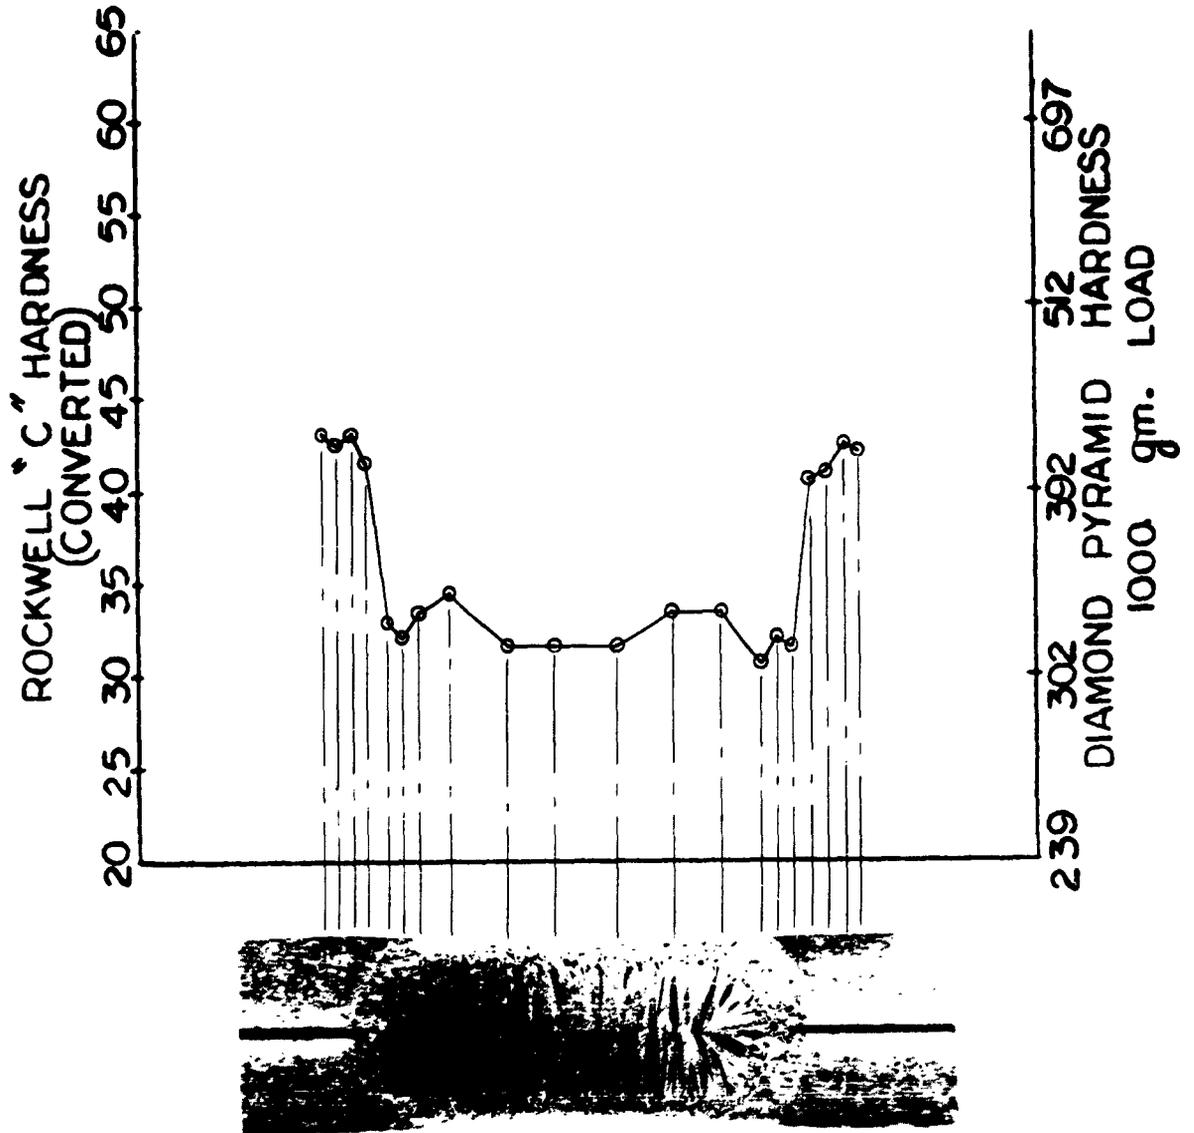
FIG. 16

WELD CROSS SECTION
KENTRON MICRO HARDNESS TESTER
DIAMOND PYRAMID PENETRATOR

SPEC. NO. EJO-1 WELD TYPE Resistance MAG. 9X
 ETCHANT _____

MATERIAL T1 13V-11Cr-3Al GAGE 0.060

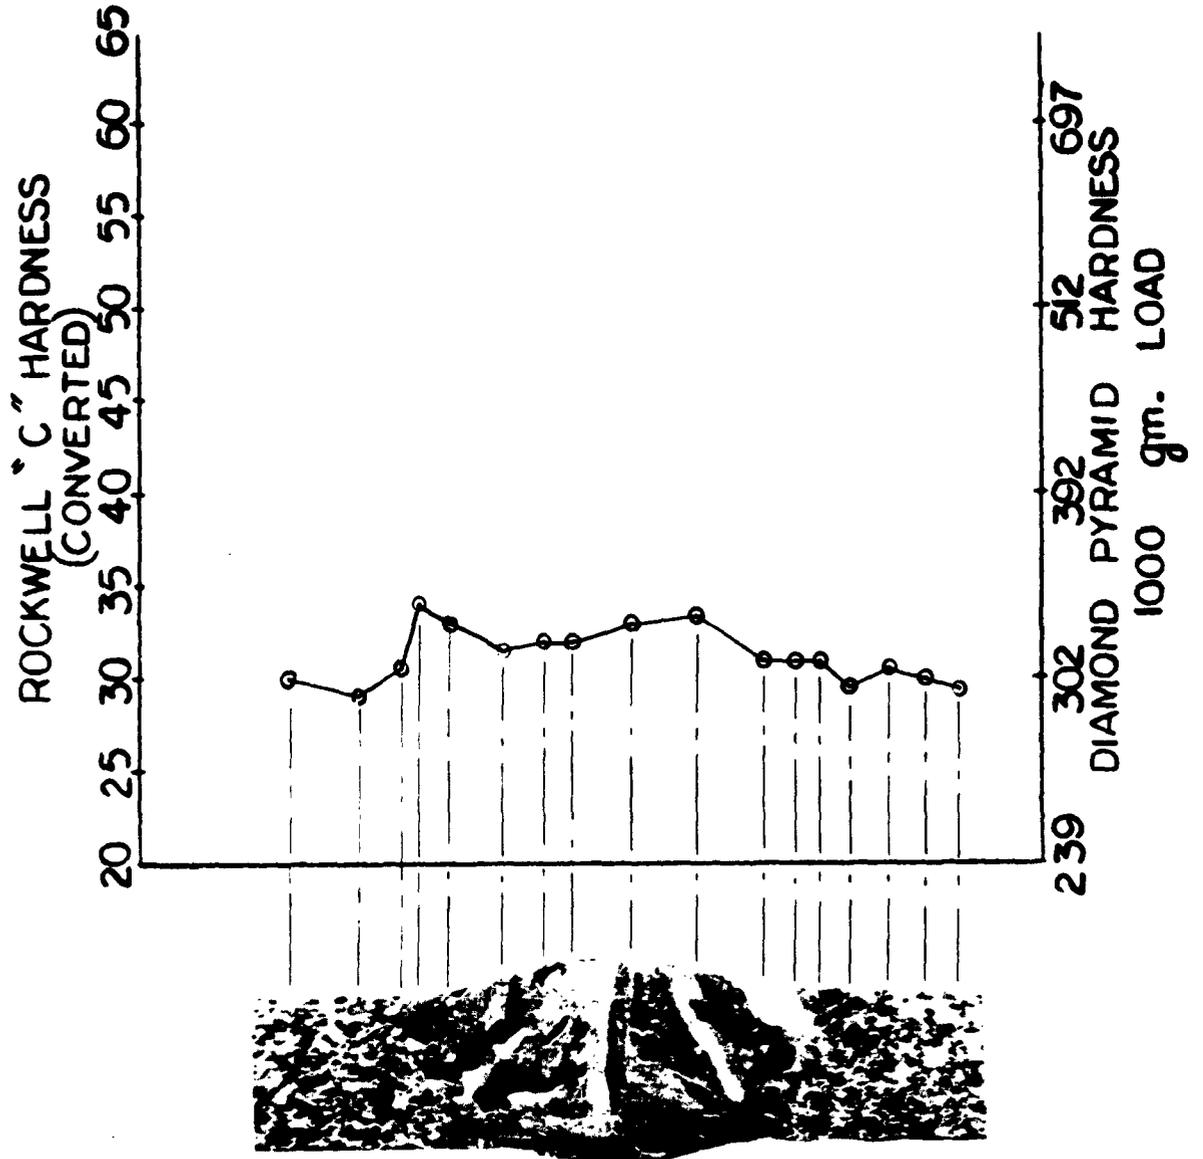
WELD CROSS SECTION
KENTRON MICRO HARDNESS TESTER
DIAMOND PYRAMID PENETRATOR

SPEC. NO. EA0-2 WELD TYPE ARC (TIG) MAG. 12X
 ETCHANT 2% HF + 10% HNO₃ + H₂O

MATERIAL Ti 13V-11Cr-3Al GAGE 0.060

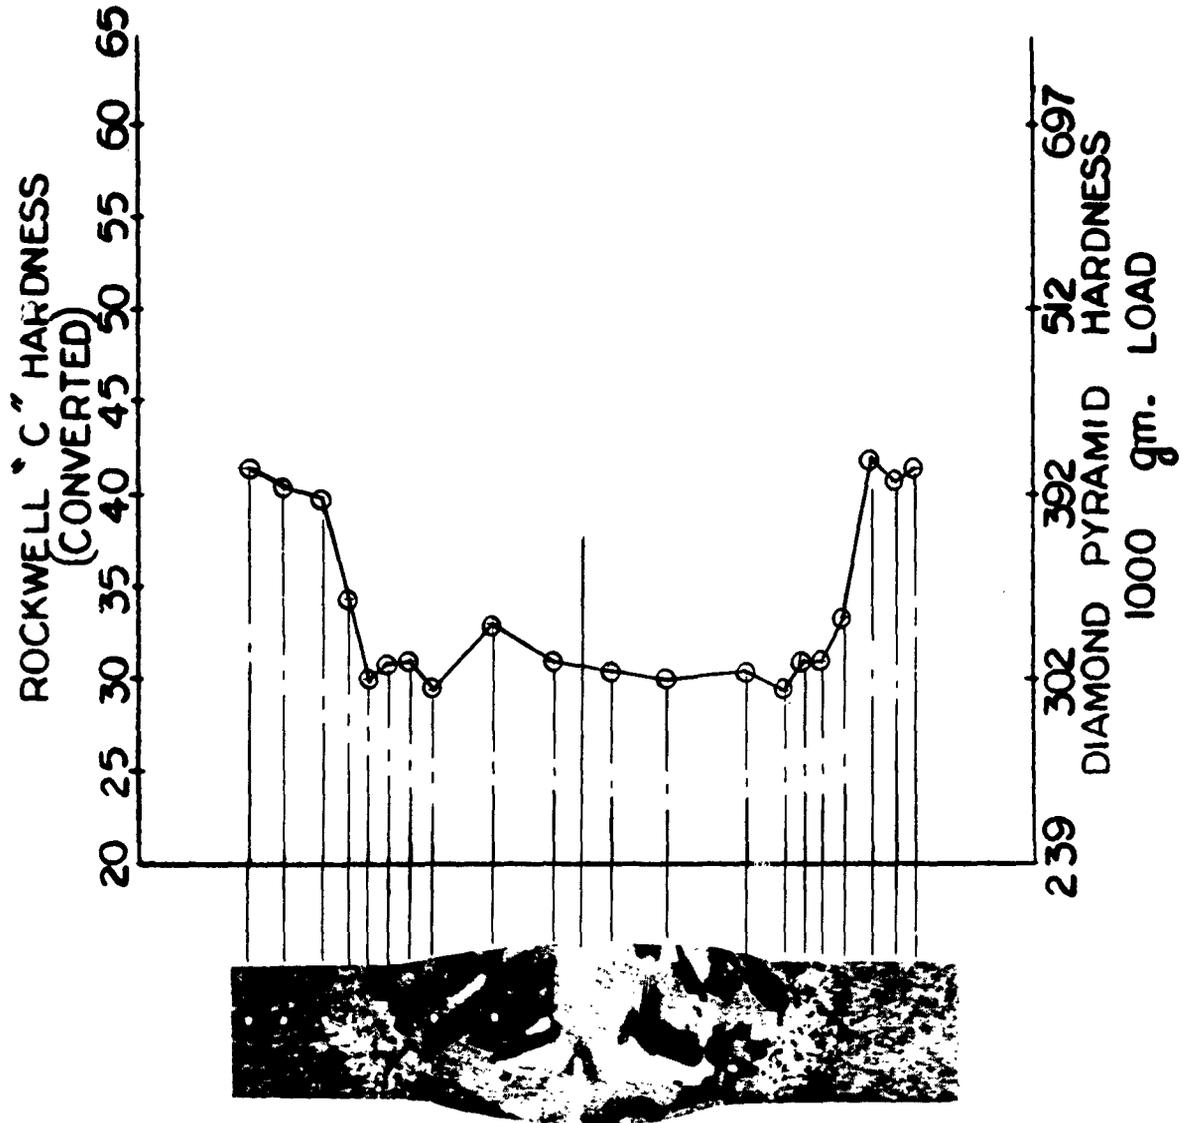
FIG. 19

WELD CROSS SECTION
KENTRON MICRO HARDNESS TESTER
DIAMOND PYRAMID PENETRATOR

SPEC. NO. EJO-2 WELD TYPE TIG MAG. 12X
 ETCHANT 2% HF + 10% HNO₃ + H₂O

MATERIAL Ti 13V-11Cr-3Al GAGE 0.060

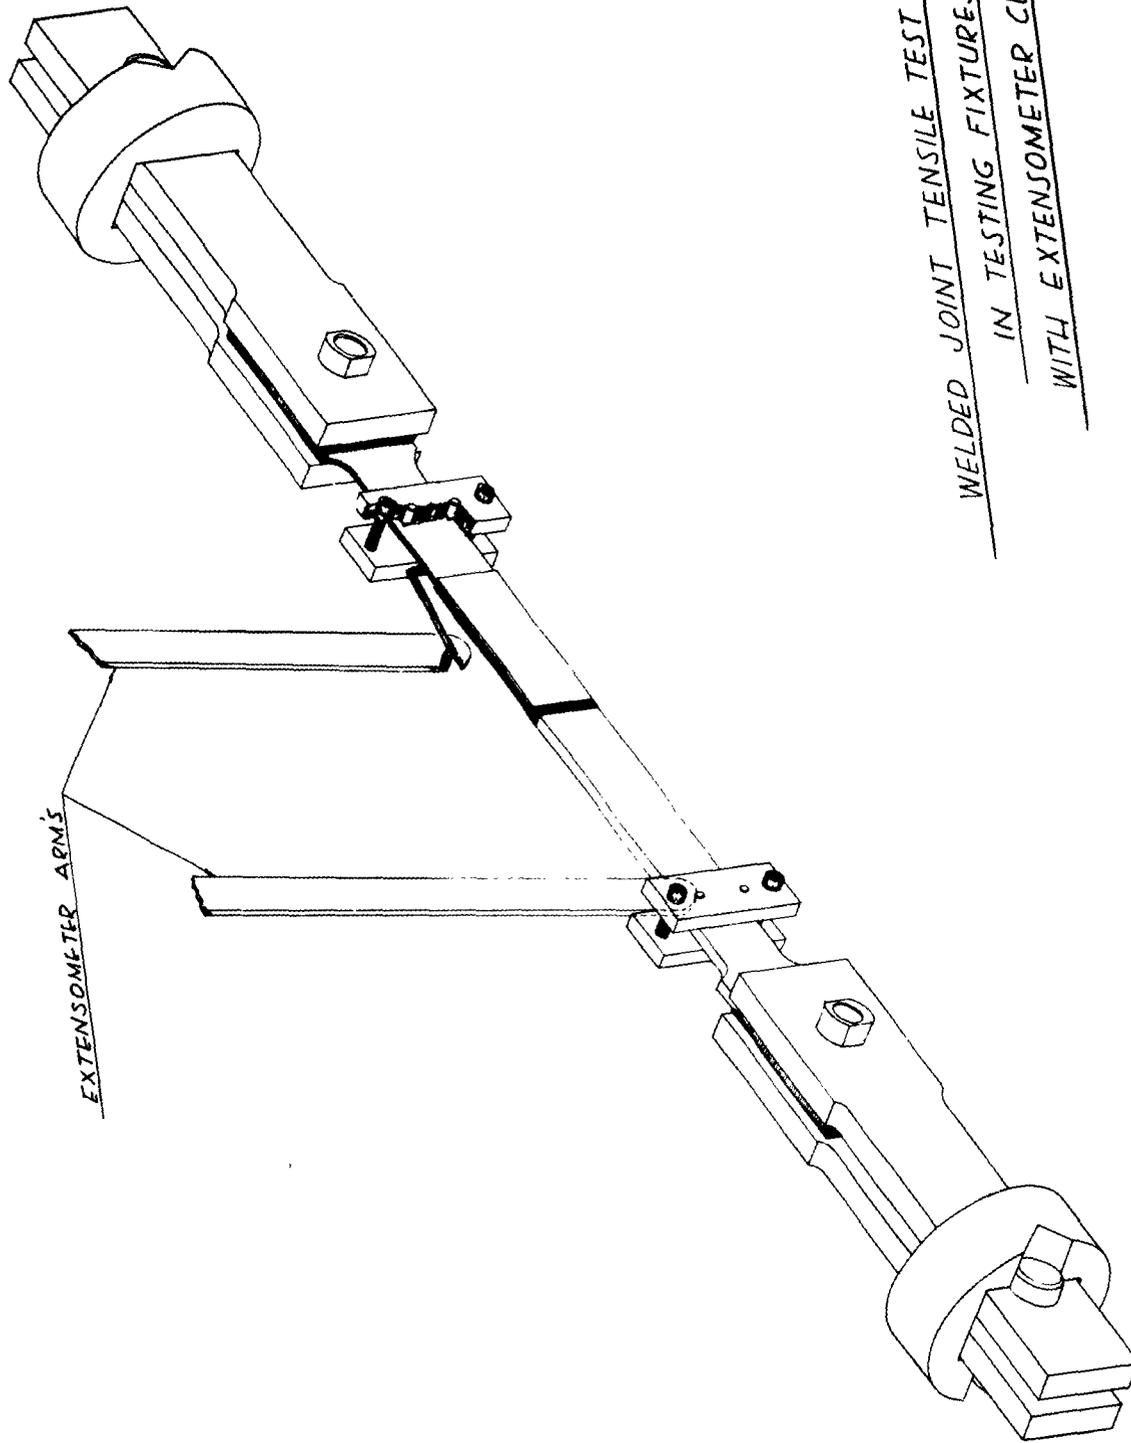
EXTENSOMETER ARMS

WELDED JOINT TENSILE TEST SPECIMENS
IN TESTING FIXTURES
WITH EXTENSOMETER CLAMPS

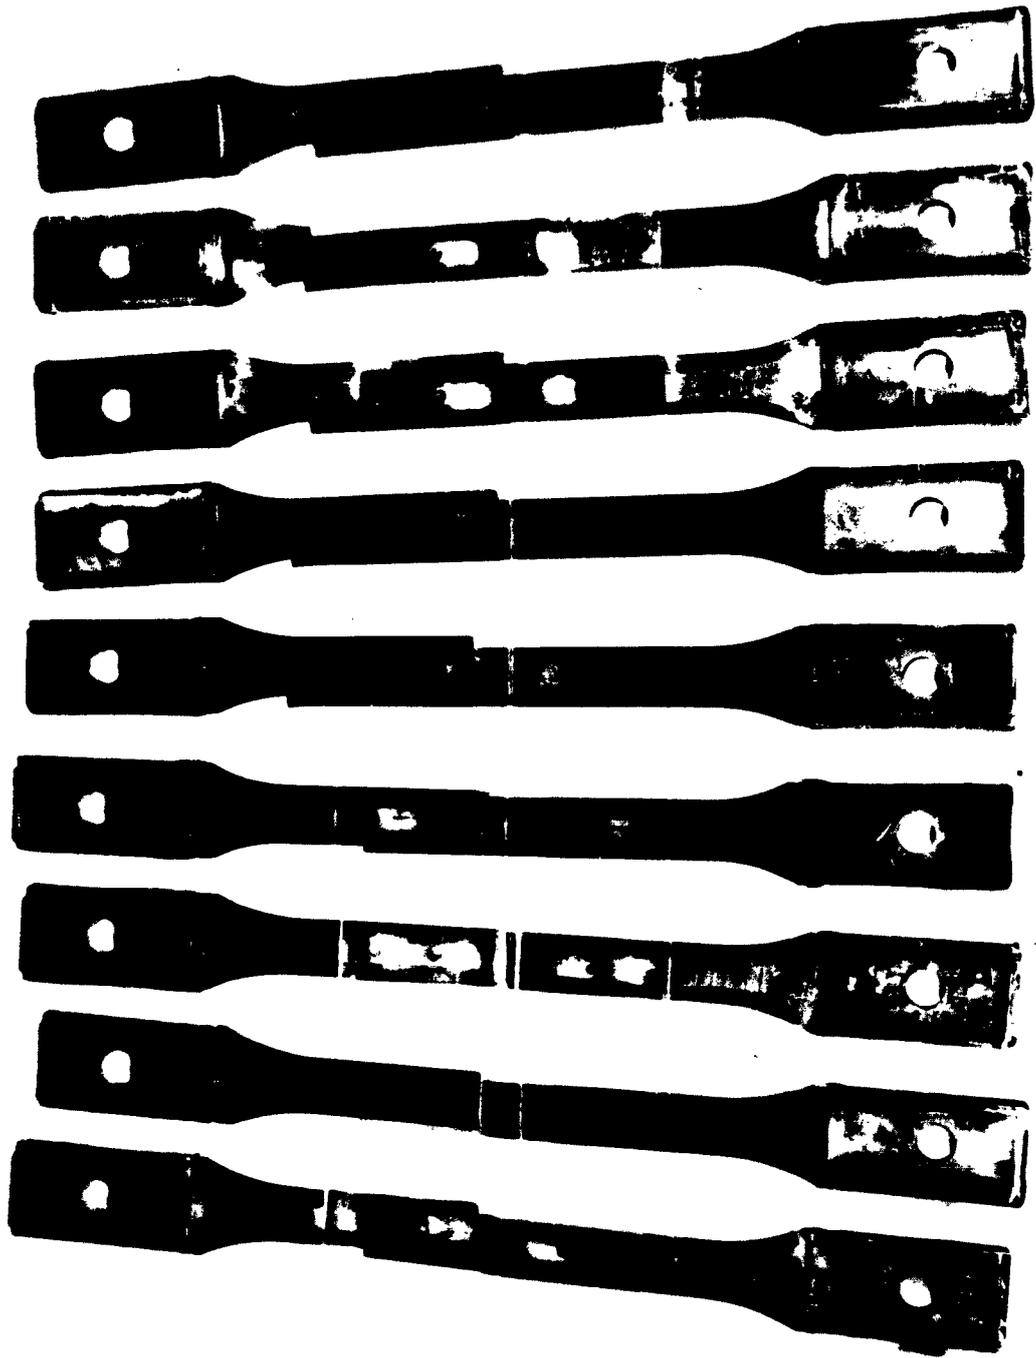
FIGURE 25

AM-355 SCCRT, PH 15-7 MO WELDED TENSILE TEST SPECIMENS SHOWING
FRACTURE LOCATIONS

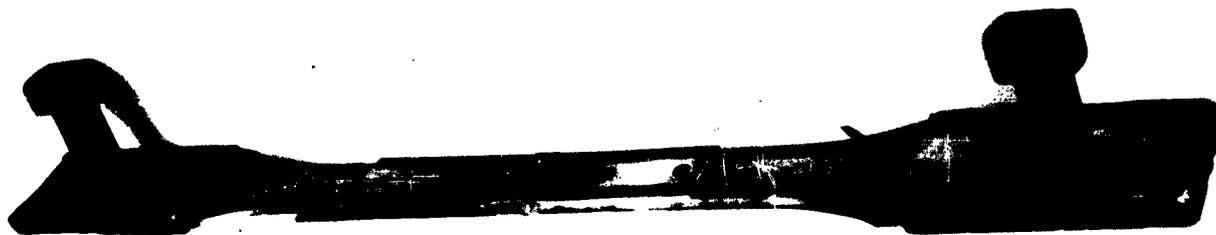
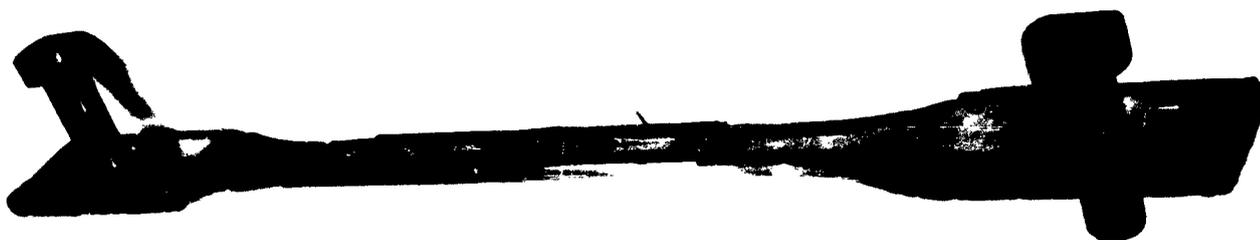
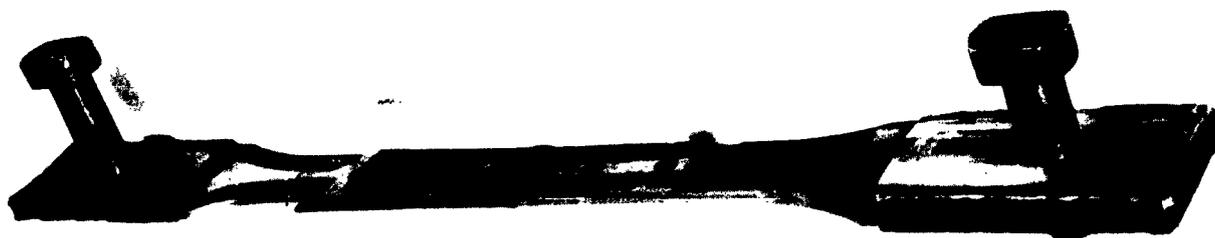
FIGURE 25

AM-355 SCCRT, PH 15-7 MO WELDED
TENSILE TEST SPECIMENS
SHOWING FRACTURE LOCATIONS

SPECIMEN B480-SK-0013
HEAD TO SHELL JOINT

SPECIMEN B480-SK-0014
HEAD TO SHELL JOINT

SPECIMEN B480-SK-0015
HEAD TO SHELL JOINT

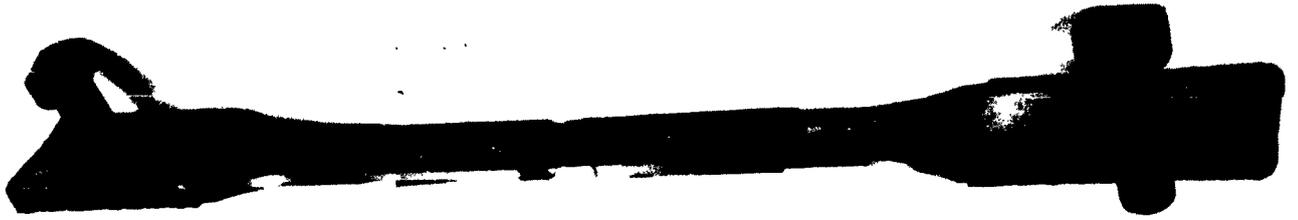
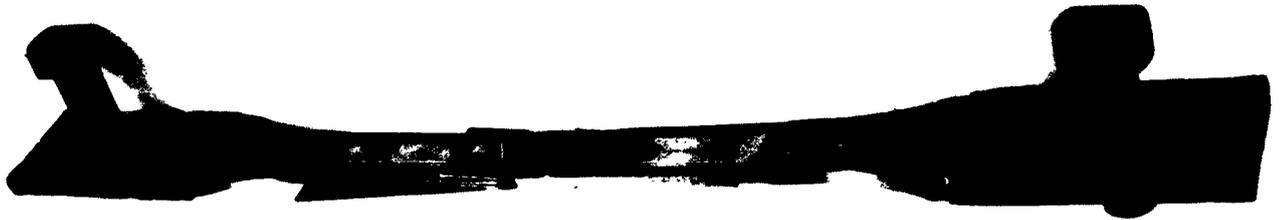
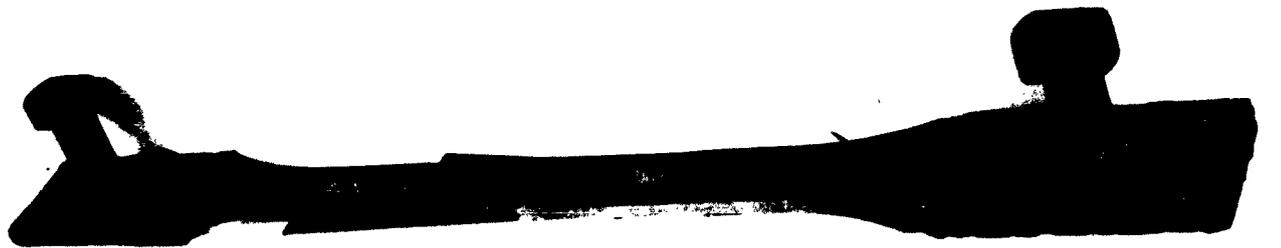
FIGURE 25

AM-355 SCRT, PH 15-7 MO WELDED
TENSILE TEST SPECIMEN
SHOWING FRACTURE LOCATIONS

SPECIMEN B480-SK-0010
HEAD TO SHELL JOINT

SPECIMEN B480-SK-0011
HEAD TO SHELL JOINT

SPECIMEN B480-SK-0012
HEAD TO SHELL JOINT

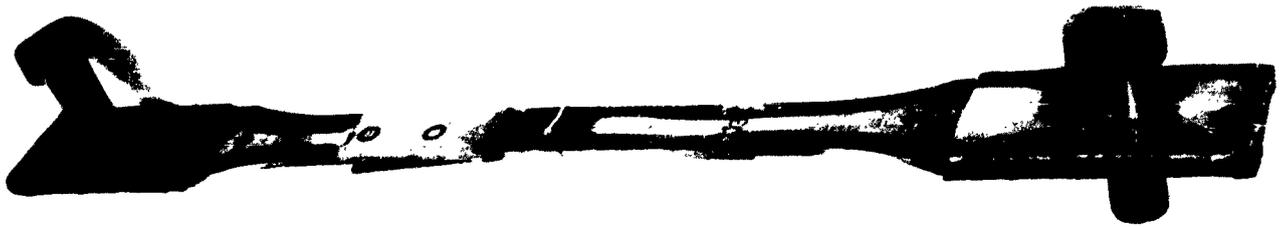
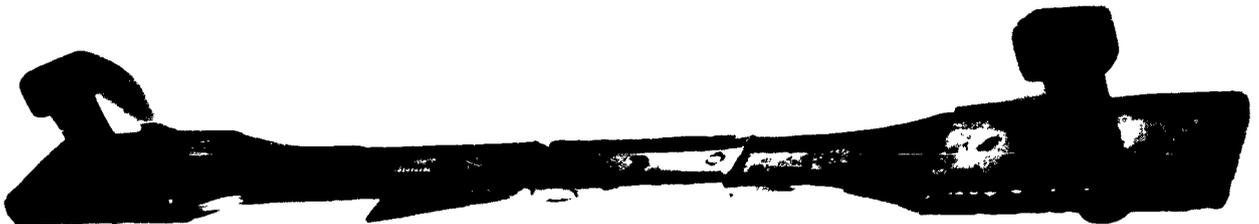
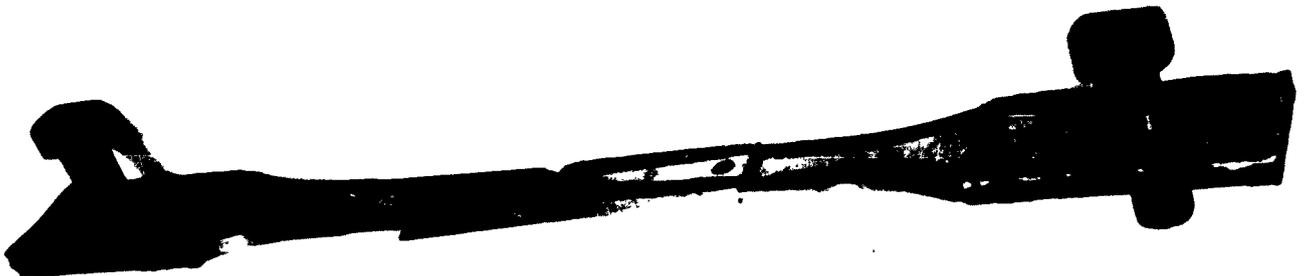
FIGURE 25

AM-355 SCRT, PH 15-7 MO WELDED
TENSILE TEST SPECIMENS
SHOWING FRACTURE LOCATIONS

SPECIMEN B480-SK-0007
SHELL TO SHELL JOINT

SPECIMEN B480-SK-0008
HEAD TO SHELL JOINT

SPECIMEN B480-SK-0009
HEAD TO SHELL JOINT

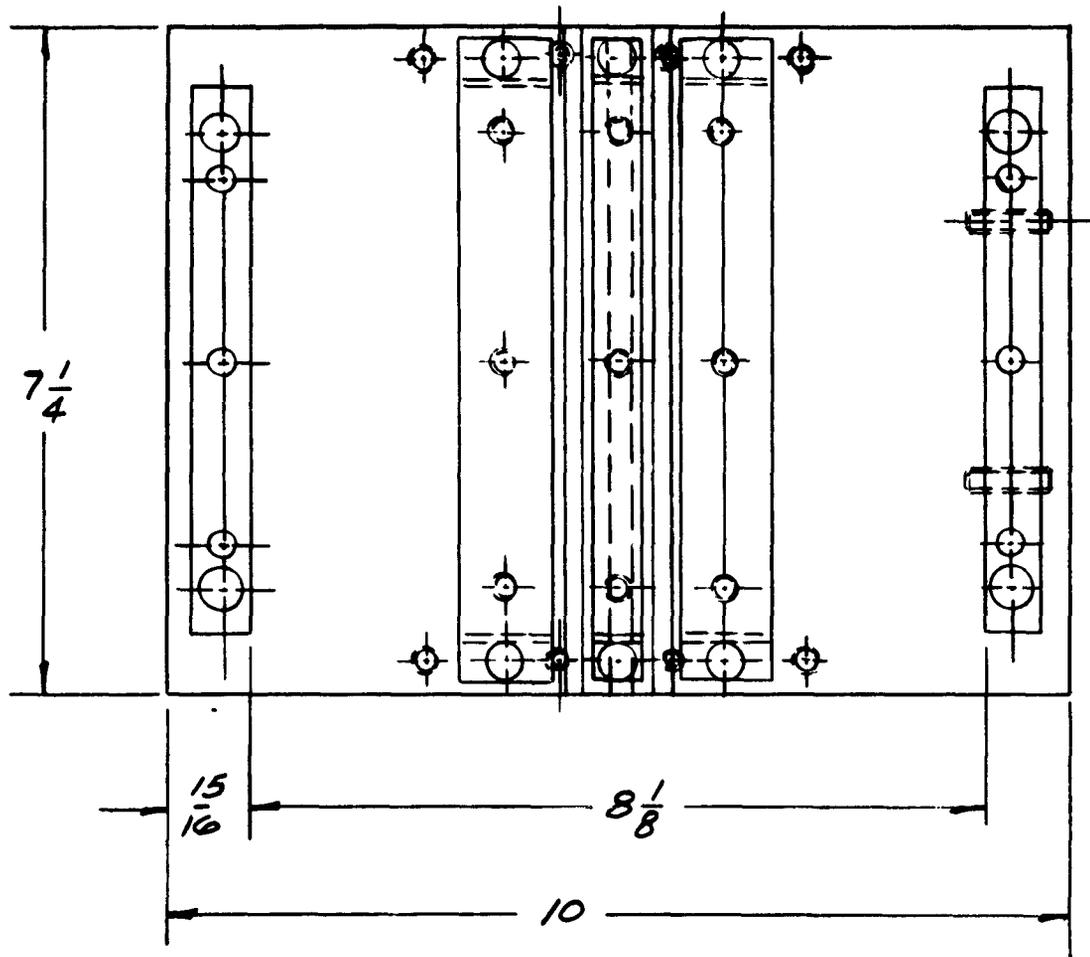
COPPER INSERTS

WELDING FIXTURE
 SCALE: HALF-SIZE
 (BRISTOL MACHINE & TOOL Co. INC.)

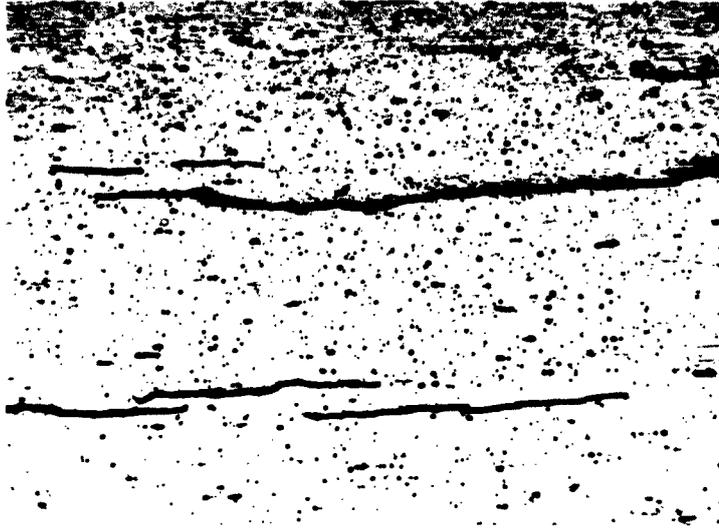
JLS 300 Steel Strip 0.40" thick. Cold rolled and tempered to 340 Ksi yield strength. Cracks parallel to direction of rolling and surfaces of strip.
