DEVELOPMENT OF HIGH PERFORMANCE ROCKET MOTOR CASE

QUARTERLY REPORT NUMBER 12

PRODUCT DEVELOPMENT DEPARTMENT
THE BUDD COMPANY
Philadelphia 32, Pennsylvania

ENGINEERING QUARTERLY PROGRESS REPORT NUMBER 12

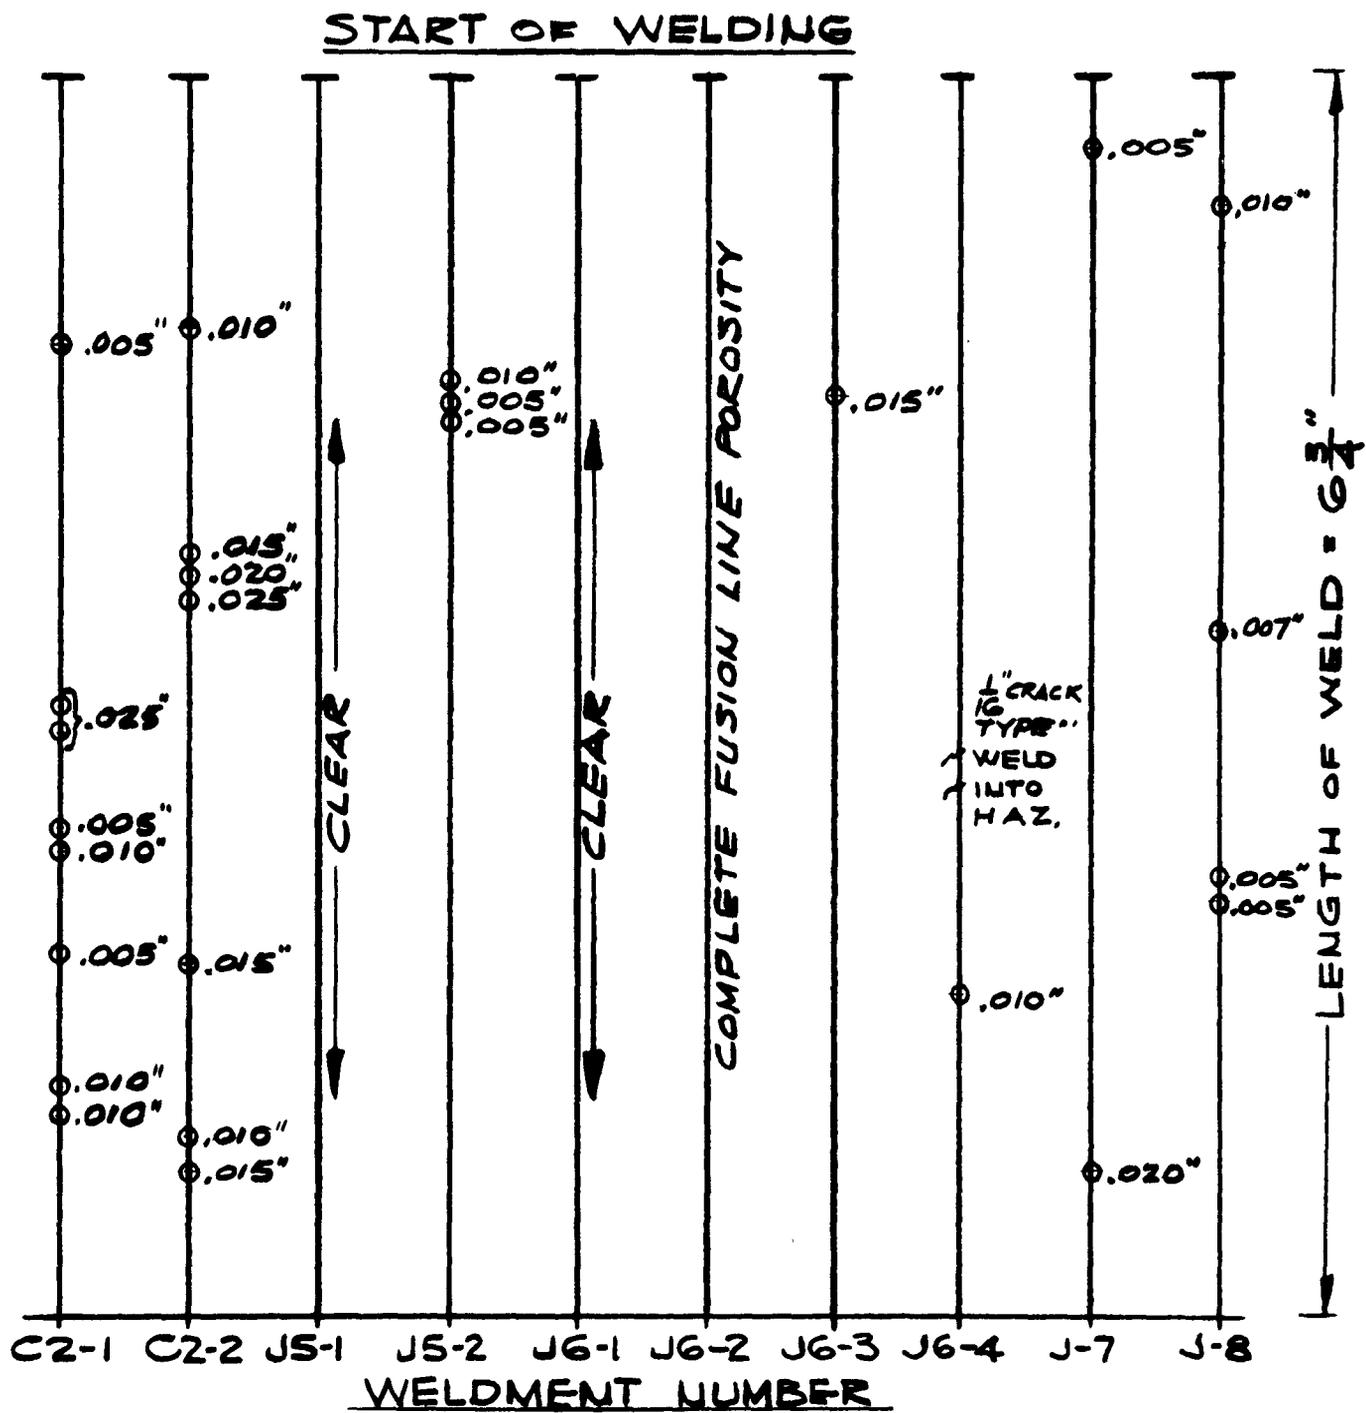
FIG. 29

RADIOGRAPH INDICATIONS, ELECTRON BEAM WELDMENTS.
Ti, 13V, 11Cr, 3Al, SHEET.

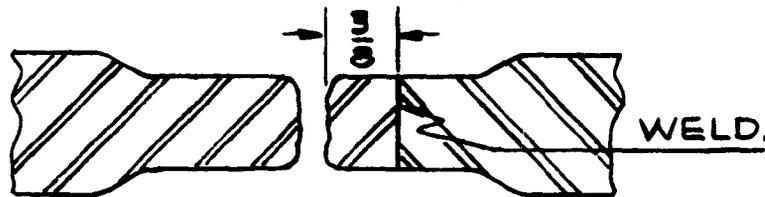
SPECIMEN-C1-1.

SOLUTION ANNEALED, WELD. BASE METAL FRACTURE.

DUCTILE FRACTURE, NECKING AND GOOD ELONGATION.

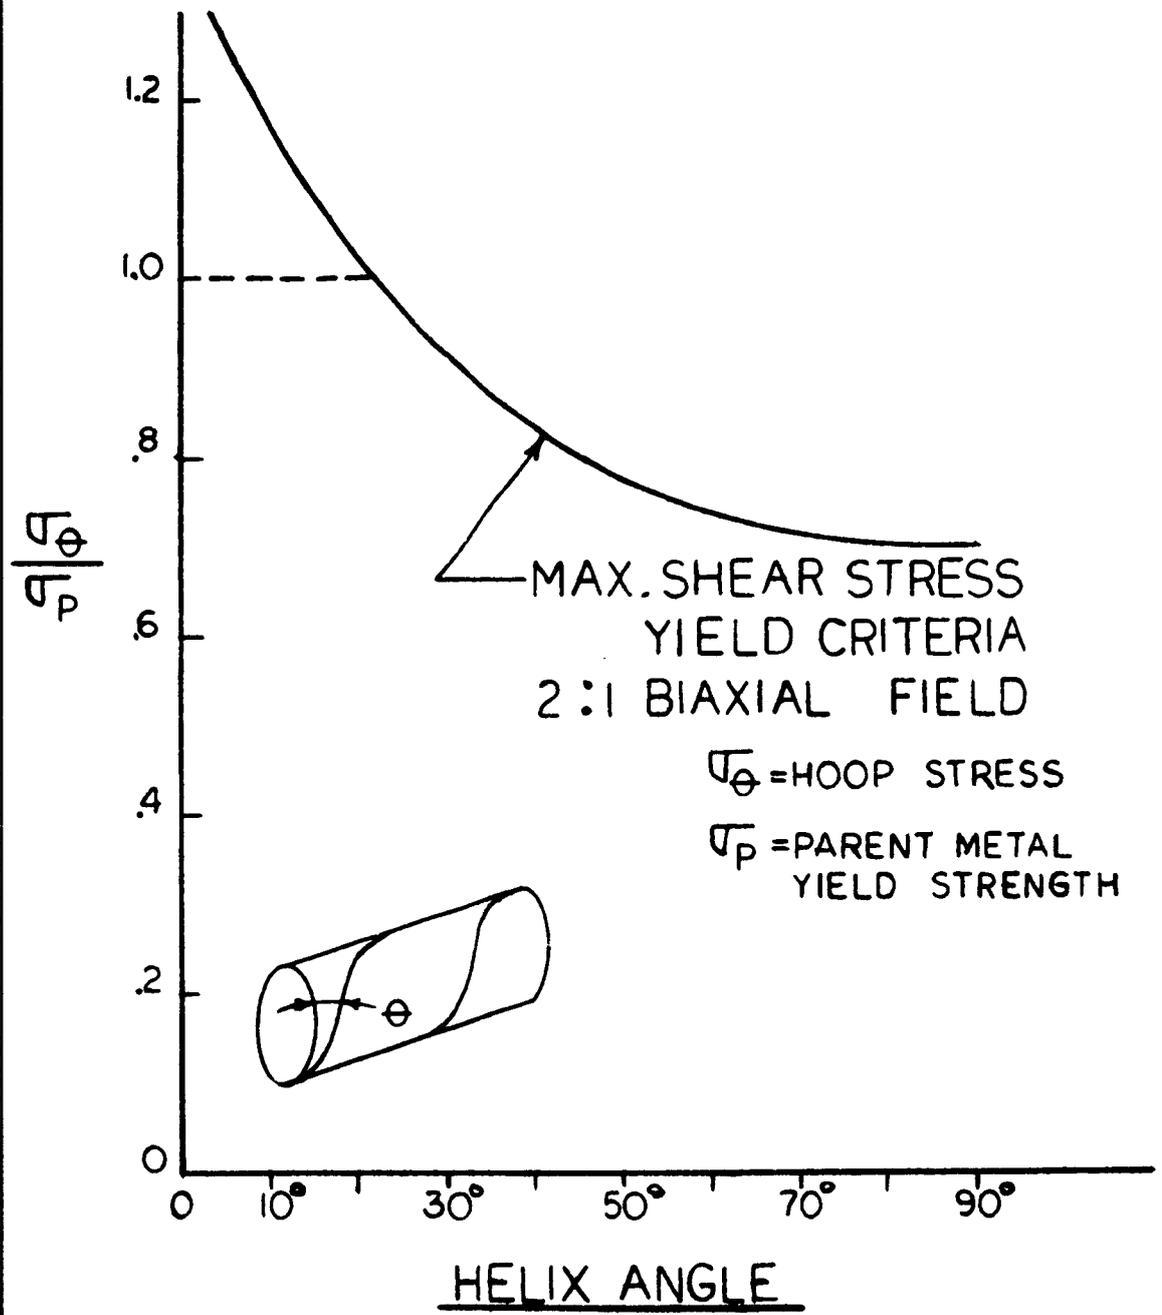
FIGURE-33

EFFECT OF HELIX ANGLE ON THE
YIELD STRENGTH OF A CYLINDER

material considered can be plotted and optimum helix angles can be established. From tests of sub-scale 20° cylinders we expect to obtain actual data to confirm the validity of the design and the cumulative effect bending stresses, etc. on the performance of the cylinder.

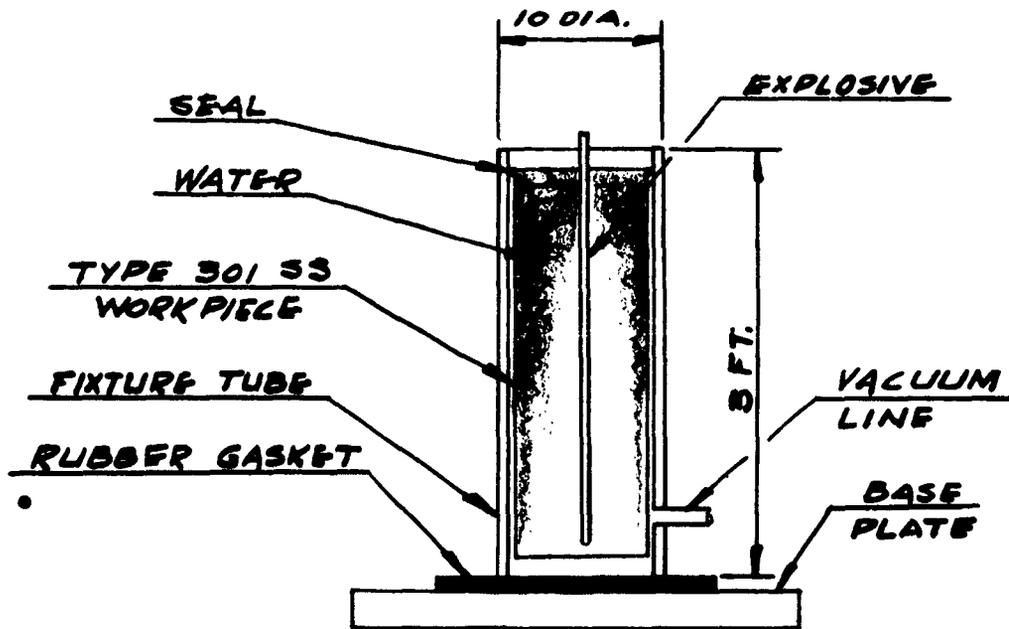
FIG.-35

EXPLOSIVE SIZING ARRANGEMENT
10" DIA. TYPE 301 STAINLESS
SHELL

SCHEMATIC DIAGRAM OF EXPLOSIVE SIZING
ARRANGEMENT

In addition to the welding development of 10" cylinders noted above, we are working on an explosive sizing technique. Figure 35 shows a photograph and schematic design of an experimental setup used to size a 10" cylinder. The .020" thick cylinder was sized to between 1% and 2% of its diameter explosively in a steel

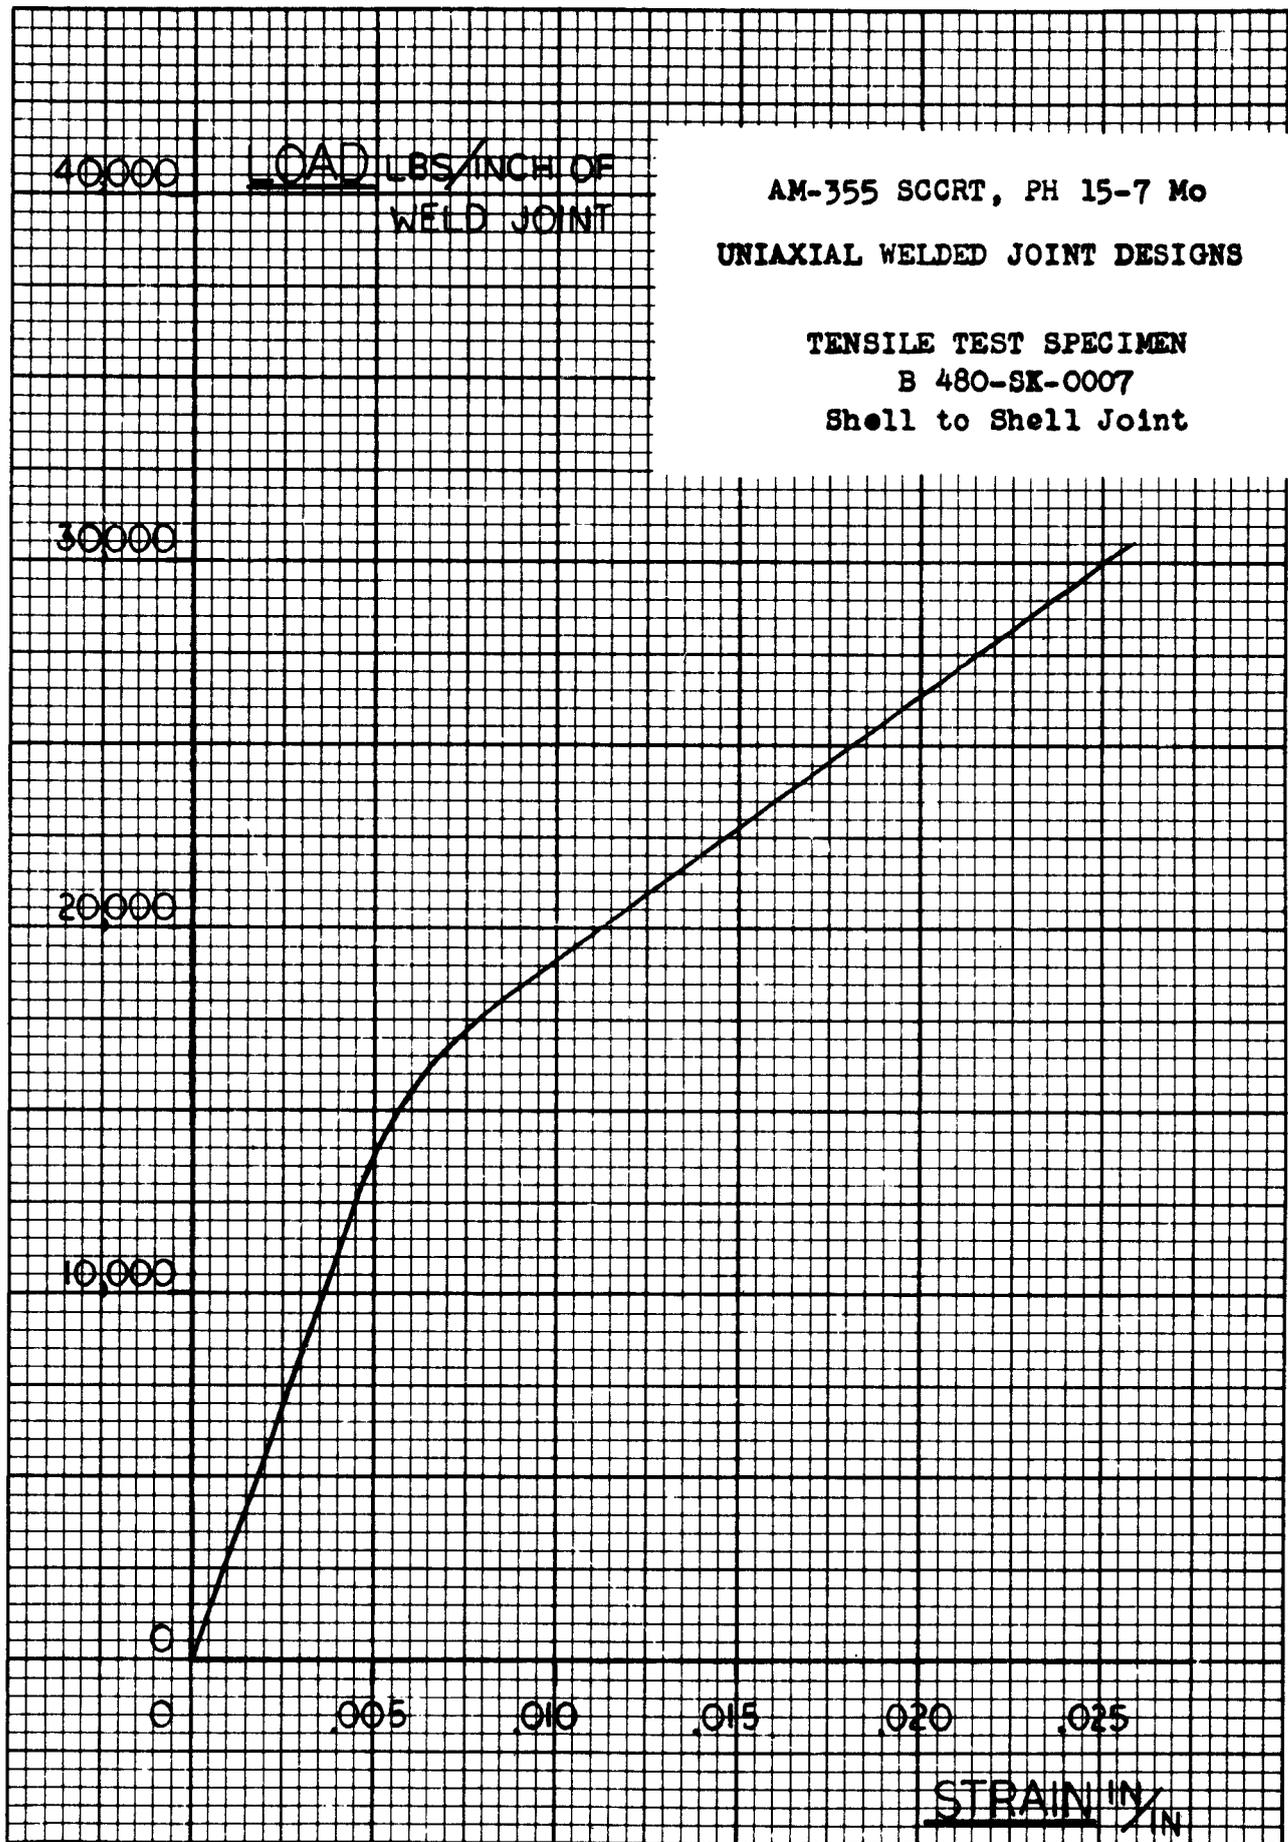
1. Initial failure occurred in the doubler spot welds. These welds sheared from the two thickness shell plate structure.
2. The load was then transferred to the two thickness shell plate structure, producing joint failure in the heat affected zone of the outer seam weld.
3. The maximum load was 30,500 pounds per linear inch of fusion weld with a maximum strain of 0.0256 inches per inch.
4. There was noticeable straining (necking) at the seam weld areas on both sides of the fusion weld.
5. A graph of the Load in pounds per linear inch of fusion weld versus the Total Strain in inches per inch is shown on the following page.

PREPARED BY: FOX, C.R.	THE BUDD COMPANY PRODUCT DEVELOPMENT PHILADELPHIA, PA.	PAGE NO. 97
CHECKED BY:		REPORT NO.
DATE:	AM-355 SCCRT, PH-15-7-MO UNIAXIAL WELDED JOINT DESIGNS	PROJECT NO.

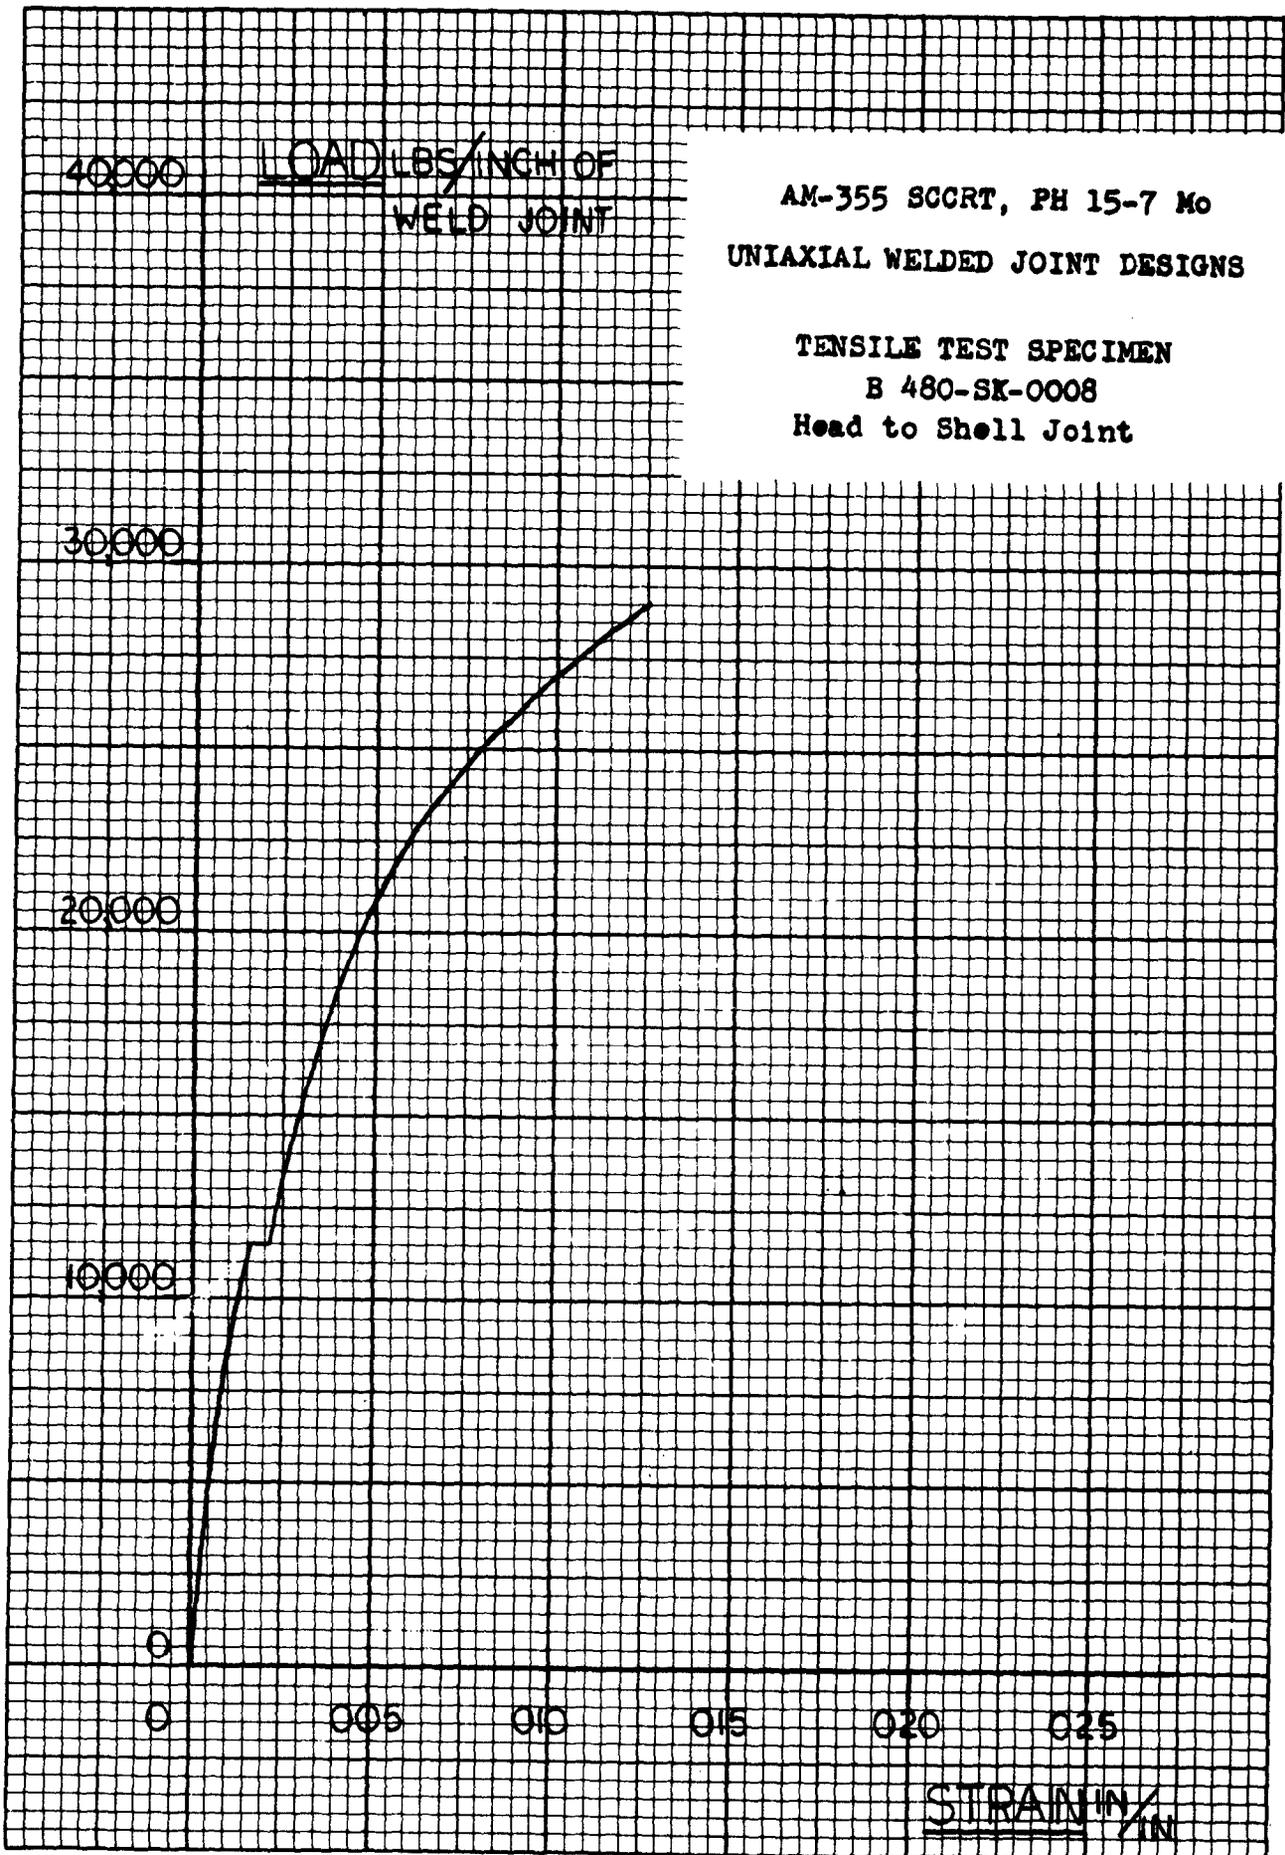
2. The joint failed in the fusion weld at a load of 28,850 pounds per linear inch of fusion weld. A maximum strain of 0.0125 inches per inch was recorded.
3. There was a noticeable straining (necking) in the seam weld area.
4. A graph of the Load in pounds per linear inch of fusion weld versus the Total Strain in inches per inch is shown on the following page.

PREPARED BY: FOX, G.R.	THE BUDD COMPANY PRODUCT DEVELOPMENT PHILADELPHIA, PA.	PAGE NO. 07
CHECKED BY:		REPORT NO.
DATE:	AM-355 RCRT, PH 15-7 MO UNIAXIAL WELDED JOINT DESIGNS	PROJECT NO.

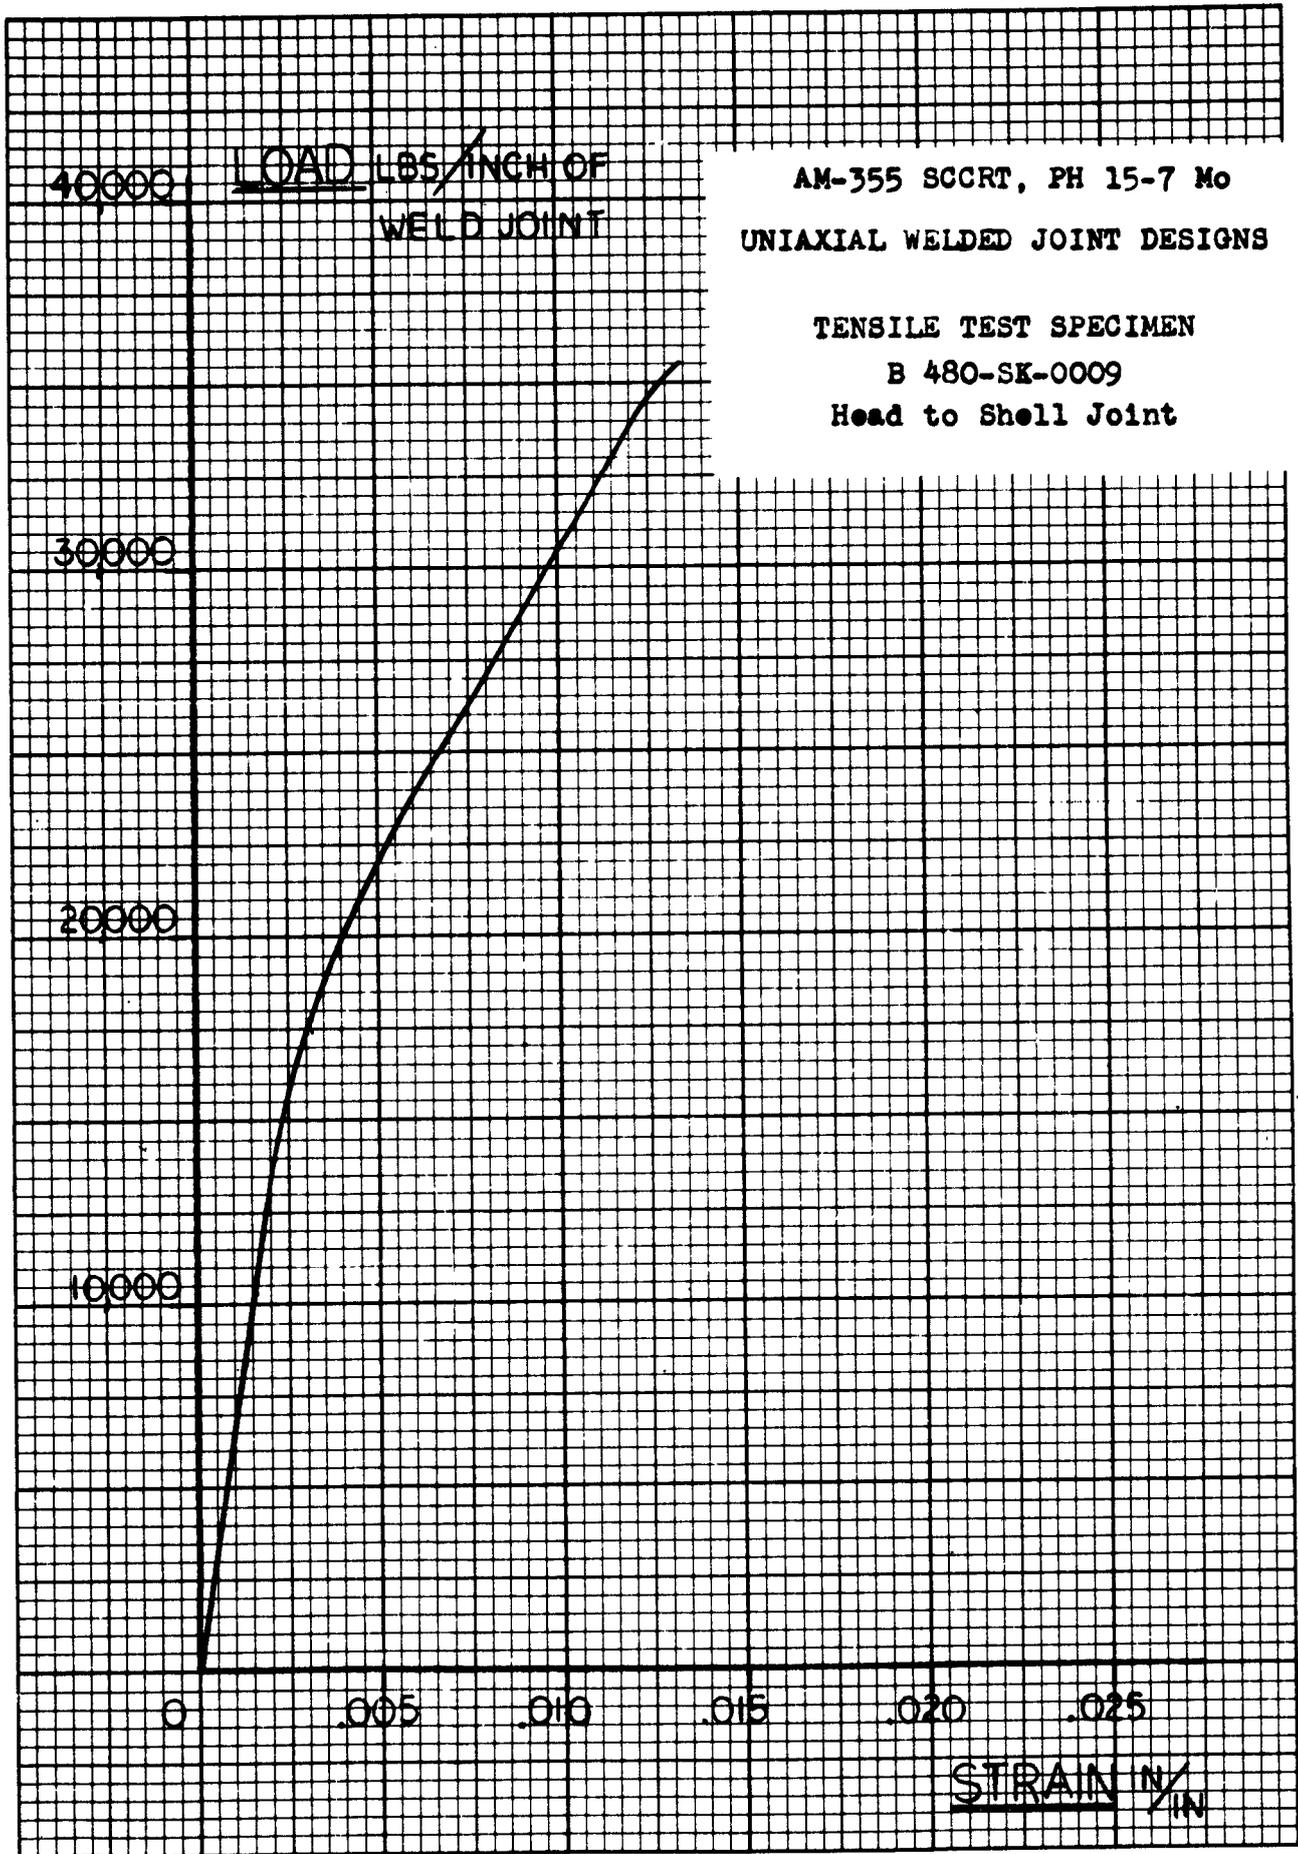
1. Initial failure occurred in the spot welds holding the AM-355 doubler to the PH 15-7 Mo plate. These spot welds failed in shear.
2. There was noticeable straining in the fusion weld area before the spot weld failures. When the doubler on the PH 15-7 Mo plate was no longer transmitting its share of the load to the plate, due to the doubler spot welds failure, severe straining began in the PH 15-7 Mo plate fusion weld heat affected zone. This caused the joint to fail in this area.
3. The joint failed at 35,500 pounds per linear inch of fusion weld with a maximum strain of 0.01325 inches per inch.
4. A graph of the Load in pounds per linear inch of fusion weld versus the Total Strain in inches per inch is shown on the following page.

PREPARED BY: Fox, C.R.	THE BUDD COMPANY PRODUCT DEVELOPMENT PHILADELPHIA, PA.	PAGE NO. 07
CHECKED BY:		REPORT NO.
DATE:	AM-355 SCRT, PH 15-7 MO UNIAXIAL WELDED JOINT DESIGNS	PROJECT NO.

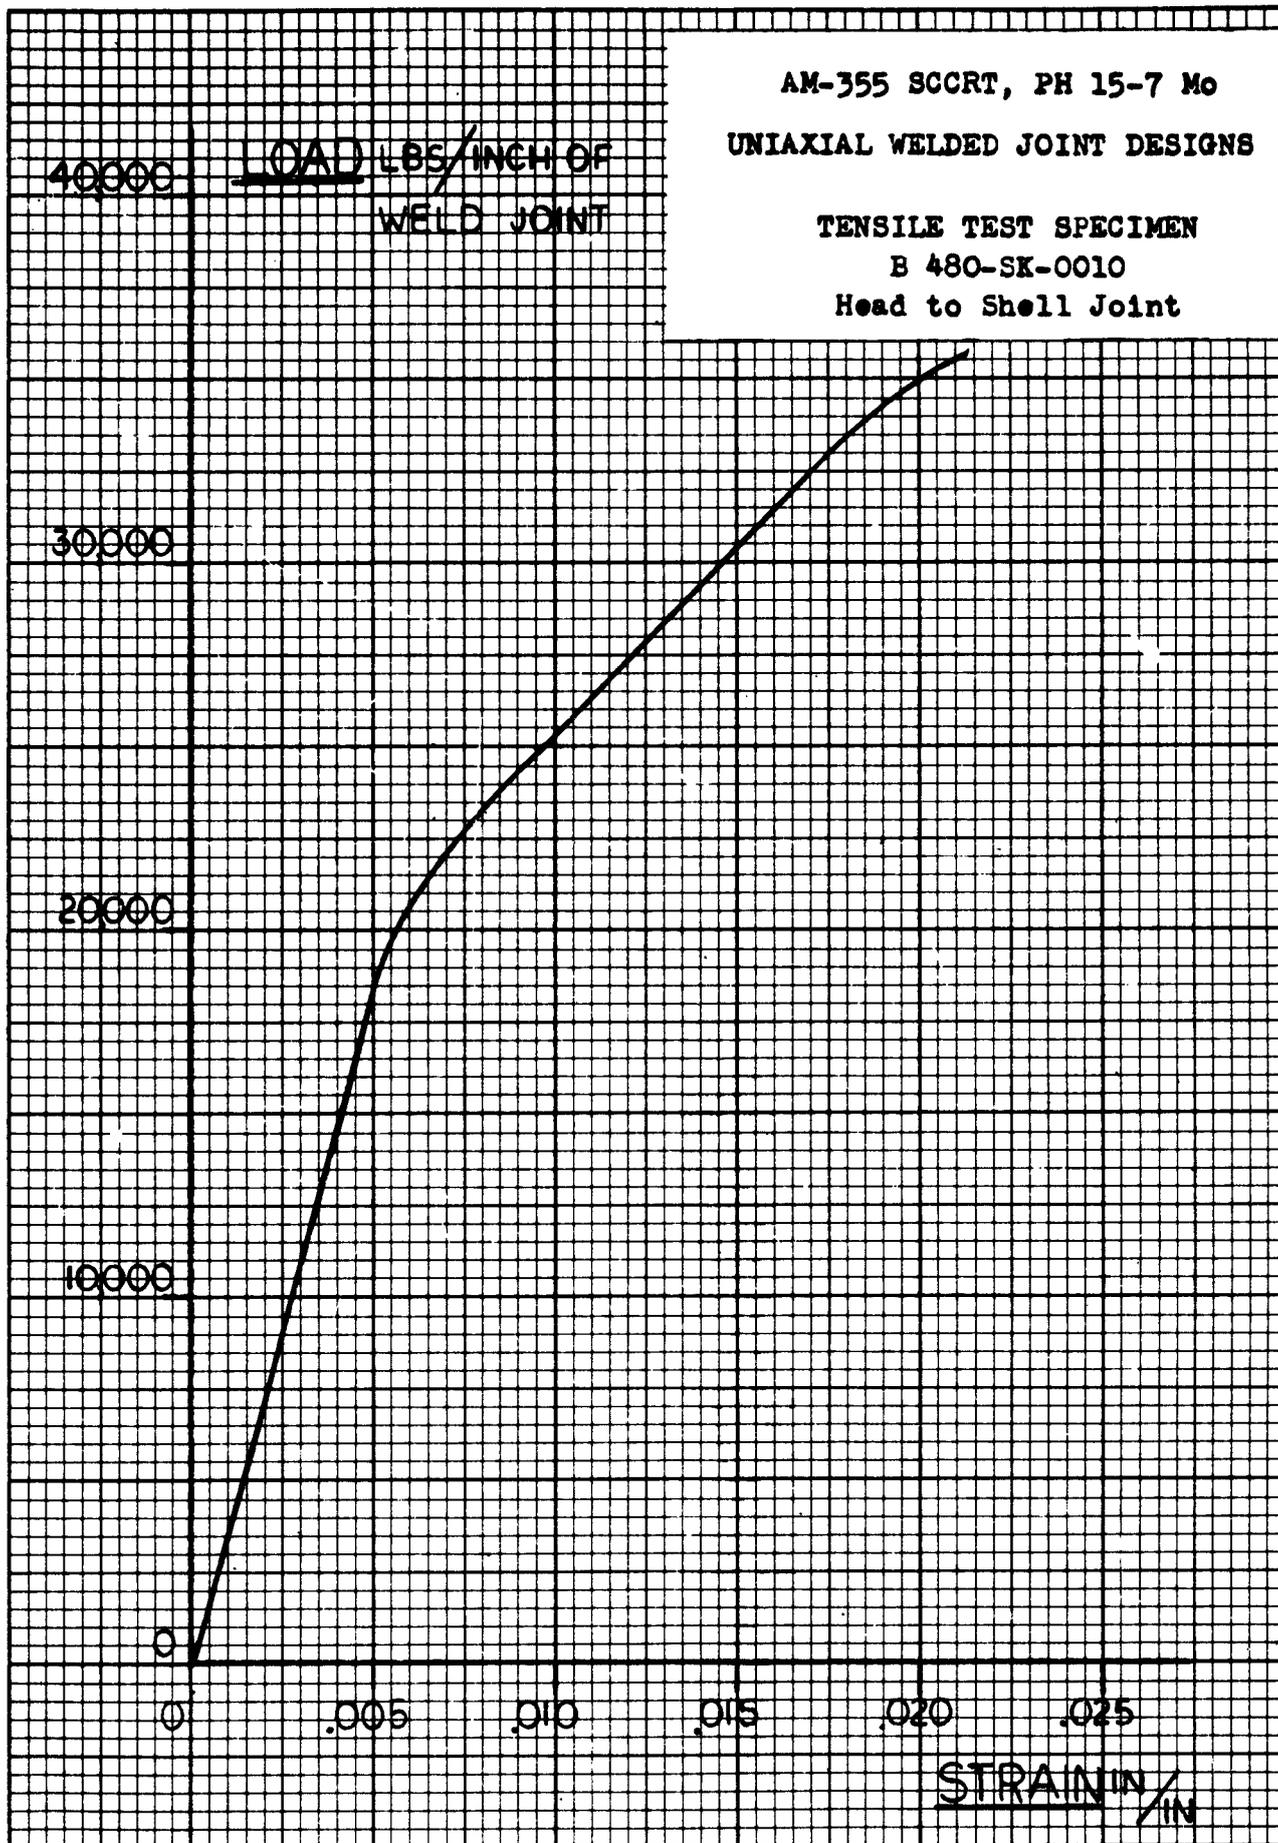
TENSILE TEST SPECIMEN
B 480-SK-0010
Head to Shell Joint

PREPARED BY: FOX, G.R.	THE BUDD COMPANY PRODUCT DEVELOPMENT PHILADELPHIA, PA.	PAGE NO. _____ OF _____
CHECKED BY:		REPORT NO. _____
DATE:	AM-355 SCORT, PH 15-7 NO UNIAXIAL WELDED JOINT DESIGNS	PROJECT NO. _____

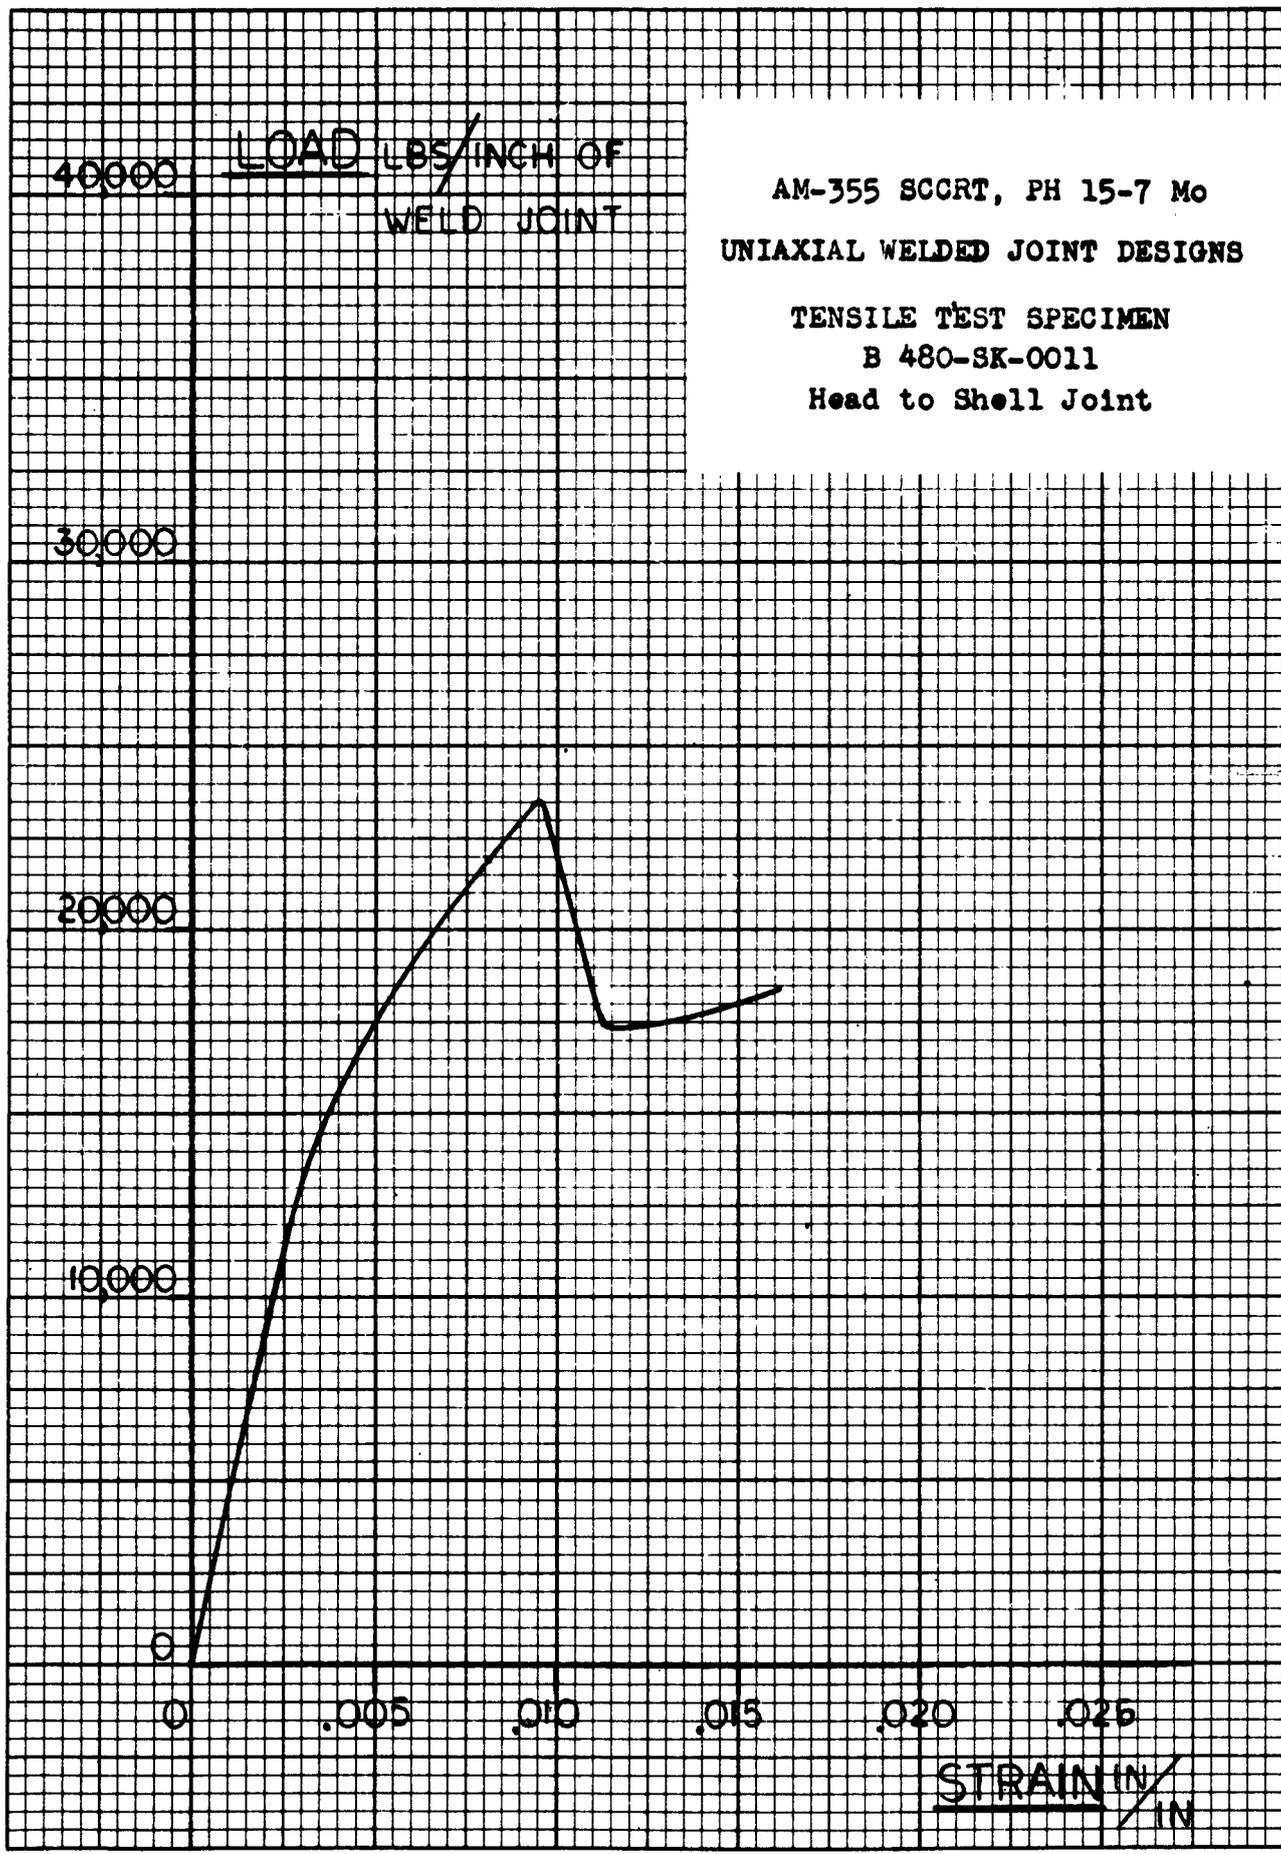
2. The initial fractures were at a load of 23,460 pounds per linear inch of fusion weld. After the initial fractures the load fell to 17,150 pounds per linear inch of fusion weld. Joint failure was at 18,430 pounds per linear inch of fusion weld. There was a small amount of straining (necking) in the fusion weld and a maximum recorded strain of 0.01625 inches/inch.
3. A graph of the Load in pounds per linear inch of fusion weld versus the Total Strain in inches per inch is shown on the following page.

AM-355 SCRT, PH 15-7 Mo
UNIAXIAL WELDED JOINT DESIGNS
TENSILE TEST SPECIMEN
B 480-SK-0011
Head to Shell Joint

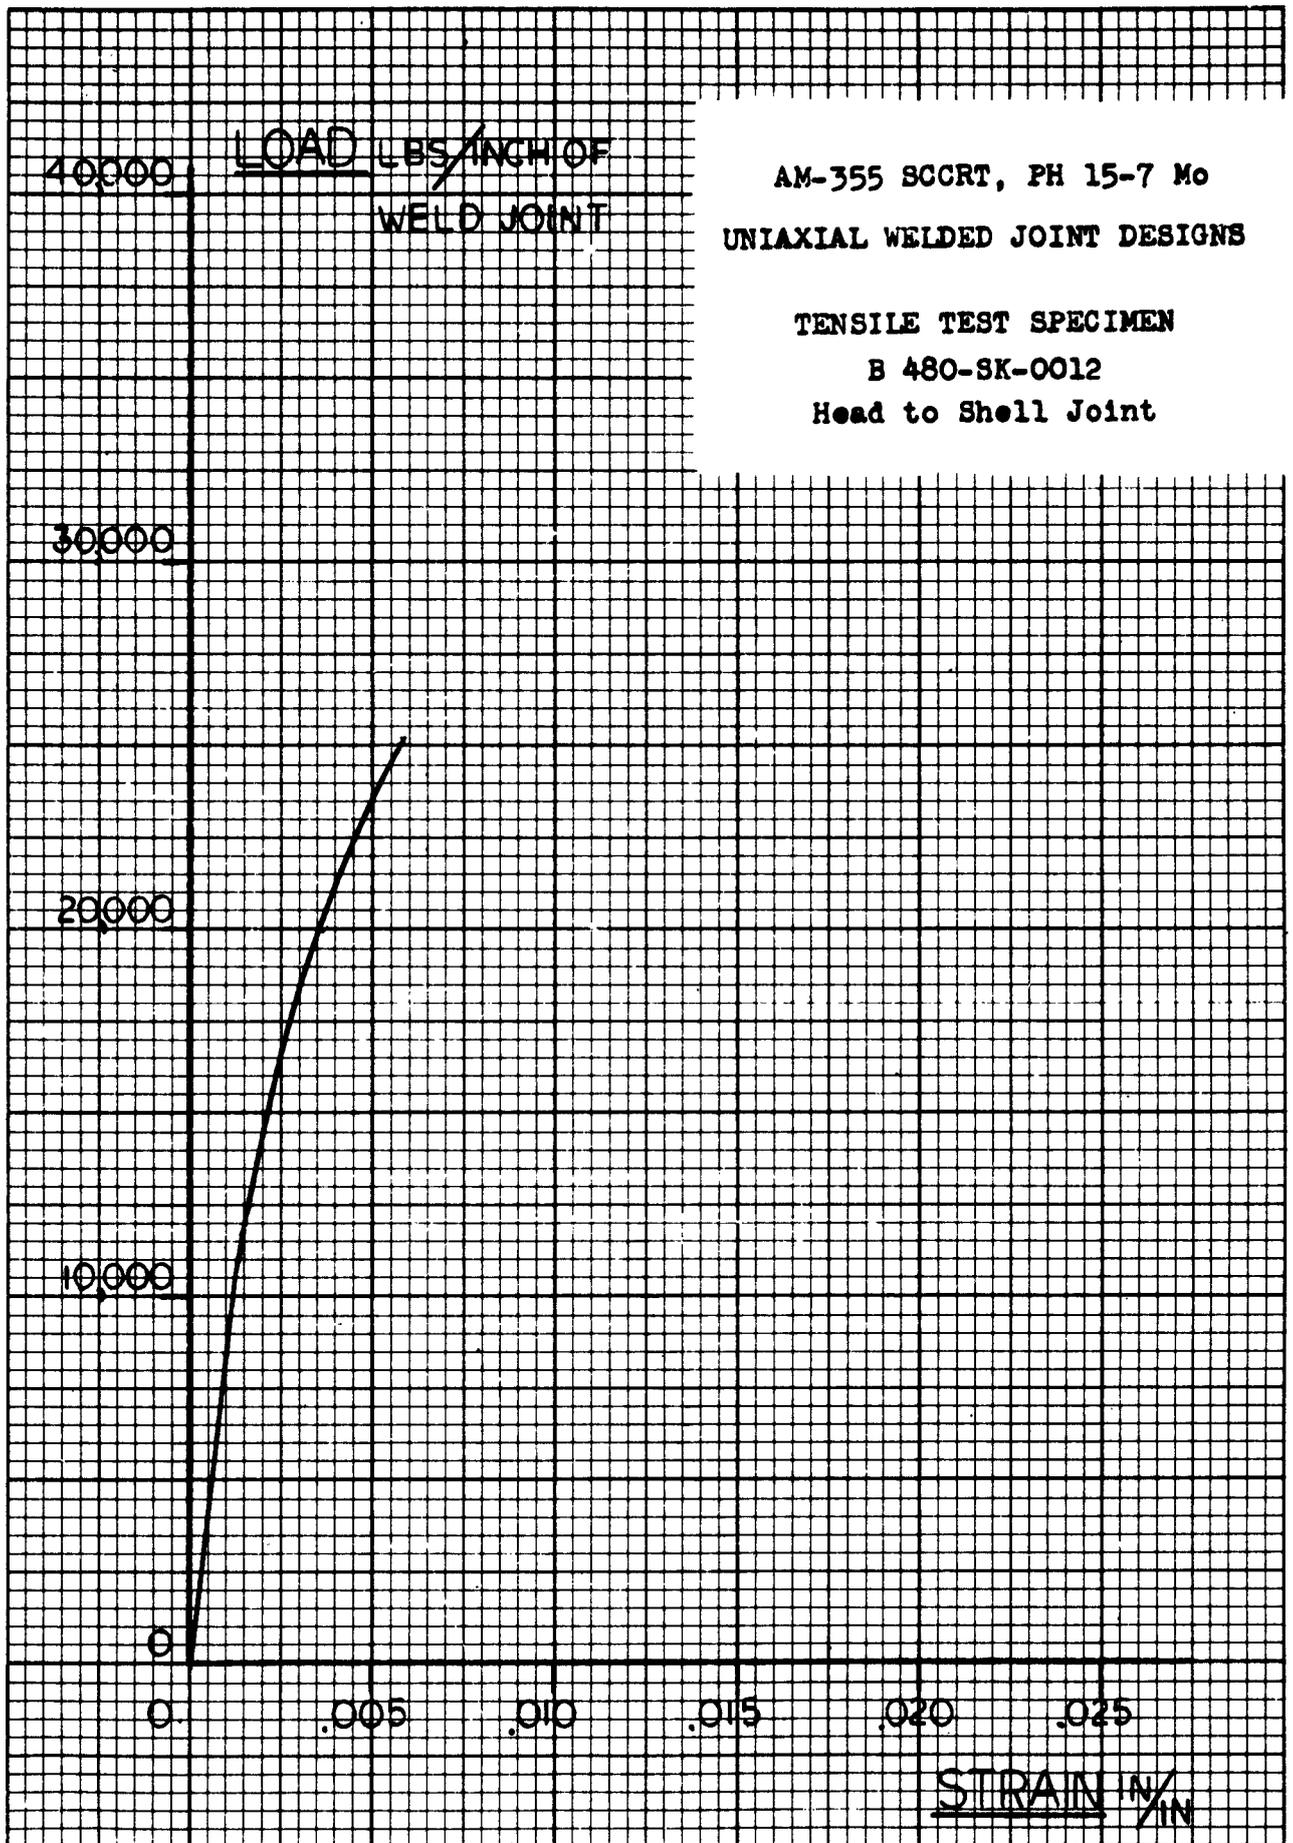
1. Initial failure occurred in the spot weld holding the doubler to the two thickness shell plate structure. This spot weld failed in shear.
2. There was a small amount of straining (necking) in the fusion weld. The most noticeable straining occurred in the shell plate assembly seam weld heat affected zone. This was the failure area.
3. The joint failed at a load of 25,180 pounds per linear inch of fusion weld with a maximum strain of 0.00563 inches per inch.
4. A graph of the Load in pounds per linear inch of fusion weld versus the Total Strain in inches per inch is shown on the following page.

PREPARED BY: FOX, C.R.	THE BUDD COMPANY PRODUCT DEVELOPMENT PHILADELPHIA, PA.	PAGE NO. _____ OF _____
CHECKED BY:		REPORT NO. _____
DATE:	AM-355, SCRT, PH 15-7 MO UNIAXIAL WELDED JOINT DESIGNS	PROJECT NO. _____

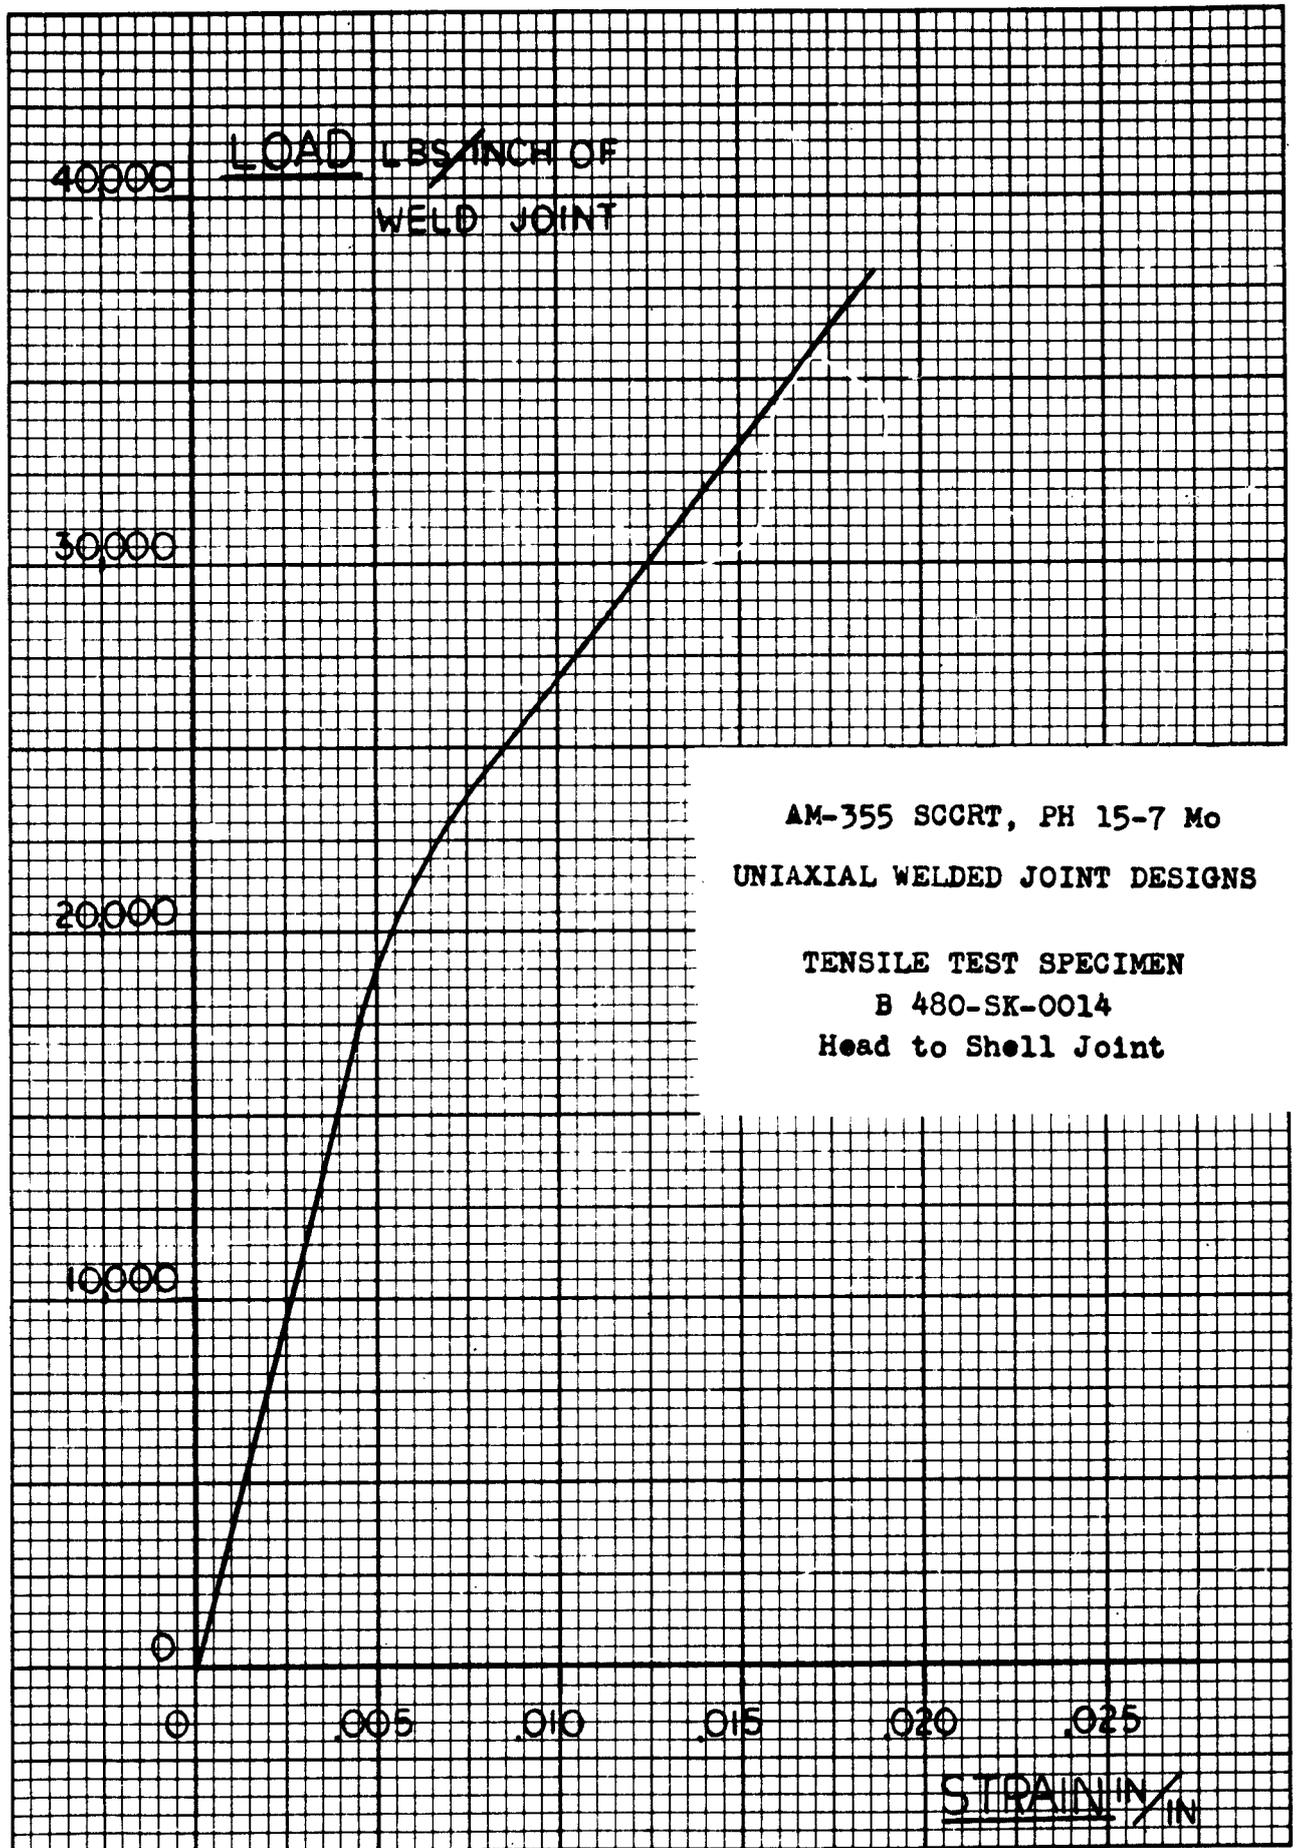
1. The joint failed in tension through the outer spot weld on the long doubler of the shell plate assembly.
2. Analysis of the failure indicated that this was the weakest point in the design and failure could be expected around 35,800 pounds per linear inch of fusion weld. The load at failure was 37,960 pounds per linear inch of fusion weld.
3. There was a very definite amount of straining (necking) in the fusion weld with a maximum recorded strain of 0.01875 inches per inch.
4. A graph of the Load in pounds per linear inch of fusion weld versus the Total Strain in inches per inch is shown on the following page.

PREPARED BY: FOX, C.R.	THE BUDD COMPANY PRODUCT DEVELOPMENT PHILADELPHIA, PA.	PAGE NO. 07
CHECKED BY:		REPORT NO.
DATE:	AM-355 SCRT. PH 15-7 NO UNIAXIAL	PROJECT NO.
	WELDED JOINT DESIGNS
