DC-TR: 5-61

PRODUCTION ENGINEERING
OF
METAL AND OTHER INERT PARTS
FOR
M30 ROCKET MOTOR
FOR
NIKE HERCULES MISSILE
(FINAL ENGINEERING REPORT)

AMMUNITION GROUP
PICATINNY ARSENAL, DOVER, NEW JERSEY

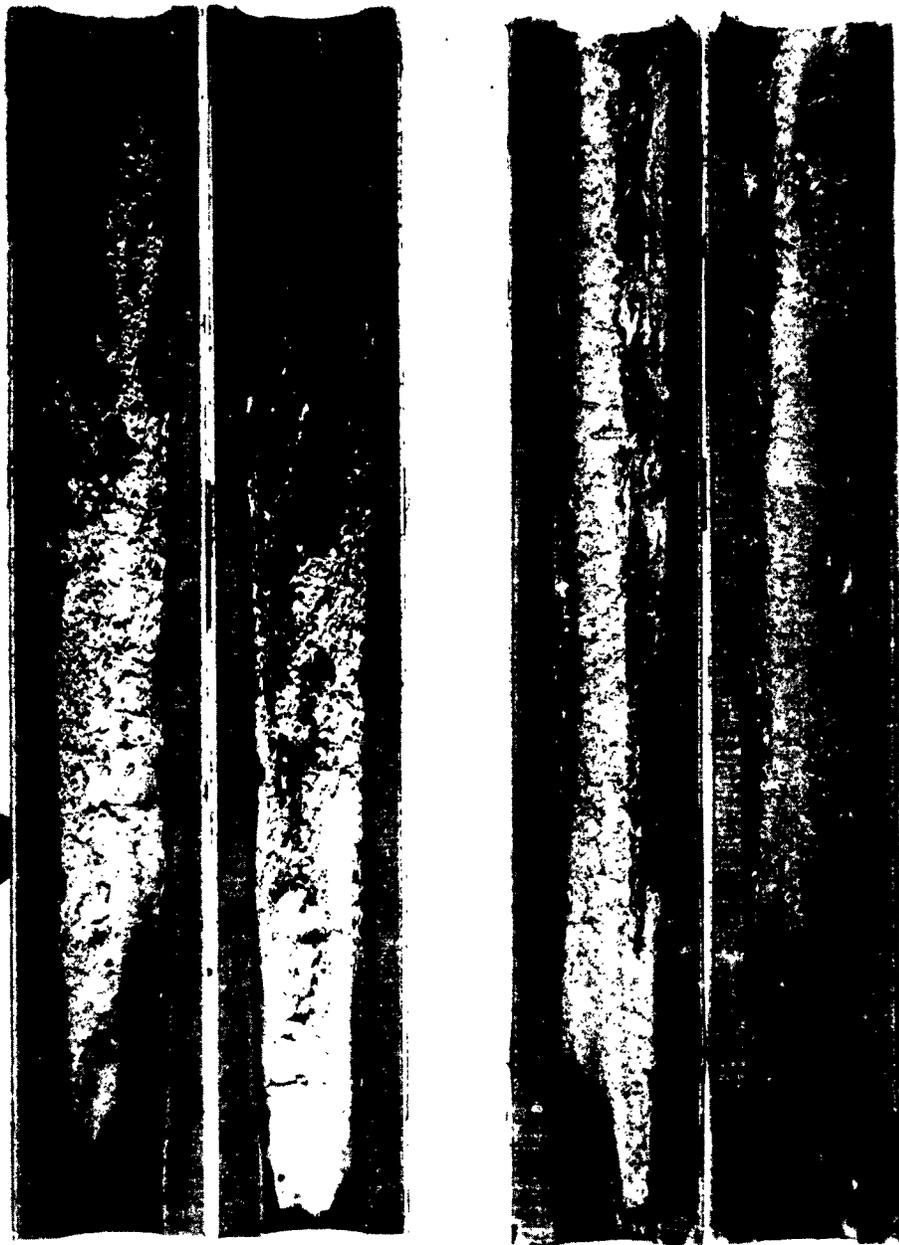
Figure 16. Raybestos - Manhattan 41 RPD

Raybestos-Manhattan 41-RPD - Both samples withstood test firing without failure. Patterns of erosion and char were symmetric.
