TECHNICAL INSPECTION REPORT

U.S.S. CARLISLE (APA 69)

TEST ABLE

OPERATION CROSSROADS

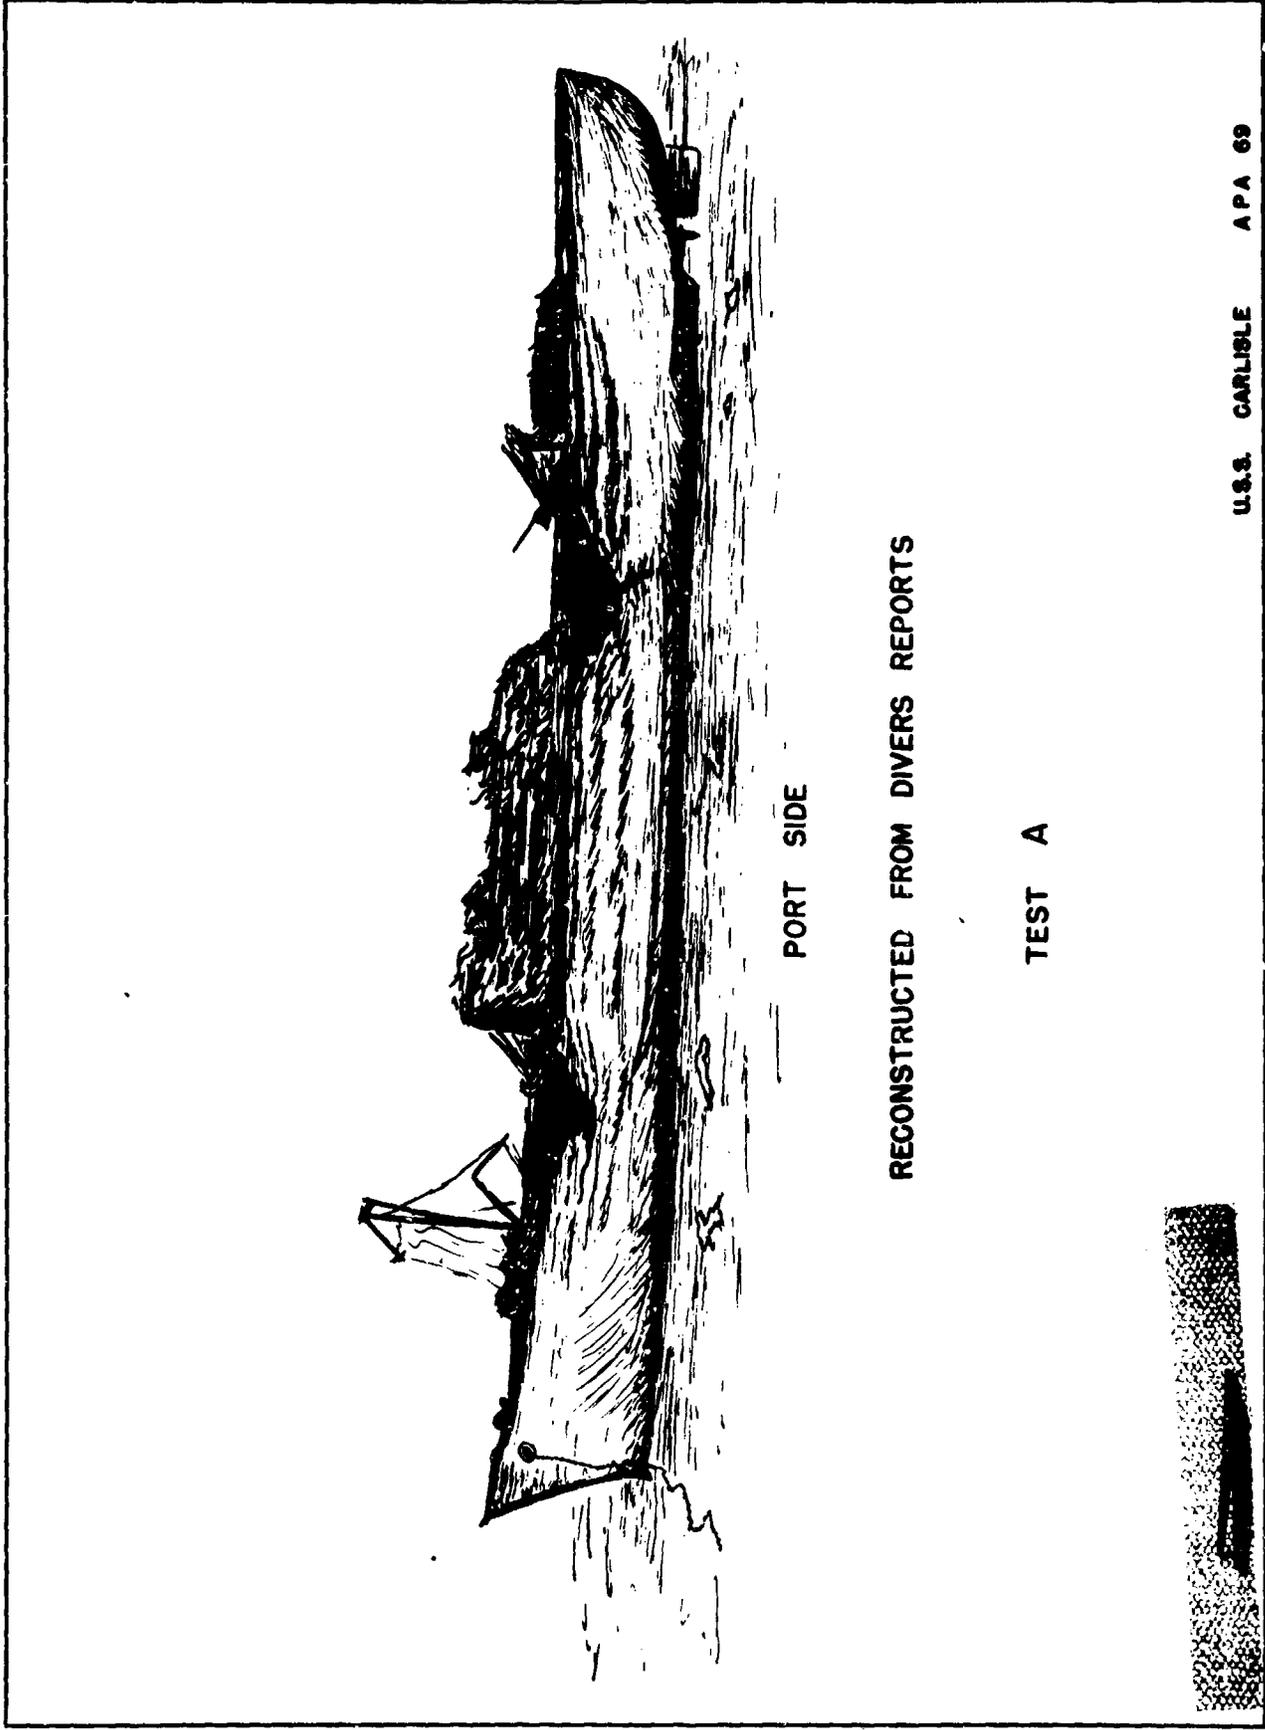
PORT SIDE

RECONSTRUCTED FROM DIVERS REPORTS

From the bcwto frame 20 port there is little evidence of damage. From frame 20 to 27, slight transverse buckles are apparent in the upper deck plating. From frame 27 to frame 60, the port side shell plating from a few feet above the turn of the bilge to the upper deck is blown into the ship. Below this hole, the shell

plating is dished between frames but is without visible rupture. At frame 30 above this hole, the upper deck has been ripped loose from the shell plating and doubled back on itself until the set of bits on the deck edge are overhead and upside down. The deck is pushed up several feet on the port side and is generally buckled to the centerline. Near the foremast, there is a tear in the upper deck which runs inboard 6 or 8 feet from the port deck edge.

A second and similar break in the port shell plating exists between frames 95 and 120. Between the two large breaks and aft to about frame 130, considerable horizontal buckling of the side is present but with no ruptures being noticed by the divers. From frame 130 aft there is no visible damage.

The CARLISLE was found in about 170 feet of water and with a small list of about 5 degrees to port. The underwater photographs (photo on Pages 14 thru 21) show none of the major structural damage reported by the divers. The sketch on Page 22 has been sketched from their reports.
