ARMY CONCEPT TEAM IN VIETNAM
APO San Francisco 96243

**ARMOR ORGANIZATION FOR
COUNTERINSURGENCY
OPERATIONS
IN VIETNAM (U)**

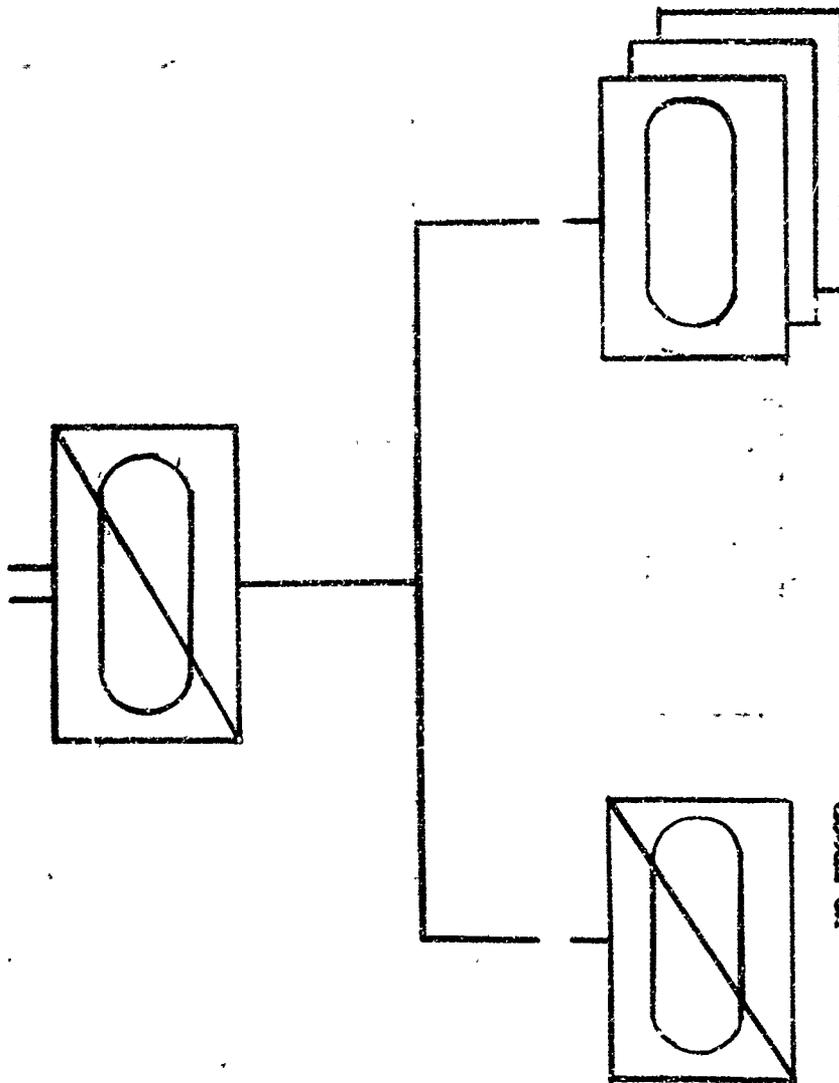
5TH ARMORED CAVALRY SQUADRON
HIGH COMMAND, RVNAF RESERVE

TANK TROOP
17 M24 TANKS

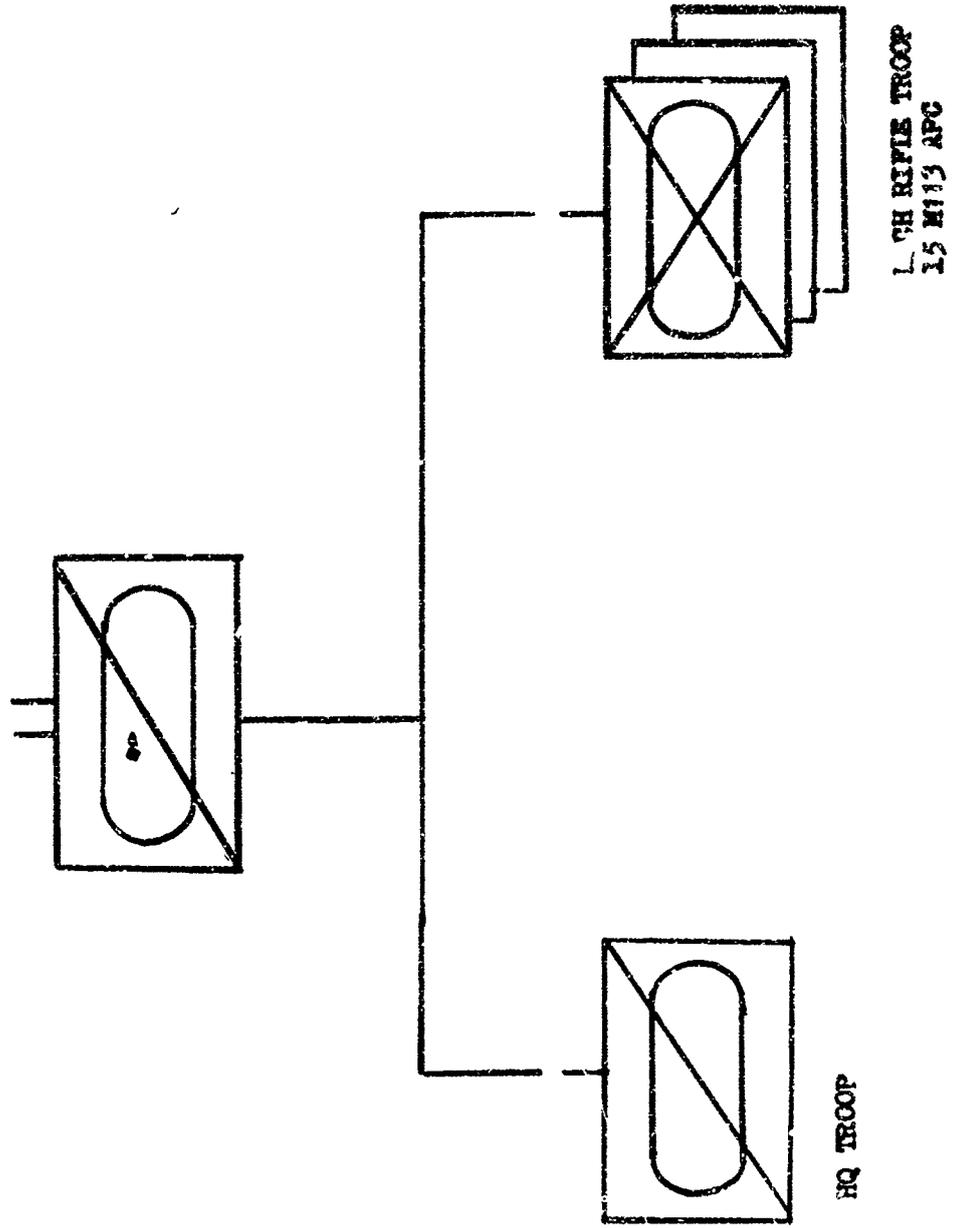
6TH ARMORED CAVALRY SQUADRON
HIGH COMMAND, RVNAF RESERVE

1st RIFLE TROOP
15 M113 APC

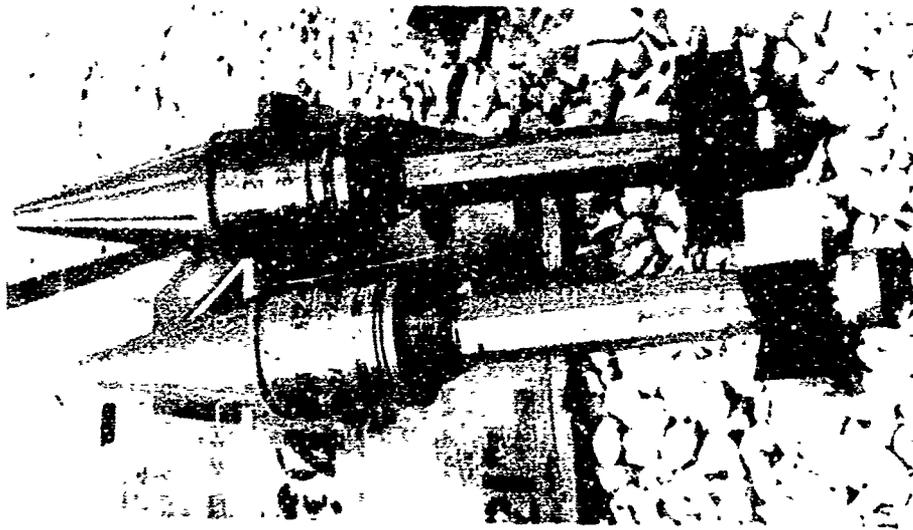
(U) FIGURE F-2. Communist anti-tank rockets.

Half of the rocket launcher is covered with insulation to protect the gunner's face and shoulder from heat.

Caliber	82mm
Weight	6 pounds
Muzzle velocity	276 fps
Rate of fire	4 to 6 rpm
Type of ammunition	HE, anti-tank ammunition
Weight of ammunition	3.3 pounds
Penetration	6 to 7 inches
Sight	Stationary front sight Rear sight made of sheet metal, folding type, and is installed with 3 sight holes 50, 100, and 150 meters range.
