AFRPL-TR-68-145

**DEVELOPMENT OF PYROLYTIC  
GRAPHITE COATINGS FOR  
ROCKET NOZZLES**

(U) A program was conducted to develop pyrolytic graphite (PG) coatings for advanced rocket nozzle service. The program included three phases: (1) coating development and improvement including firing tests, (2) a study of chemical corrosion of PG in different solid propellant environments, and (3) a study of the application of PG-coated nozzles to restart motor service.

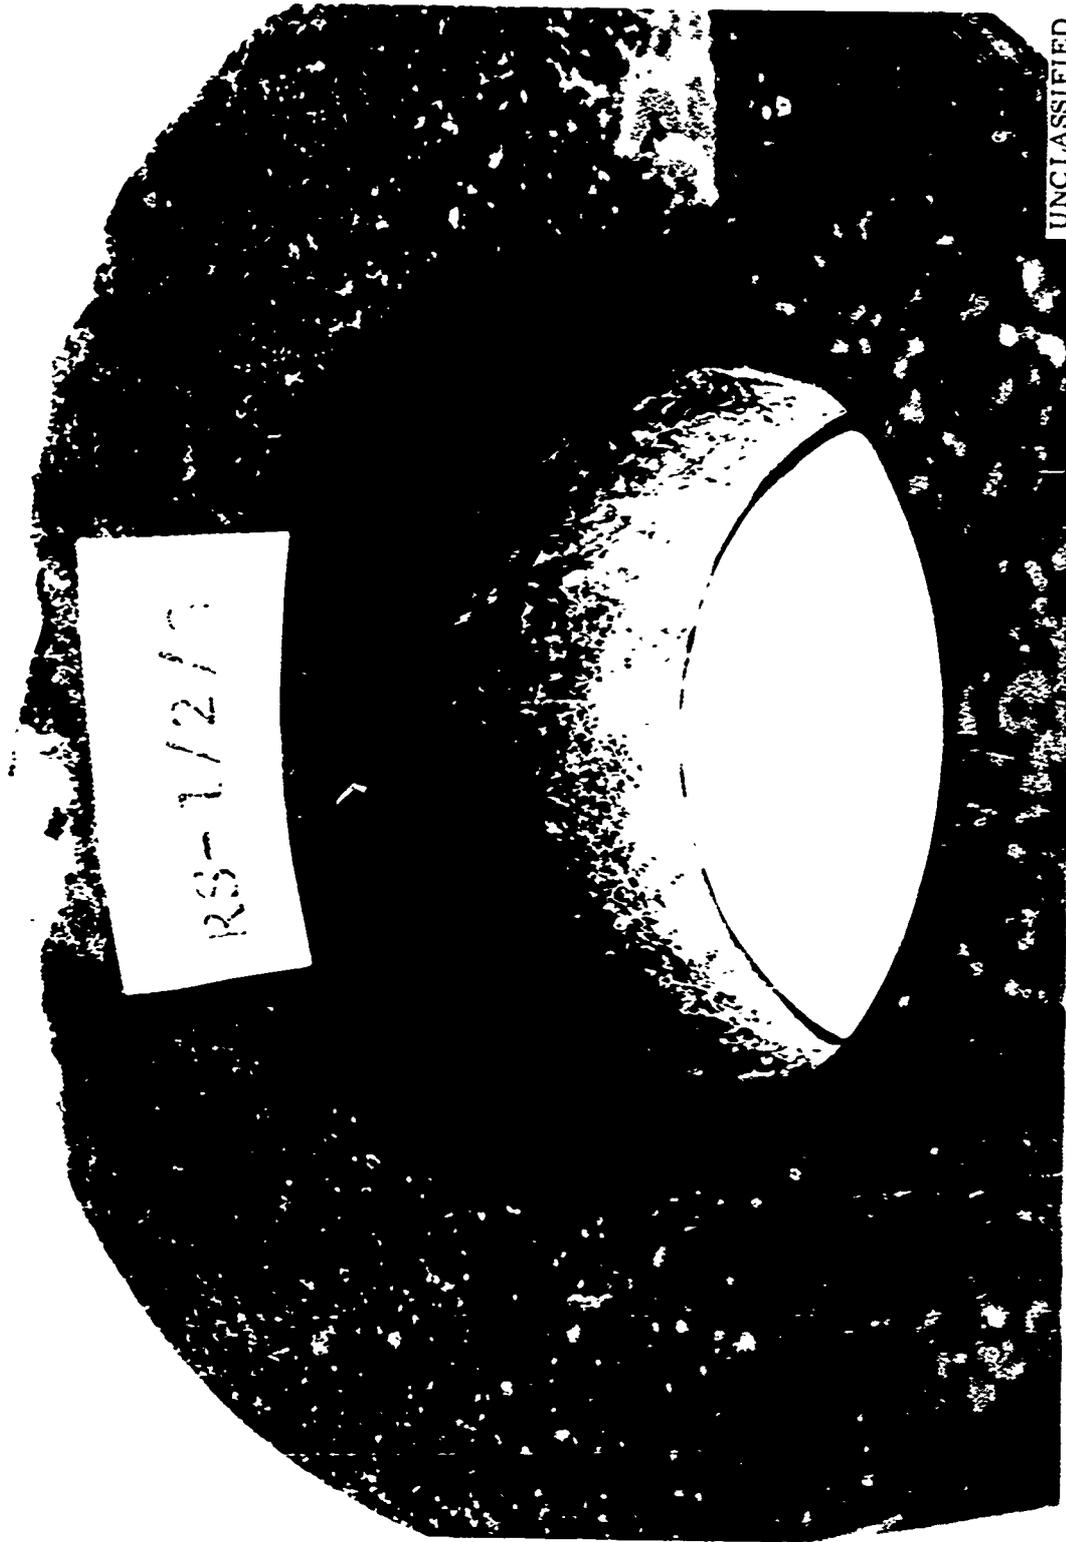
Figure 31. Post Firing View of Restart Test Insert after Firings RS-1, 19515  
RS-2 and RS-3 with APG 112 (6550°F) Propellant and  
Cumulative Duration of 57 Seconds.
