**DIAMOND POWER SPECIALTY CORPORATION
DIAMOND MODEL DP-3000 DURA-PORT GAGE**

**Evaluation Report
NBTL Project No. B-518
Subtask 4181
SF013-06-16
12 March 1963
by
J. ISINGER**

**NAVAL BOILER AND TURBINE LABORATORY
PHILADELPHIA NAVAL SHIPYARD
PHILADELPHIA 12, PENNA.**

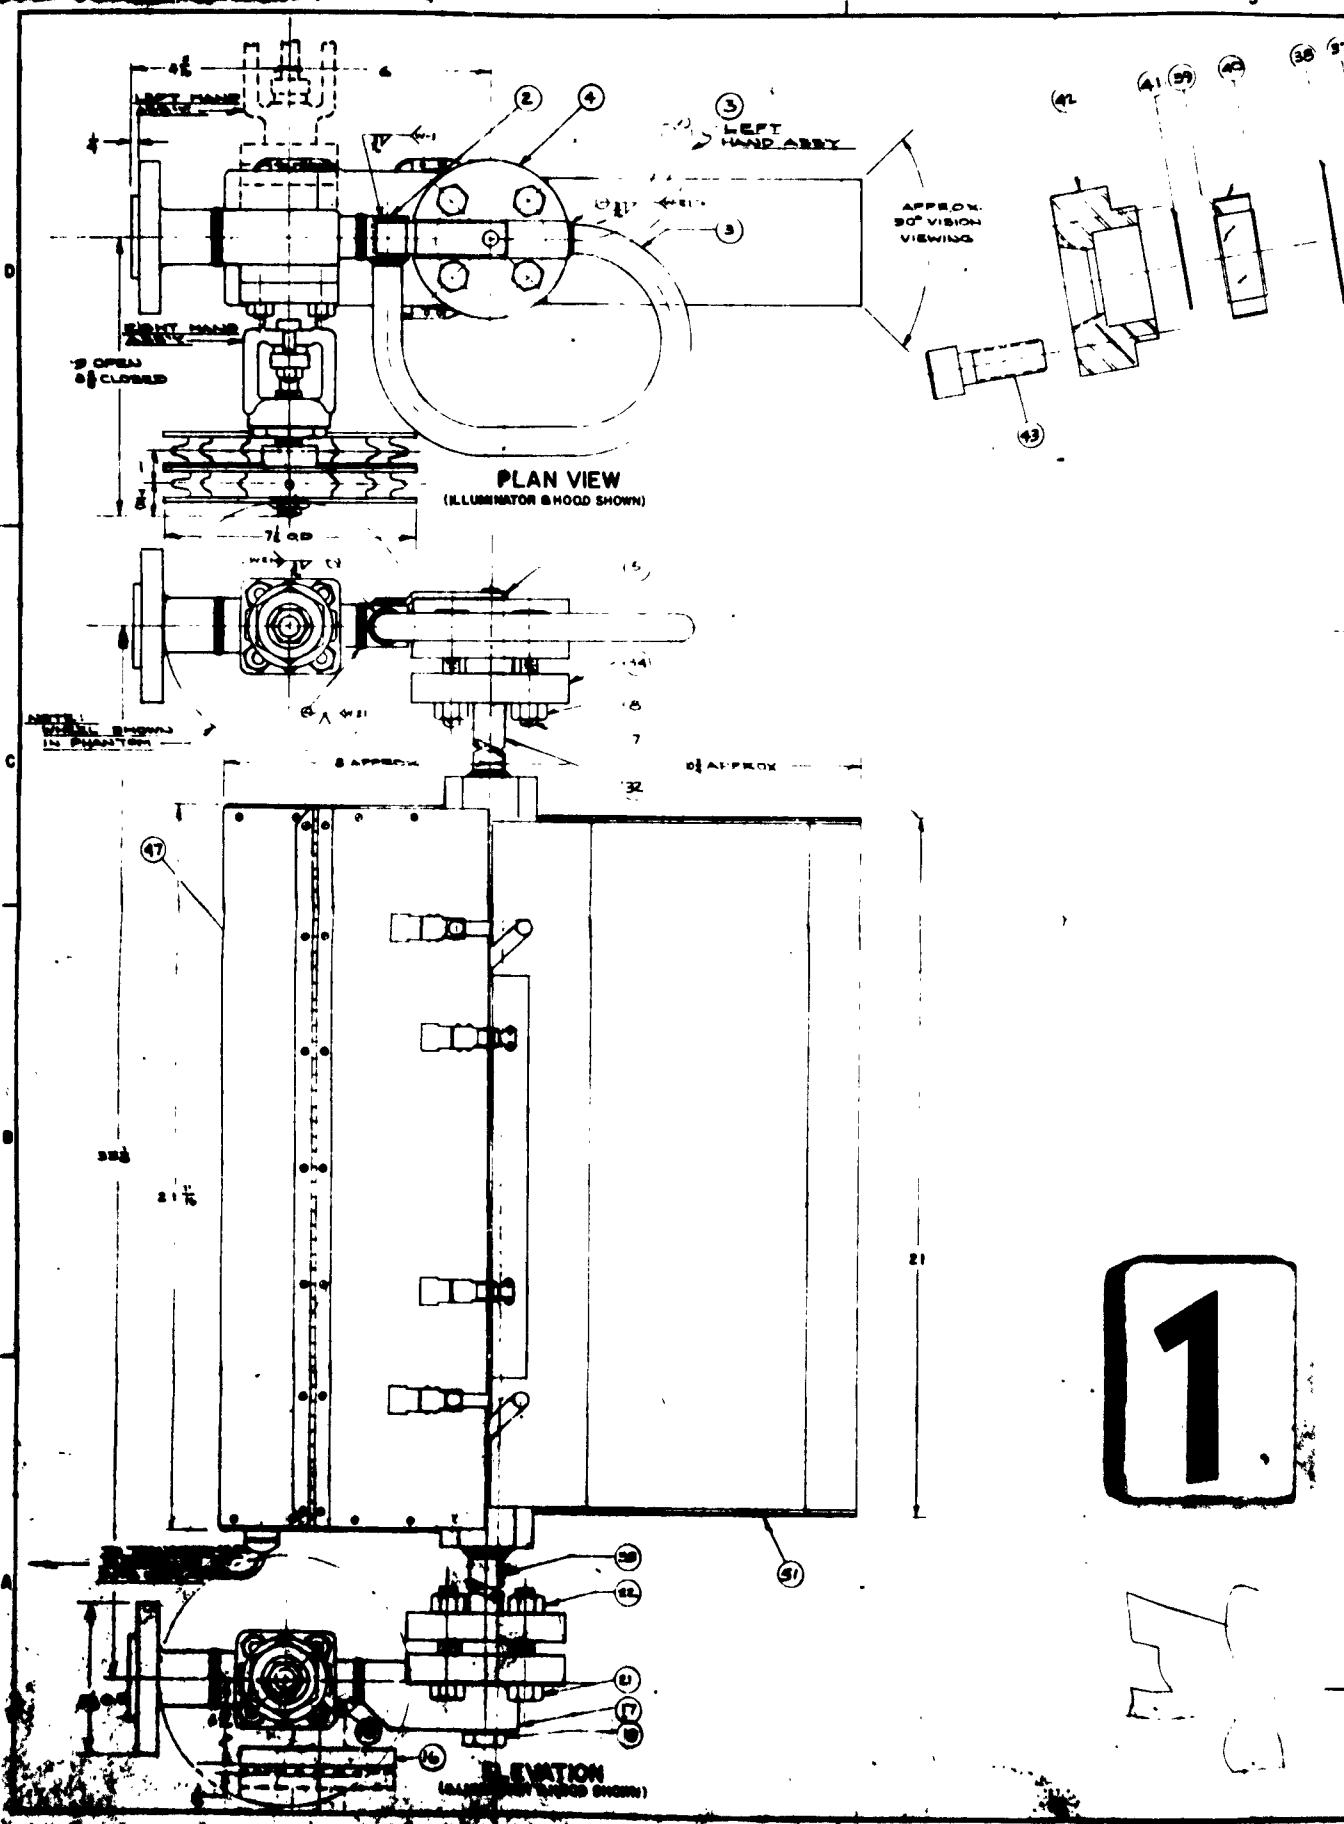
(Dura-Port) BI-Color Navy Type Water Gage Assembly Dwg. No. 103656-1056	1
Illuminator and Wide Angle Hood Assembly Dwg. No. 103657-1154	2
Photograph-Main Body of Gage	3
Photograph-Gage with Viewing Hood and Illuminator Attached	4

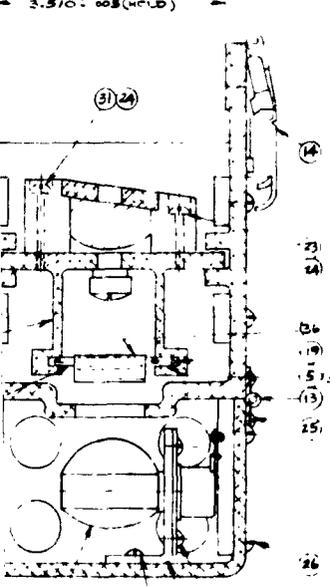
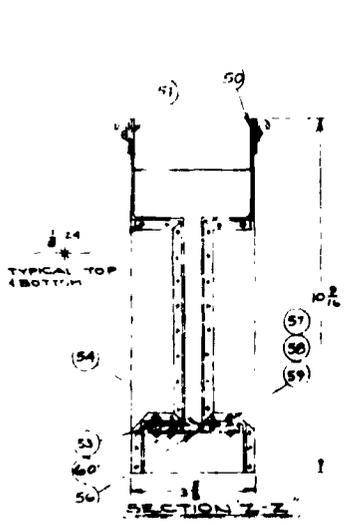
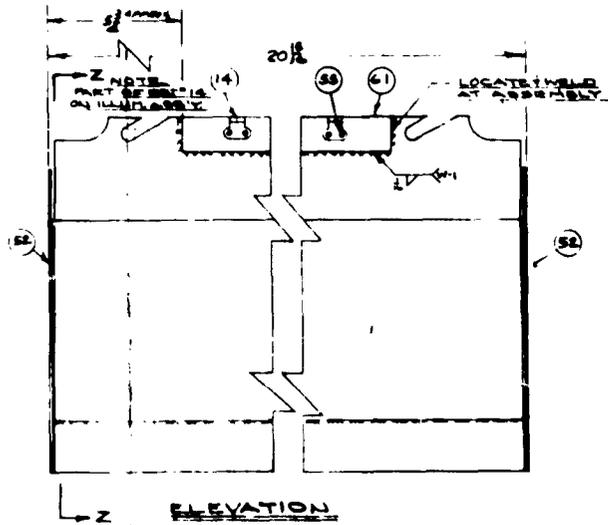
DRAWN BY CHECKED BY DATE 6-2-51	MASTER DRAWING ILLUMINATOR WIDE ANGLE HOOD ASBY. FOR DP-5000 (SURA-PORT) SC. NAVY TYPE GAUGE.	DWS. NO. 103486-1087 NAVY DEPT. ENGINEERING
PLATE 2

(5) HOOD ASBY. 103486-1087

SECTION X-X

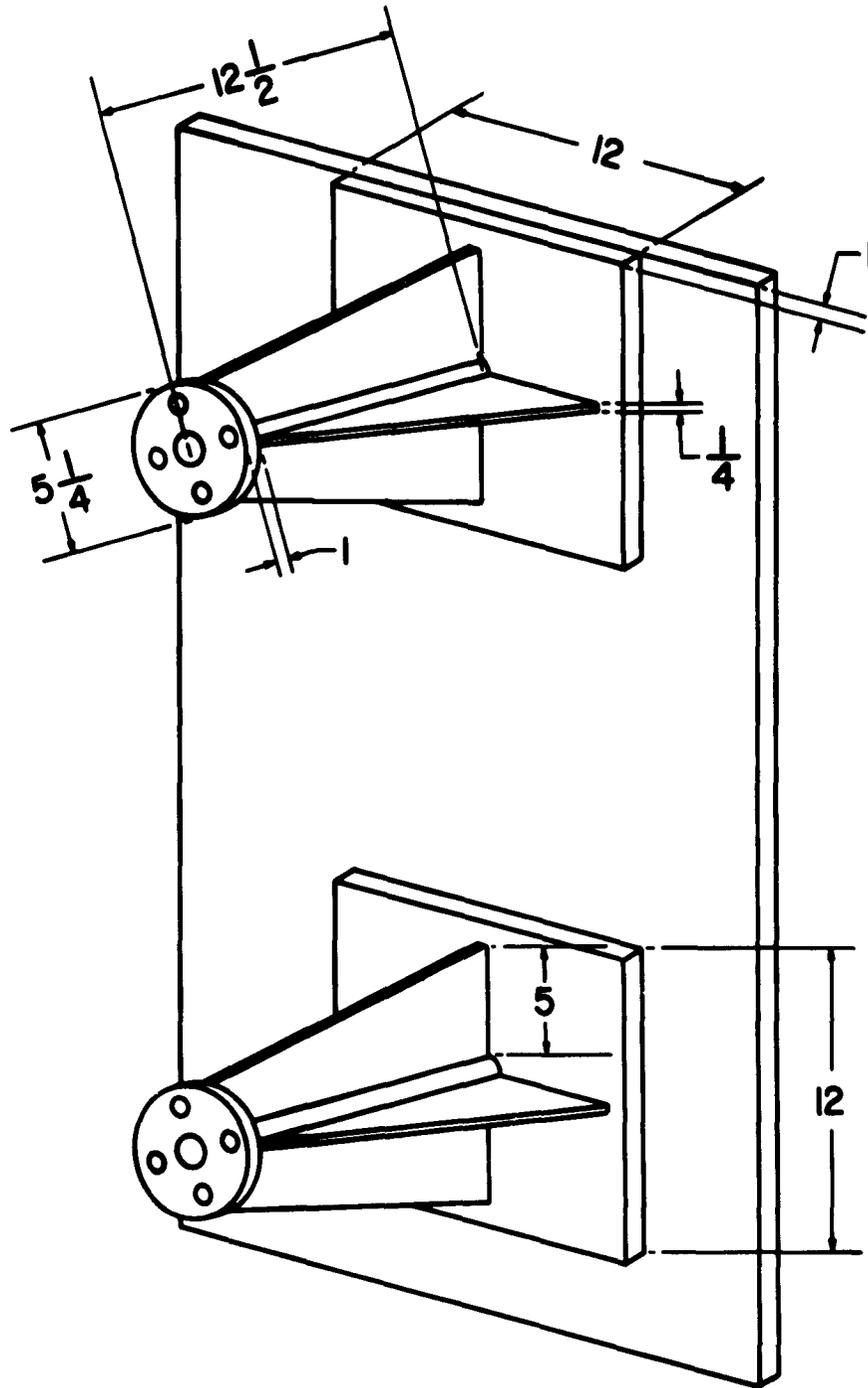
Figure 3

BOILER GAUGE NOZZLE REINFORCEMENT
