RESULTS OF THE PHASE I LONG-TERM  
ENVIRONMENTAL STORAGE TEST PROGRAM  
FOR THE RJ43-MA-11 RAMJET ENGINE  
OCTOBER 1960 THROUGH MARCH 1963

Contract AF 33(657)-7770  
Project 273  
Model RJ43-MA-11

**Marquardt**  
CORPORATION OGDEN DIVISION

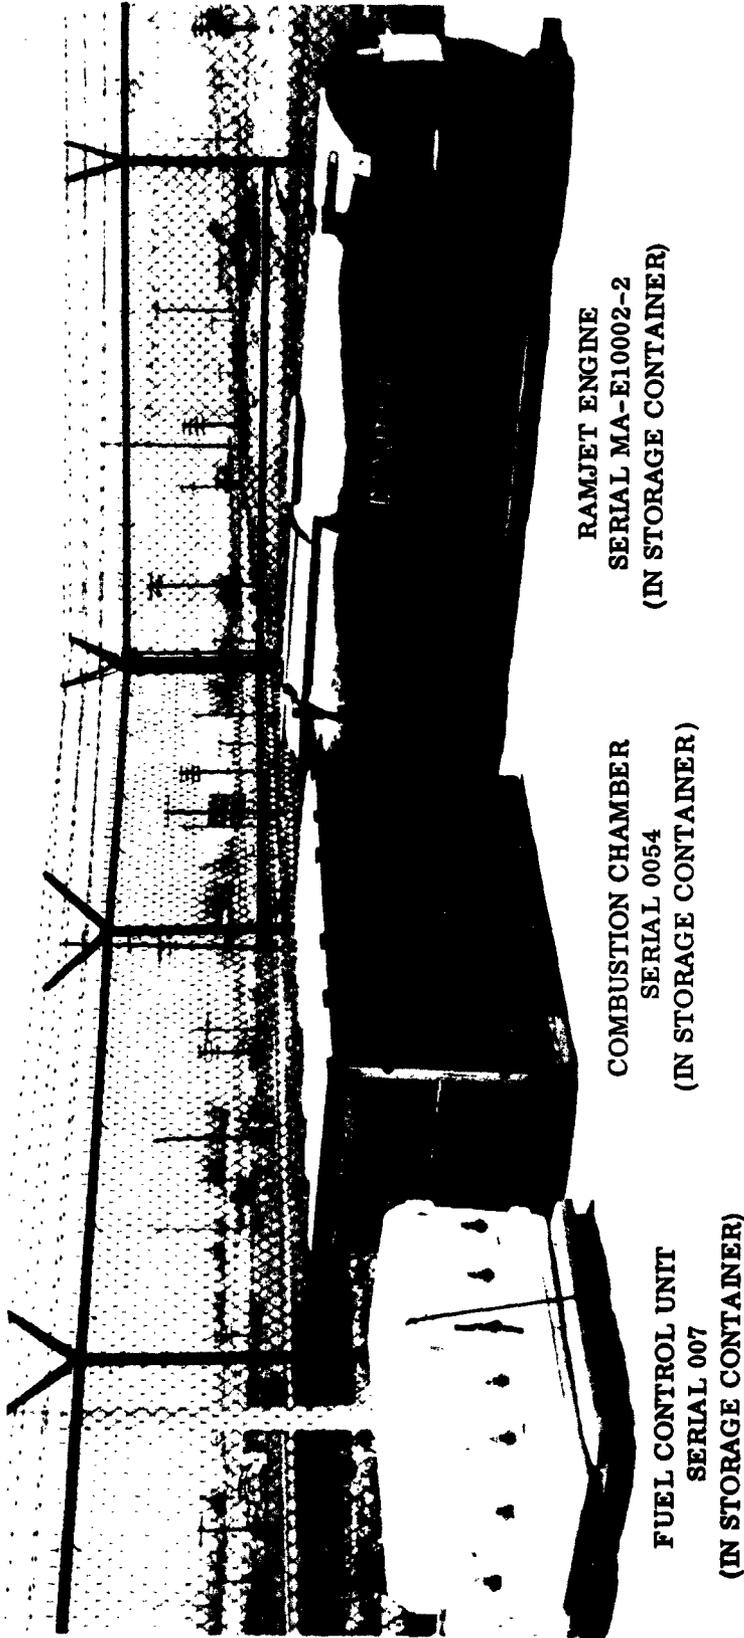
1.14.3-22

**FIGURE 3 - Storage Area Site, From November 1962 to January 1963, For the RJ43-MA-11 Phase I Long Term Storage Test. Area is Located at The Marquardt Corporation Main Plant in Ogden, Utah.**

The engine, combustion chamber assembly, and fuel control unit were stored in their respective storage containers in an outdoor, unprotected locale for a period of two years. The storage area, illustrated by Figure 2, was located at AF-MJL-O from January 1961 to November 1962. In November 1962 the deactivation of AF-MJL-O forced the movement of the test specimens to a new locale at the TMC-Ogden main plant, as illustrated by Figure 3. The test hardware remained at this location until the storage period ended in January 1963.

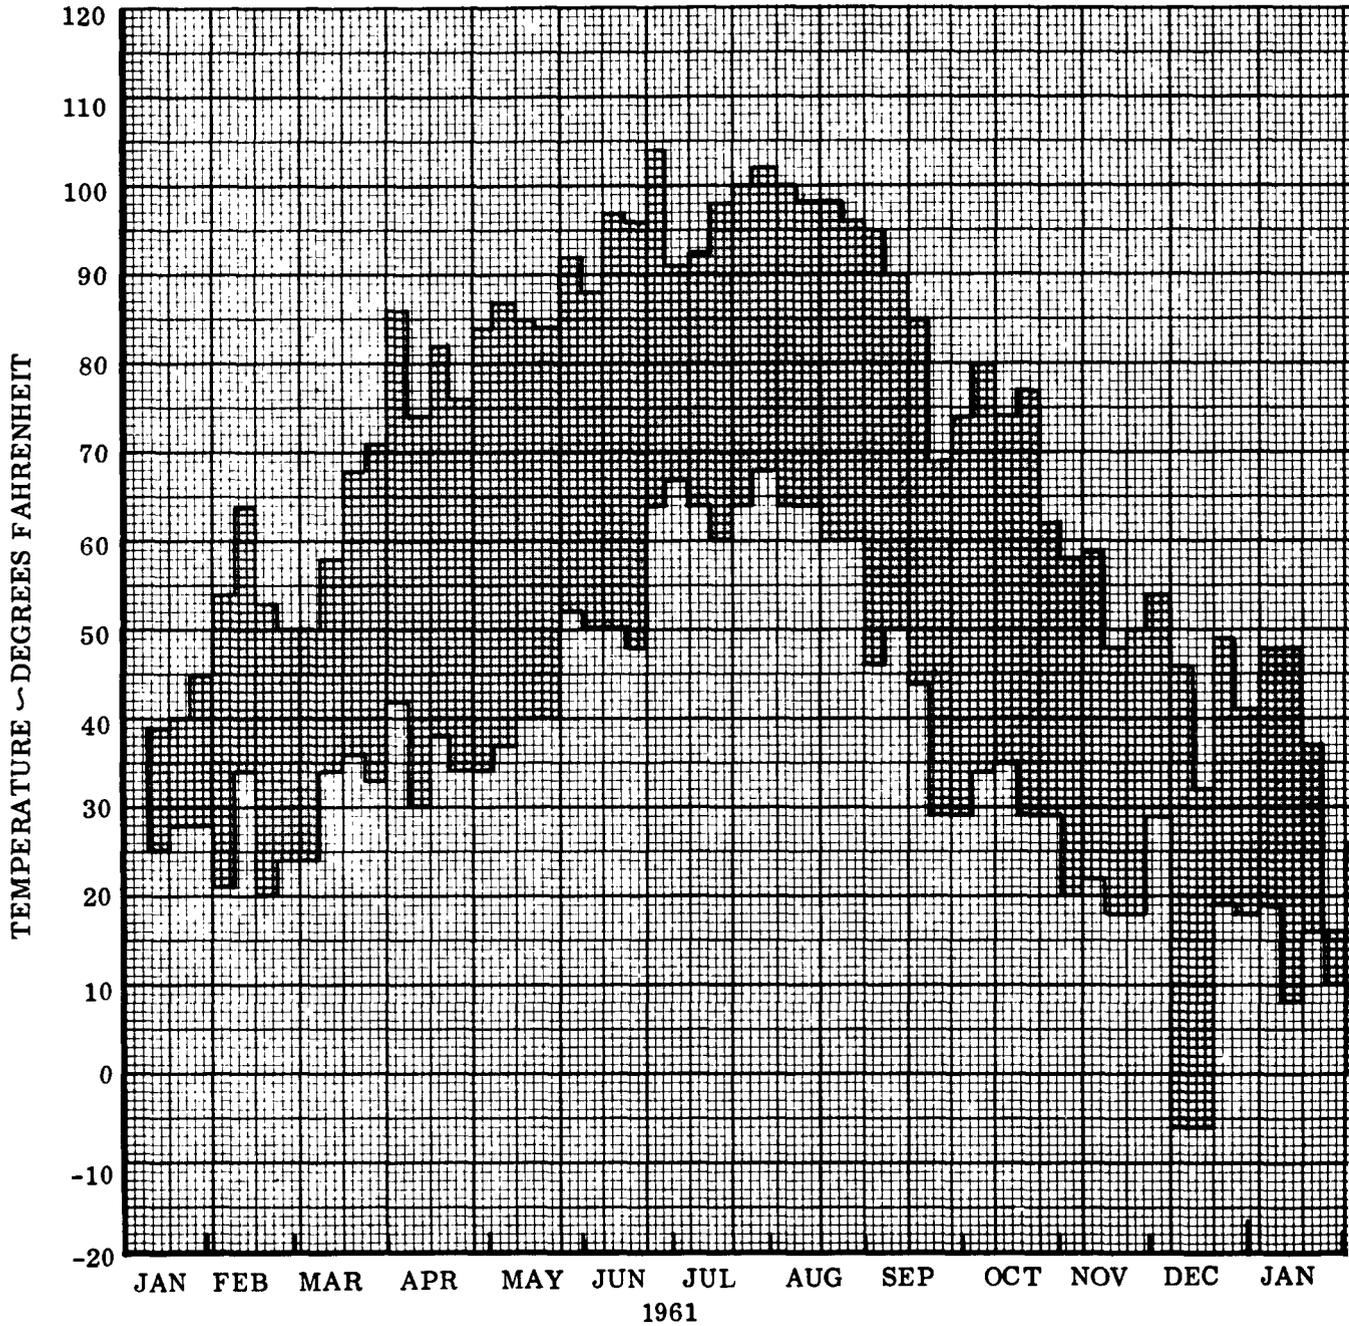
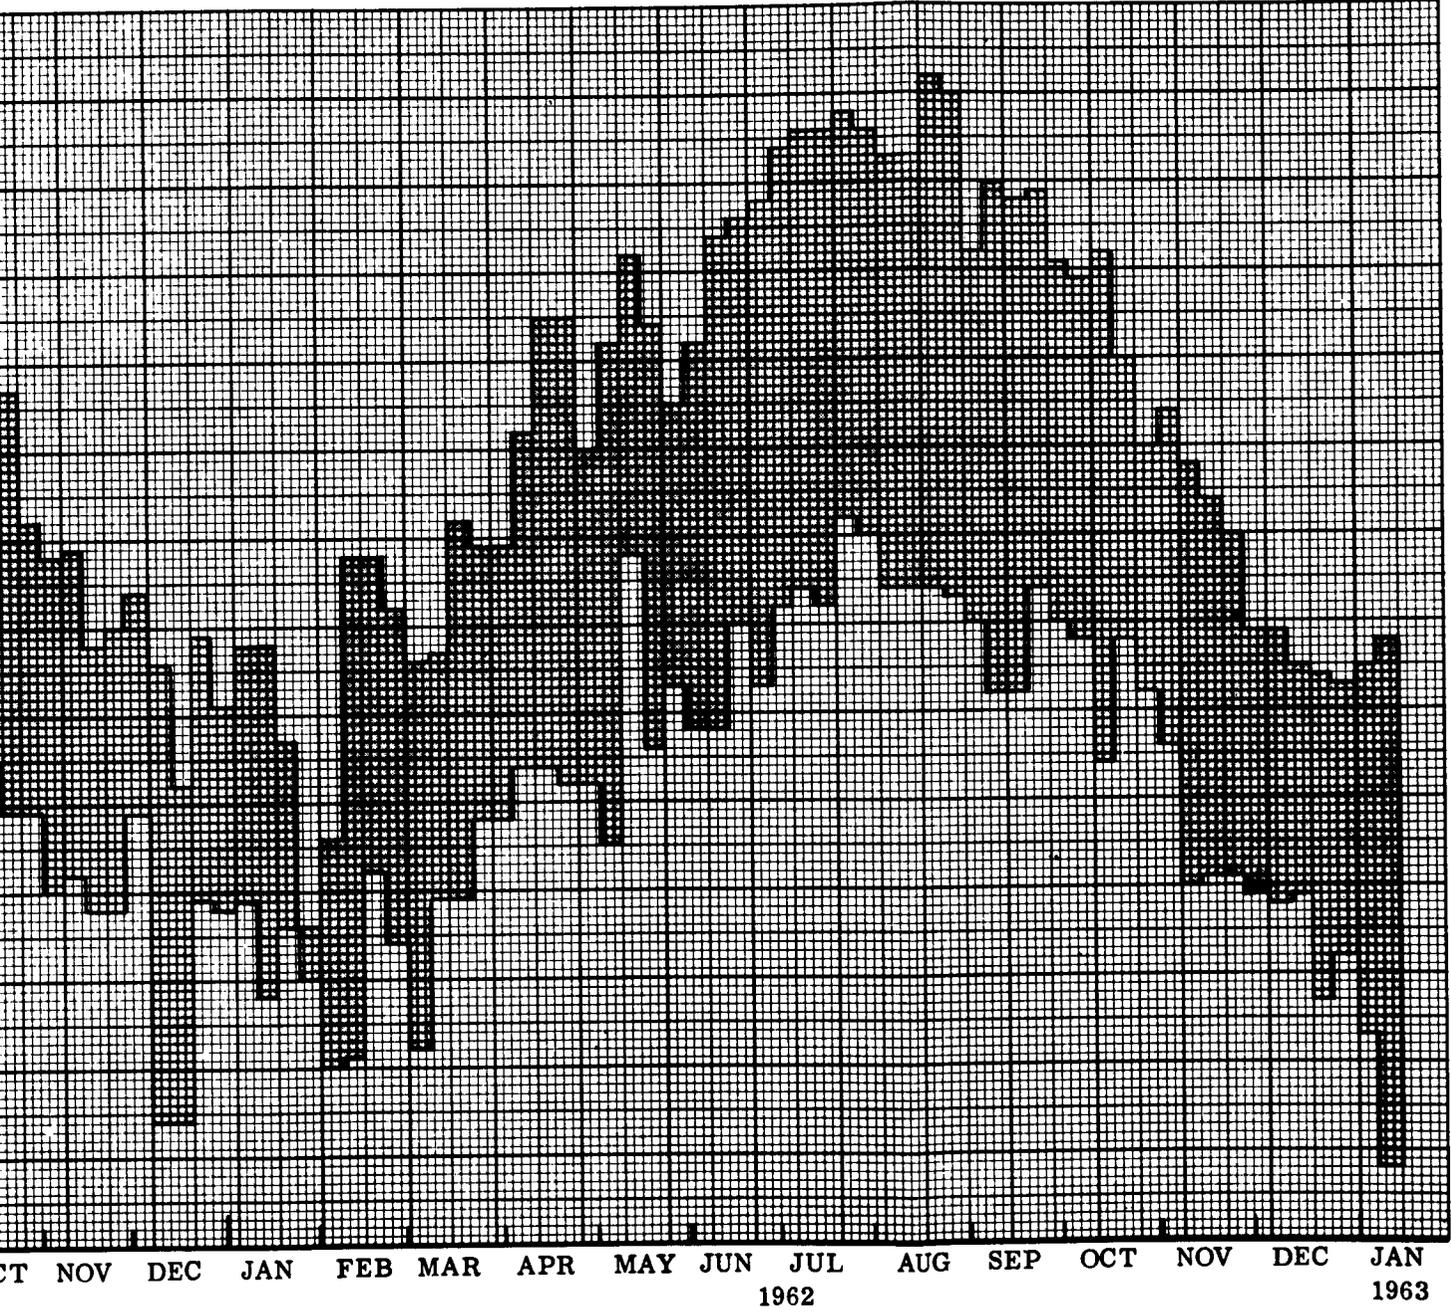
FIGURE 4 - Weekly High and Low Temperatures Recorded in the Outdoor S Long-Term Storage Test.

ARM STORAGE TEST PERIOD ~ WEEKS  
Recorded in the Outdoor Storage Area During the RJ43-MA-11 Phase I

The storage containers were exposed to widely varying weather conditions during the two-year storage period including ice, snow, rain, dust, salt spray, wind, and sunshine. The outside temperature extremes experienced during the two-year storage period were -12°F and +112°F. Figure 4 presents the weekly high and low temperature readings recorded during the storage period.

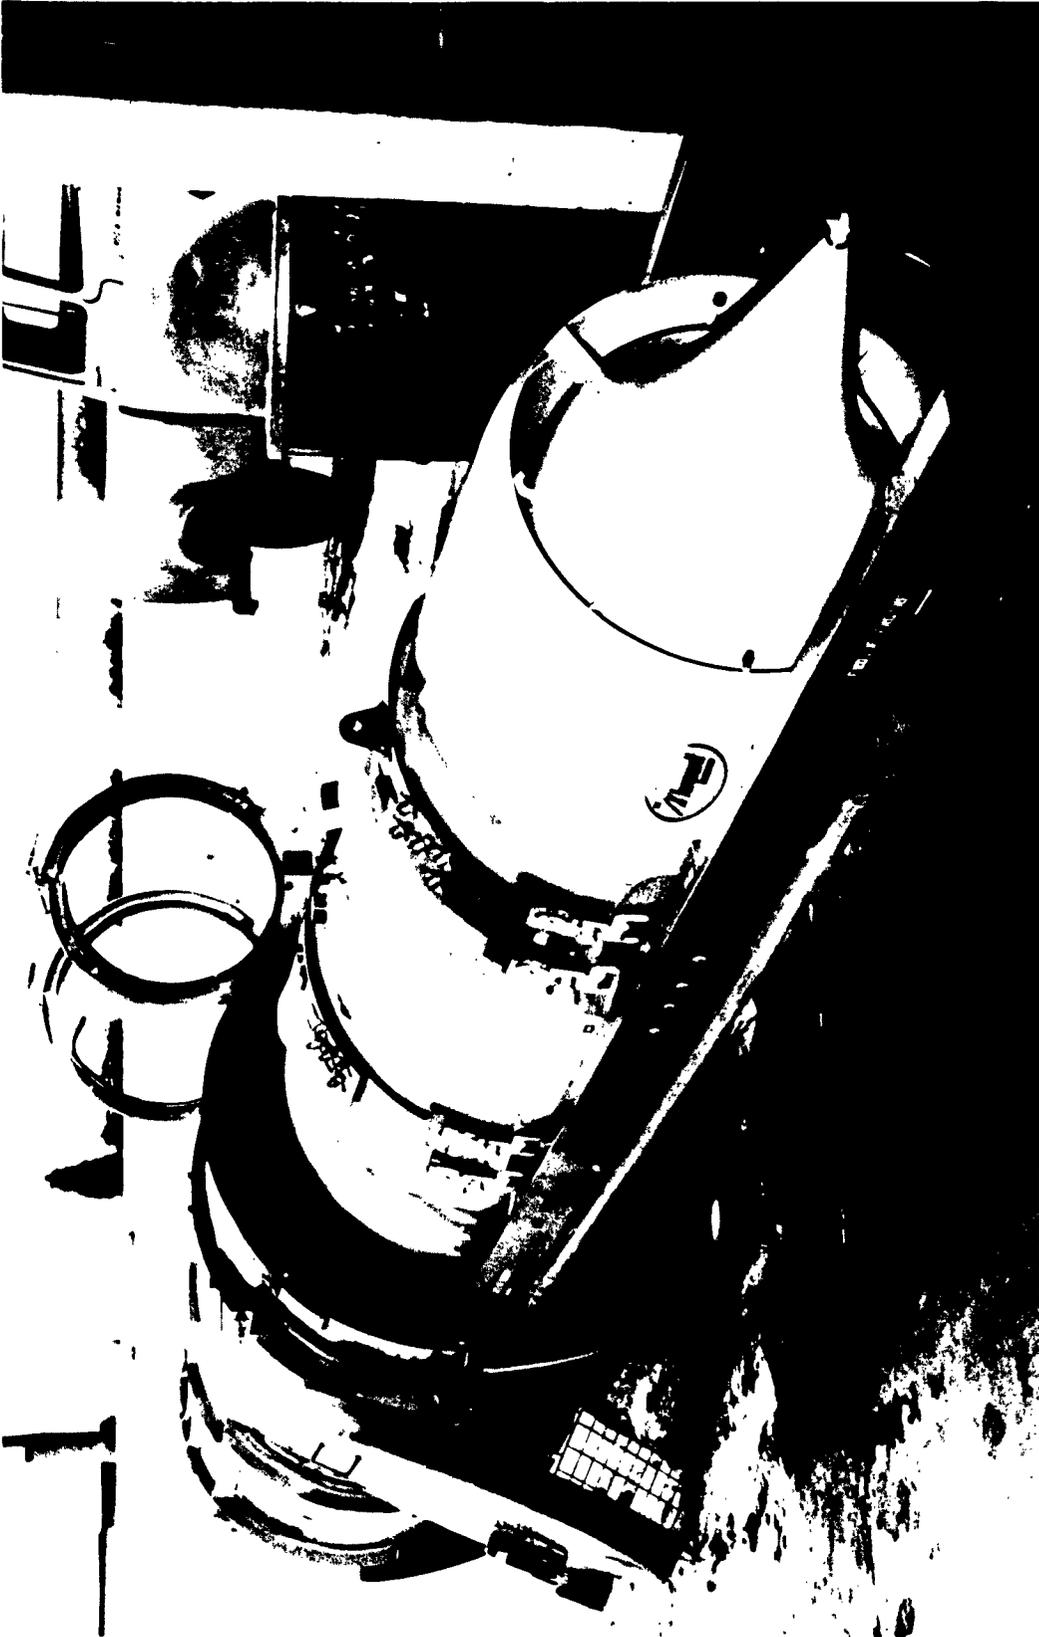
1.14.3-24

FIGURE 5 - RJ43-MA-11 Ramjet Engine Serial MA-E10002-2 Being Removed From its Storage Container at the Conclusion of the RJ43-MA-11 Phase I Long Term Storage Test.

On 15 January 1963 the containers were opened in the presence of the local Air Force Quality Control representative. The fuel control unit storage container, which automatically adjusts the pressure level within the container, was found to be slightly pressurized when opened. A superficial inspection of the test specimens was conducted and all specimens appeared to be in excellent condition. Figures 5 through 7 show the test items at the time the containers were opened.

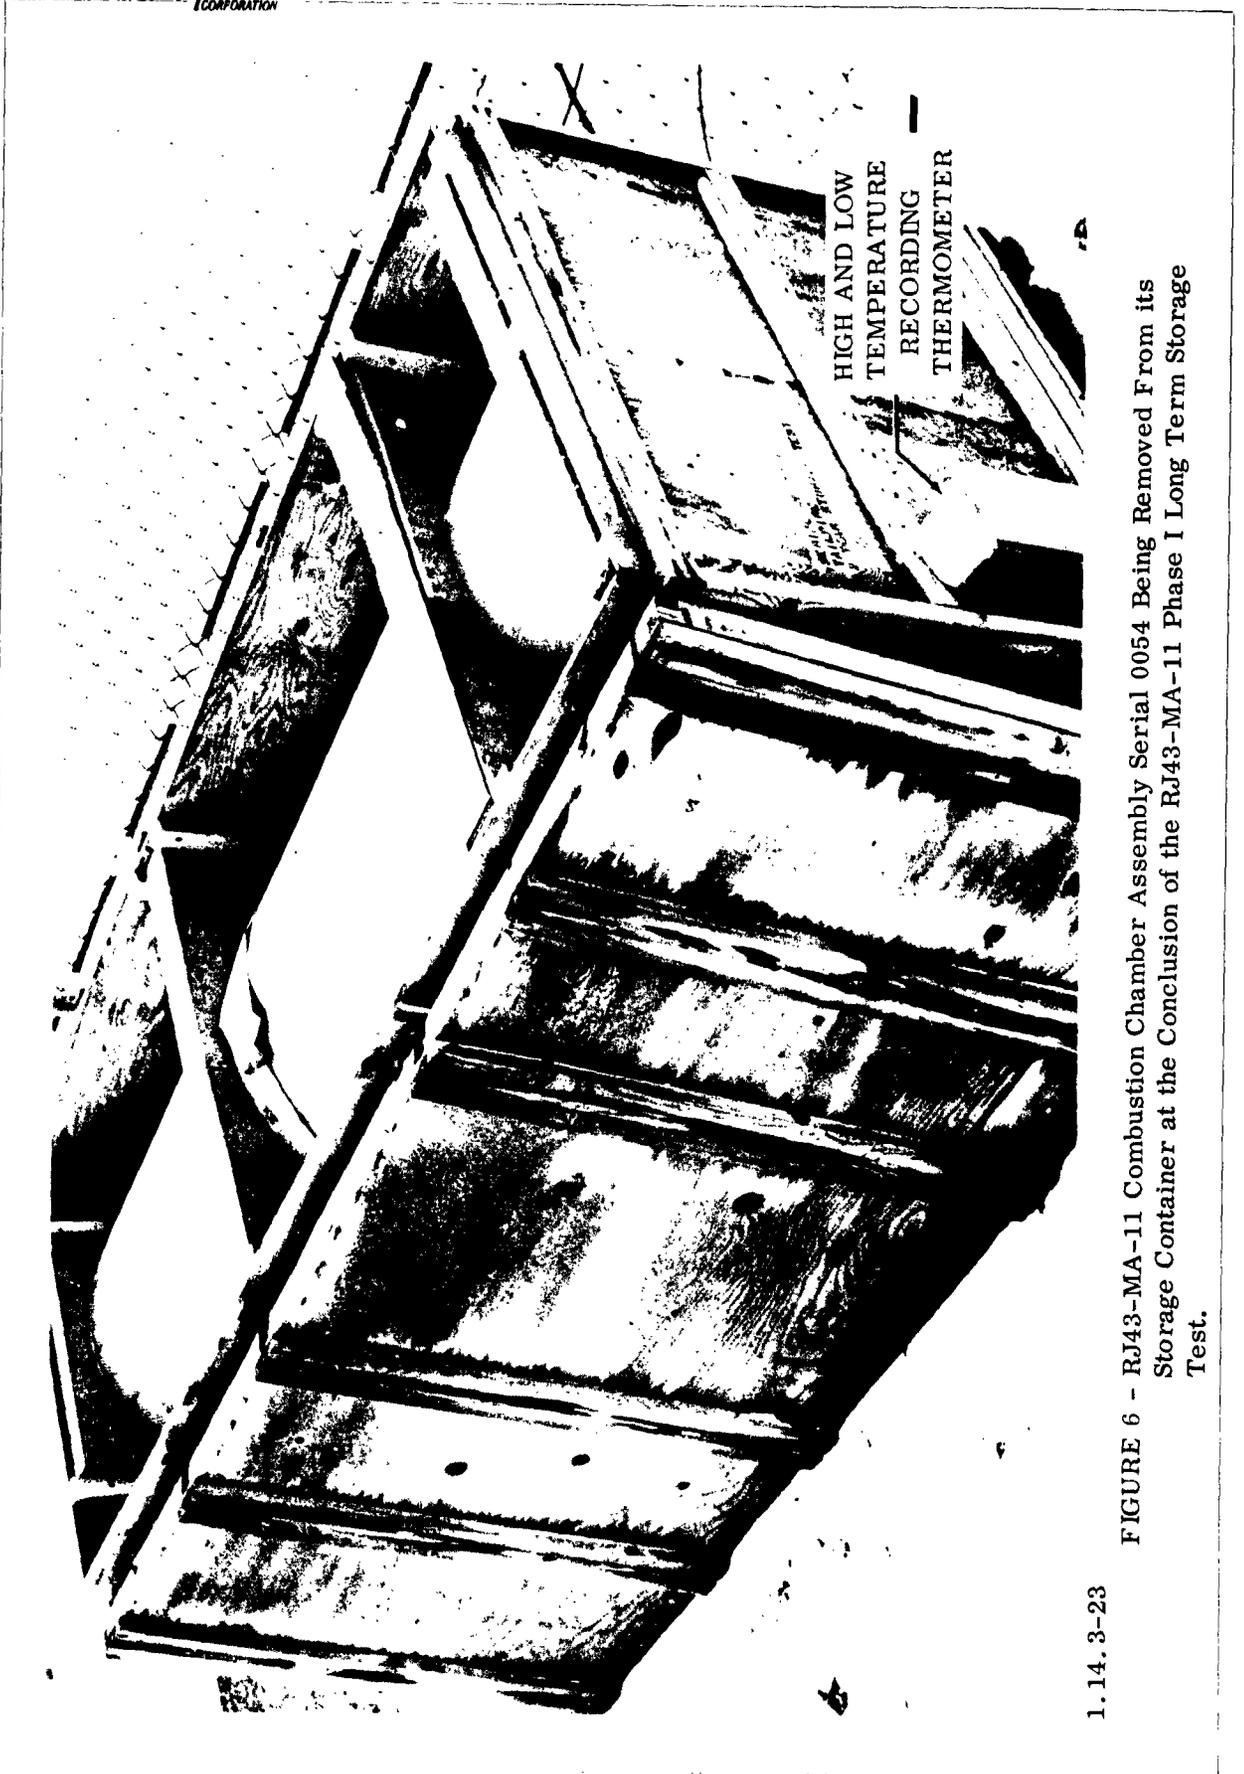
1.14.3-23

FIGURE 6 - RJ43-MA-11 Combustion Chamber Assembly Serial 0054 Being Removed From its Storage Container at the Conclusion of the RJ43-MA-11 Phase I Long Term Storage Test.

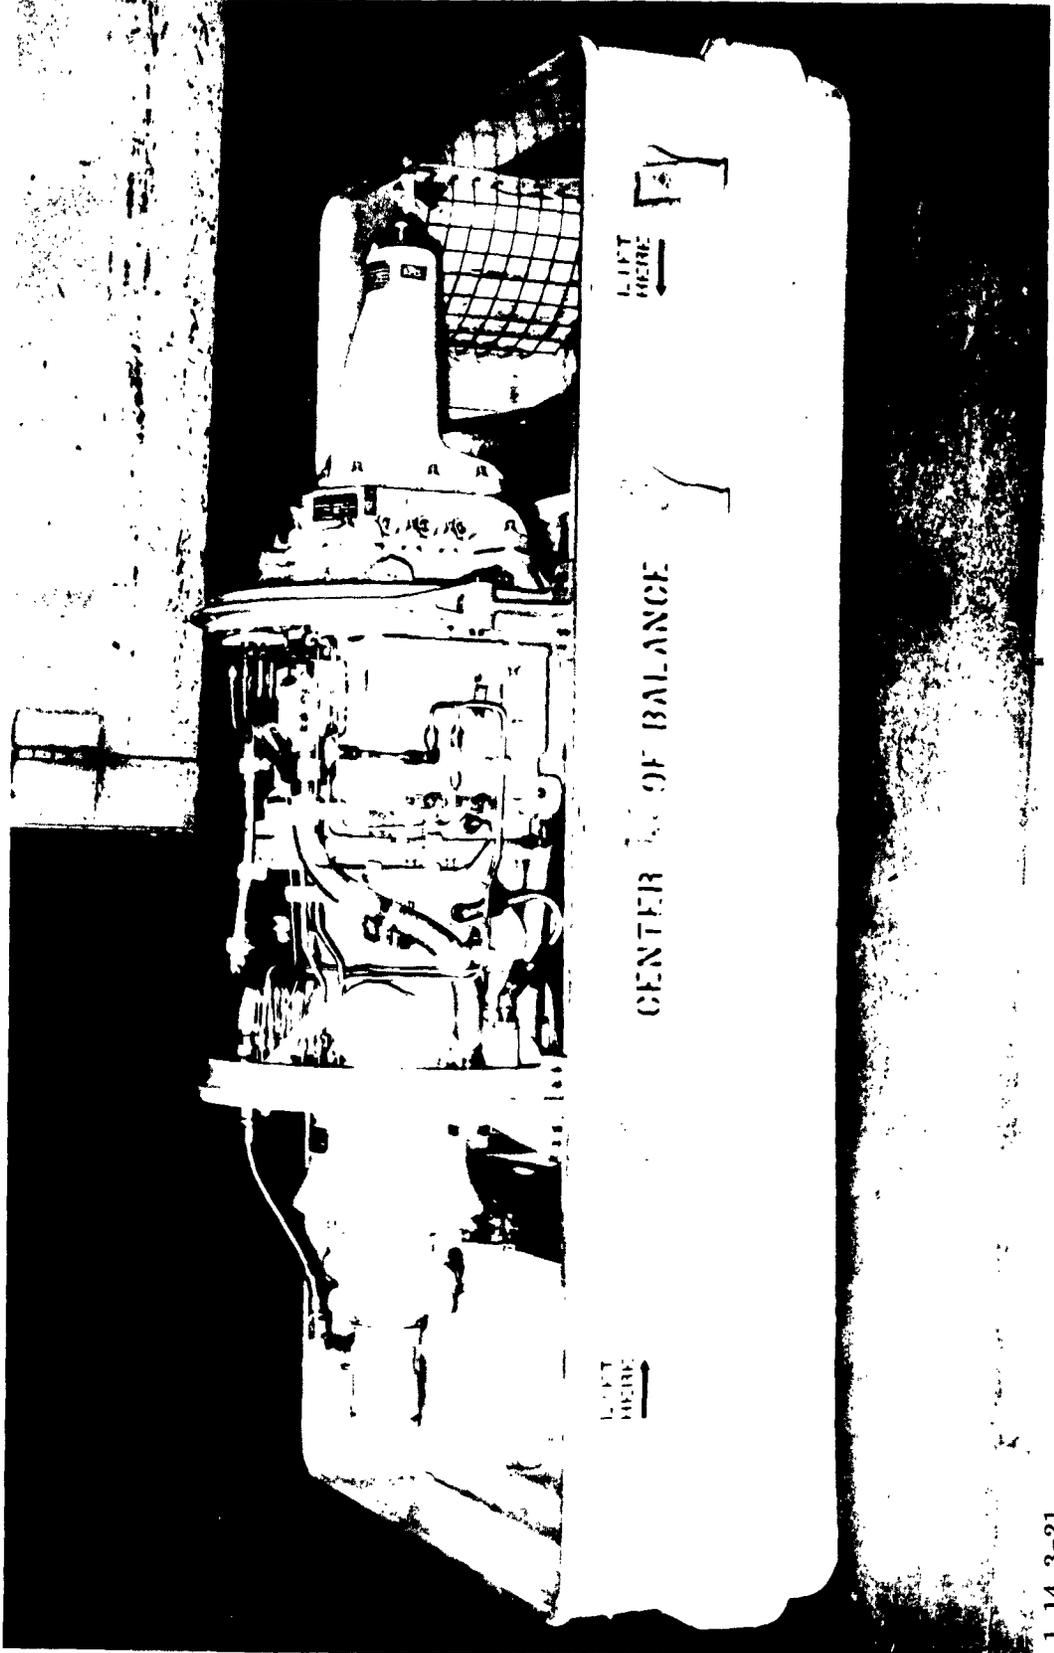
1.14.3-21

**FIGURE 7 - RJ43-MA-11 Fuel Control Unit Serial 007 Being Removed From its Storage Container at the Conclusion of the RJ43-MA-11 Phase I Long Term Storage Test.**

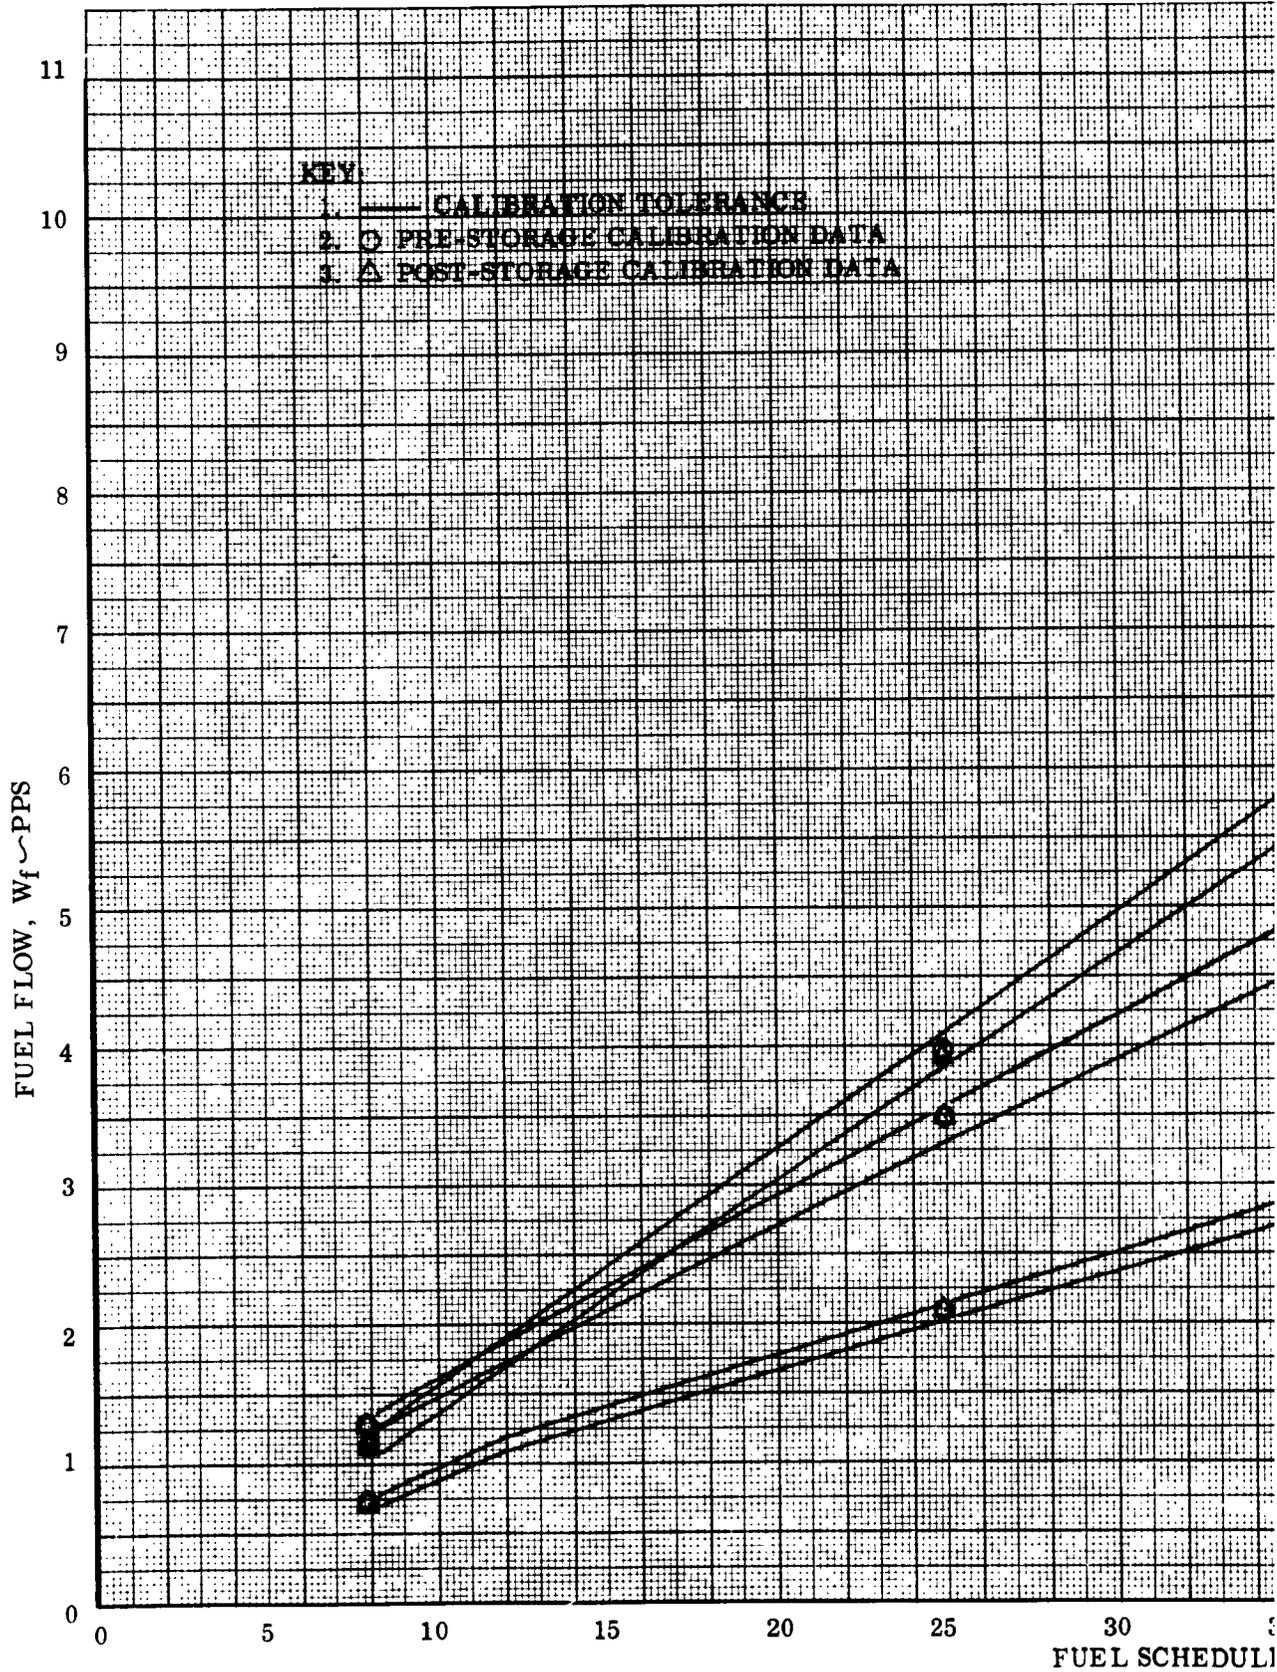
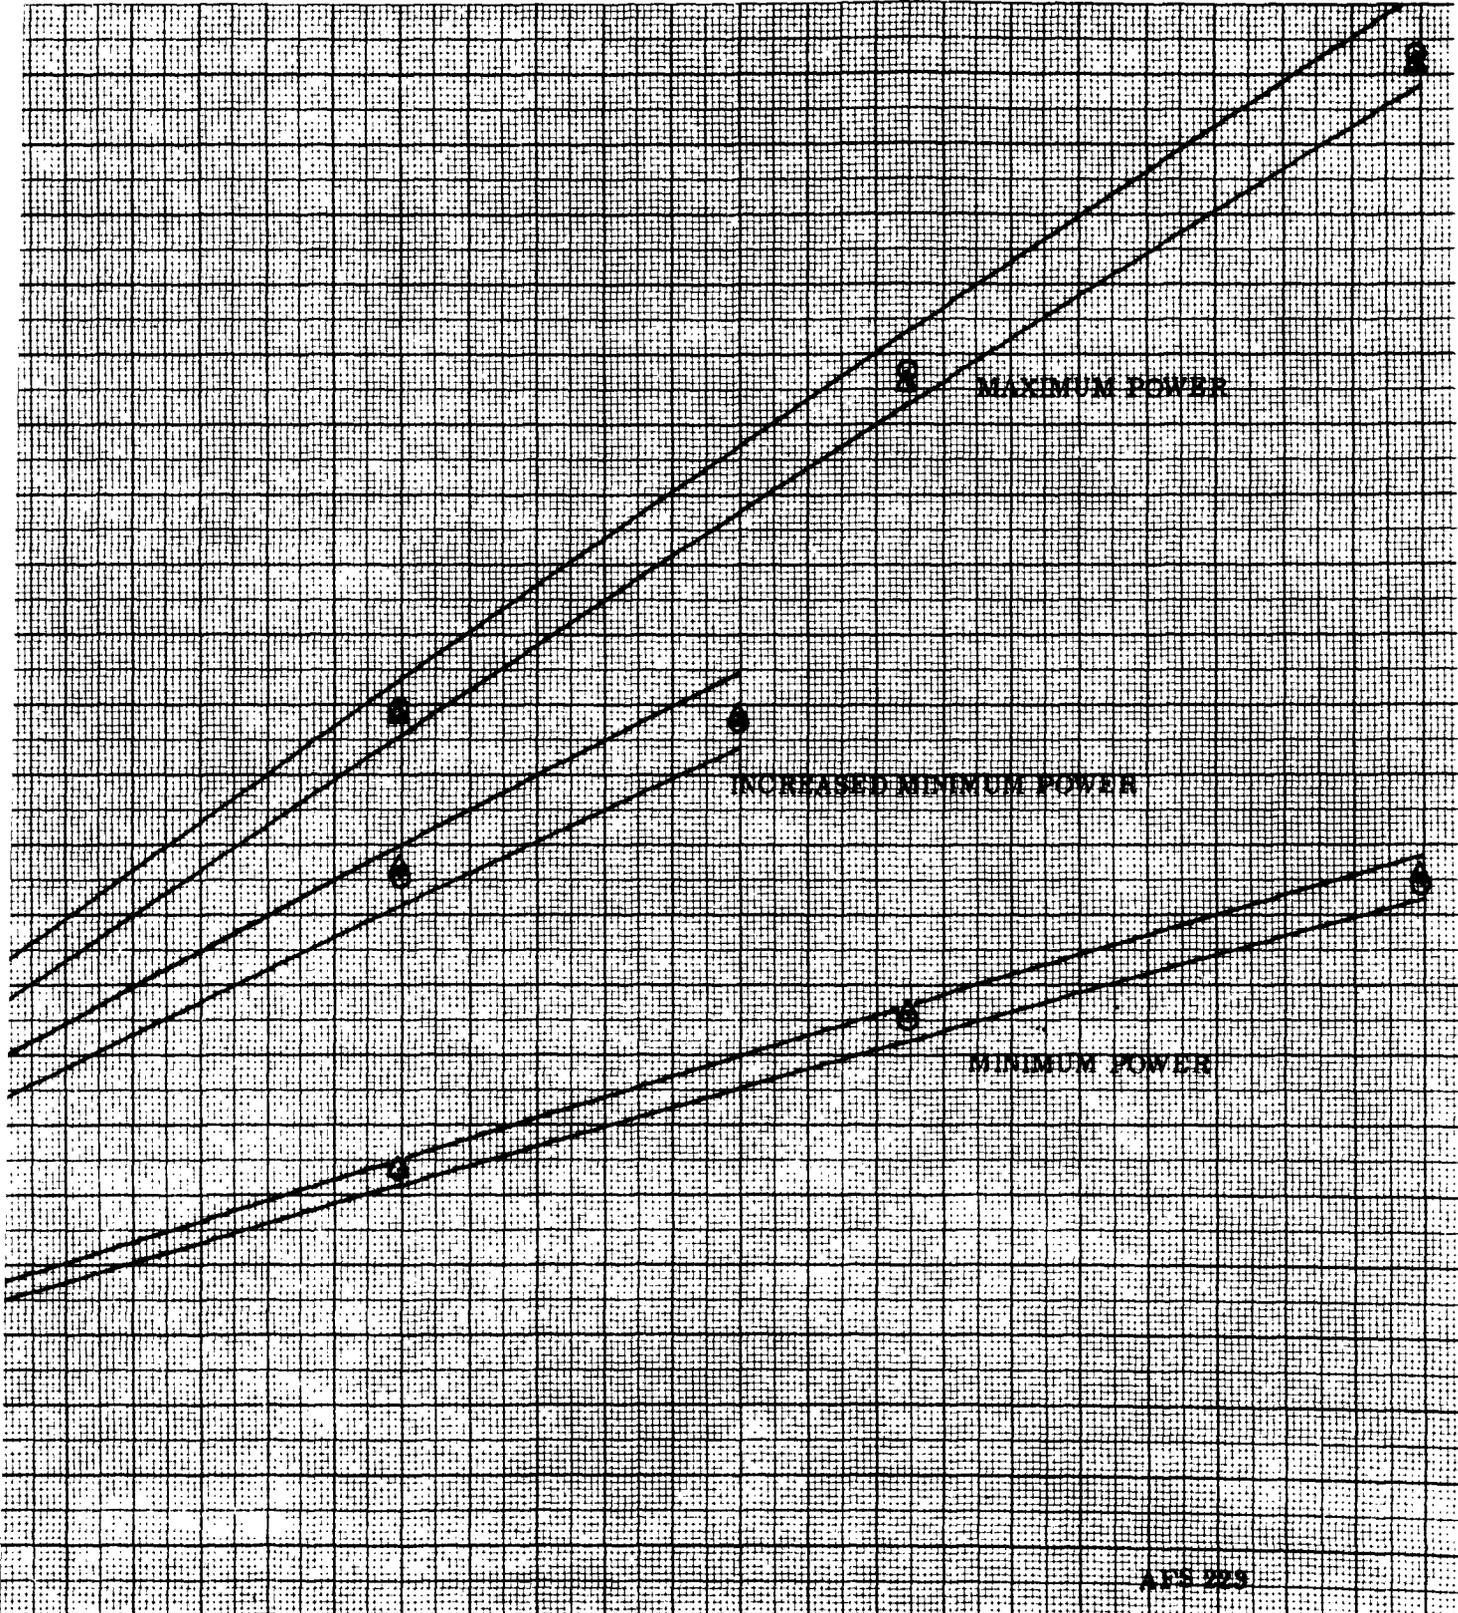
FIGURE 8 - RJ43-MA-11 Ramjet Engine Serial MA-E10002-2 Over-all Power Control Sys

Power Control System Calibration Data Before and After the RJ43-MA-11 Phase I Long-Term Storage Test.

Results of the combustion test and calibration tests conducted on engine Serial MA-E10002-2 met all requirements of Reference 4 with one exception. During the post-burn calibration test, the dynamic response of fuel flow to a step in the  $P_{t1.4}$  scheduling parameter did not entirely satisfy the Reference 4 requirement (see Table III). The engine was accepted for use in the storage tests without correcting this discrepancy on the basis that the engine would still provide the comparative type data required for a test of this nature. The final or post-burn calibration data are presented in Figures 8 through 10.

The calibration data obtained from the post-storage operational test of engine Serial MA-E10002-2 showed excellent over-all agreement with the prestorage calibration data. There was a slight shift in the data; however, all data remained within calibration tolerances except the  $Pt_{1.4}$  dynamic response data which was originally accepted outside the calibration tolerance. A comparison of the pre- and post-storage data for the over-all power control system calibration, Mach sensor calibration, shock position control calibration, and turbopump performance are shown in Figures 8 through 10. Dynamic response data are presented in Table III. Functional tests of the signal selector valve system and fuel transfer valve were conducted and performance was satisfactory.

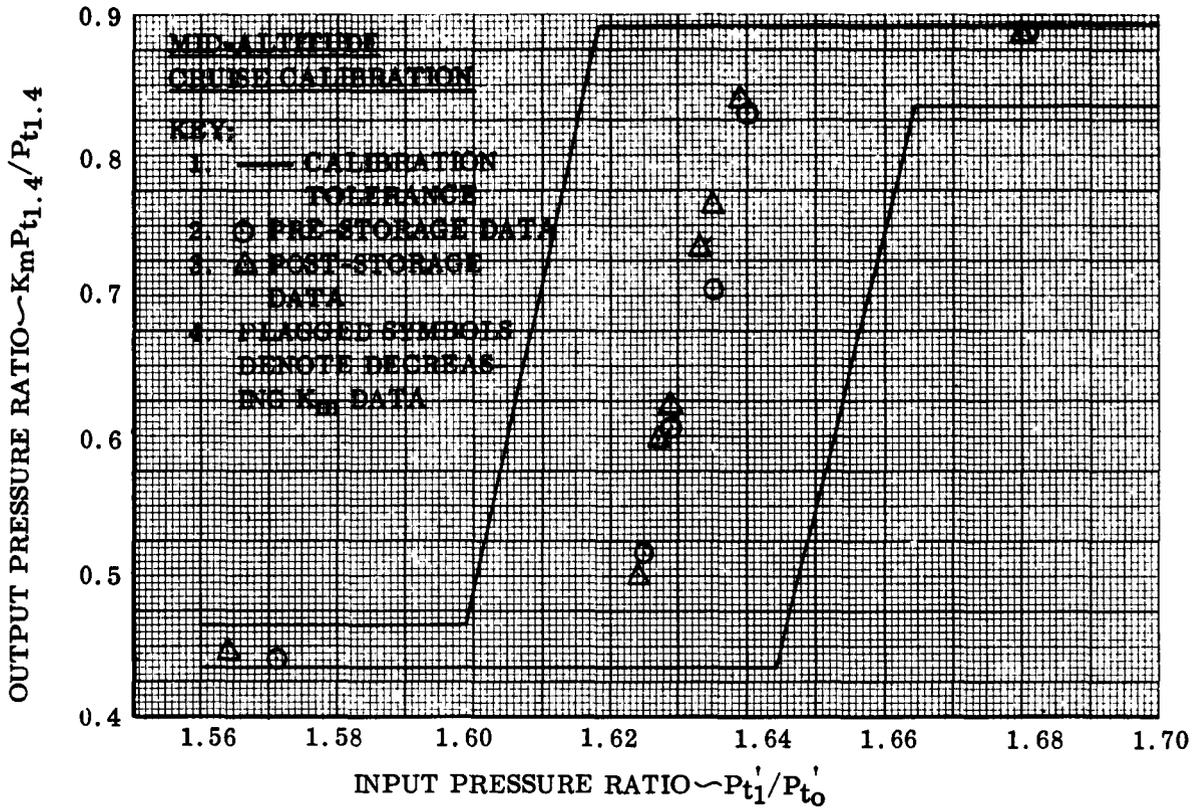
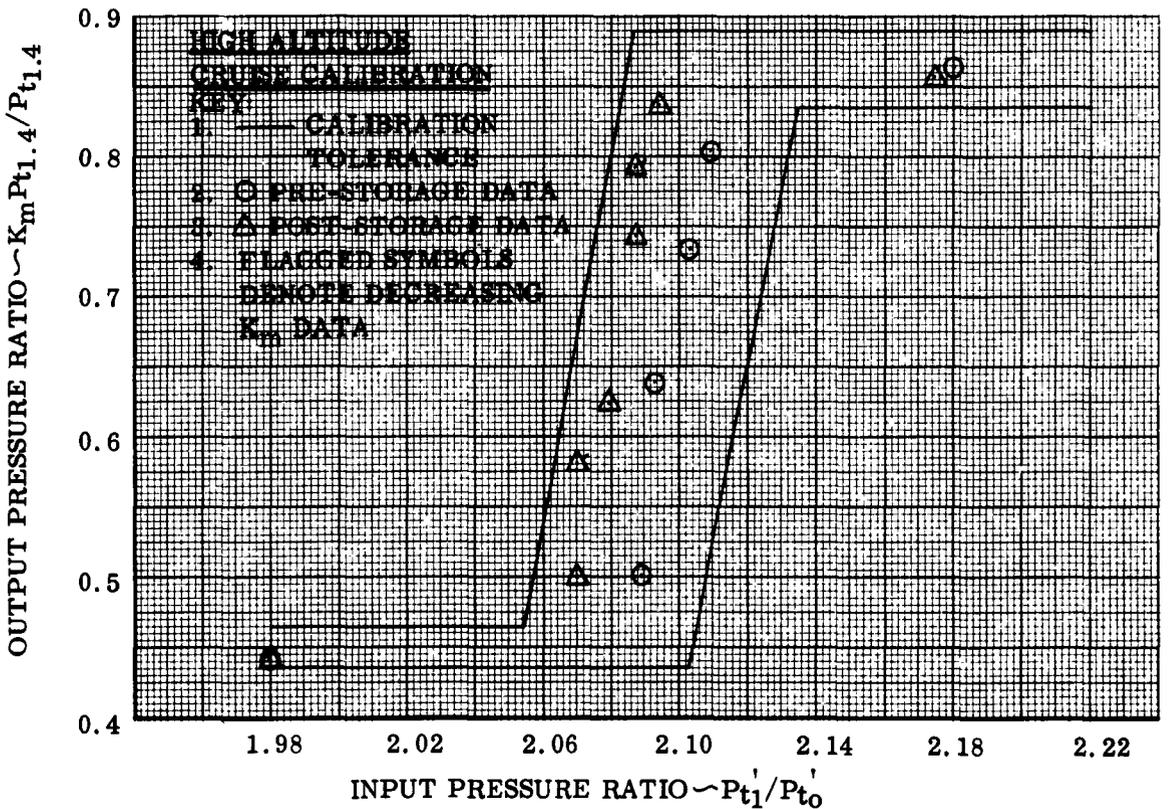
FIGURE 9 - RJ43-MA-11 Ramjet Engine Serial MA-E10002-2 Mach Sensor Control Calibration Data Before and After the RJ43-MA-11 Phase I Long-Term Storage Test.

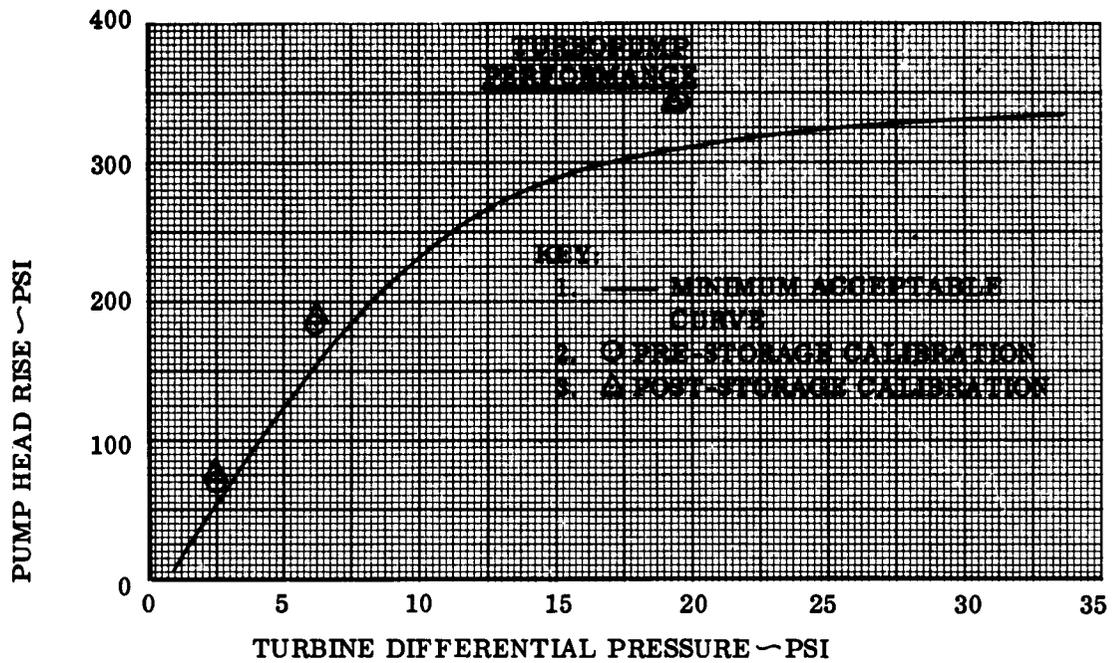
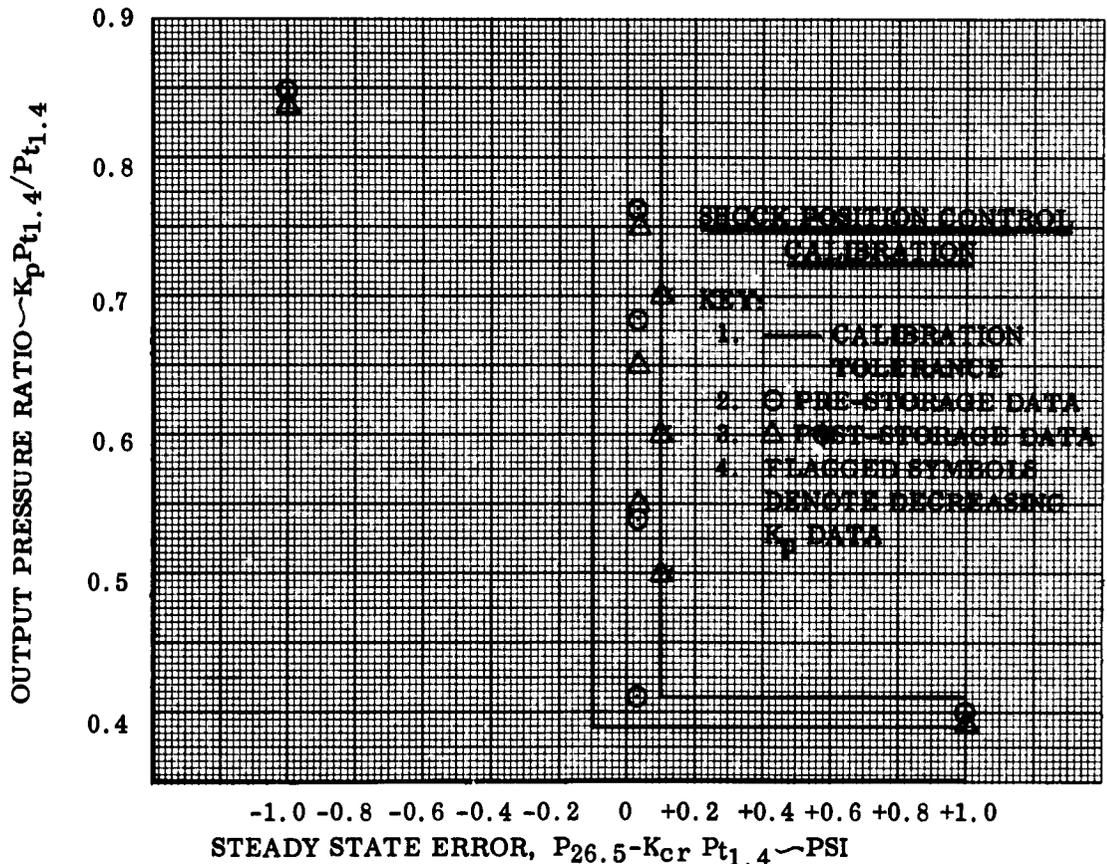
FIGURE 10 - RJ43-MA-11 Ramjet Engine Serial MA-E10002-2 Shock Position Control Calibration and Turbopump Performance Data Before and After the RJ43-MA-11 Phase I Long-Term Storage Test.
