RESULTS OF THE PHASE I LONG-TERM  
ENVIRONMENTAL STORAGE TEST PROGRAM  
FOR THE RJ43-MA-11 RAMJET ENGINE  
OCTOBER 1960 THROUGH MARCH 1963

Contract AF 33(657)-7770  
Project 273  
Model RJ43-MA-11

**Marquardt**  
CORPORATION OGDEN DIVISION

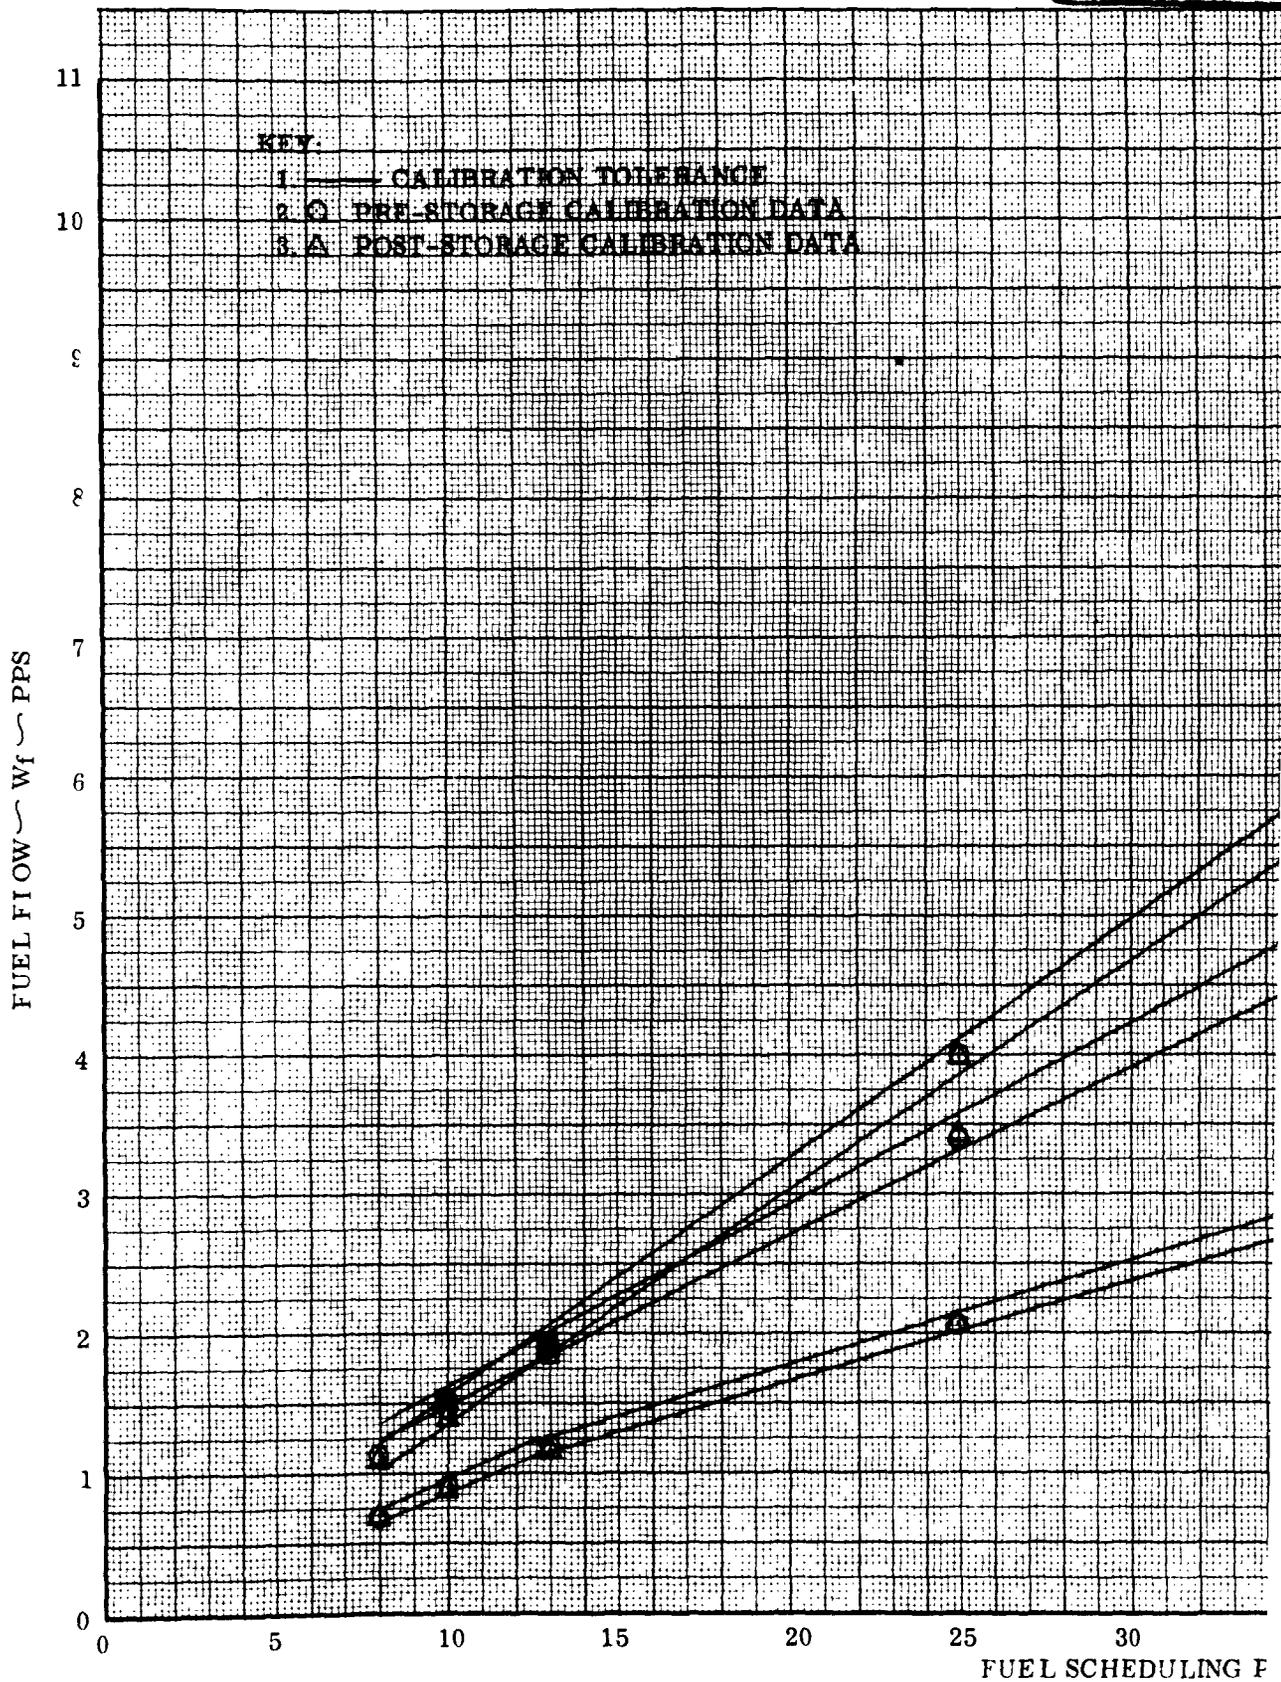
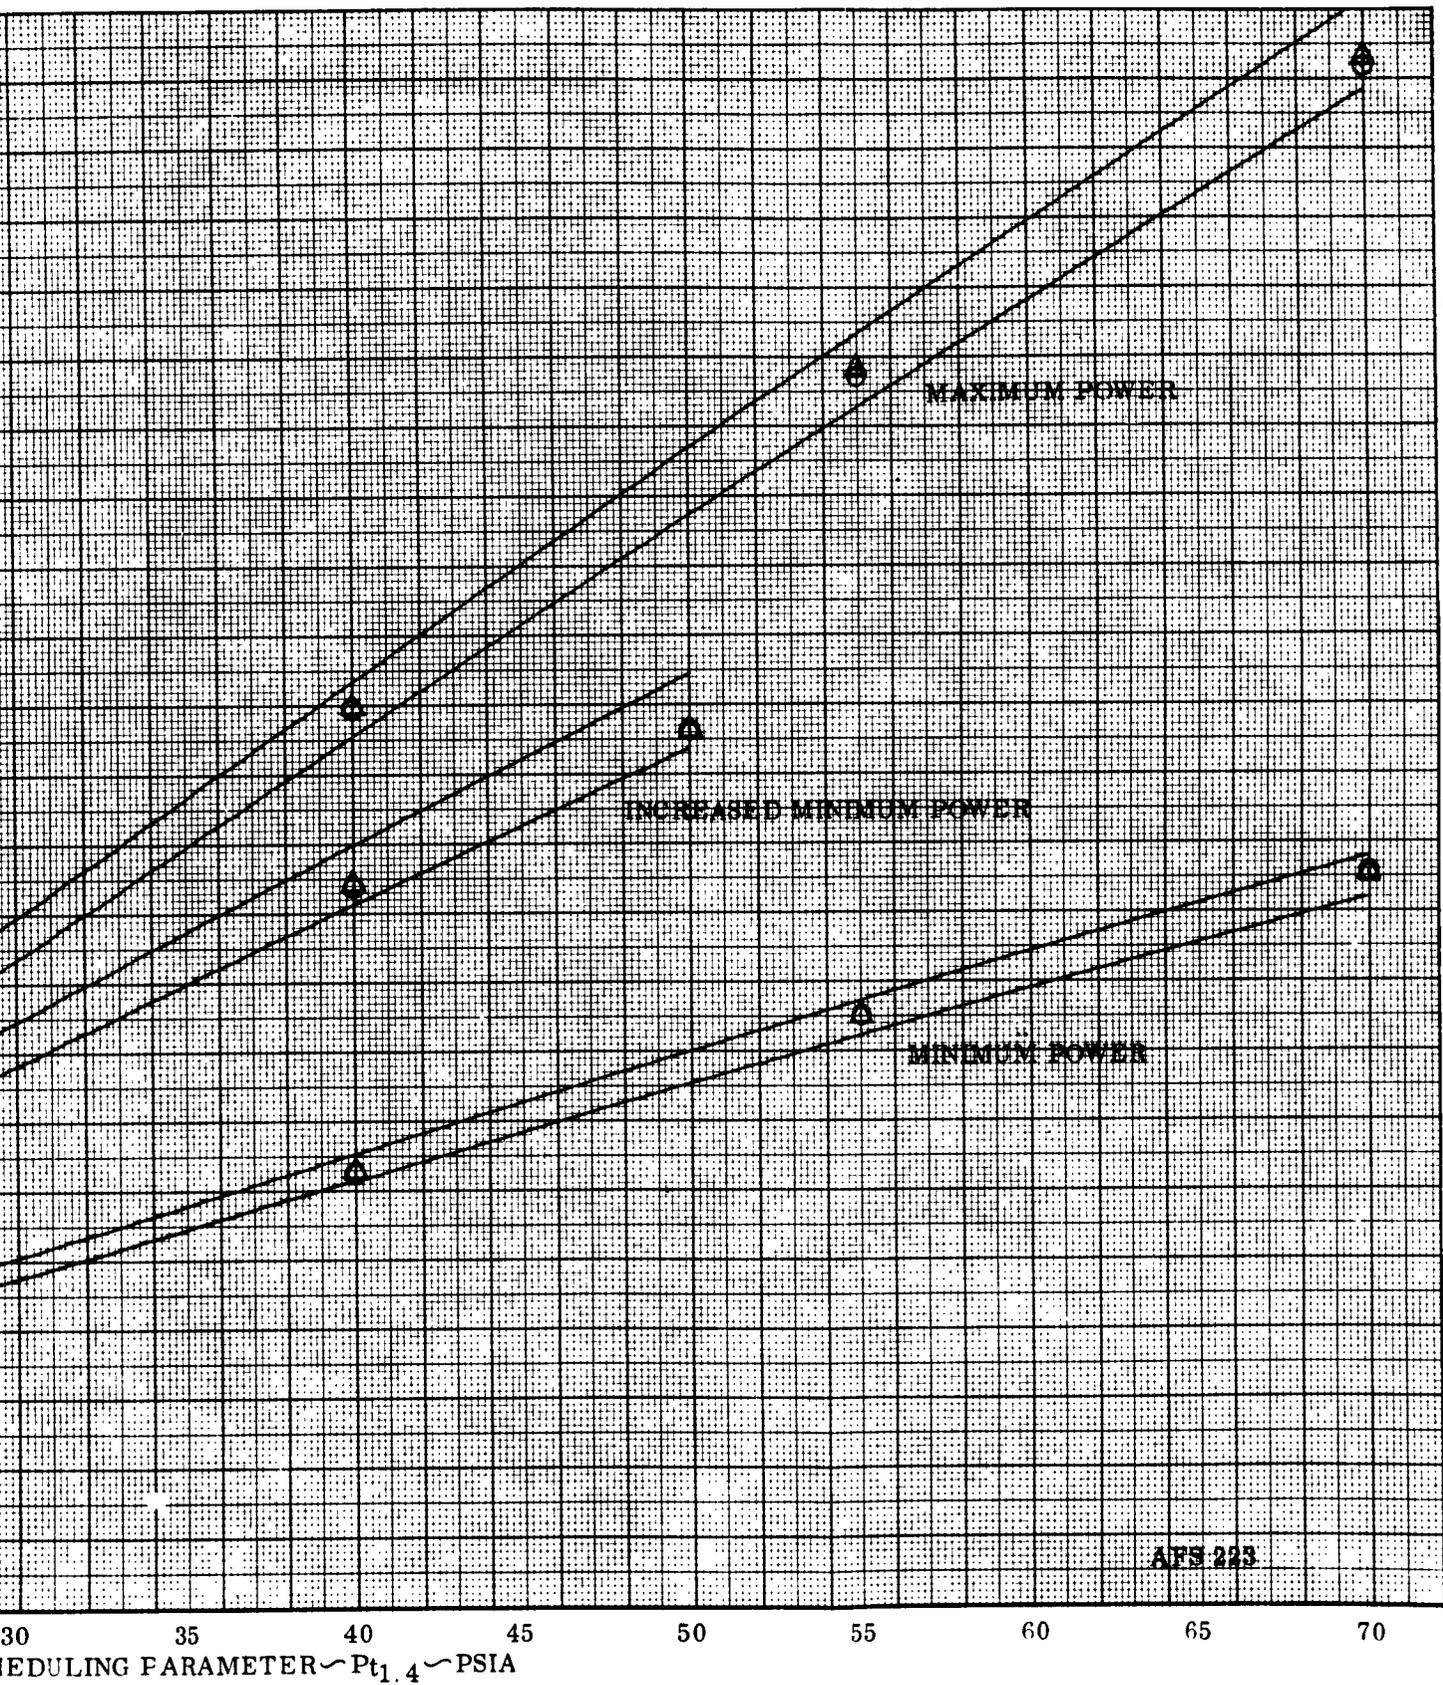
FIGURE 11 - RJ43-MA-11 Fuel Control Unit Serial 007 Over-all Power Control

Power Control System Calibration Data Before and After the RJ43-MA-11 Phase I Long-Term Storage Test.

Results of the calibration test conducted on fuel control unit Serial 007 met all requirements of Reference 5. Data are presented in Figures 11 through 14.

The calibration data obtained from the post-storage operational test of spare fuel control unit Serial 007 showed excellent over-all agreement with the prestorage calibration data except for a lean shift of the minimum power fuel flow schedule at the lower  $Pt_{1.4}$  scheduling parameter values. Though the minimum power fuel flow data remained within calibration tolerances, the effect of the minimum power shift caused the maximum power fuel flow datum point at  $Pt_{1.4} = 13$  psia to fall 0.017 pps below the lean calibration tolerance. The fuel flow obtained at this point, however, was still well within the operational tolerances. The other systems, although exhibiting some slight shift in data, were all within calibration tolerances. A comparison of the pre- and post-storage data for the over-all power control system calibration, Mach sensor calibration, shock position control calibration, dynamic response data, and turbopump performance are shown in Figures 11 through 14. A functional test of the fuel transfer valve showed it to be operating satisfactorily.

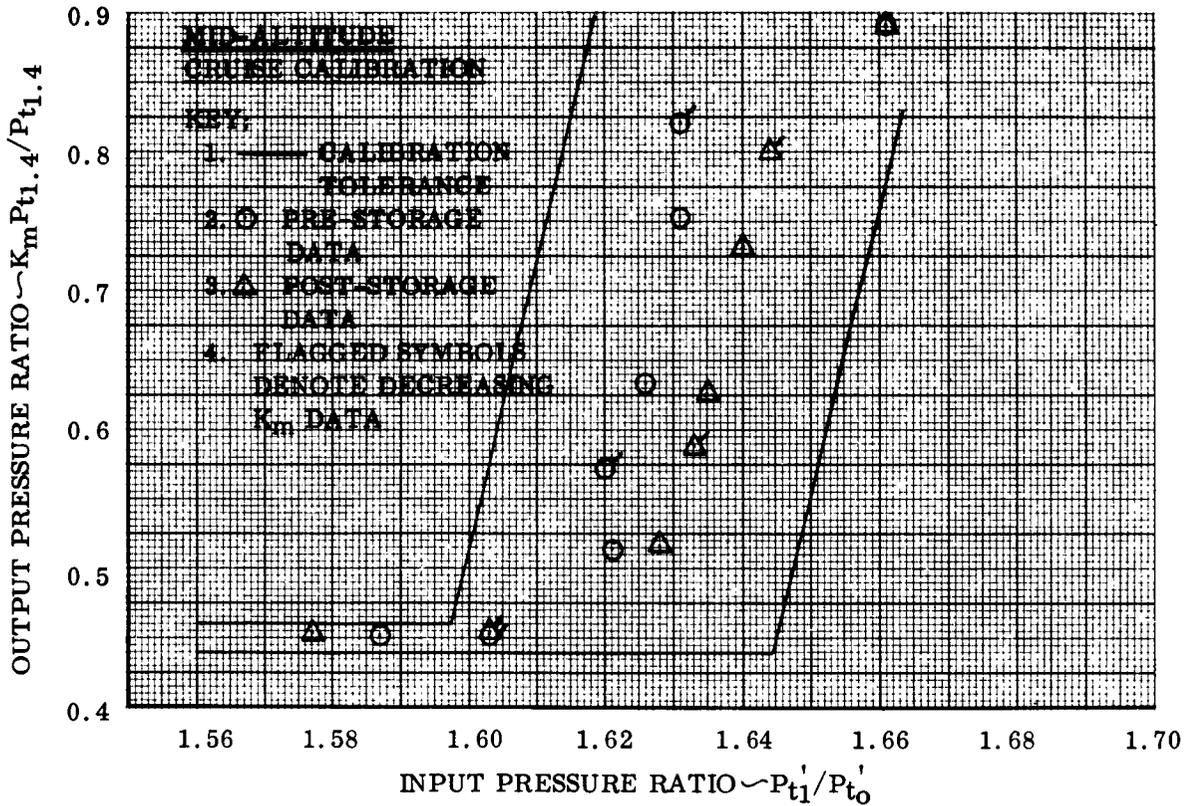
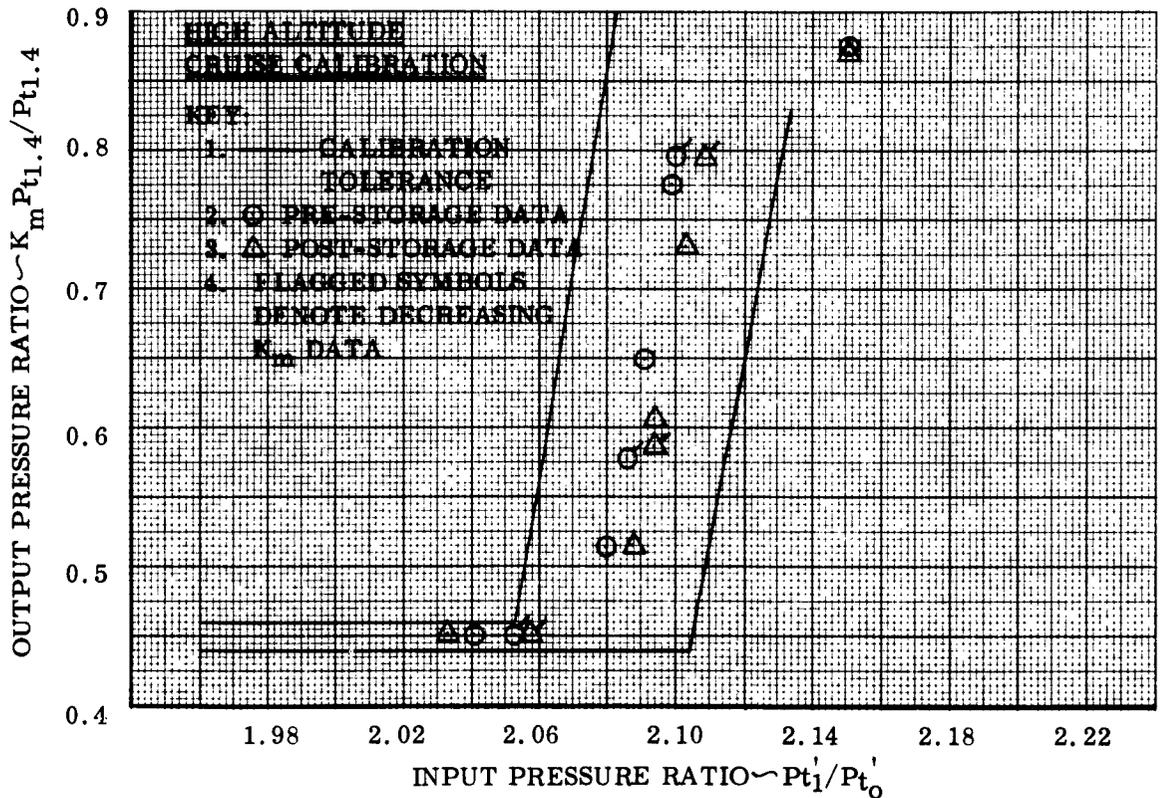
FIGURE 12 - RJ43-MA-11 Fuel Control Unit Serial 007 Mach Sensor Control Calibration Data Before and After the RJ43-MA-11 Phase I Long-Term Storage Test.

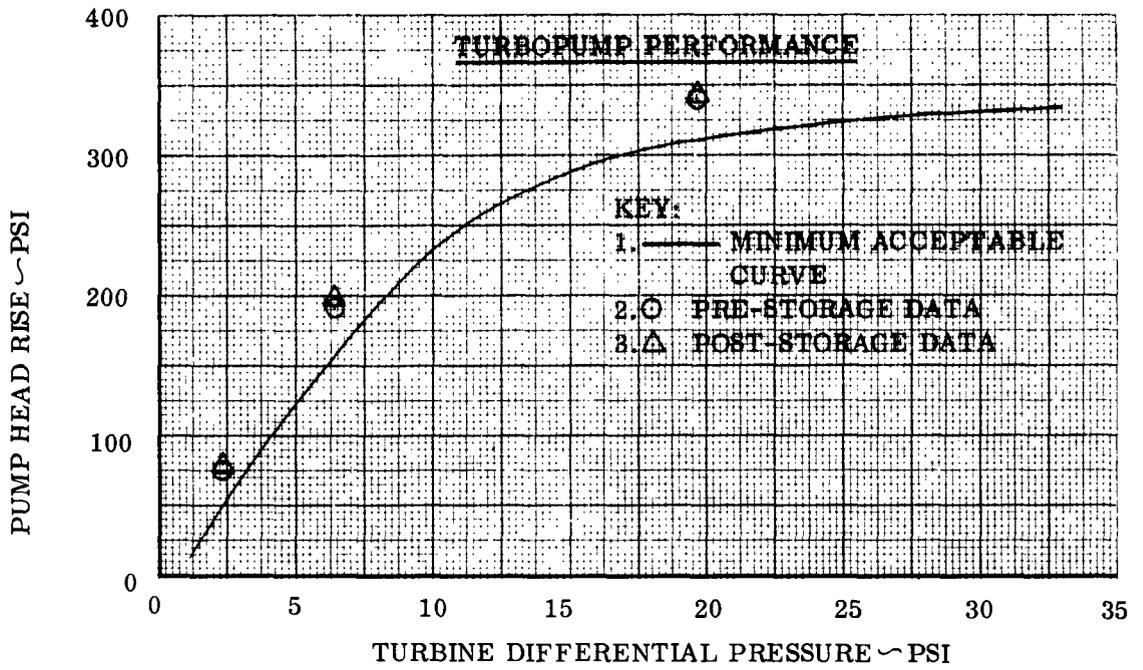
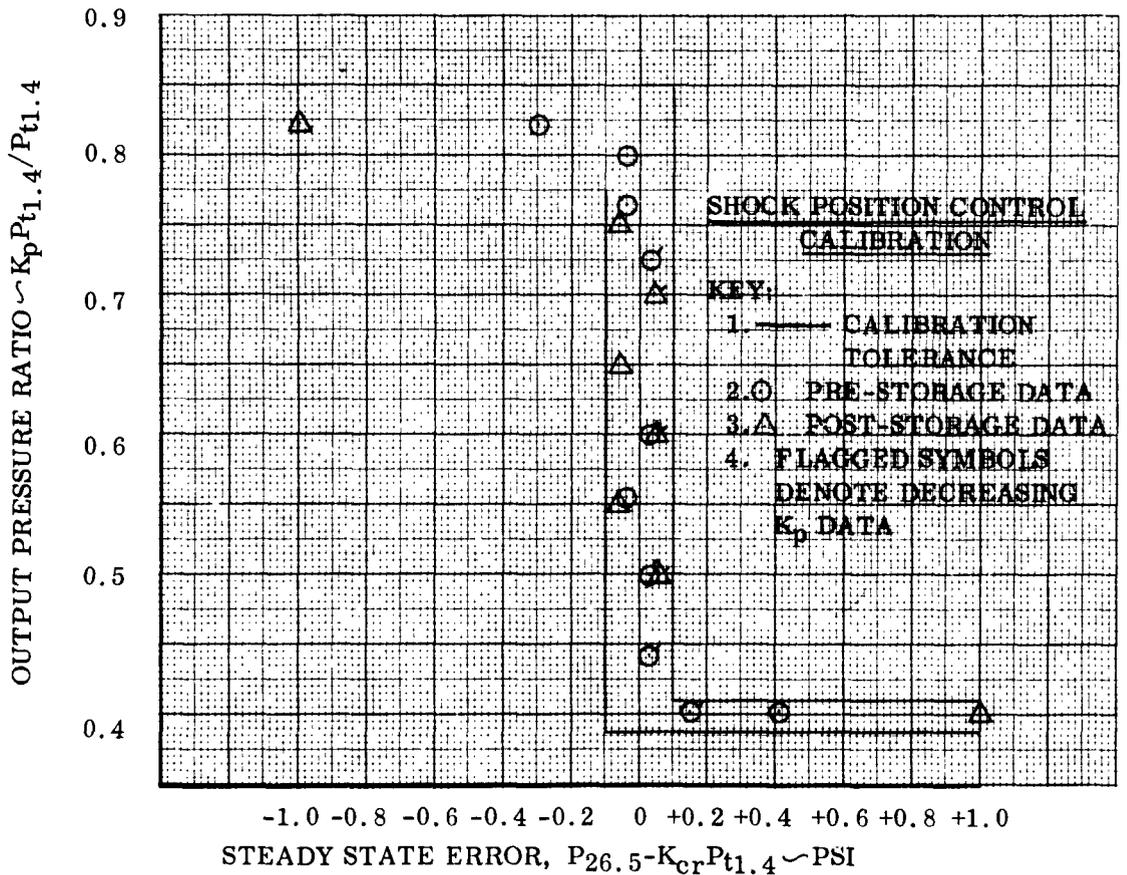
FIGURE 13 - RJ43-MA-11 Fuel Control Unit Serial 007 Shock Position Control Calibration and Turbopump Performance Data Before and After the RJ43-MA-11 Phase I Long-Term Storage Test.

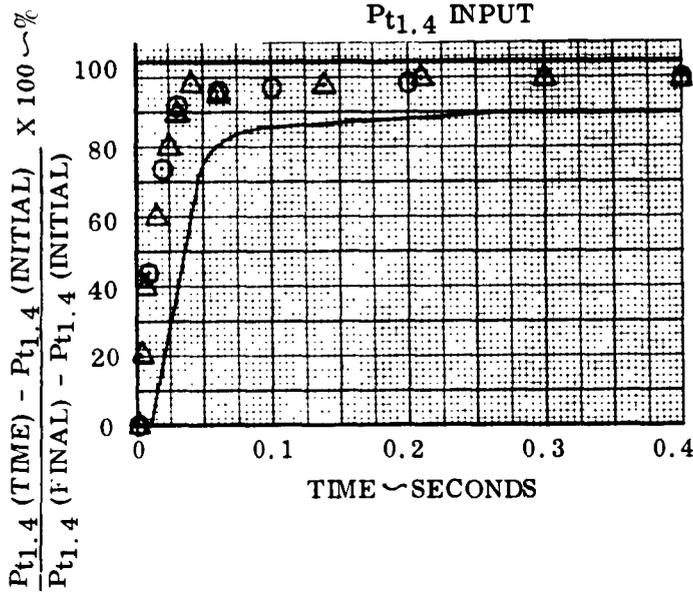
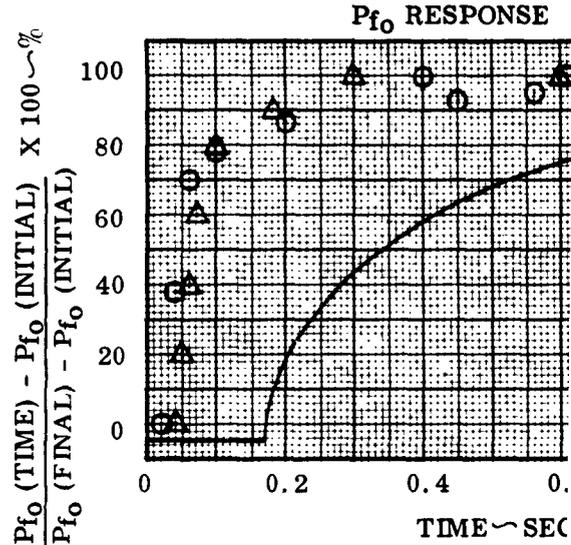
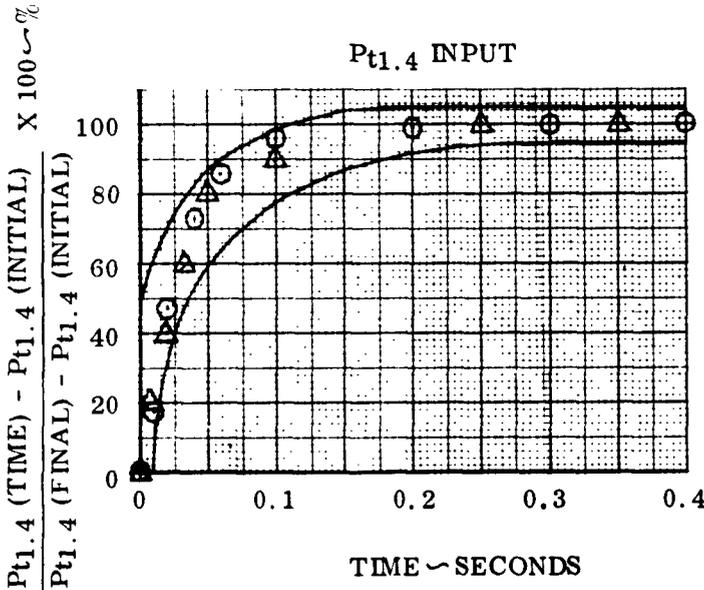
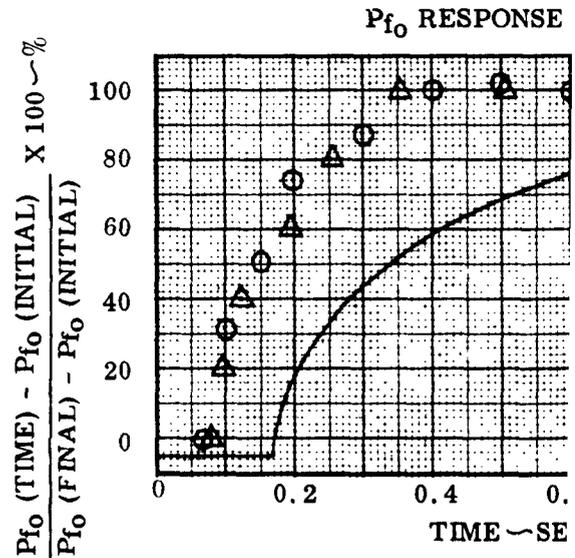
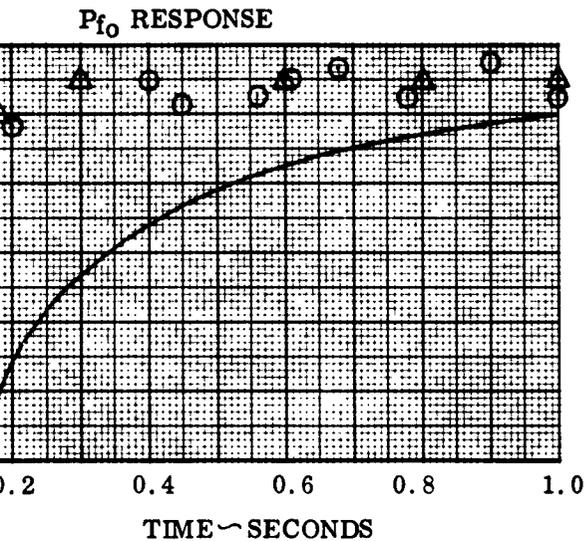
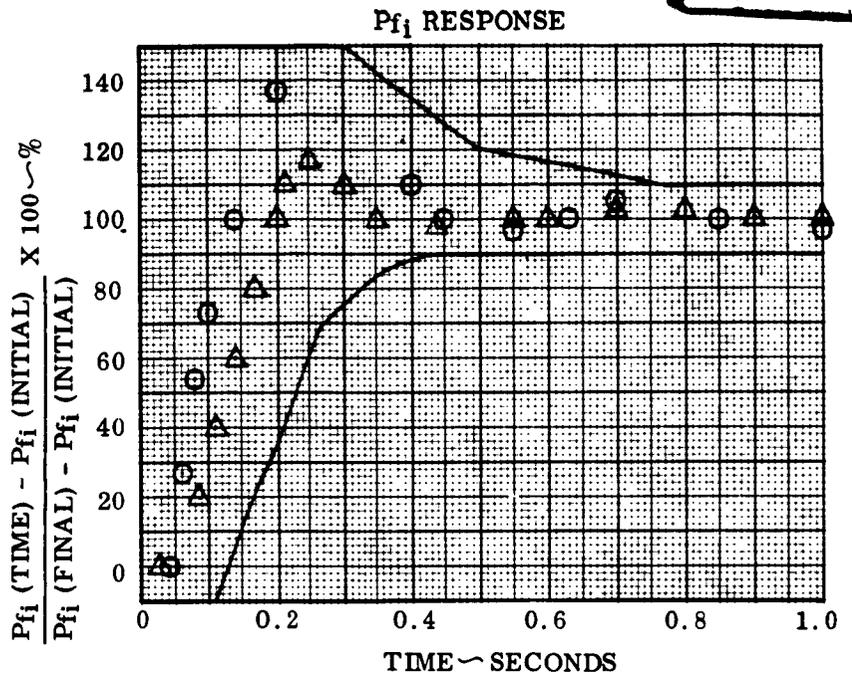
FIGURE 14 - RJ43-MA-11 Fuel Control Unit Se Data Before and After the RJ43-M Storage Test.

1 Fuel Control Unit Serial 007 Dynamic Response  
and After the RJ43-MA-11 Phase I Long-Term  
t.

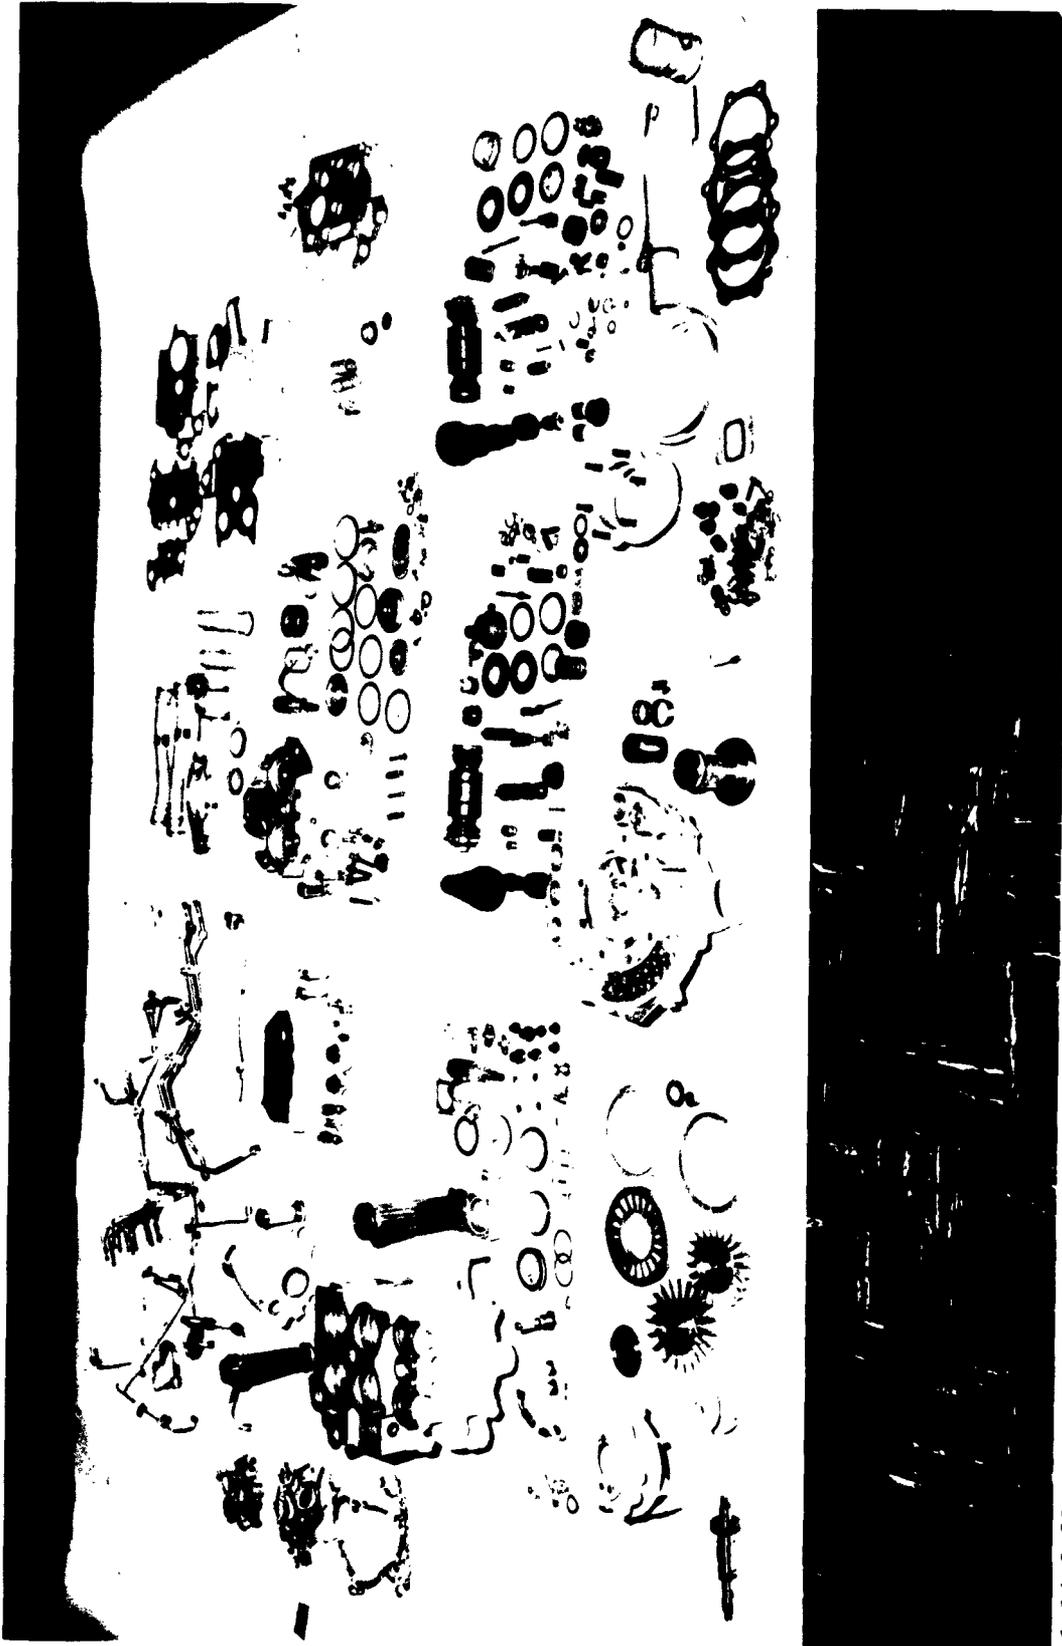
1.14.3-32  
FIGURE 18 - Disassembled Components of Spare RJ43-MA-11 Fuel Control Unit Serial 007 Following the RJ43-MA-11 Phase I Long Term Storage Test.

Each test specimen was disassembled to the degree that any deterioration of the part could be determined. The degree to which the test specimens were disassembled is shown in Figures 15 through 18. The disassembly was conducted under cognizance of the resident Air Force Quality Control representative. An inspection of each part was made by representatives of the resident Air Force Quality Control office, TMC Quality Control Department, and TMC Engineering Department.

Spare fuel control unit Serial 007 was also found to be in excellent condition. One minor discrepancy was noted on the Mach sensor-shock position control housing. This consisted of a small area on the housing, shown in Figure 20, where slight corrosion was evident. This area is open to the atmosphere and, from residue found in the area, had been covered with leak detection soap at the time of initial calibration. It is felt that a flaw in the protective coating in this area combined with the soap, produced the resultant corrosion. This area of the housing has no function other than to provide the area to which the cam adjustment retainer is bolted.

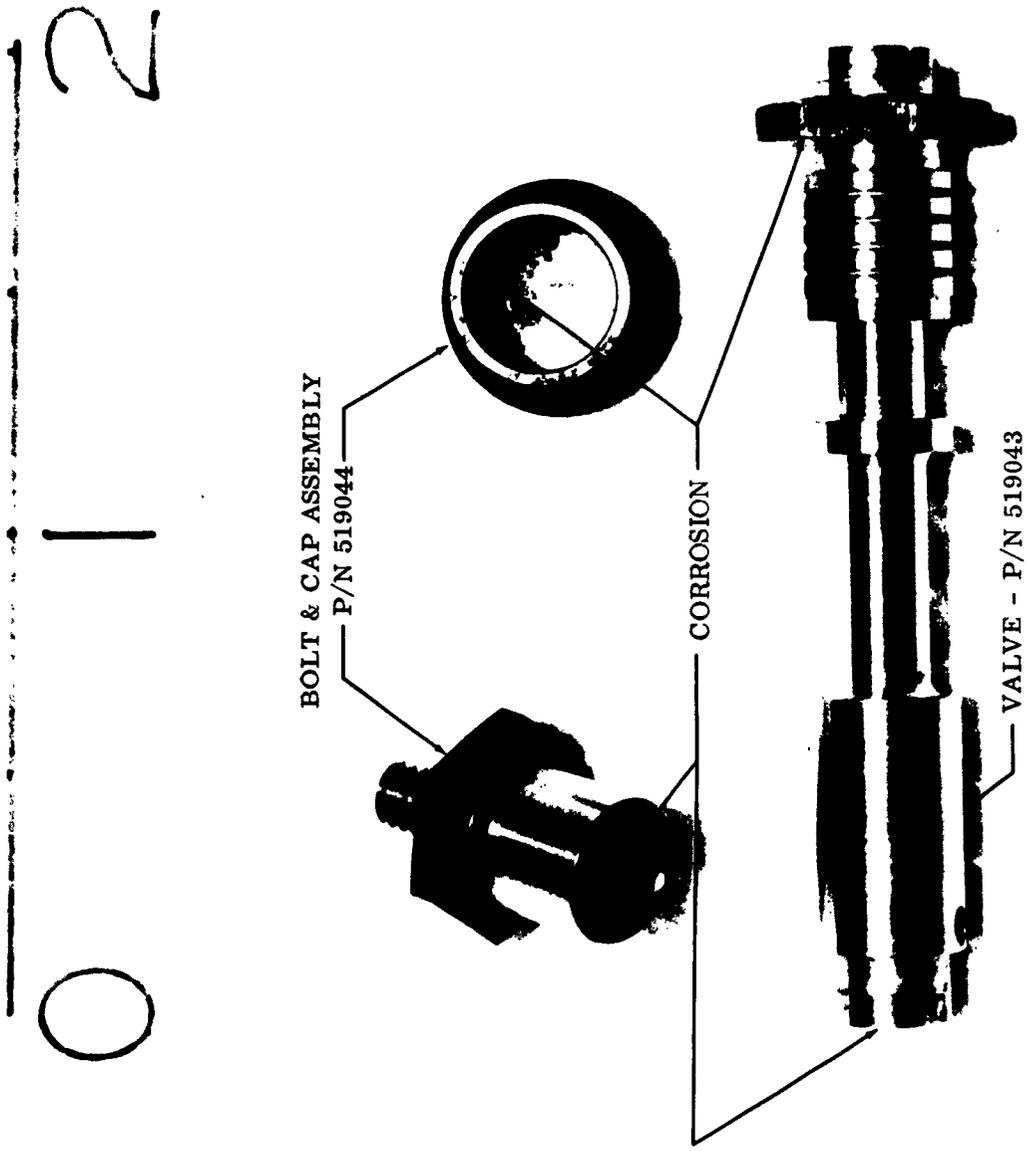
1.14.3.-25

When disassembled, engine Serial MA-E10002-2 and its associated fuel control unit, Serial 002, were found to be in excellent condition with no signs of deterioration. There was one discrepant area found during disassembly of the fuel control unit but it cannot be attributed to the storage program. Approximately 25 cubic centimeters of water were found in the shock position control assembly. The water was obviously inducted into the control during the post-storage operational test and probably during the functional test of the signal selector valve system. The water, which remained in the control for approximately one week, caused some corrosion on the shock position control valve and bolt and cap assembly, shown in Figure 19. Function of the shock position control was unaffected.

FIGURE 19 - Shock Position Control Valve and Bolt and Cap Assembly From RJ43-MA-11 Fuel Control Unit Serial 002 Showing Corrosion Caused by Improper Test Procedures Which Followed the RJ43-MA-11 Phase I Long Term Storage Test.

Magnesium elements of this particular engine and fuel control did not have the additional protection afforded by the Marquardt-developed "Marquardt" epoxy coating. Production RJ43-MA-11 engine had this processing applied to all magnesium parts with the exception of the external skins.

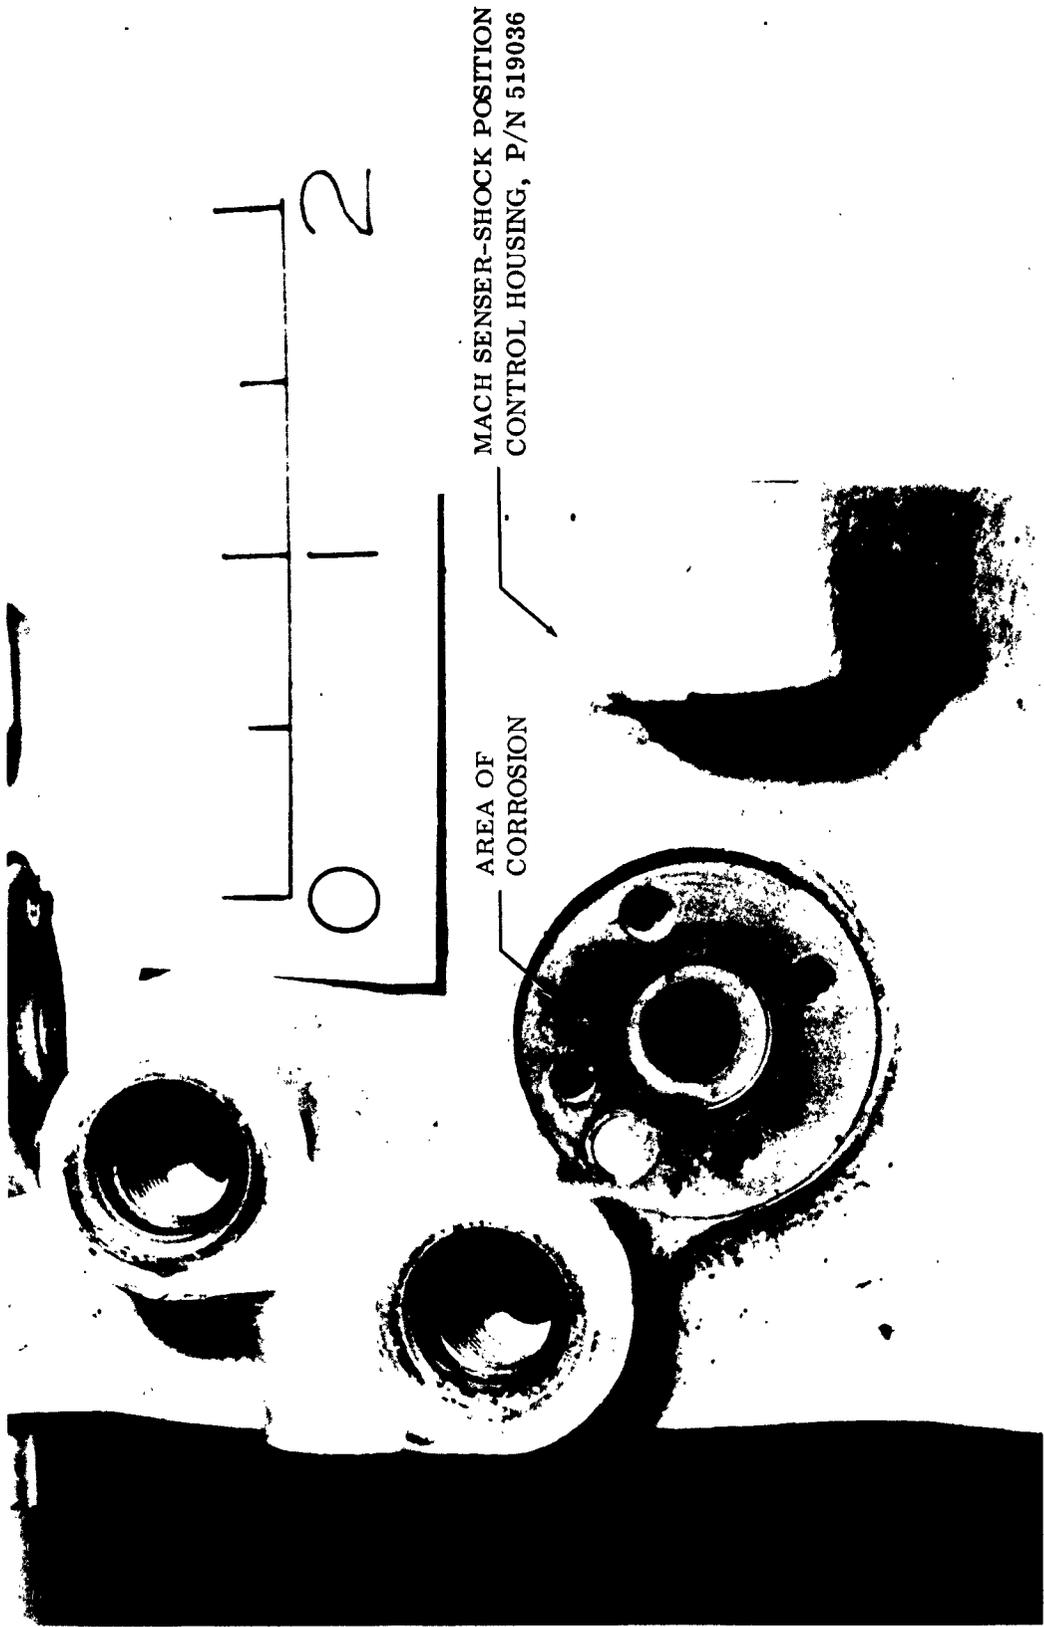
AREA OF  
CORROSION

1.14.3-26 **FIGURE 20 - Mach Senser-Shock Position Control Housing From RJ43-MA-11 Fuel Control Unit Serial 007 Showing Minor Area of Corrosion Discovered Following Completion of the RJ43-MA-11 Phase I Long Term Storage Test.**
