USATECOM PROJECT NO. 7-5-0524-01-9

FINAL REPORT OF
MILITARY POTENTIAL TEST OF
MARSH SCREW AMPHIBIAN
(PLAN A - M113)

DECEMBER 1964

U S ARMY
GENERAL EQUIPMENT TEST ACTIVITY
FORT LEE, VIRGINIA

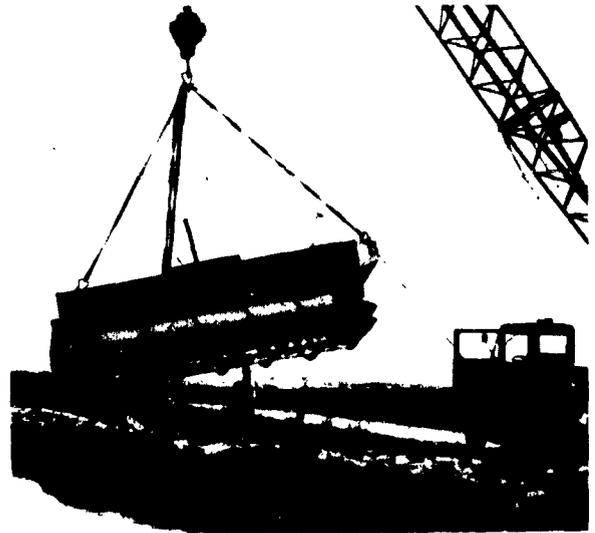
Figure 6. Marsh Screw Amphibian being unloaded and placed in drainage ditch at Messick test site.

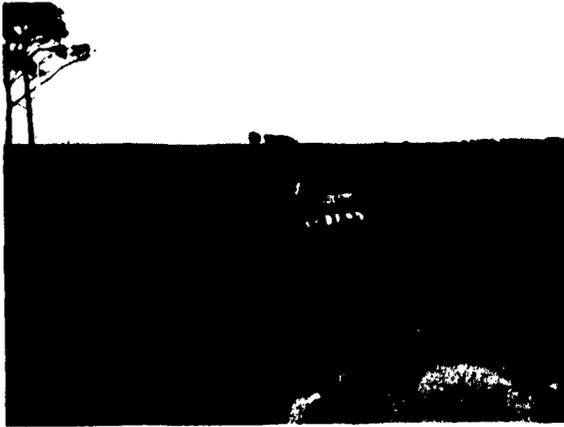
Figure 8. Type of swamp terrain at Messick test site. The Marsh Screw was unable to negotiate this area in forward direction.

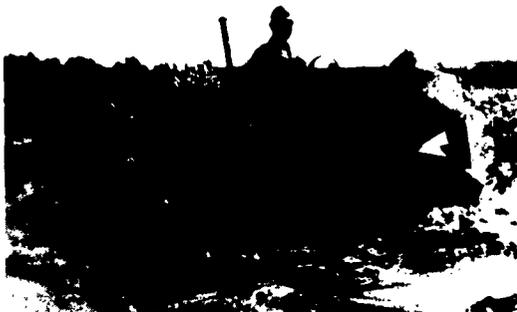
Figure 10. Marsh Screw Amphibian negotiating heavily vegetated water area at Chickahominy test site.

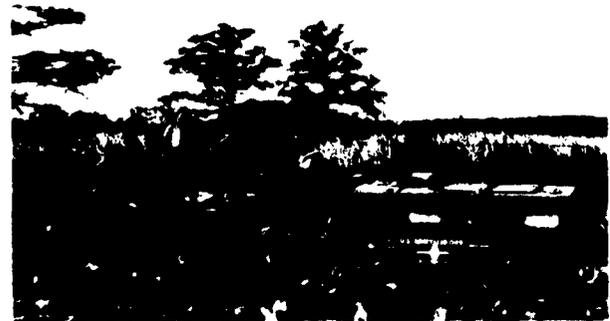
Figure 11. The M113 immobilized in heavily vegetated water area at the Chickahominy test site. Recovery vehicle is the M116 personnel carrier.

d. The M113 armored personnel carrier was subjected to swimming tests through the surface and sub-surface growths as listed above. In a full float condition, the vehicle was able to slowly pass through those areas where the vegetative growth was not heavily concentrated. In a half float condition, the vehicle would proceed with great difficulty even in water without vegetation. Under this condition,

where the vehicle's tracks were in slight contact with the river bottom, even small amounts of water vegetation were sufficient to halt all forward movement. The operator, however, was able to reverse direction and free the vehicle; and, in some cases, the operator was able to find a route which circumvented the vegetated areas. Frequently the vehicle was immobilized and became completely mired. Very seldom was the M113 able to extricate itself. The M113 could not be relied upon to negotiate any portion of the river unless it was able to maintain a full float condition; this required a minimum of 66 inches of water. Where water depth was less than 66 inches, the vehicle would sink into the river bottom mud until it became mired. Retrieving was difficult and time consuming, requiring the use of the M116 unarmored personnel carrier (gross weight, 10,600 pounds). The M116 had to be positioned on firm ground or lashed to a tree before its winch could be utilized to extricate the 23,900 pound M113. In one particular area, heavy-rooted growth floated on the surface of the water for acres in large concentrated masses. Water depths varied from 3 1/2 to 6 feet deep under the masses. The M113 whether in a swimming condition or with its tracks in contact with the soft bottom could only negotiate this growth three to four feet before losing all forward motion.

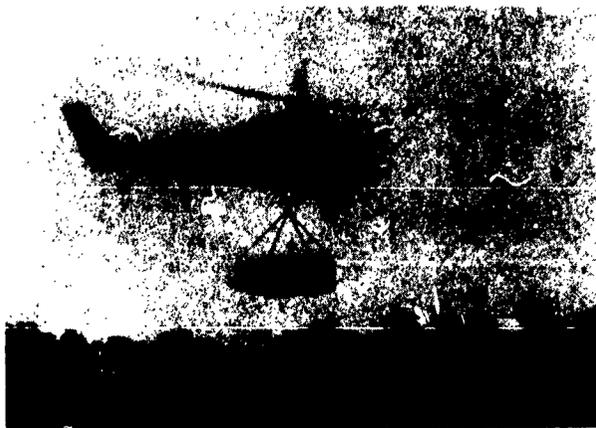
Figure 19. CH-34 transporting the Marsh Screw Amphibian.

Six lifts of the MSA were made by a CH-34 helicopter. The item was picked up in both an empty and loaded condition from firm ground, very soft mud and from the Appomattox River. The initial lift was made using an Army standard helicopter 12-foot external sling. Discussion with the pilot immediately after the lift indicated that a shorter length sling would probably provide him with a better air cushion ground effect for lift purposes. He considered this to be especially needed for lifts from water surfaces and for all maximum weight vehicle lifts. A nine-foot sling was secured and utilized for the remainder of the tests and found to be satisfactory.

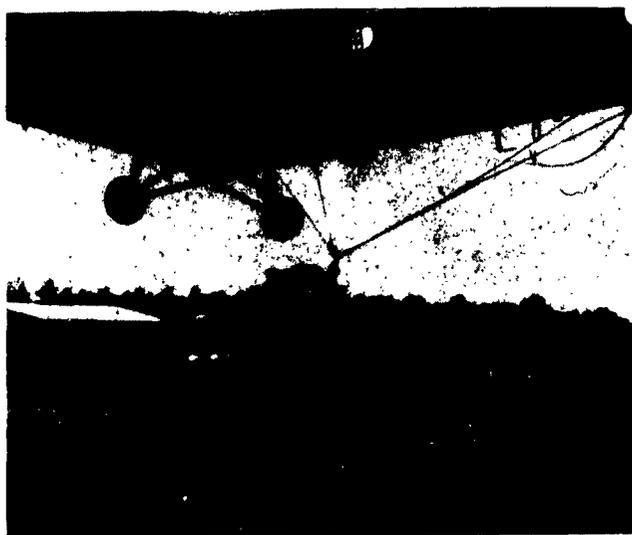
Figure 20. CH-21 unsuccessfully attempting to lift the Marsh Screw Amphibian.

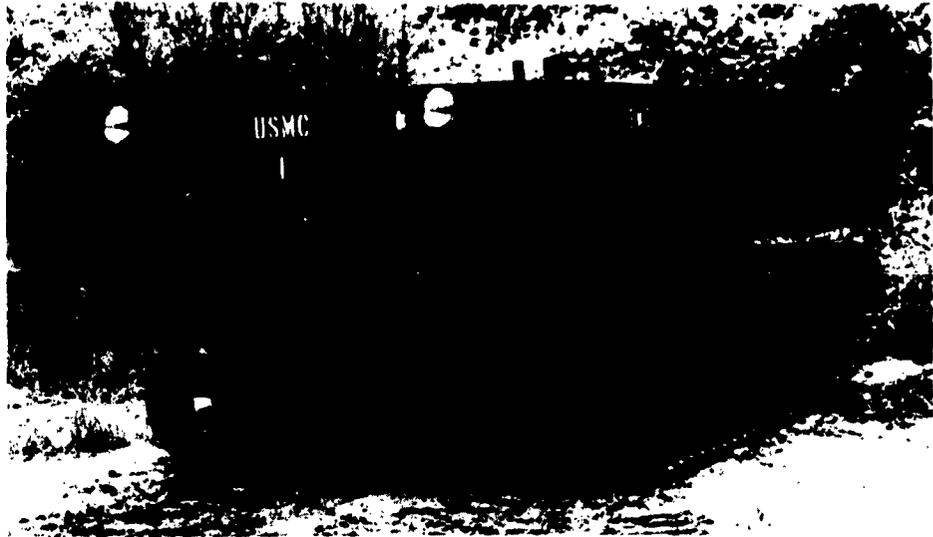
Figure 1. Swamp Spryte Amphibian.

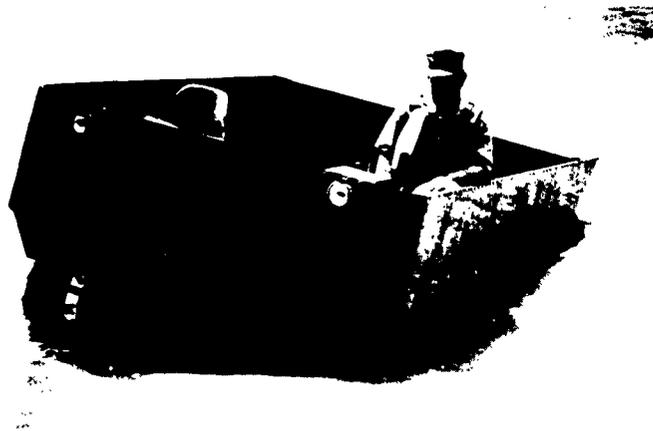
Figure 2. The Swamp Spryte immobilized due to the soft mud bottom of the Appomattox River.
