EXPERIMENTAL AND THEORETICAL  
ASPECTS OF LIQUID  
METAL EMBRITTLEMENT

December 1964

U. S. Army  
Ballistic Research Laboratories  
Aberdeen Proving Ground, Maryland

Martin Company  
Orlando, Florida

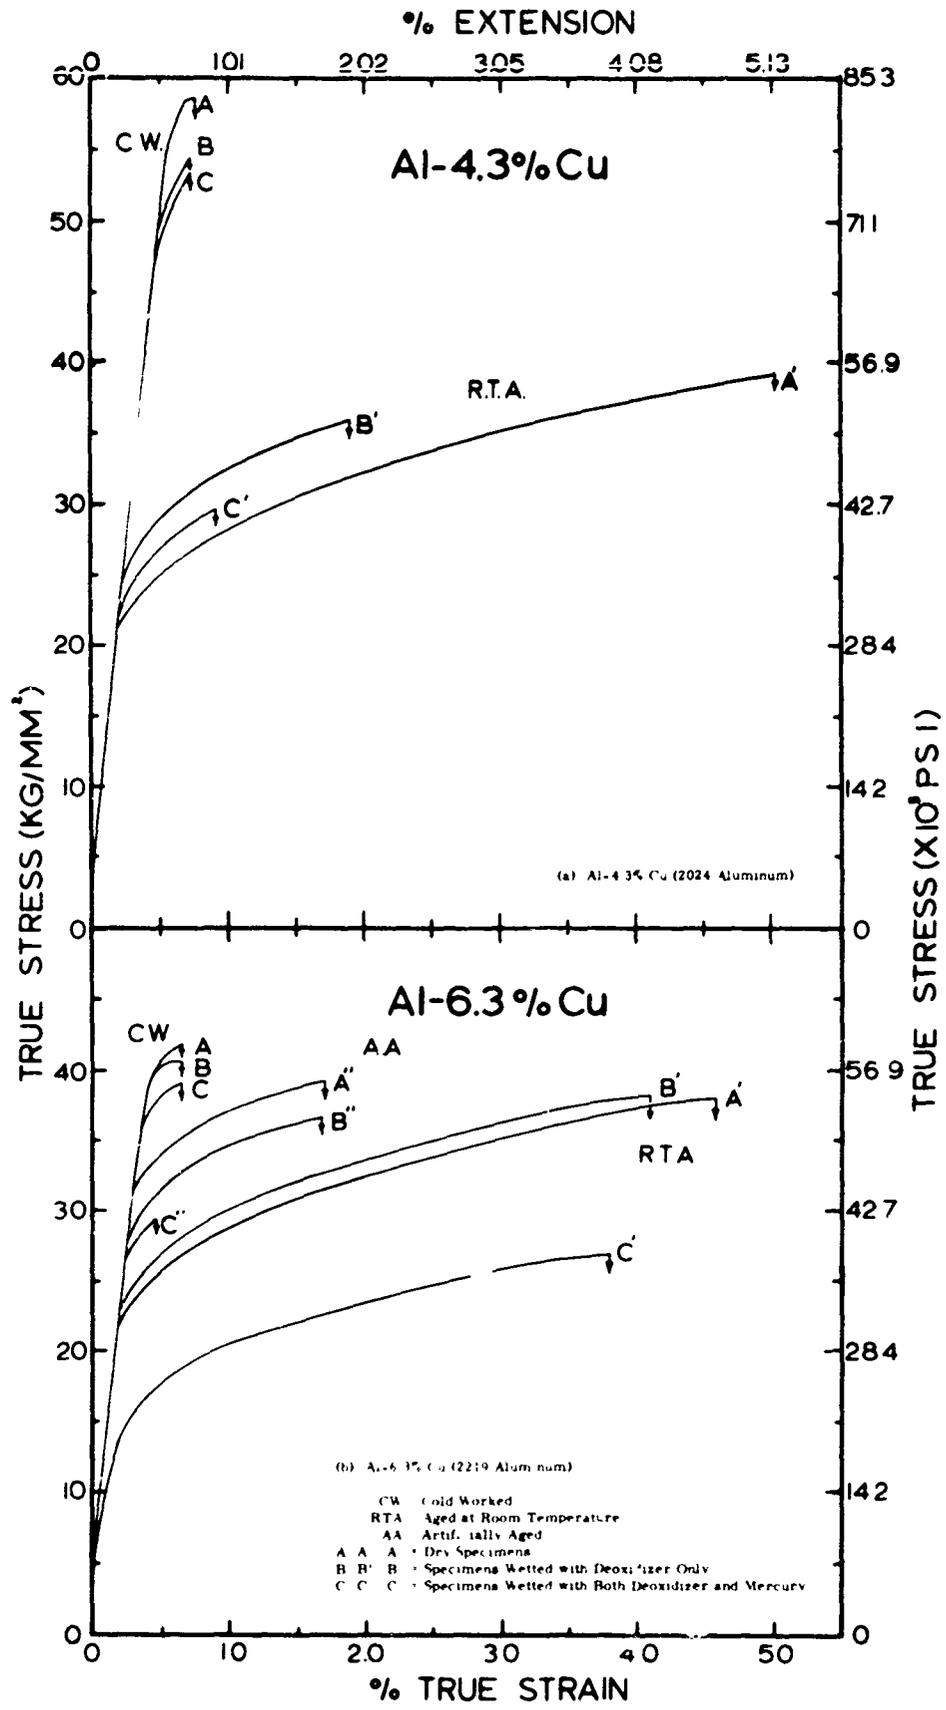
Figure 1. Effect of Thermal-Mechanical Treatment on Embrittlement by Mercury at Room Temperature of Two Aluminum-Copper Alloys Tested in Tension

The results of the tensile tests for the aluminum alloys and the brass specimens, heat treated in various ways and tested in the wetted and unwetted conditions, are shown in the true stress-strain curves of Figures 1 and 2. Critical points from these curves are summarized in Tables II and III, and discussed briefly below.

The slight variations between the yield points of wetted and unwetted specimens subjected to the same heat treatment (Figures 1 and 2, and Table III) must be viewed with reserve. The results are preliminary since they are based on an insufficient number of tests. To establish a standard of deviation for the yield point values, further tests are necessary, which will determine whether or not the differences observed are within the experimental scatter. Other investigators (References 4 and 5) have reported no effect on the yield point of materials exposed to liquid metal. Although the difference in the yield point is sometimes positive and sometimes negative (Table III), the effect, if real, could be discussed in terms of the liquid metal influencing the release or unpinning of dislocations at the yield point (Reference 6). Such a discussion is best delayed till more data are gathered.

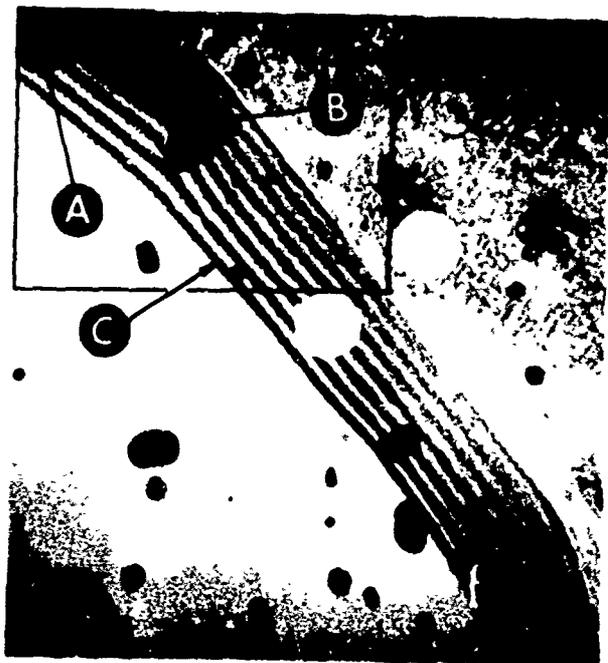
Figure 3. Transmission Electron Micrographs of Al-4.3% Cu (2024 Aluminum) After Solution Treatment (540°C, 45 Minutes, Water Quenched to 0°C) and Aging at Room Temperature for More Than Two Days

(a) Typical grain boundaries (A), and precipitates (B, C), lying at different orientations relative to foil surface 0.5  $\mu$

(b) Helical dislocations (A), and precipitates (B) 0.25  $\mu$

(c) Bright-field transmission electron micrograph of precipitates (A) and (B) lying within a high-angle grain boundary (C) 0.5  $\mu$

(d) Dark-field image of Figure 3(c). (A), (B), and (C) represent by a reversal of phase contrast, the dark field image of the correspondingly labeled objects in Figure 3(c) 0.5  $\mu$

Figure 3 shows transmission electron micrographs of Al-4.3% Cu after the AA treatment. The precipitates appear to be cylindrical in shape, as may be seen from (B) and (C) in Figure 3(a). Figure 3(b) shows, in addition to the precipitates (B), helical dislocations such as (A), which have been interpreted as resulting from condensation, during quenching, of vacancies onto dislocation lines.

Although precipitates in the Al-4.3% Cu alloy, such as those shown in Figure 3(a) and 3(b), have been observed in aluminum-copper alloys of similar composition (Reference 7), the possibility that these structures may be due to surface contamination was investigated by taking bright- and dark-field micrographs of the same area (rectangle in Figures 3(c) and 3(d)) containing the precipitates. A partial reversal in contrast for the precipitates marked (A) and (B) in Figures 3(c) and 3(d) indicates strongly, but not conclusively, that these structures are probably true precipitates and not surface contamination. However, other experimental tests are available and will be applied in future experiments to determine the true nature of the precipitates.

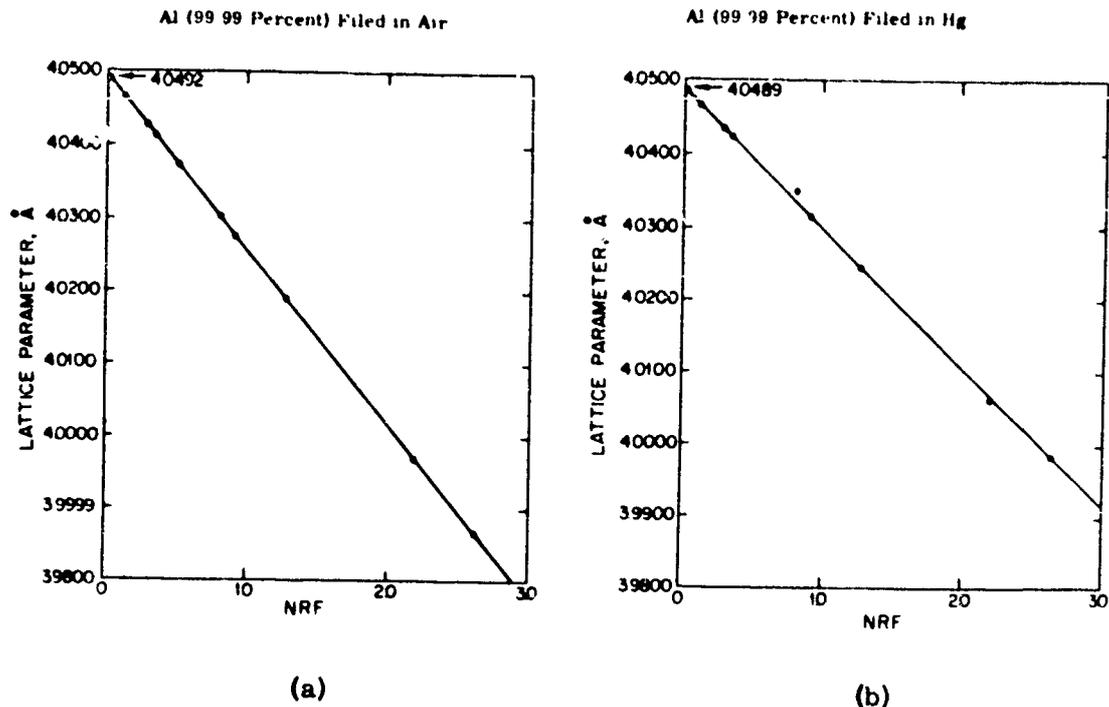
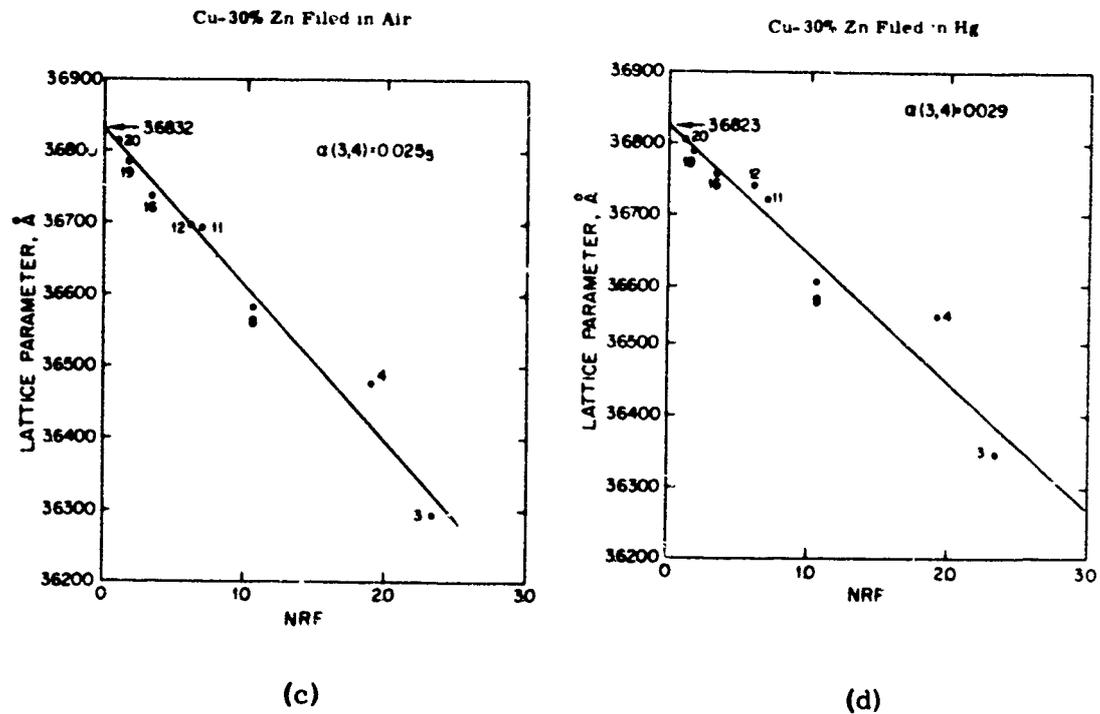
$$NRF = \frac{1}{2} \left( \frac{\cos^2 \theta}{\sin \theta} + \frac{\cos^2 \theta}{\theta} \right)$$
 is the extrapolation function;  $\theta$  is the Bragg angle

$\alpha(3,4)$  = Stacking fault probability obtained from the change in separation of lines 3 and 4

Figure 9. Effect of Filing Under Mercury at Room Temperature Instead of in Air on Lattice Parameters of Aluminum (99.99 Percent Pure) and Alpha-Brass (Cu-30% Zn)

where  $\theta$  is the Bragg angle. The corrected lattice parameter is obtained by extrapolation to zero for this function. In the case of zinc, two lattice parameters,  $a_0$  and  $c_0$ , are involved, and their calculation is less straightforward. A least squares analysis (Reference 15) was therefore adopted and programmed on an IBM 7094 computer to calculate from the observed diffraction peak positions the lattice parameters of the zinc specimens filed in air and in mercury.

While the lattice parameters of aluminum and alpha-brass appear to have been reduced by an amount outside the range of experimental error, those of zinc seem to have increased. The zinc data were obtained from a pattern that also included reflections from a hexagonal zinc-mercury compound formed when zinc is filed in mercury. Of the total of 22 reflections, only seven could, with reasonable confidence, be identified as belonging to zinc. Hence, the relatively large lattice parameter changes calculated from the zinc data are considerably less reliable than those obtained from the other two FCC materials, which exhibited lattice parameter changes in the direction postulated. However, there is a possibility that cannot be dismissed at present that the observed changes may have been caused by the mercury atoms entering into solid solution with the
