**BAK-14/F32 RETRACTABLE CABLE SUPPORT
SYSTEM**

TECHNICAL REPORT ASD-TR-69-9

AUGUST 1969

DEPUTY FOR ENGINEERING
AERONAUTICAL SYSTEMS DIVISION
AIR FORCE SYSTEMS COMMAND
WRIGHT-PATTERSON AIR FORCE BASE, OHIO

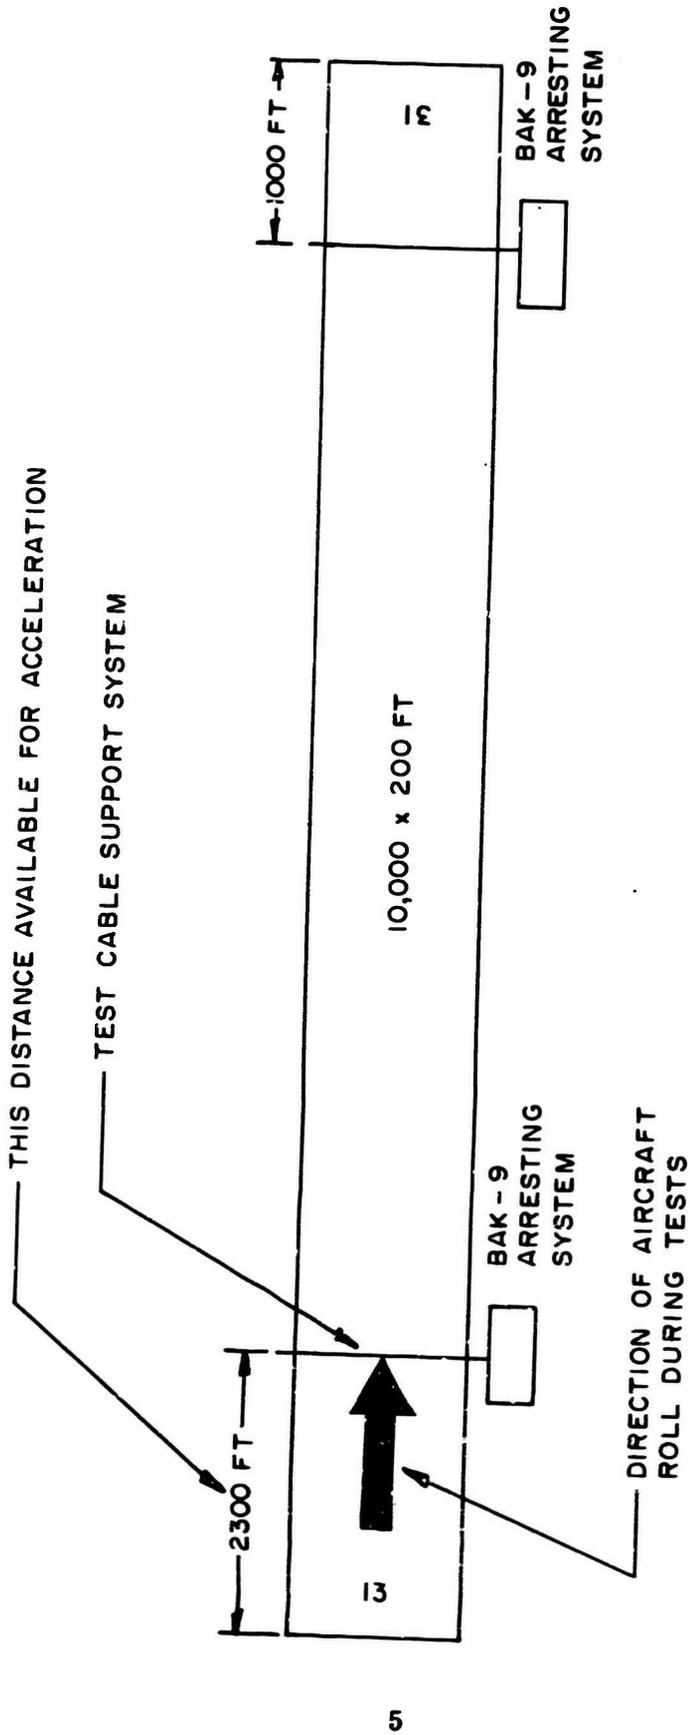
Figure 2. Test Runway at NAFEC

All tests were conducted at the approach end of runway 13 (Figure 2). This location provided a 2,300 foot acceleration distance and 7,700 feet deceleration distance in the event of a missed engagement. As an additional safety factor, the far end arrester was available as an emergency arresting system.

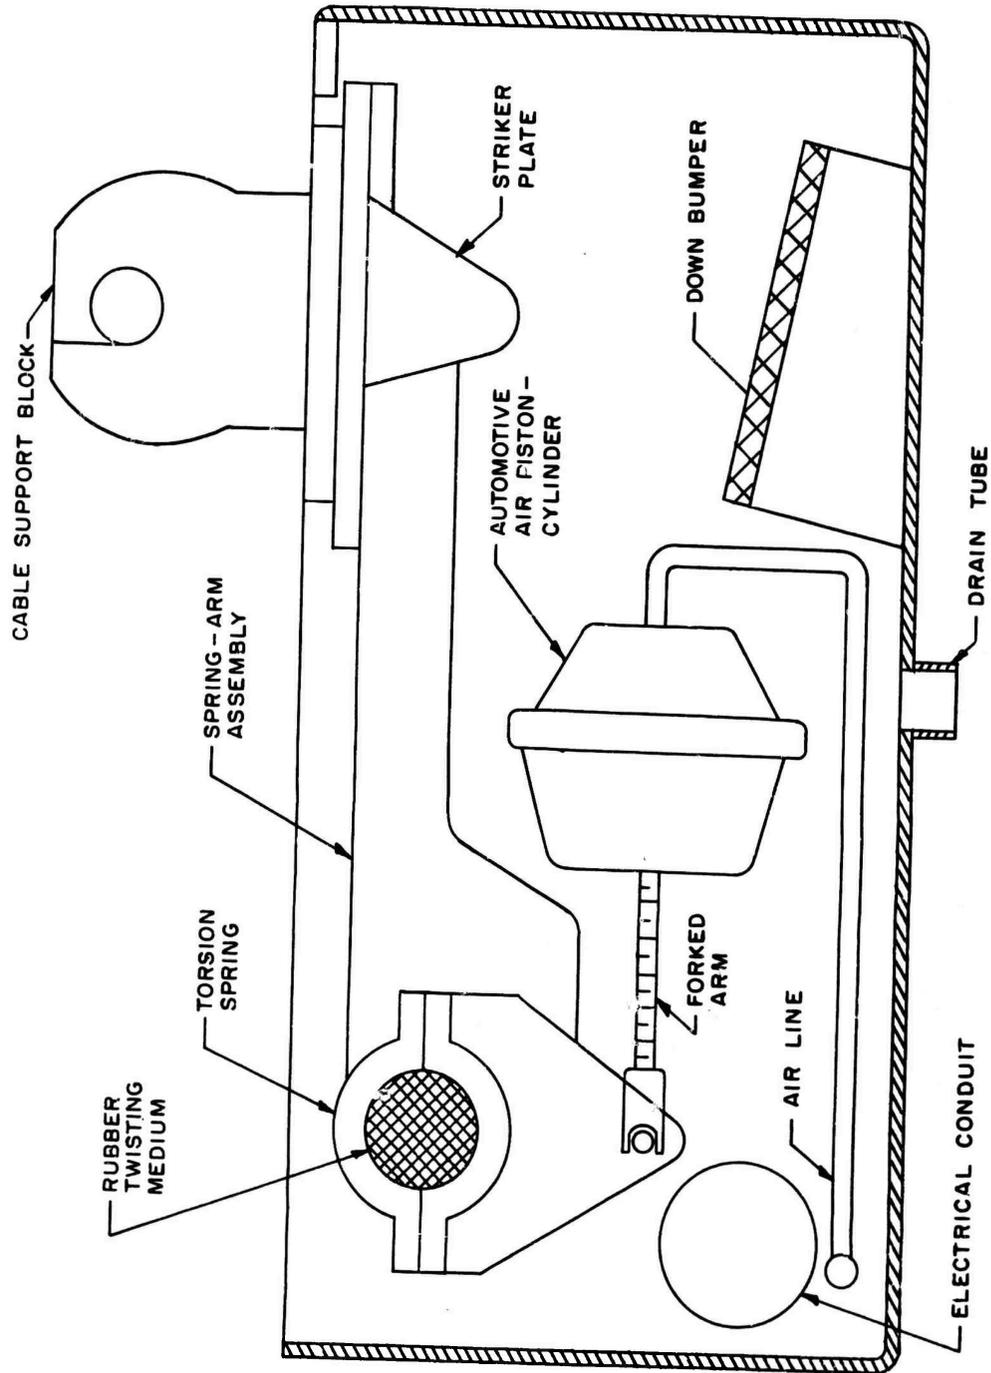
Figure 6. Schematic Sketch of Cable Support Box

A schematic diagram of a single support box can be seen in Figure 6. The block that held the cable (referred to as the cable support block in this report) was mounted on a lever arm (spring-arm assembly) which pivoted about a rubber torsion spring. In order to retract the supports when not in use, air was remotely applied at a pressure of 125 psi via a solenoid actuated valve to a commercially available automotive air piston chamber and linkage. The rubber torsion bar provided the force to raise the supports when the air pressure was released, either intentionally or because of a malfunction. This feature always assured that the raised or fail-safe position was available in the event of equipment failure. Limit switches, installed on the spring-arm assembly indicated the raised (up) or retracted (down) positions for each support. The system could be either radio or wire controlled to raised or retracted position from either the control

The down bumpers were a 1/2-inch thick 40 durometer neoprene rubber pad (Figure 6) which was designed to absorb the energy of an aircraft rolling over the raised or retracted cable. Due to the electrical failure which raised the system, the impacts of heavyweight and high speed aircraft rolling over the system caused problems in the support boxes. The down bumpers in the center 12 boxes were partially damaged (Figure 20) because they weren't designed to absorb this much energy.

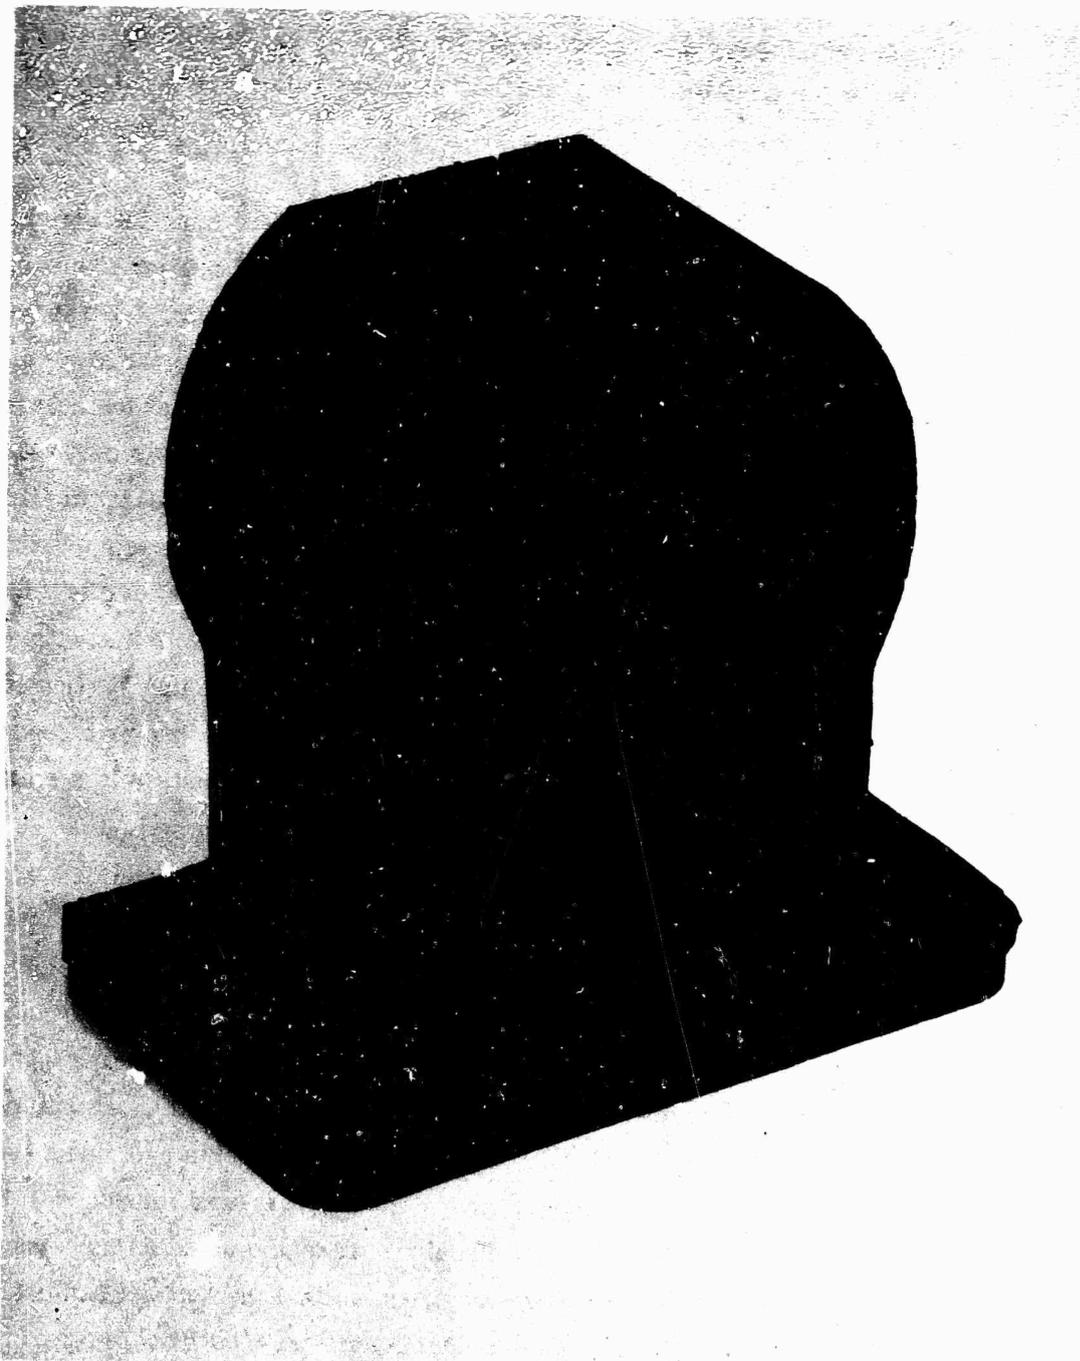
Figure 7. Type A Cable Support Block

In the raised position, the cable support blocks (Figures 7, 8, and 9) firmly retained the cable 2-1/2 inches above the runway surface and shedded it during an arrestment. Type A supports had a tough, solid neoprene rubber construction (50 durometer hardness). They were three inches wide and extended five inches above the runway surface in the raised position. They were attached to the spring-arm assembly with clamps and four bolts. Type B supports had a neoprene construction (50 durometer hardness) and a metal plate was imbedded in its base for extra strength. The major dimensions were the same as the Type A supports. The "nose" on the block was designed so that the support had better cable retention than the Type A supports during spin-up. The front hooked onto the runway edge (Figure 10). The Type C supports (60 durometer hardness) had the same internal construction as Type B, but they were designed to break-away under severe spin-ups, instead of retaining the cable when heavy spin-ups occurred (Figure 11). The breakaway donuts then supported the cable. This support was only two inches wide. All the blocks were readily replaceable when

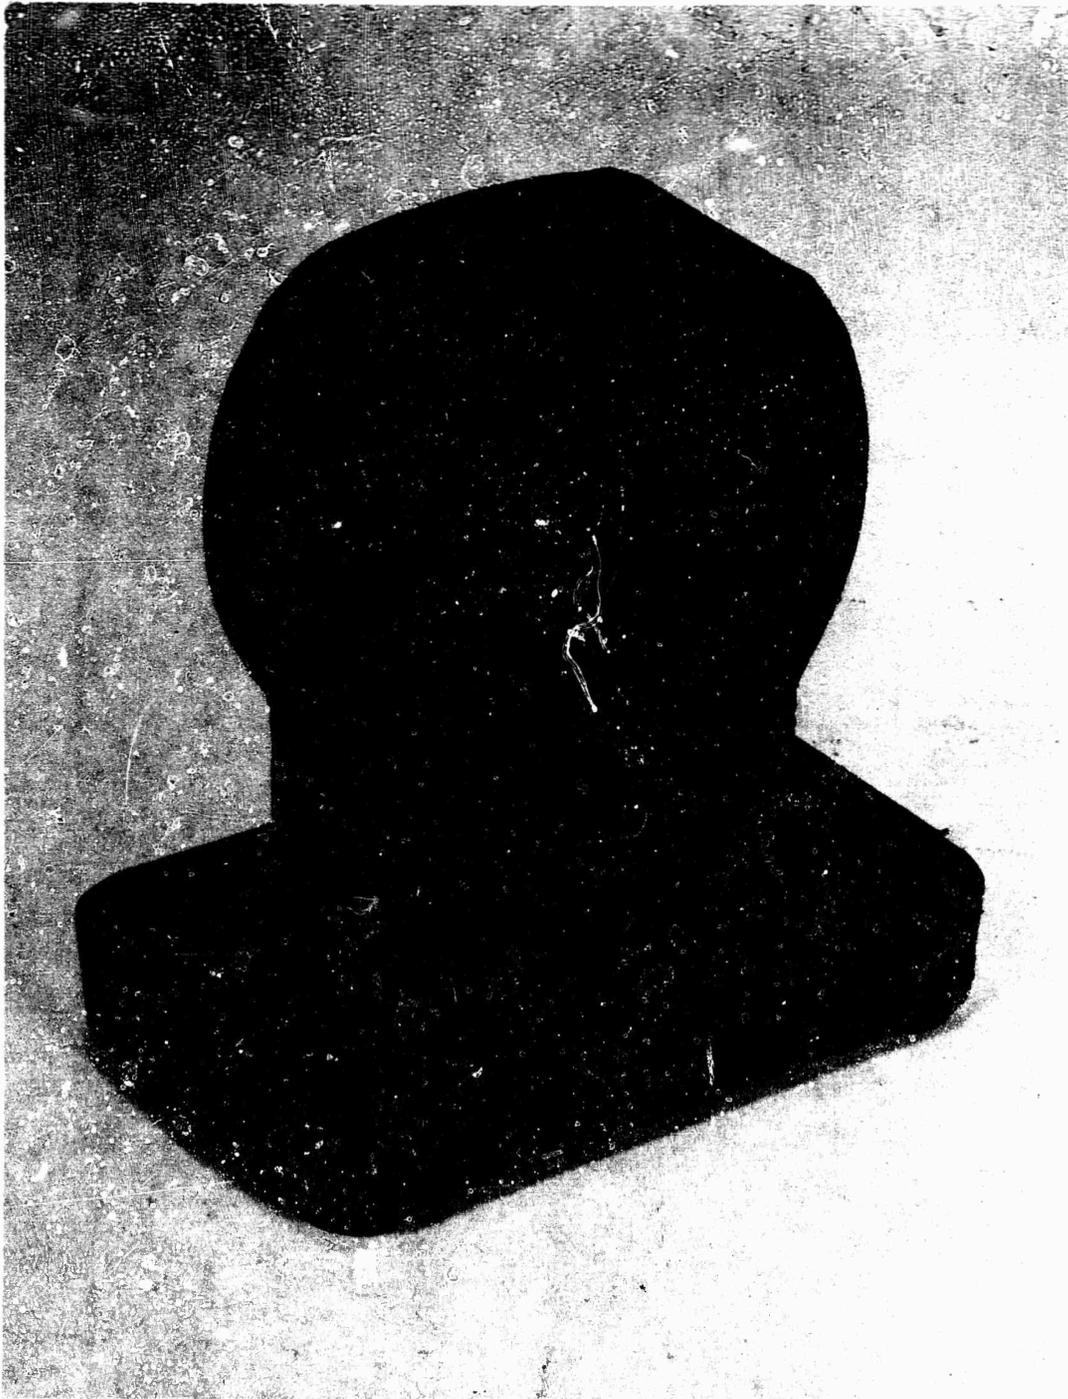
Figure 9. Type C Support Block

As a result of this failure, it was decided to test the system with different support blocks which would have increased cable gripping characteristics (Appendix II). Type B (Figure 8) and Type C (Figure 9) supports were thus developed and tested in Phase II. It should be noted that during the six month interval between the Phase I and Phase II tests the system was returned to the standard donut supports. During this time period a groove had been worn across the middle half of the runway with a mean depth of $3/4$ inch and a maximum depth of $1\ 1/4$ inches.

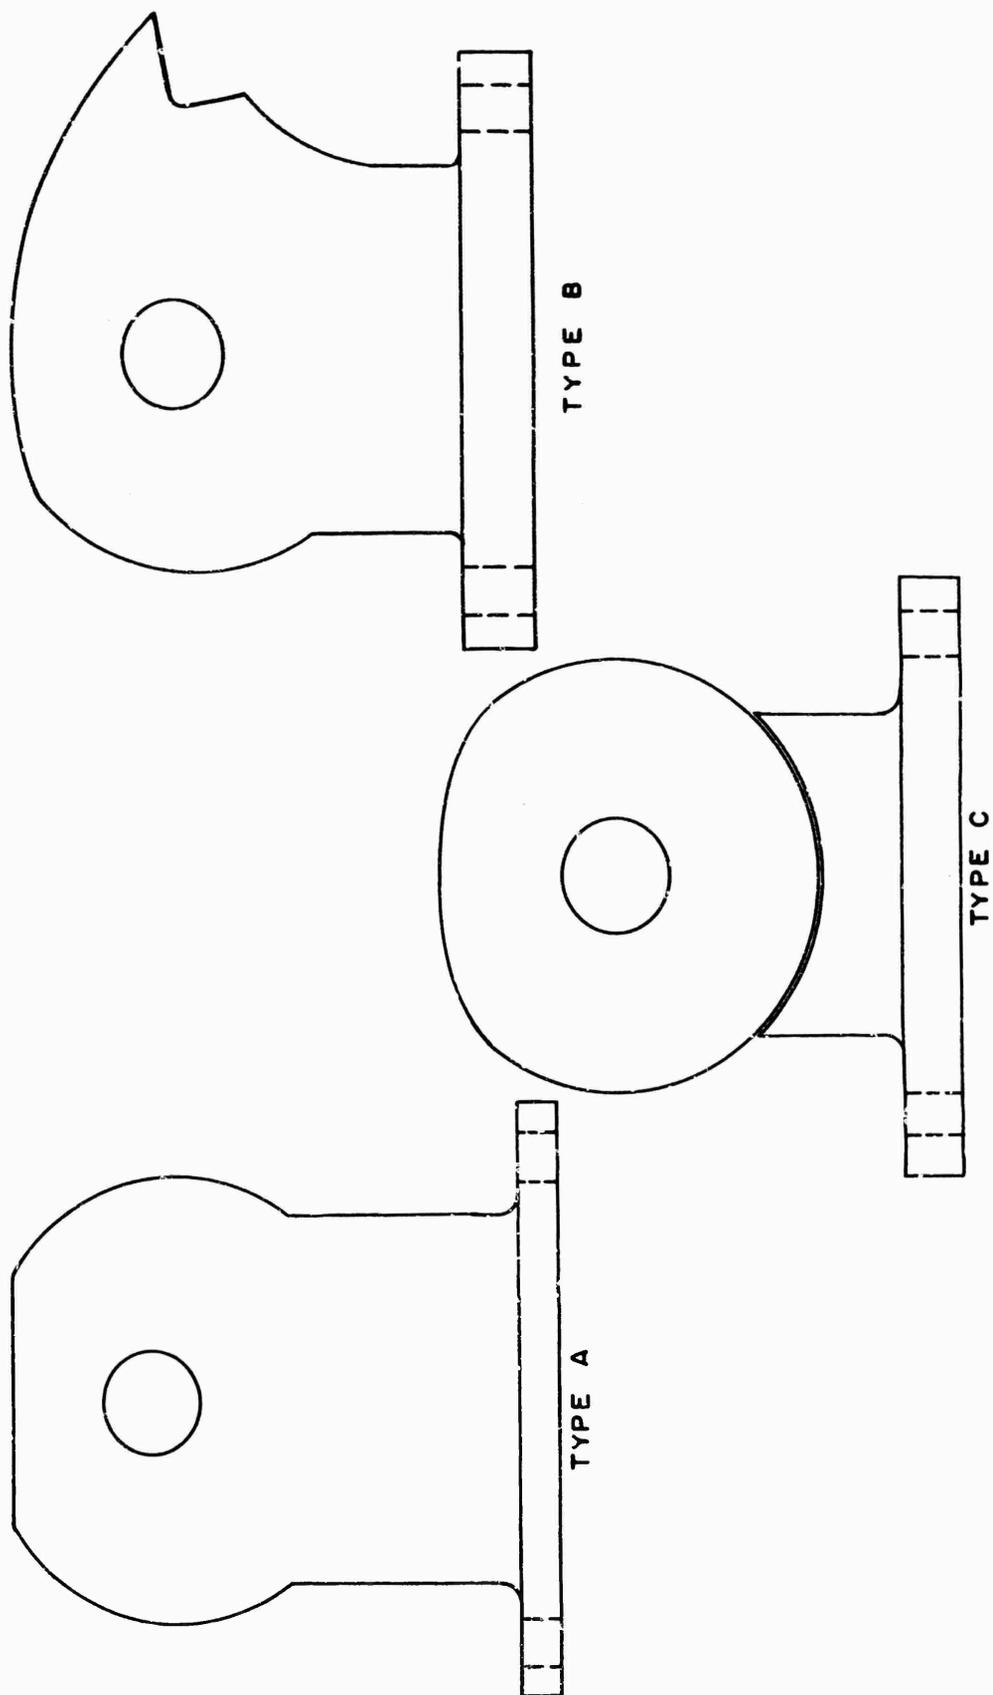
Figure 12. Sketches of Support Blocks

To solve the spin-up problem, various block designs (Figure 12) were studied, but all configurations were inadequate. Type A supports were primarily designed to support an arresting cable for hook engagements, with minor concern being given to spin-ups. The Type A blocks were excellent cable supports, but during spin-ups their leading edge was too weak to resist the heavy impact loads and the cable was easily able to roll out of the supports. The Type B supports were designed so that the block's leading edge would be restrained from moving by hooking onto the edge of the support box (Figure 10). Based on static pull tests, these supports had a 50 percent greater cable retention capability than Type A (Appendix II). Under actual test conditions, the Type B blocks performed very well under spin-up, with only the supports on each side of the tires shedding the cable. Type C supports were designed to prevent cable shedding under most conditions; however, if cable shedding should occur, a part of the support would breakaway with the cable and support it until maintenance personnel could install new supports. In tests, these supports were unable to satisfactorily retain the cable, but in every case the breakaway portion separated from the block and supported the cable.

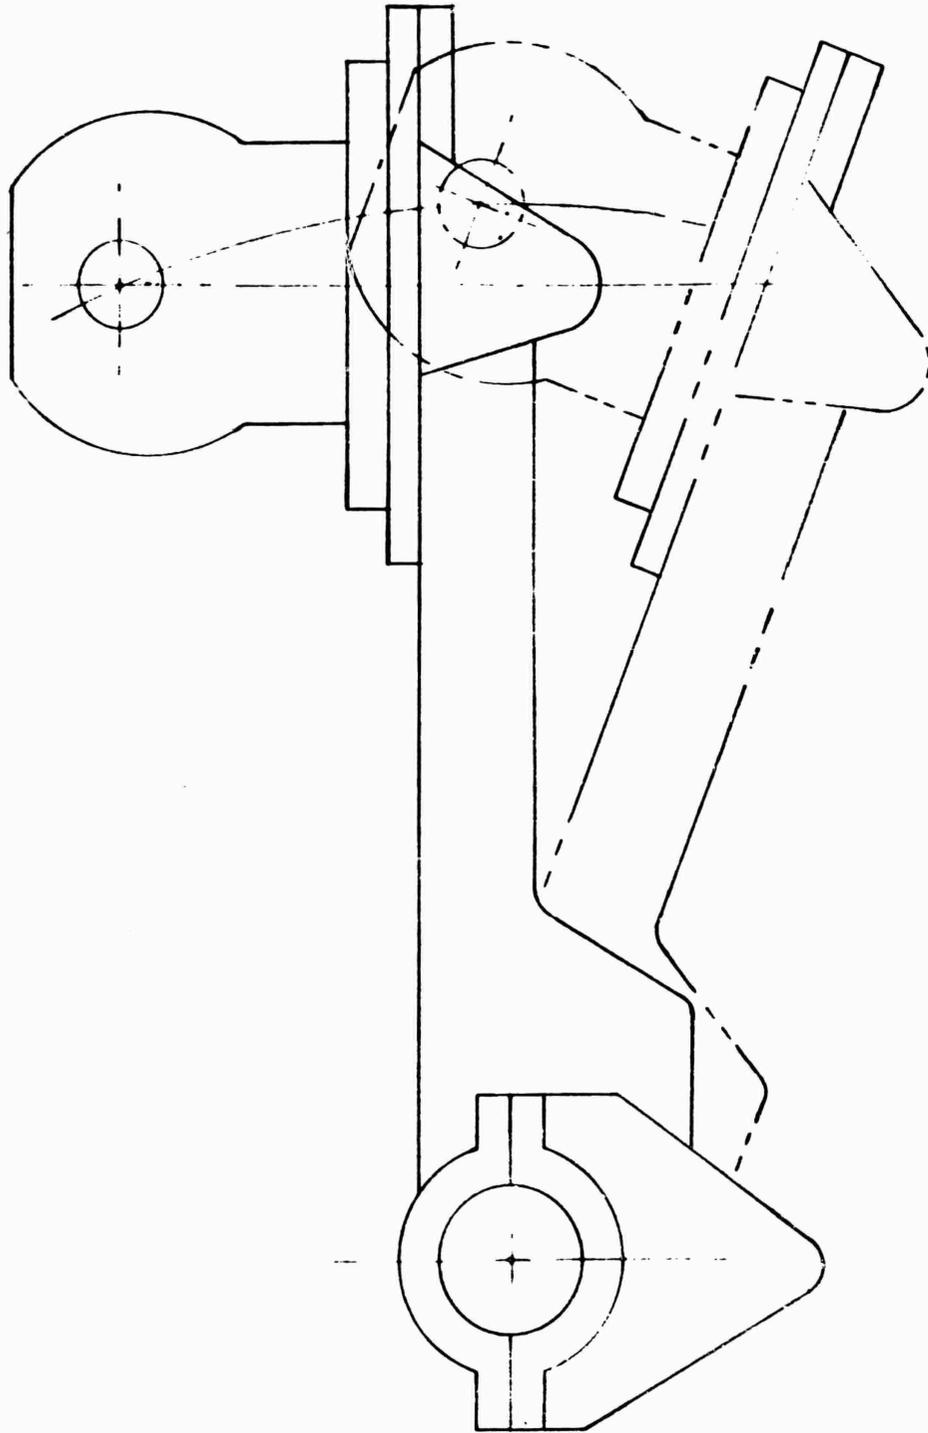
Figure 13. Off-Center Characteristics of BAK-14

It was believed that a cross-runway groove would work with this system because it was unique to any other grooved system. This uniqueness evolved because the support was located on a lever arm which pivoted about a fixed point and the centerline of the retracted cable was off-center from the centerline of the raised cable (Figure 13). The theory was that when the aircraft wheels rolled over the raised cable, the cable was thrown forward and then cable dynamics caused the cable to vibrate vertically along its extended centerline. Thus, if the slot's centerline was not in line with the cable centerline then the cable would not enter the groove.

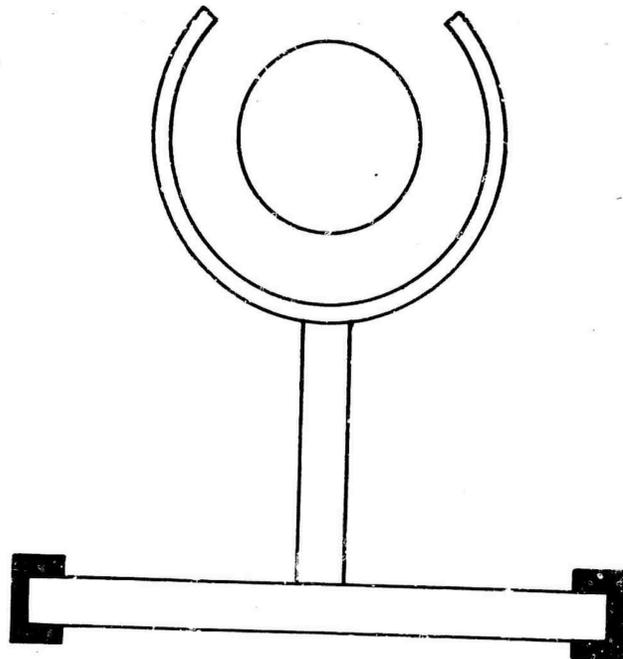
Figure 15. Schematic Sketch of Cable Support Block

Analysis of this problem revealed that the block anchorage to the spring lever arm was sub-marginal. The engaging characteristics of the supports can be depicted diagrammatically as a wine glass cross section attached at the extremities of its base (Figure 15). The action of the support during cable extraction was (Figure 16): the wine glass opened to release the cable and the support was bent and pulled severely on the aft anchorage. Blocks adjacent to the engaging point tore out at their aft anchor bolts, necessitating the replacement of two blocks after an arrestment.

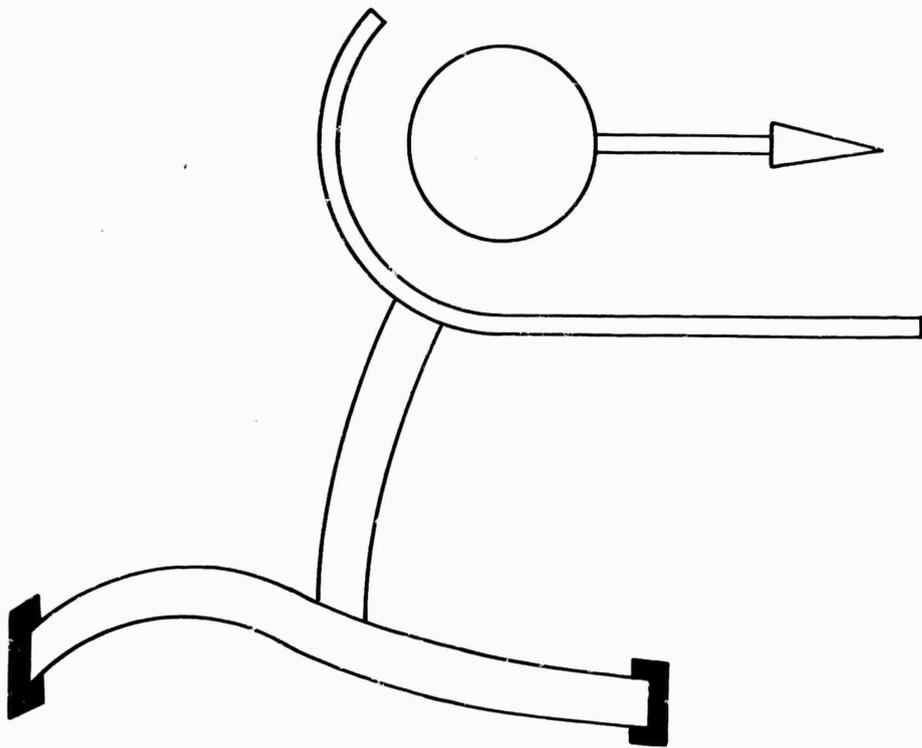
Figure 16. Schematic Sketch of Cable Being Pulled from Block

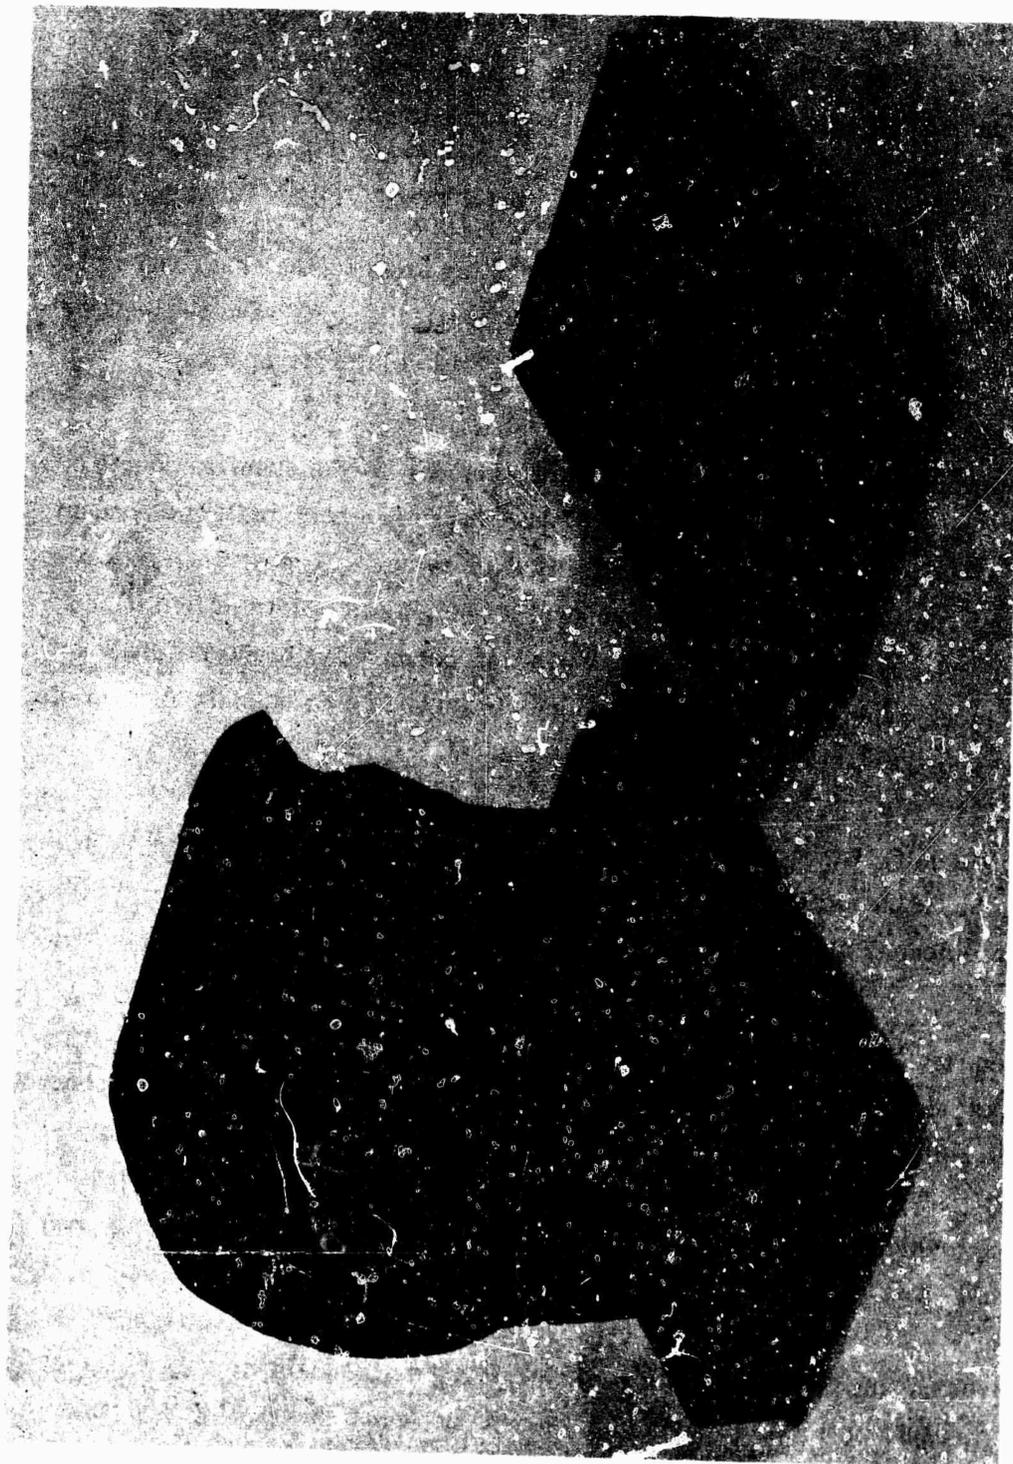
Figure 17. Type B with Separated Base Plate

The situation was remedied by imbedding a metal plate (Figure 17) into the bases of Type B and C blocks. This fix strengthened the base considerably

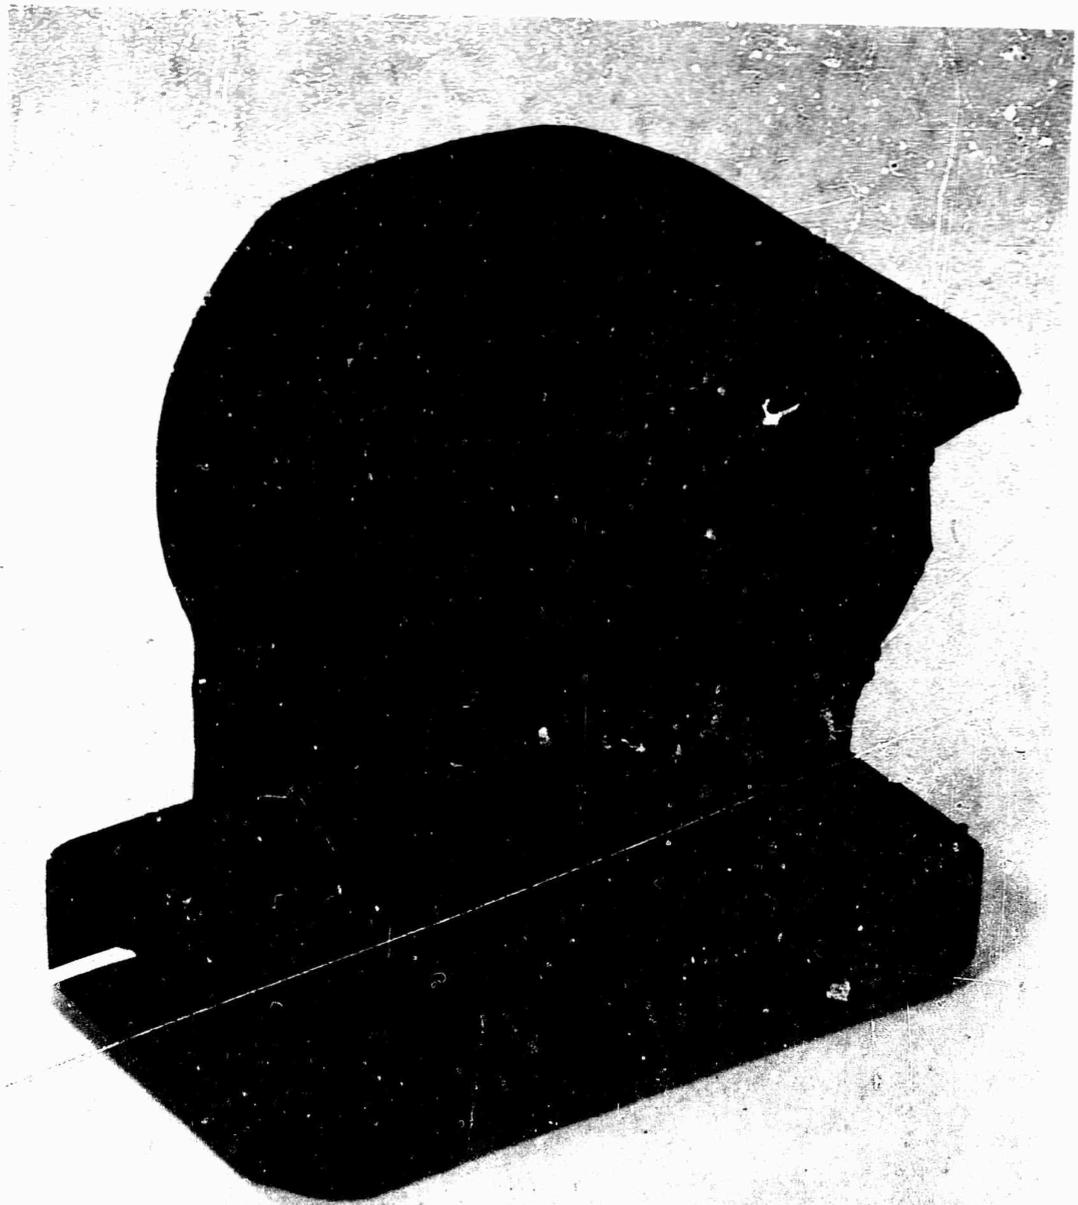
Figure 18. Type B Support with Fatigue Crack

so that the Type B blocks failed only because of fatigue in the block itself (Figures 18 and 19). At higher engaging speeds, the blocks failed by tearing apart at the fatigue cracks. The Type B supports which were newly installed for the high speed arrestments were not destroyed during the highest speed arrestments. It is believed that a softer rubber would better stand repeated arrests and not fail in fatigue until after many arrestments.

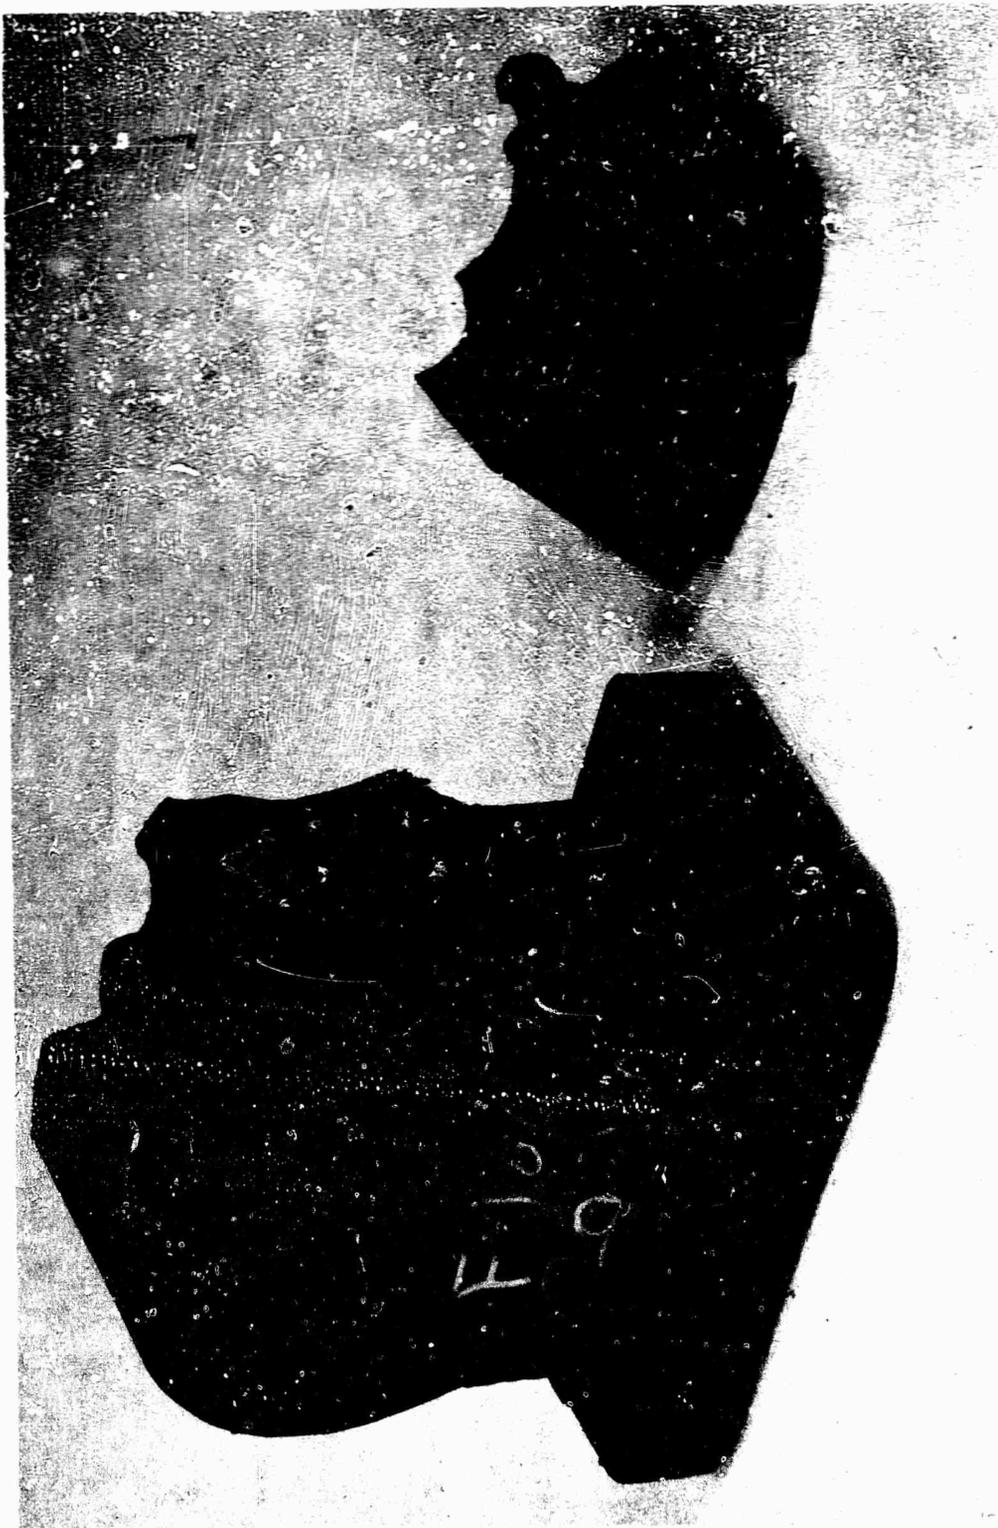
Figure 19. Type B Support Damaged by F-106 After 120 Knot Engagement

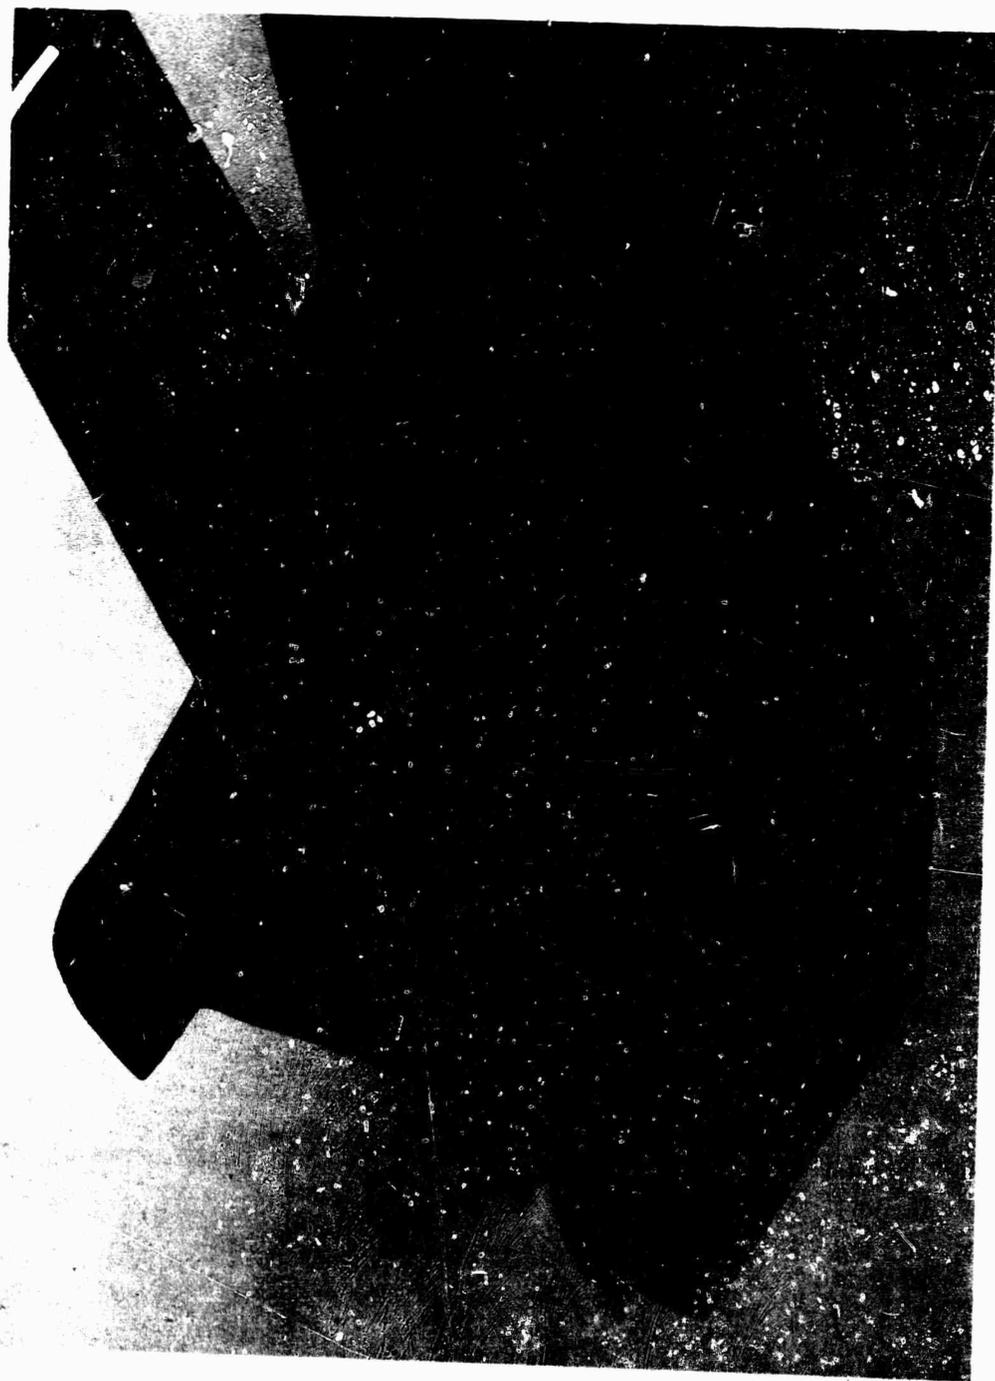
Figure 21. Striker Plate of Spring-Arm Assembly

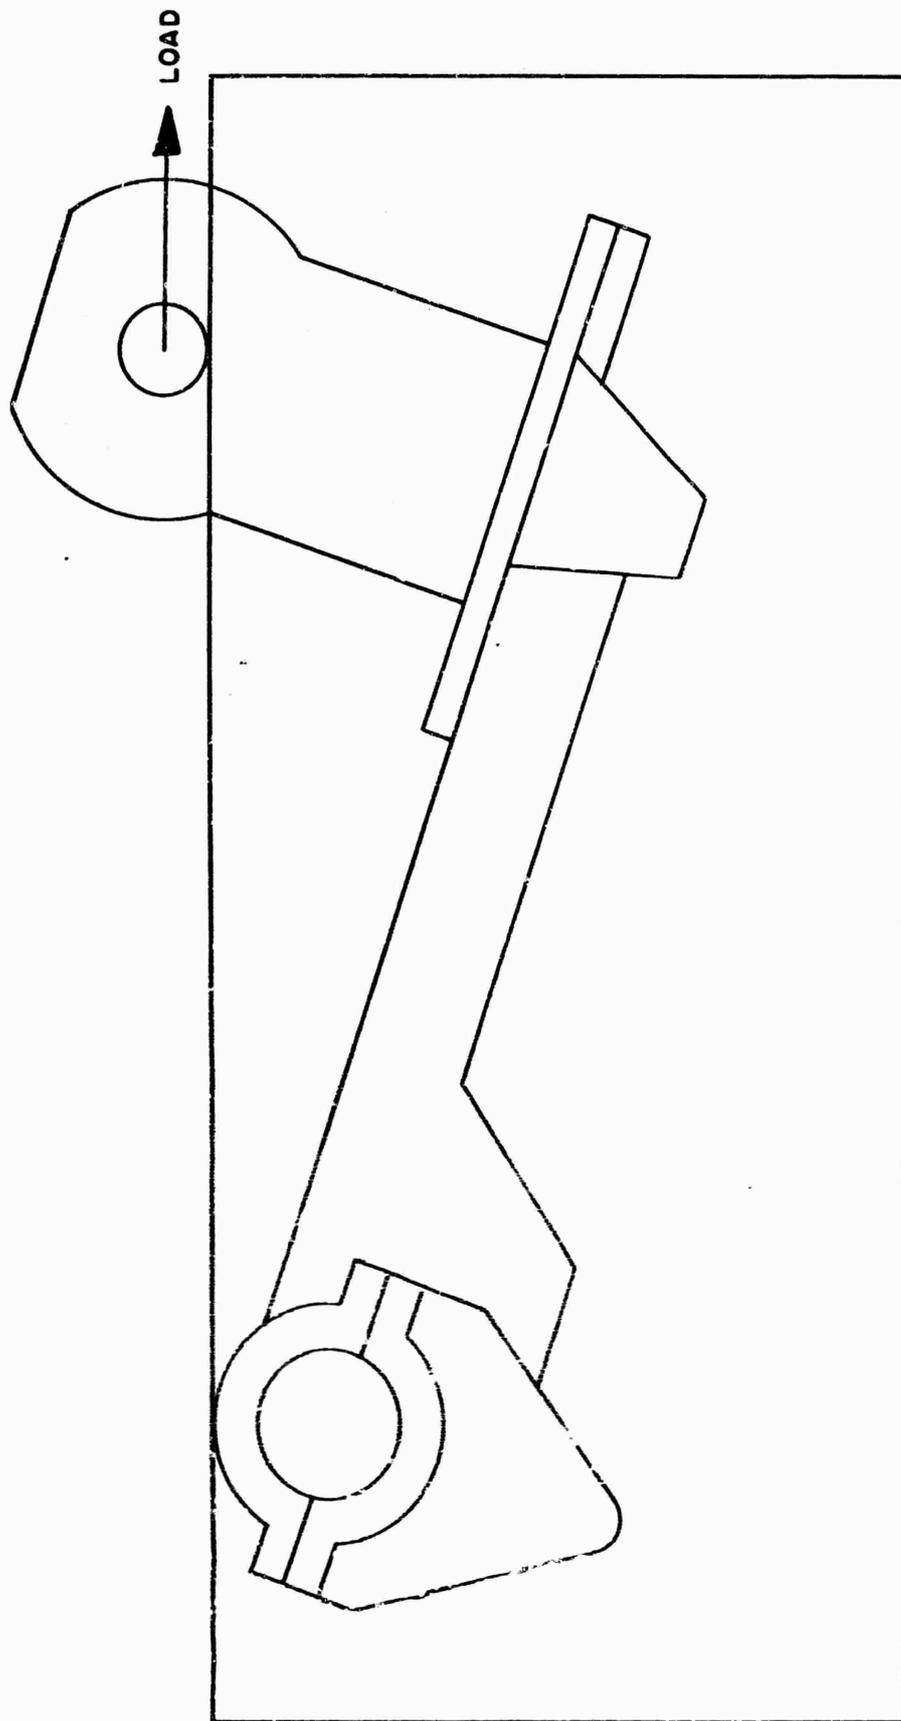
Figure 24. Static Test Set-Up

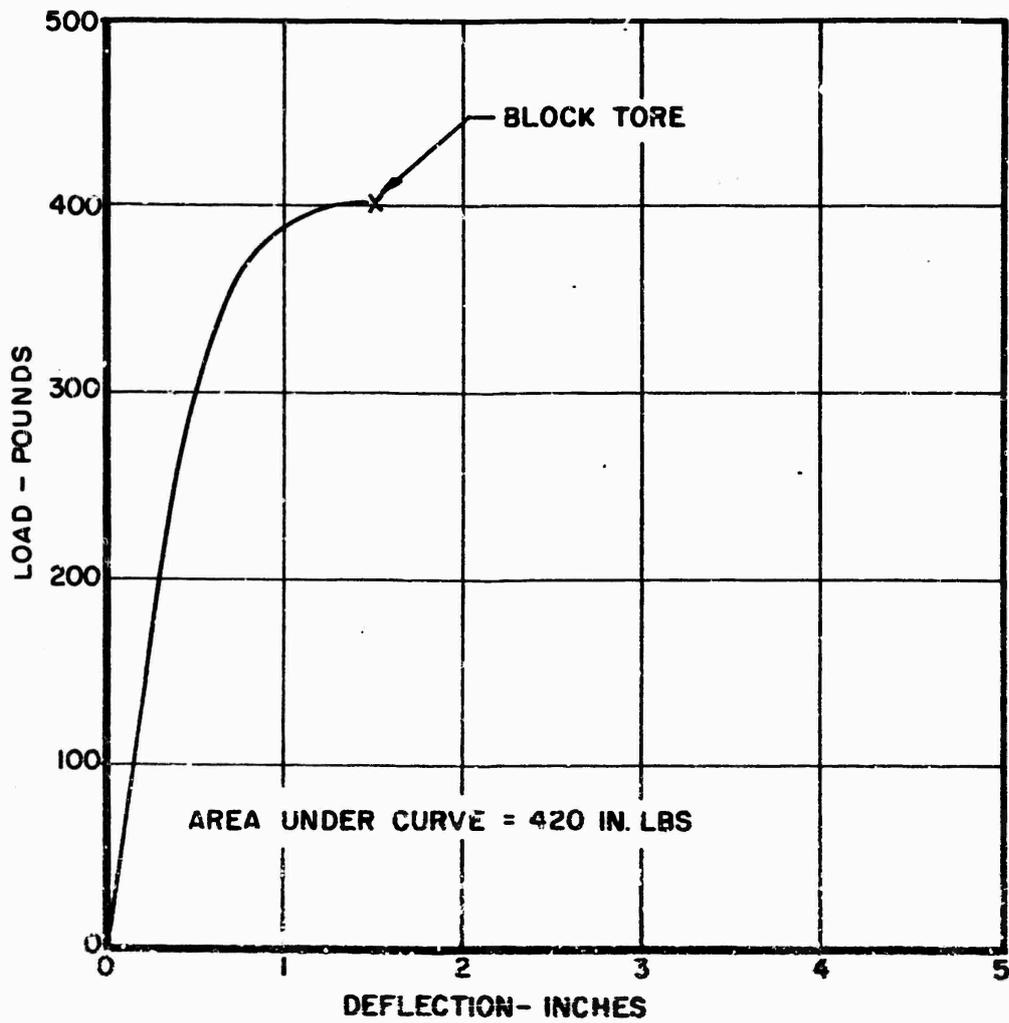
Figure 25. Deflection Curve for Slit Type A Support Blocks

The leading edge of the slit Type A support failed by tearing before 1 1/2 inches of deflection was recorded (Figure 25). This premature tear resulted because the block had been improperly cured. However, observation during the test indicated that it would have shed the cable even if it hadn't torn.

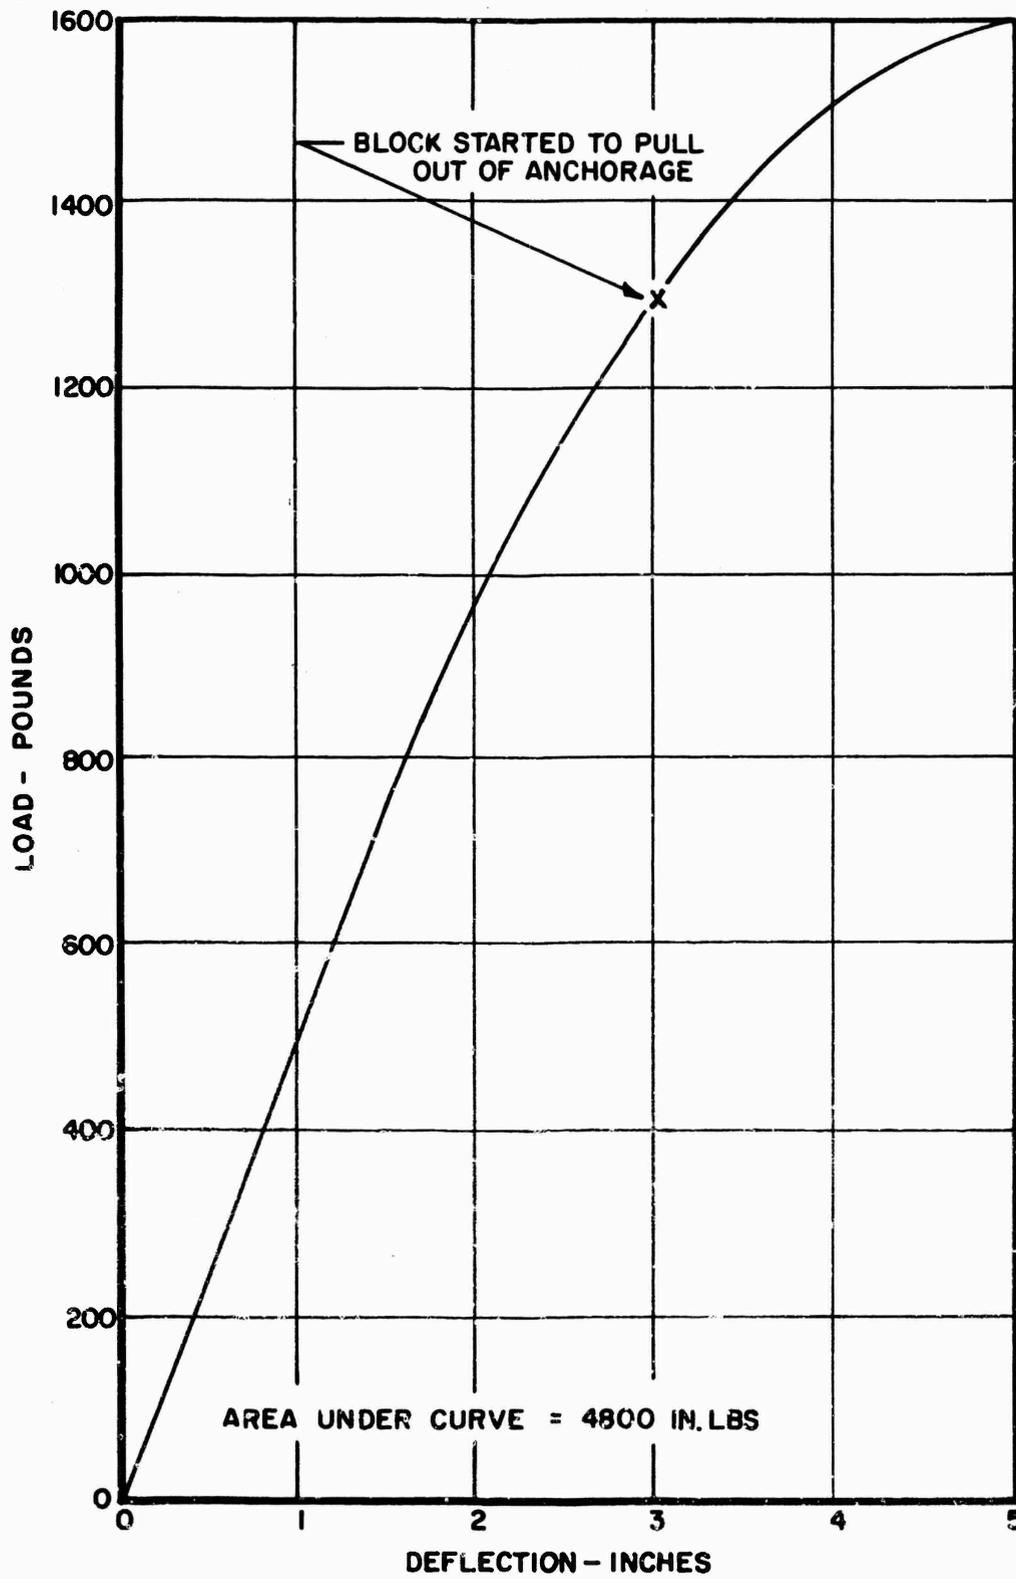
Figure 26. Deflection Curve for Unslit Type A Support Blocks

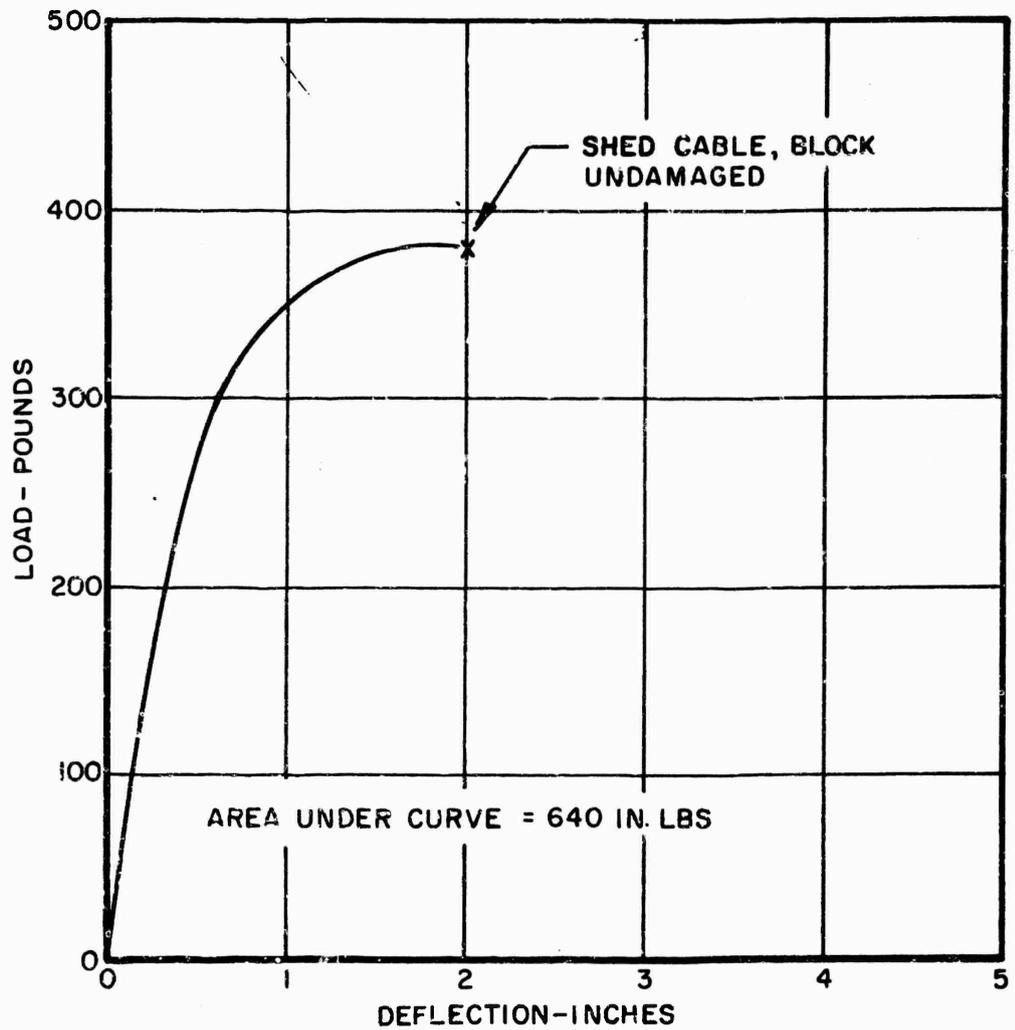
Figure 27. Deflection Curve for Slit Type B Support Blocks

The slit support was able to provide a 50 percent greater cable gripping characteristic (Figure 27) than the Type A supports.
