**BAK-14/F32 RETRACTABLE CABLE SUPPORT
SYSTEM**

TECHNICAL REPORT ASD-TR-69-9

AUGUST 1969

DEPUTY FOR ENGINEERING
AERONAUTICAL SYSTEMS DIVISION
AIR FORCE SYSTEMS COMMAND
WRIGHT-PATTERSON AIR FORCE BASE, OHIO

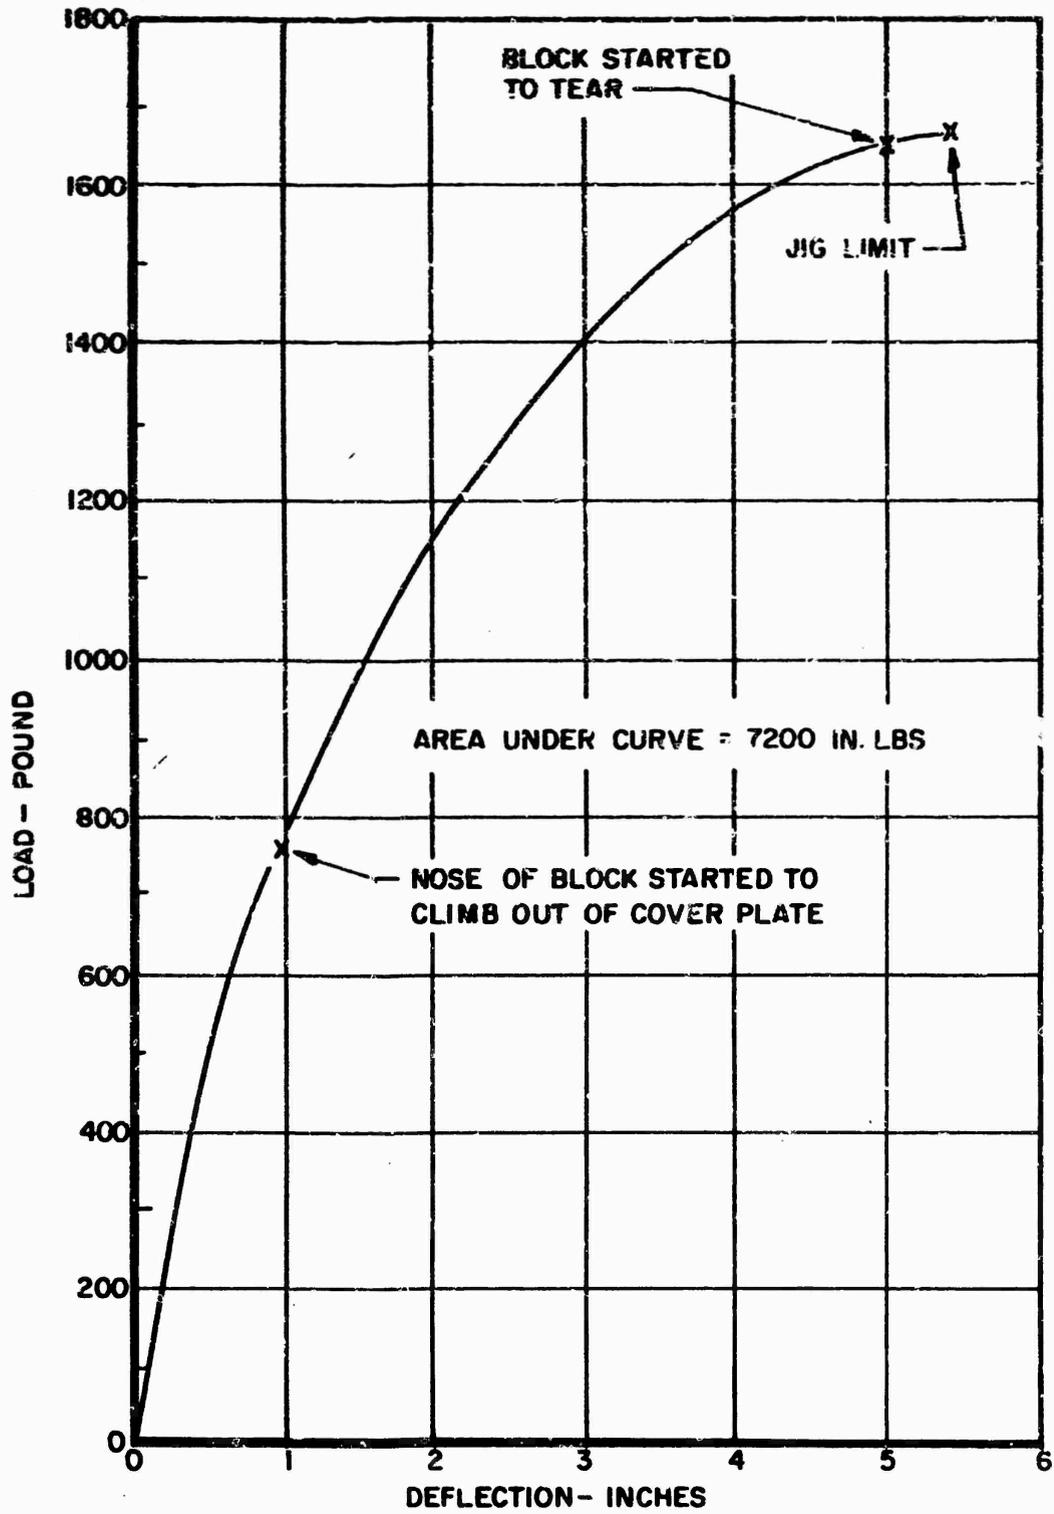
Figure 28. Deflection Curve for Unslit Type B Support Blocks

The unslit supports retained the cable after full deflection of the test fixture (Figure 28). Failure started by tearing the rubber on the tension side of the attachment plate. The tear propagated through the cylindrical portion of the neoprene and extended through the attachment plate, while

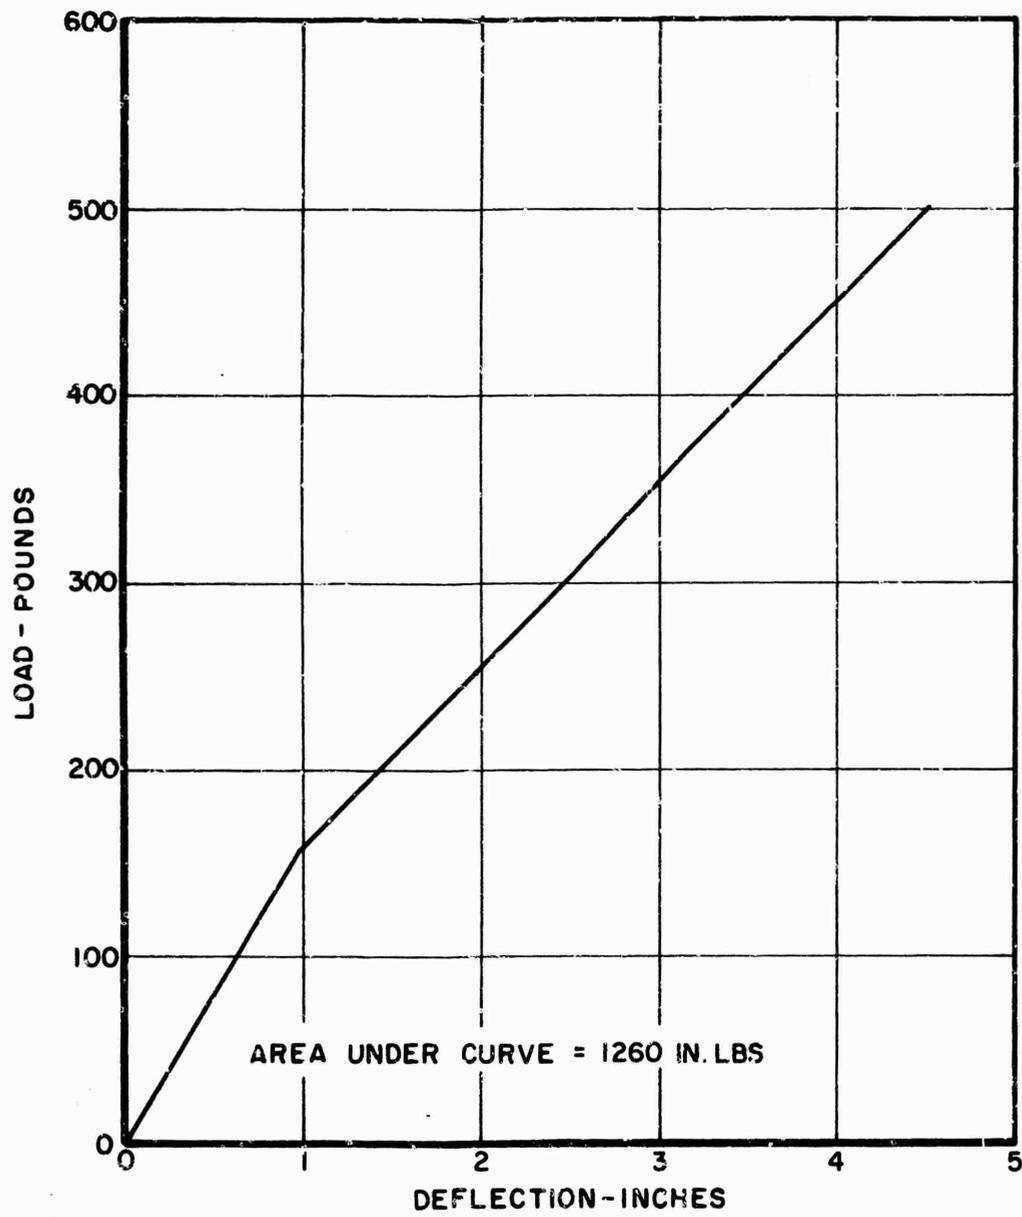
Figure 29. Deflection Curve for Slit Type C Support Blocks

With the sawcut added, the block flexibility was further increased and the failure occurred along the slot. When this failure started, it slowly progressed along the slot until it became complete. Thus a perfect donut was left. However, the price for achieving this failure is a sizeable reduction in holding power (Figure 29).

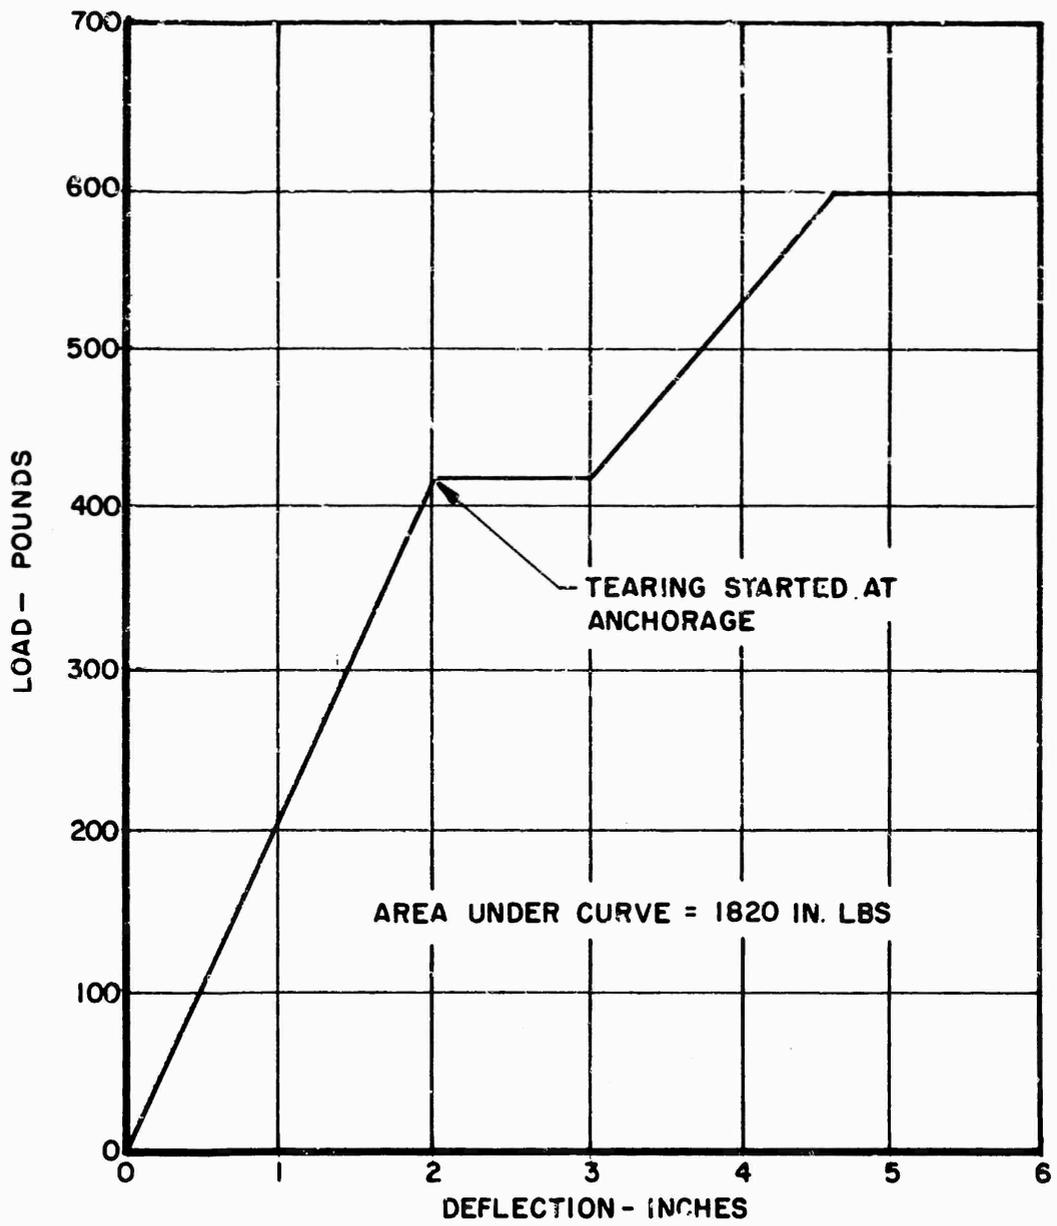
Figure 30. Deflection Curve for Unslit Type C Support Blocks

The uncut Type C support failed at its attachment plate, similar to the unslit Type B supports (Figure 30).

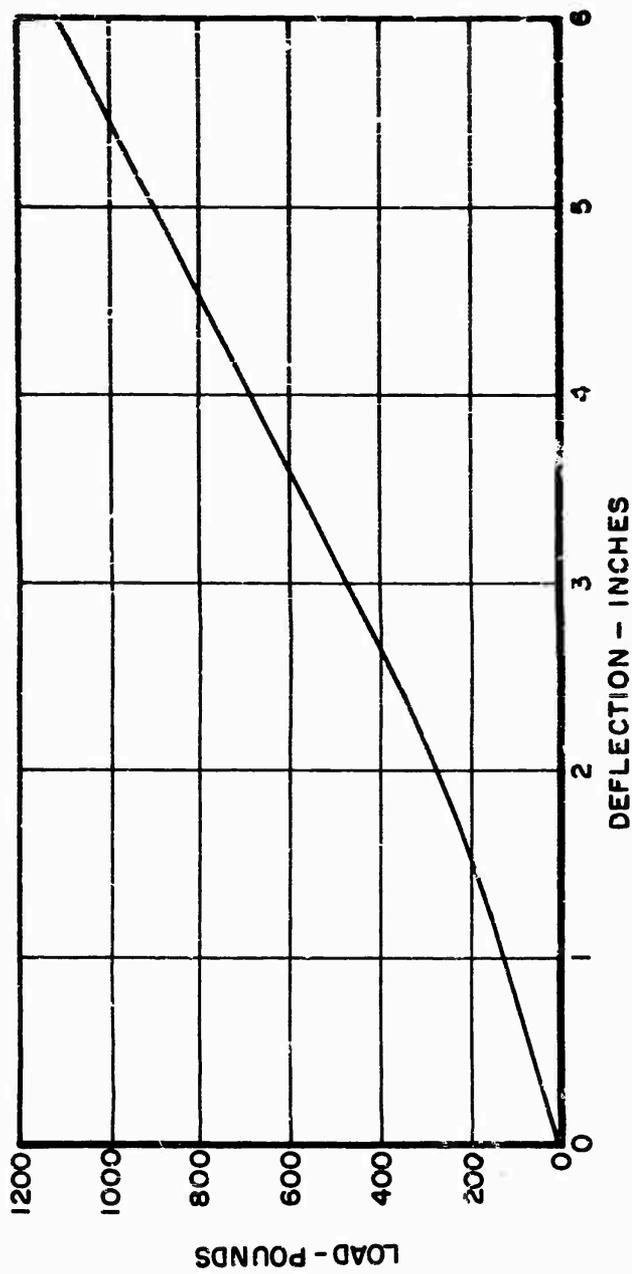
Figure 31. Deflection Curve for Polyurethane Type C Support Blocks

- a. The modulus of elasticity of the polyurethane was slightly lower than that of the neoprene, resulting in a more flexible block.
- b. The toughness of the polyurethane was far greater than that of neoprene. This can be reflected by the ratios of the areas under the load deflection curves. The area for the polyurethane support was greater than the closest neoprene support.
