CLEANING AND CHEMICAL TREATMENT OF AIRCRAFT SURFACES  
TO PROVIDE OPTIMUM CLEANING PROPERTIES

Final Summary Report  
(23 October 1967 to 23 October 1970)

Lockheed-Georgia Company  
A Division of Lockheed Aircraft Corporation  
Marietta, Georgia

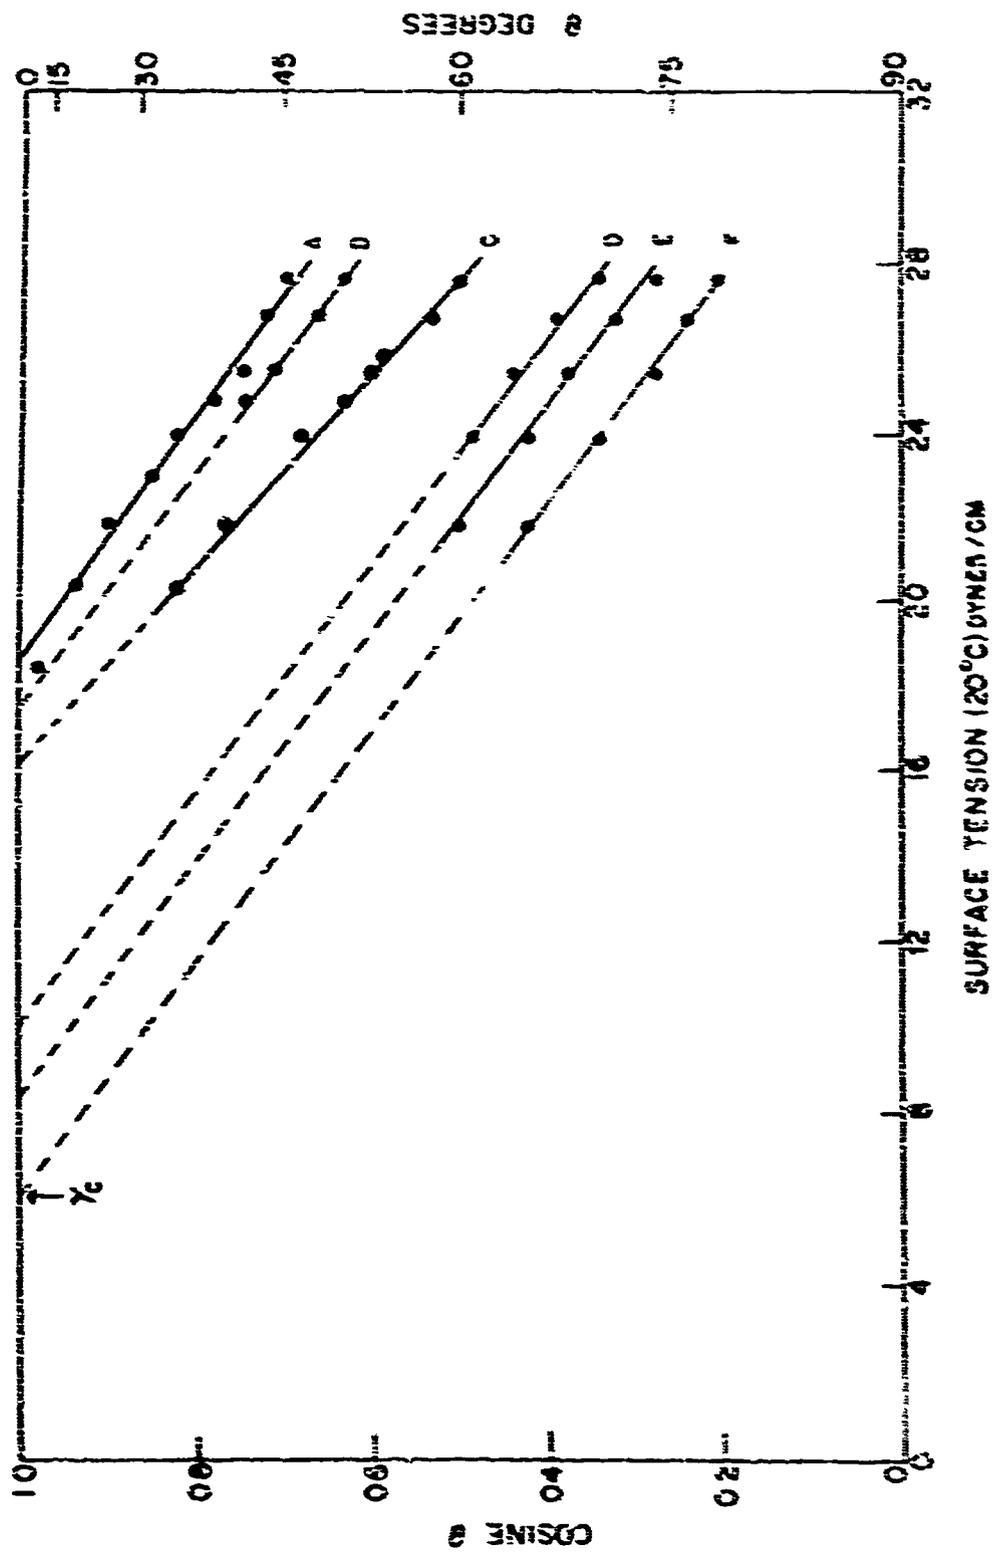
FIGURE 2 WETTABILITY OF VARIOUS PERFLUORINATED LOW-ENERGY SURFACES BY THE n-ALKANE LIQUIDS

Dr. Zisman used n-alkane liquids as his homologous series for low-energy solids. Figure 2 summarizes the plots which he obtained for a number of different surfaces. Curve A is the plot for smooth, clean polytetrafluoroethylene (Teflon). B was obtained for the copolymer of tetrafluoroethylene and hexafluoropropylene, and C is for polyhexafluoropropylene. D, E, and F were obtained for clean, smooth platinum which had adsorbed a monomolecular layer of a perfluoroalkanoic acid. Platinum normally has a high-energy surface, but the adsorbed layer caused it to act like a material with a surface energy lower than

that of Teflon. These plots emphasize the importance either of painting an aircraft as soon as possible after it has been cleaned or of protecting the cleaned surface until the paint system is applied. It is also of interest that the lines which represent each type of surface have approximately the same slope.

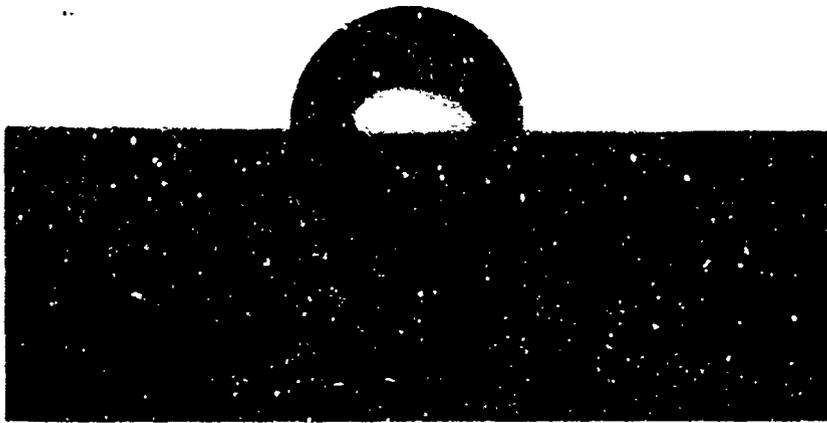
FIGURE 3 PROFILE OF DROP OF DISTILLED WATER ON TEFLON,  
CONTACT ANGLE  $97^\circ$  (20X)

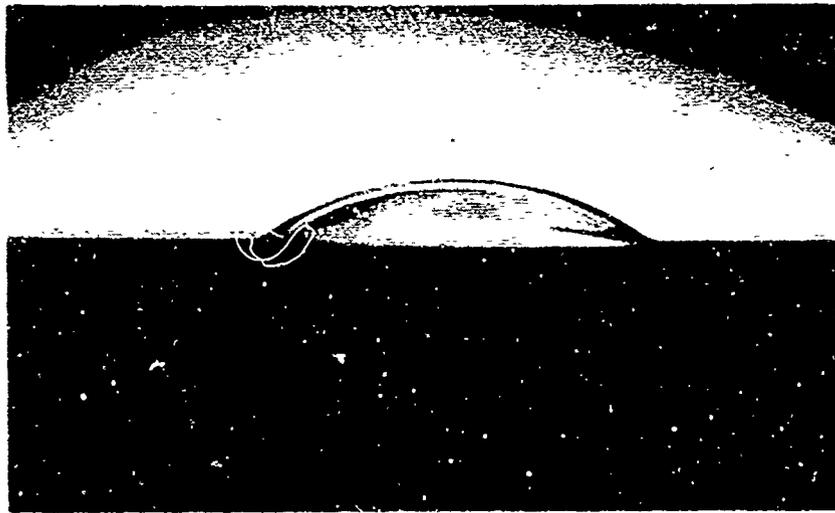
FIGURE 4 PROFILE OF DROP OF DISTILLED WATER ON GLASS,  
CONTACT ANGLE  $34^\circ$  (20X)

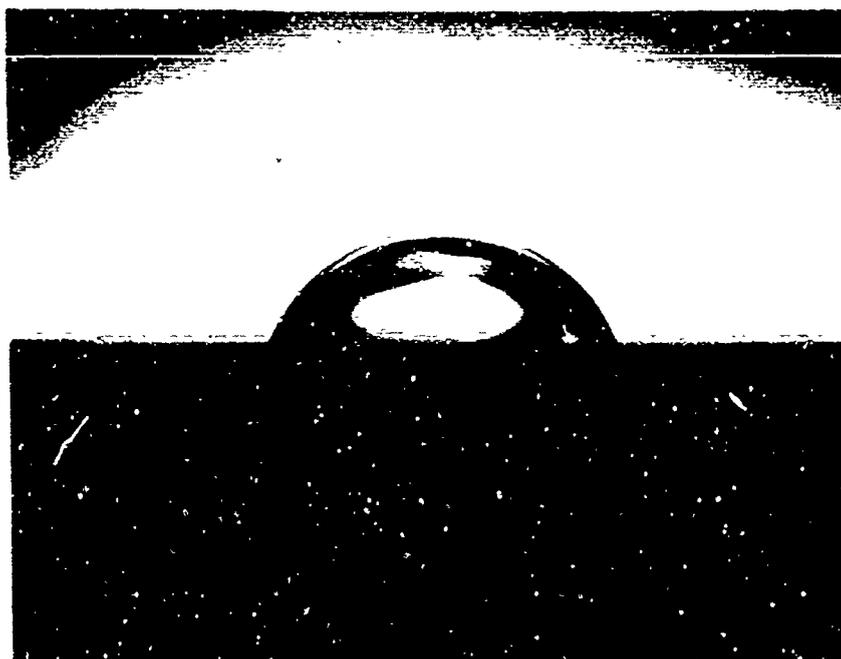
FIGURE 5 PROFILE OF DROP OF DISTILLED WATER ON ALUMINUM,  
CONTACT ANGLE  $68^{\circ}$  (20X)

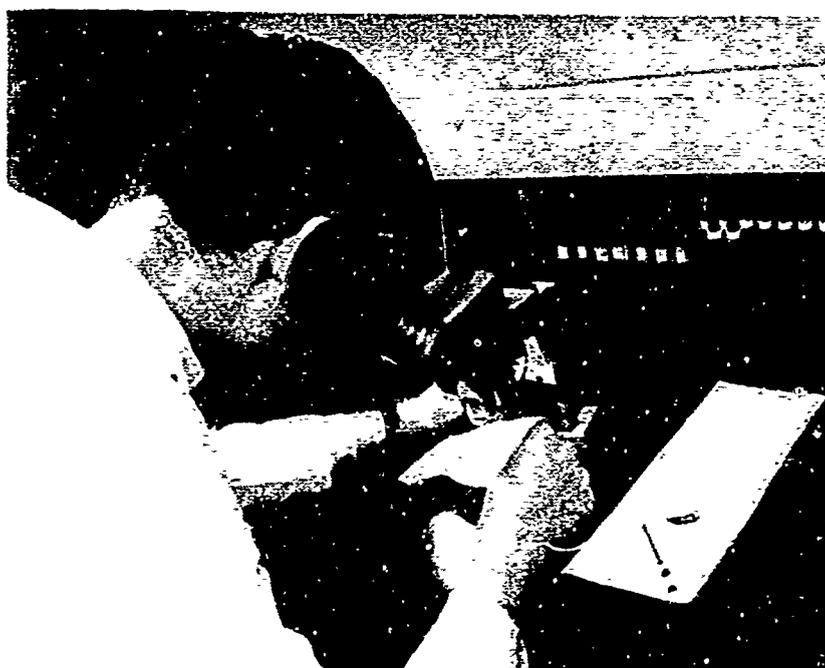
FIGURE 6 LABORATORY MEASUREMENT OF DIAMETERS OF DROPLETS OF  
DISTILLED WATER ON ALUMINUM PANELS. MICROSYRINGE  
AT RIGHT IS USED TO MEASURE DROP VOLUME OF  
5 MICROLITERS.

The method consists of placing droplets of distilled water, exactly 5 microliters in volume, on the surfaces to be investigated, measuring the diameter of the droplets with the graduated eyepiece of a microscope, and converting the droplet diameters to values which represent the critical surface tension of wetting of the metal surface. Figure 6 illustrates the measurement of drop diameters.

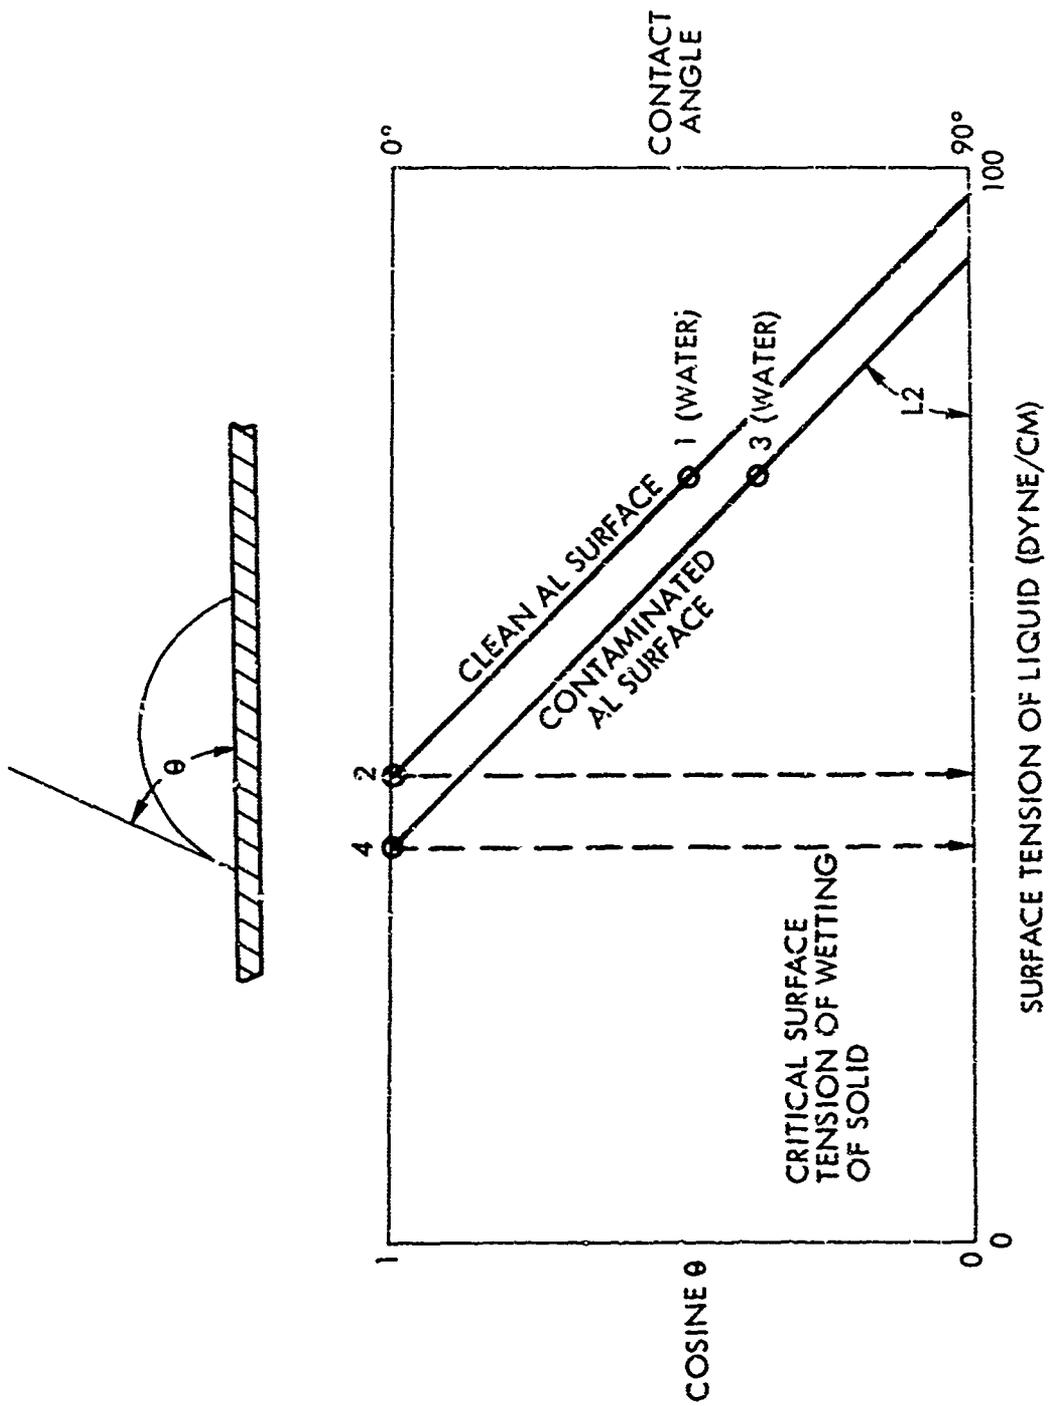
FIGURE 7 RELATIONSHIP BETWEEN CONTACT ANGLES AND SURFACE ENERGY OF SOLIDS

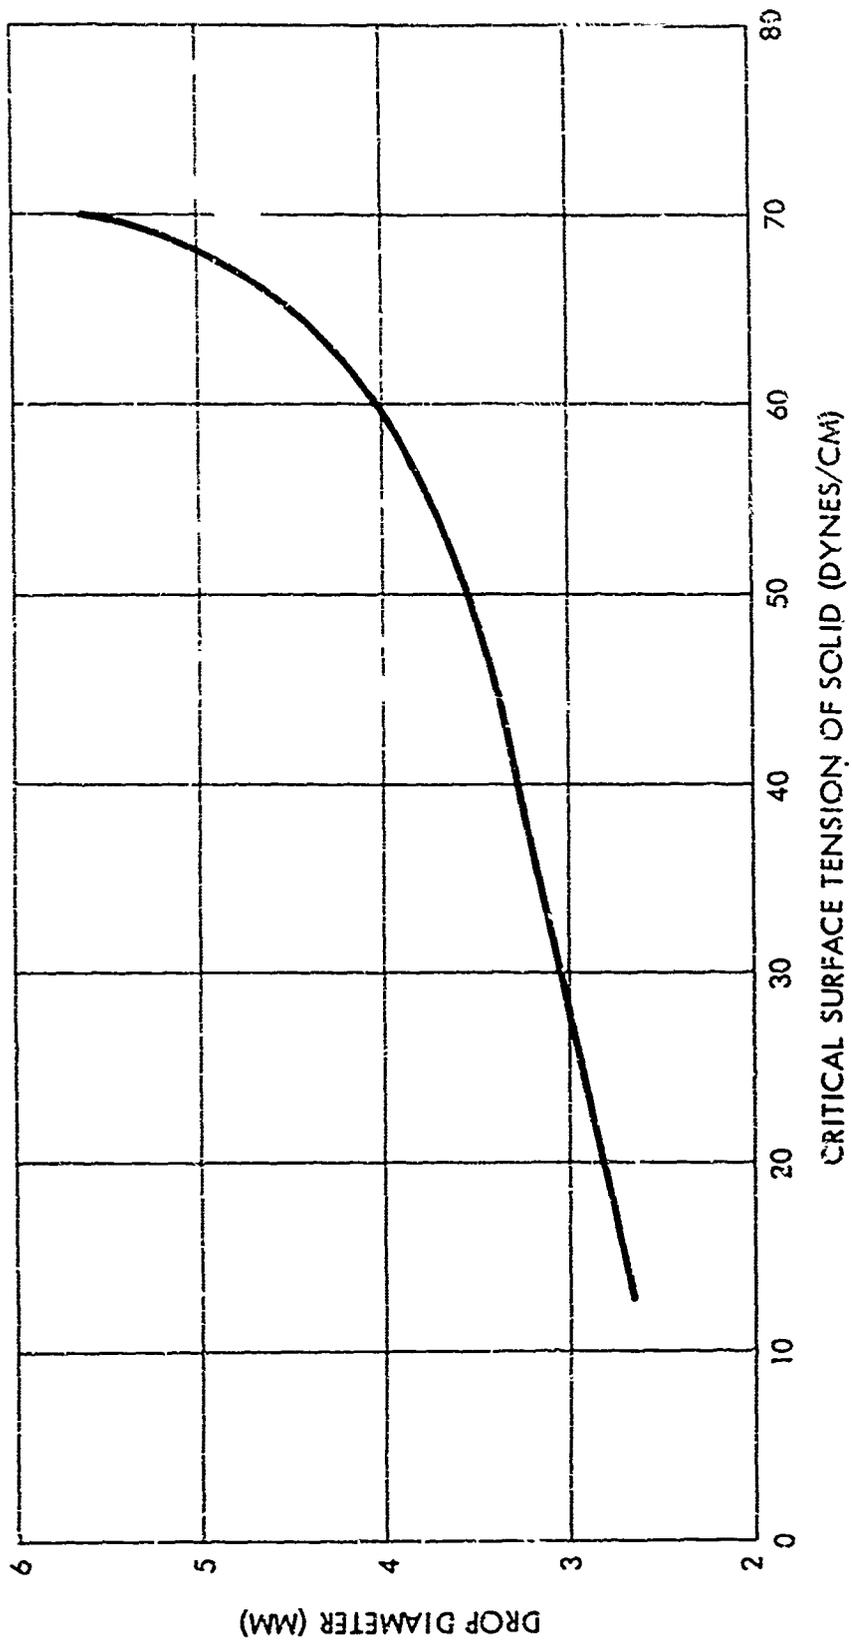
FIGURE 8. RELATIONSHIP BETWEEN DROP DIAMETER AND CRITICAL SURFACE TENSION OF SOLID (5 MICROLITER DROPS)

The last column in Table I was then completed, and the data were plotted to give Figure 8, the plot of Drop Diameter versus Critical Surface Tension of Wetting of Solid. Since the data were determined for standard conditions, 77°F and 50% relative humidity, it was necessary to determine the correction factors to be applied with deviations from the standard.

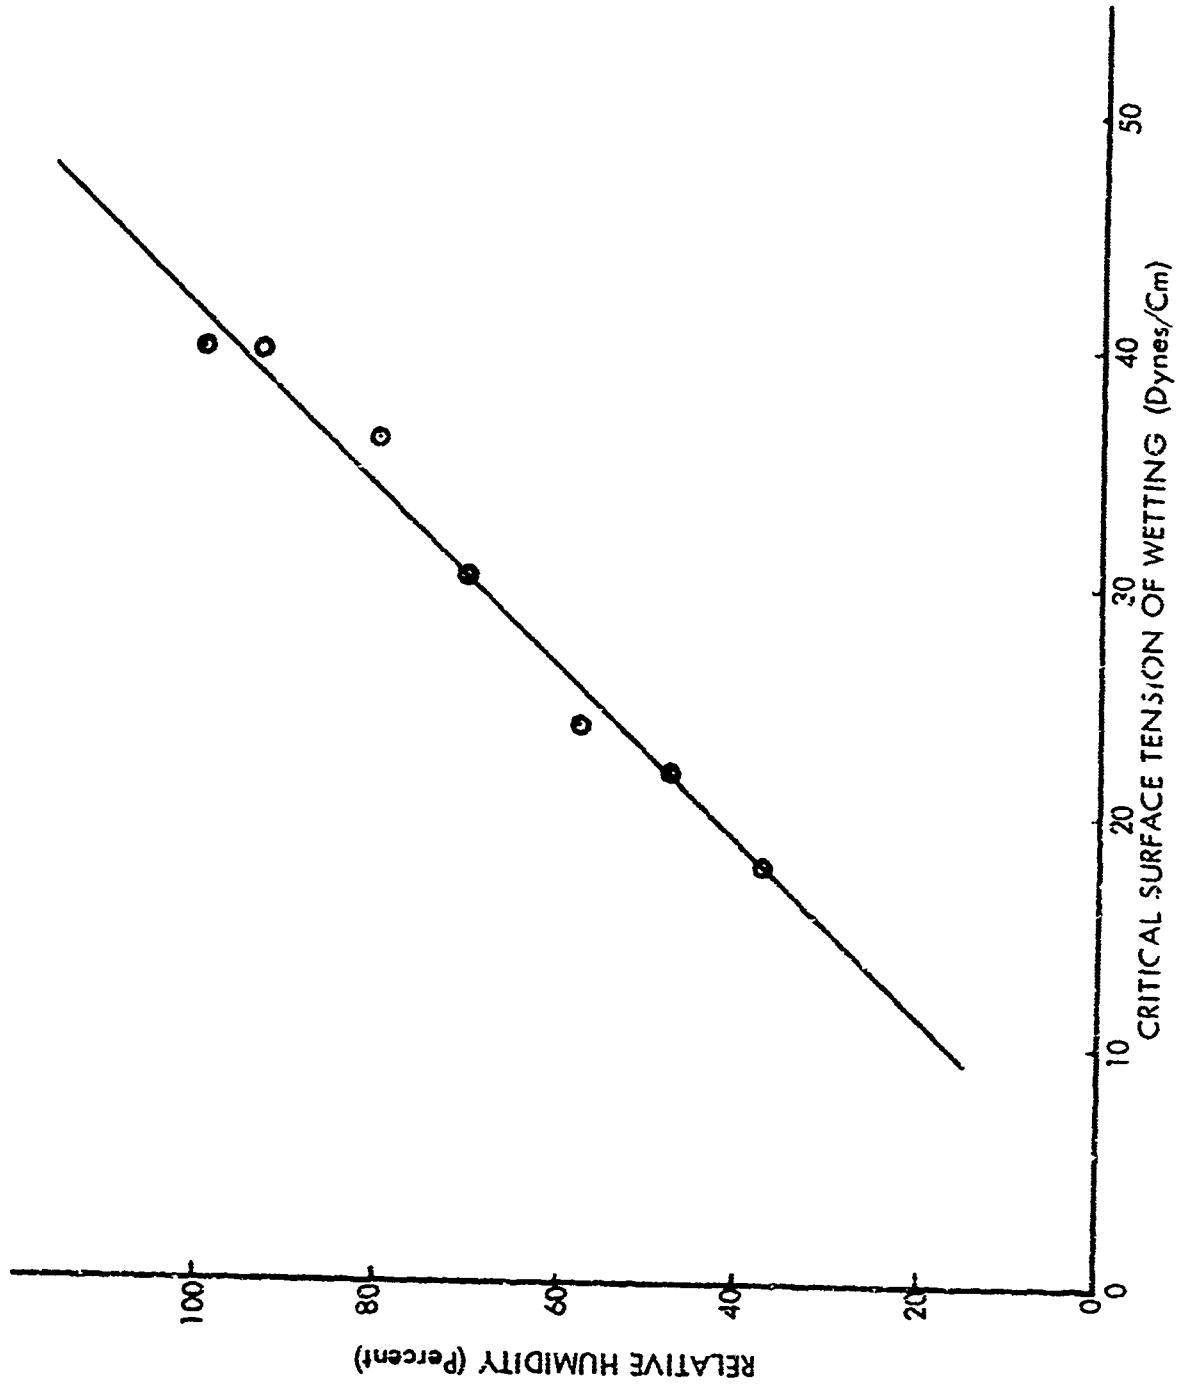
FIGURE 9 EFFECT OF RELATIVE HUMIDITY ON SURFACE ENERGY OF 7075-T6 CLAD ALUMINUM AT 77°F

Studies were made in a humidity chamber to determine the effect of relative humidity on surface energy. The data obtained are plotted in Figure 9. The results indicate that a correction of 4 dynes/cm should be made for each variation of 10% from the standard relative humidity value of 50%. The correction factor should be added for readings taken at relative humidities of more than 50% and should be subtracted for readings taken at lower relative humidities. Deviations from the standard temperature of 77°F had no significant effect on the surface energies of the test panels.

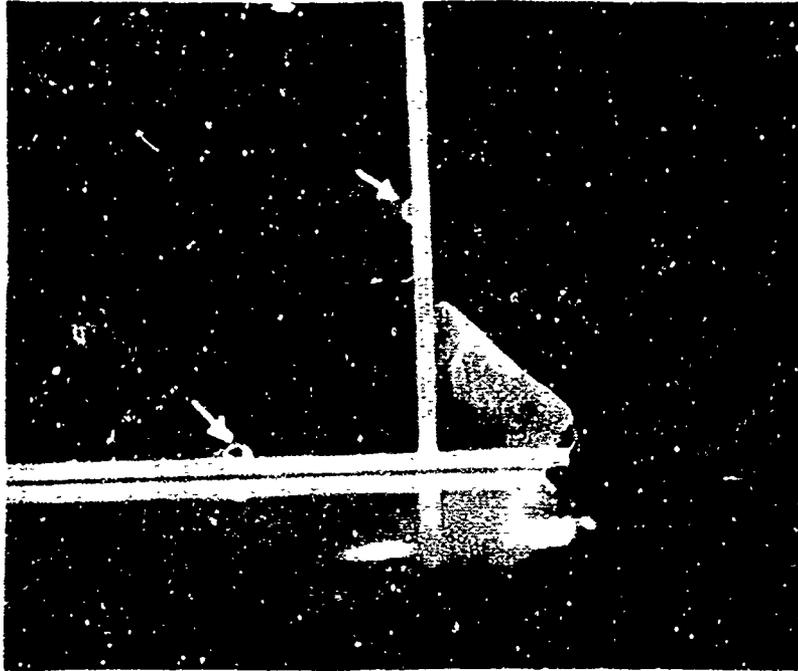
FIGURE 11 PROFILE OF 5-MICROLITER DROPS OF DISTILLED WATER ON HORIZONTAL AND VERTICAL CLAD 7075-T6 PANELS

In a supplementary experiment, drops of distilled water 5 microliters in volume were placed on horizontal and vertical panels of clad 7075-T6 aluminum, and the profiles of the drops were photographed. Figure 11 is an edge view of the panels showing the drop profiles. There is a slight difference between the upper and lower contact angles of the drop on the vertical panel, but the difference in diameter between the vertical and horizontal drops is only 0.1 mm.

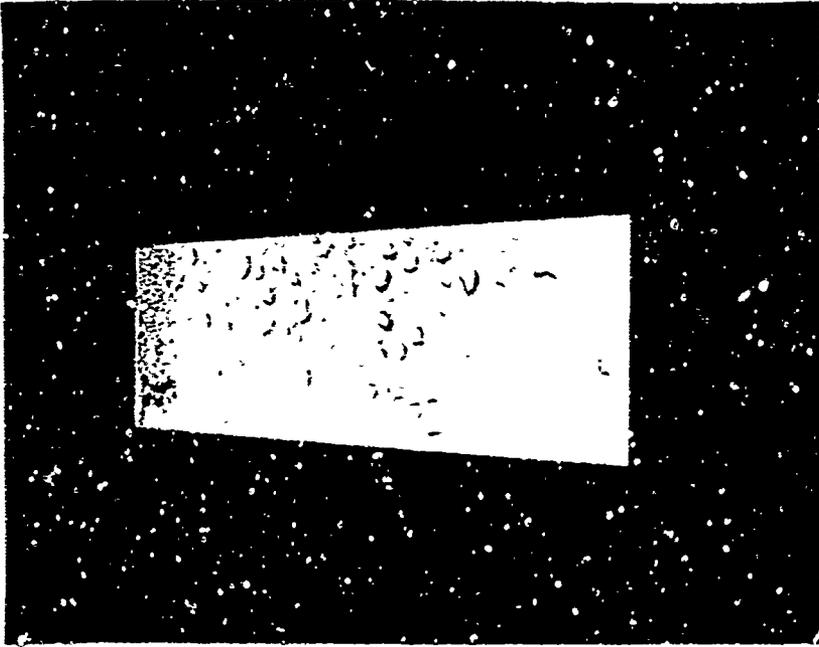
FIGURE 12 DROPS ON CLEAN PANEL ARE IRREGULAR  
IN OUTLINE AND TEND TO FORM  
CONTINUOUS FILM

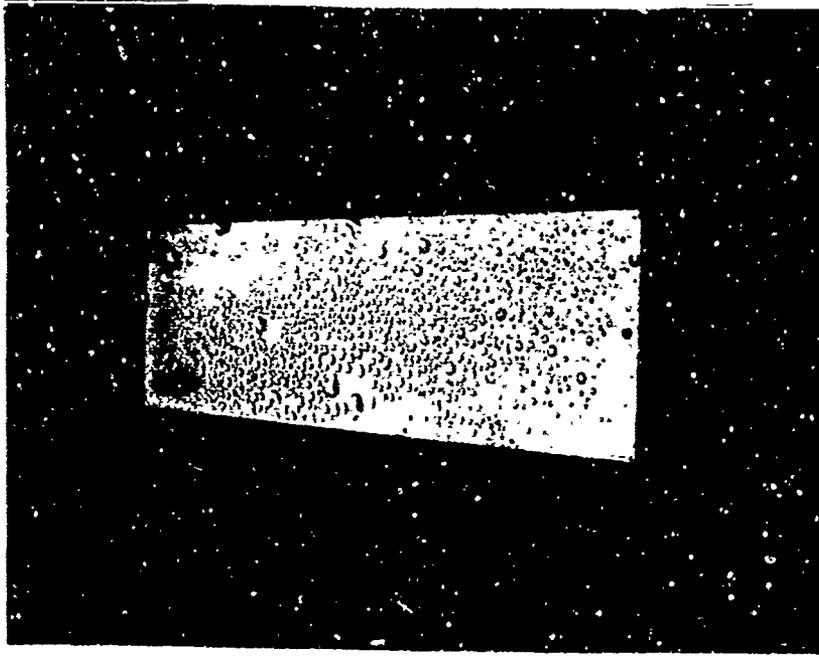
FIGURE 13 DROPS ON CONTAMINATED PANEL ARE  
SPHERICAL AND RUN OFF READILY

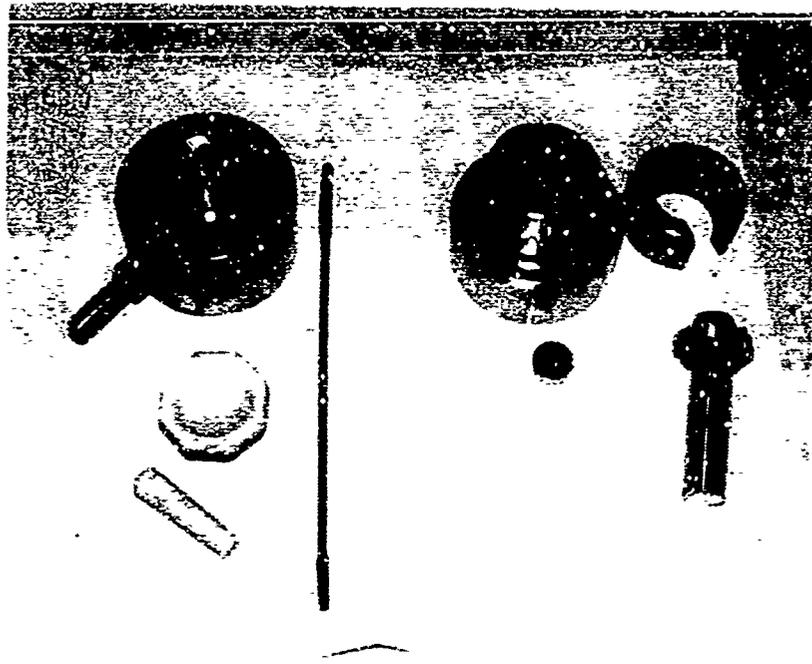
FIGURE 14 MOLD AND PLUNGER ASSEMBLY FOR MAKING 1/2-INCH DIAMETER POTASSIUM BROMIDE DISCS

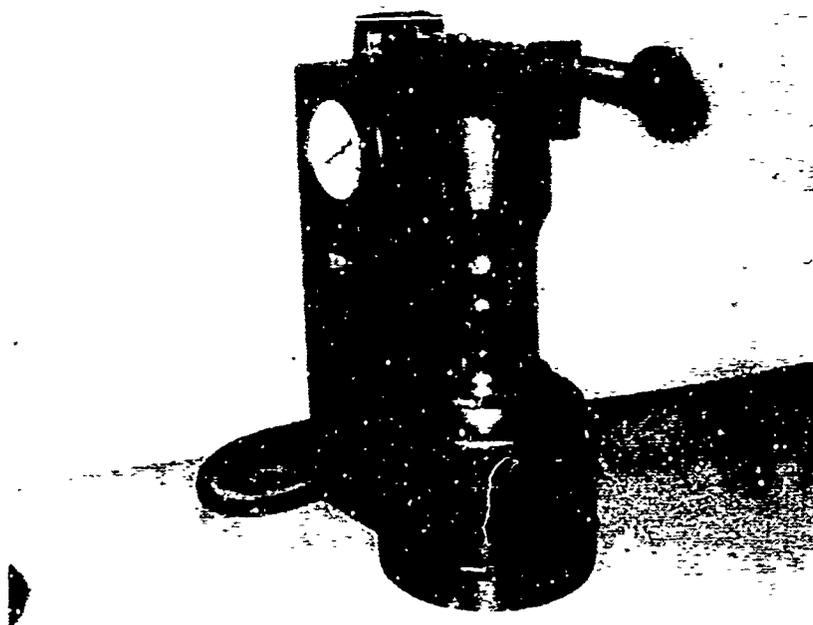
FIGURE 16 PRESS USED FOR THE PRODUCTION OF 1/2-INCH DIAMETER POTASSIUM BROMIDE DISCS

bromide powder on a test panel and a molded potassium bromide disc; the molding press is shown in Figure 16.

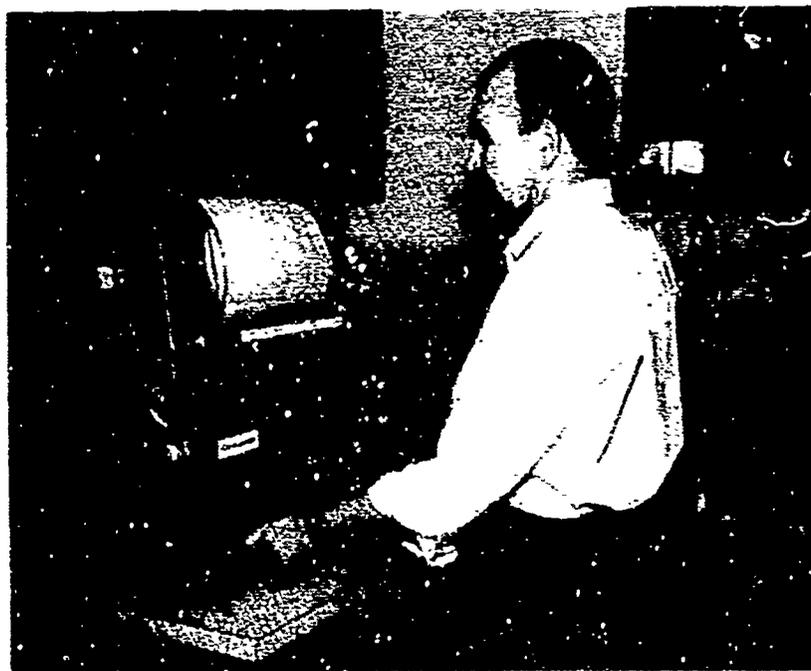
FIGURE 17 ABSORPTION CHARACTERISTICS OF POTASSIUM BROMIDE DISCS BEING OBTAINED WITH A PERKIN-ELMER MODEL 621 INFRARED SPECTROPHOTOMETER

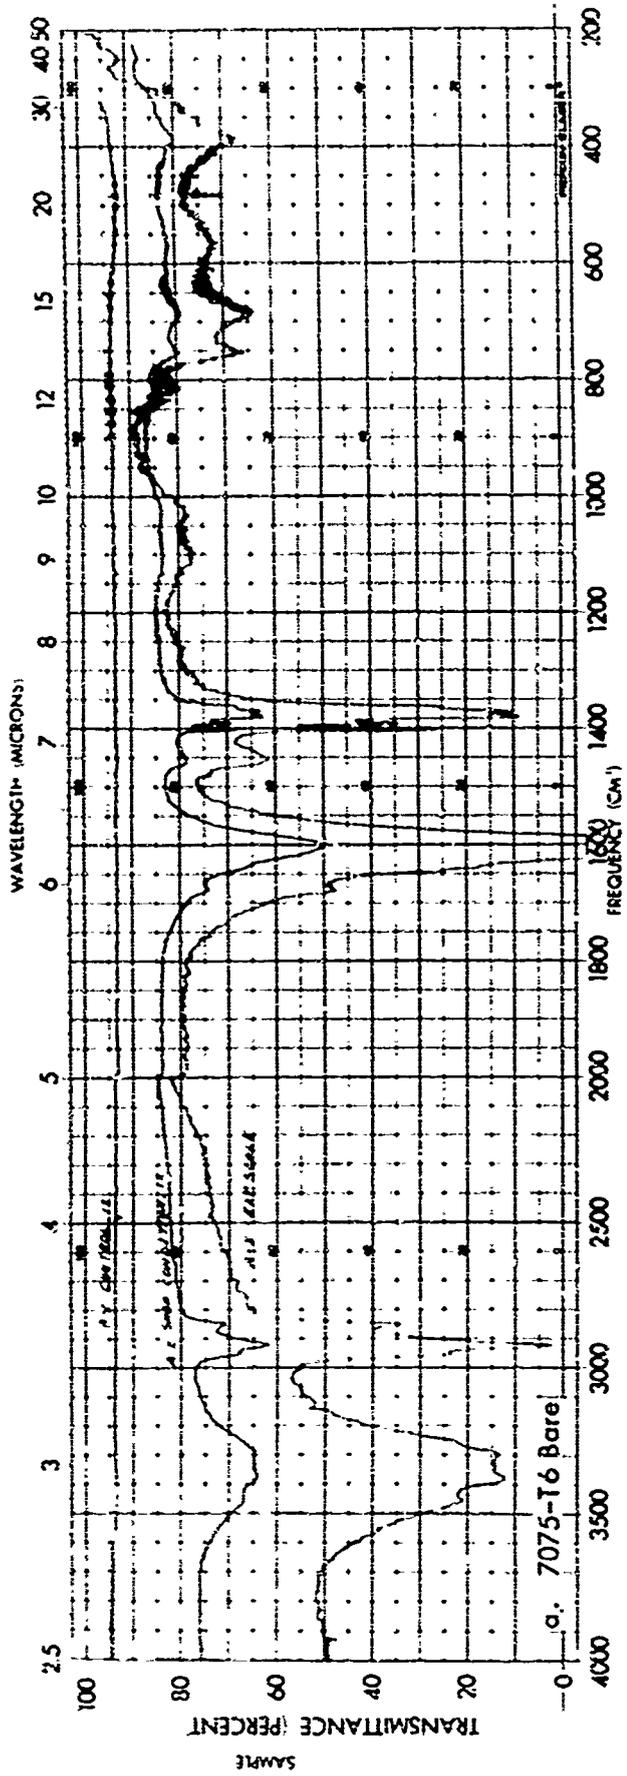
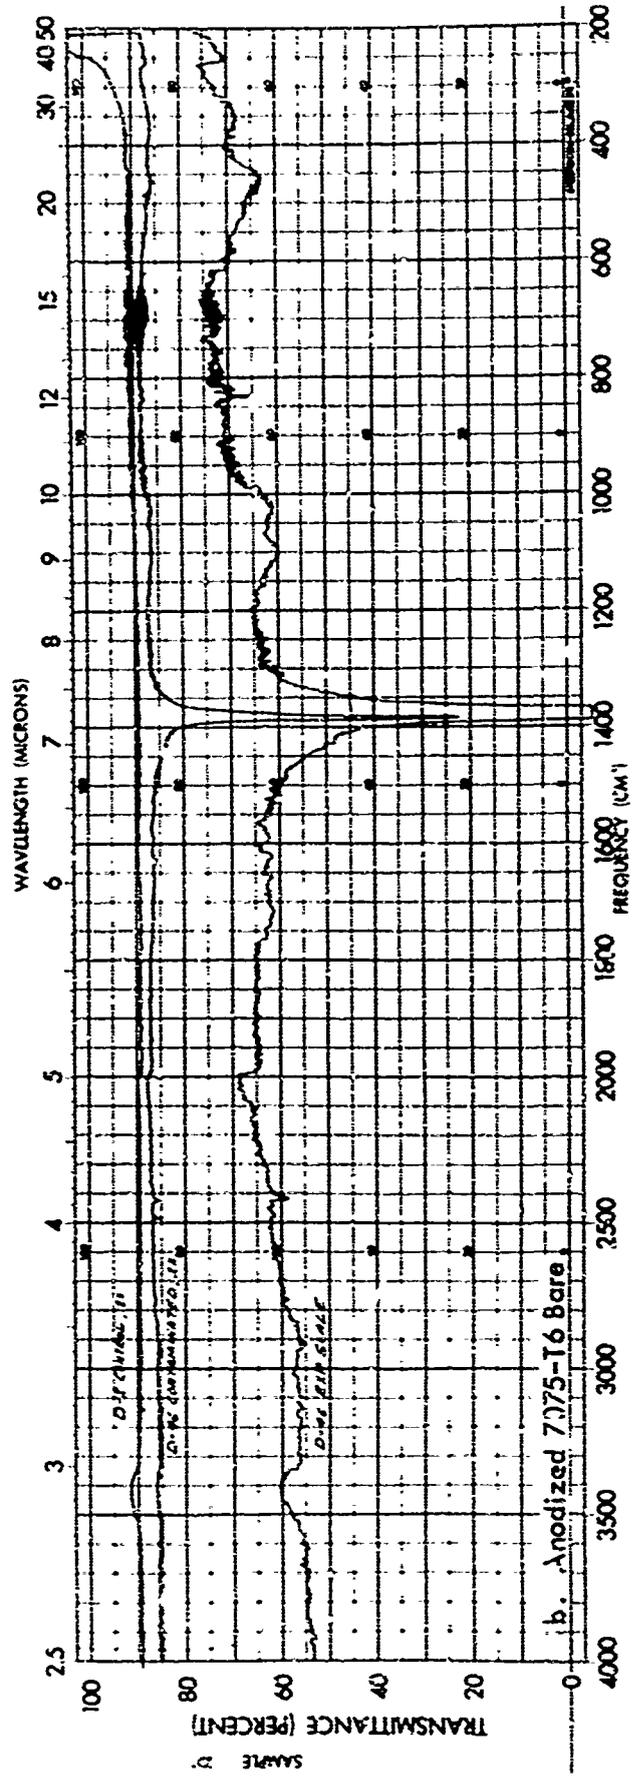
FIGURE 18 INFRARED ABSORPTION SPECTRA OF CONTAMINANTS ON ALUMINUM PANELS

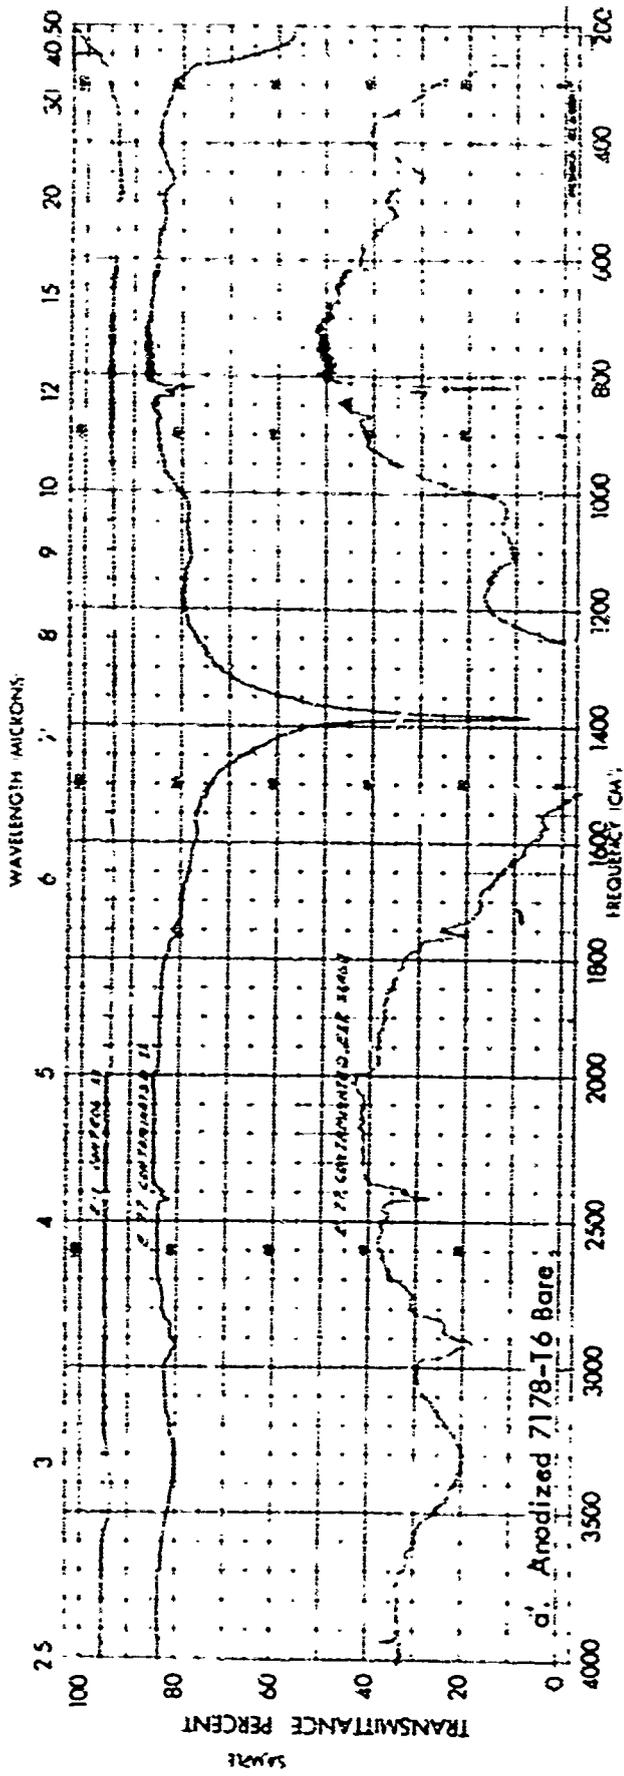
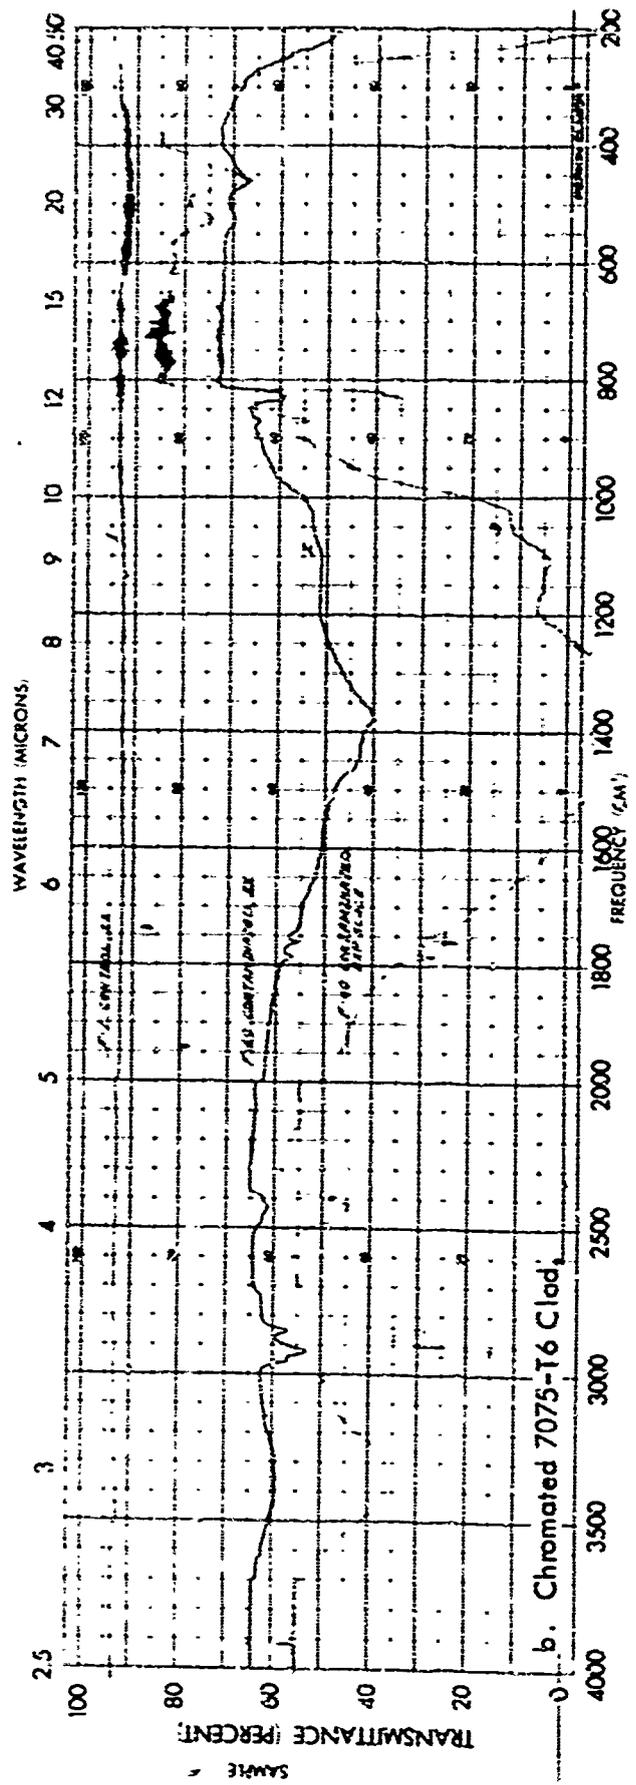
FIGURE 19 INFRARED ABSORPTION SPECTRA OF CONTAMINANTS ON ALUMINUM PANELS

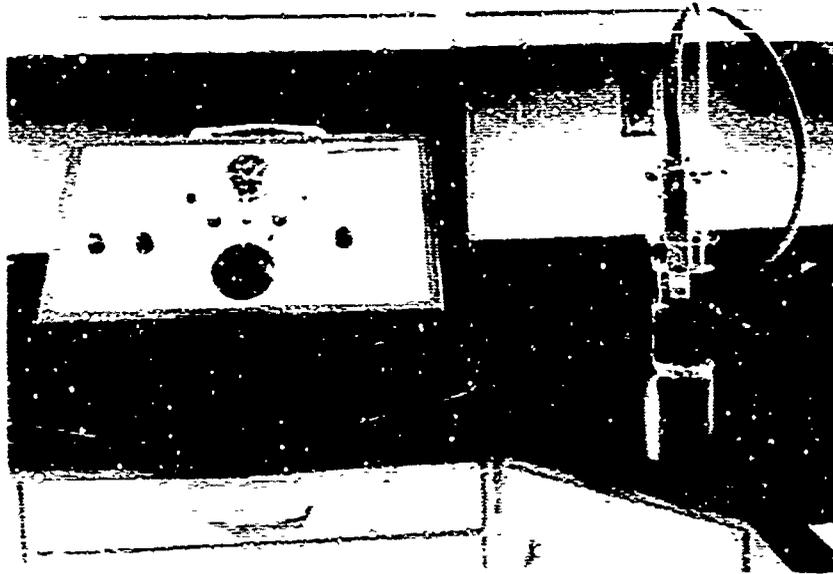
FIGURE 21 DETERMINING HYDROGEN EMBRITTLEMENT CHARACTERISTICS OF CLEANING SOLUTION WITH LAWRENCE HYDROGEN GAUGE

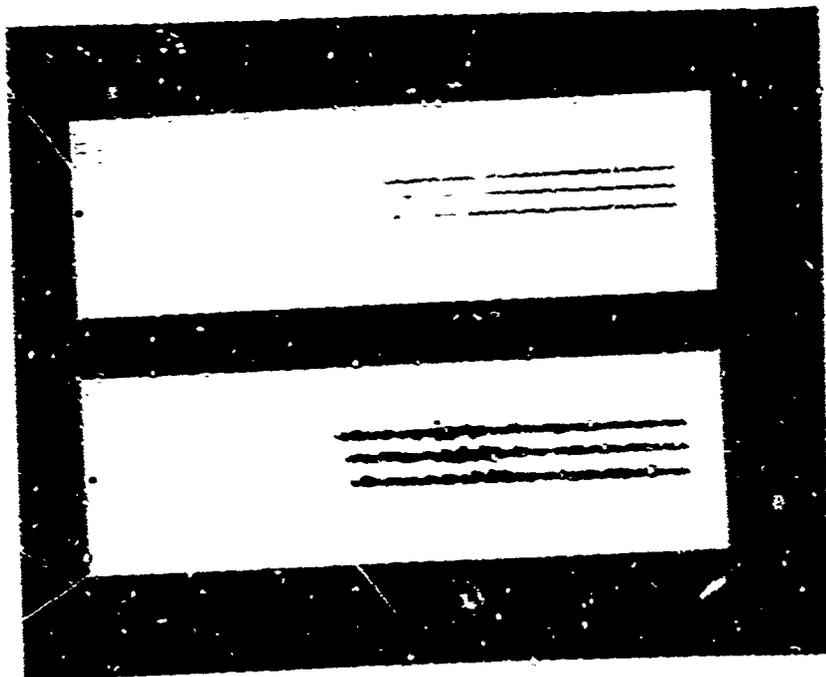
FIGURE 27 TEST SCRATCHES ON PANELS WITH GOOD AND POOR PAINT ADHESION

Figure 26 is a photograph of the "Scratchmaster" paint adhesion tester. Figure 27 is a view of specimens with good and poor paint adhesion. Detailed instructions for operating the "Scratchmaster" are in Appendix B.

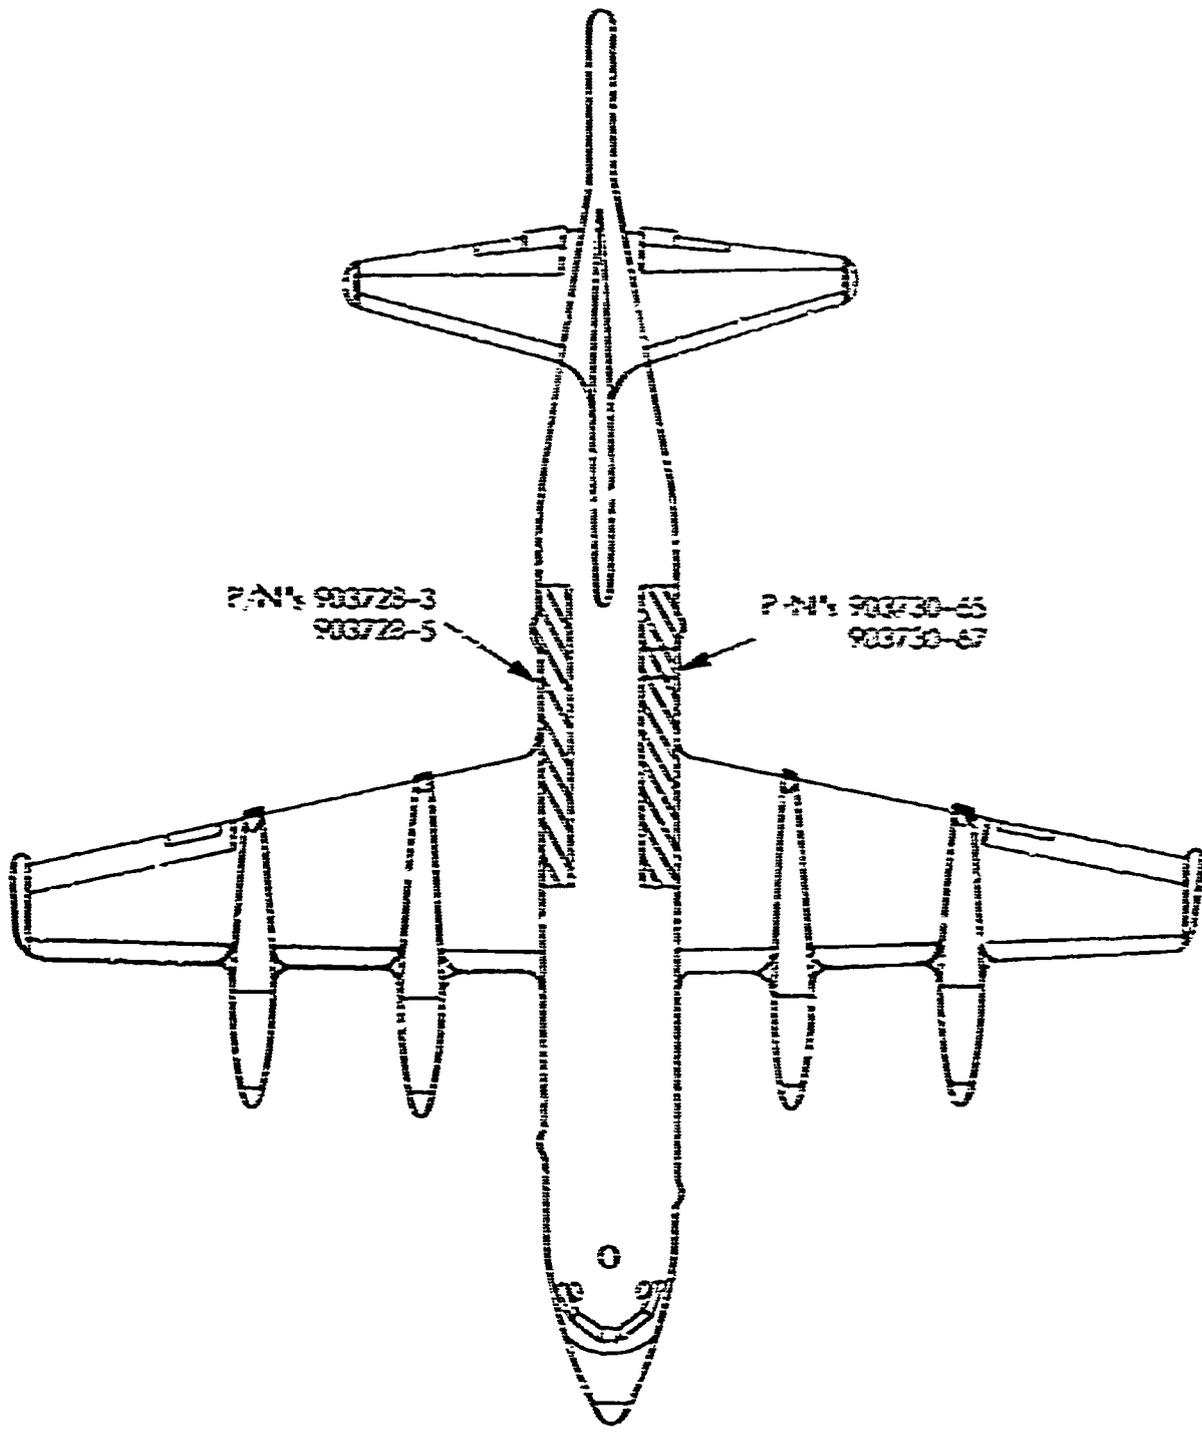
FIGURE 28 LOCATION OF TEST PANELS IN FUSELAGE OF P-3 AIRCRAFT

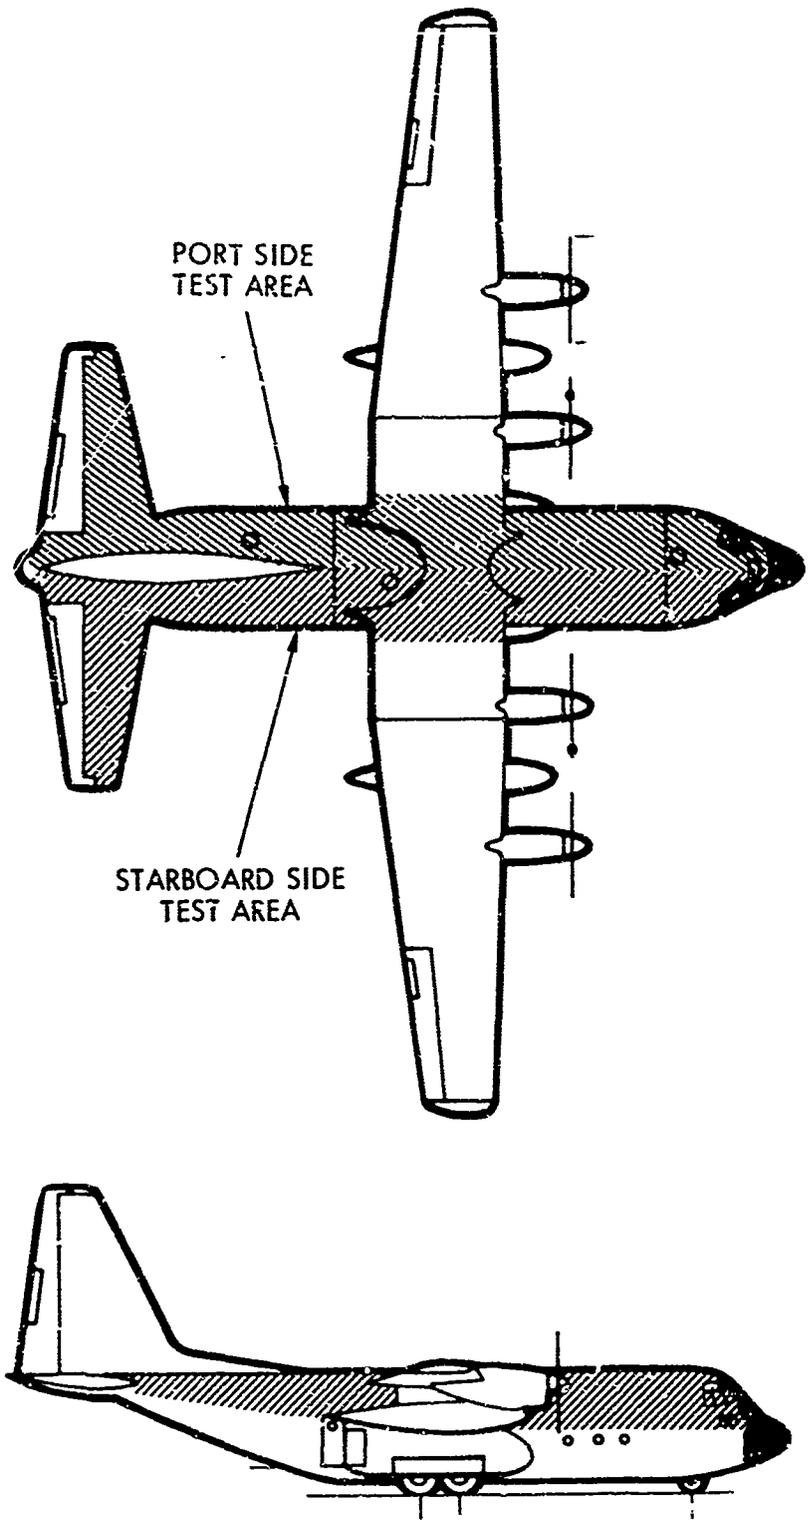
FIGURE 29 TEST AREAS ON NAVY C-130 AIRCRAFT NO. 150685
