Special Report 163

# SNOW SURFACE EROSION FROM A PERIPHERAL JET CUSHION ACV

Gunars Abele and William H. Parrott

October 1971

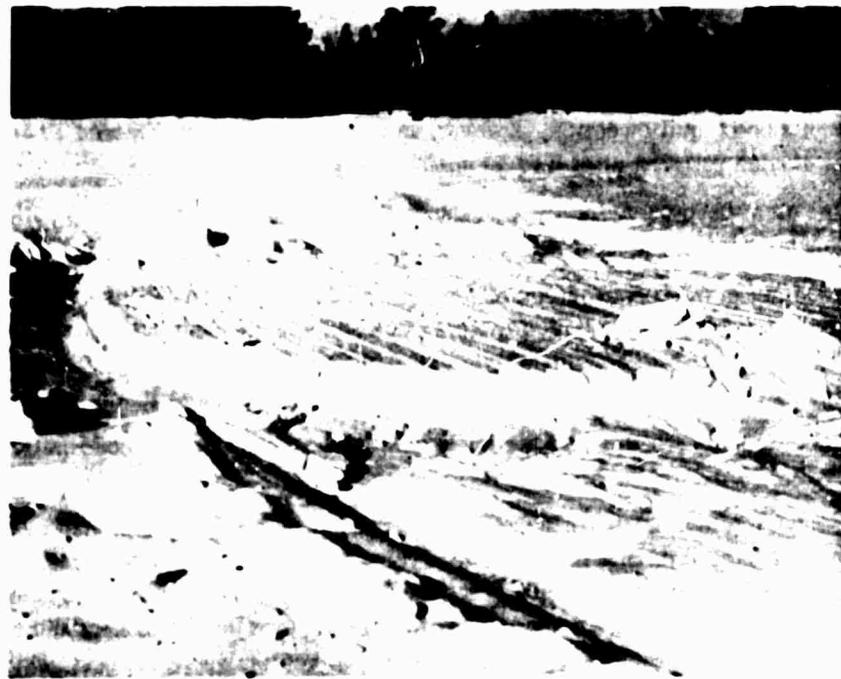
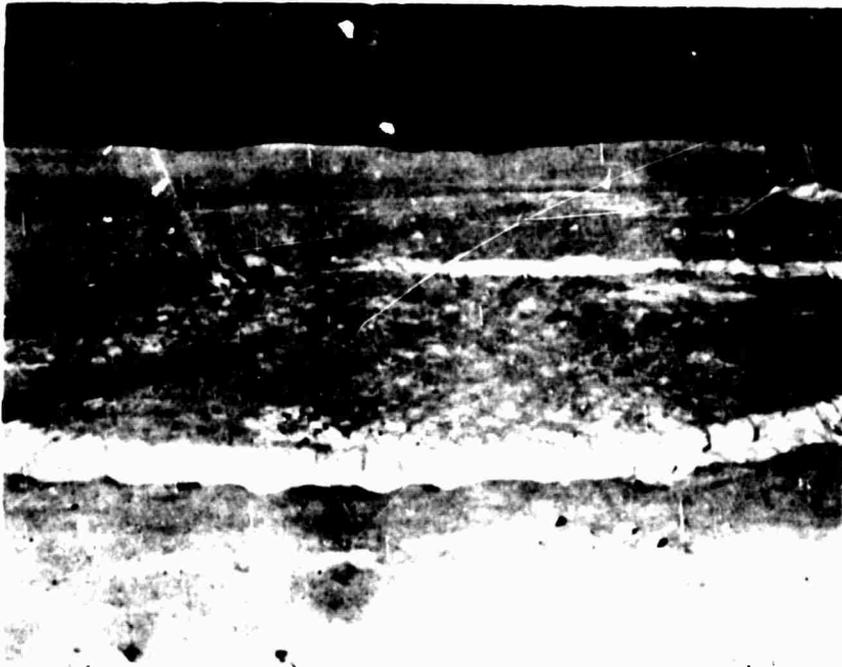
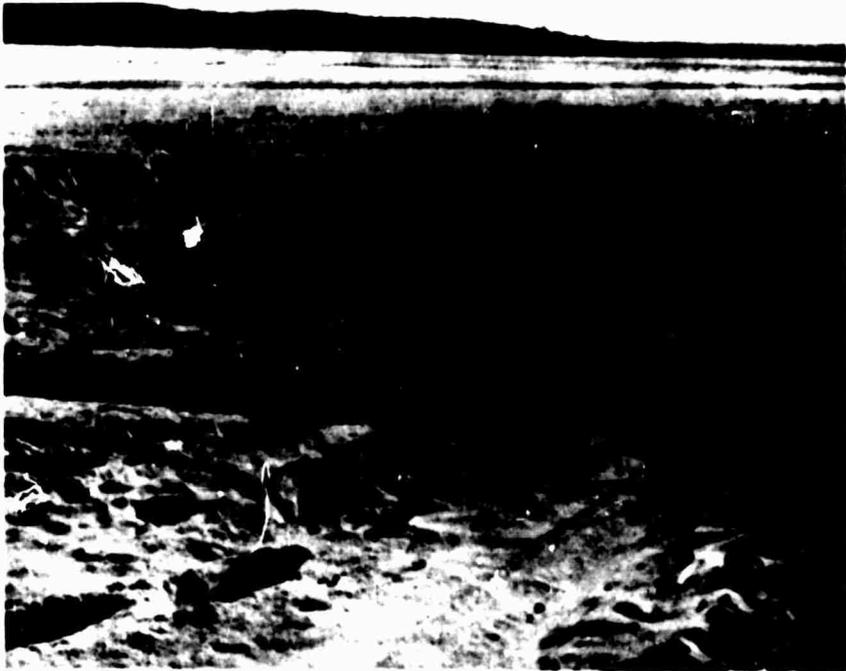
*Figure 6. Erosion of soft snow surface, hovering time 15 seconds.*

*Figure 7. Erosion of soft snow surface, hovering time 30 seconds.*

*Figure 8. Erosion of soft snow surface, hovering time 1 minute.*

*Figure 9. Erosion of soft snow surface, hovering time 2 minutes.*

Typical results of hovering the test vehicle over adjacent soft snow surfaces for periods of 15 seconds, 30 seconds, 1 minute and 2 minutes are shown in Figures 6-9. The sinkage of a man in this test area was 12 in. or more. It is apparent that the only significant erosion of the snow surface occurred below the peripheral skirt and the rear bags. The depression of the snow surface below the cushion chamber was relatively shallow, 2 to 3 in. Again, it was not clear how much of the snow below the cushion chamber was actually removed by air movement.

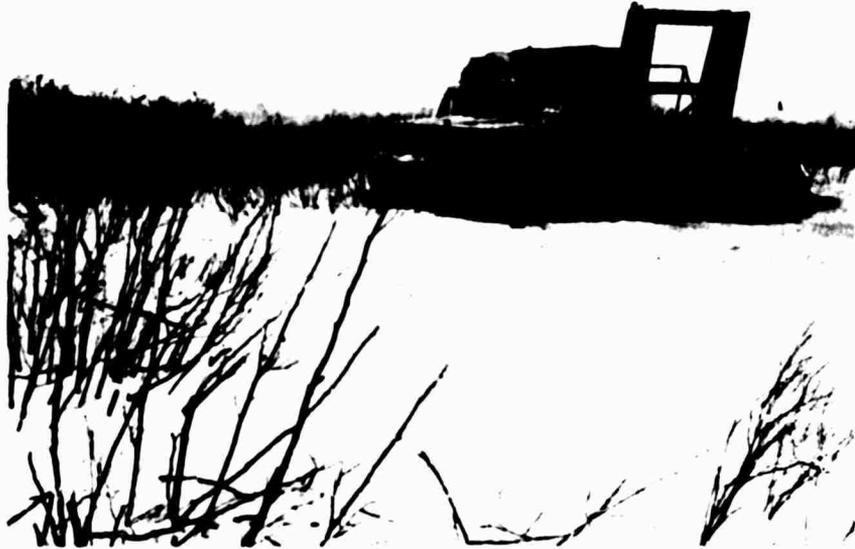
*Figure 18. Test vehicle hovering on deep, soft snow.*

Figure 18 shows the vehicle after several minutes of hovering in the deep snow area described above. Note the complete absence of snow spray. The limit of erosion on this terrain for this particular vehicle at that particular spot had apparently been reached. As soon as the vehicle started to proceed forward on a fresh, undisturbed snow surface, a snow cloud was produced (Fig. 19).

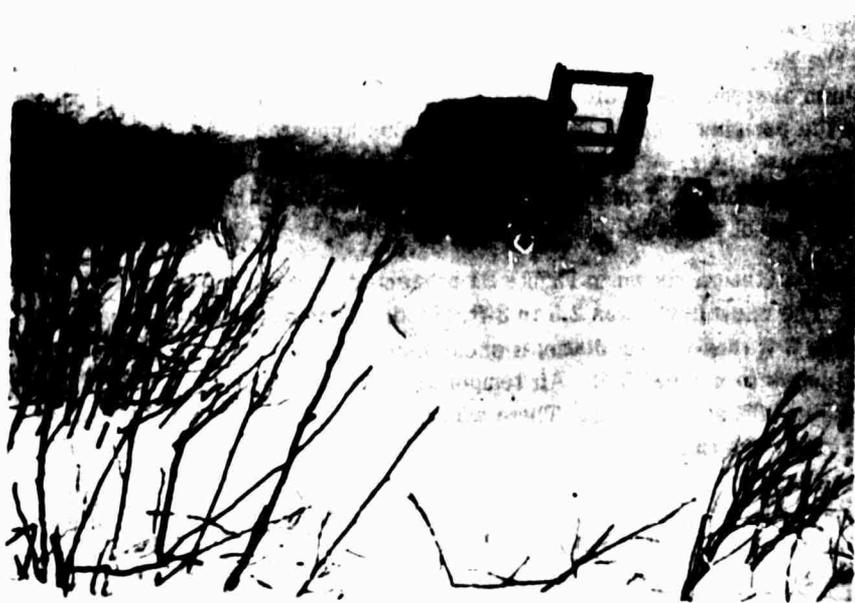
*Figure 19. Test vehicle proceeding forward onto undisturbed soft snow surface.*

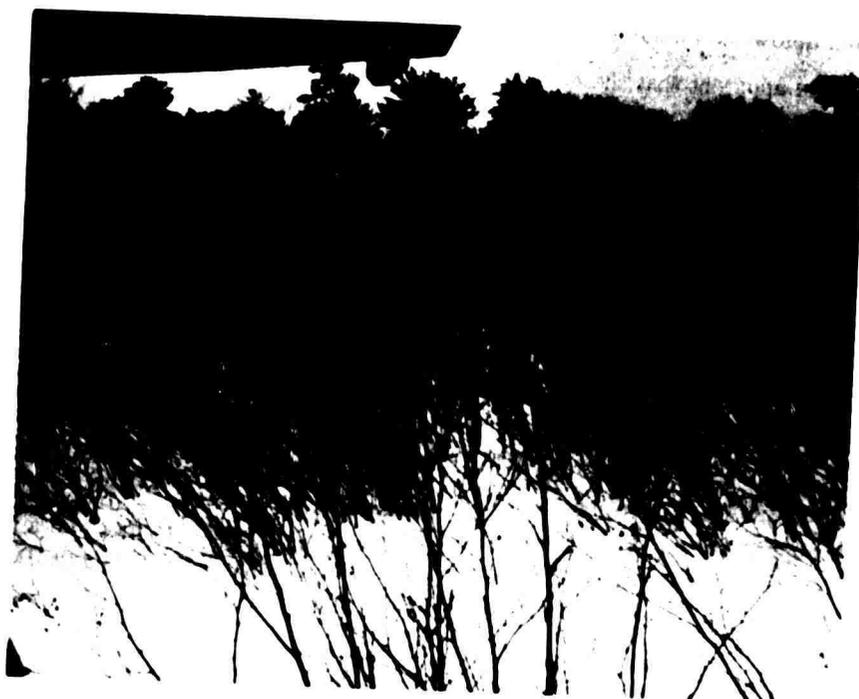
*Figure 21. Deep snow test area with thick brush (willow).*

The type of vegetation shown in Figure 21 presented no problems to either hovering or travel of the vehicle. The snow depth was 2.5 to 3 ft, the brush (willow) height above snow surface was mostly in the 6 to 8 ft range, stem diameter occasionally up to 1 in. (average =  $\frac{1}{2}$  in.) and stem spacing a few inches to several feet. Air temperature was approximately 10°F. One pass with the vehicle broke 20 to 50% of the stems. There was no difficulty in proceeding forward after stopping in the brush or after hovering for as much as 15 minutes. Because of the difficulty of rescue operations in these test areas, attempts were not made to determine vegetation characteristics which would cause immobilization of the vehicle. That is, no tests were performed in areas of denser brush where the operator felt the vehicle might get stuck.
