NAVIGATION CHANNEL IMPROVEMENT,
GASTINEAU CHANNEL, ALASKA; HYDRAULIC
MODEL INVESTIGATION

TECHNICAL REPORT H-72-9

NAVIGATION CHANNEL IMPROVEMENT GASTINEAU CHANNEL, ALASKA

Hydraulic Model Investigation

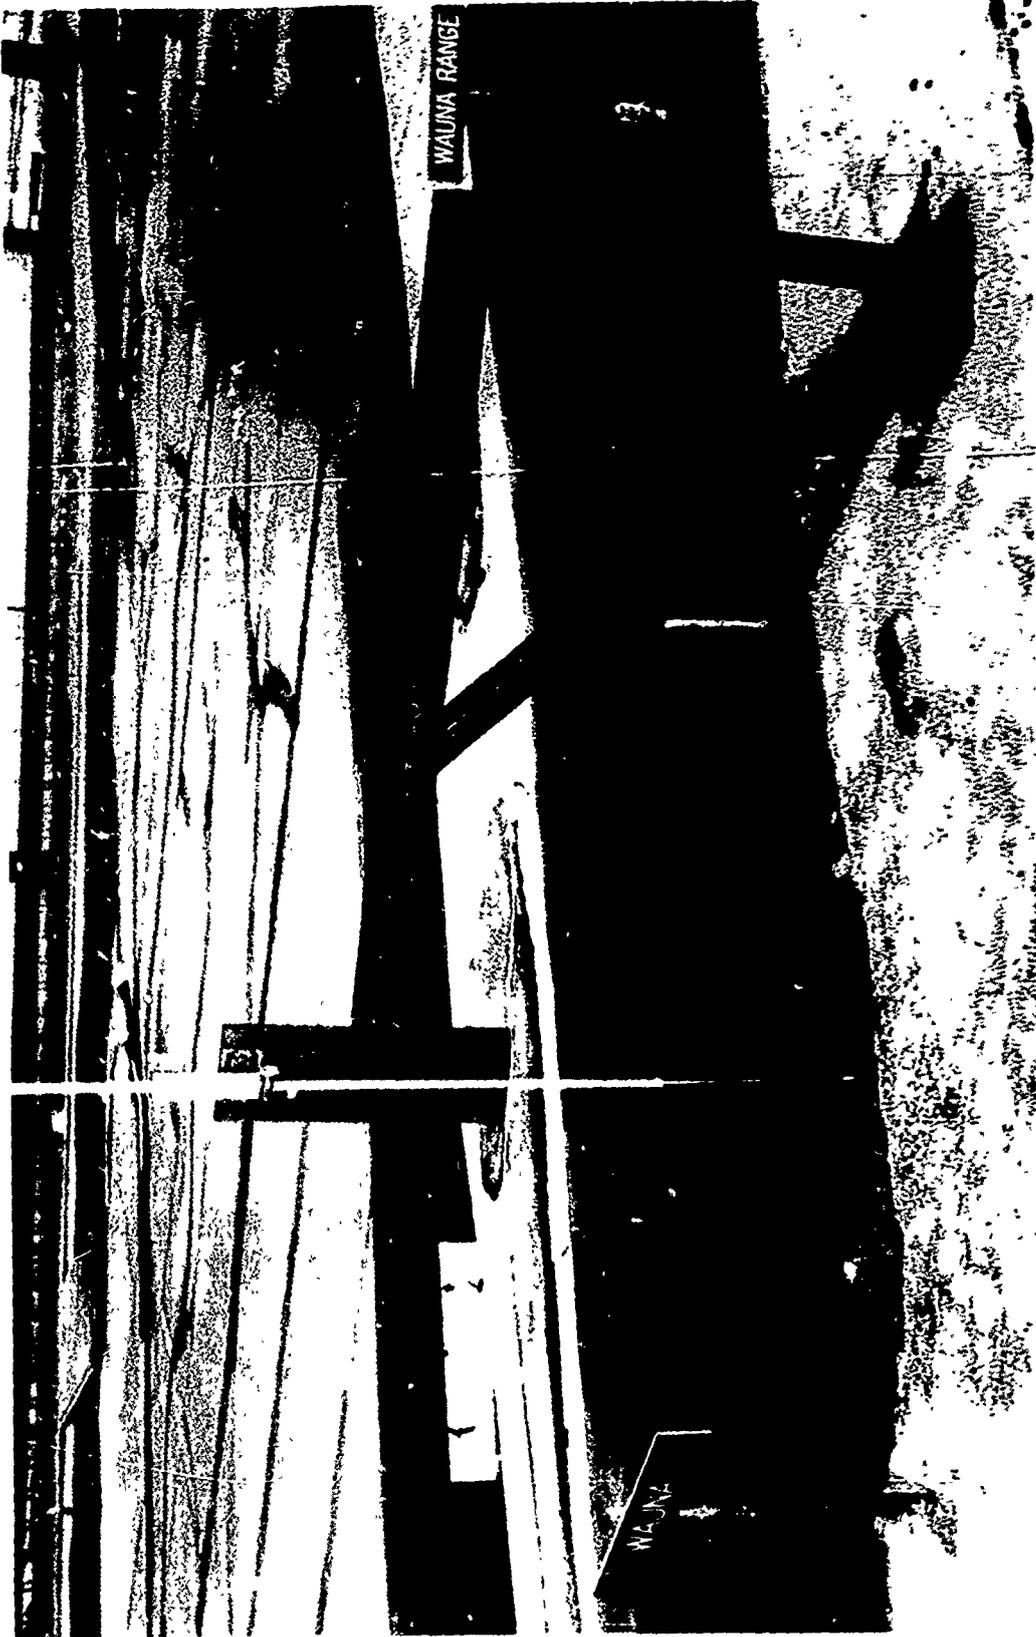
PHOTO 3

18. Permanently mounted point gages (photo 3) were installed at the locations of the four recording tide gages used for collection of field tide data (fig. 3). The model gages were graduated in 0.001 ft (0.1 ft prototype) and were used to measure tidal elevations throughout the model. Portable point gages were used to measure tidal elevations at other points as required.

POINT GAGE

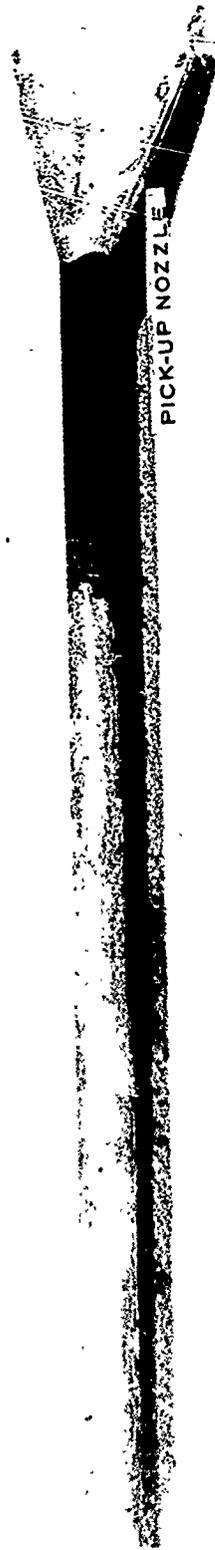
PHOTO 7

23. Shoaling was reproduced in the model by injecting granulated polystyrene plastics. Known volumes of the shoaling material were hand-placed at predetermined locations in the model before and during each shoaling test. At the end of the model test, the shoaling material deposited within the limits of the navigation channel was recovered by suction using a flared nozzle connected by hose to an aspirator (or hydraulic ejector) (photo 7); the material was then measured volumetrically.

SHOALING APPARATUS

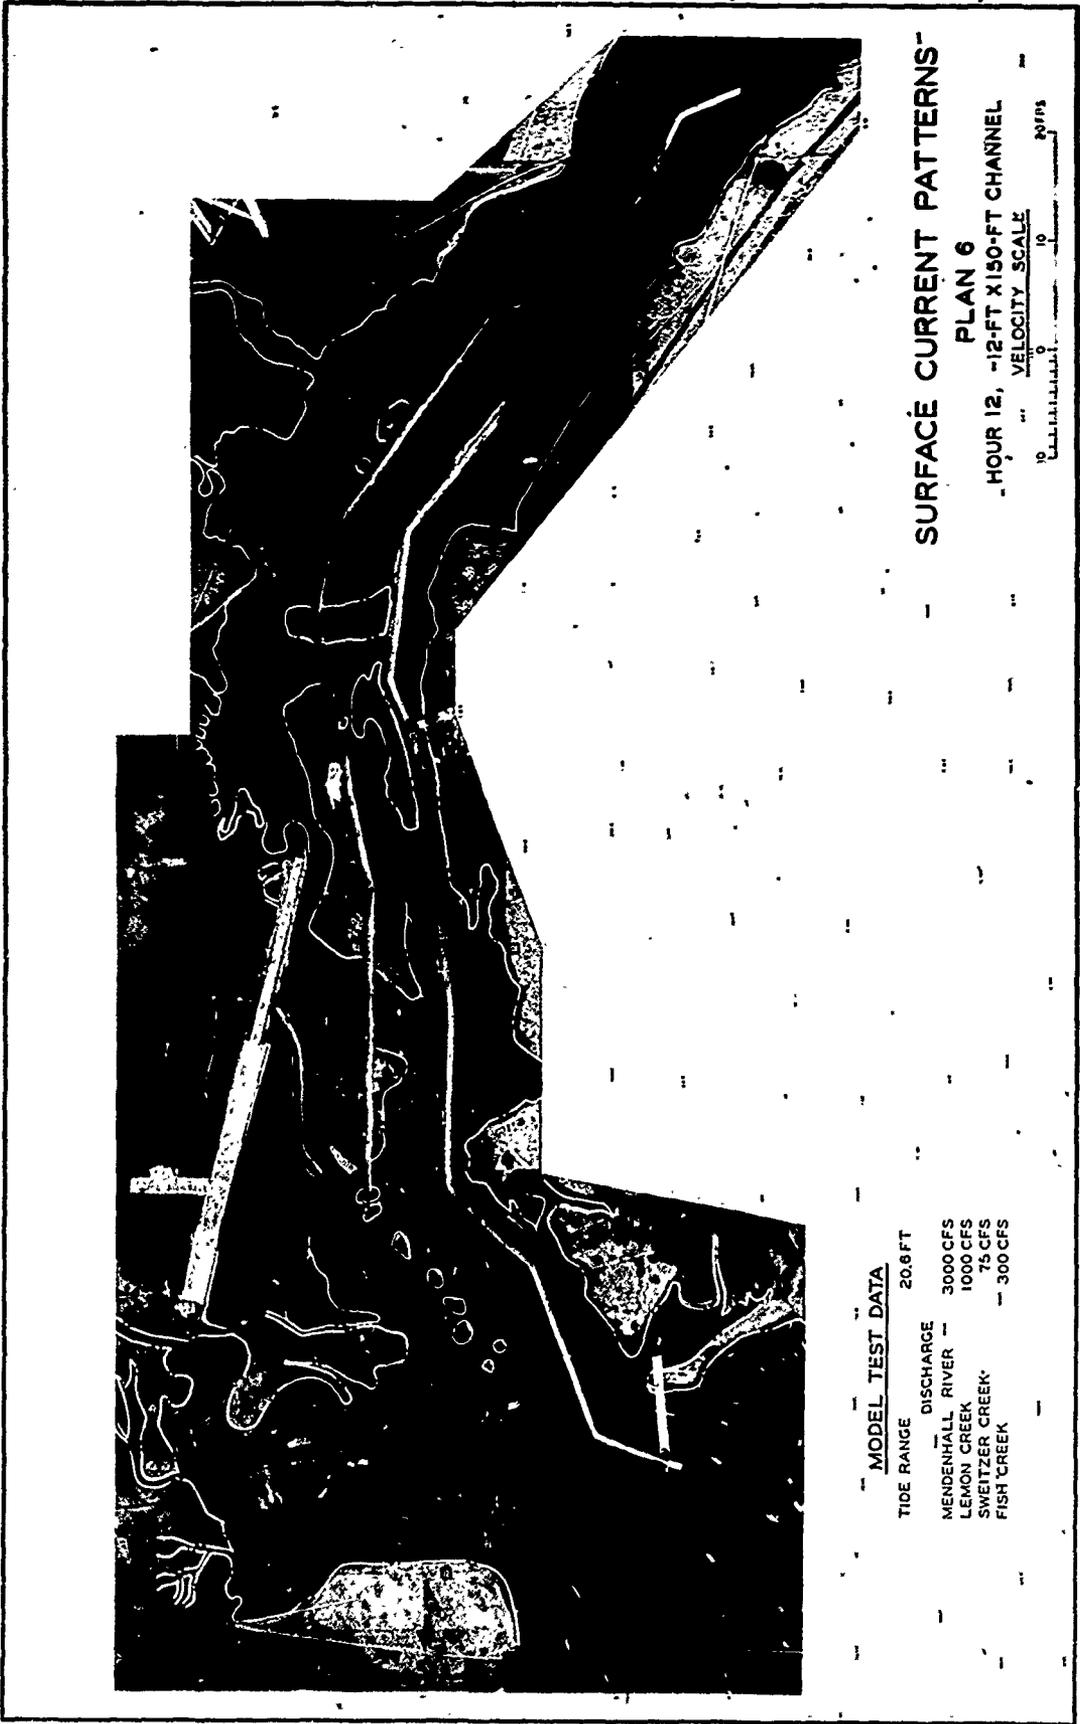
PHOTO 58

81. Photos 55-60 show surface current patterns for plan 6. Photo 55 shows conditions at the time of hhw. Comparison of photos 55 and 50 indicates that there is no difference in the waterlines for conditions of plans 5 and 6; on the other hand, photo 56, which was taken at the time of llw, indicates extensive areas behind the plan 6 dike will remain flooded rather than becoming completely exposed as in plan 5 (photo 51). Maximum surface velocities in the areas shown in fig. 15 (but outside the limits of the navigation channel) are presented in table 6. Compared with plan 5, the maximum ebb velocity observed between the Juneau end of the dike and the bankline (area 1) was increased from 3.0 to 5.5 fps, the maximum ebb velocity observed between the dike and the seaplane basin (area 5) was increased from 1.5 to 3.5 fps, while the maximum ebb velocity observed near the mouth of Jordan Creek (area 4) was reduced from 4.5 to 1.5 fps. Photos 57 and 58 are the most representative of surface current patterns at the times of strength of ebb and strength of flood, respectively. Crosscurrents near the mouth of Jordan Creek and the Juneau end of the dike developed during the flood phase of tide and are shown in photo 59. Similar crosscurrents were observed during tests of plan 1 (photo 37). Also during the flood phase of the tide, a rather strong eddy developed around the navigation channel near the Juneau end of the dike in area 2 (photo 60).

SURFACE CURRENT PATTERNS

PLAN 6
