WEAR RESISTANT COATINGS FOR TITANIUM ALLOYS:
FRETTING FATIGUE OF UNCOATED Ti-6Al-4V

R.K. Betts
General Electric Company

Technical Report AFML-TR-71-212

1971 November

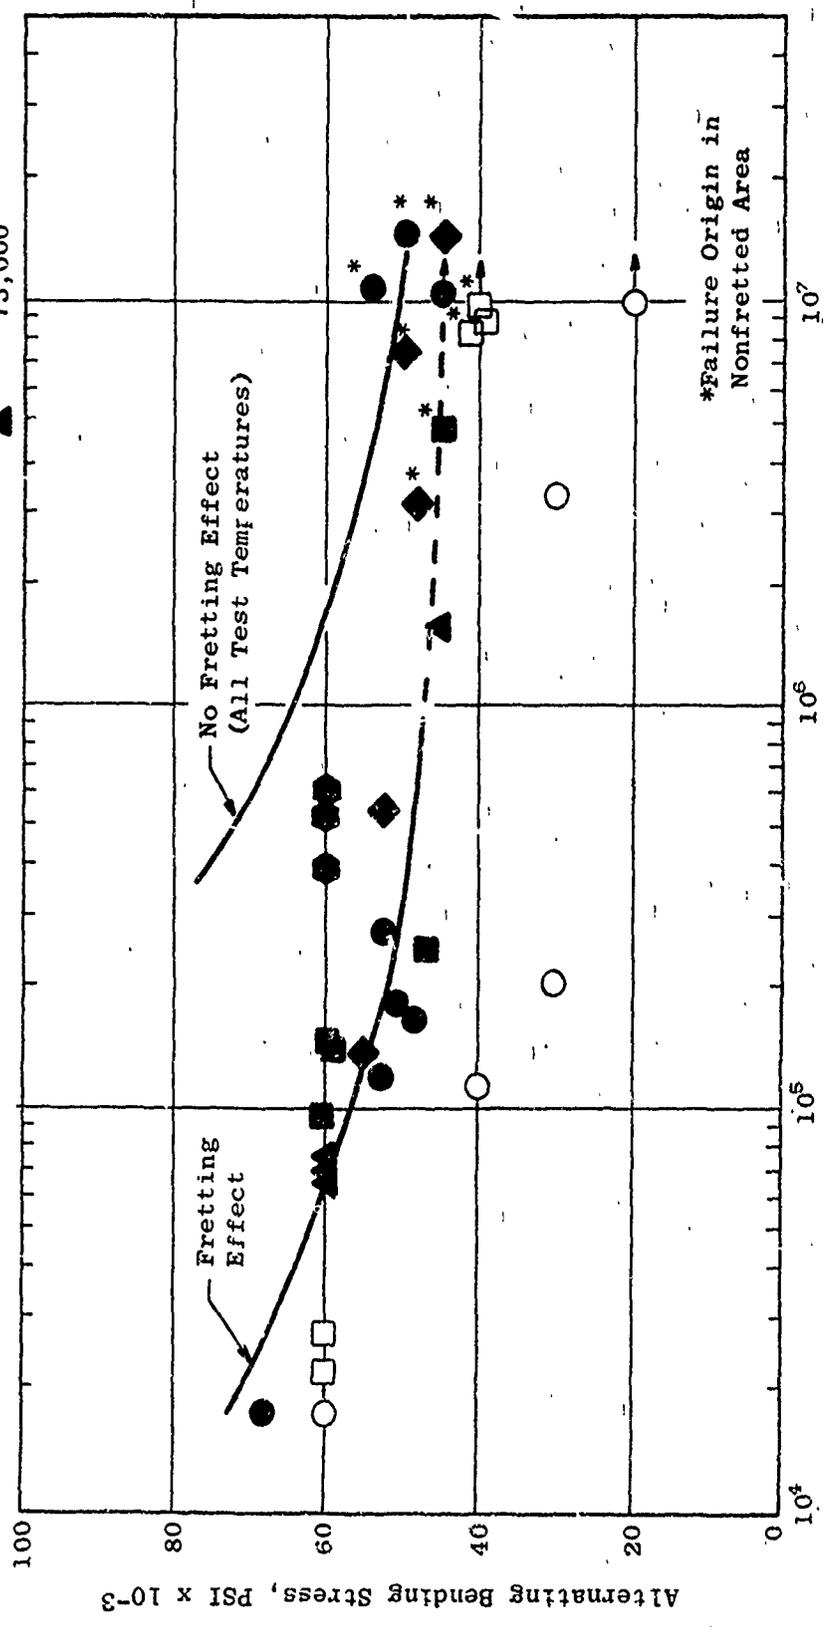
Figure 1. Effect of In-Situ Fretting During High Cycle Fatigue of Shot-Peened Ti-6Al-4V at Room Temperature, 400° F, and 650° F.

Classic fretting fatigue performed in an in-situ manner between surfaces of shot-peened, forged Ti-6Al-4V was found not to affect the run-out stress capability compared to nonfretted specimens in tests at room temperature. However, at 400° F, a slight decrease in the run-out stress was observed, and at 650° F a decrease of 30% resulted from severe surface interaction.

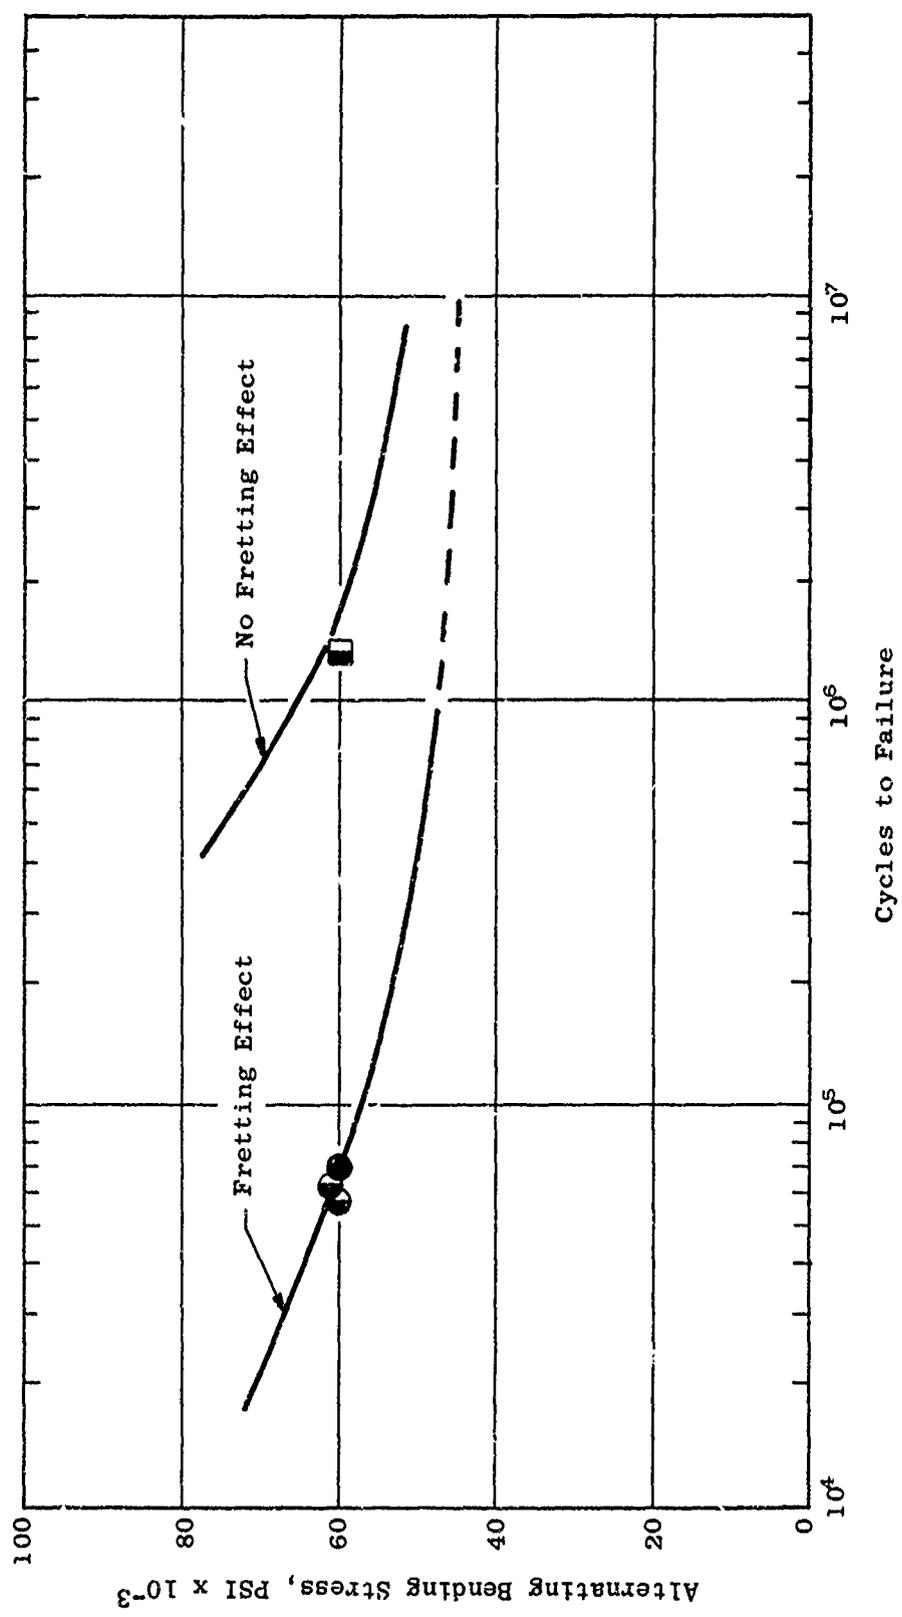
Figure 2. Effect of Interrupted In-Situ Fretting During High Cycle Fatigue of Shot-Peened Ti-6Al-4V at Room Temperature and 25,000 PSI Pressure.

A series of interrupted fretting fatigue tests were performed at 25,000 psi shoe-contact pressure and 60,000 psi fatigue stress (overstress region). Specimens were subjected to fretting fatigue for preselected numbers of cycles prior to expected failure, inspected, then continued to failure after removal of the fretting shoes. The purpose was to determine at what cyclic life terminal fretting damage was incurred and whether the damage could be assessed by nondestructive fluorescent penetrant inspection. The fatigue results are shown in Figure 2, compared to the general data curves. They indicate a narrow threshold between 10^4 and 5×10^4 fretting fatigue cycles within which inexorable fatigue damage developed. Fluorescent penetrant revealed cracks in the short-lived specimens (none in the unaffected specimen) before each was subsequently tested to failure with no additional fretting.

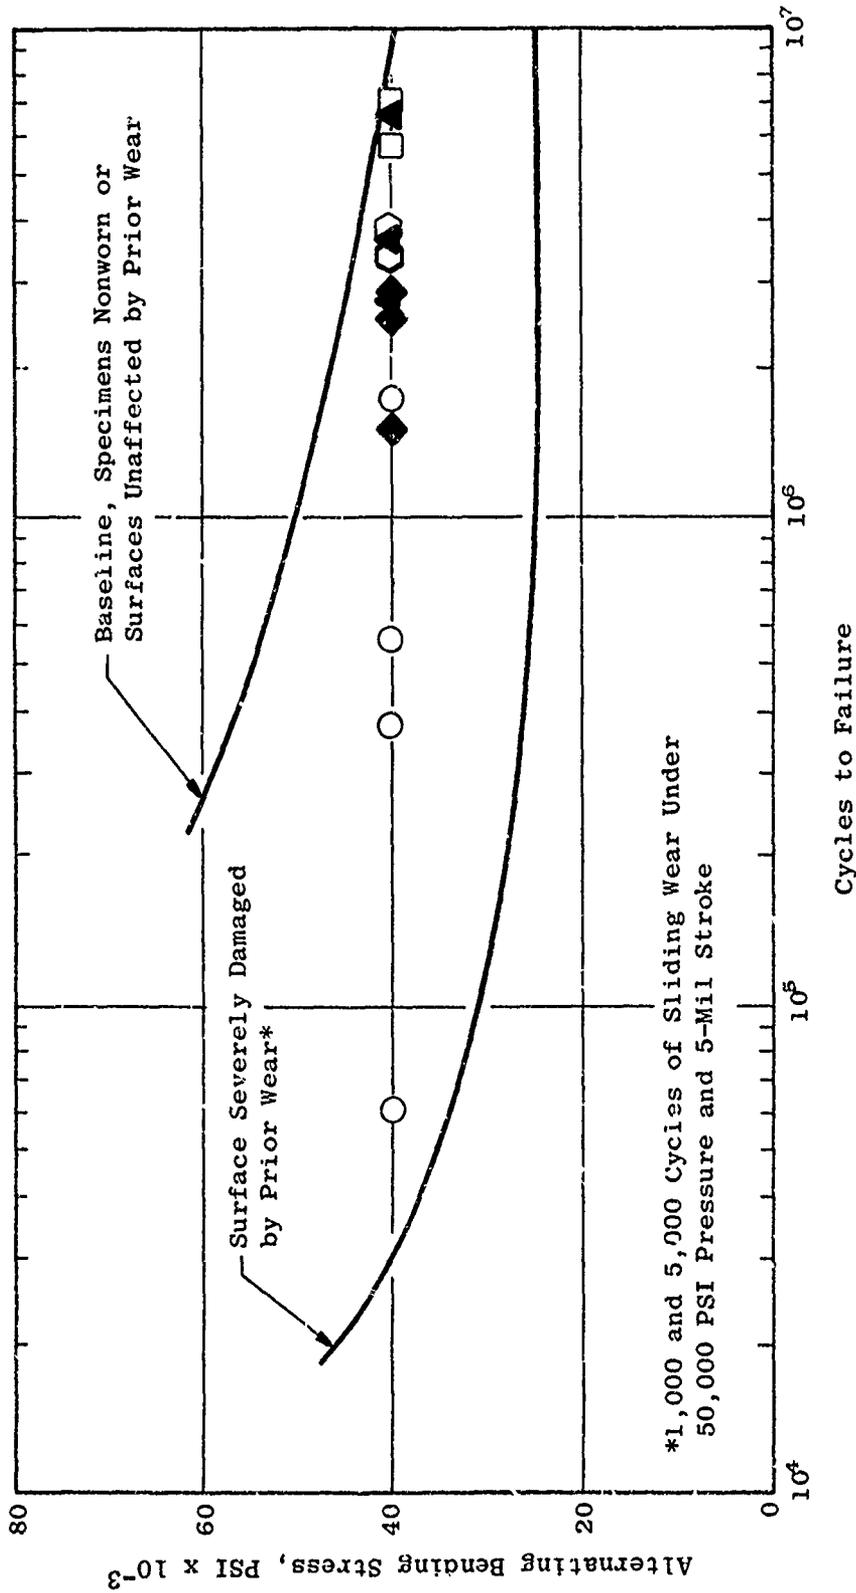
Figure 3. Effect of High Pressure Sliding Wear Damage on High Cycle Fatigue Properties of Shot-Peened Forged Ti-6Al-4V. Background Curves from Testing Reported in Reference 7. Of Data Points from Contract Tests, Only those Specimens with Fatigue Lives Less than 10⁶ Cycles Failed from Wear Damage Origins.

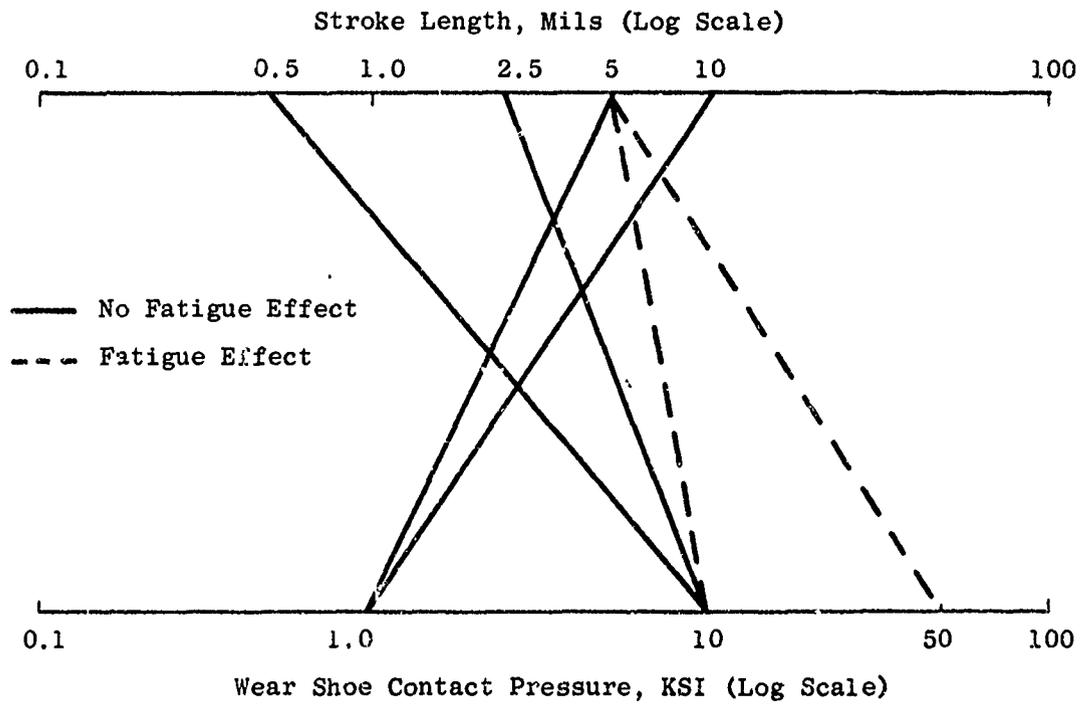
Figure 4. Summary of Wear Test Conditions for 1000 Strokes, Indicating the Effect on High Cycle Fatigue-Properties of Shot-Peened Ti-6Al-4V.

Figure 4 summarized these results in a nomograph form. Connecting lines depict the specific test conditions of contact pressure and stroke length for which fatigue-affecting wear damage did or did not occur within 1000 wear strokes.

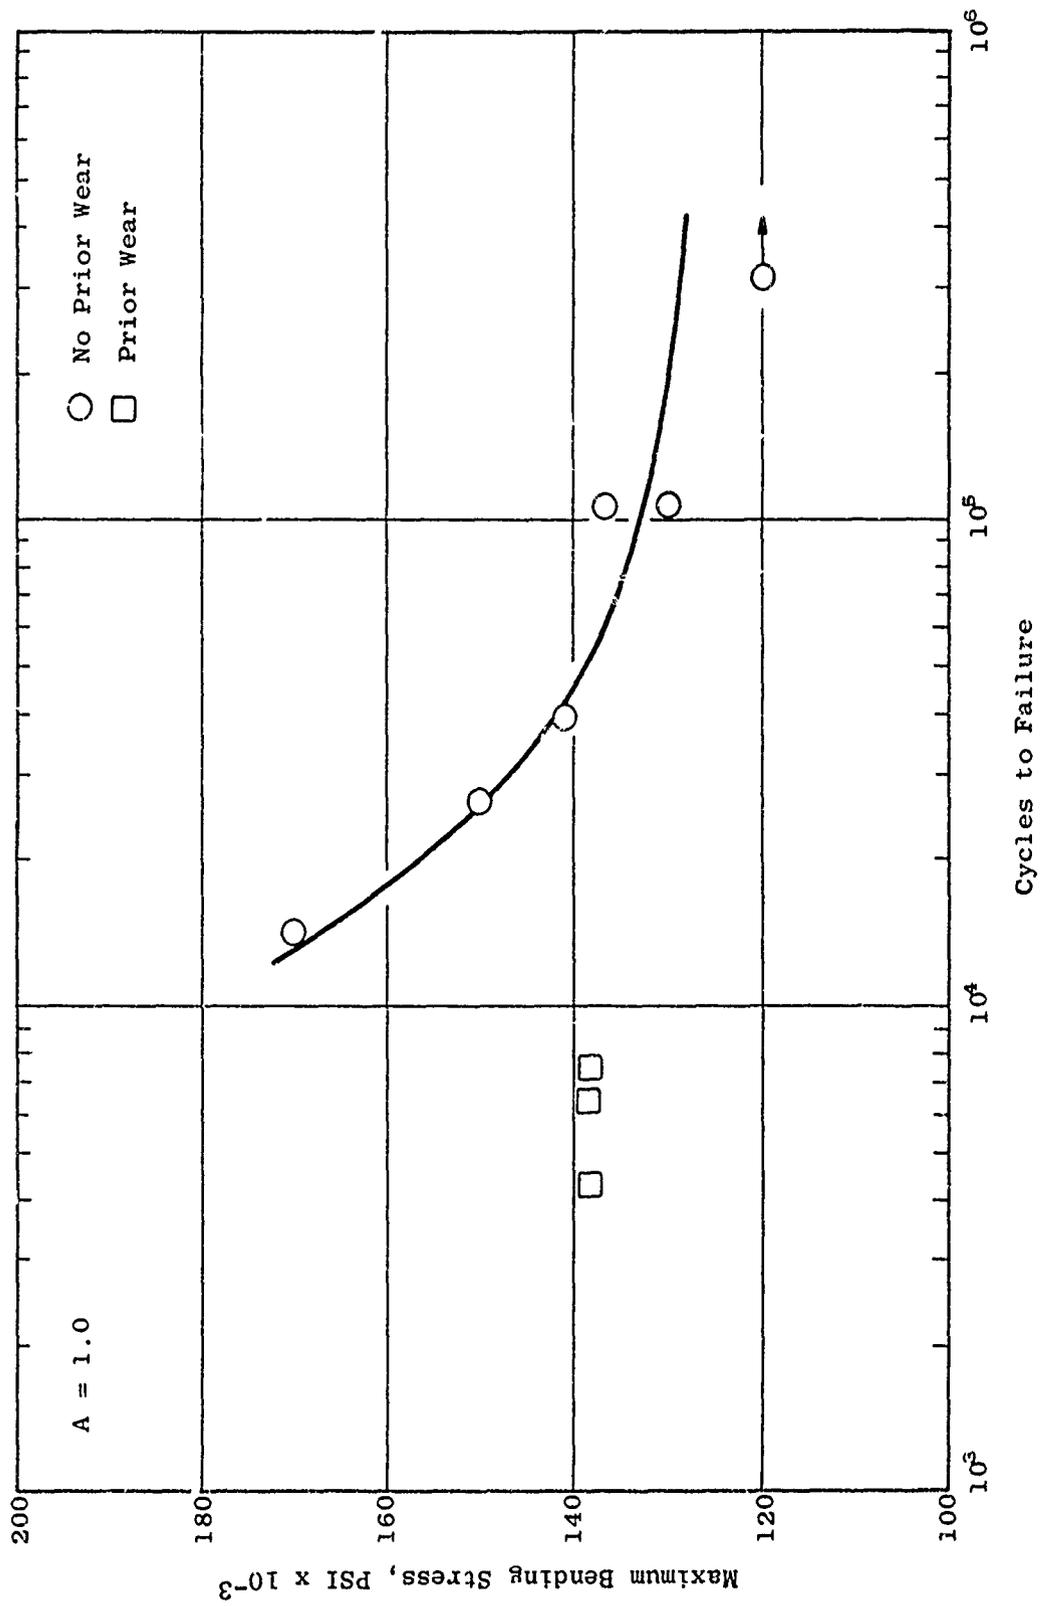
Figure 5. Low Cycle Fatigue Properties of Shot-Peened, Forged Ti-6Al-4V. Prior Wear Under 50,000 PSI Contact, 5-Mil Stroke, 1000 Cycles.

Low cycle fatigue tests in bending at $A = 1$ were performed on specimens subjected to wear under 50,000 psi and a 5-mil stroke. The results are shown in Figure 5. The imposed wear damage reduced the fatigue life by about 1 order of magnitude at the bending stress level equivalent to 10^5 cycles for nonworn specimens.

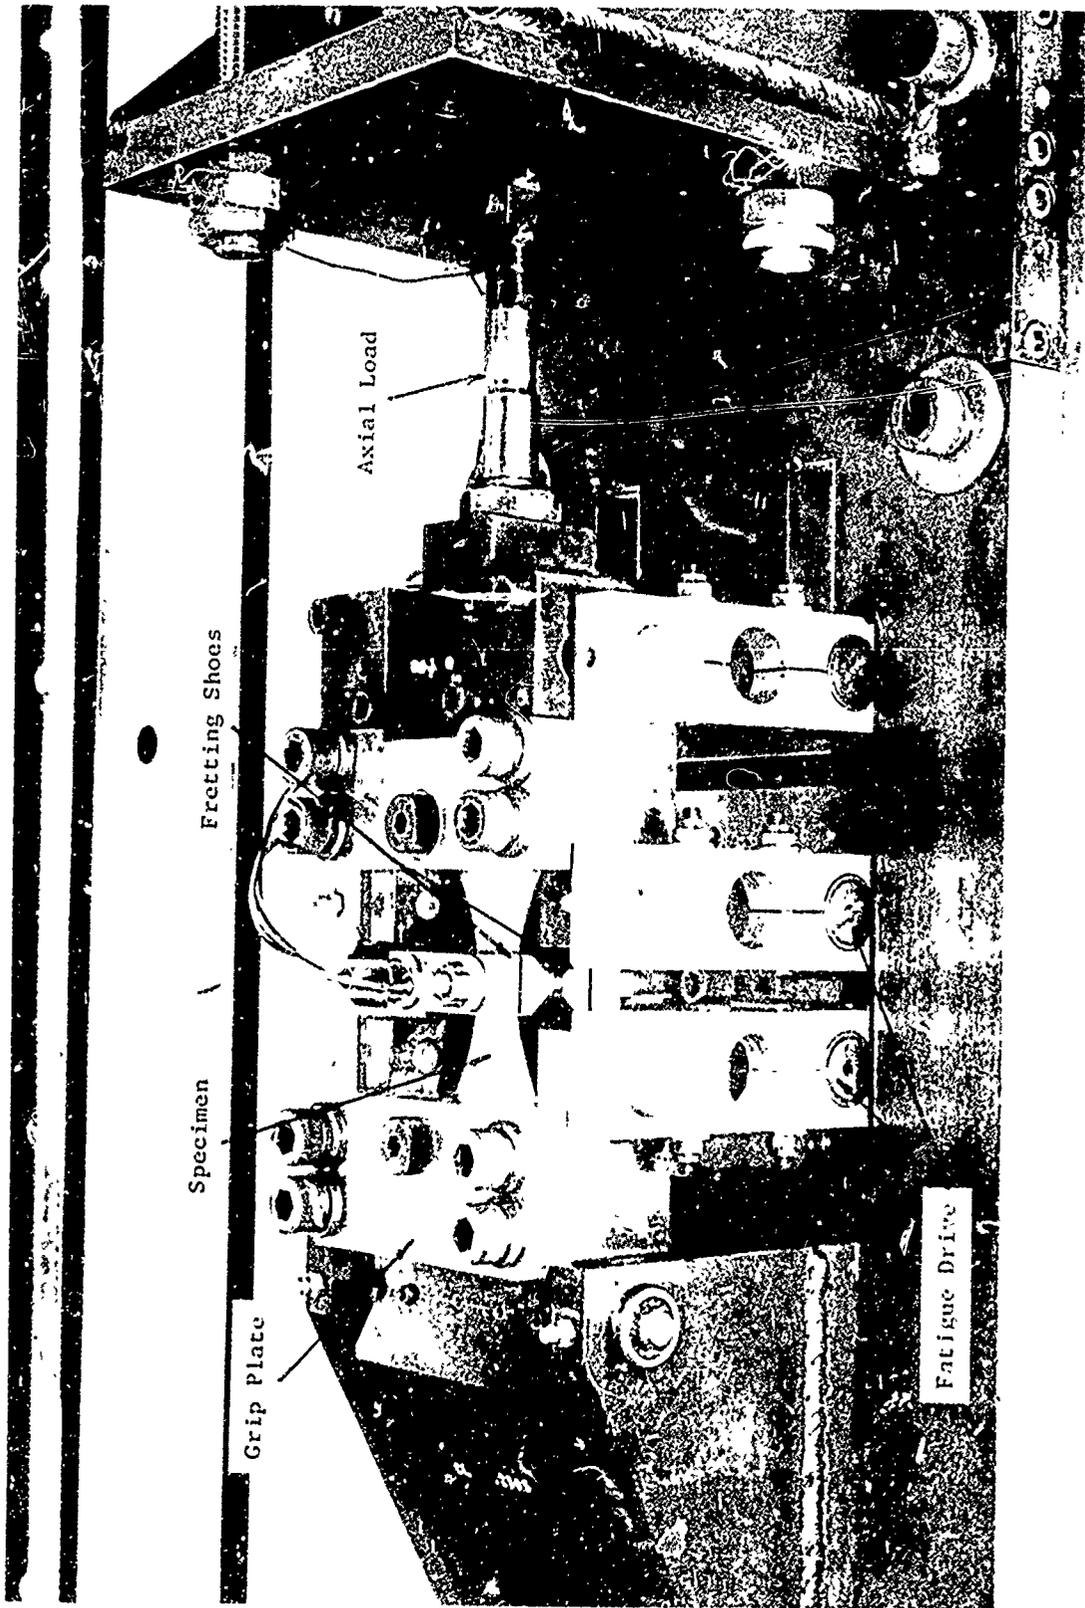
Figure 6. Overall View of Tension-Bending Fatigue Fixture Attached to Sonntag Shake Table

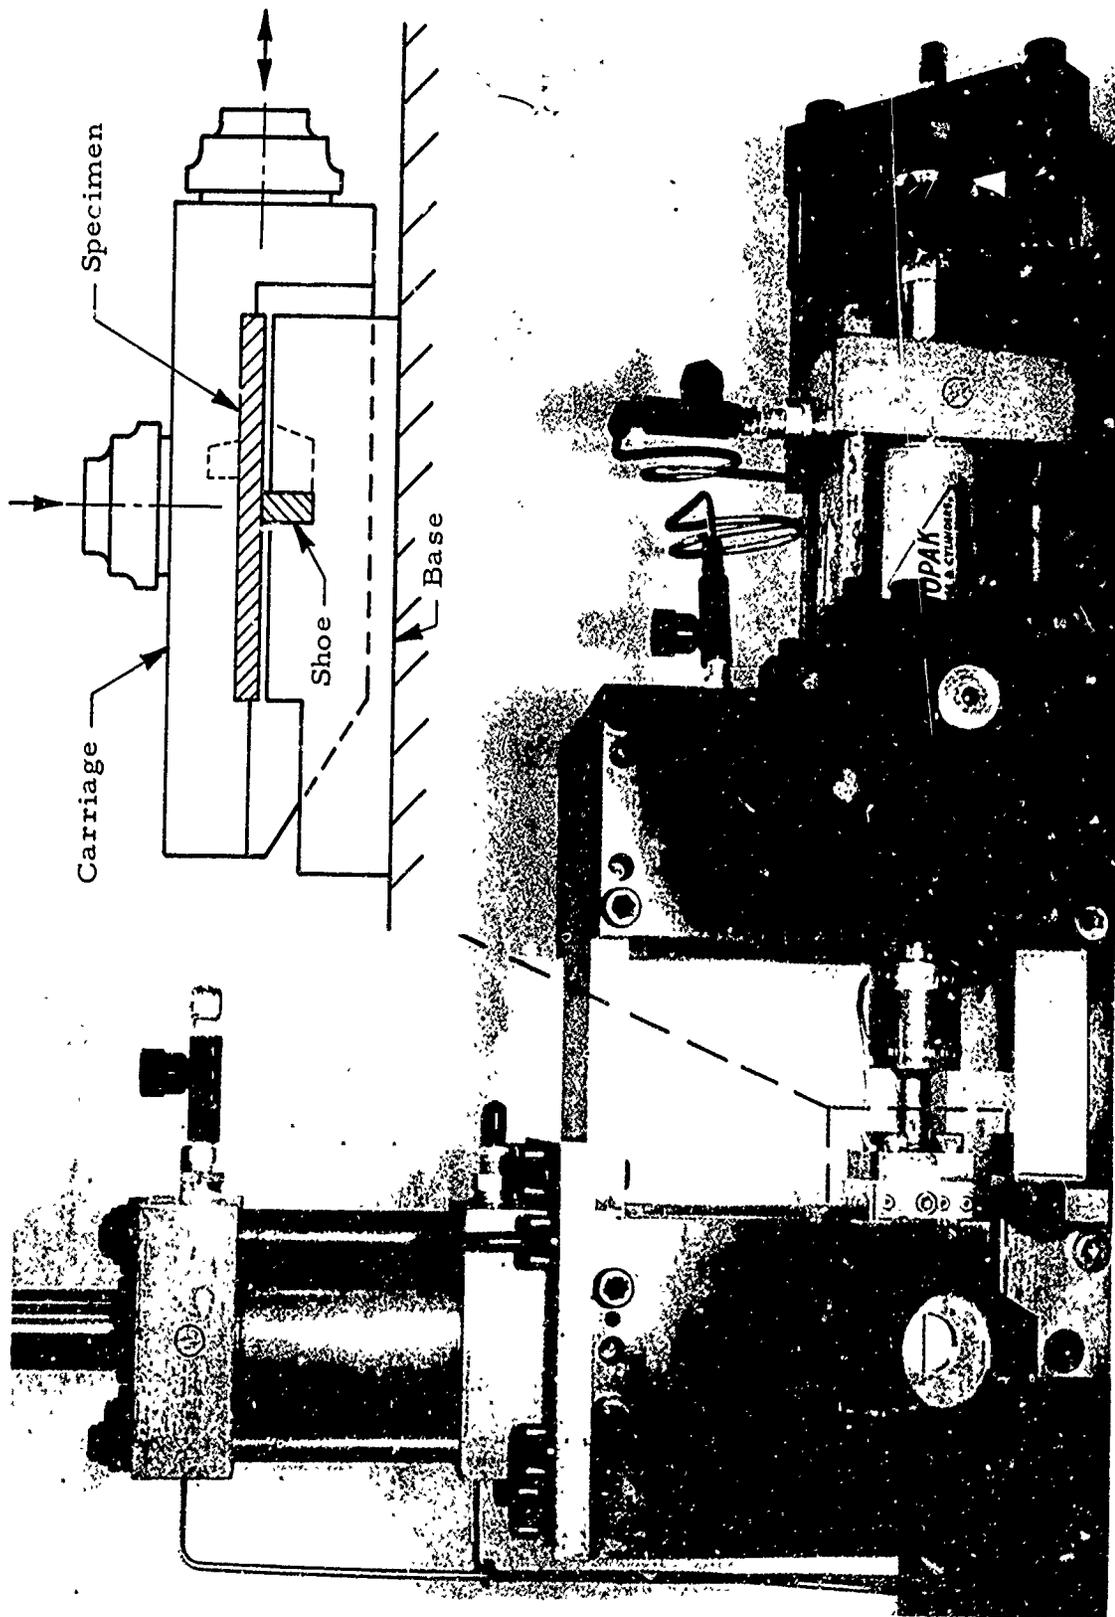
Figure 7. Apparatus for High Pressure Sliding Wear Testing. Schematic Illustrates Details of Fixture Containing Specimen and Shoe

A test to simulate this condition is a two-step method involving (1) the wear of a fatigue specimen under high contact pressure, followed by (2) fatigue of the worn specimen. The wear apparatus is shown in Figures 7 and 8.

The test specimen is mounted in the carriage fixture which is hydraulically actuated. The shoe is held in the fixed base block of the apparatus. Pressures to 80,000 psi on a 1/4 X 1-inch contact area are possible. The subsequent fatigue test is four-point bending in either the HCF or LCF mode.

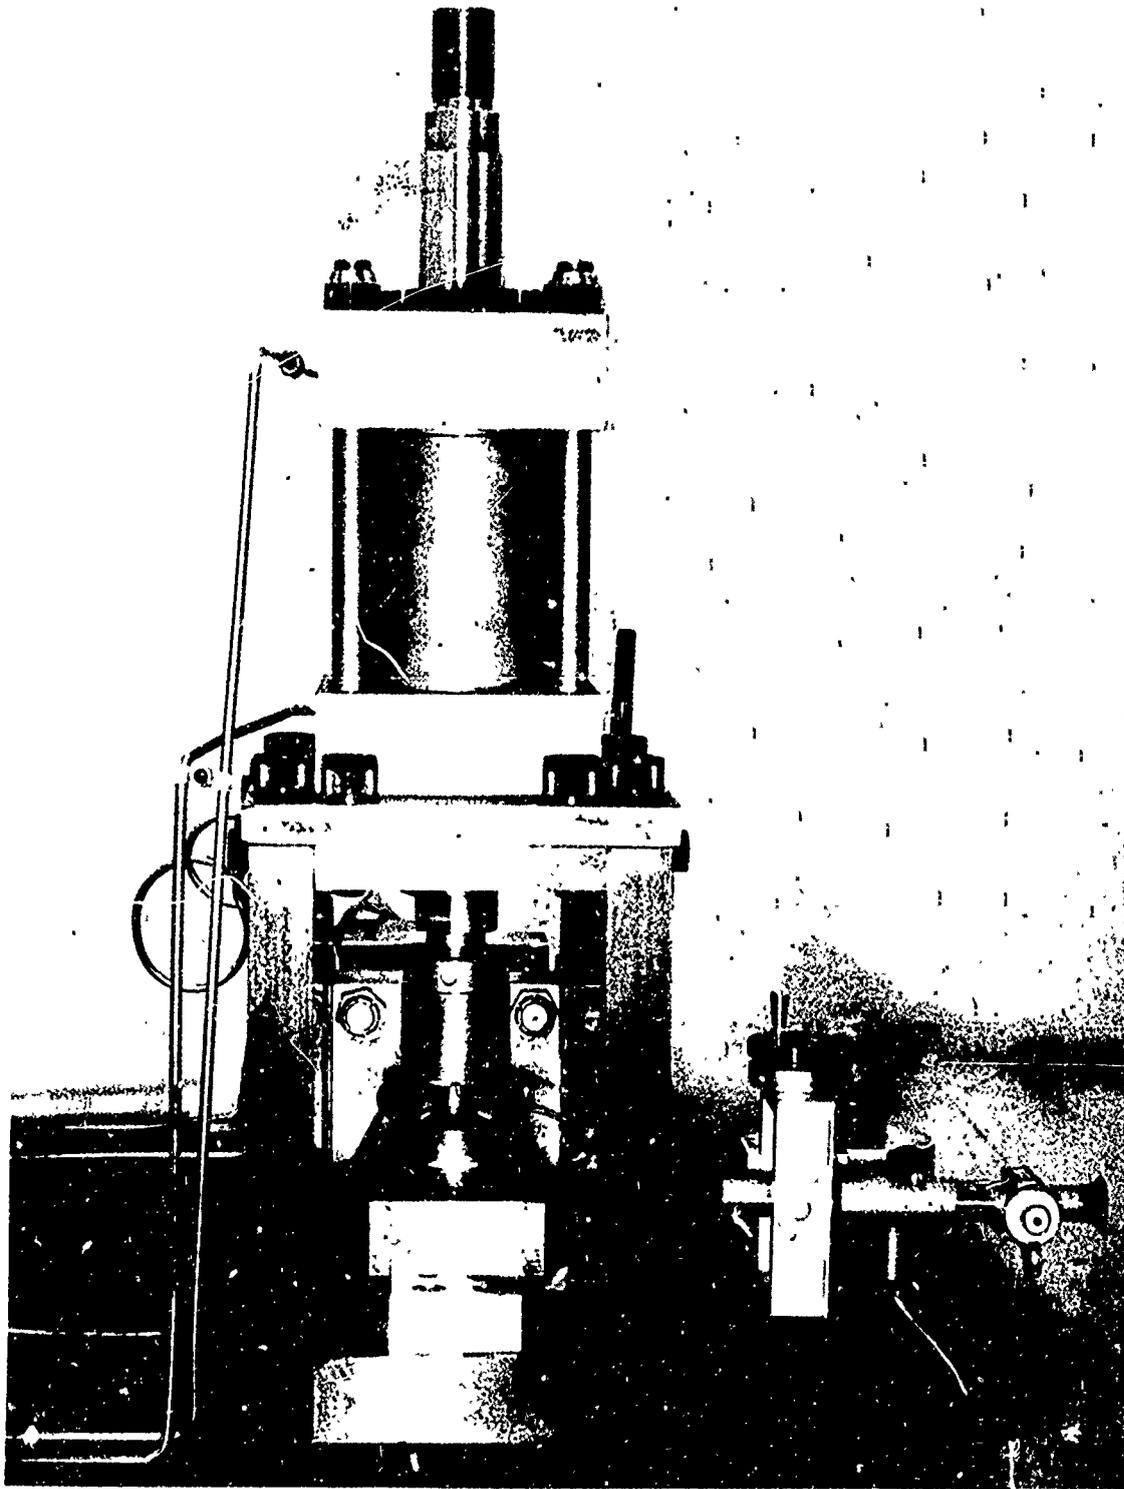
Figure 8. End View of Apparatus for High Pressure Sliding Wear Testing

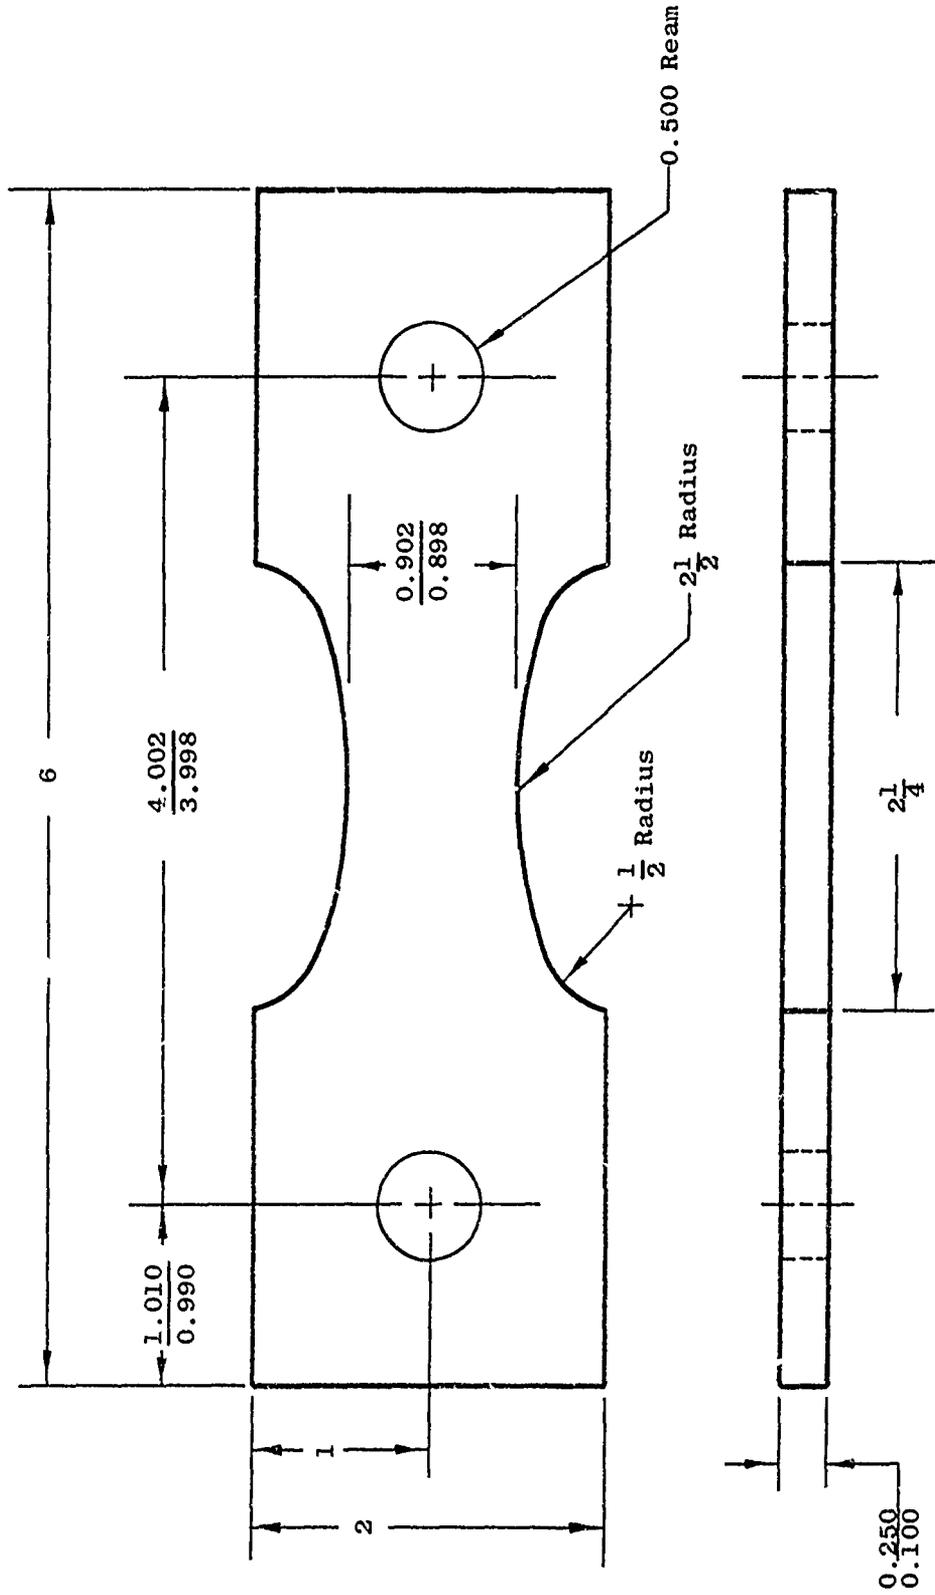
Figure 9. Configuration of High Cycle Fatigue Specimen.

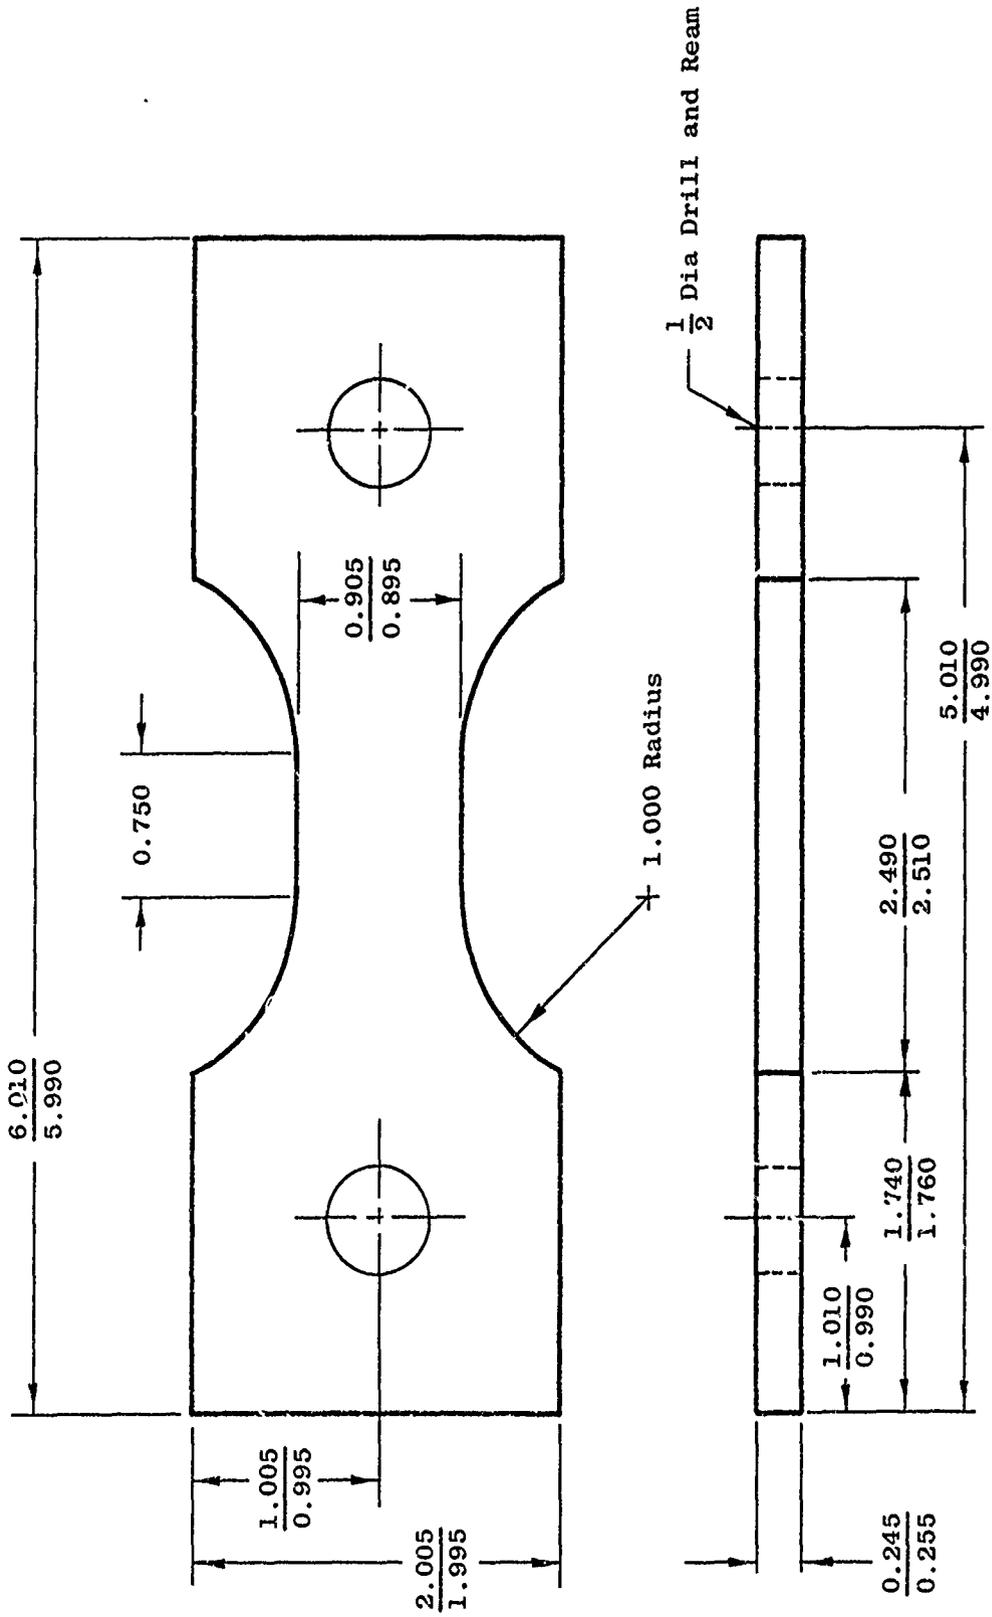
Figure 10. Configuration of Low Cycle Fatigue Specimen.

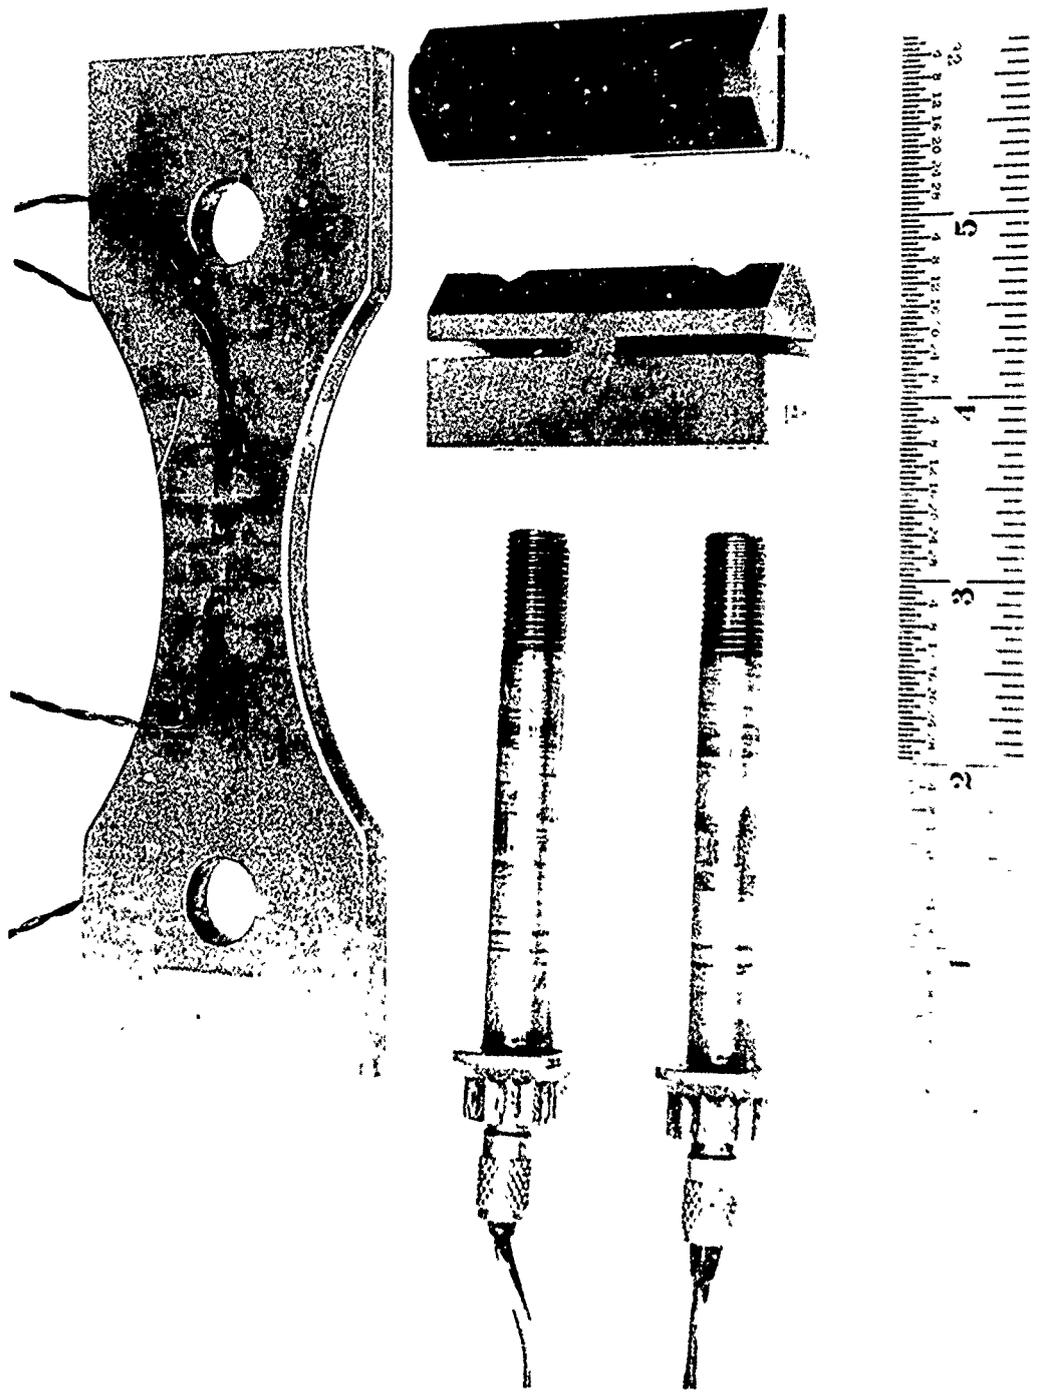
Figure 11. Fretting Fatigue Test Specimen with Pair of Wear Shoes and Internally Strain-Gaged Clamping Bolts. Strain Gages on Calibration Specimen Indicates Location where Reported Bending Stress is Monitored and Controlled.

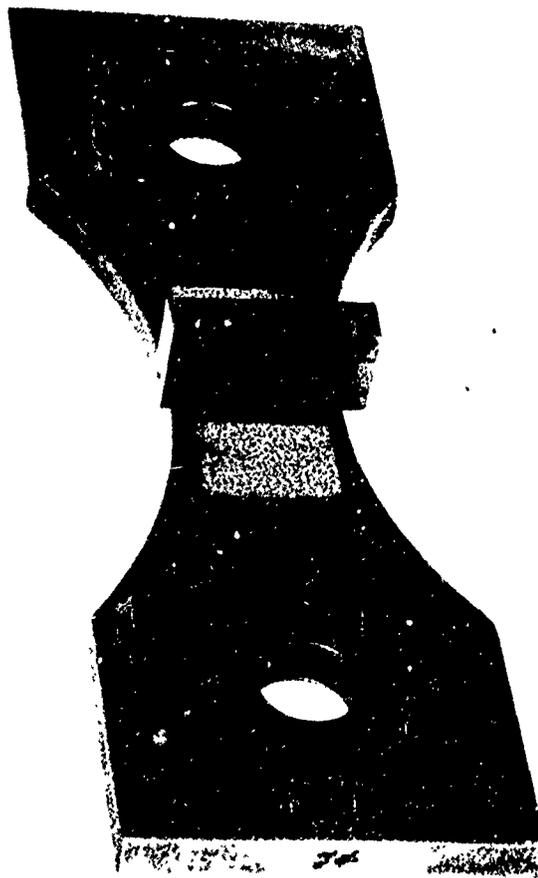
Figure 12. Specimen and Shoe Combination for High Pressure Sliding Wear Test

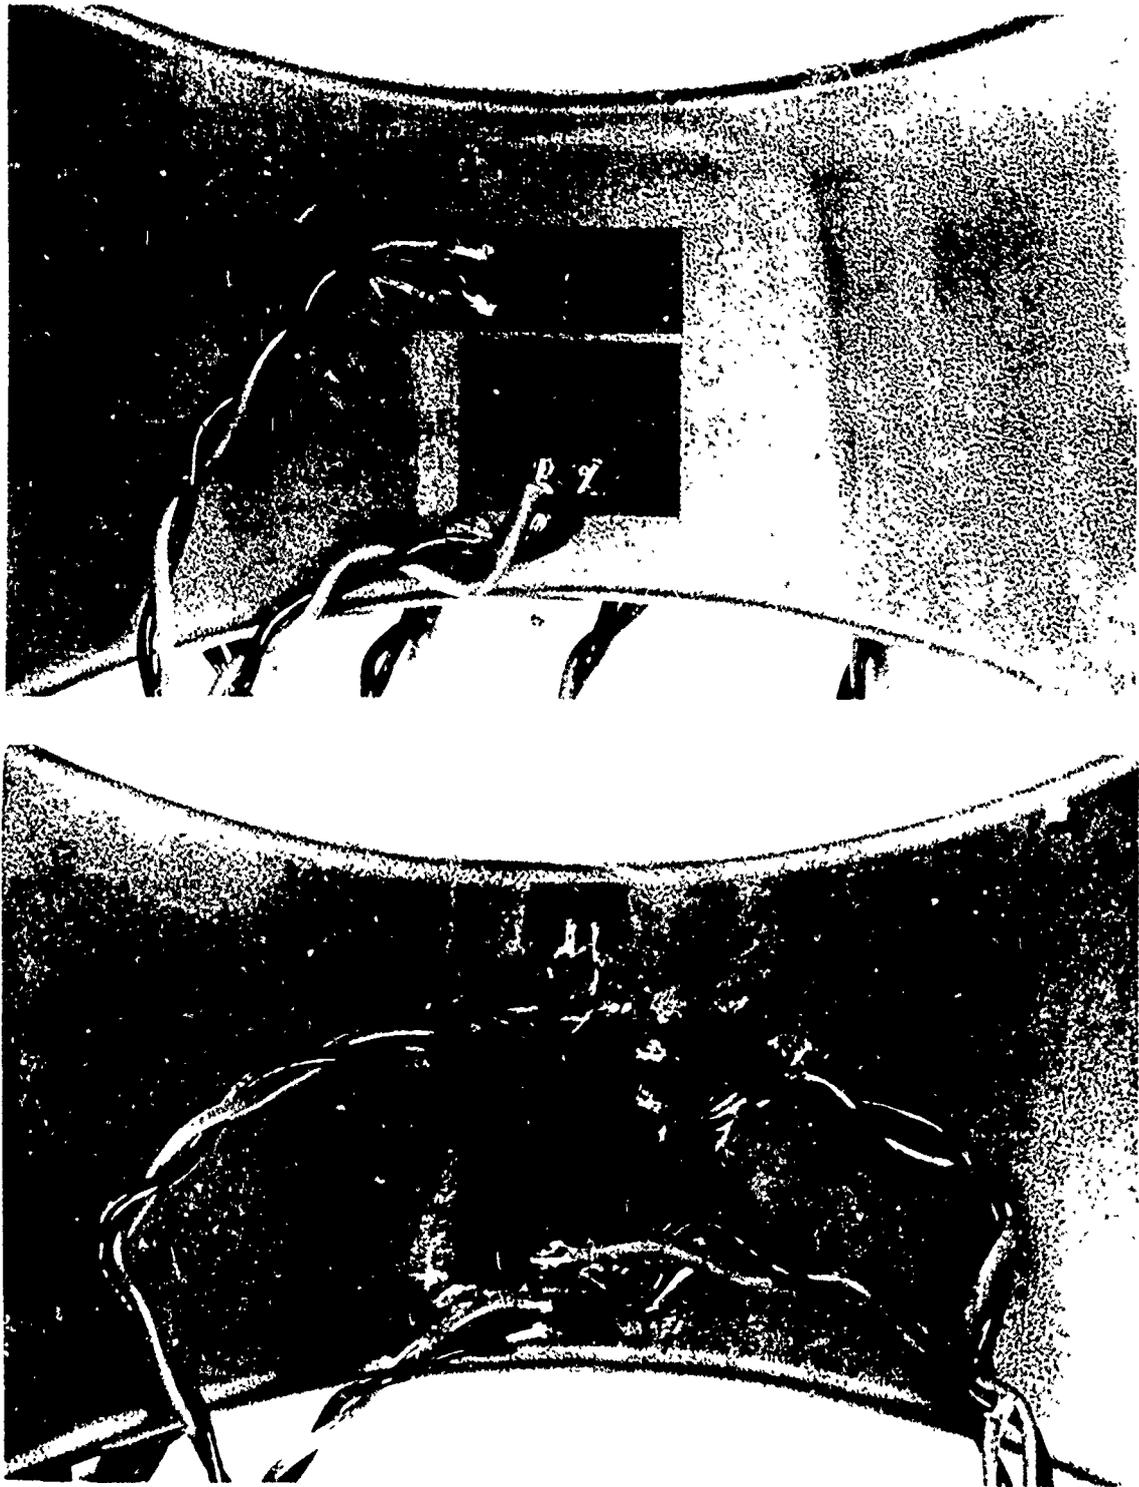
Figure 13. Calibration Specimen Illustrating Placement of Strain Gages on Specimen Surfaces

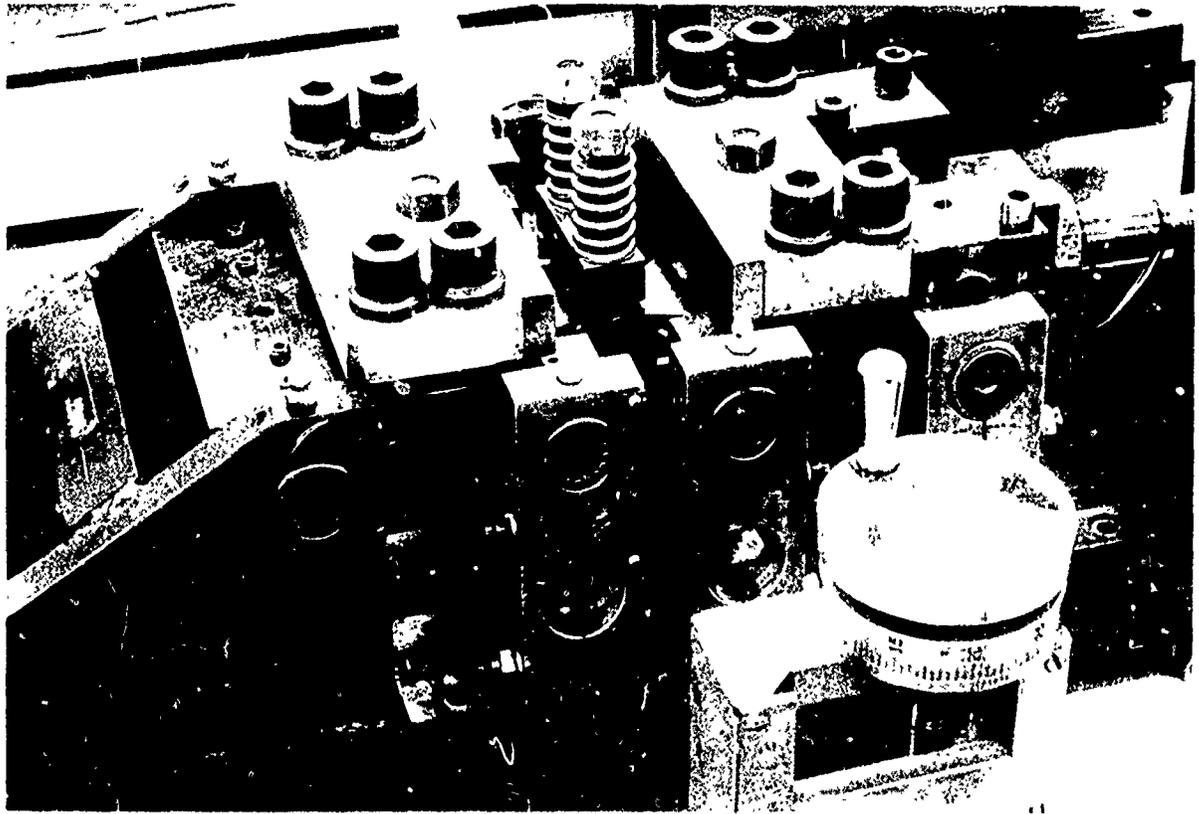
Figure 14. View of the Fretting Fatigue Test Fixture Illustrating the Method of Shoe Assembly for Low Contact Pressure (500 PSI). The Springs were Precalibrated to Provide Approximately 90 Lb of Contact Force (500 PSI).

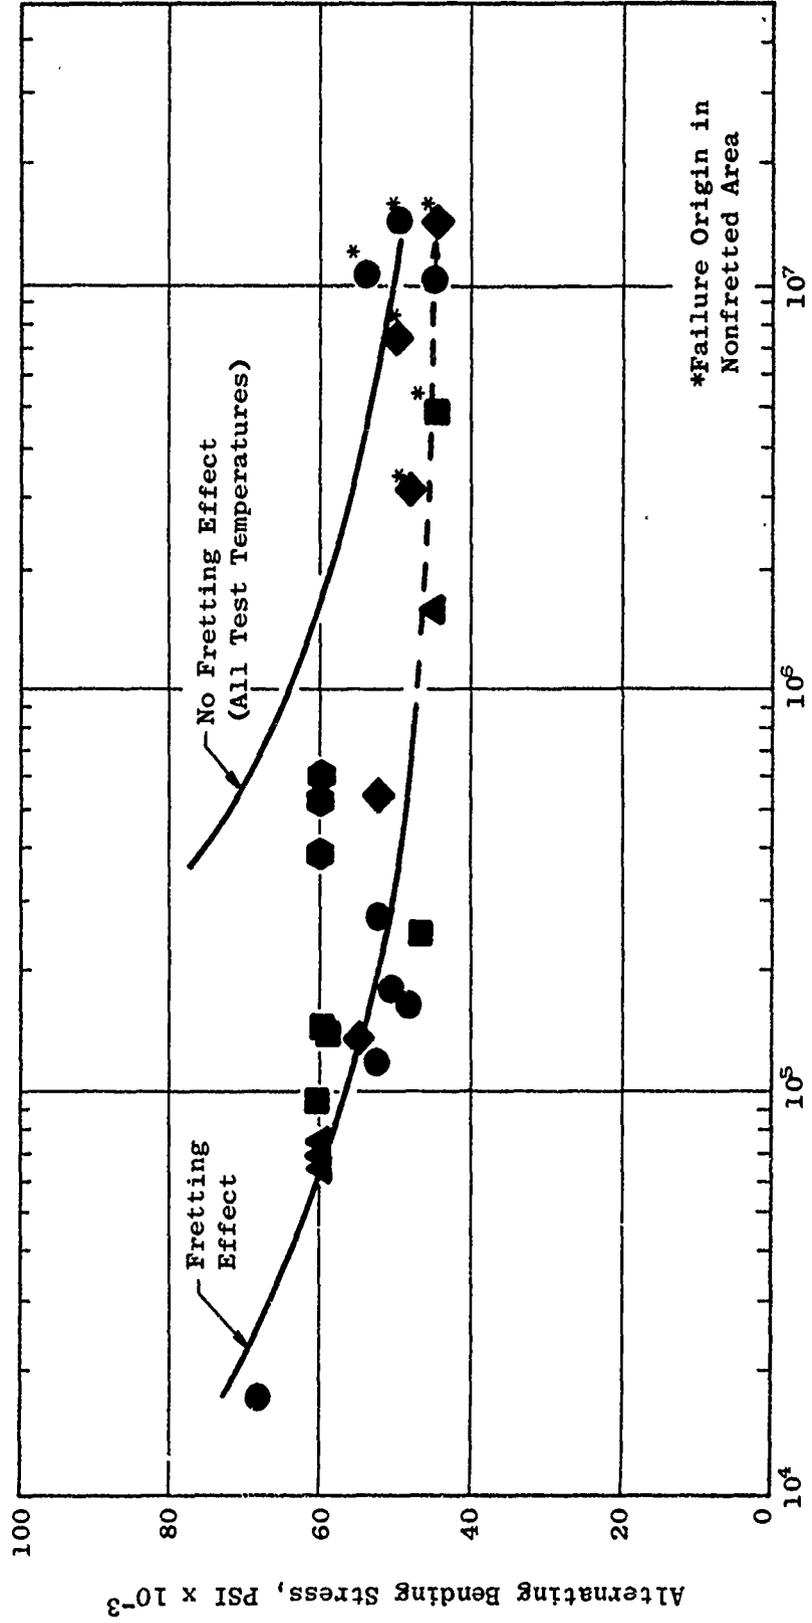
Figure 15. Effect of In-Situ Fretting During High Cycle Fatigue of Shot-Peened Ti-6Al-4V at Room Temperature.
