WEAR RESISTANT COATINGS FOR TITANIUM ALLOYS:
FRETTING FATIGUE OF UNCOATED Ti-6Al-4V

R.K. Betts
General Electric Company

Technical Report AFML-TR-71-212

1971 November

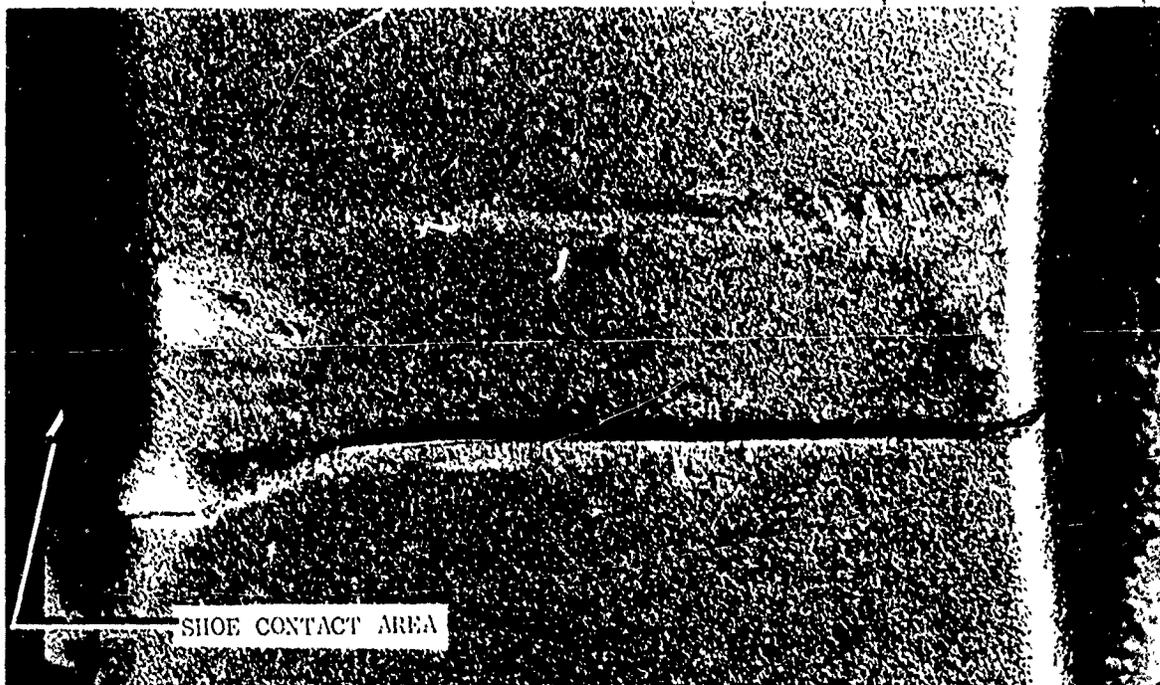
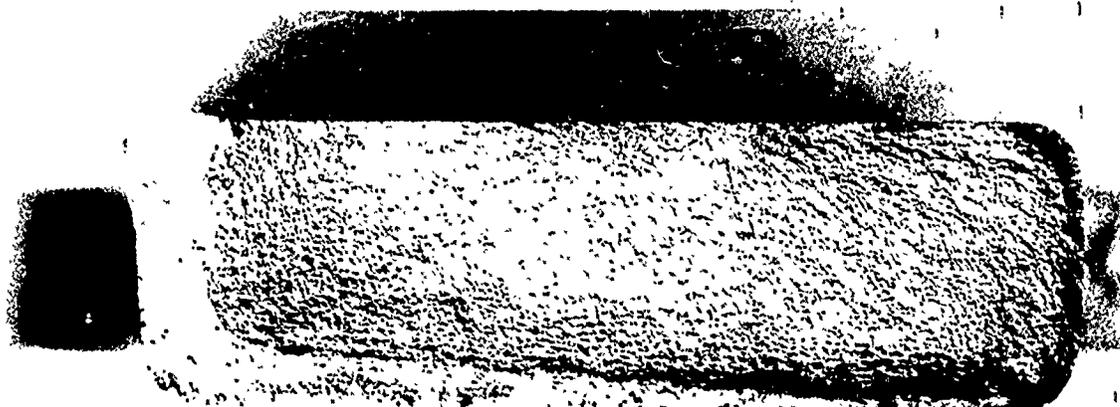
Figure 16. Fretting Fatigue Specimen 56 Tested Under 500 PSI Shoe Contact Pressure at 20,000 PSI Mean Tension and 60,000 PSI Alternating Bending Stress to 6×10^5 Cycles. The Shoe Contact Area Shows Fretting Debris Along the Edges and Pits at the Ends. The Failure Initiated from a Single Origin Visible on the Fracture Face, Corresponding to Fretting Damage Along the Edge of the Shoe Contact Area. (6X)

Figures 16, 17, and 18 illustrate the typical surface appearance of fretting fatigue specimens tested under 500, 5000, and 75,000 psi, respectively. Visually

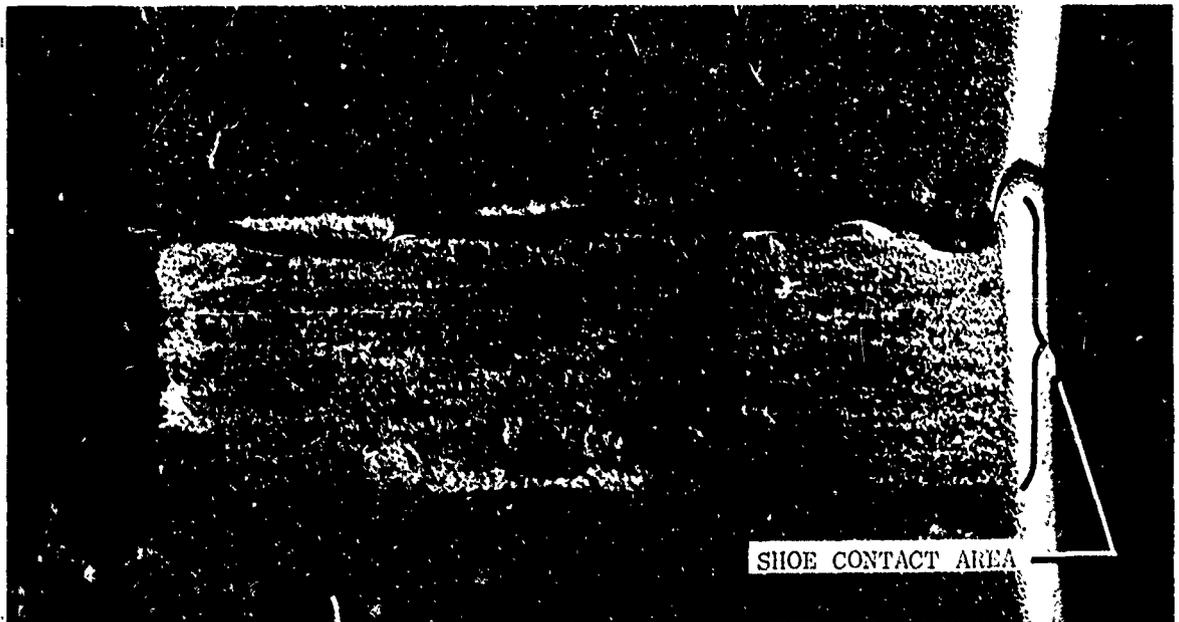
Figure 17. Fretting Fatigue Specimen 48 Tested Under 5,000 PSI Shoe Contact Pressure at 20,000 PSI Mean Tension and 60,000 PSI Alternating Bending Stress to 9.4×10^4 Cycles. Upper Photograph Illustrates the Fretted Area where the Shoe was in Contact. Origins Visible in the Lower Photograph Show the Initiation of Failure from Surface Damage at the Edge of the Shoe Contact Area. (6X)

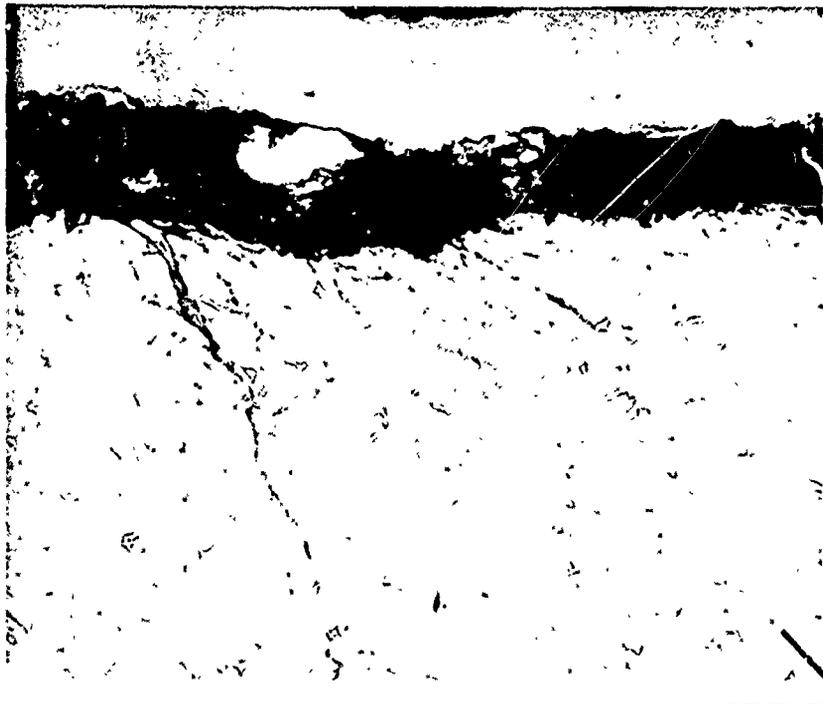
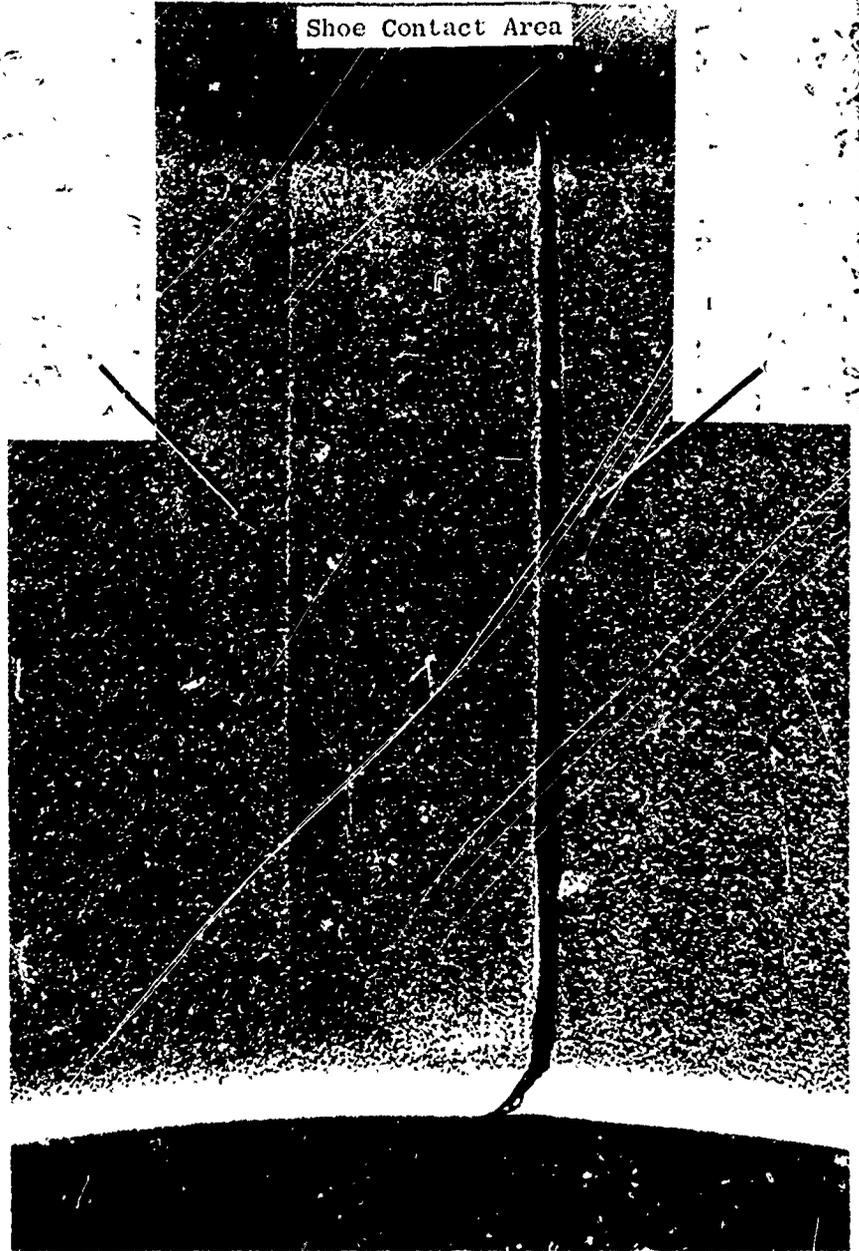
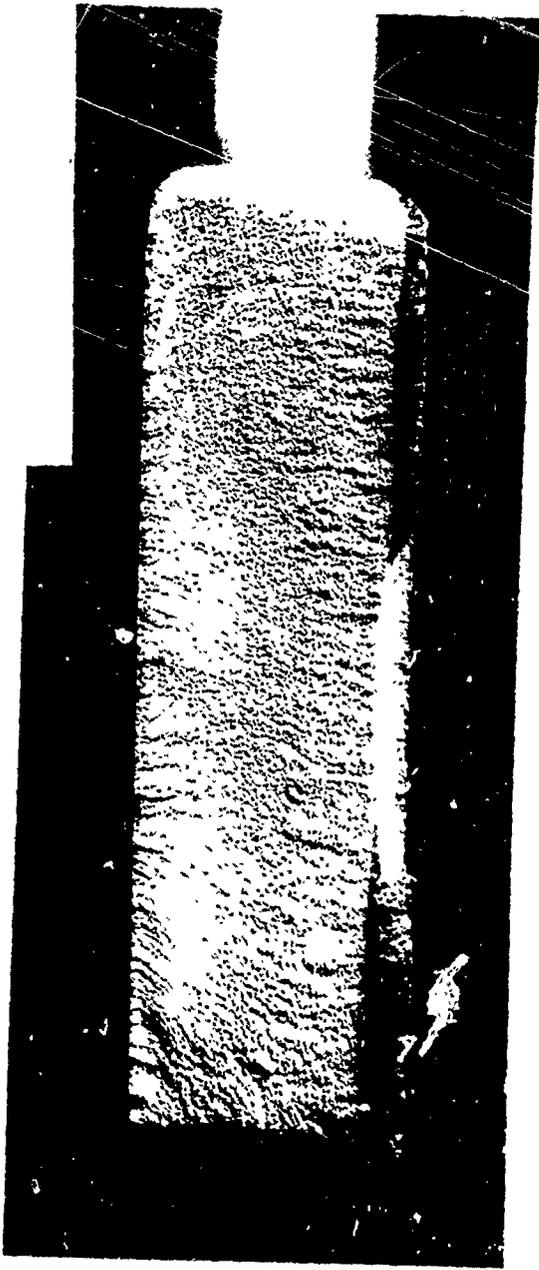
Figure 19. Composite Macro- and Microphotographs of Specimen 52 After Fretting. The Metallographic Sections Reveal Oblique Shear Cracks and Wear at Shoe Edges. An Incipient Fatigue Crack is Visible in View C, Taken from Multiple Origins. SEM Photographs of Such a Wear Surface are

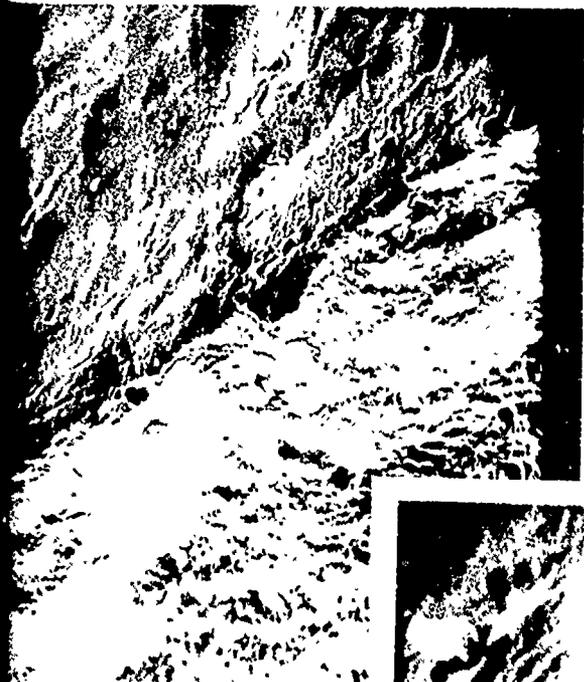
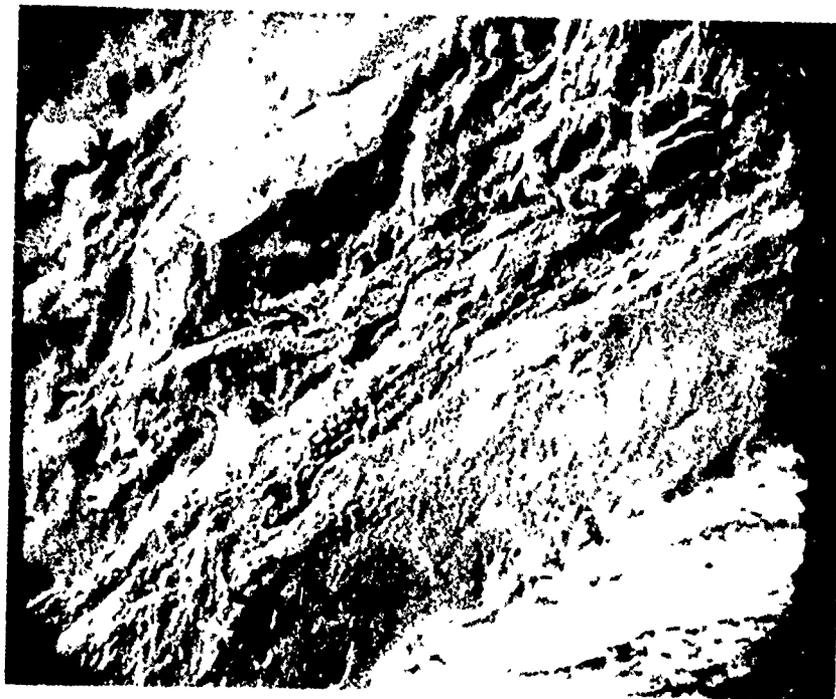
Figure 20. Composite SEM and Macrophotographs of Specimen Surface. Specimen Surface was Illustrated Previously in Figure 19 Previously Illustrated Typical Metallurgical Surface. Fracture Face in the Origin Reveal the Surface. Typical Shot-Peened Surface in a Nonfretted Area.

Figure 20 is a series of SEM photographs of Specimen 60 illustrated previously in Figure 18. Figure 20A shows a macrophoto of the single major origin. Figure 20B shows the origin in perspective with the fracture edge and the dimpled peened texture of the specimen surface (part of the shoe contact area during test). Successively detailed views of the origin in Figures 20C and 20D reveal no readily discernable primary site of failure. Nonetheless, they show the fretted band from shoe contact along the fracture edge. In the center view it

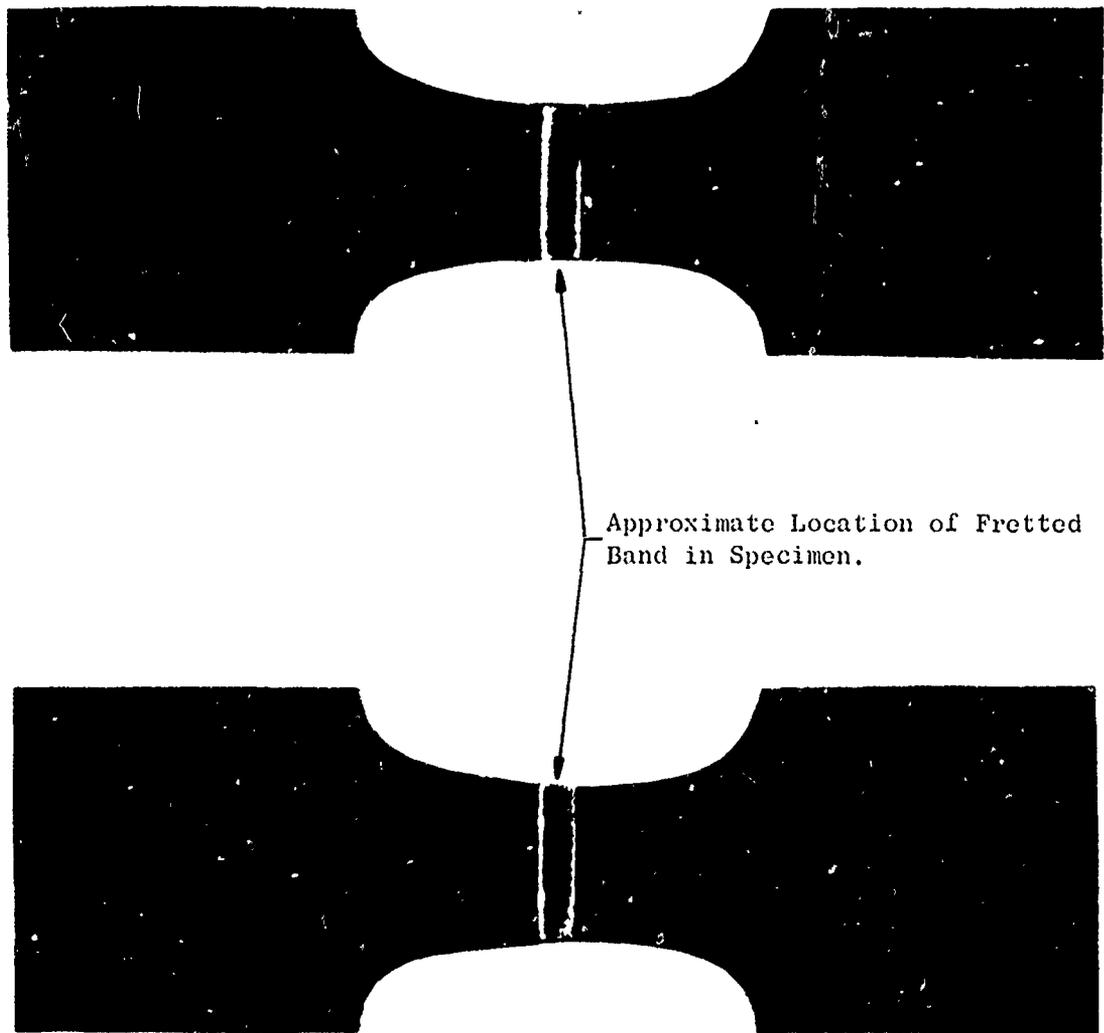
Figure 21. Autoradiograph Exposures of Kryptonized Fretted Specimens. The Fretted Bands were Effectively Outlined by the Method, but Crack Detection was Difficult. (Industrial Nucleonics)

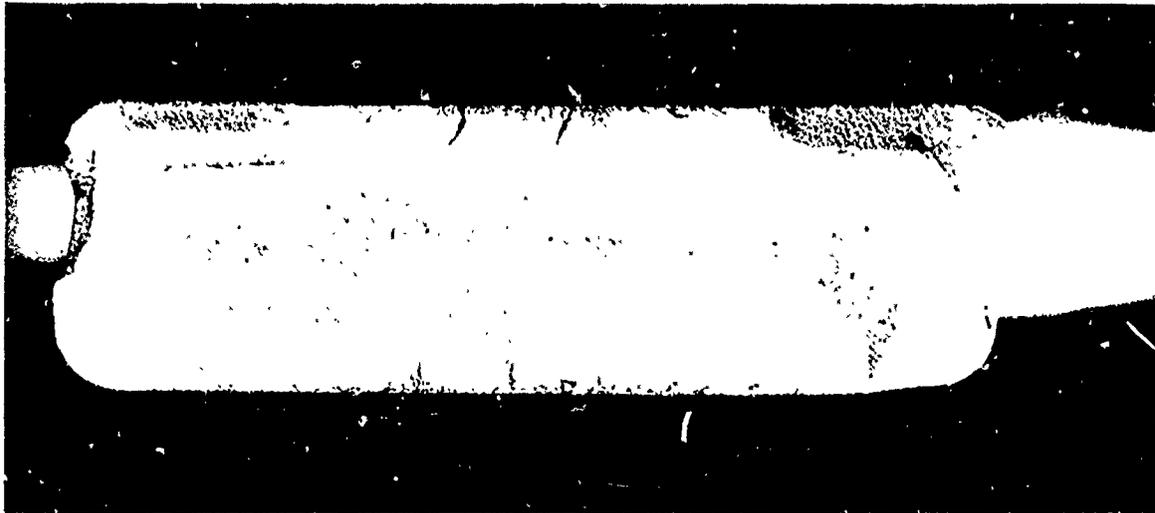
Figure 23. Fretting Fatigue Specimen 61 Tested Under 25,000 PSI Shoe Contact Pressure at 20,000 PSI Mean Tension and 60,000 PSI Alternating Bending Stress. Fretting was Interrupted at 5×10^4 Cycles for Fluorescent Penetrant Inspection Shown in Figure 22. Fatigue was Continued, Without Fretting, to Failure at 6.6×10^4 Cycles. Fracture Originated from Both Surfaces where Cracks were Disclosed at Inspection.

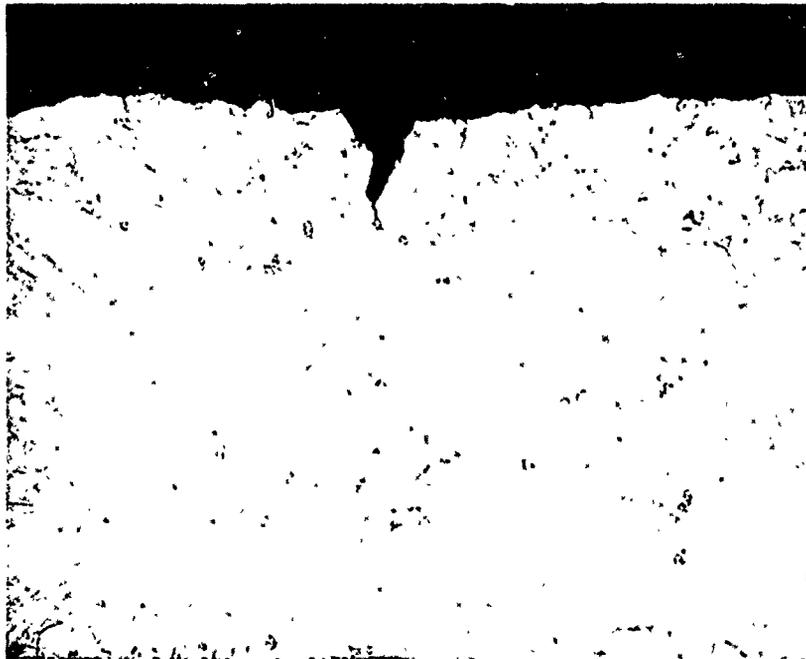
Mount 2012, Neg G 6311, 1000X

Figure 24. SEM and Metallographic View of Specimen 61 Showing Fretting Fatigue Cracks Enlarged by Etching for Fluorescent Penetrant Inspection The Metallographic Sections Show Apparent Propagation During Subsequent Fatigue Without Fretting.

Figure 24 shows an SEM view of Specimen 61, interrupted from fretting, then fatigued to early failure. Both photographs illustrate fretting fatigue cracks which were enlarged and blunted by the HNO_3 -HF chemical cleaning prior to penetrant inspection. Figure 24 also shows a metallographic cross section of such a crack. Acid pitting of the general surface is also evident in the SEM photographs. The upper photograph illustrates the fretted band at the edge of fracture.

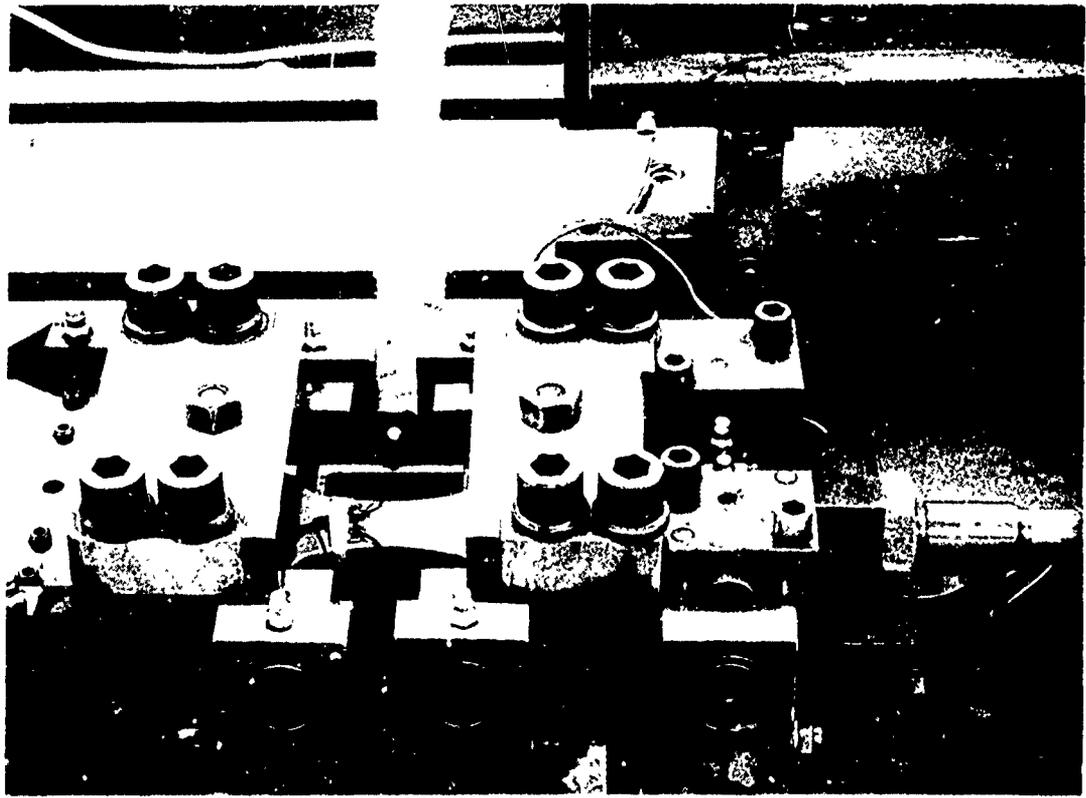
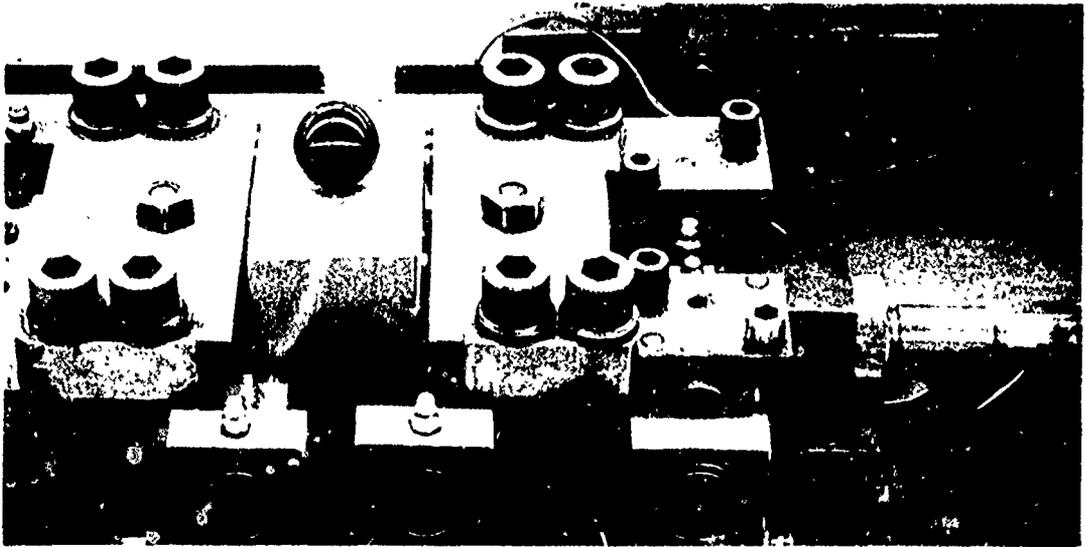
Figure 25. View of the Fretting Fatigue Fixture Showing the Assembly for 400° F Testing. Heated Air from a Tube Furnace is Blown into the Chamber (Lower Photograph) which Contains the Instrumented Specimen, Exposed in the Upper Photograph.

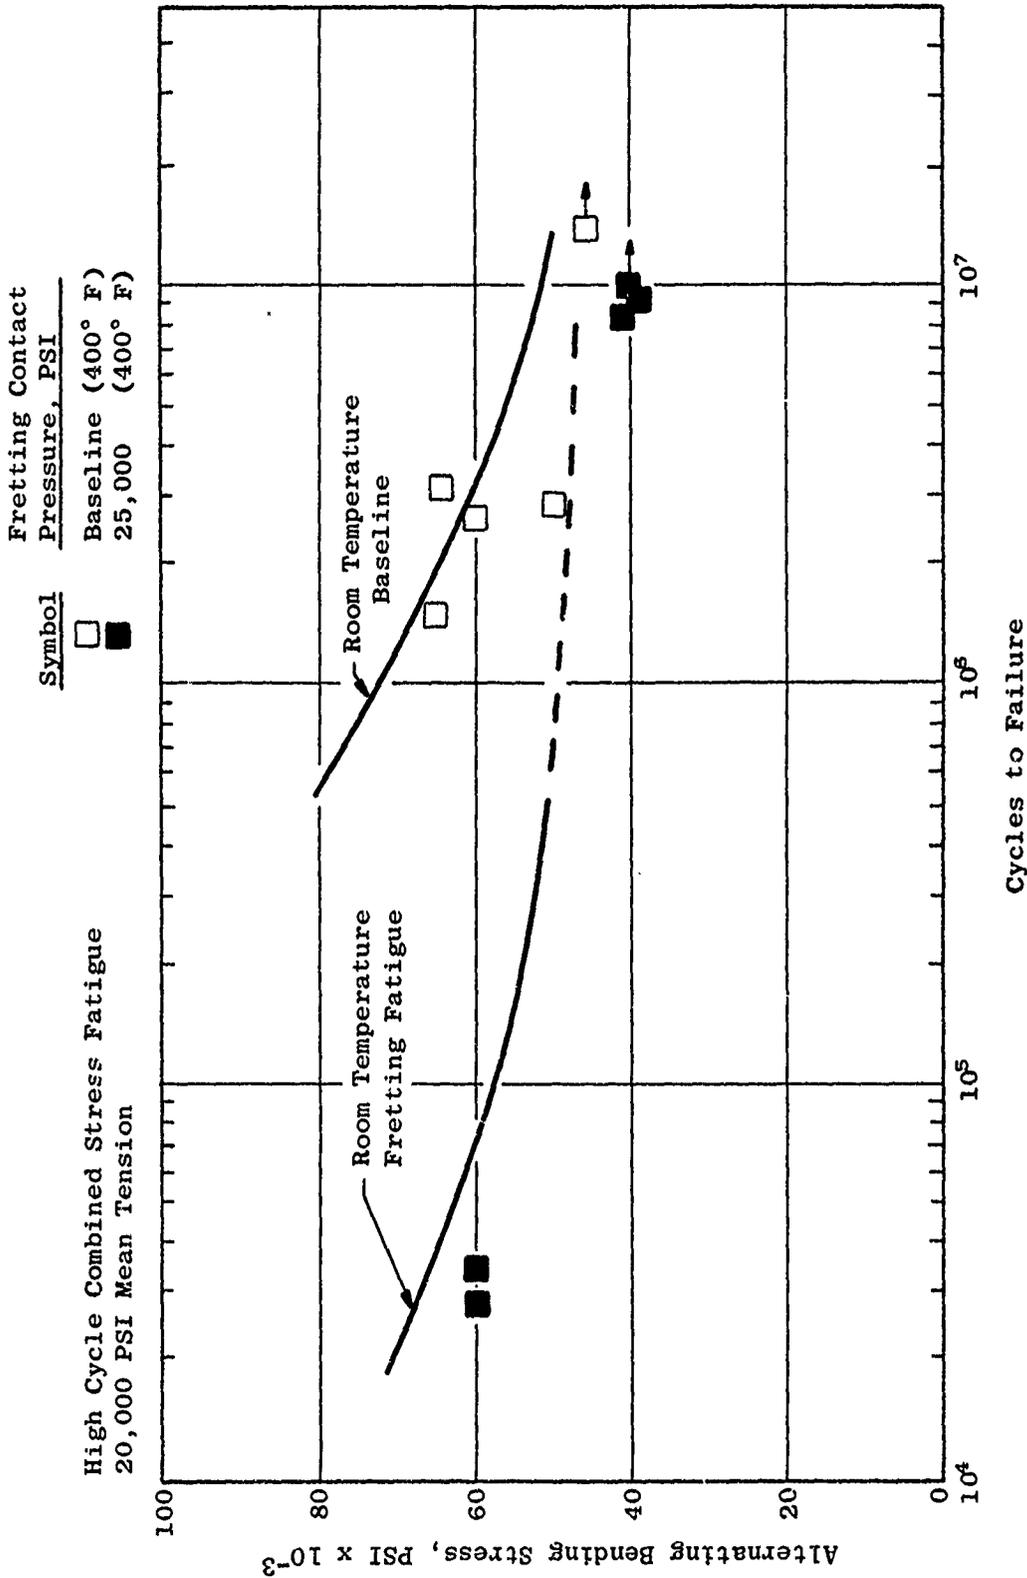
Figure 26. Bending Fatigue Strength of Shot-Peened Ti-6Al-4V at 400° F Compared to Room Temperature Baseline and Fretting Curve.

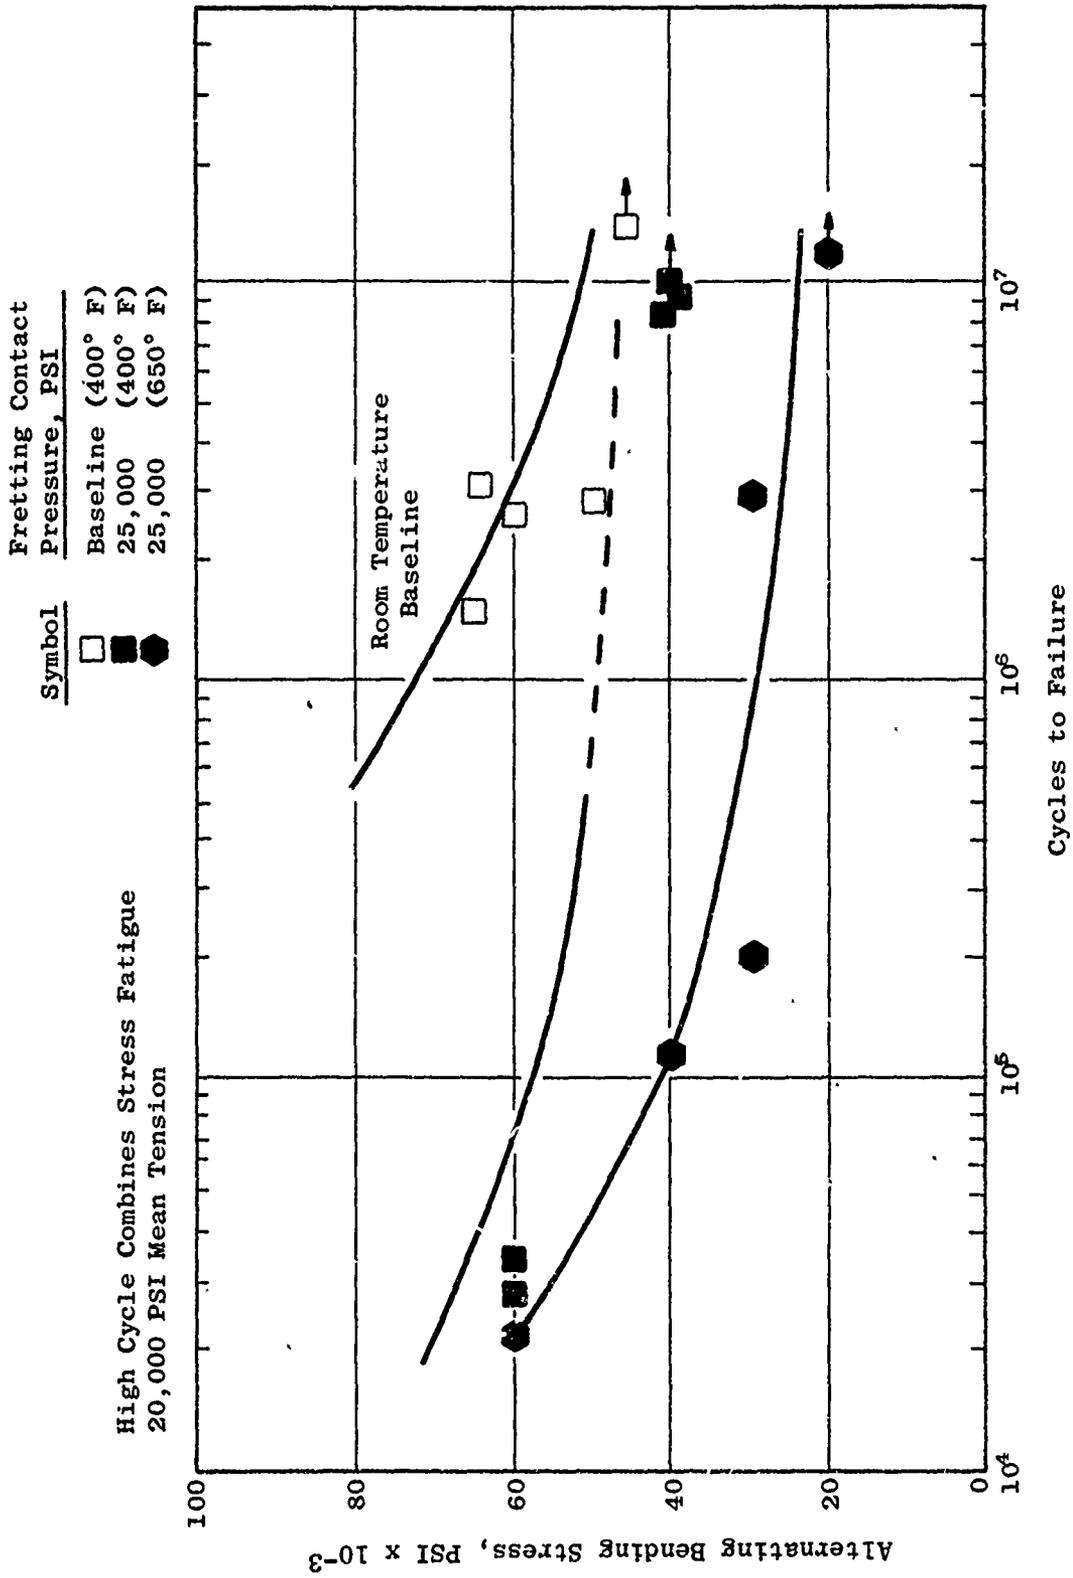
Figure 27. Effect of Elevated Temperature of 400° and 650° F on the Fretting Fatigue Strength of Shot-Peened Ti-6Al-4V.

The results are compared in Figure 27 with General Electric Company test results at 650° F. The tests at 650° F at the higher stress levels resulted in the same substantial reduction in fatigue life as occurred at 400° F and at room temperature. However, there was a significant difference in the effect of temperature in tests at lower stresses. Figure 27 shows that at 650° F there was greater loss of fatigue life due to fretting at the run-out stress level. This effect appeared to be related to more severe damage incurred by the specimens, damage as severe as that occasioned by galling during sliding wear tests to be discussed in Task 2.

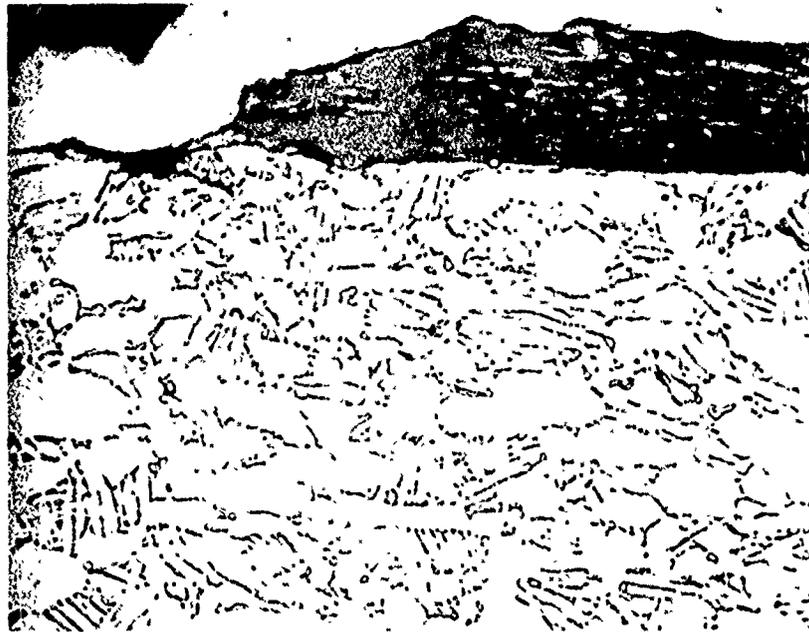
Figure 30. Cross Sections of Specimen 75 After 400° F Fretting Fatigue Showing Fretting Oxide Debris in Area of Fatigue Fracture Origin. Lower Photograph Illustrates a Lump of Fretting Oxide Debris Such as Shown in the Macrophotographs in Figures 28 and 29. (HNO₃-Hf etchant, 1000X)

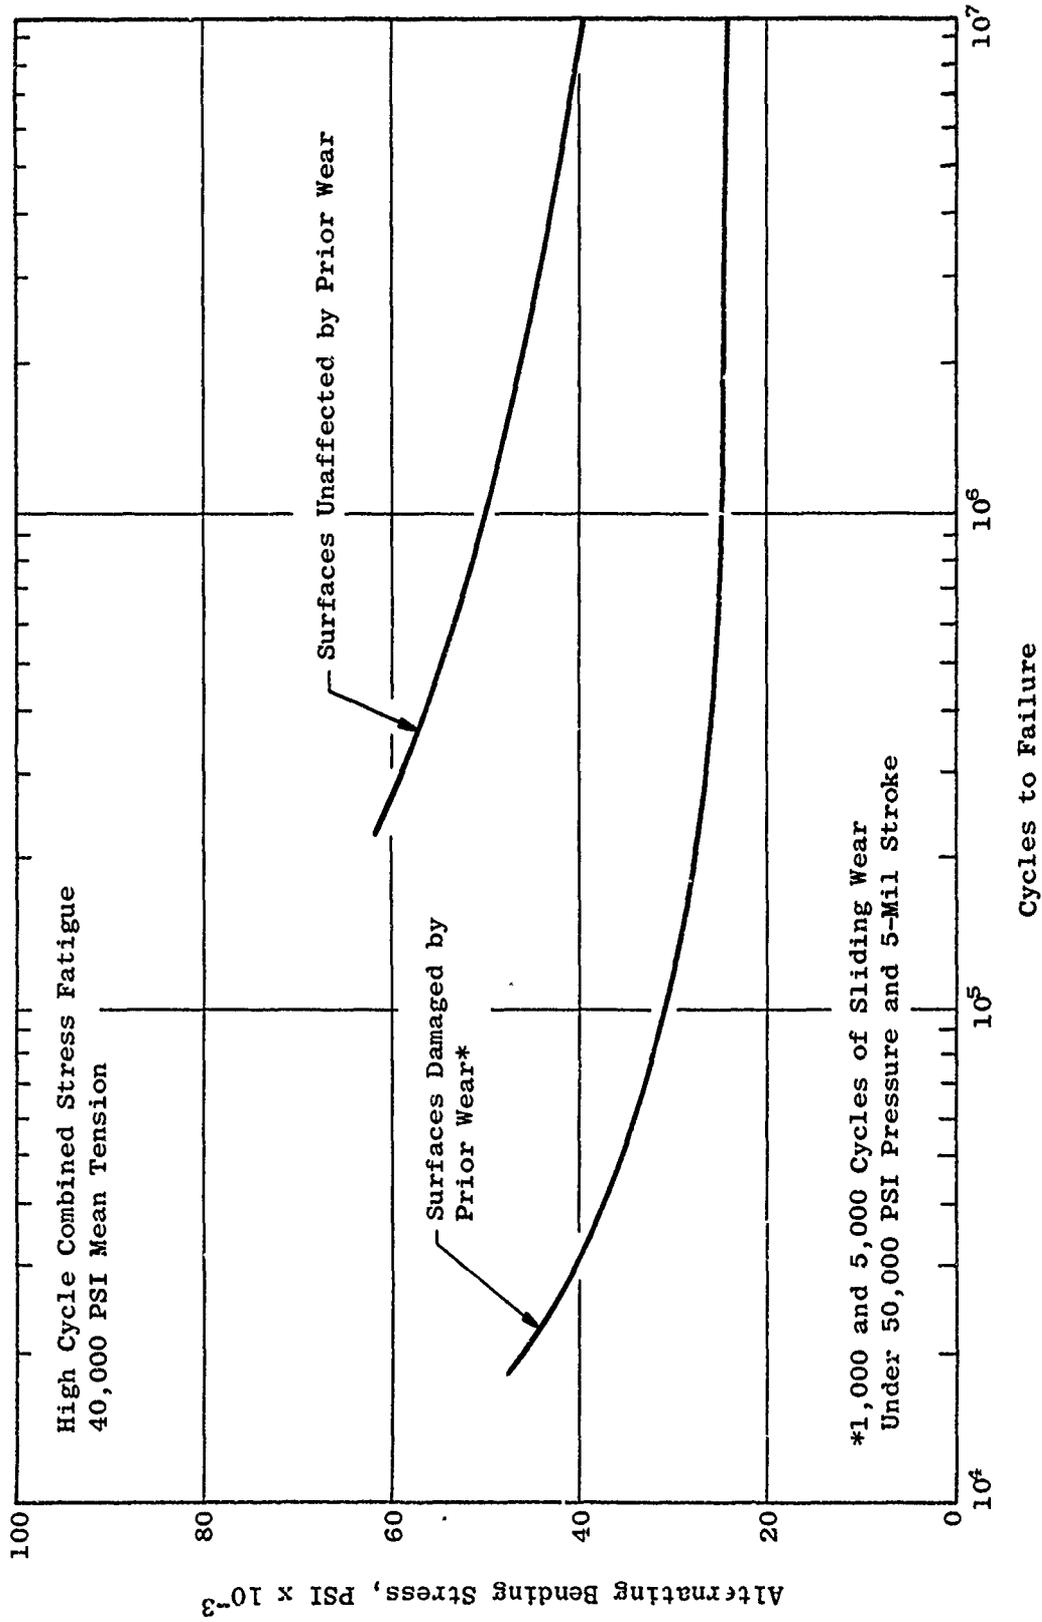
Figure 32. Effect of High Pressure Sliding Wear Damage on High Cycle Fatigue Properties of Shot-Peened, Forged Ti-6Al-4V.

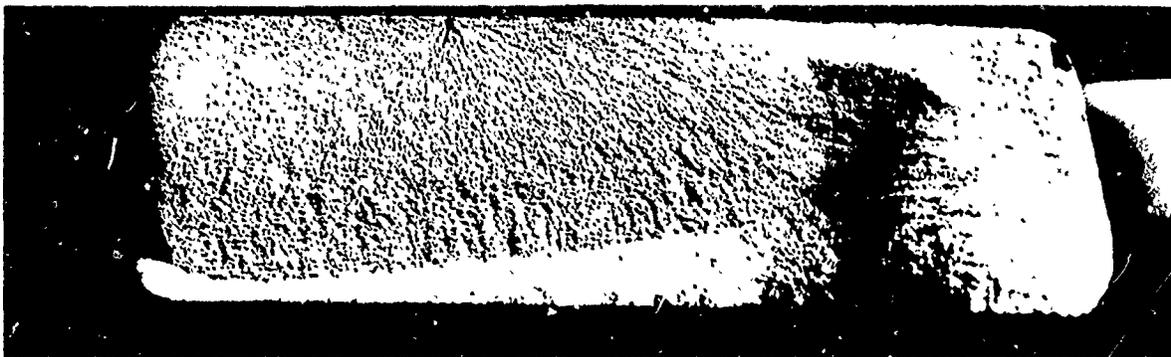
Figure 33. Specimen 38 Illustrating the Galling Wear and Fatigue Fracture Pattern After Testing Under 10,000 PSI Contact Pressure and 5-Mil Stroke.

Figure 33 illustrates Specimen 38, its wear shoe and fracture face. It was tested in the 10,000 psi contact pressure series with a 5-mil stroke. The shoe exhibits many scoured-out pits while the specimen wear surface shows an accumulation of debris. A detail of Specimen 39 in Figure 34 shows that it consists mainly of pits, smeared debris, and isolated areas of original peened

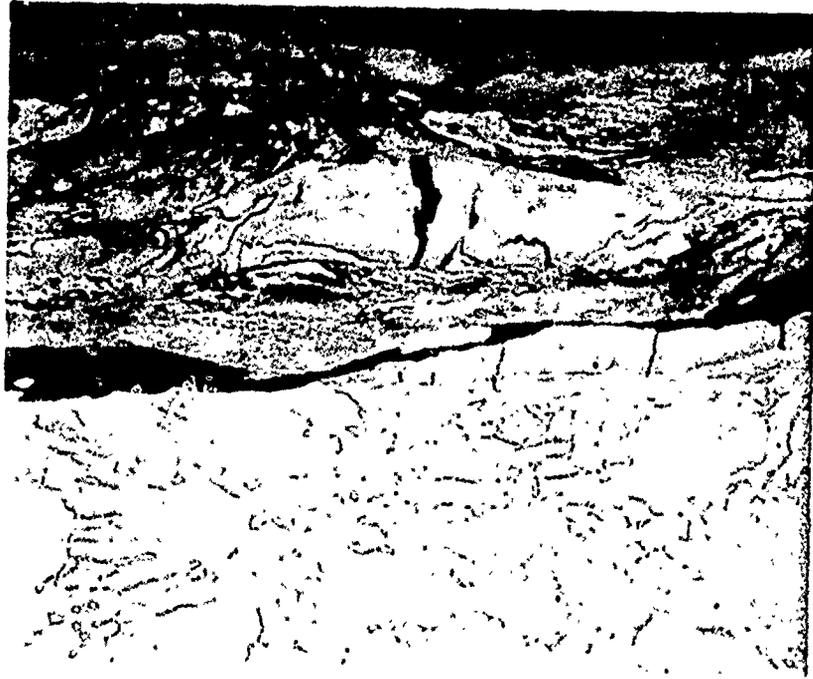
Figure 36. Metallographic Section of Specimen 38
Showing Wear Debris Layer in Substrate
Pit. (Mount 1917, Neg G6305, 1000X)

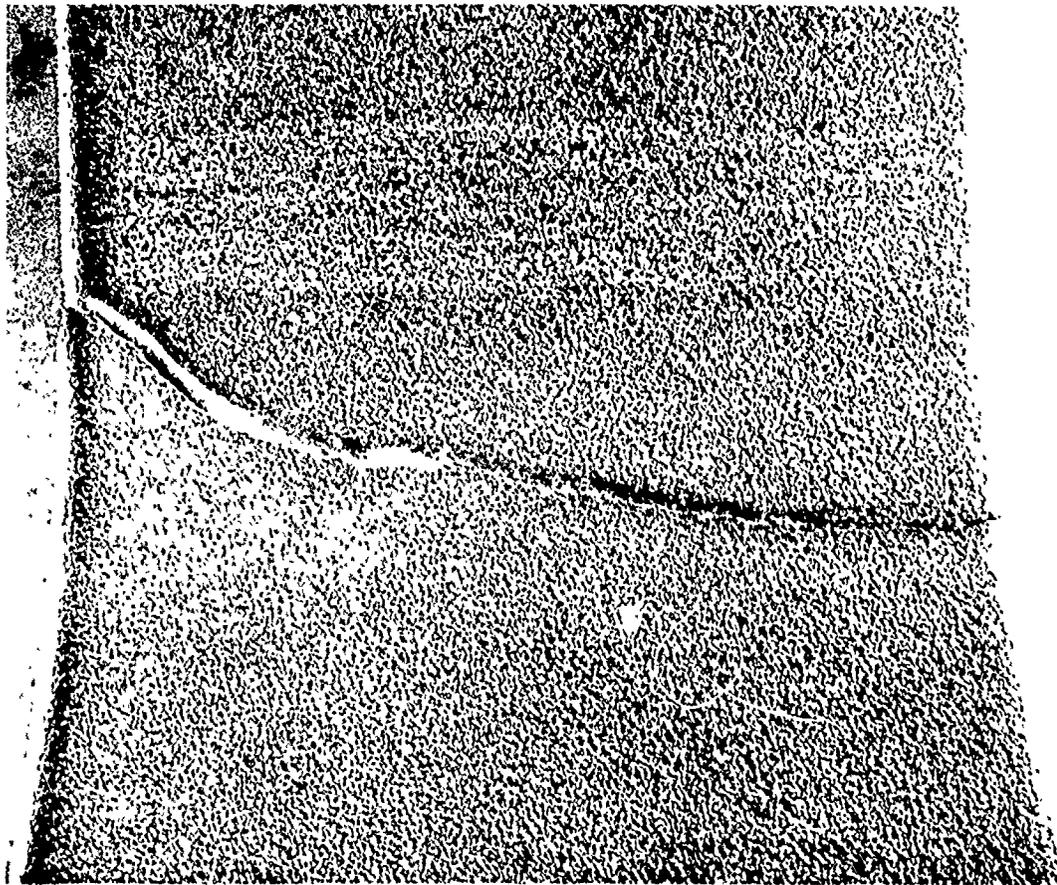
Figure 37. Specimen 11 Illustrating Very Mild Wear Pattern on Shoe and Specimen After Wear Test Under 10,000 PSI Contact Pressure and 0.5- to 1-Mil Stroke. (Metcut, 6X)

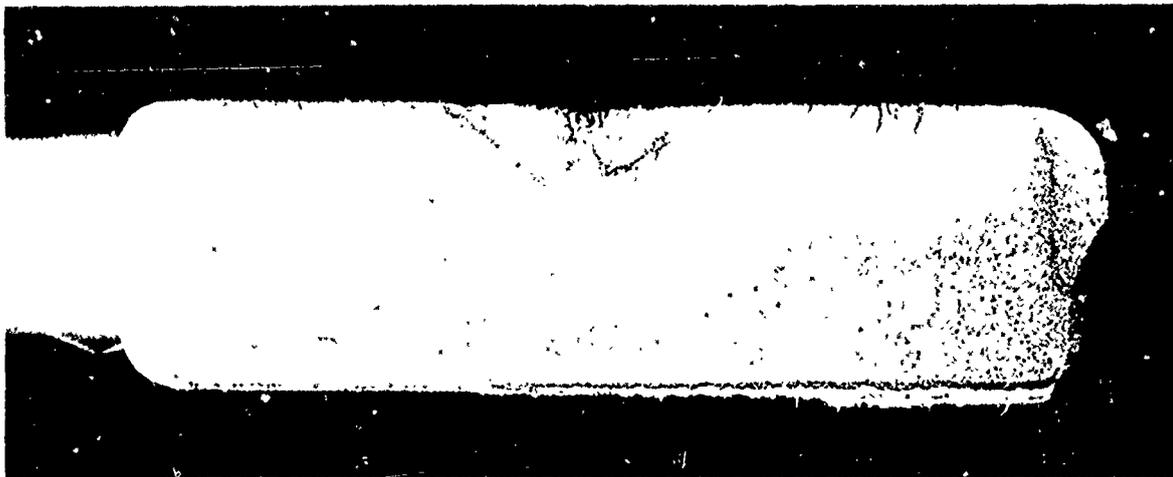
Figure 39. Specimen 27 Showing Wear and Fracture Pattern After Low-Cycle Fatigue Wear Testing Under 50,000 PSI Contact Pressure and 5-Mil Stroke. (Metcut, 6X)

Figure 39 illustrates the surface appearance of Specimen 27 and its fracture face. SEM observations of the specimen and its shoe shown in Figure 40 reveal the typical presence of galled metallic-appearing flakes on the specimen and the accumulation of debris on the shoe. Metallographic sections of the specimen and wear shoe are shown in Figure 41. The shoe is seen to have not only an accumulation of debris, but also a shear crack indicating the mode of surface breakdown which has been described for the specimens themselves. Shown below the shoe is the fracture edge of Specimen 27, showing the characteristic shear cracks, debris-filled pockets, and disturbed metal at the surface.
