CUTTING ICE WITH HIGH PRESSURE WATER  
JETS

Malcolm Mellor, et al

Cold Regions Research and Engineering Laboratory  
Hanover, New Hampshire

1. Report No. <b>CG-D-15-73</b>		2. Government Accession No.		3. Recipient's Catalog No.	
4. Title and Subtitle <b>Cutting Ice with high pressure water jets</b>				5. Report Date <b>July 1973</b>

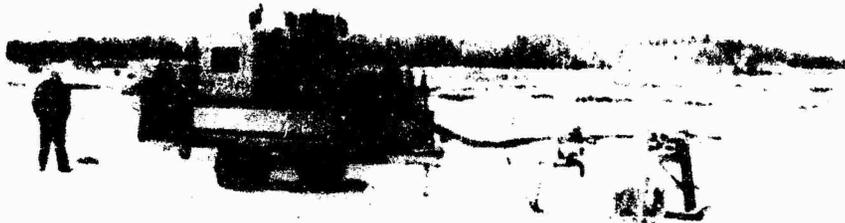
Figure 1. Power trailer and intensifier skid on the ice.

The IITRI high pressure unit arrived at Houghton late on Wednesday, 21 March, and was off-loaded on Thursday, 22 March. There were logistic difficulties in preparing the unit for operation and in moving it to the test site (among other things, the unit sank in the mud and the bulldozer broke down), but by mid-morning of Friday, 23 March, the unit was on the ice and ready for testing (Fig. 1).

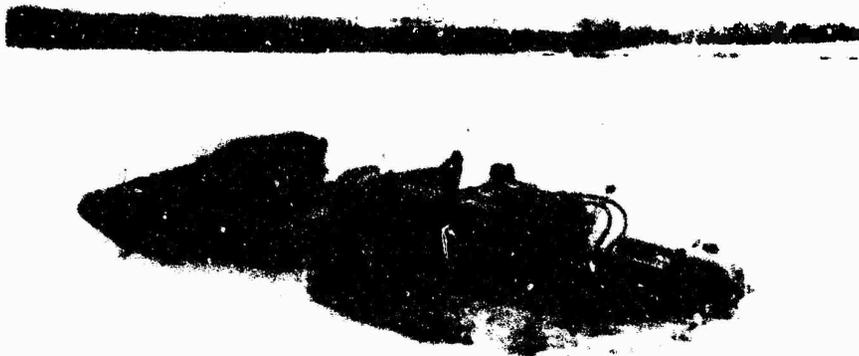
Figure 2. HD-5 Traxcavator in trouble.

At the start, the power trailer and intensifier skid were towed across the ice by means of a winch and cable, but this improvised arrangement only gave speeds up to about 1 knot, and the motion was unsteady. A direct tow with a light oversnow vehicle was then attempted, but this 2½-ton machine was unable to move the 7½-ton ITRI unit. It was then decided that a tow by the HD-5 Traxcavator (about 6-ton) would have to be risked. Two good test runs were then made at almost 3 knots before the tractor broke through the ice and sank (Fig. 2), at which time tests on floating ice were terminated by decree of the equipment superintendent. Appendix A gives some notes on this bearing strength problem.

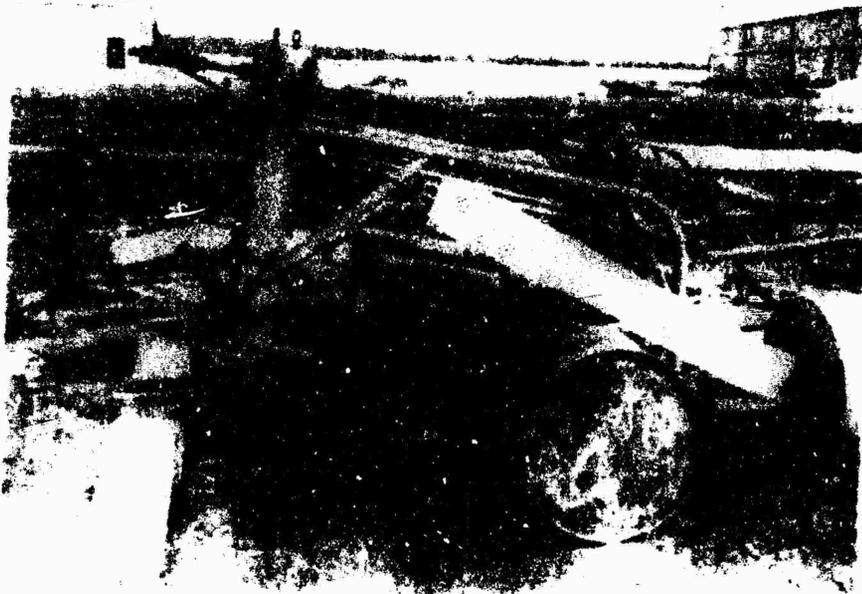
Figure 6. Improvised arrangement for static penetration tests on ice blocks.

Static penetration tests were run in order to set an upper bound for penetration as traverse velocity tends to zero. For a penetration test, an ice block was set up with its long dimension parallel to the nozzle axis (Fig. 6), the nozzle was brought up to operating pressure with a steel deflector protecting the ice, and then the jet was allowed to attack the ice for 20 seconds. In some of these tests the jet broke out through the side of the block, since the ice on one side of each block was very weak due to grain-boundary melting. In all cases the cavity cut by the jet tended to

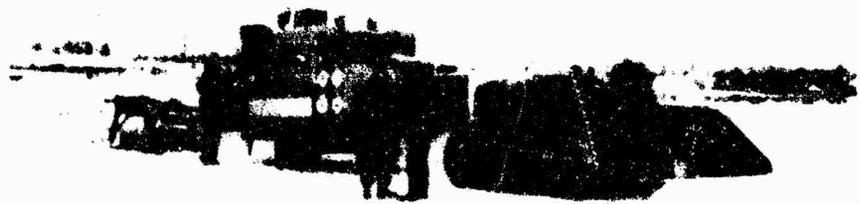
Figure A-2. Jet unit coupled to DD-5.

loads (Fig. A-2) consisted of the intensifier skid (1000 lb), the power trailer (15,000 lb), and the tractor (11,500 lb). The plan was to make a test run across the ice, and then return to a safe parking place near the shore while preparations were made for the next test. However, it was impractical for the equipment to cross the shoreline transition ice, and so the train was parked over what was believed to be shallow water.

After the second towing test, the train had been parked for about 5 minutes when the ice under the tractor began to sag increasingly at a perceptible rate, and water flooded the depressed ice surface. The coupling between the tractor and trailer was released and an attempt was made to drive the tractor away, but as soon as the tractor moved the ice gave way.
