NAVAL SHIP RESEARCH AND DEVELOPMENT CENTER

THE EFFECT OF SURFACE PREPARATION AND REPAINTING PROCEDURES ON THE FRICTIONAL RESISTANCE OF OLD SHIP BOTTOM PLATES AS PREDICTED FROM NSRDC FRICTION PLANE MODEL 4125

May 1973

Report 4084

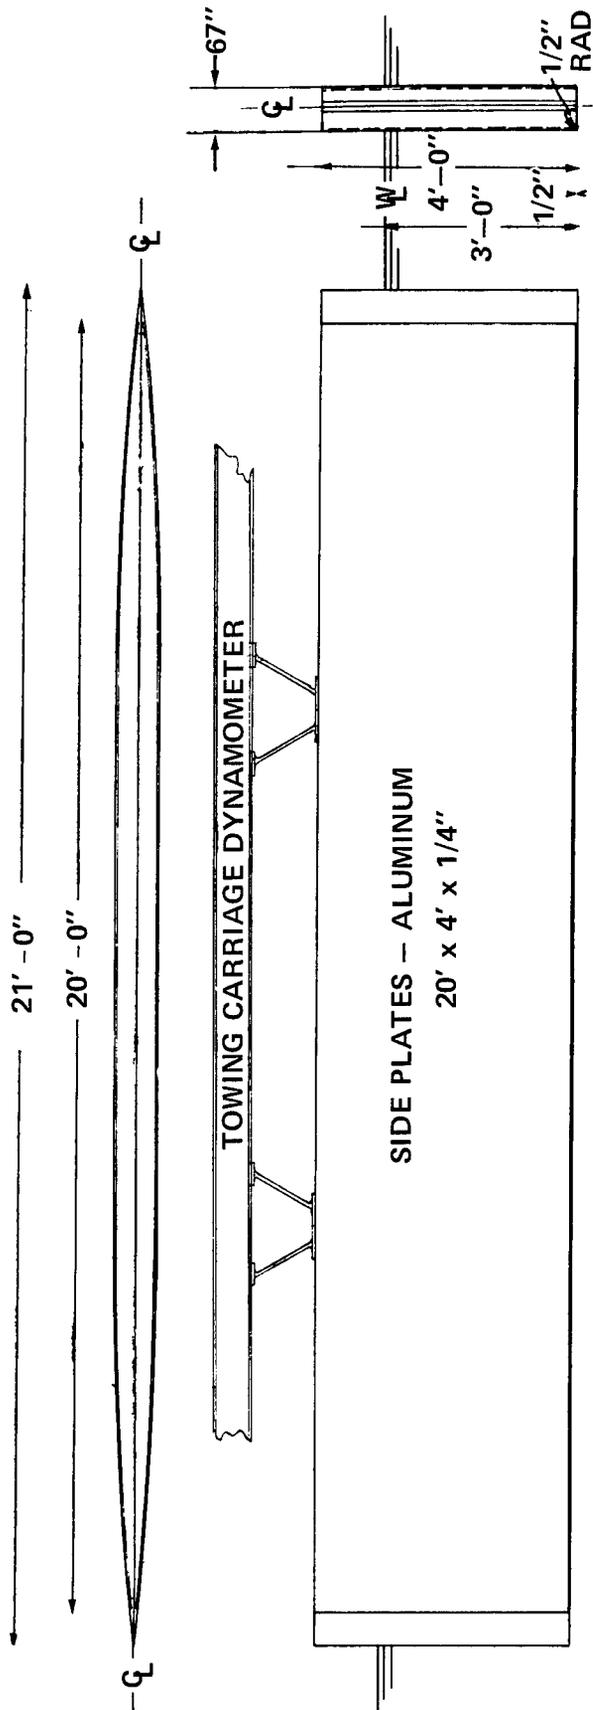
Figure 1 - Details of NSRDC Friction Plane and Connection to Towing Carriage

The tests were run in the NSRDC deep water basin utilizing carriage 2. NSRDC friction plane (Model 4125) served as the test vehicle. It is 21 feet long and has a maximum beam of 6.7 inches. For the experiments reported here, it was towed at a draft of 3 feet. Figure 1 indicates the shape and principal dimensions of the friction plane, and Figure 2 shows it at rest and under tow.

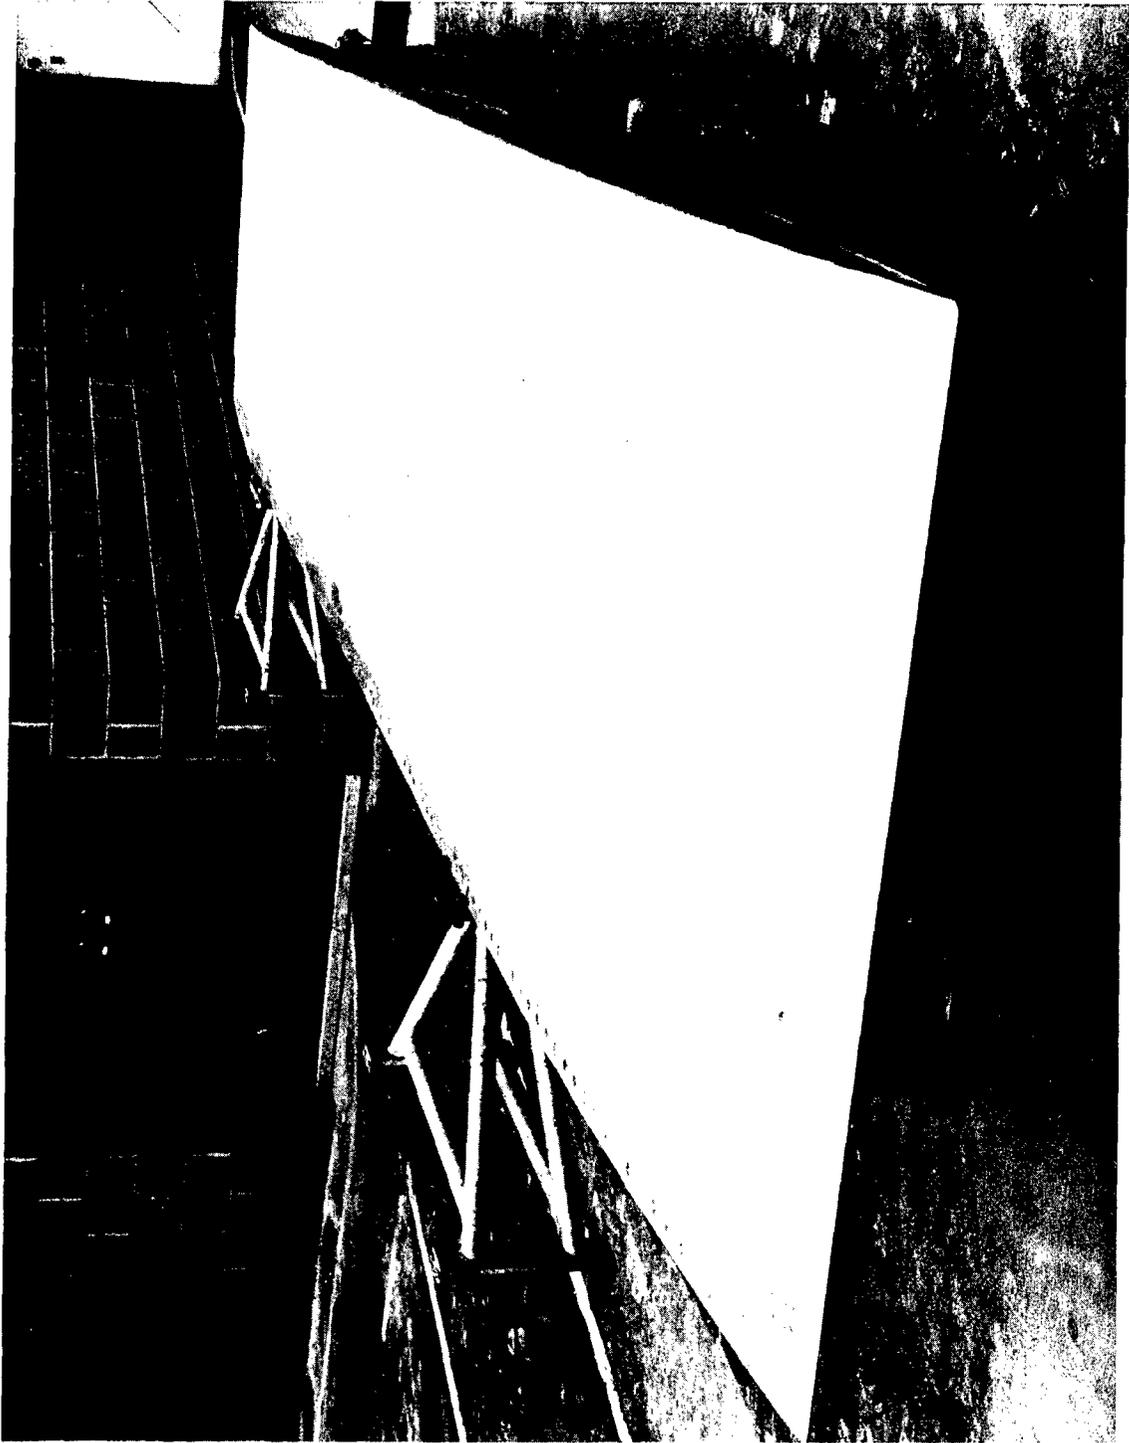
Figure 6 – Friction Plane Fitted with Fiberglass Plates

Following these runs, the friction plane was fitted with fiberglass plates (Figure 6). These represented the ship bottom plates and were made from molds formed from the OMNIUM bottom plating. Mold "A" (hereinafter referred to as Plate A) was taken from the bottom plating as it came from the hull; see Figure 7. Mold "B" (hereinafter referred to as Plate B) was made after the plating had been given the normal treatment for annual drydocking (hand wire brushing followed by the application of one coat of zinc chromate primer, one coat of MARAD anticorrosive paint, and one coat of MARAD antifouling paint); see Figure 8. Mold "C" (hereinafter referred to as Plate C) was made after the plating had been grit blasted to bare metal and painted with the Navy vinyl system (one coat of wash primer, four coats of vinyl red lead, and one coat of vinyl antifouling paint); see Figure 9.

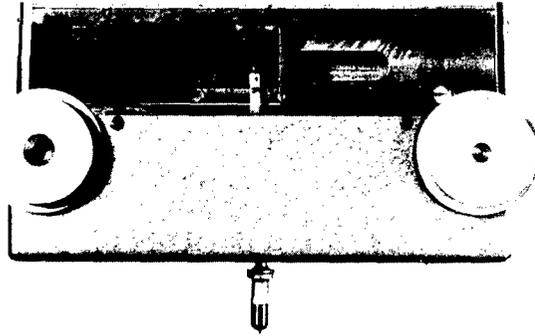
Figure 10 – BSRA Profilometer

Panel 0-23 of SNAME had forwarded a BSRA profilometer (Figure 10) for NSRDC use in measuring the comparative surface roughnesses of the paints and plates. However, the 1:1 ratio was not sensitive enough

to measure the difference in paint roughness, and an NSRDC profilometer (Figure 11) was used for this purpose.³ The BSRA profilometer was utilized to measure the roughness of the ship bottom plates in the three surface conditions.

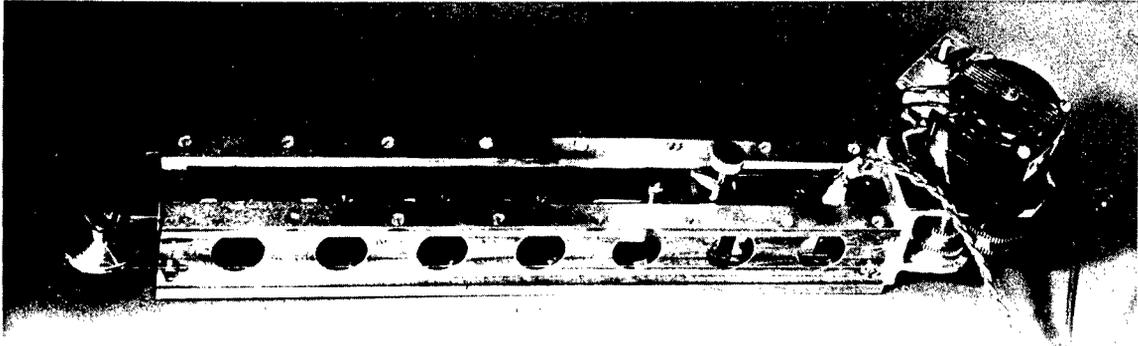
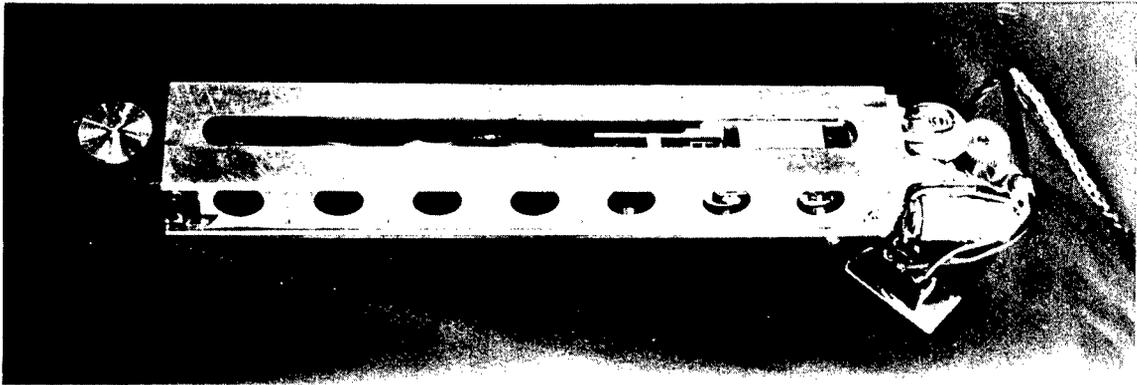
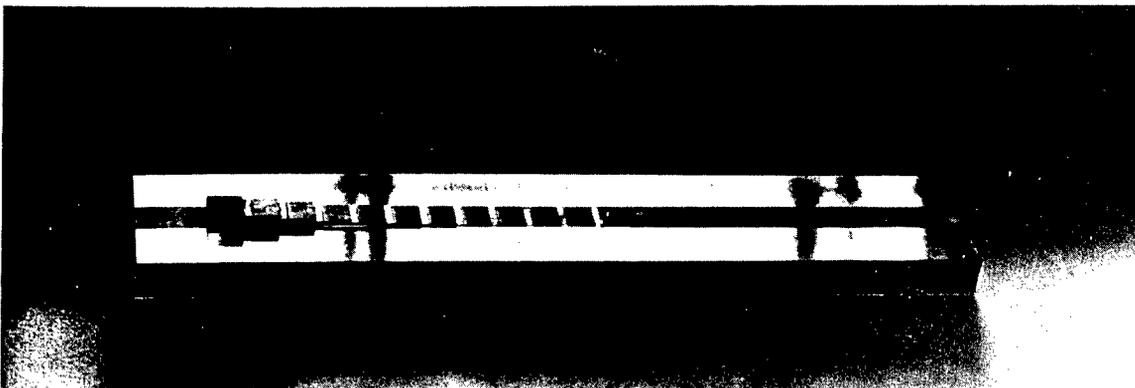
Figure 11 – NSRDC Profilometer

RECORDING POSITION

PROBE MECHANISM SHOWING

CALIBRATION BLOCK

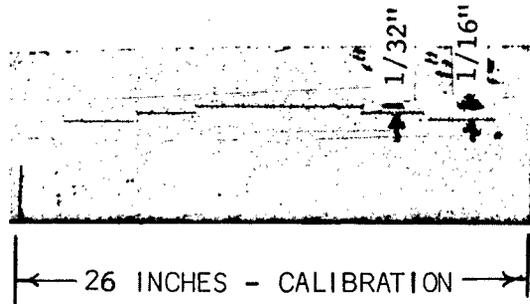
Figure 12 – Surface Roughness of Plate A as Measured with BSRA Profilometer

BSRA profilometer measurements of the plates for the three surface conditions are shown in Figures 12–14. The roughness measurements of the paint surface on the friction plane as made with the NSRDC profilometer are presented in Figures 15–17. For purposes of comparison, Figure 18 indicates a roughness measurement made with the BSRA profilometer at the same points on the friction plane as shown in Figure 16.

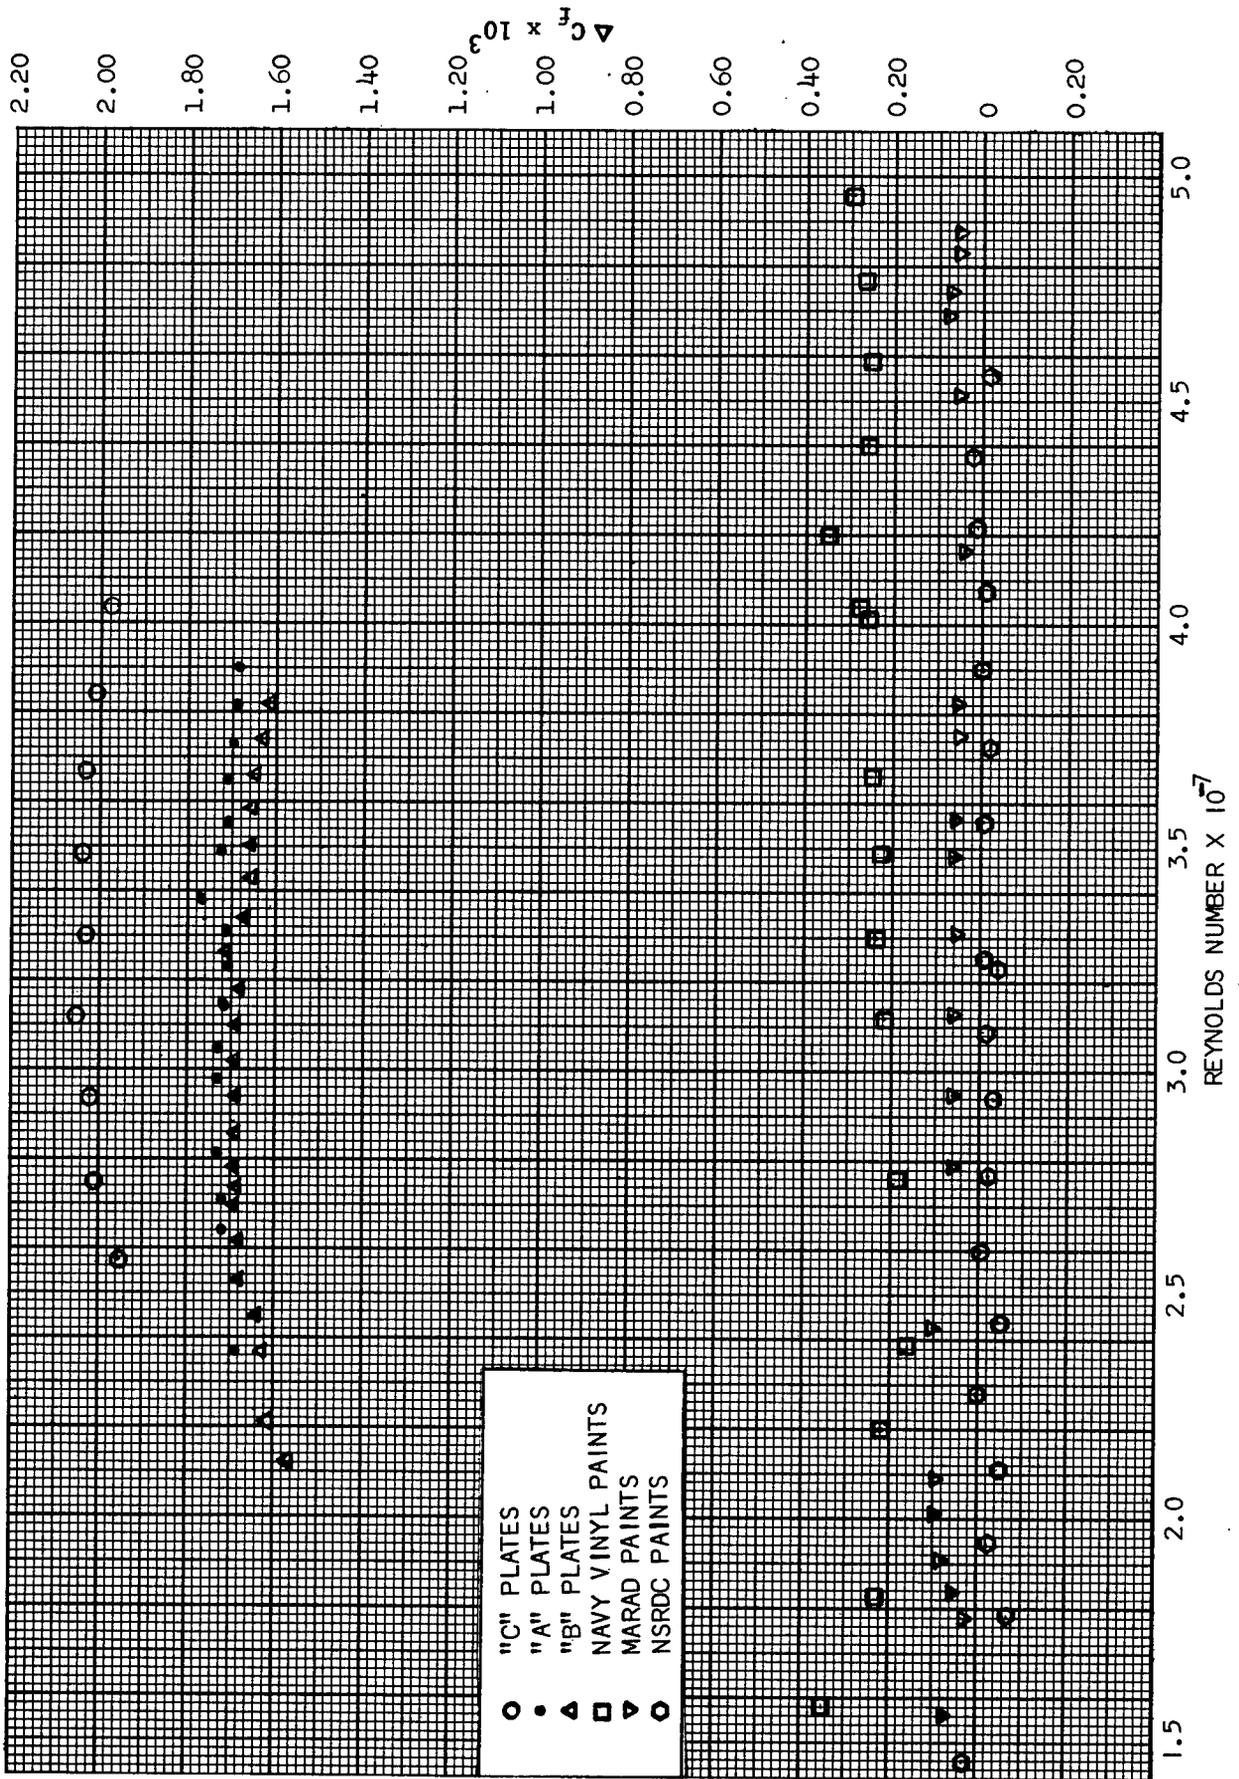
Figure 19 - ΔC_f versus Reynolds Number

The experimental points were converted to resistance coefficients for all paints and plates tested. The total resistance coefficient C_t is expressed as $R_t / (1/2\rho SV^2)$ where R_t is the total resistance, S is the wetted surface of the plates, ρ is the water density, and V is the speed in feet per second. The points shown in Figure 19 represent the actual differences between the measured total resistance coefficients and the faired values for the bare metal experiments. Thus, the zero line corresponds to the bare metal condition.

For several reasons, the roughness allowance coefficient ΔC_f values shown in Figure 19 are comparable only with each other and should not be used to compare correlation allowances obtained from full-scale vessels with the same paint. One obvious reason is that the aluminum plates used on the friction plane were very smooth compared to typical ship bottom plating with its welds, laps, mill scale, and/or pitting. The ship also has scoops, sea chests, and similar appendages that are not fitted to a model. In model experimenting, no correction is made for the effect of moving water through the condensers or the scale effect on appendages such as rudders and struts used on models during experiments.

hull operating in smooth, deep sea water with a temperature of 59 F. The value obtained for the friction plane coated with MARAD paint was about 0.00006 (see Figure 19).

Although some detail was lost in the photographs of the fiberglass plates (Figures 7-9), it can be noted that the pit marks or depressions in Plate C were deeper and larger in cross section than those in Plates A or B. Further evidence of this condition is shown in Figure 19. Plate C had the highest resistance of the three sets of plates. Apparently, sand blasting removed rust that had not been removed by other methods of cleaning and caused larger depressions in Plate C.

1. The degree of roughness measured on Plates A, B, and C caused huge increases in ΔC_f values. Increases of such magnitude should be expected to cause a large increase in the frictional resistance of a ship.
