WEAR, FRICTION AND THERMAL FATIGUE OF
GUN BARREL MATERIALS

Rockwell International Corporation

WEAR, FRICTION AND THERMAL FATIGUE
OF GUN BARREL MATERIALS
FINAL REPORT

Contract DAAF07-73-C-0582

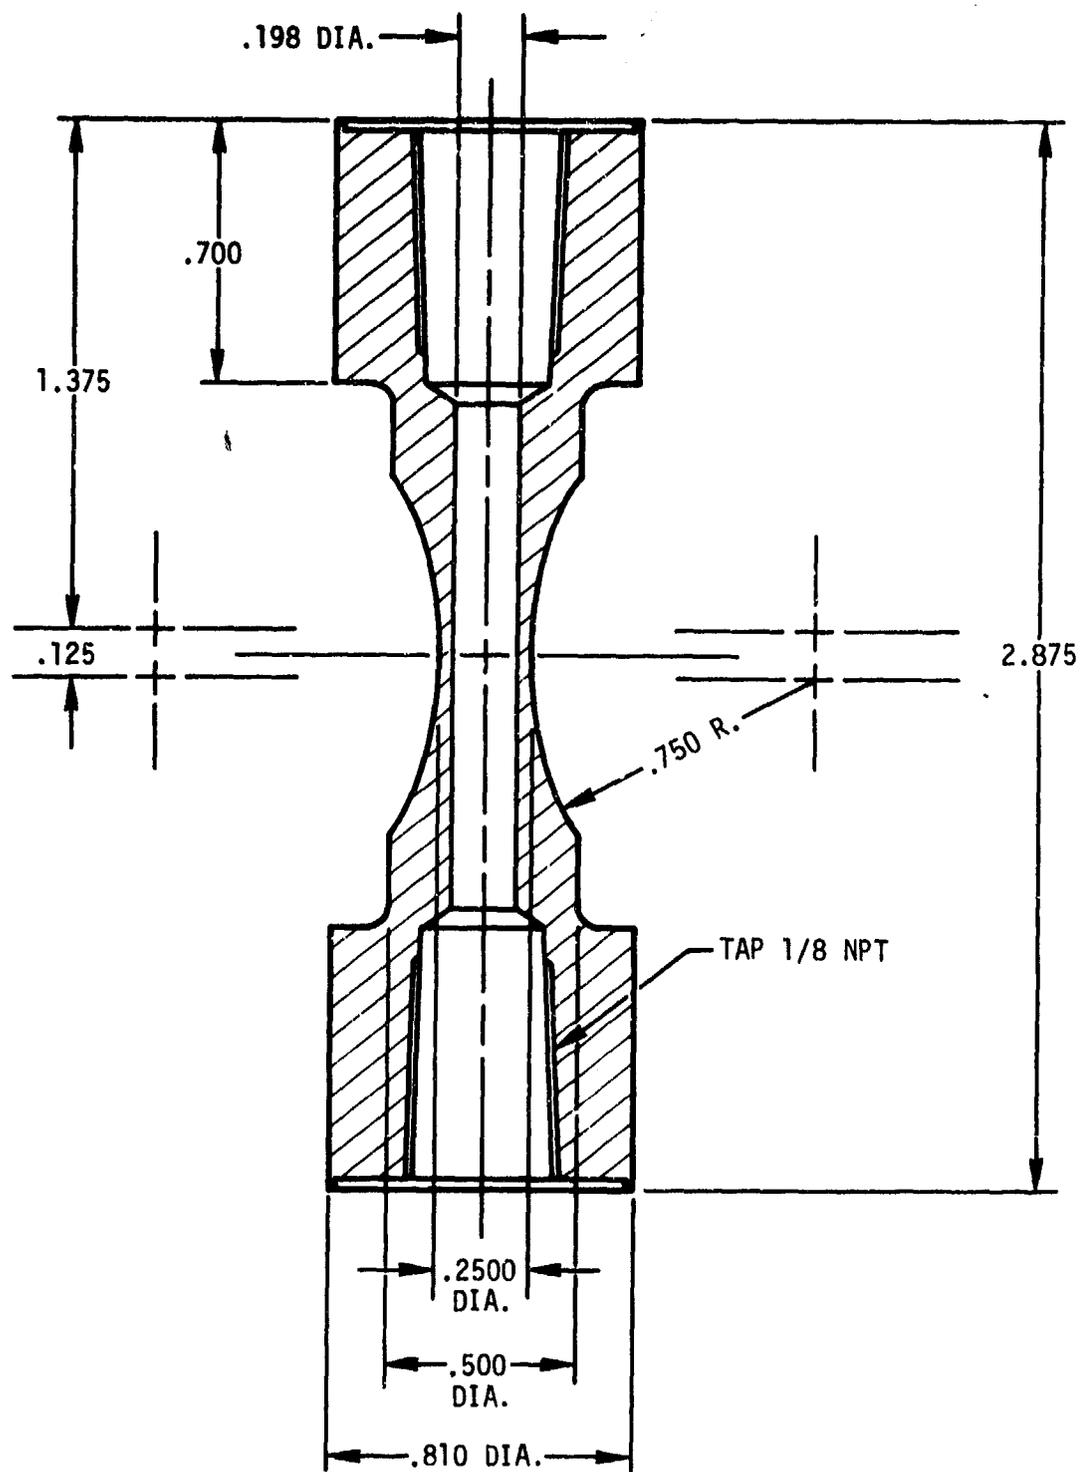
Fig. 1 Steel thermal fatigue specimen.

2.2.1 The Thermal Fatigue Specimen. The basic test specimen used in this effort was a thermal fatigue specimen of a configuration compatible with the thermal fatigue test equipment available at the Science Center. The standard specimen geometry used to fatigue both the steel materials is shown in Fig. 1. For the coated steel tests the selected coating materials were simply electroplated on to steel specimens of this standard geometry. The thermal fatigue specimen used for the tantalum-10% tungsten is illustrated in Fig. 2. The differences between the two thermal fatigue specimen forms were dictated by diameter limitations on the as-received tantalum-10% tungsten material and by machining requirements set by the hardness of the tantalum alloy. The hole through the center of each specimen provides the conduit by which each is cooled for the cool down portion of each thermal cycle. Heating is accomplished by induction. The gage section of the two specimen geometries is identical: it consists of a hollow tube of wall thickness 0.025 inch with outside diameter 0.25 inch. Considerable care was taken to ensure that the tube wall thickness was always uniform around the specimen circumference. The steel specimen geometry provides a larger end diameter which is internally threaded to transmit the load from the test machine to the specimen. Fabrication of this specimen requires a starting rod of about 7/8 inches in diameter. The tantalum-10% tungsten specimen geometry has a smaller end diameter than the steel specimen, and the mounting is externally threaded. This alloy is quite difficult to machine. By using a smaller specimen end, it was possible to start with a rod only 5/8 inches in diameter and reduce the required machining. Steel loading fixtures were designed and fabricated

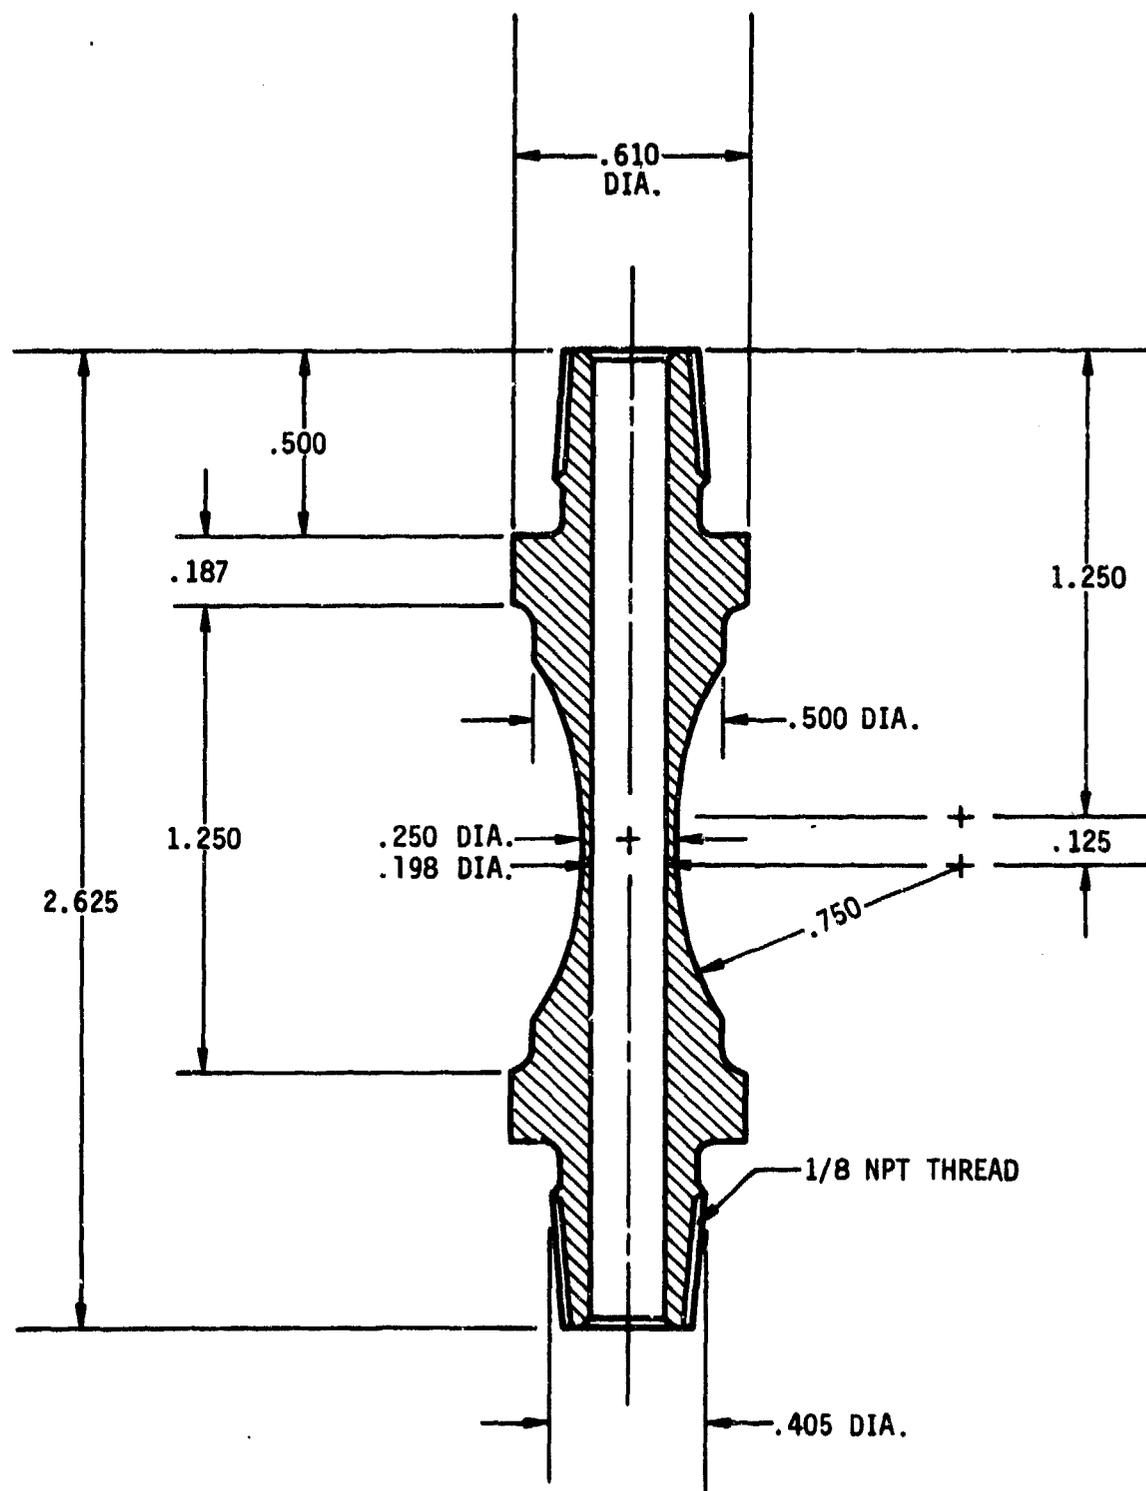
Fig. 2 Tantalum-10% tungsten thermal fatigue specimen.

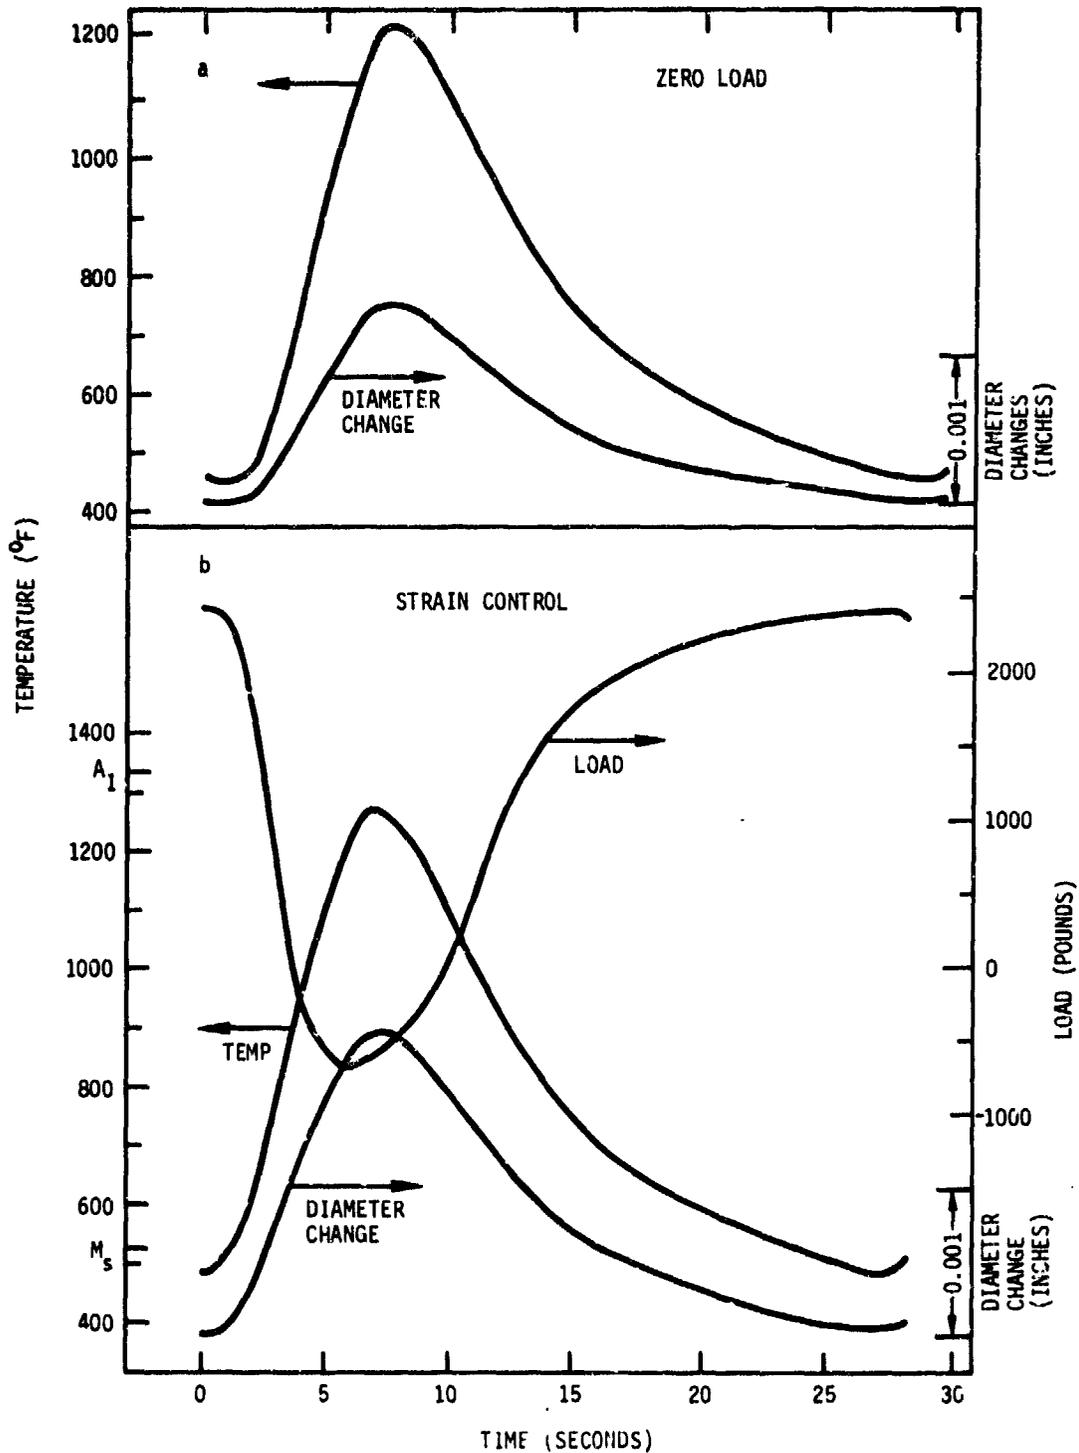
Fig. 3 Thermal fatigue cycles for chromium plated specimen BB. a) zero load (free expansion) cycle. b) Cycle showing load imposed to constrain diameter.

The means of selecting and controlling the operating strain is illustrated by Fig. 3. The specimen was first cycled over the desired temperature range, in this case 480° F to 1250° F, under zero load and the diameter change measured, being in this case 0.00136 inch, as noted above. The

In Fig. 3b the temperature, diameter change, and load curves shown correspond to cycling in the first temperature range, where the temperature is always below A_1 . In Fig. 5 is shown a corresponding plot for cycling through the third temperature range, above A_1 and below M_s on each cycle.

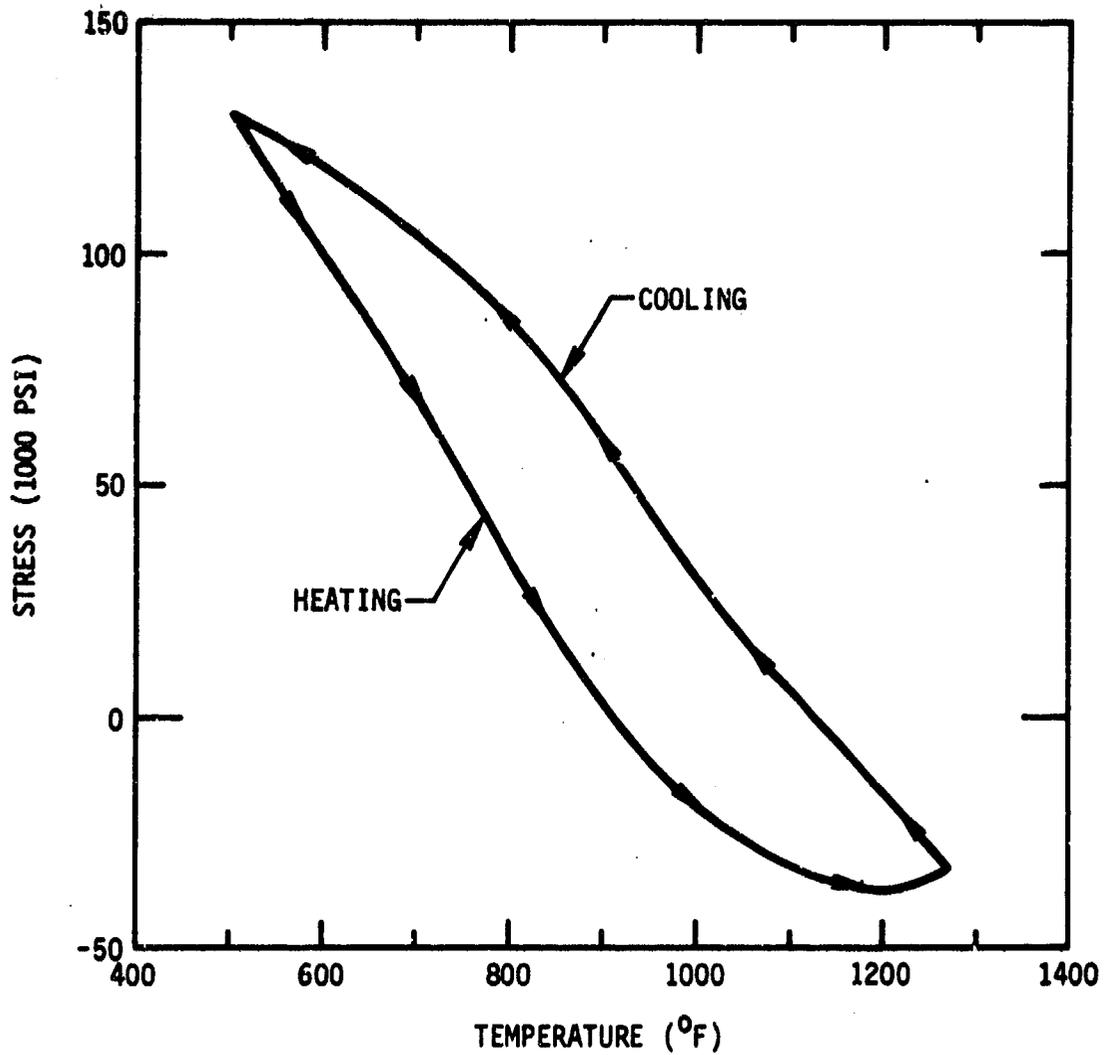
Fig. 4 Stress versus temperature for specimen BB for the constrained thermal fatigue cycle of Fig. 3b.

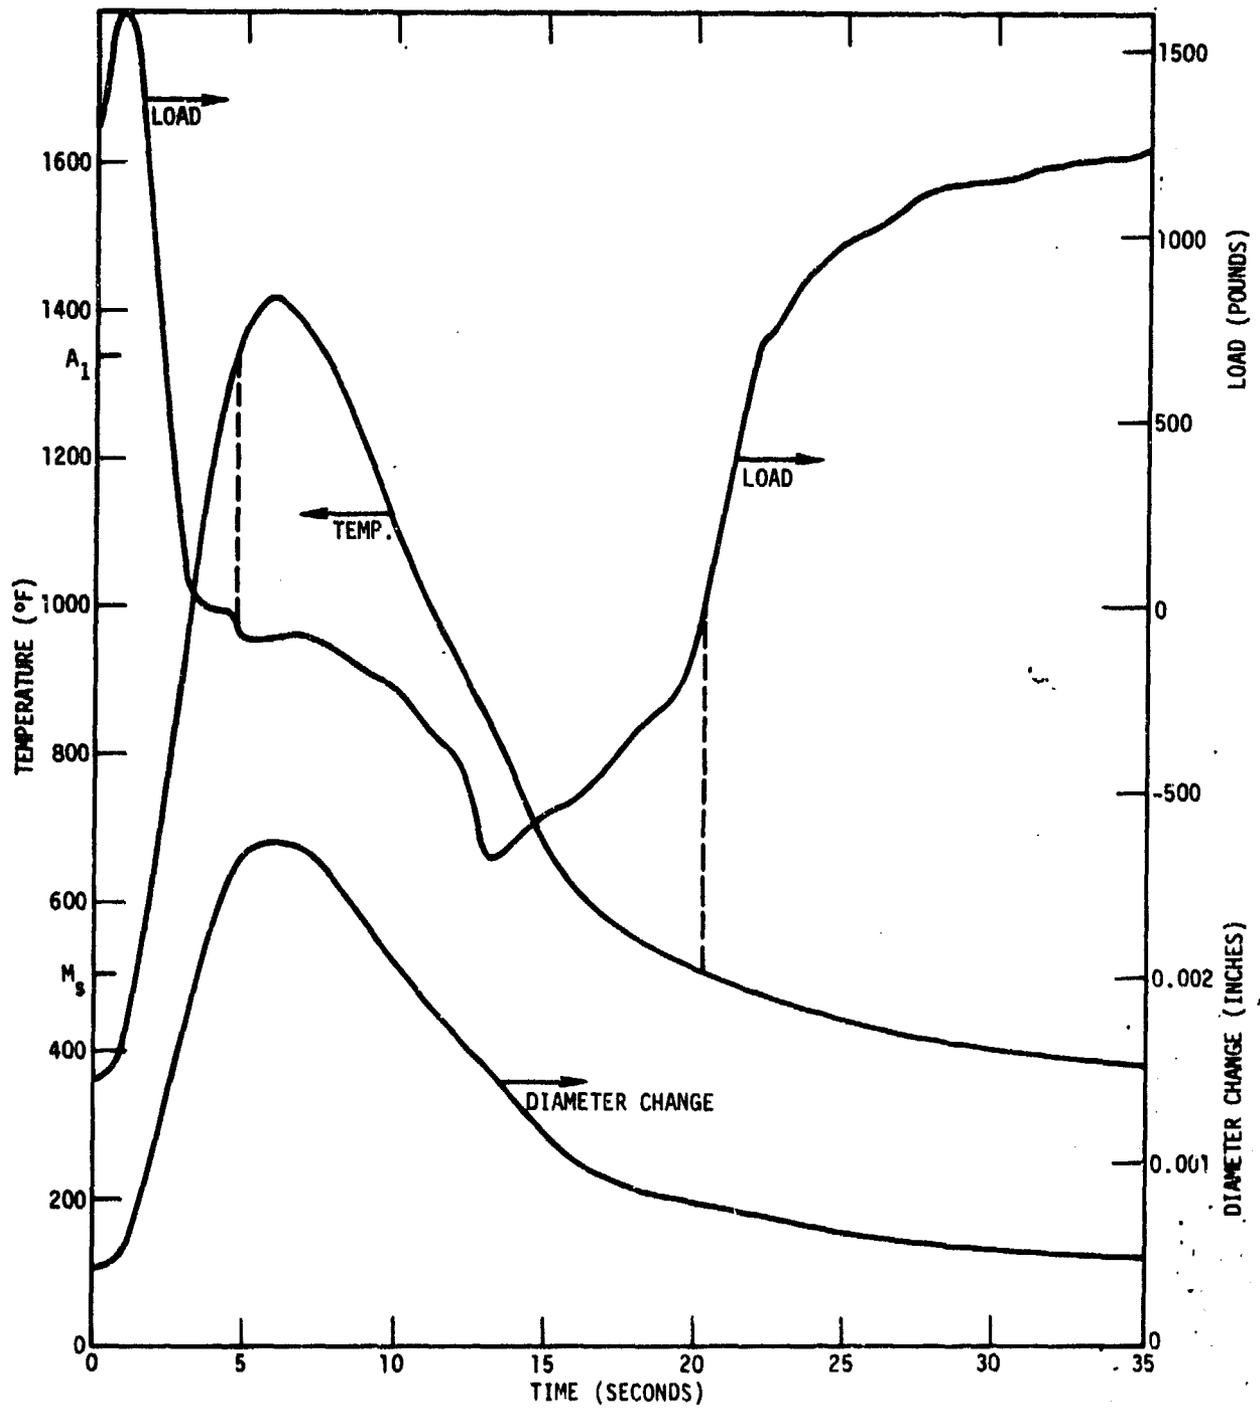
Fig. 5 Thermal fatigue cycle for bare specimen BK cycled above A_1 and below M_s

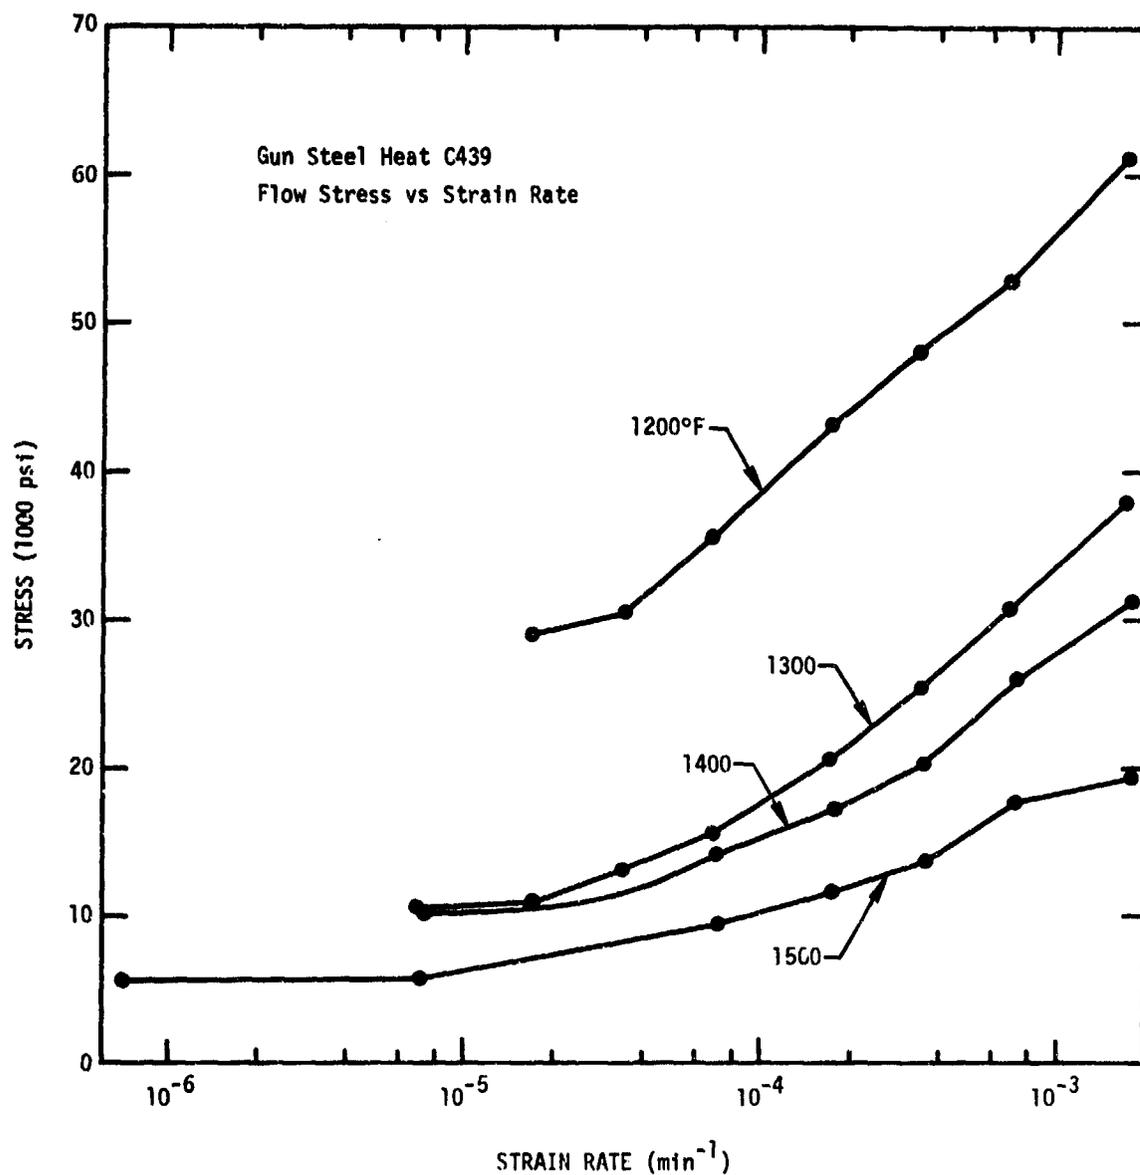
Fig. 13 Flow stress versus strain rate at various temperatures for gun steel.

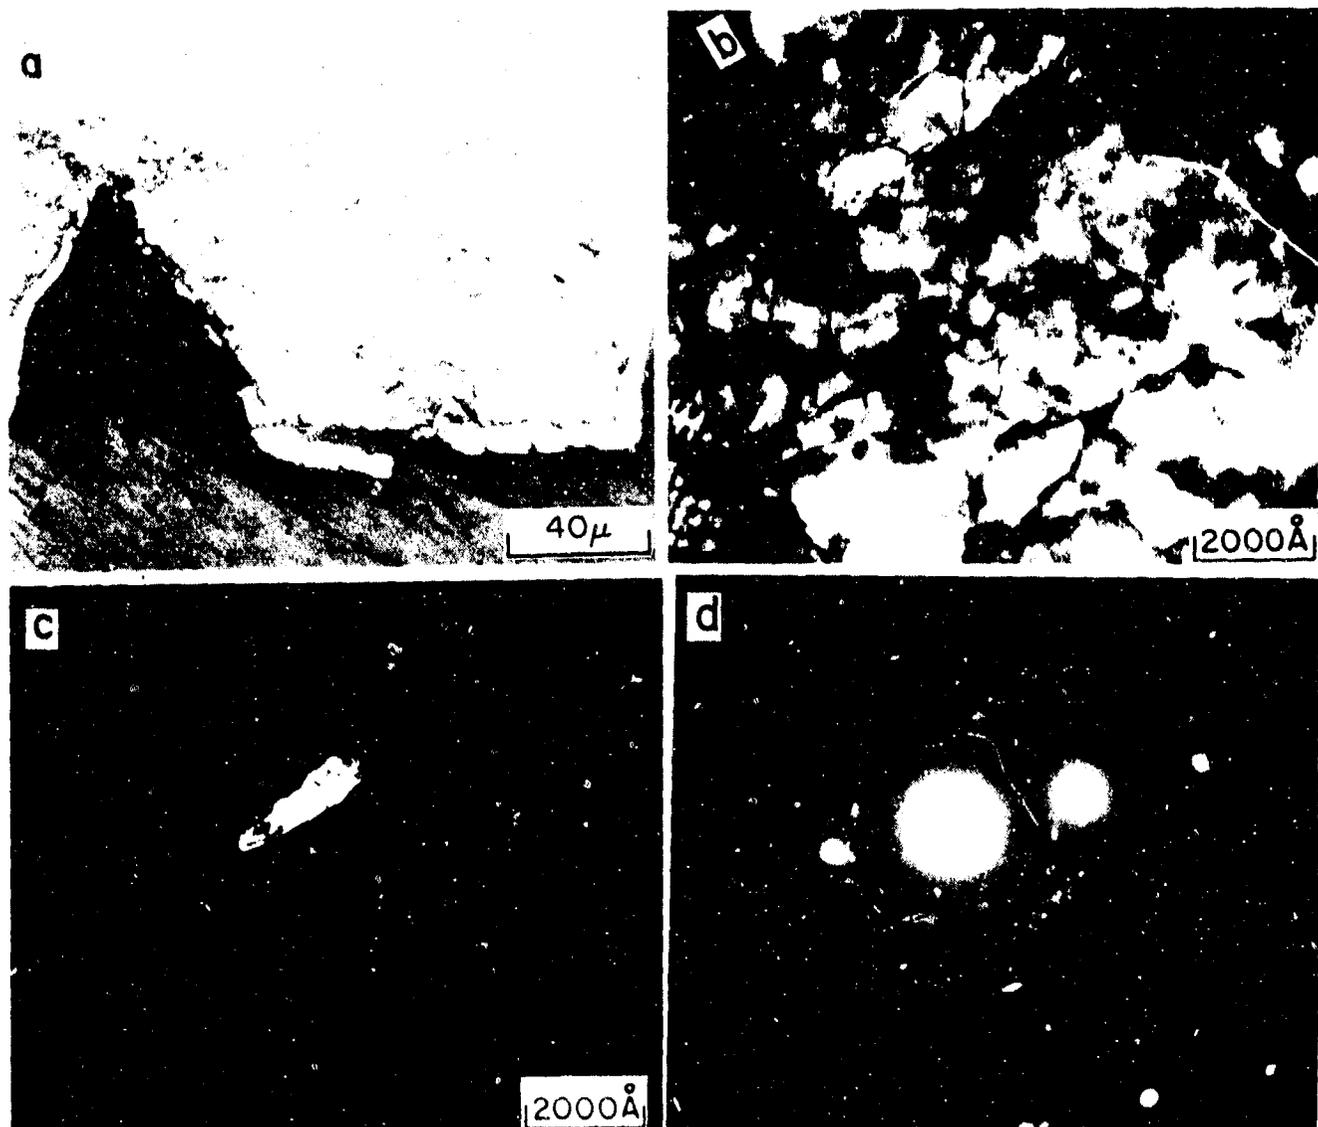
Fig. 15 Microstructure of specimen BV. a) Optical micrograph of inner surface; b) transmission micrograph of bulk structure; c) dark field view of carbide particle; d) diffraction pattern of area in b).

Figure 15 shows micrographic results for specimen BV, 4340 steel cycled below A_1 . Figure 15a is an optical micrograph showing a change in structure of the tempered martensite. The martensite has further tempered during cycling. A decarburized layer has formed on the inner specimen surface due to the exposure to air at high temperature. The inner surface typically

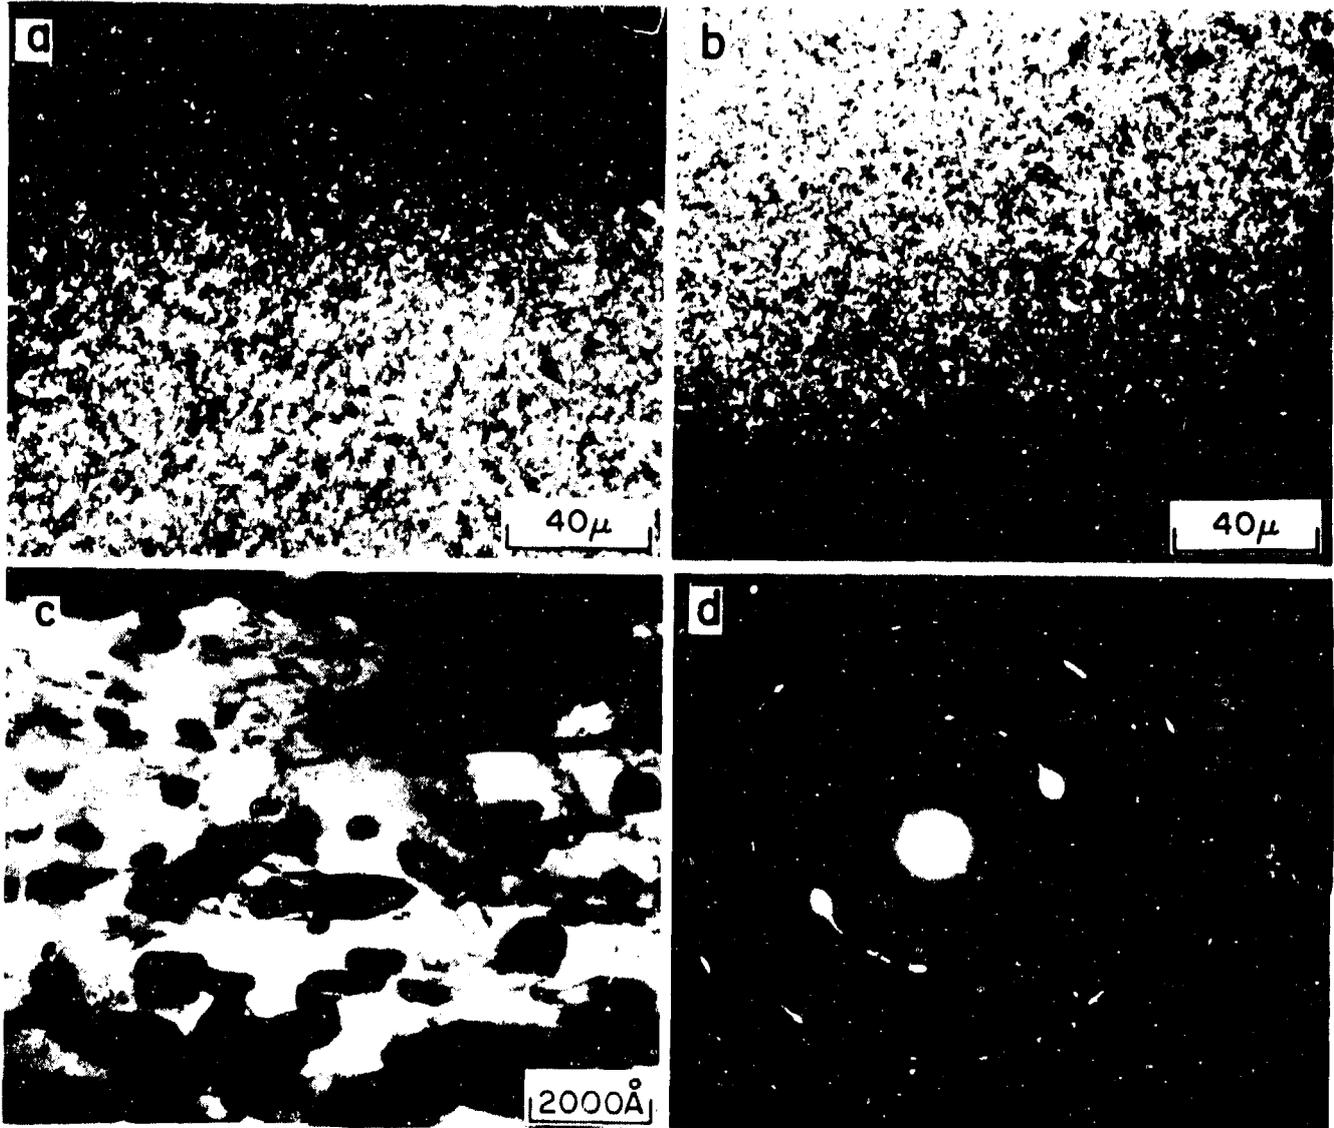
Fig. 16 Microstructure of specimen BJ. Optical micrographs of a) outer surface; b) inner surface; c) transmission micrograph of bulk area; d) diffraction pattern of area c).

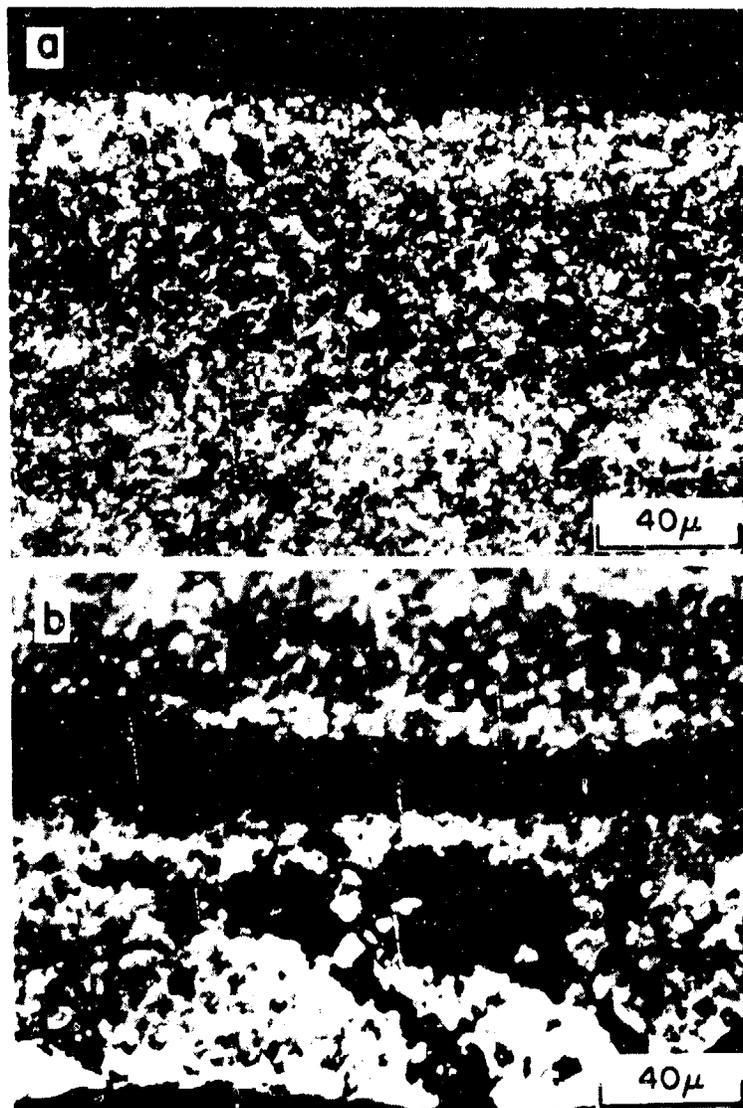
Fig. 17 Optical micrographs of specimen BW. a) Outer surface; b) inner surface.

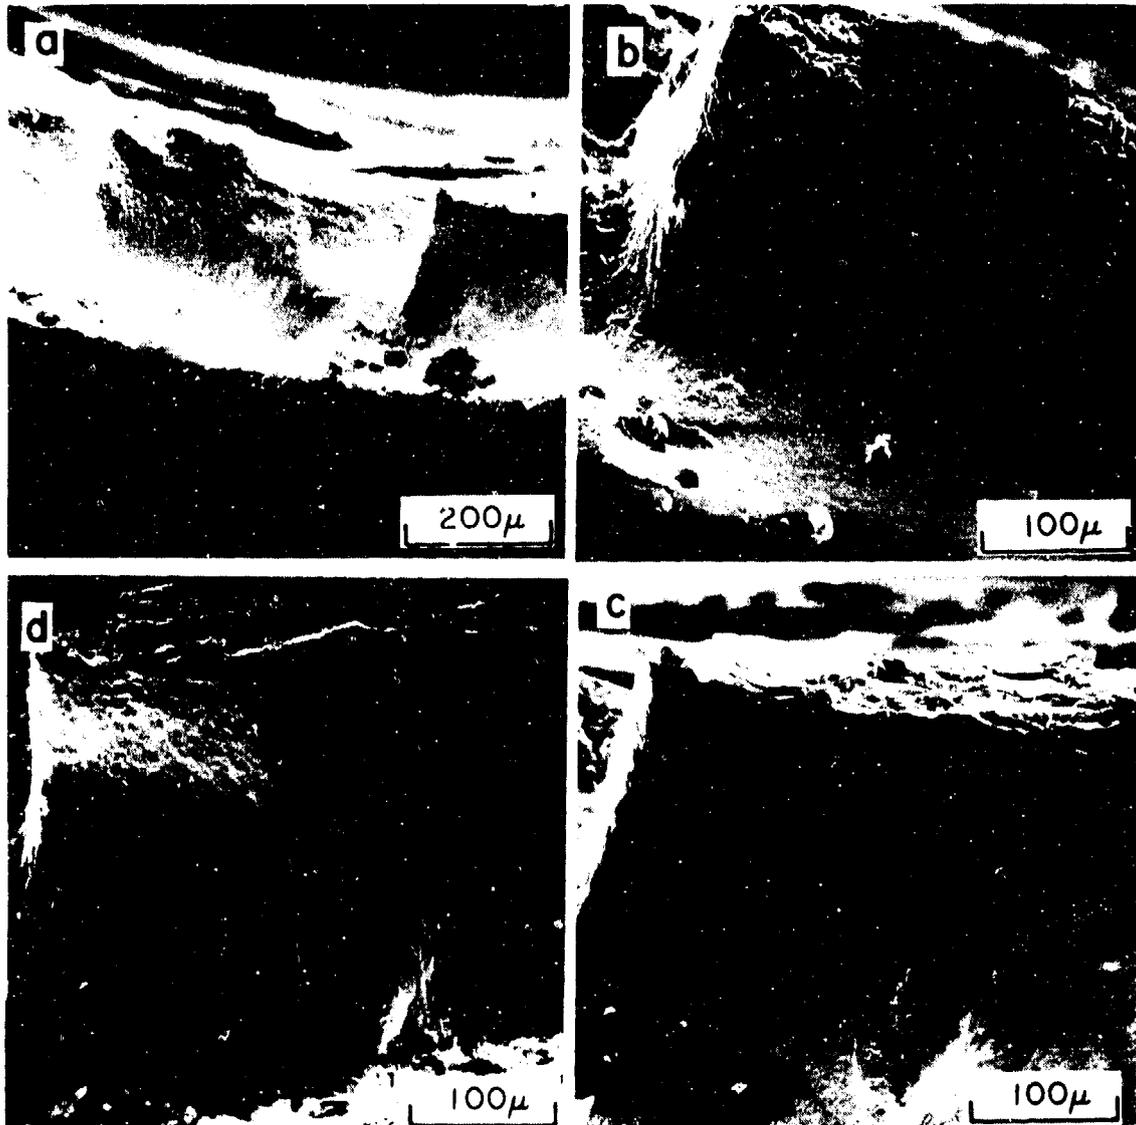
Fig. 18 Scanning electron micrographs of the fracture surface of specimen BJ.

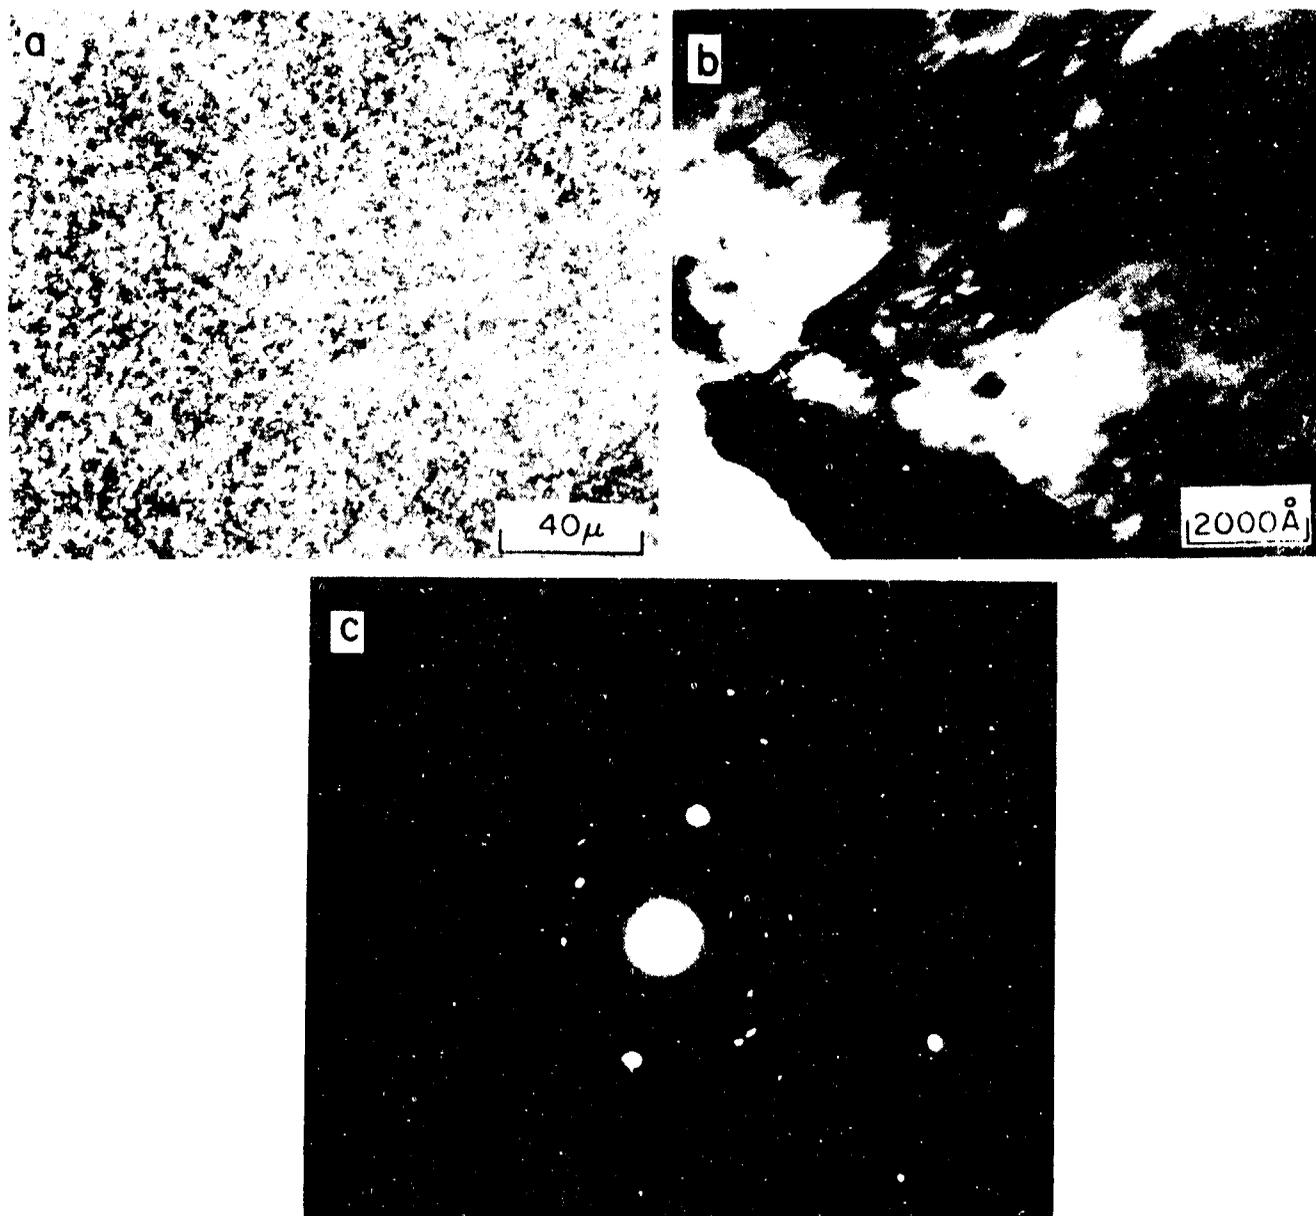
Fig. 19 Microstructure of Specimen BK. a) optical micrograph of bulk; b) transmission micrograph of bulk; c) diffraction pattern of area b).

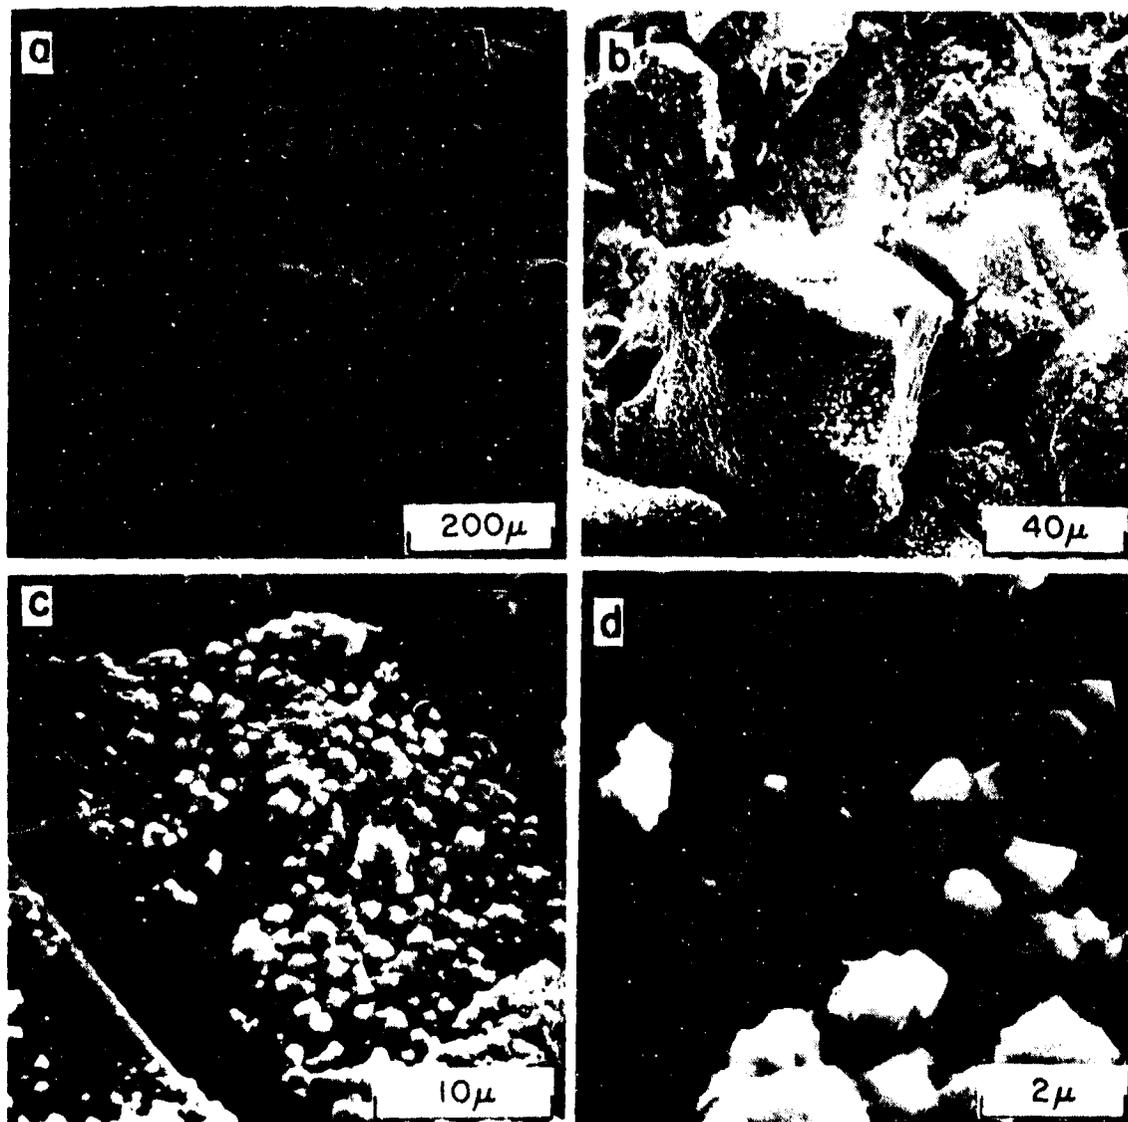
Fig. 22 Scanning electron micrographs of inner surface of specimen BK showing cracks and surface oxide particles.

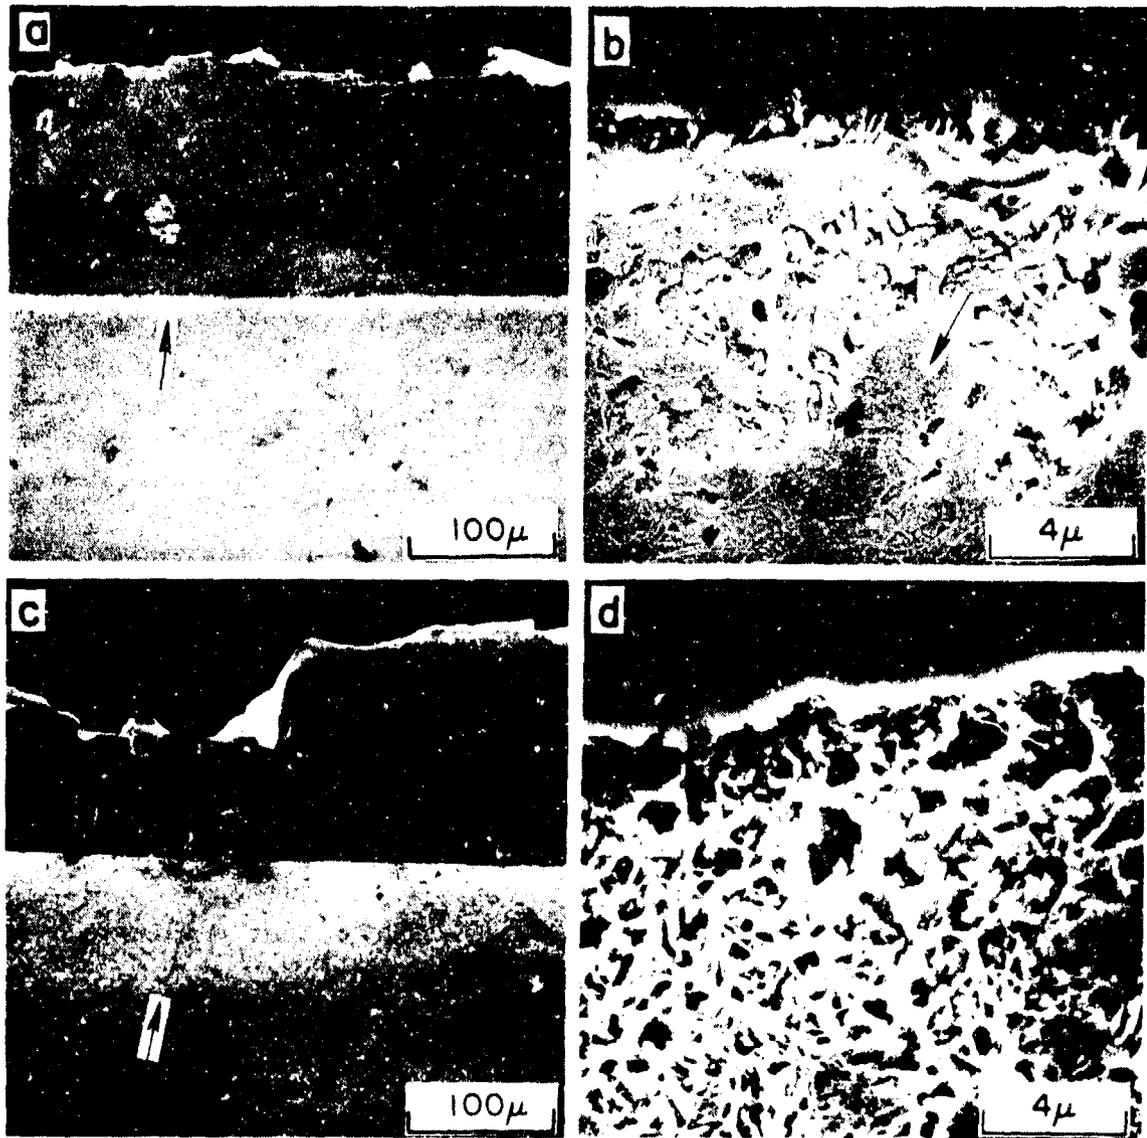
Fig. 23 Scanning electron micrographs of altered zone in the steel at chromium/gun steel interface seen in electropolished sections: a) For specimen BH, arrow at deepest penetration distance of zone of heavy etch; b) high magnification of region in (a), arrow at etch structure typical of bulk material; c) for specimen AU, arrow at deepest penetration distance of zone of heavy etch; d) high magnification of region in (c) showing heavily etched altered zone. Chromium at top.

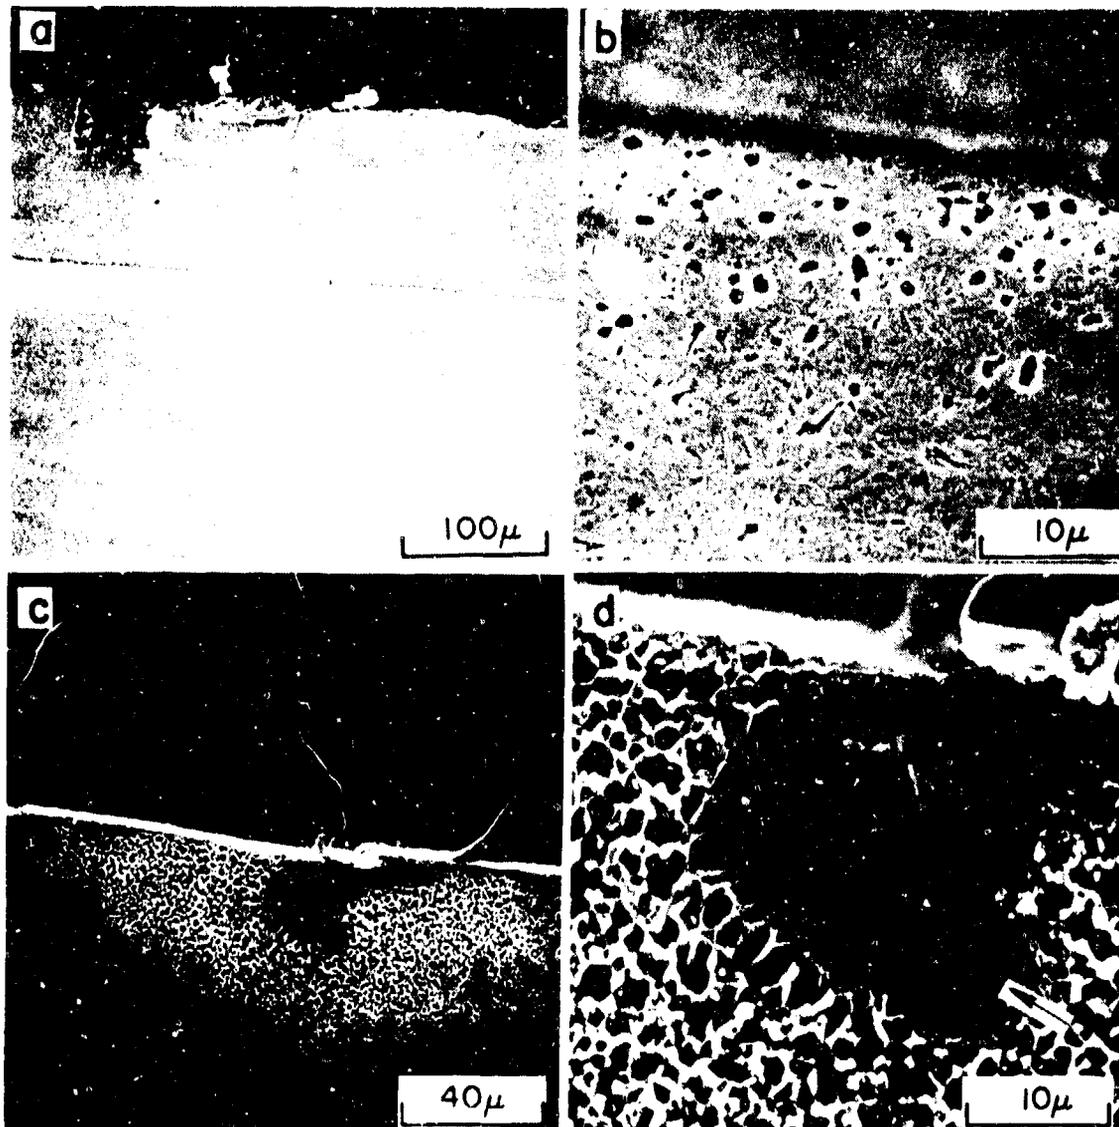
Fig. 25 Scanning electron micrographs of chromium/gun steel interface seen in electropolished sections: a) & b) For specimen BL showing slight increase in depth of altered zone over that for specimen BH cycled for 10 cycles over the same temperature range; c) & d) showing expansion of the altered zone at point of passage of crack in the chromium into the gun steel. Arrow in (d) at microcracked region having increased chromium content.

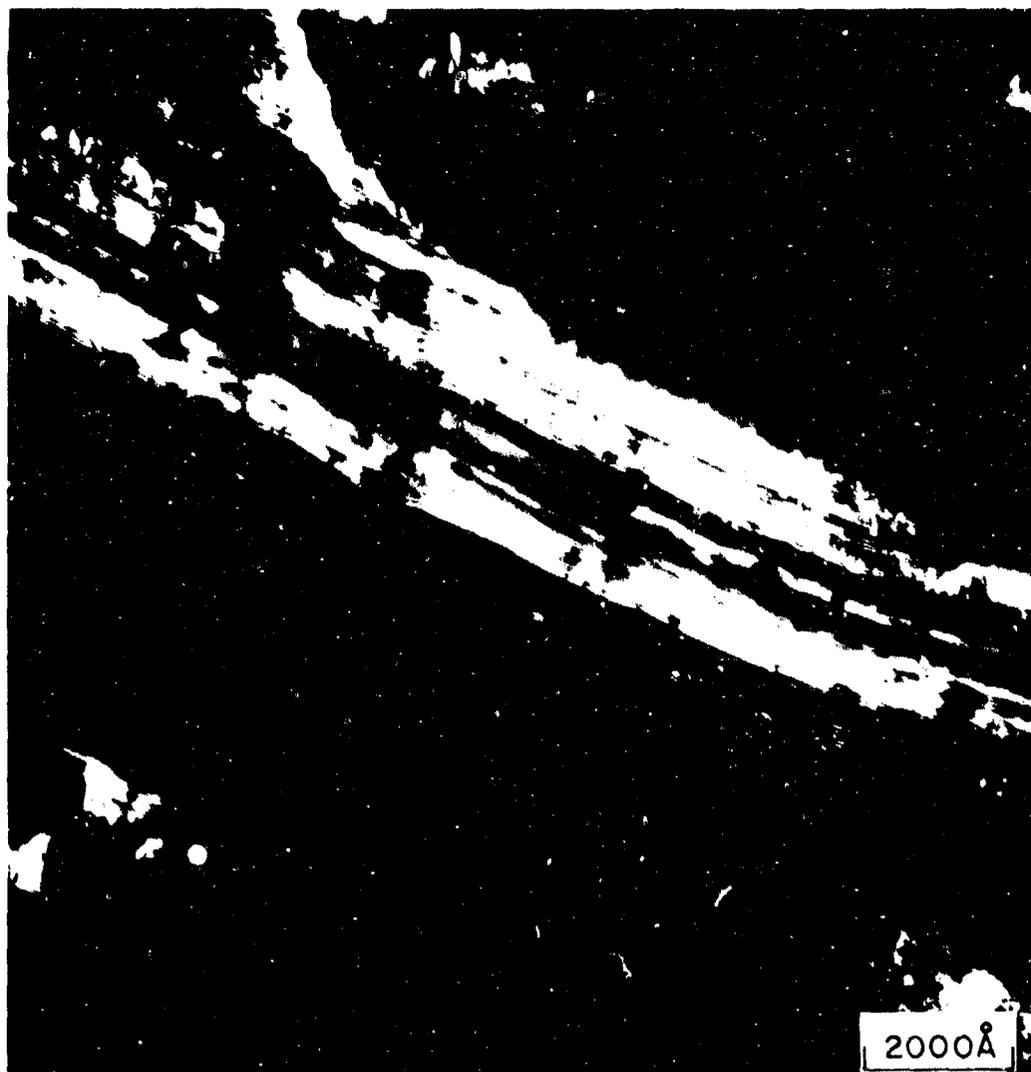
Fig. 27 Dark field transmission electron micrograph of region shown in Fig. 26 taken in matrix reflection of Cr-C.
