WEAR, FRICTION AND THERMAL FATIGUE OF
GUN BARREL MATERIALS

Rockwell International Corporation

WEAR, FRICTION AND THERMAL FATIGUE
OF GUN BARREL MATERIALS
FINAL REPORT

Contract DAAF07-73-C-0582

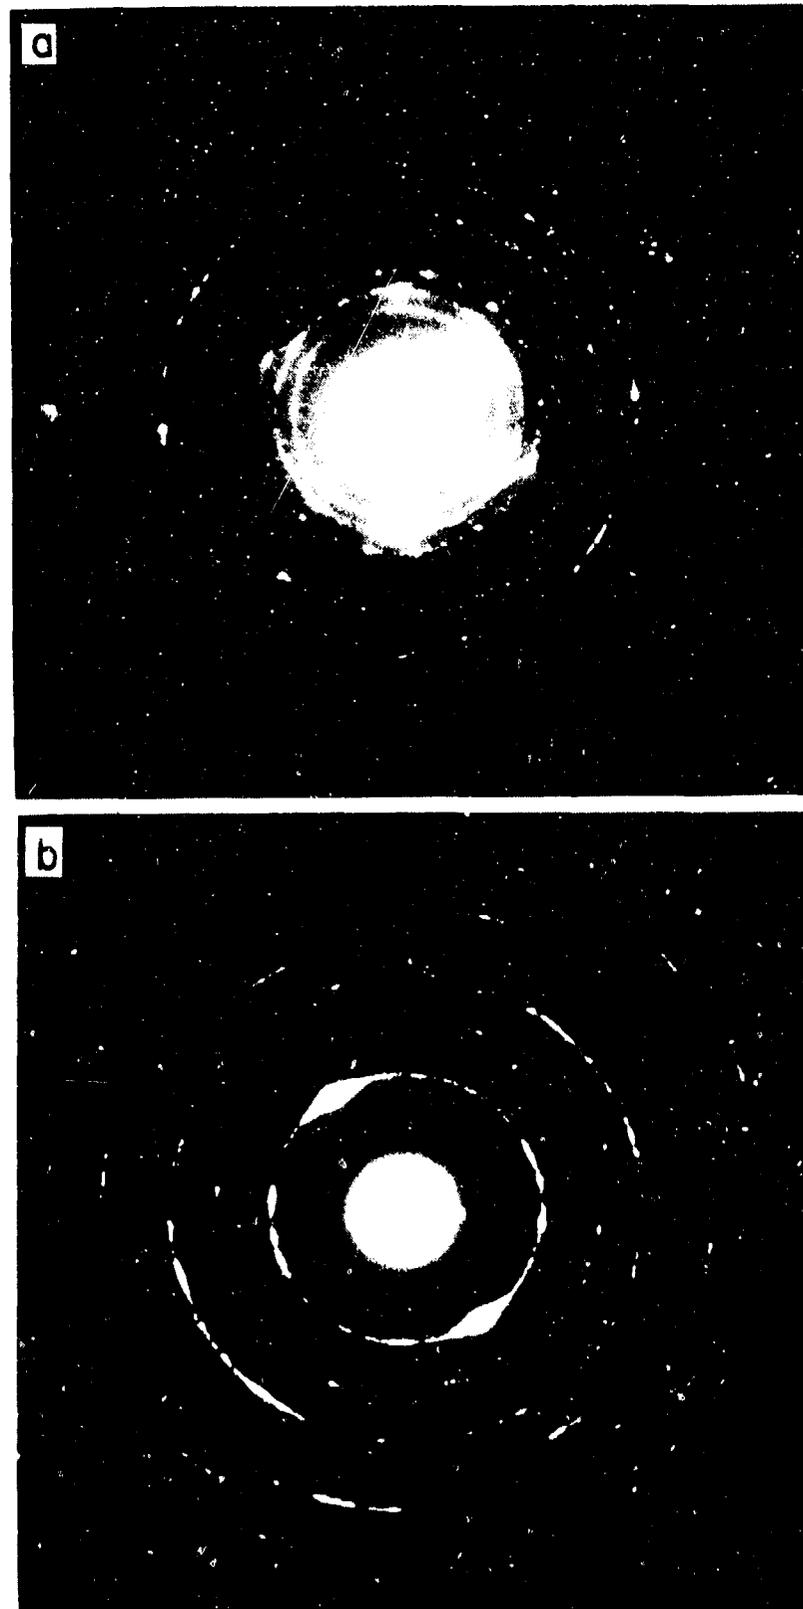
Fig. 28 a) Electron diffraction pattern of region shown in Fig. 26. In addition to the polycrystalline rings the matrix reflections of the crystal illuminated in Fig. 27 are visible. b) Comparison electron diffraction pattern taken in the Cr layer near the Cr/Co interface of specimen BK.

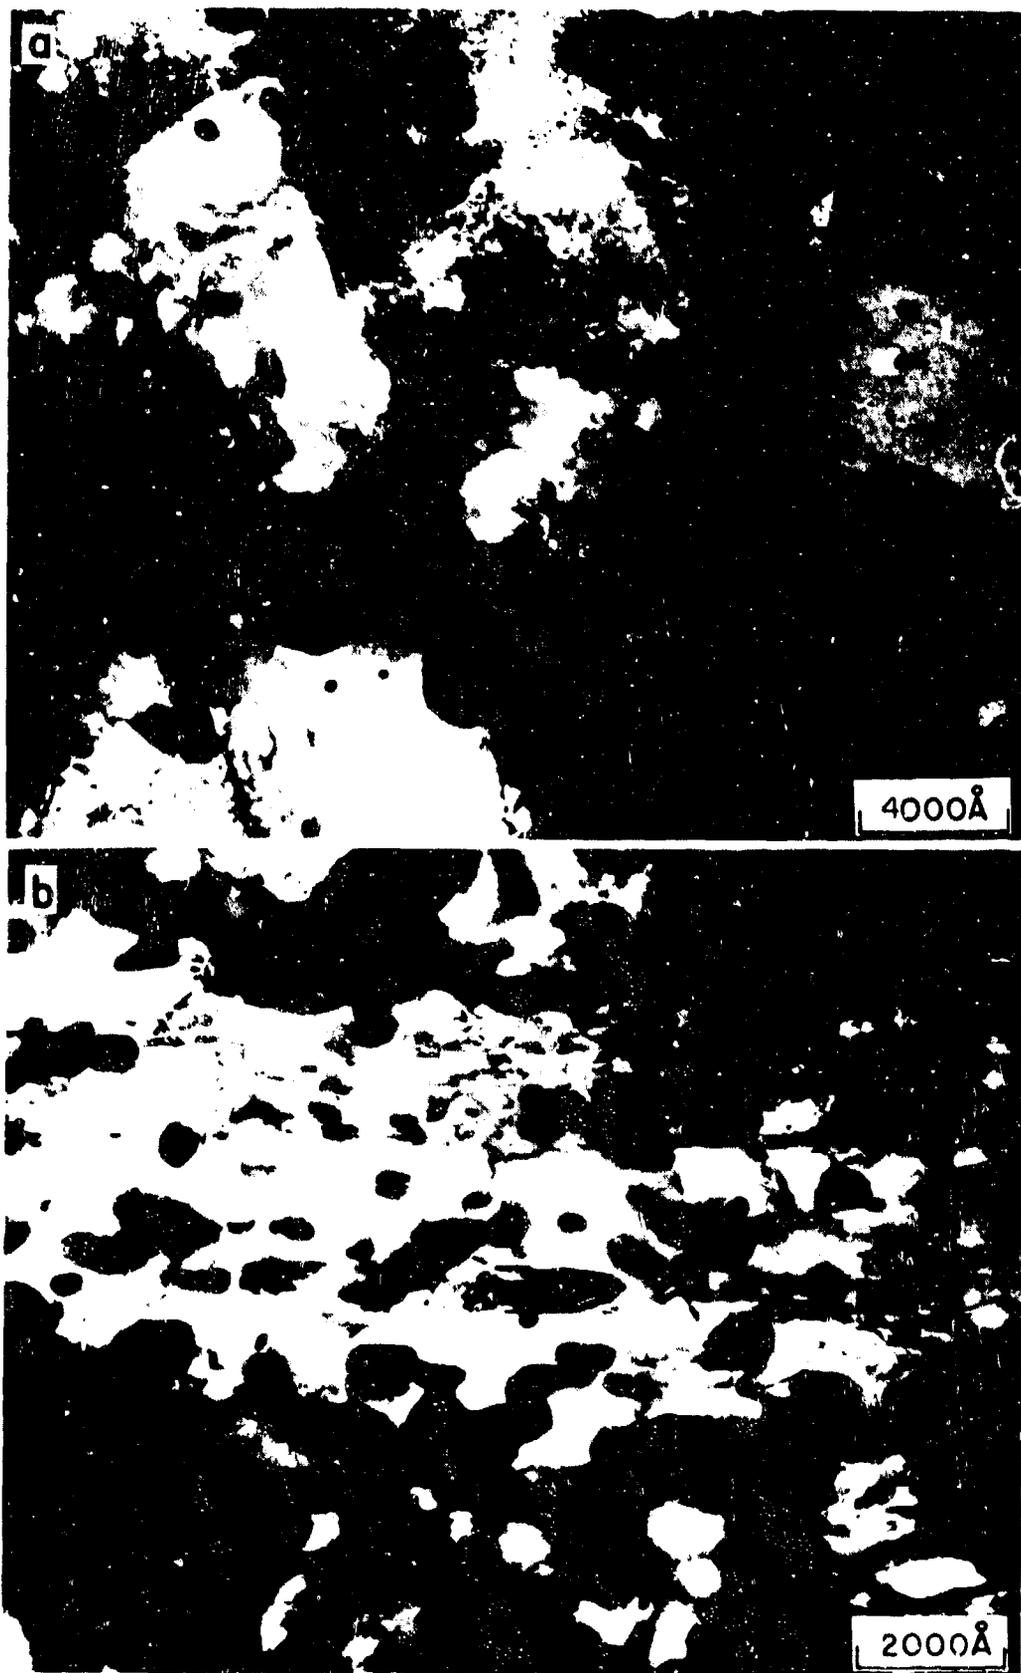
Fig. 29 Transmission electron micrographs of gun steel comparing the steel near the steel/Cr interface of specimen BL (a) to that for thermally fatigue unplated gun steel specimen, BG. (b) Precipitate density in (a) is significantly decreased.

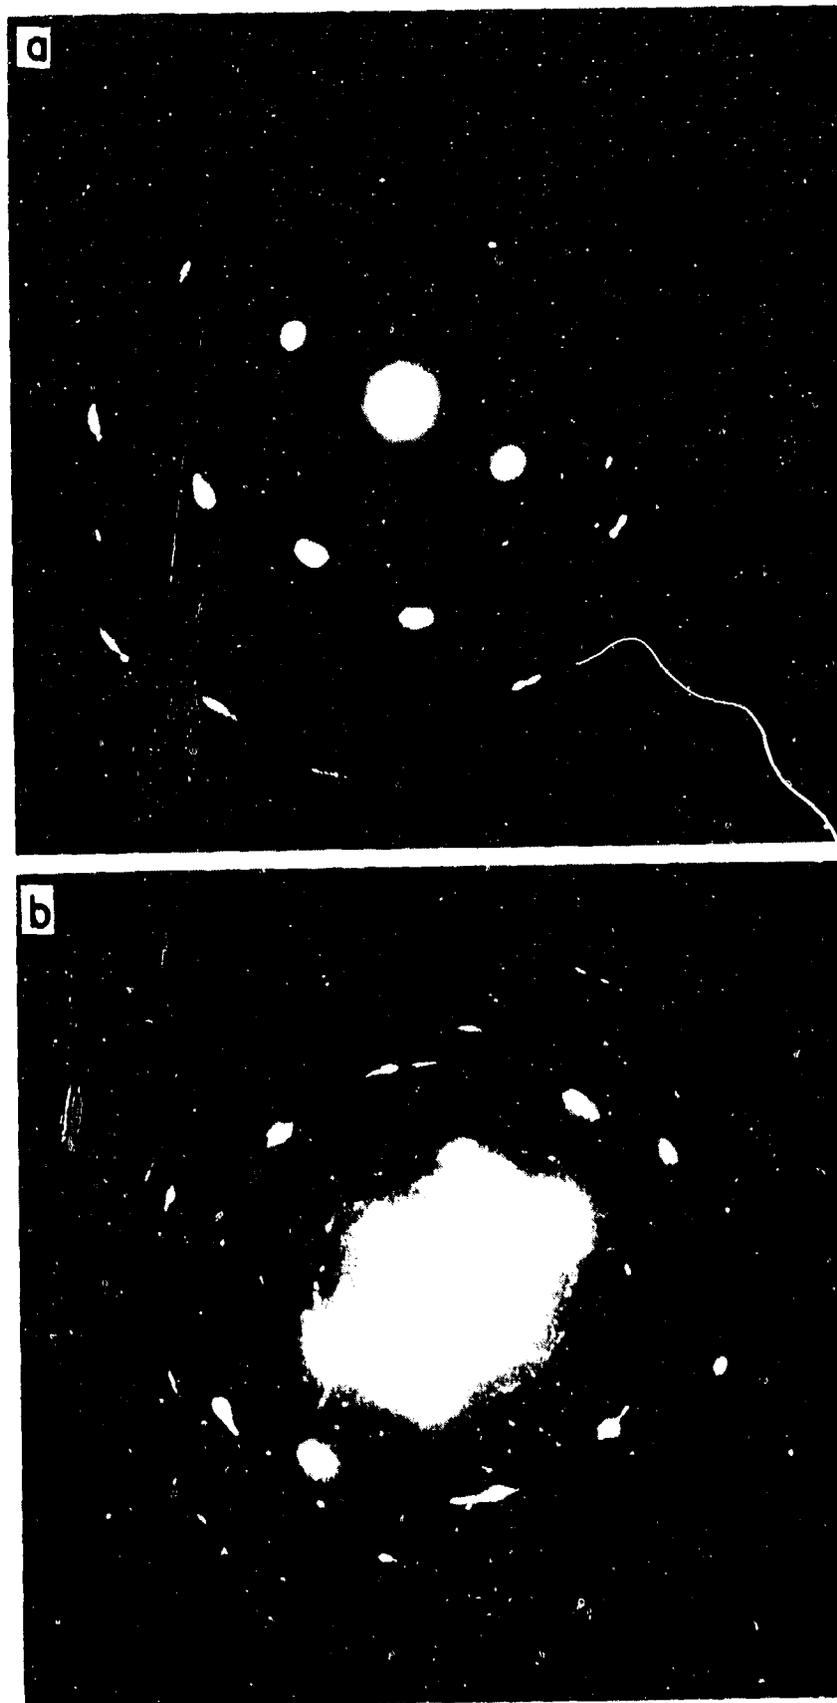
Fig. 30 Electron diffraction patterns corresponding to the micrograph regions in Fig. 29: a) specimen BL; b) specimen BG.

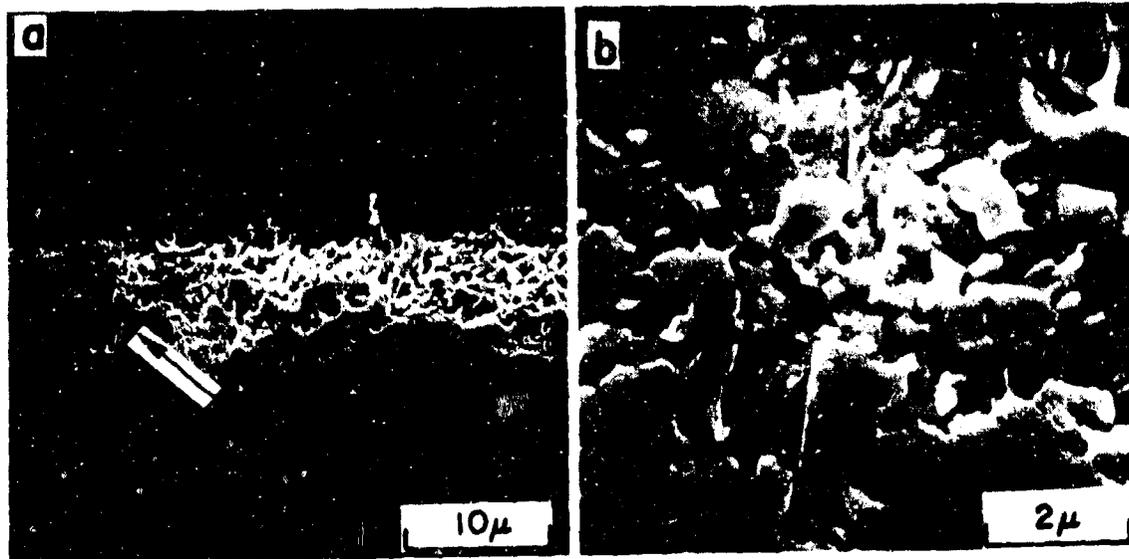
Fig. 31 Scanning electron micrographs of electropolished section of specimen BG showing apparent microcracking in altered zone not associated with Cr cracking. Arrow in (a) at region of high magnification in (b). Chromium at top.

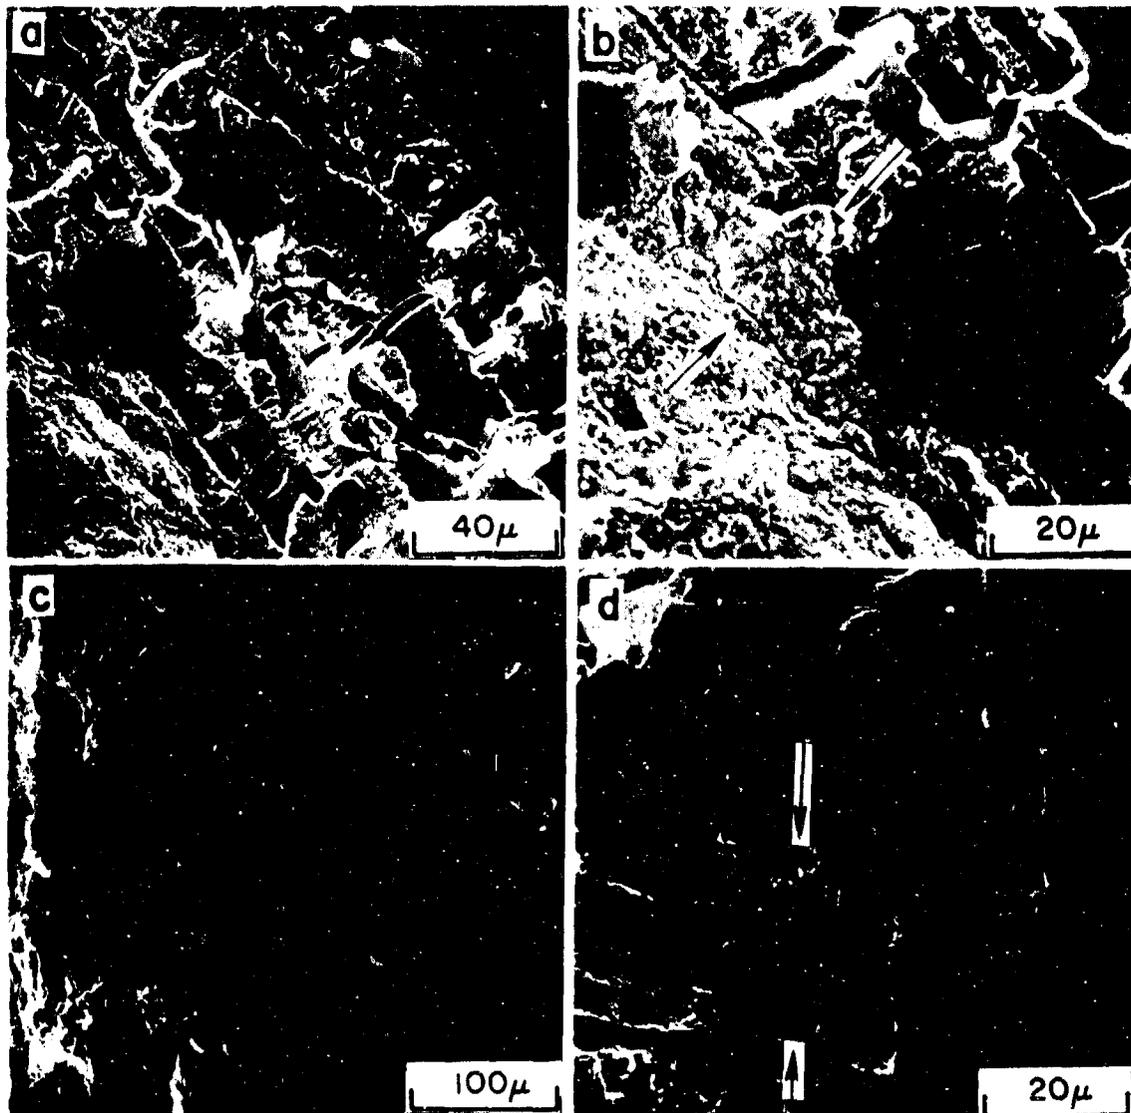
Fig. 32 Scanning electron micrographs of sections of fracture surface of specimen AU showing microcracked region in steel at Cr/steel interface: a) & b) region one, arrows in (b) define zone; c) & d) region two, arrows in (d) define zone.

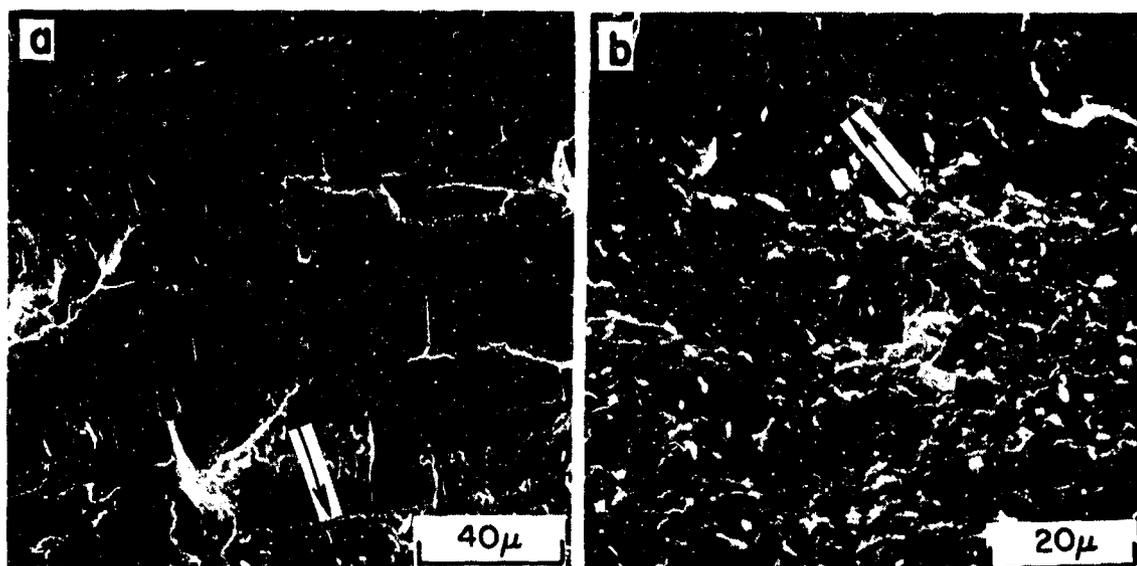
Fig. 33 Scanning electron micrographs of section of fracture surface of specimen BB. Arrows at Cr/steel interface. Cr on top.

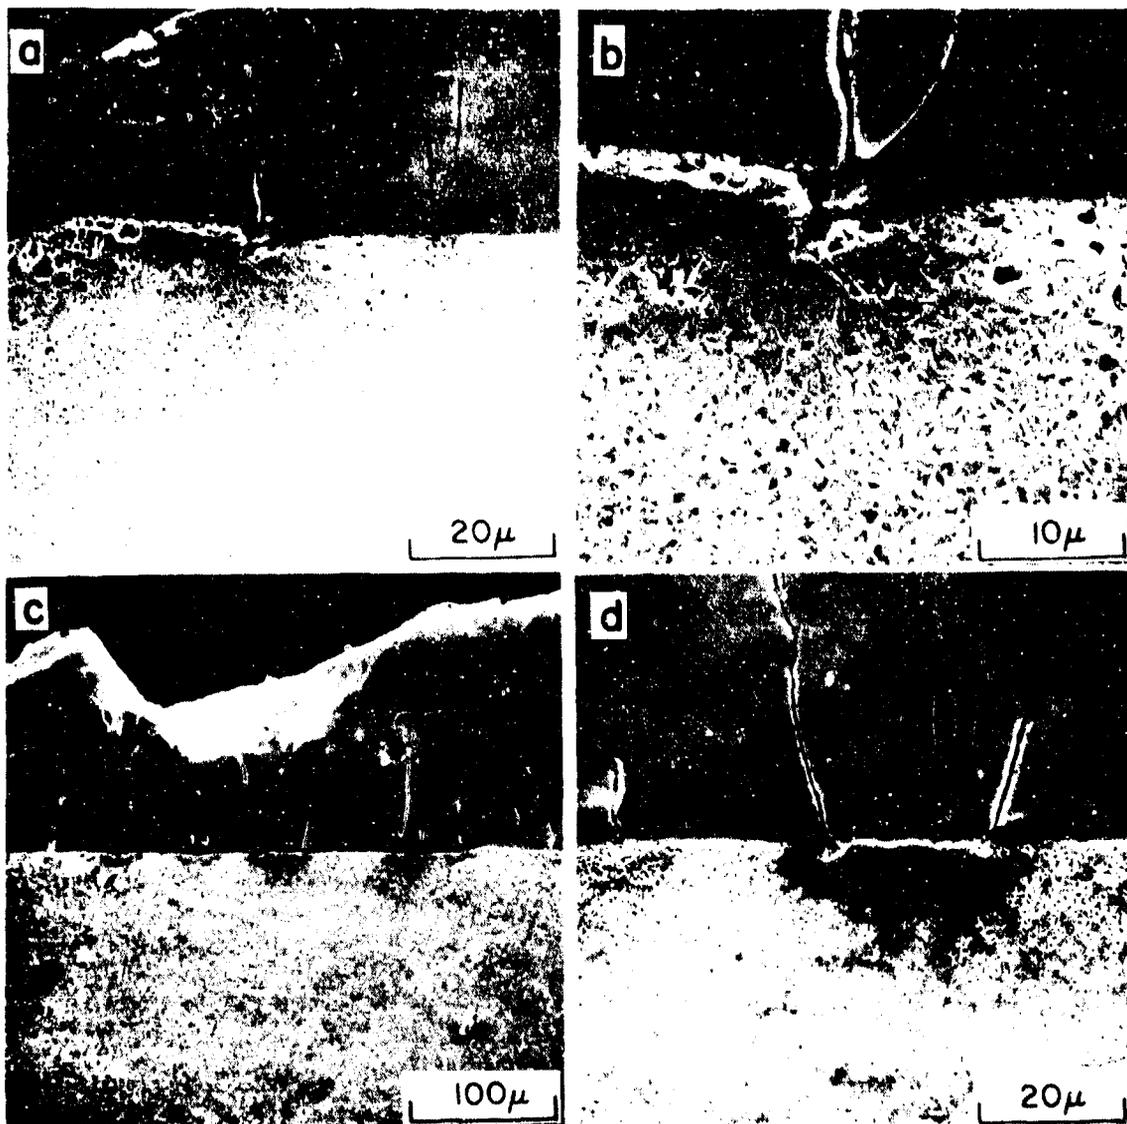
Fig. 34 Scanning electron micrographs of electropolished section of specimen AV. Connection between sub Cr plastic deformation zones can be seen associated with cracks in the Cr plate, blunted in the steel. Cr on top.

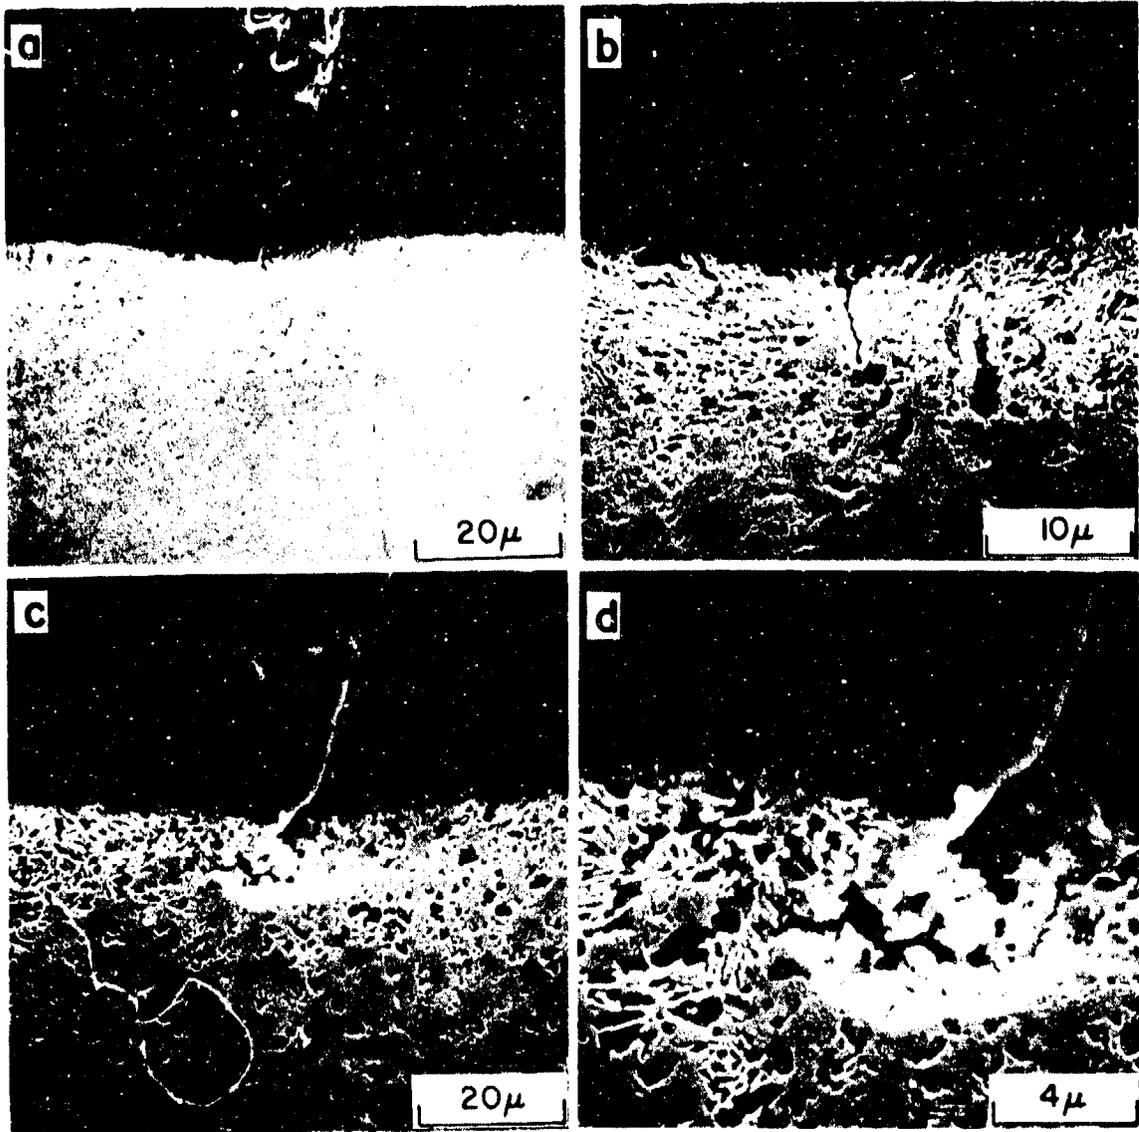
Fig. 35 Scanning electron micrographs of electropolished section of specimen AU showing crack propagation into the steel after 25 test cycles. Cr on top.

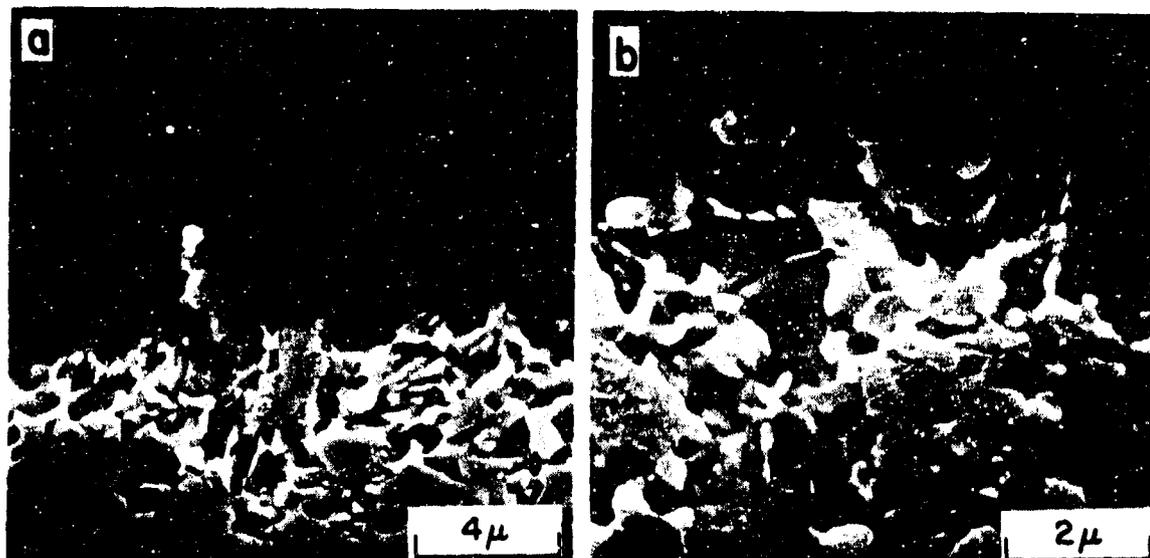
Fig. 36 Scanning electron micrograph of electropolished section of specimen BH showing crack blunting at Cr/steel interface. Cr on top.

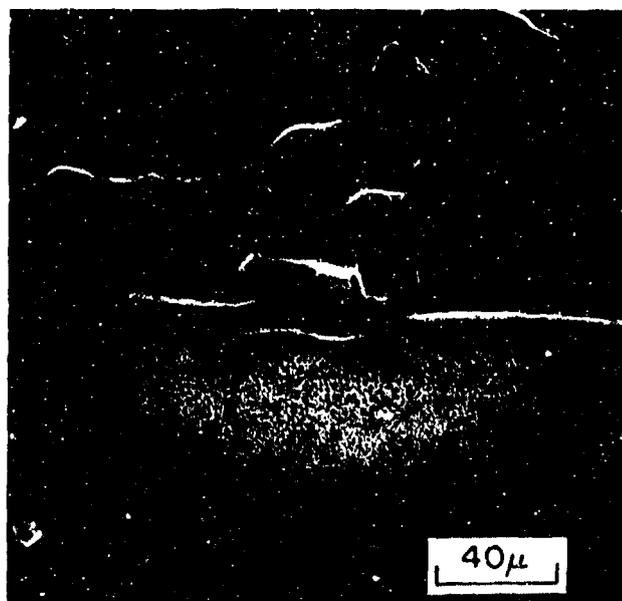
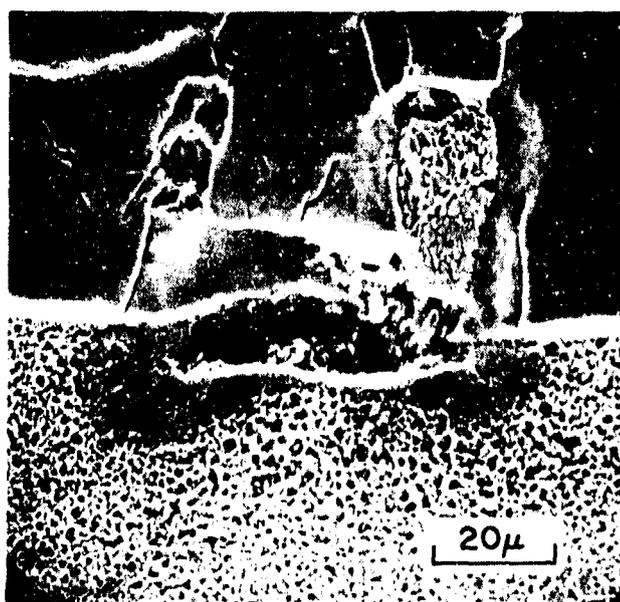
Fig. 37 Scanning electron micrographs of electropolished section of specimen BL. In addition to the heavy deformation in the steel a pinch of steel can be seen in the Cr plate. Cr on top.

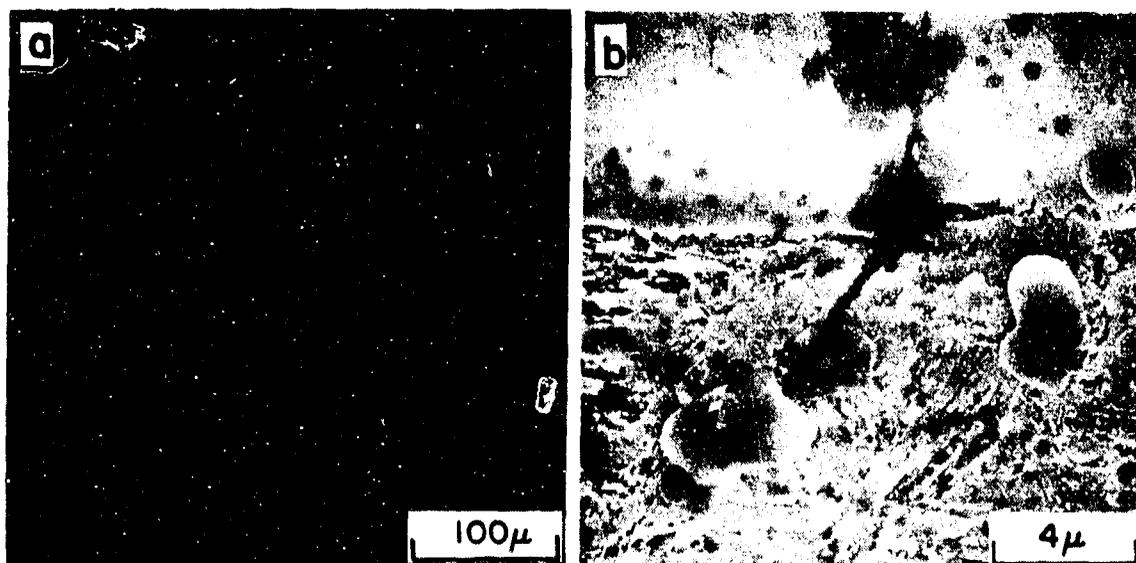
Fig. 38 Scanning electron micrographs of electropolished section of specimen AQ. Crack propagation through the Cr/steel interface is seen for this test condition and little associated deformation is noted. Cr on top.

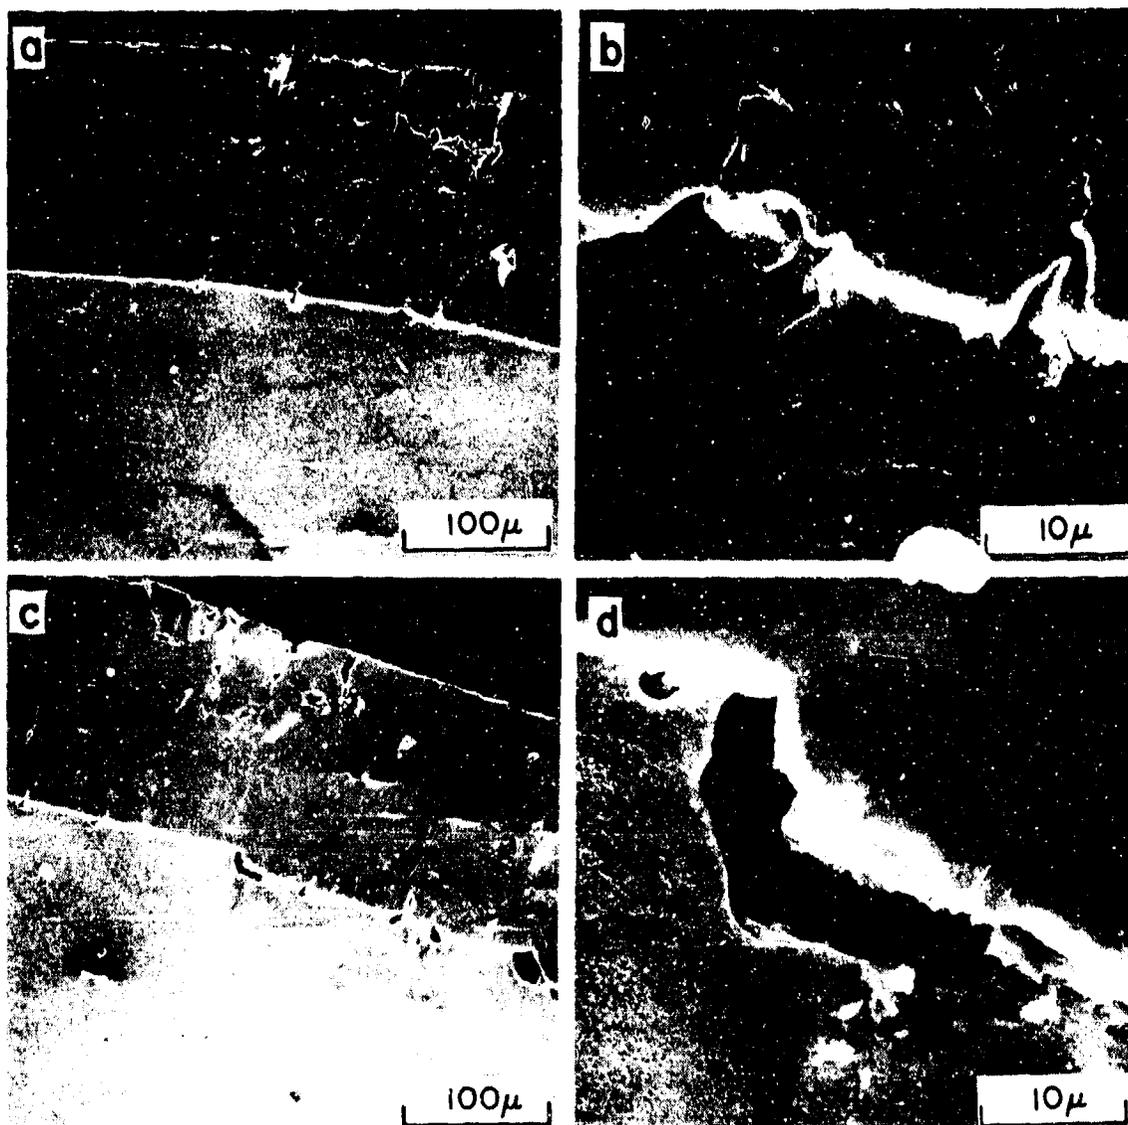
Fig. 39 Scanning electron micrographs of electropolished section of specimen BB. No crack progration through the interface is observed. Significant undermining is associated with crack blunting. Cr on top.

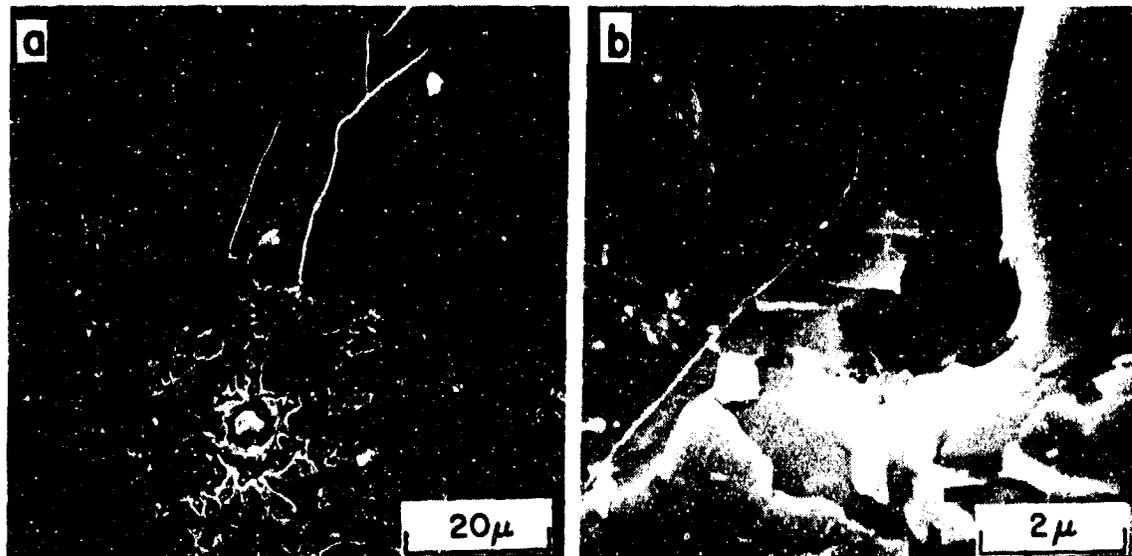
Fig. 40 Scanning electron micrographs of electropolished section of specimen AA. No crack propagation is observed through the interface and also no associated deformation is detectable. Cr on top.

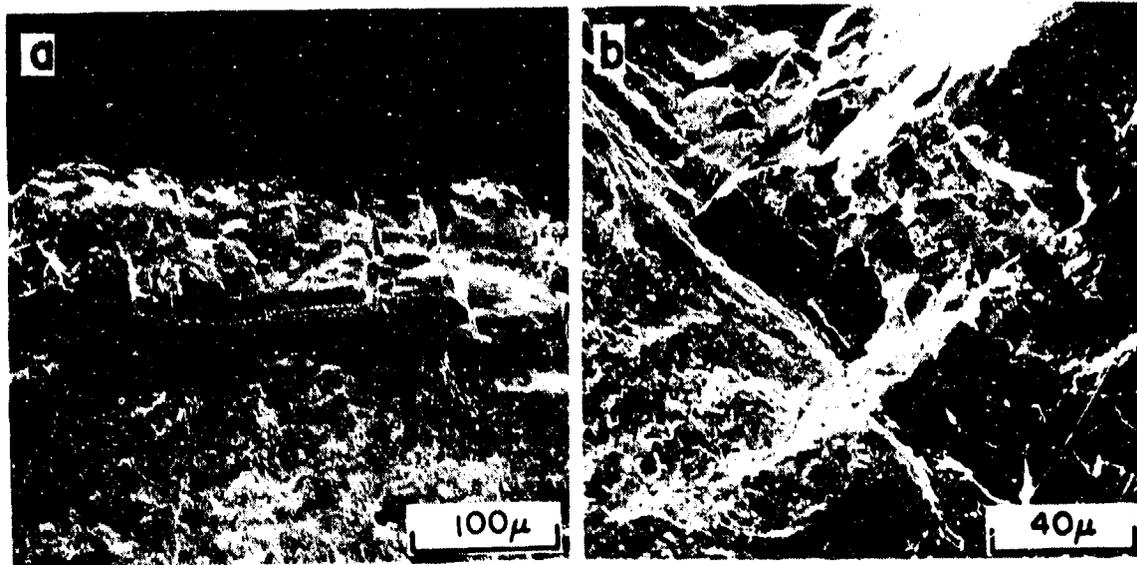
Fig. 45 Scanning electron micrograph of a segment of the fracture surface of specimen AU showing axial cracking in the Cr plate.

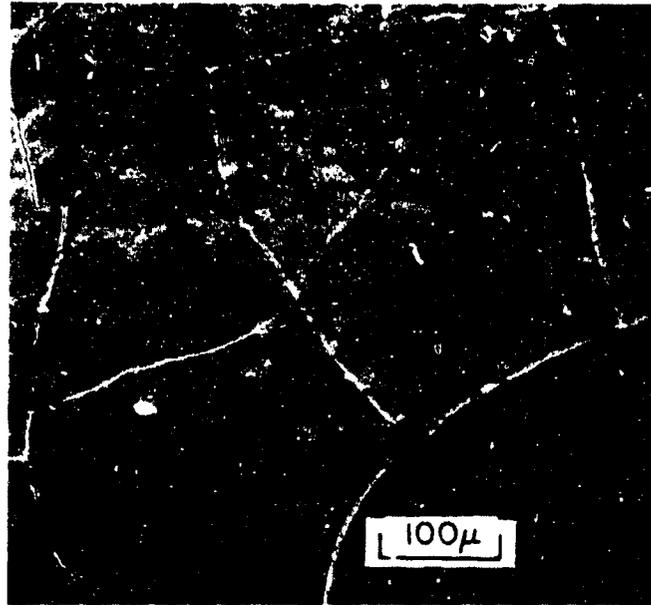
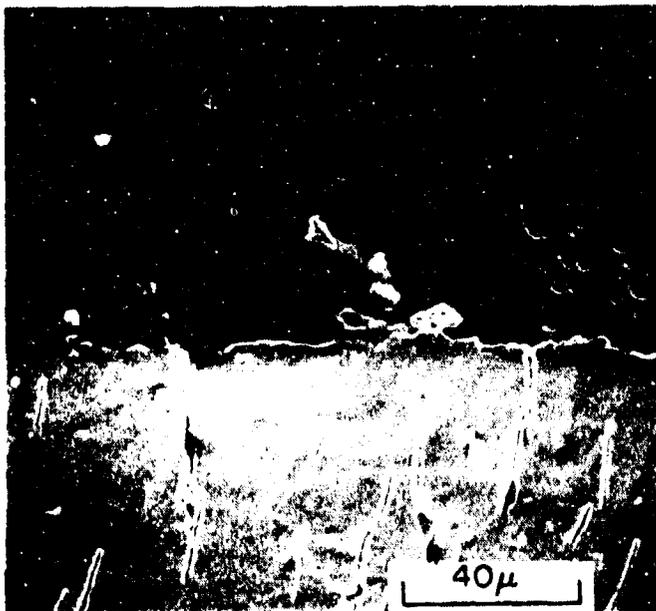
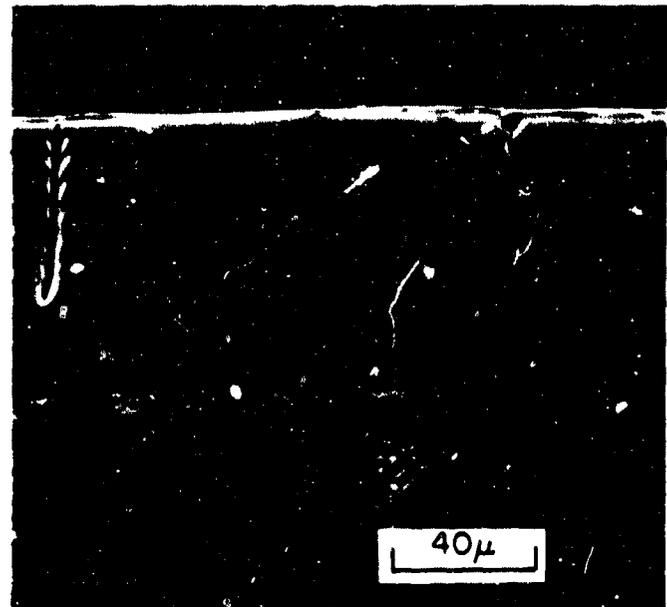
Fig. 46 Scanning electron micrographs of the surface fracture and electro-polished section of specimen AA. Crack pattern is essentially intrinsic to the electrodeposited Cr before thermal cycling.

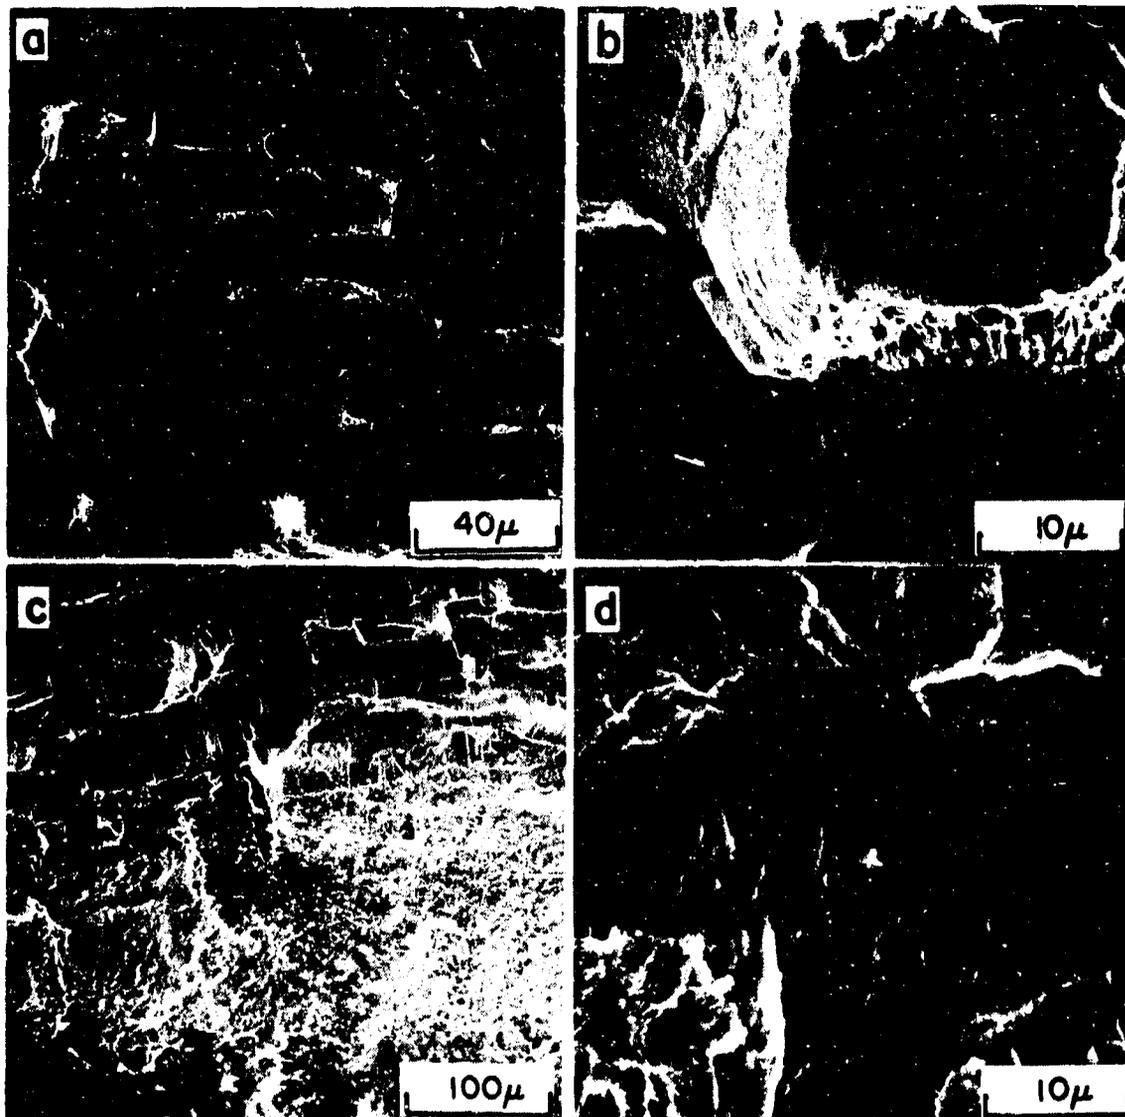
Fig. 48 Scanning electron micrographs of section of fracture surface of specimen BB. a & b show blocky appearing fracture surface possibly associated with deformation zones in the Cr. The smooth cracking in c & d may be associated with an initial through crack in the Cr.

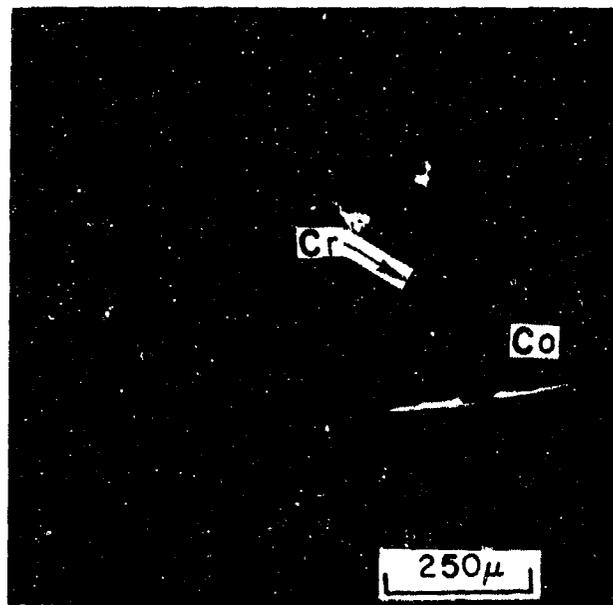
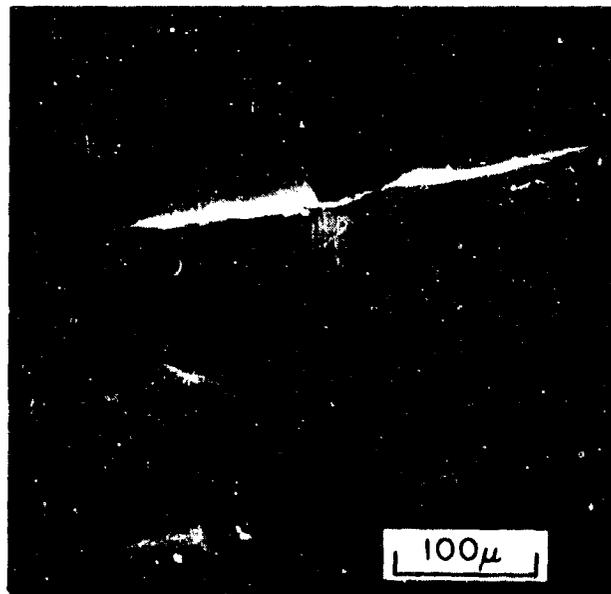
Fig. 49 Scanning electron micrographs of electropolished sections of specimen BR.

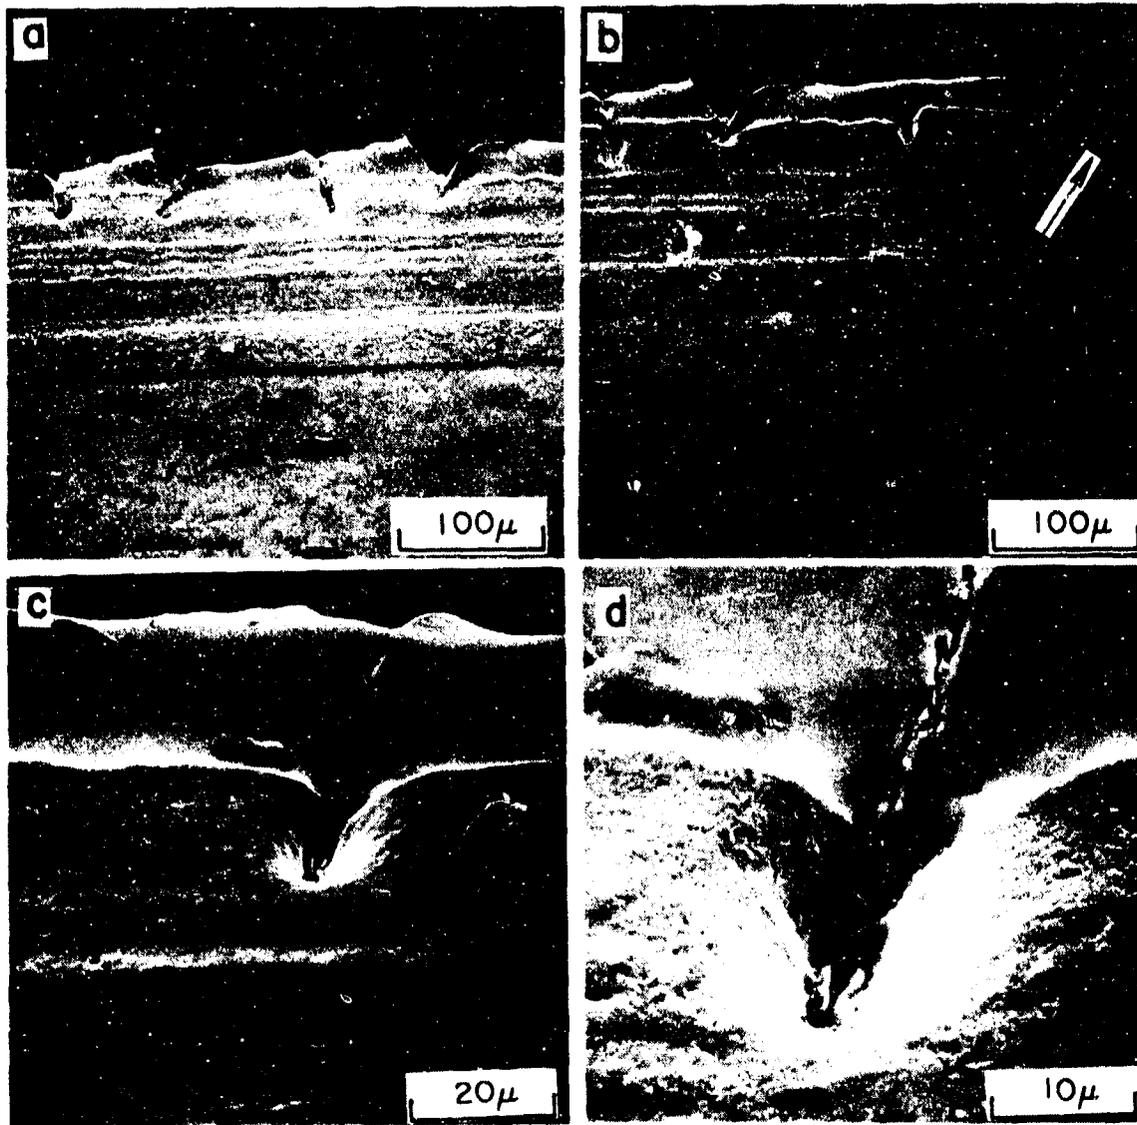
Fig. 50 Scanning electron micrographs of electropolished sections of specimen BS. Cracks in Cr have been folded into the Co, effectively blunting them. Cr layer on top.

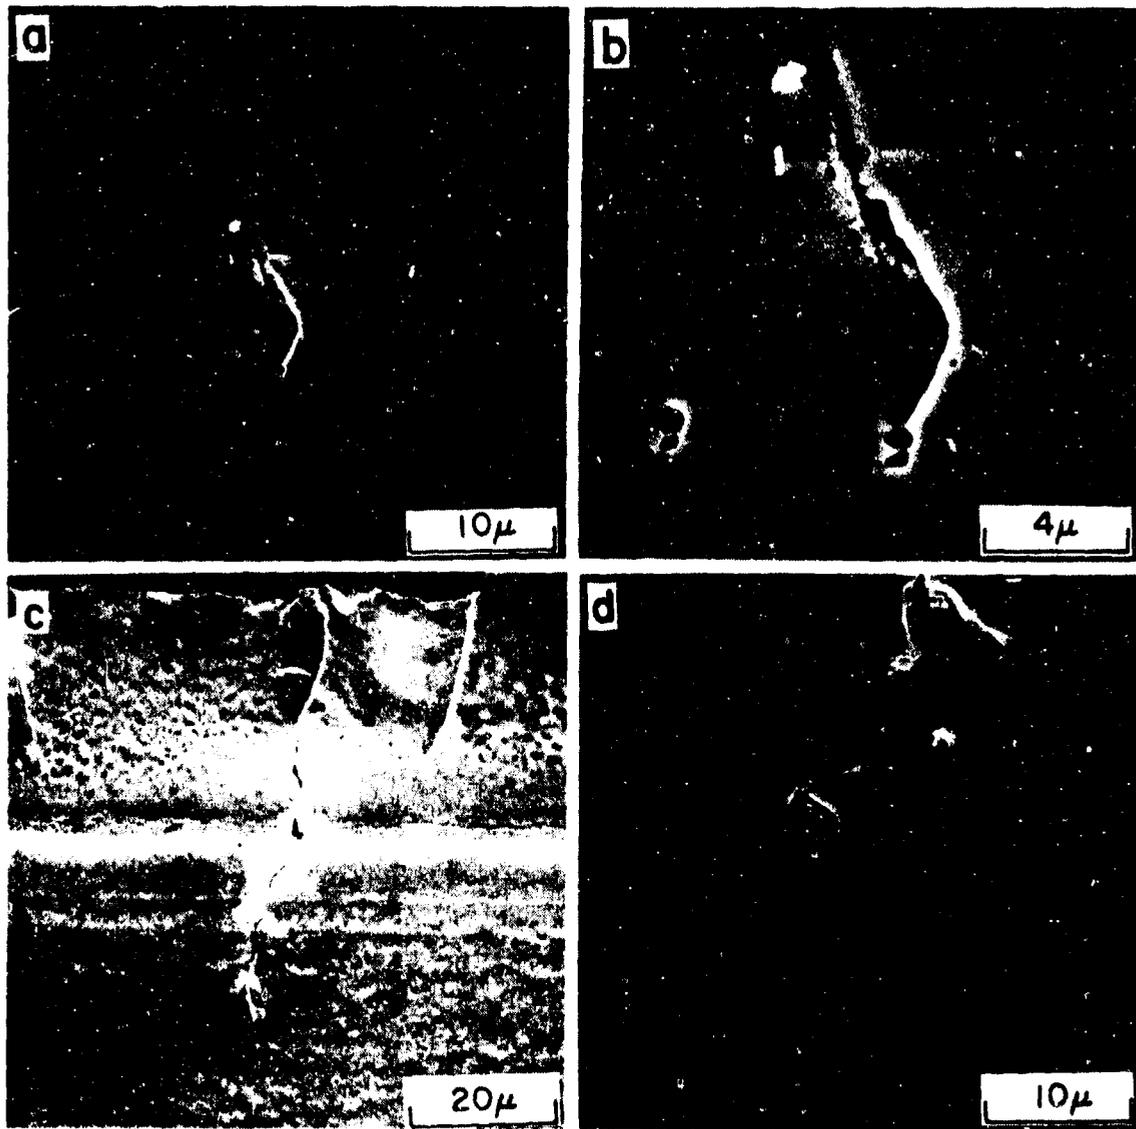
Fig. 55 Scanning electron micrographs of electropolished section of specimen BR illustrating a relationship between changes in Al_2O_3 density, seen by banding and changes in crack propagation direction. Cr layer at top.

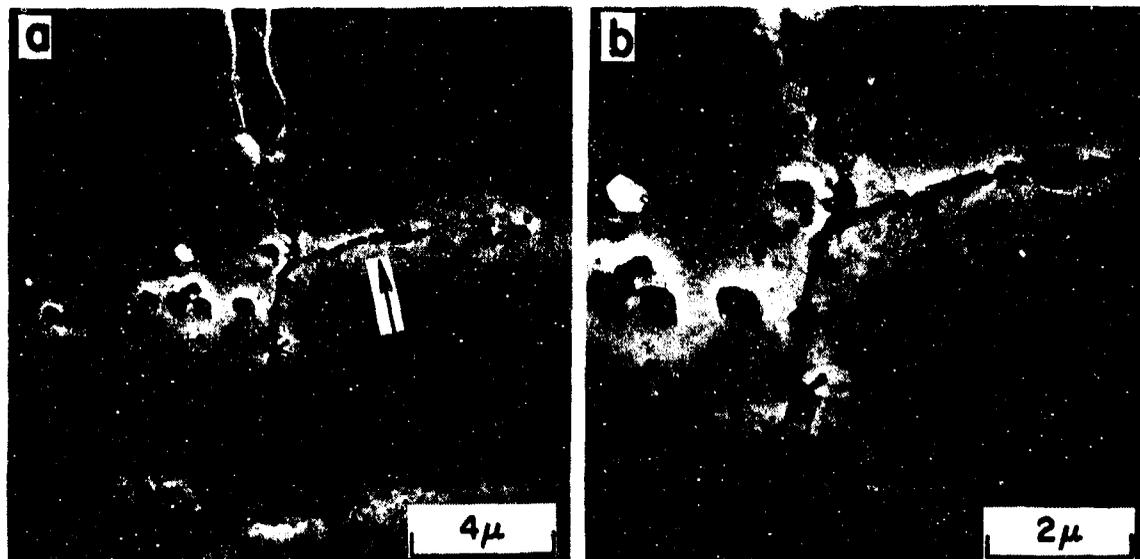
Fig. 56 Scanning electron micrographs of electropolished section of specimen BR. Arrow in (a) at plane of incipient Co debonding. Cr layer on top.

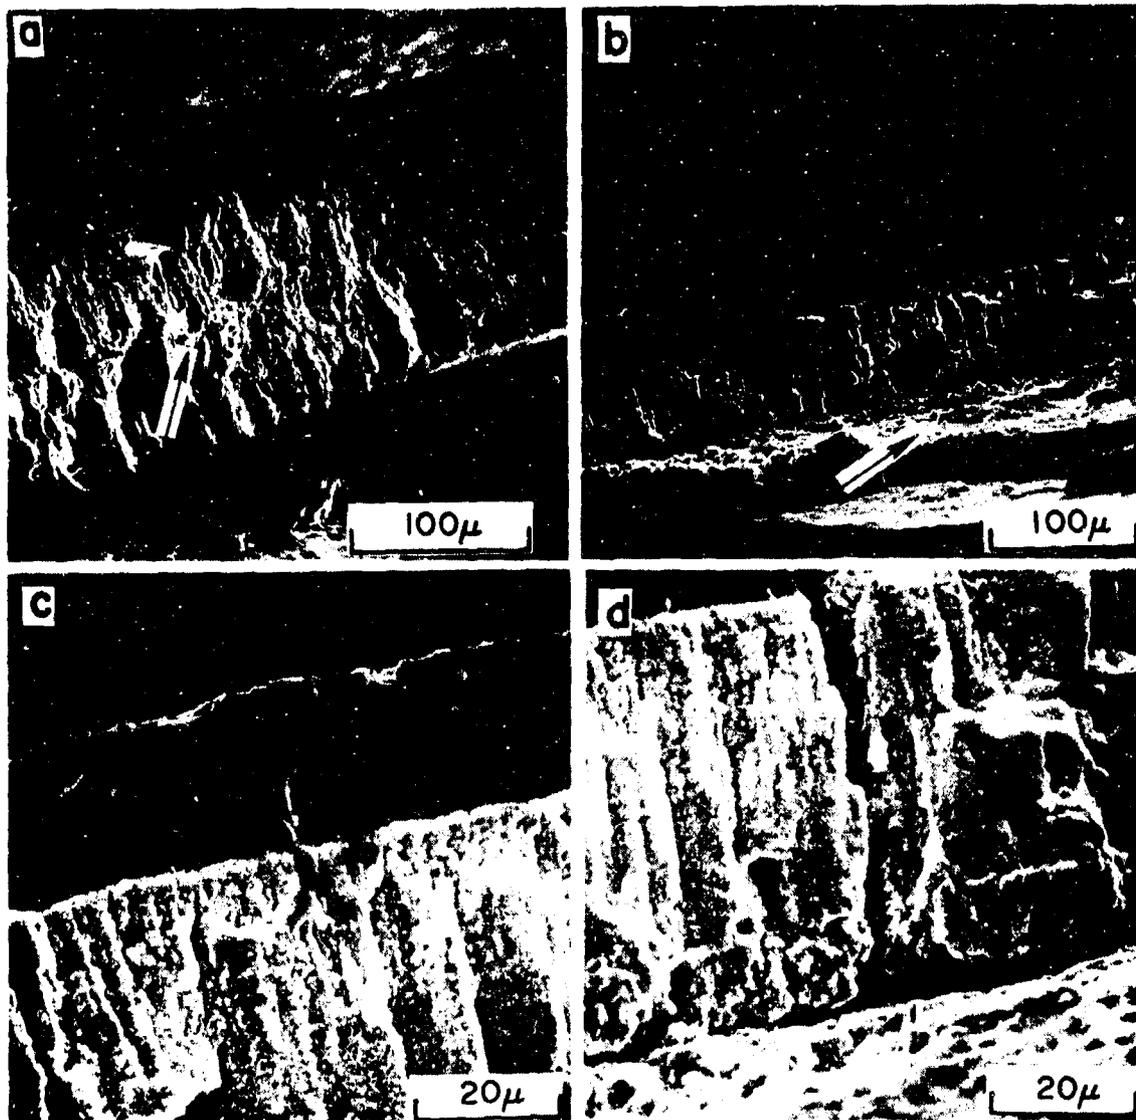
Fig. 57 Scanning electron micrographs of sections of fracture surface of specimen BS. Arrow at delamination crack in the Co in (a). Site b, c and d 180° opposite site (a) and complete Co delamination has occurred there. Arrow in (b) at plane of lower lamination.
