WEAR, FRICTION AND THERMAL FATIGUE OF
GUN BARREL MATERIALS

Rockwell International Corporation

WEAR, FRICTION AND THERMAL FATIGUE
OF GUN BARREL MATERIALS
FINAL REPORT

Contract DAAF07-73-C-0582

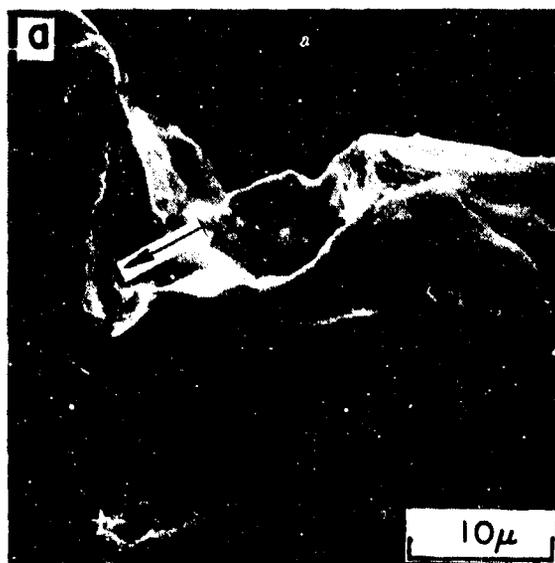
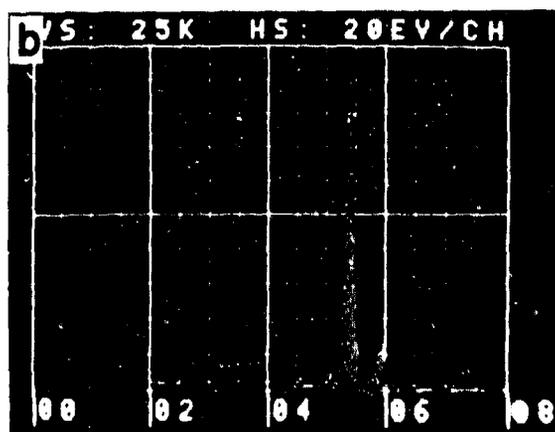
Fig. 60 Scanning electron micrographs of inclusion in Cr at initiation site of crack in Fig. 60 (a), x-ray analysis indicating the inclusion to be primarily silicon (b). The bar spectrum is the matrix, i.e., Cr and the dot spectrum is that in the region of the particle

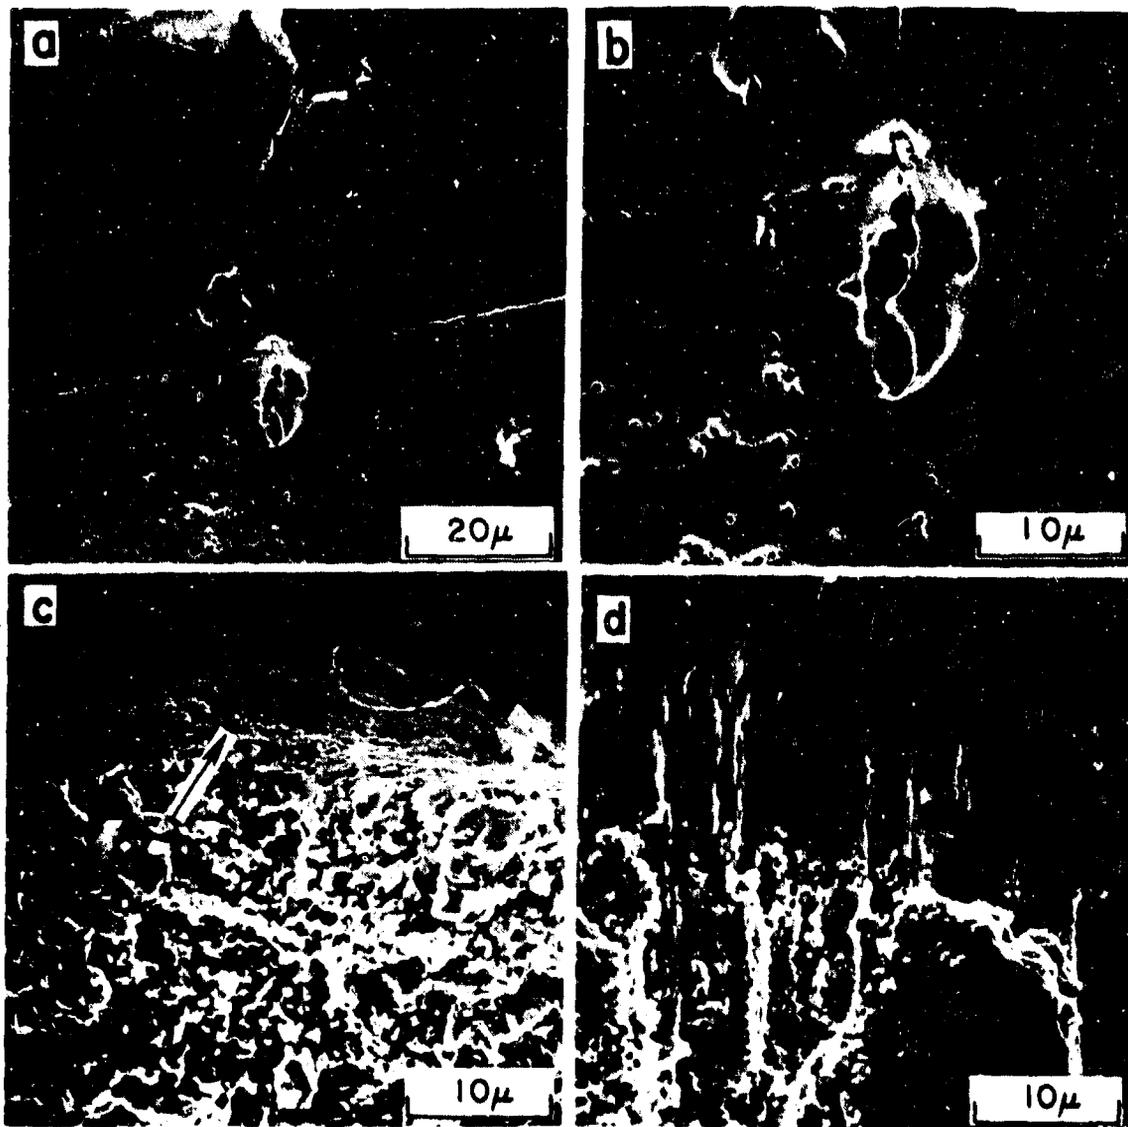
Fig. 61 Scanning electron micrographs of specimen BR: a) and b) electro-polished section; c) Co fracture and Co/steel delamination interface at arrow; d) Cr/Co fracture surface Cr on top illustrates void formation.

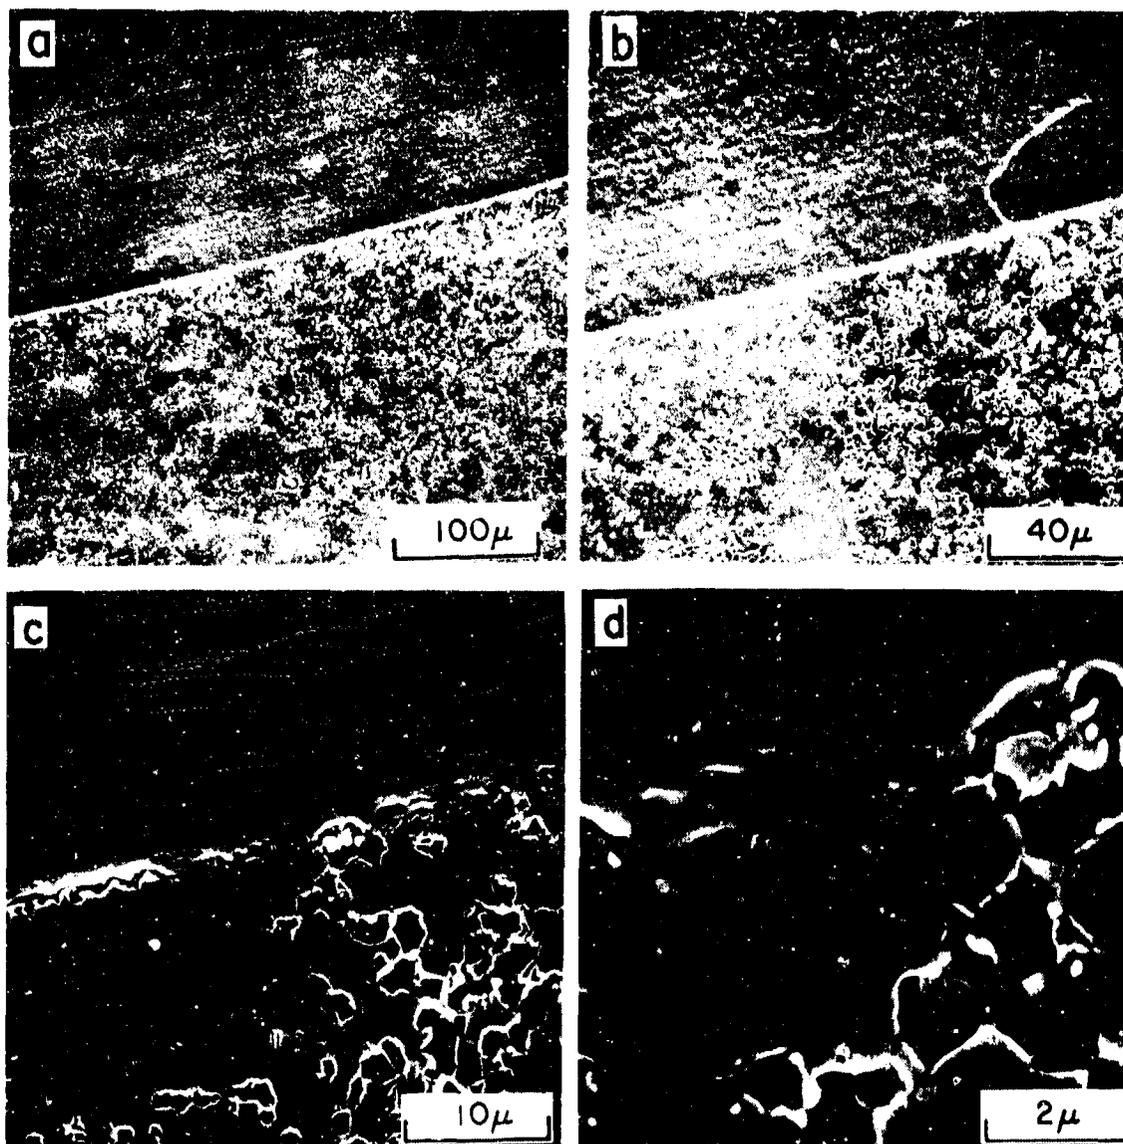
Fig. 62 Scanning electron micrographs of electropolished section of specimen BR at Co/steel interface. No interface degradation is noted. Co on top.

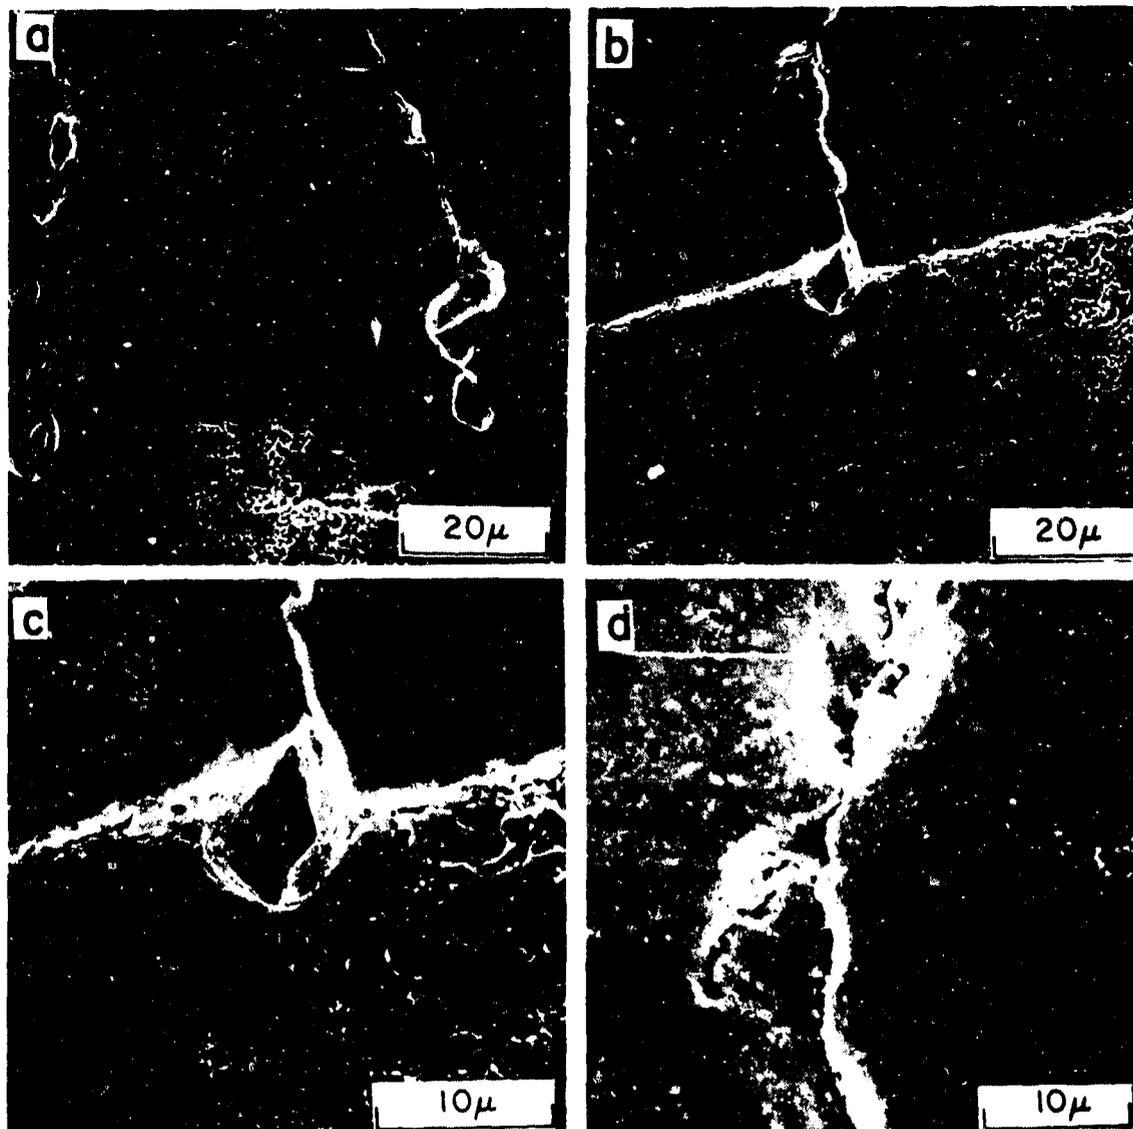
Fig. 63 Scanning electron micrograph of electropolished section of specimen BR at Co/steel interface showing crack blunting in steel. Co on top.

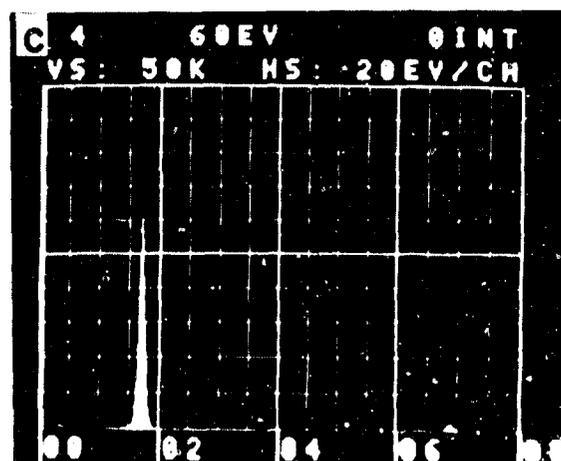
Fig. 64 Scanning electron micrographs of electropolished section and fracture surface of specimen BR at region of massive tear in the steel. Particle at arrow in (a) is silicon as shown by x-ray analysis (c).

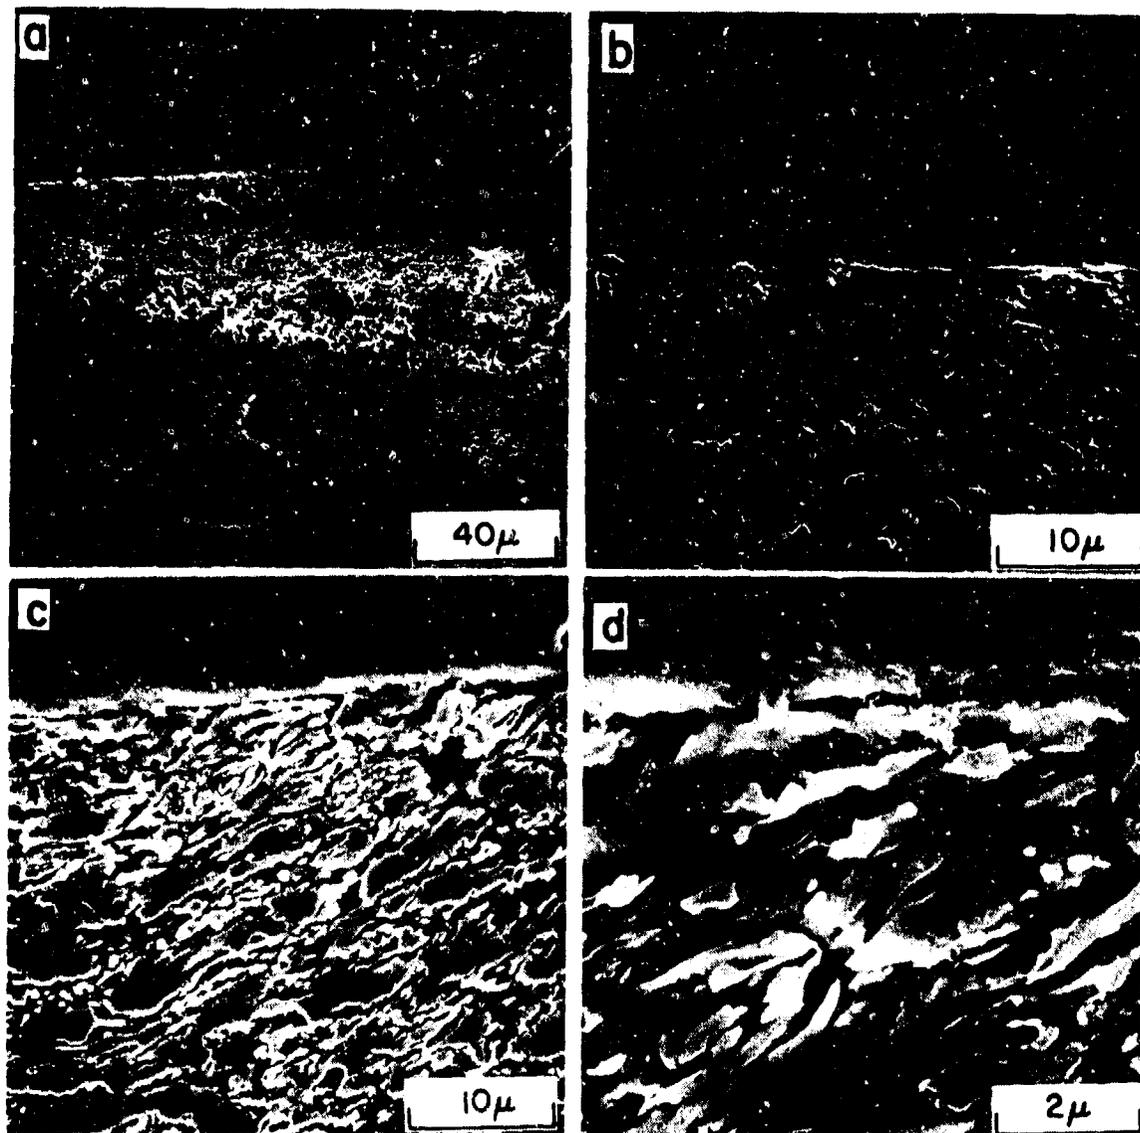
Fig. 65 Scanning electron micrographs of magnified region of tear in Fig. 64.

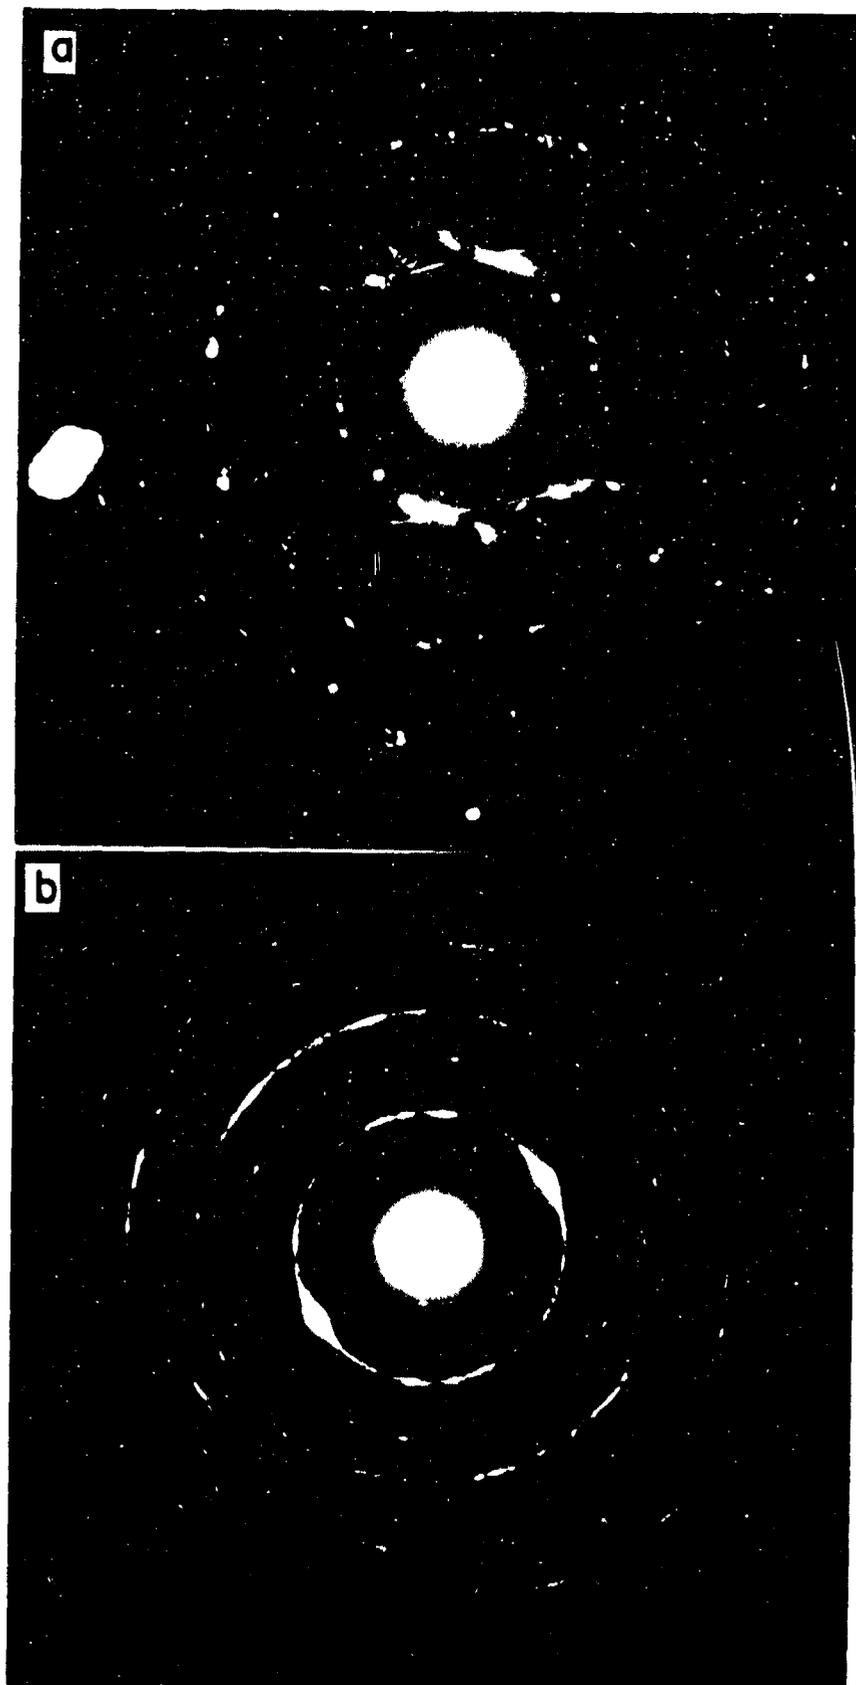
Fig. 68 Electron diffraction patterns: a) of Co at Co/steel interface of specimen BR; b) representative for Cr for specimen BR.

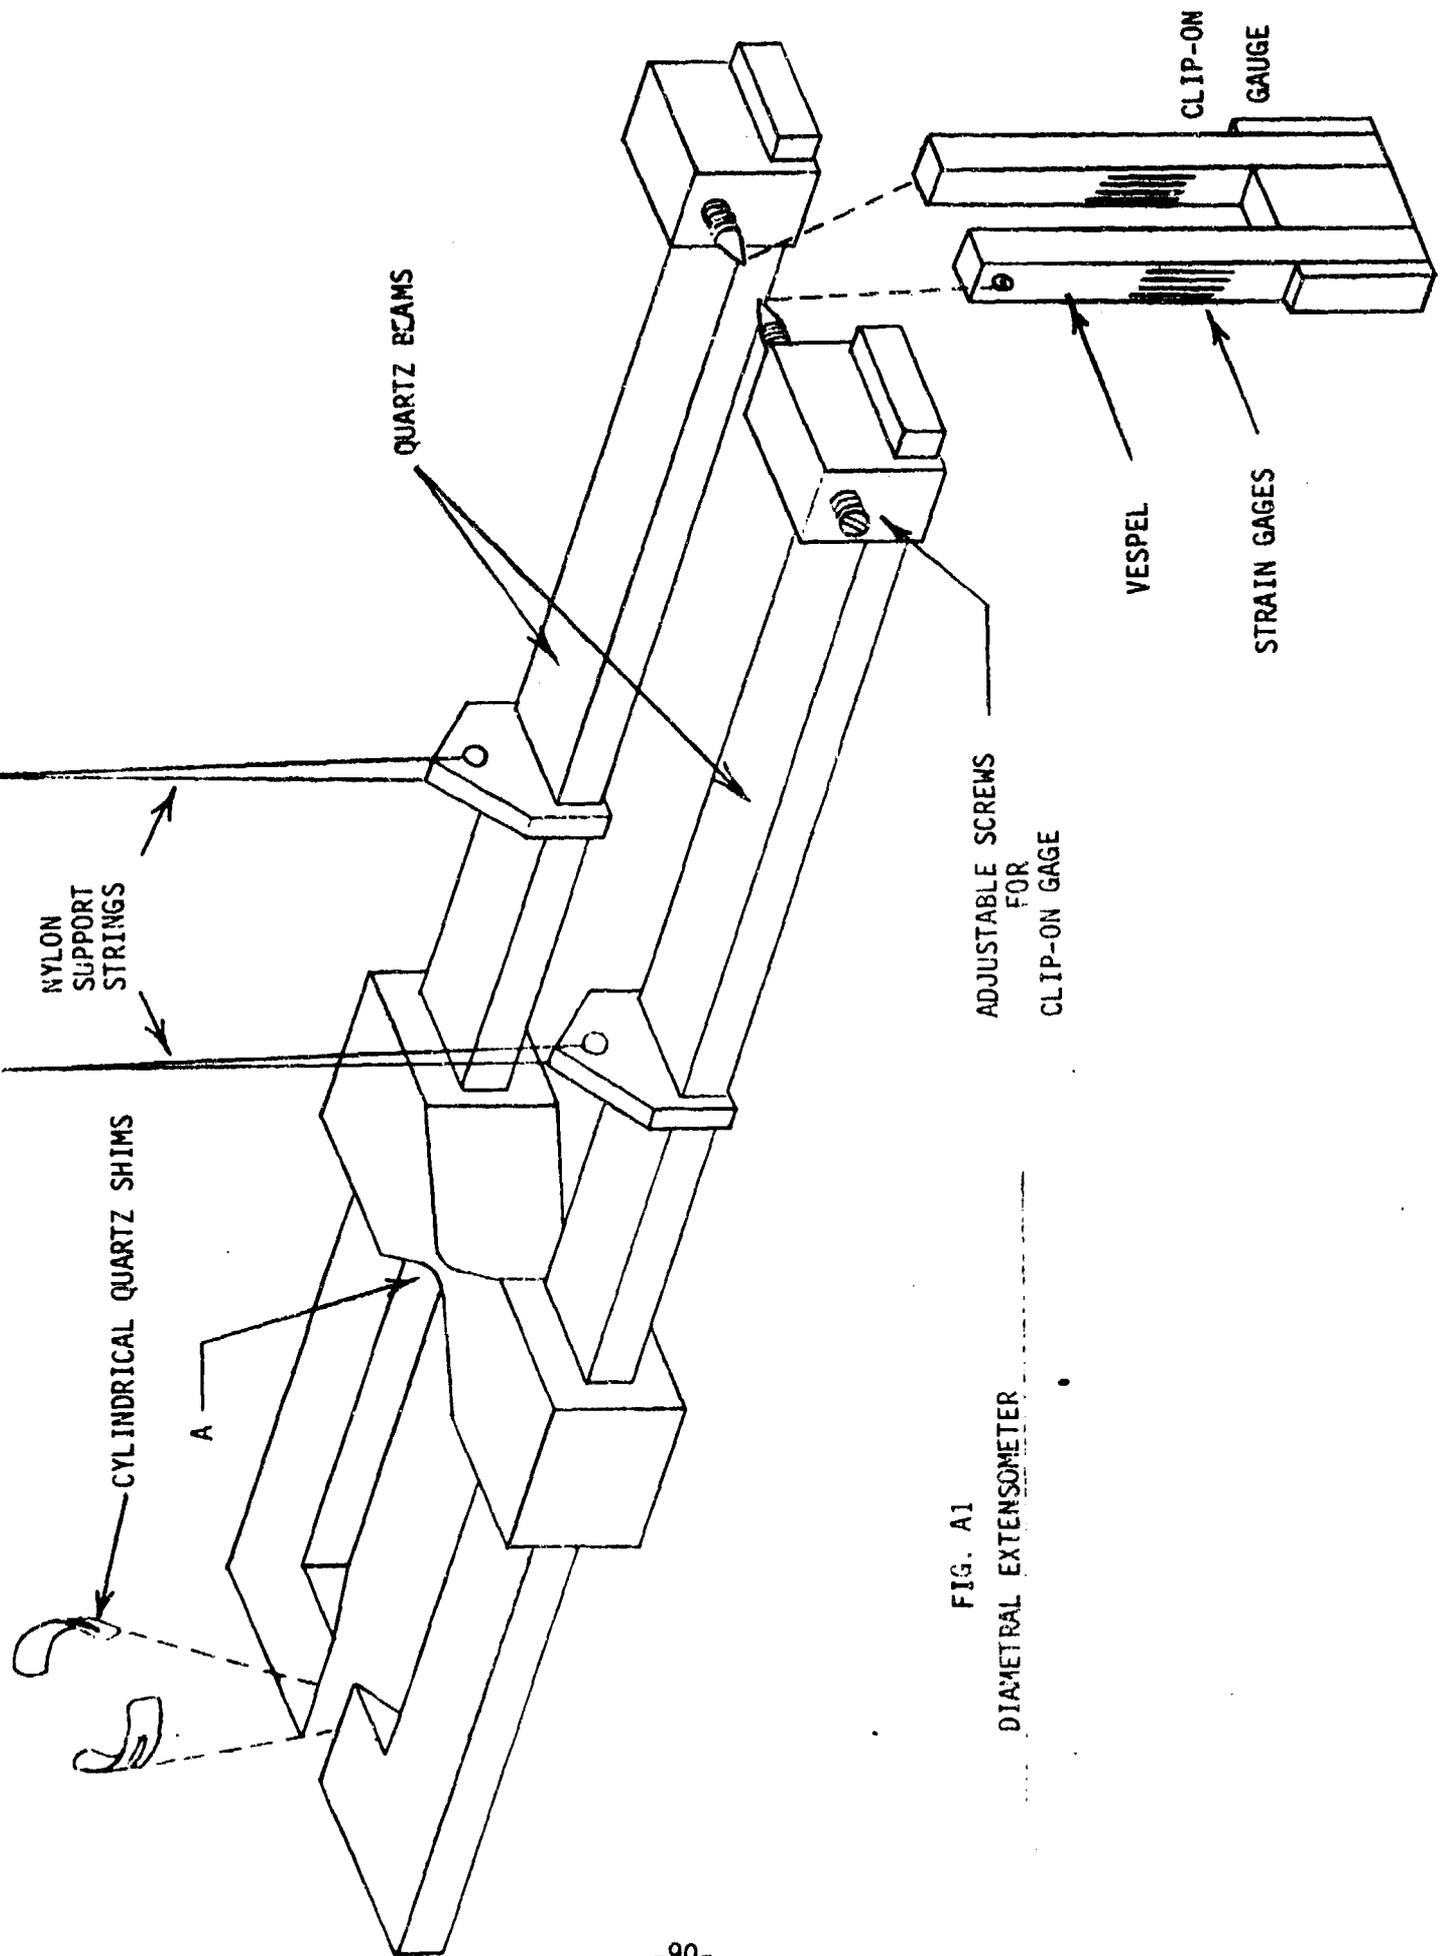
FIG. A1
 DIAMETRAL EXTENSOMETER
