**SPECIAL FRACTOGRAPHIC TECHNIQUES  
FOR FAILURE ANALYSIS**

PREPARED BY  
B.V. WHITESON  
A. PHILLIPS  
R.A. RAWE  
AND  
V. KERLINS  
MATERIALS RESEARCH AND PRODUCTION  
METHODS DEPARTMENT  
MISSILE AND SPACE SYSTEMS DIVISION  
DOUGLAS AIRCRAFT COMPANY

PRESENTED TO  
70TH ANNUAL MEETING OF AMERICAN SOCIETY  
FOR TESTING MATERIALS  
BOSTON, MASSACHUSETTS  
29 JUNE 1967

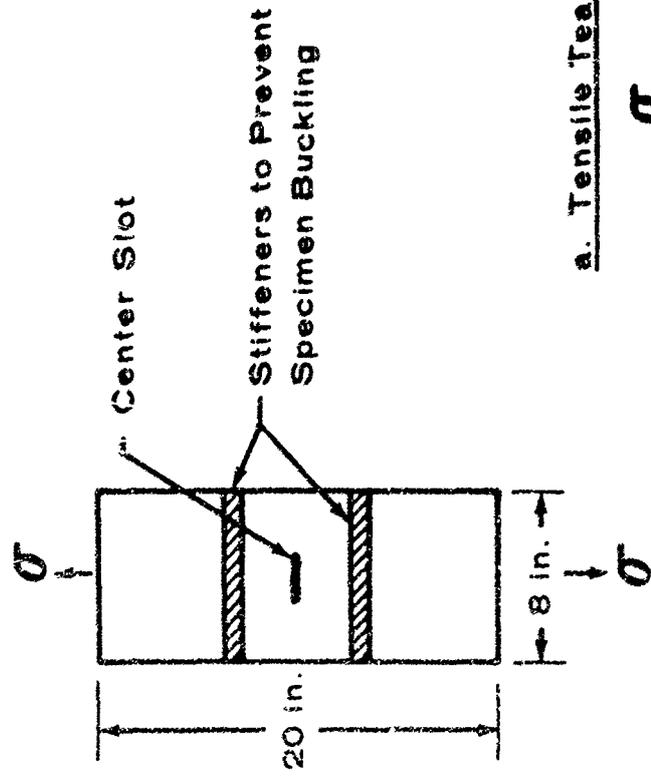
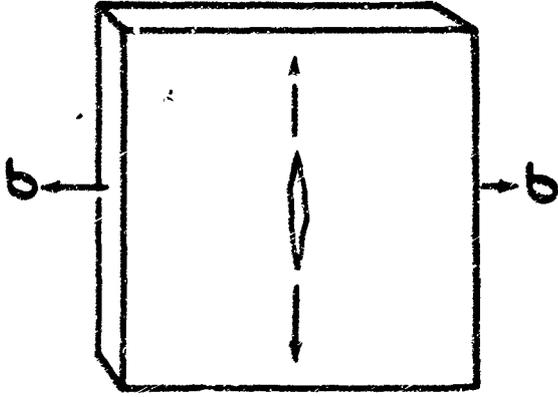
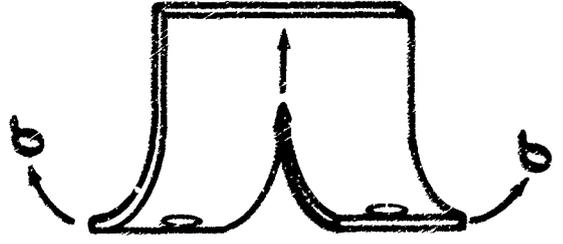
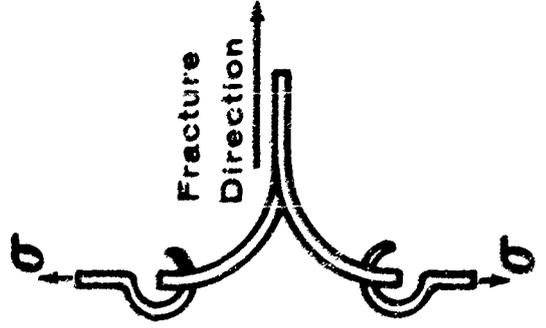
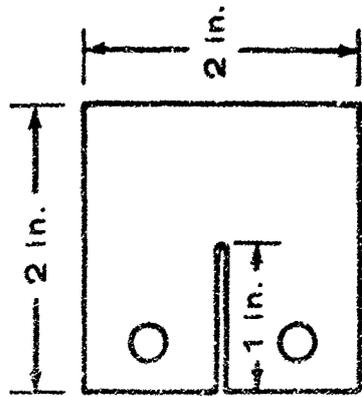
a. Tensile Tear Specimen

b. Combined Tear & Shear Specimen

tear fracture (Figure 1b). All materials failed with fractures that had 100 percent oblique shear, Figure 2, with no areas of plane strain that provided any macroscopic indication of fracture direction.

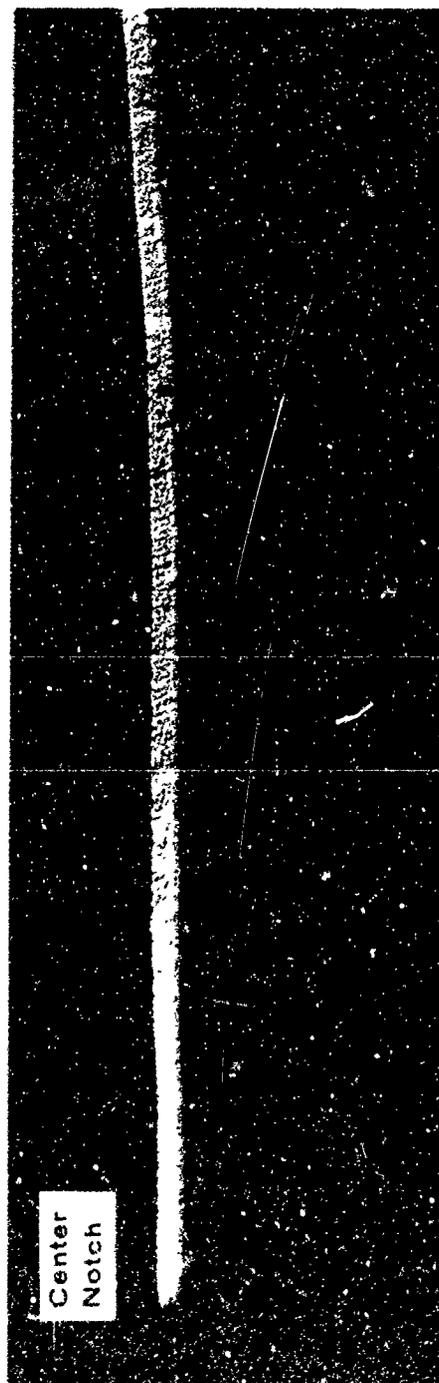
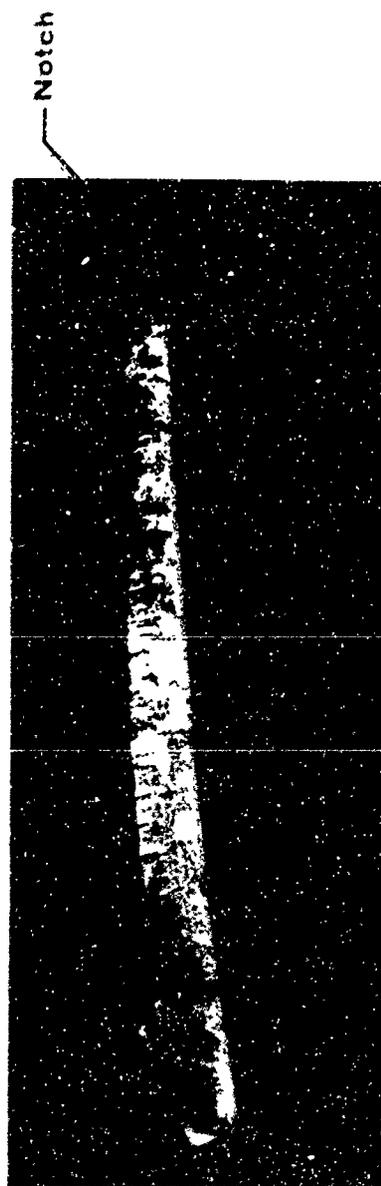
Figure 2. The Appearance of the Fracture Surfaces of Tensile Tear and Tear & Shear Specimens

Tensile Tear Specimen (fracture direction →)

Tear & Shear Specimen (fracture direction →)

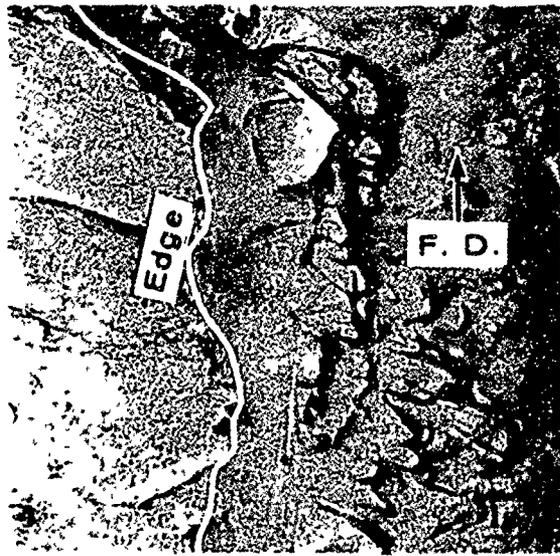
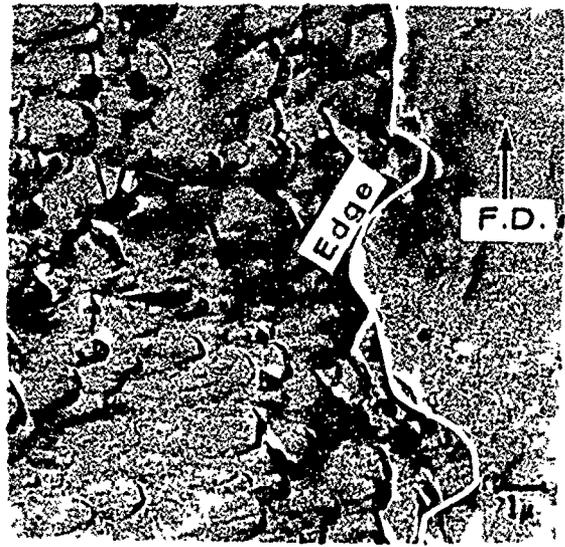
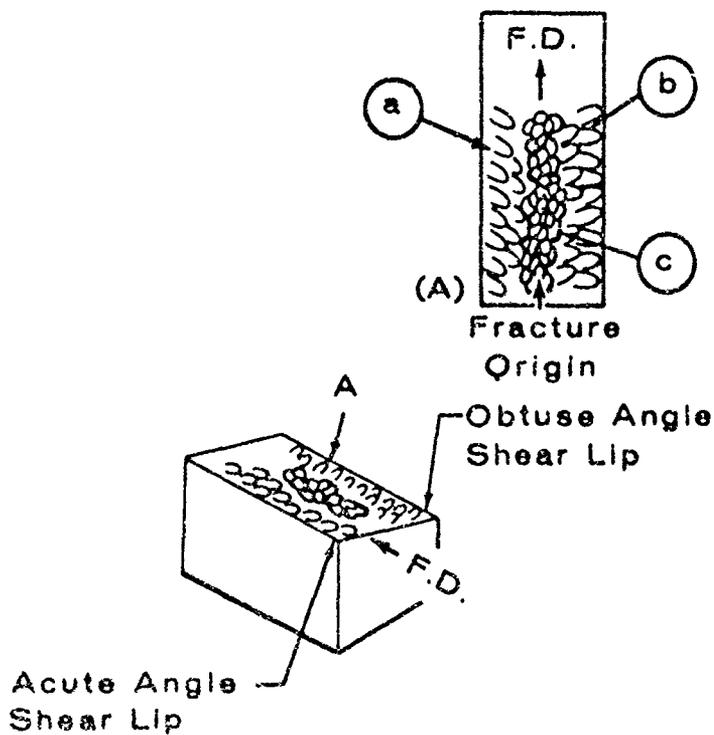
Figure 3. Relationship Between Orientation of Open Dimples Along Fracture Edge and Fracture Direction

(a) Magn. 6200X  
Open Dimples

(b) Magn. 6200X  
Closed Dimples

F.D. = Fracture Direction

(c) Magn 3500X  
Equiaxed Dimples

The basic concept of determining fracture direction that applies to all materials which fail by dimple rupture is illustrated in Figure 3. For all specimens tested, the open elongated dimples (dimples with the open end of their parabolas toward the fracture edge) along the edge of the rupture point back to the fracture origin (Figure 3a). The open dimples occur predominantly on the acute angle shear lip. The closed elongated dimples (dimples with the closed ends of their parabolas toward the fracture edge) along the obtuse angle shear lip and those found in the center of the fracture were usually randomly oriented and could not be used for fracture direction determination (Figure 3b and 3c).

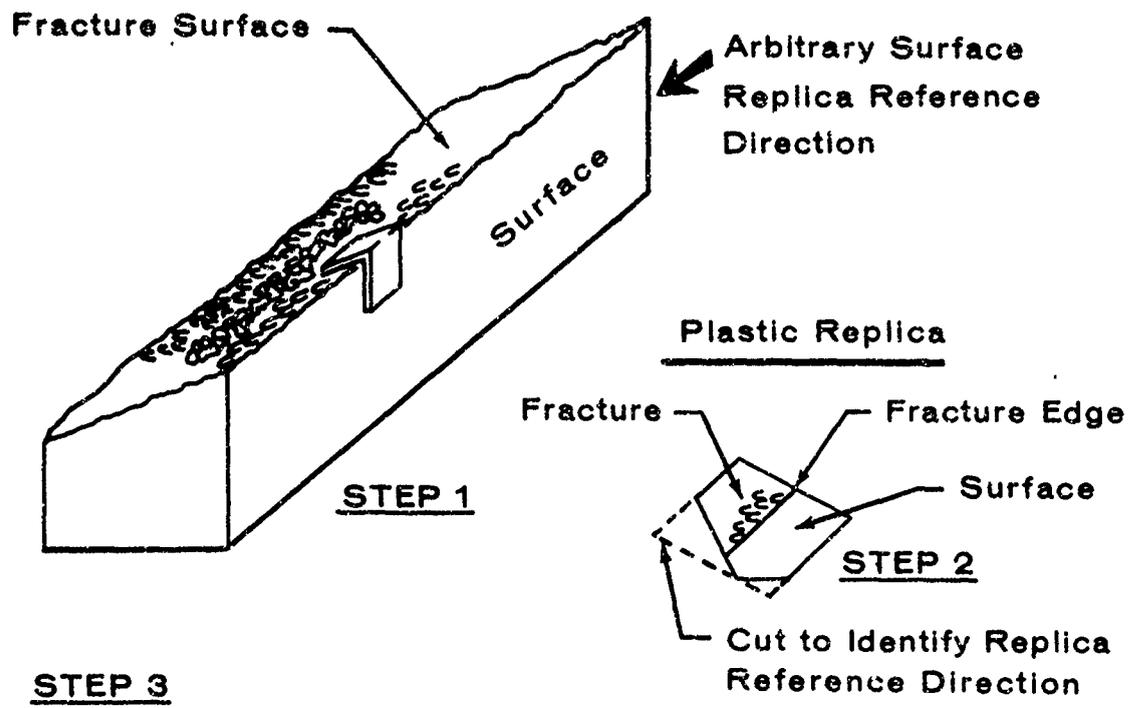
Figure 4. Fracture Direction Replication Technique.

desired orientation. The replica was then placed in the electron microscope so that the replica orientation with respect to the fracture could be maintained in the electron fractograph. The fracture direction was then related back to the actual specimen. The complete technique is illustrated in Figure 4.

The acute angle shear lip was replicated by the plastic-carbon technique<sup>(2)</sup> in such a way as to overlap the edge of the fracture. In order to orient the replica with respect to the fractured specimen, one or both corners of a rectangular replica were cut so as to indicate the

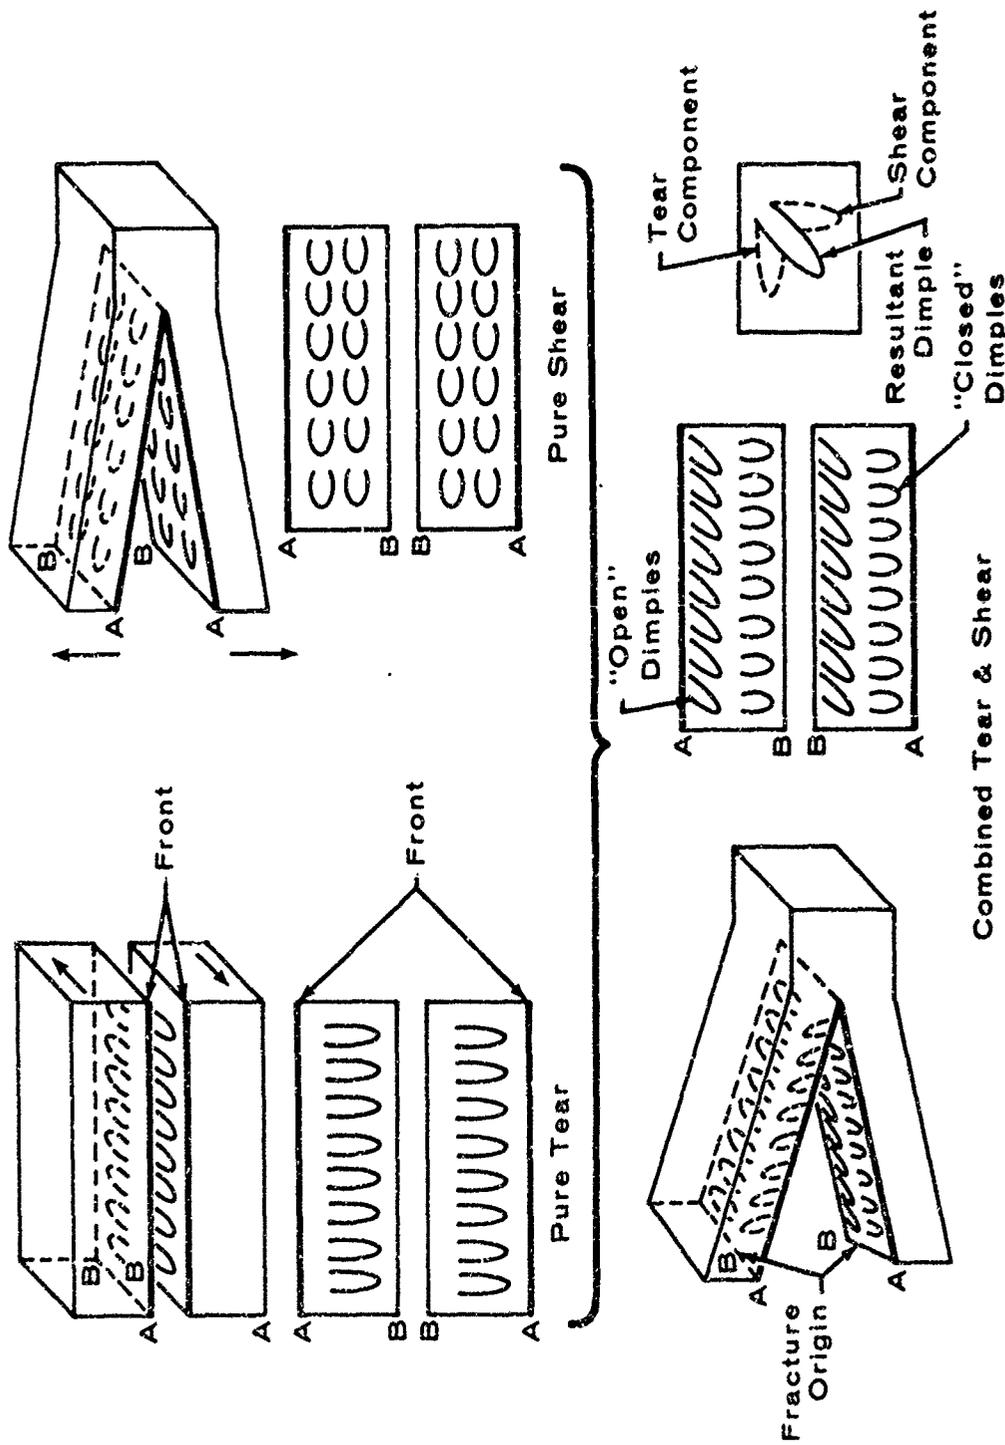
Figure 6. Relationship Between Open Dimple Orientation and Fracture Origin

type of fracture. If a fracture propagates predominantly by a tear mechanism, the elongated dimples would point more strongly in the direction of fracture origin than if it propagated primarily by a shear mechanism. This concept of resultant combined dimples is illustrated in Figure 6.

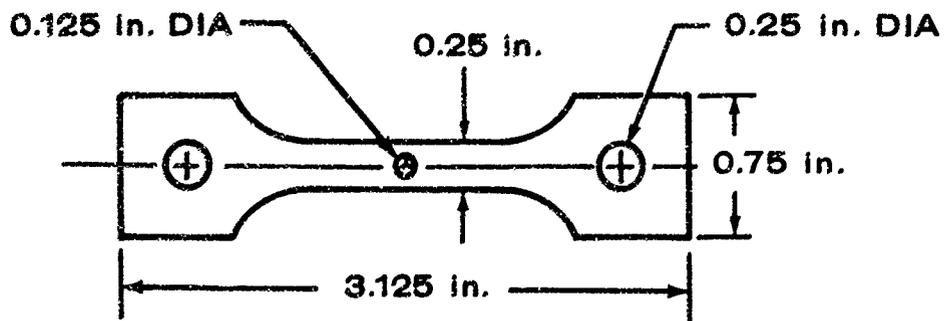
**Figure 7. Configuration of Hydrogen Embrittlement and Stress Corrosion Specimens**

Sustained load tests were conducted to produce failures due to stress corrosion or hydrogen embrittlement. The alloys selected were forged 4340, 4330M and D6AC. The mechanical properties are shown in Table 2. The sustained load specimen configuration is shown in Figure 7.

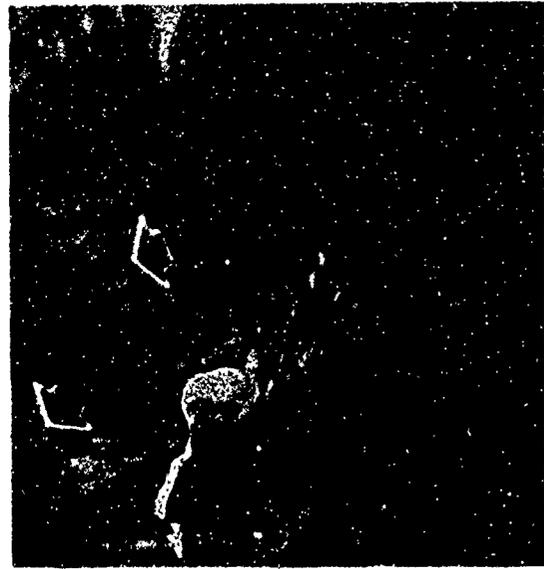
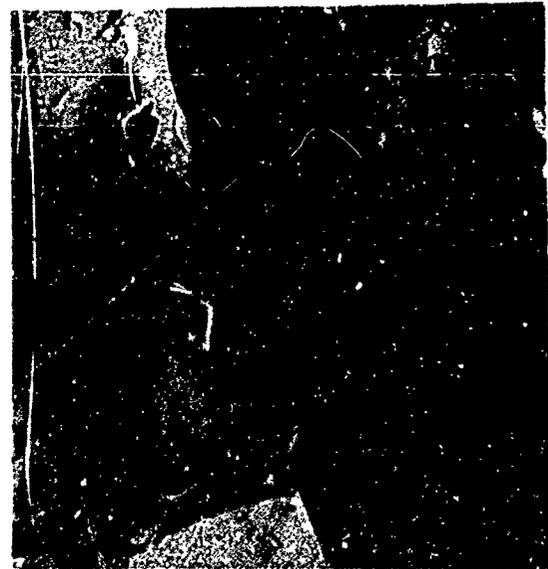
**Figure 10. Typical Electron Fractographs Showing The Distinguishing Features of Stress Corrosion and Hydrogen Embrittlement Magnified 6,500X**

**Stress Corrosion – Corrosion Products (Arrows)**

**Hydrogen Embrittlement – Partial Dimples (Arrows)**

**Stress Corrosion – Secondary Cracks and Crevices (Arrows)**

**Hydrogen Embrittlement - Hairline Indications (Arrows)**

Other features associated with each type of fracture are shown in Figure 10. Stress corrosion usually showed evidence of secondary cracking and corrosion products in the nucleus region. The hairline indications in the intergranular regions and partial dimples which are thought to be associated with the fracturing process are somewhat more distinct in hydrogen embrittlement than in stress corrosion fractures. These subtle differences are illustrated in Figure 11.

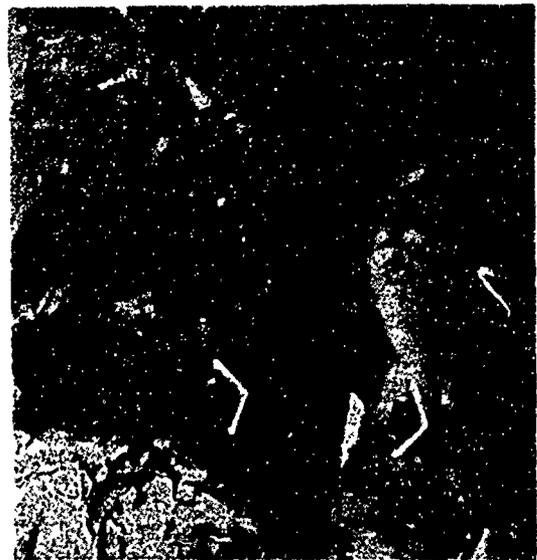
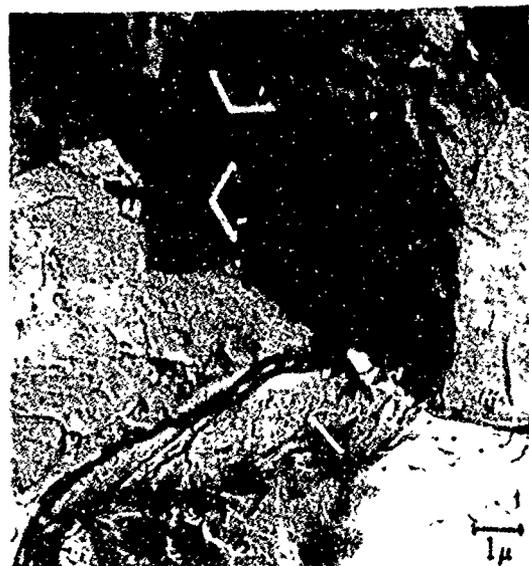
**Figure 11. Illustration of Subtle Differences Between Hairline Indications (Arrows) of Stress Corrosion and Hydrogen Embrittlement Fractures in 4340, 260/280 Steel, Magn. 6500X**

**Hydrogen Embrittlement**

**Stress Corrosion**

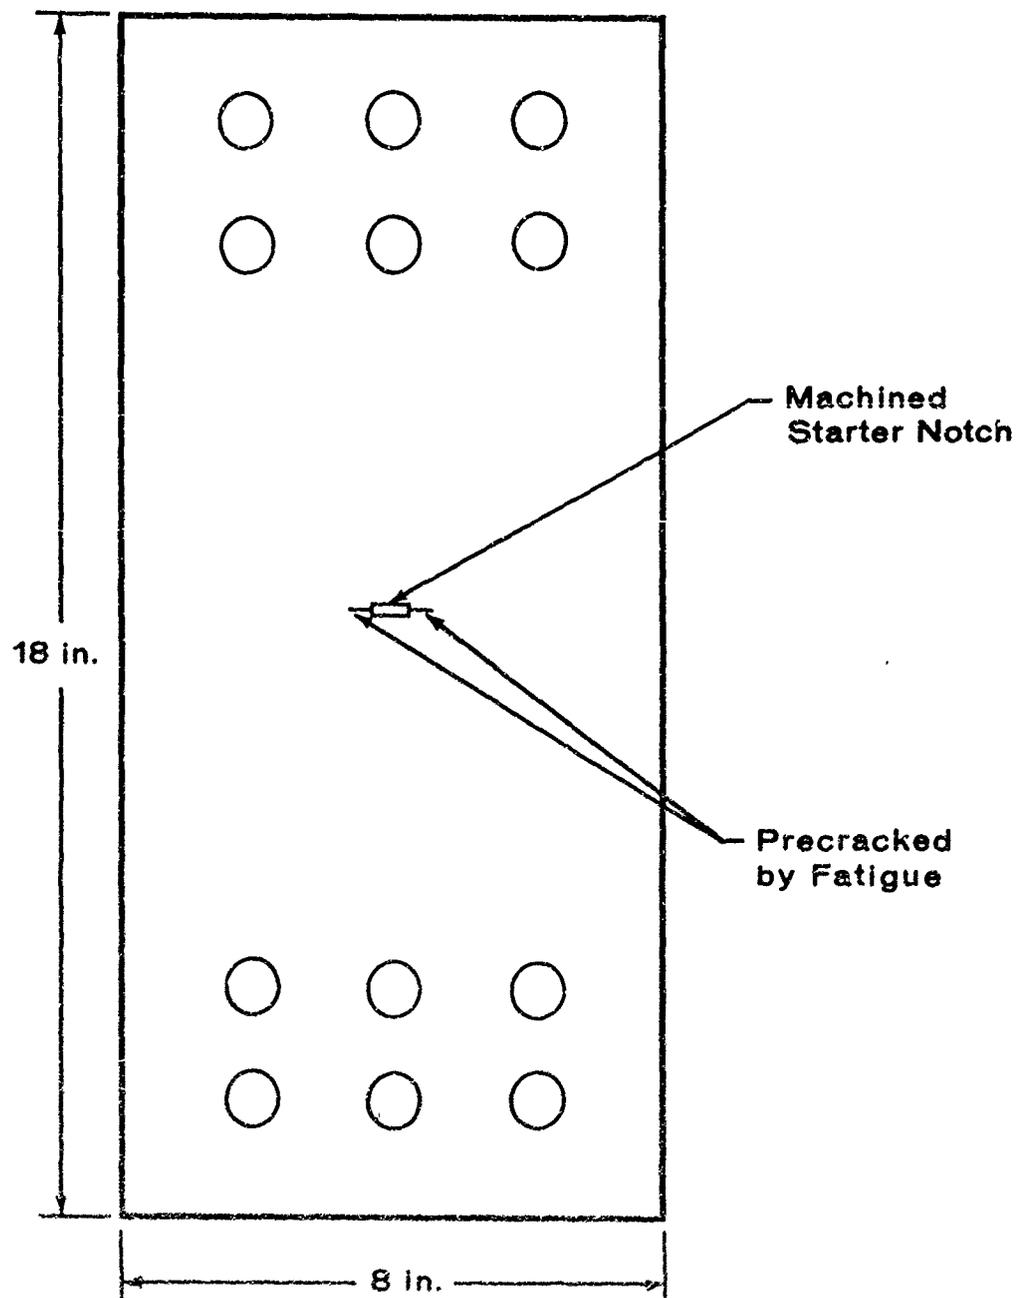
Figure 12. Fatigue Crack Propagation Specimen

Fatigue cracks were developed in 8-in. wide by 18-in. long specimens, centrally slotted and fatigue-precracked, Figure 12. Growth of the fatigue

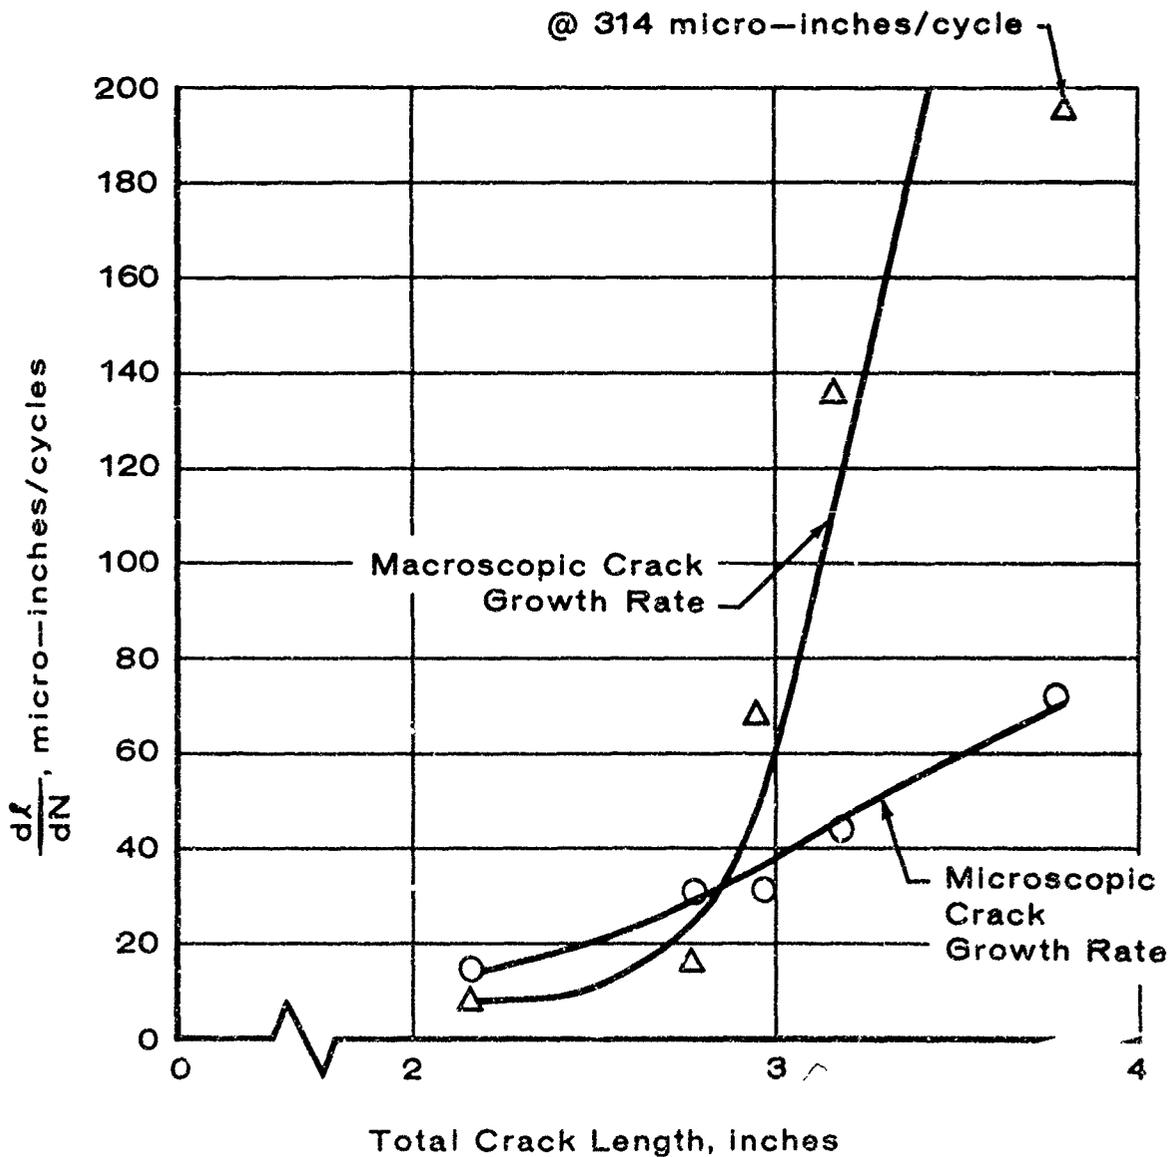
Figure 14. Relationship Between Fatigue Microscopic and Macroscopic Crack Growth Rate

○ Micro Rate |  $\sigma_a = \pm 2.50$  ksi,  
 △ Macro Rate |  $\sigma_m = 13.75$  ksi

Material: 2024-T3  
 Thickness: 0.050 in.  
 Frequency: 1000 cpm

This is illustrated in Figure 14. The first type of behavior is usually observed at relatively low crack growth rates. At higher crack growth rates conditions 1 and 2 are not observed. The large deviation of crack growth rates between the macro and micro rates in condition 3 can be explained by the presence of appreciable dimple rupture along with striation-producing fatigue propagation.

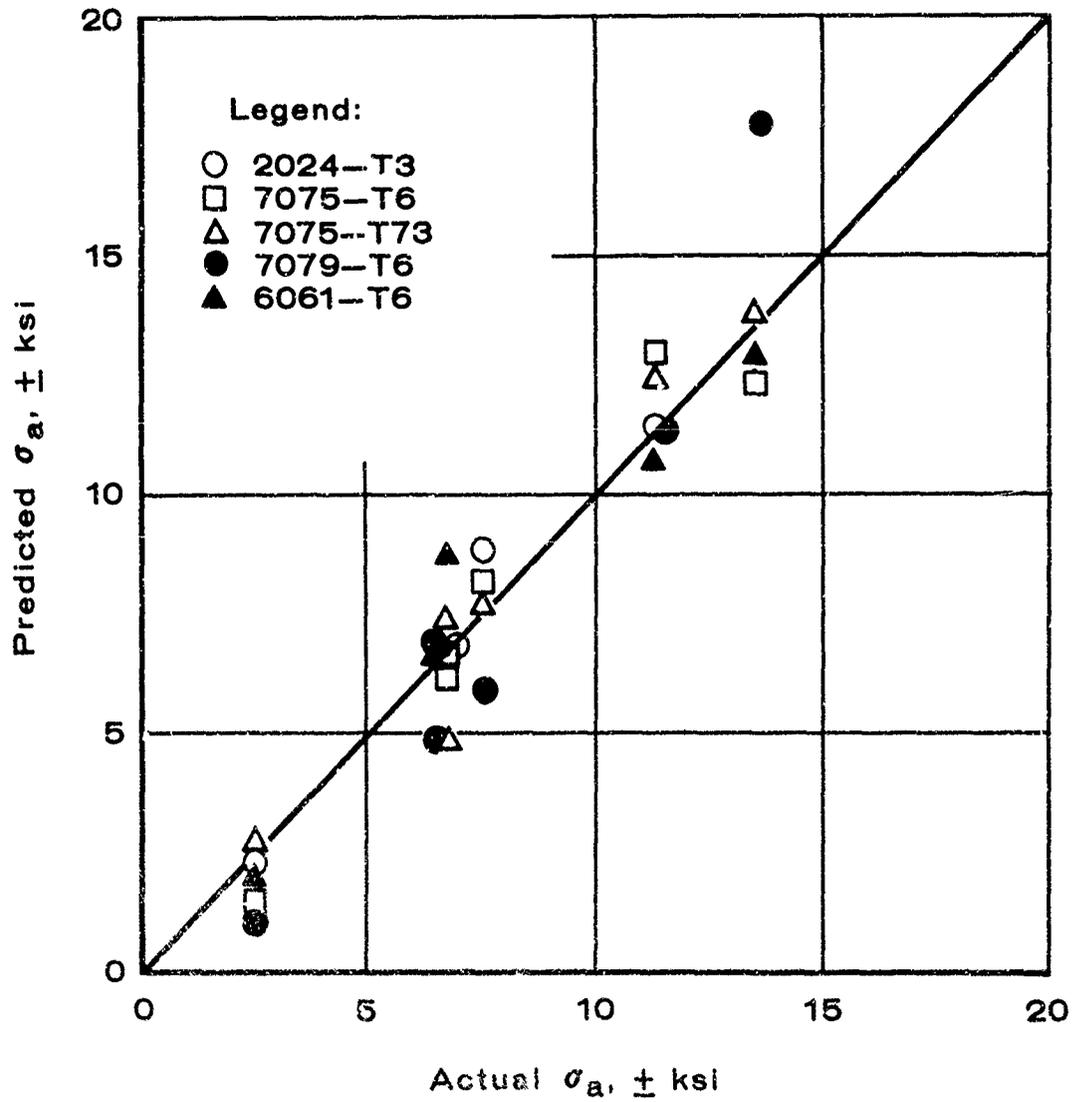
Figure 21. Comparison of Actual and Predicted Alternating Stress for 0.050-in. Thick Panels Fatigue Cracked at 100C cpm

The ability of Eq. 7 to describe the standard fatigue test data is demonstrated in Figure 21. In this figure, the alternating stress predicted by Eq. 7 is plotted versus the actual alternating stress. Each data point in the figure represents the average predicted alternating

stress computed for each striation spacing measurement made in a given test. For most tests, the predicted value of alternating stress is within 1 or 2 ksi of the actual stress.
