IITRI Project J6107  
Final Report

FRAGMENTATION OF REINFORCED CONCRETE SLABS

Subcontract B-70942(4949A-34)-US  
OCD Work Unit 3322B

October 1968

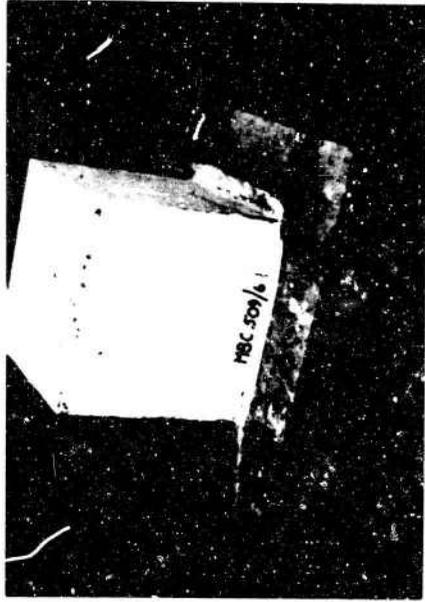
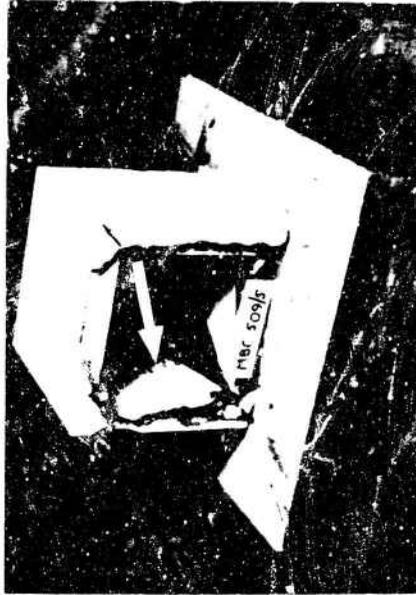
Figure 1 REINFORCED CONCRETE CUBICLES AFTER DYNAMIC LOADING

Remark I: Post-test photographs of R/C cubicles which were subjected to the blast loading are shown in Figure 1. In the case of both the scale model and the full size cubicle, failure was in the nature of the steel fracturing along the diagonals with the resulting petals bending back out of the wind.

Remark II: None of the side walls or roof slabs in the R/C cubicles shown in Figure 1 exhibit any damage.

Remark: Steel failures occurred along the classic "x" static yield line pattern in the front wall of two of the R/C cubicles shown in Figure 1.

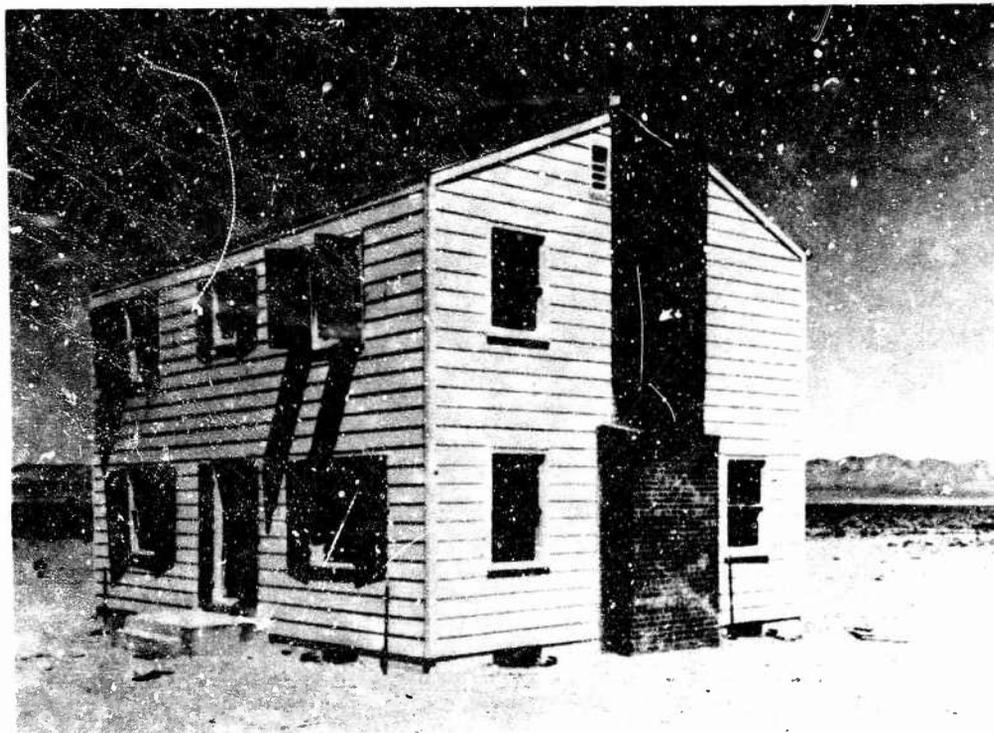
Remark I: Two-story wood-frame houses were exposed to the air blast from a nuclear weapon. A postshot photograph of the exterior of the house at the 2.6 psi overpressure range is shown in Figure 2. The damage to the first floor joists in this house is shown in Figure 3 and the even more severe damage to the first floor joists of a similar house at the 4 psi overpressure range is shown in Figure 4. However, even in the house at the 4 psi range, the second floor showed little damage - thus indicating rapid pressure equalization above and below the floor.

Figure 2 STRENGTHENED WOOD FRAME HOUSE AFTER EXPOSURE  
TO 2.6 PSI OVERPRESSURE

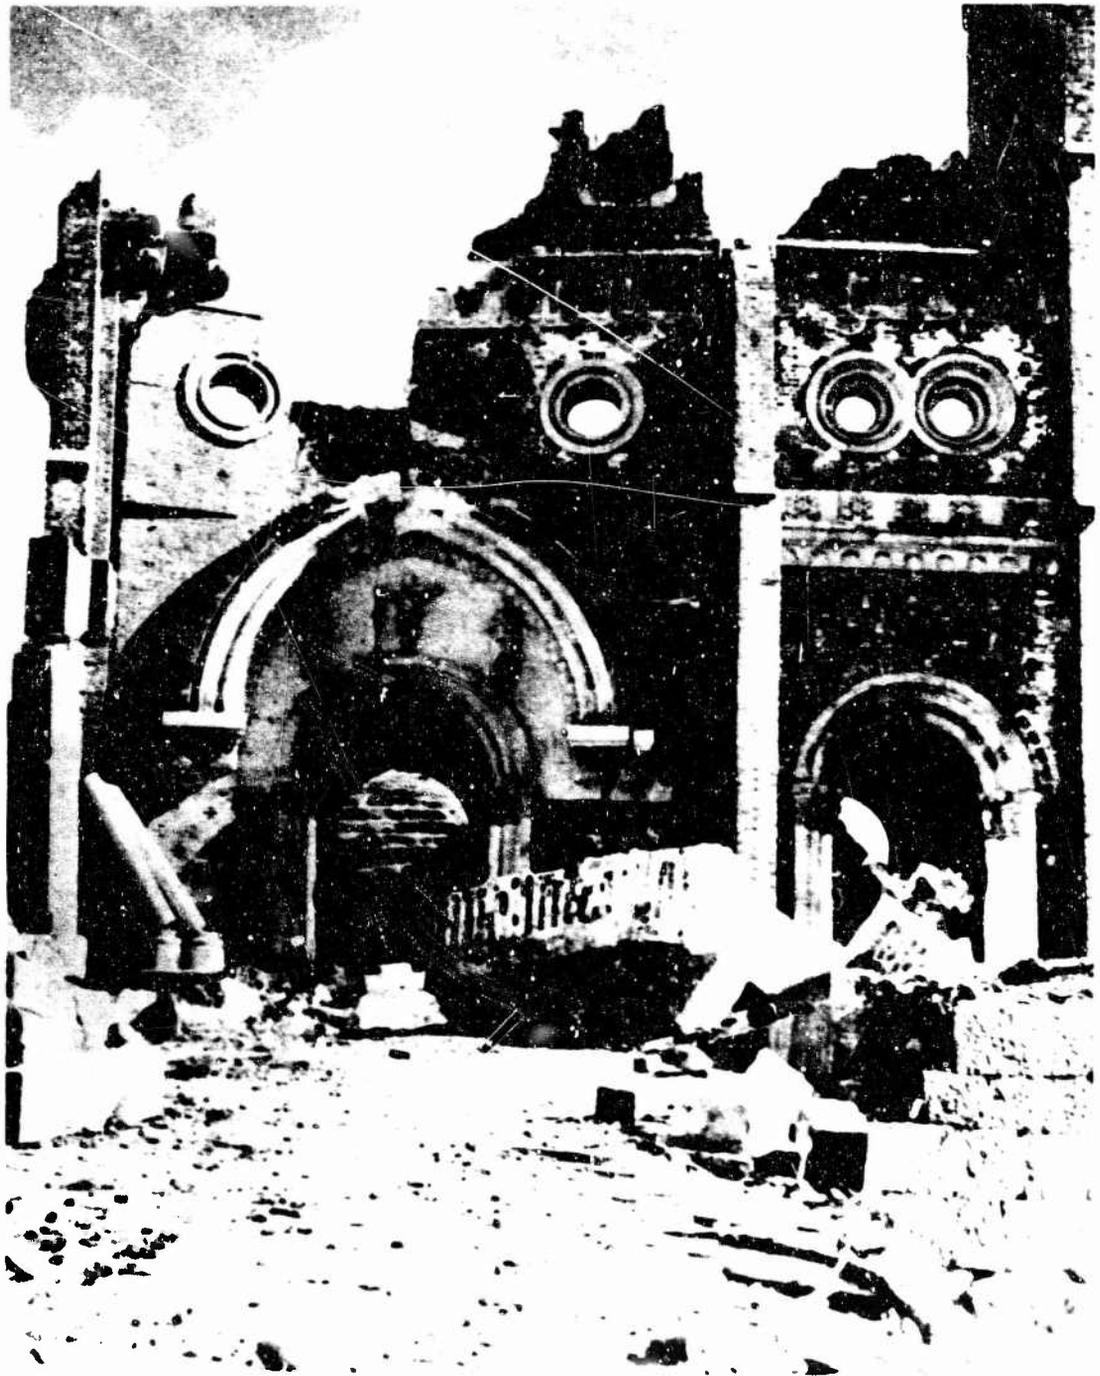
Figure 8 HEAVY WALL BEARING STRUCTURE LOCATED 0.34 MI  
FROM GROUND ZERO AT NAGASAKI

We anticipate that potential primary fragments will have dimensions of the same order of magnitude as the full size slab. To get some idea of the response of such large fragments we can examine the structures shown in Figures 8, 9 and 10. The first of these shows a massive section of wall that was dislodged from the structure at a height of 60 to 70 ft. We estimate that the fragment was transported 14 ft horizontally. The structure was located at a distance of 0.34 miles from ground zero. The photographs shown in Figures 9 and 10 show two engine lathes weighing 7000 and 12,000 lb respectively. The small lathe displaced about 7 ft under a 10 psi overpressure; the large lathe, with a ballistic coefficient about 7 times greater, did not move from its anchors. As a final example, primary fragments have been produced from the brick chimneys of the two houses shown in Figures 11 and 12. In both cases, the final position of the primary fragments was in the immediate vicinity of the base of the chimney.

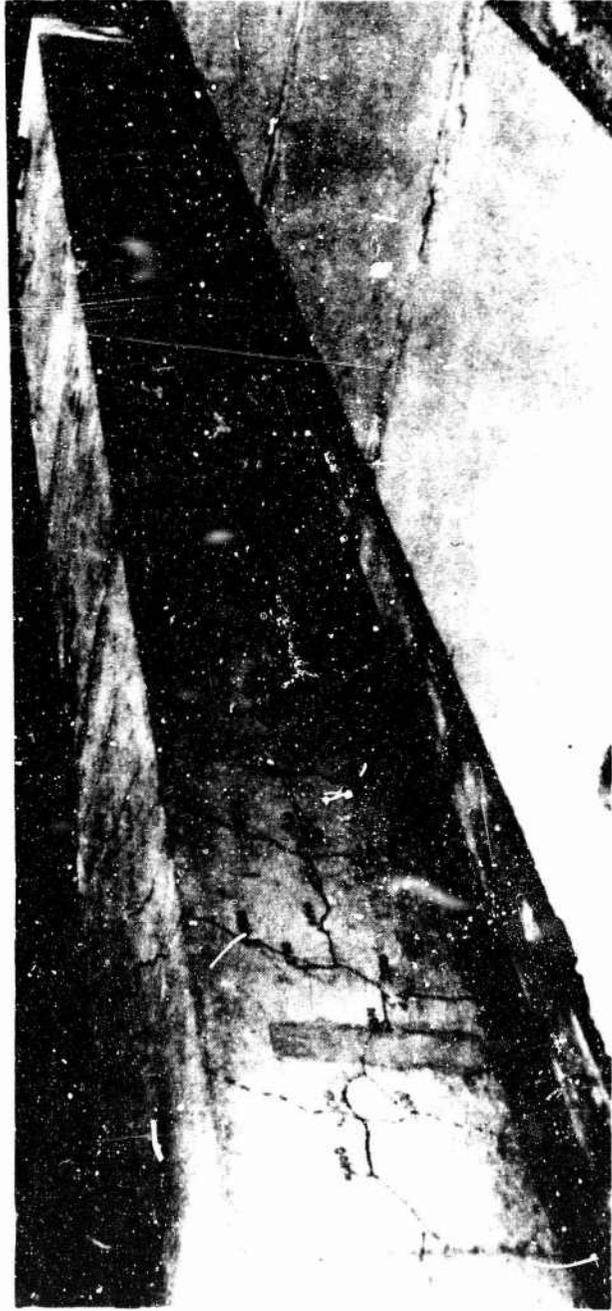
Studies directed principally to the fragmentation of R/C slabs are almost nonexistent and, for this reason, we have chosen to examine the byproducts of investigations concerned with the analysis and design of conventional and blast resistant R/C structures. The most frustrating problem encountered in this approach is that the previous investigators were not motivated to report findings which are relevant to fragmentation. Also, most experimental work is confined to beams. Finally, these programs are generally concerned with only the range of behavior up to severe cracking. Unlike the homogeneous concrete bending members, this cracking is a necessary but not sufficient condition for the production of primary fragments. Indeed, tension cracks are always present in a R/C bending member under working loads; they become visible in great profusion under higher loads as shown in Figure 14.

Figure 14 LONGITUDINAL CRACKING OVER CONSTANT MOMENT LENGTH (MIDDLE THIRD)  
WITH SINGLE REINFORCING BAR

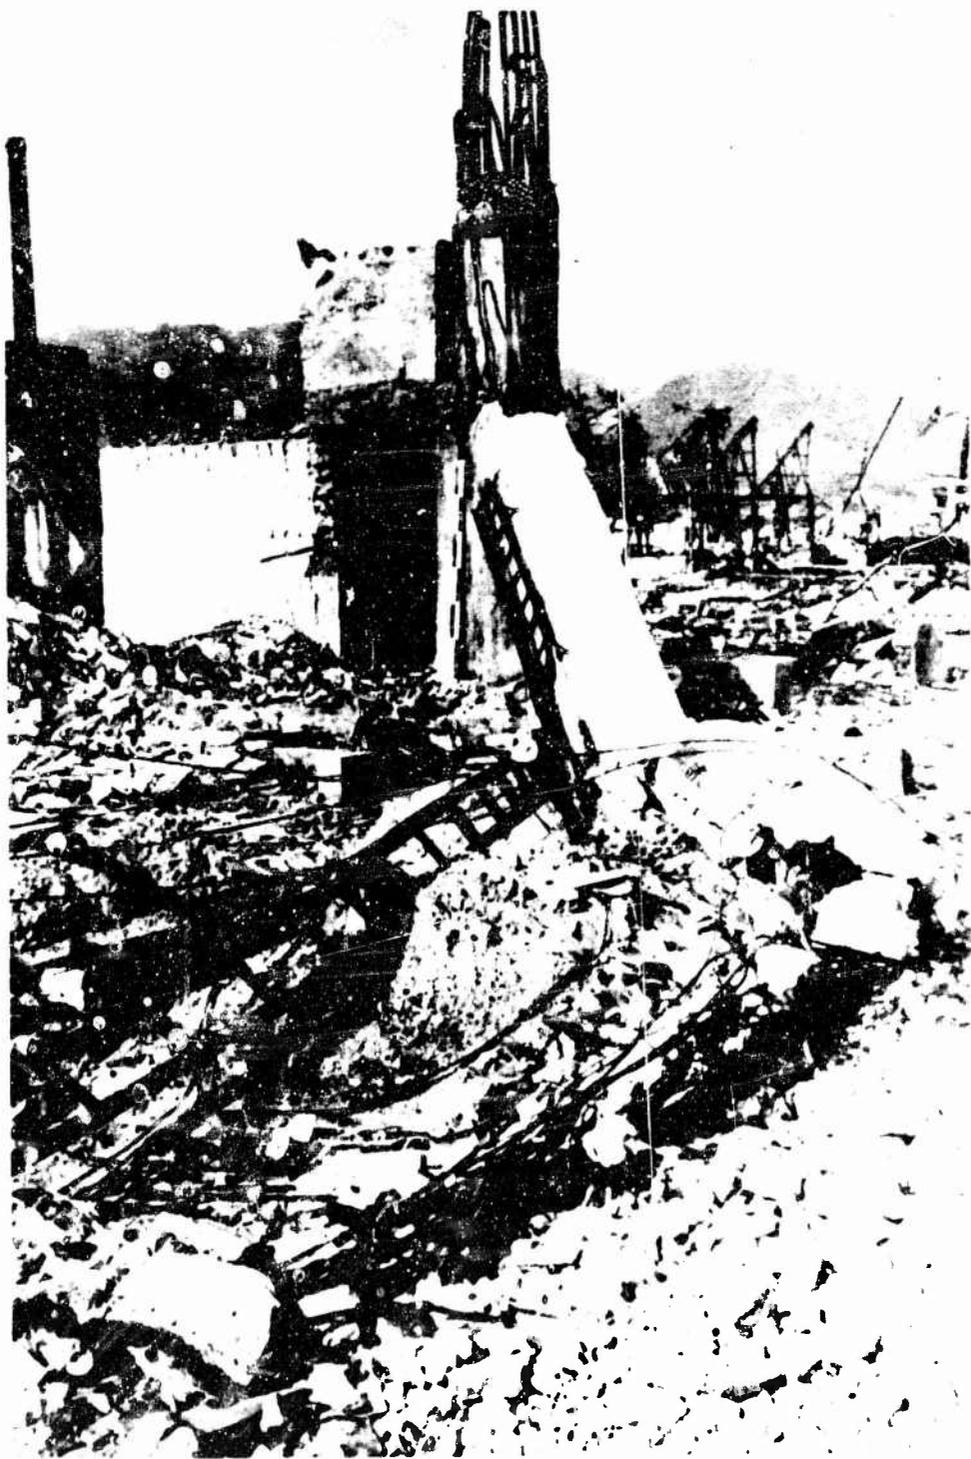
Remark III: A circular 60-ft high R/C stack located 0.34 mile from ground zero at Hiroshima was very severely damaged by the blast wave. Referring to Figure 17, it is observed that the stack remained intact up to a height of 15 ft above the base. The top 45 ft has been toppled over and now consists of two relatively intact sections and the top section which has been completely pulverized. The reinforcing rods continue to link all the major fragments together. The top section of the stack where the steel is completely exposed probably was denuded when that section impacted the ground.

Figure 17 CIRCULAR 60-FT HIGH R/C STACK LOCATED 0.34 MI  
FROM GROUND ZERO AT HIROSHIMA

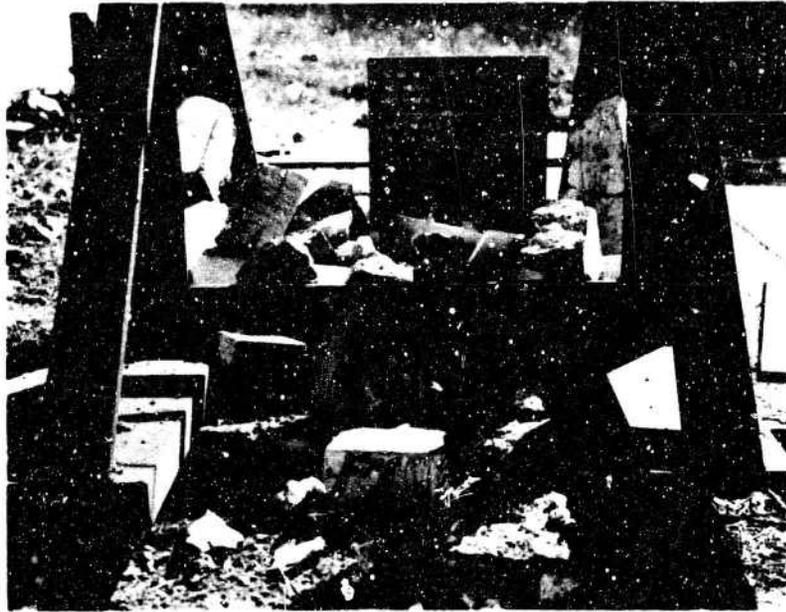
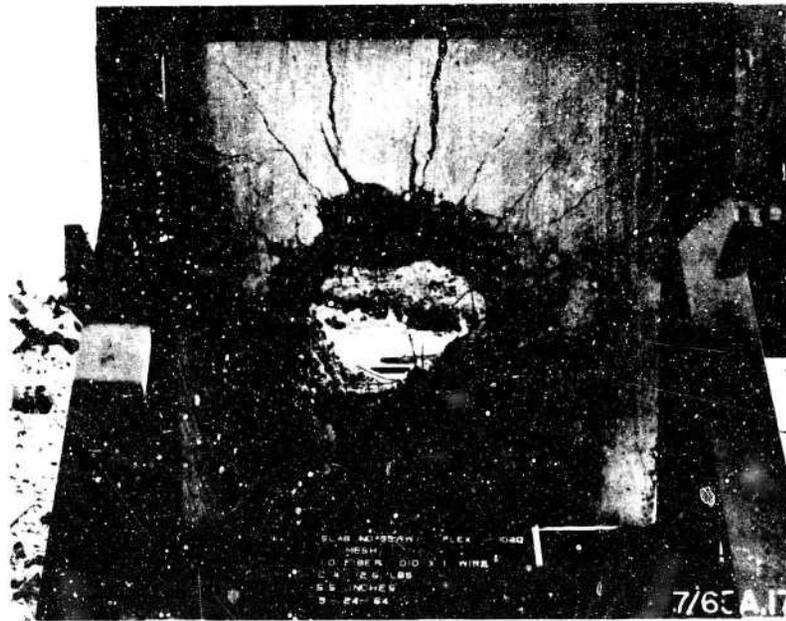
Figure 20 EFFECT OF WIRE REINFORCEMENT ON TENACITY OF CONCRETE SLABS EXPOSED TO HIGH EXPLOSIVE LOADINGS

a) Plain Concrete Slab After Testing with High Explosive

b) Wire-Reinforced Concrete Slab After Testing with High Explosive, 1 percent, 0.010 in., 1 in. Lengths

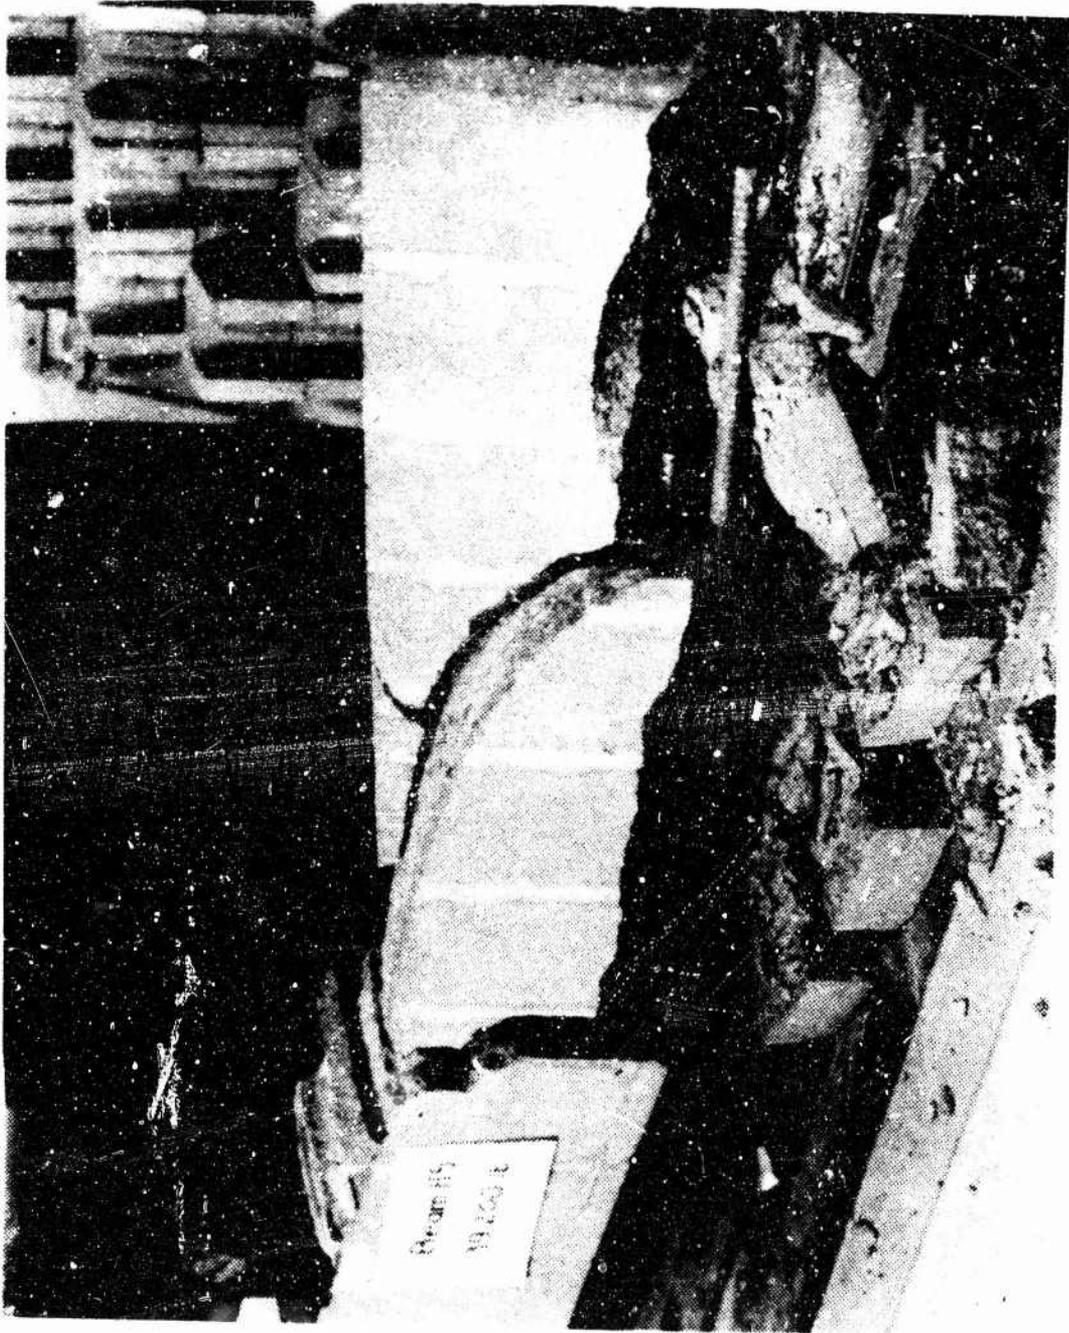
Remark: The response of the R/C block beam shown in Figure 21, is typical of most monolithic R/C beam behavior under either static or impact loading. Yielding of the bars is not uncommon and it is usually followed by horizontal cracking which tends to expose portions of the tension steel by stripping away the concrete from the tension face of the beam. Literally no beam tests were encountered where fracture took place in the reinforcement. The literature survey included all of the issues of the Journal of the American Concrete Institute from 1955 through 1967.

Figure 21 PRIMARY YIELD FAILURE OF A R/C BLOCK BEAM WITH SECONDARY  
SHEAR FAILURE THROUGH CONCRETE FILL AND MASONRY

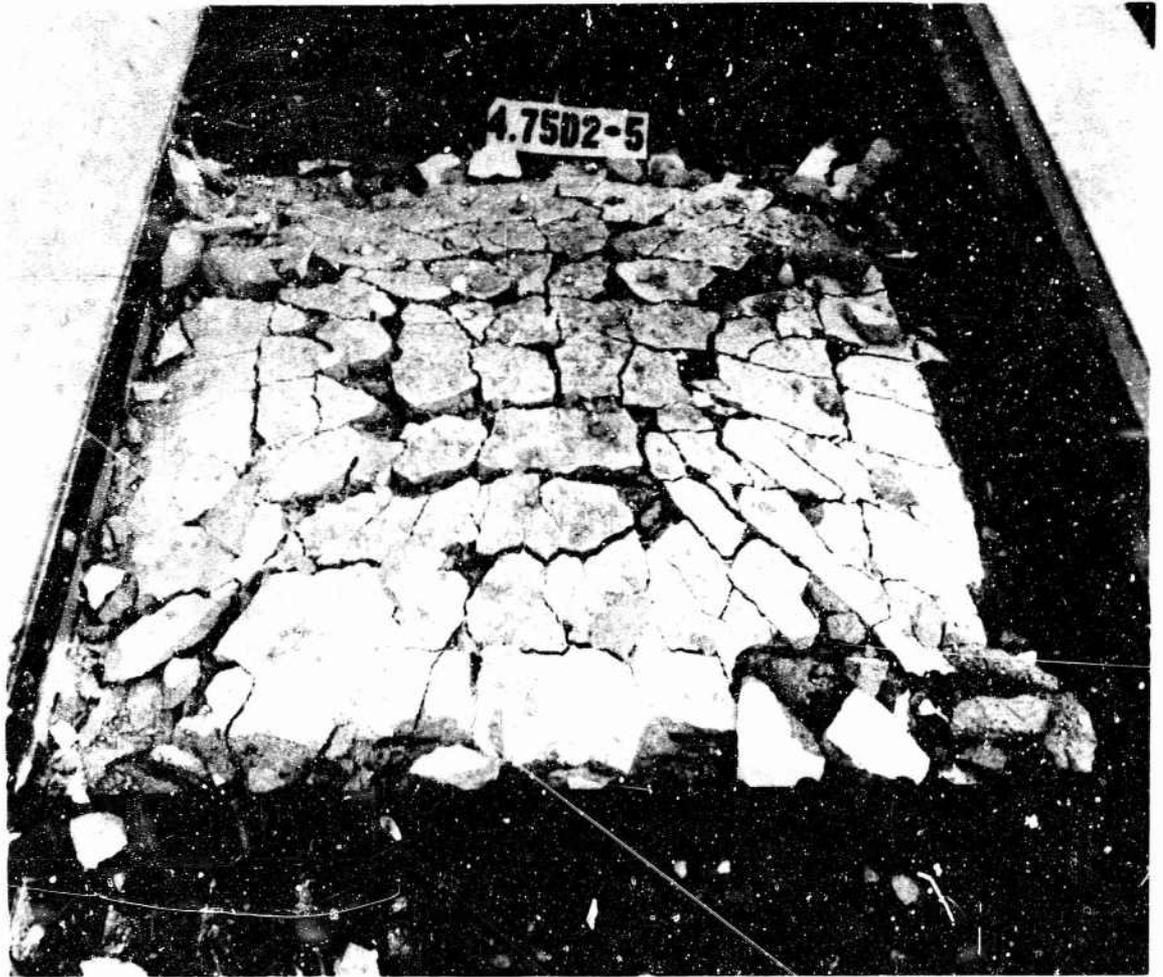
**Remark:** The slab shown in Figure 23 has fixed edges which are laterally restrained. The member is typical of a series of R/C slabs which have been tested under uniform dynamic pressures as high as 120 psi. Although none of the reinforcing bars were fractured in the slab shown, necking down and fracturing occurred with some regularity near the edges of the slabs. In the most extreme case, such fracturing occurred in all the bars along two adjacent edges; however, primary fragments did not form because the slab segments were held together by the bars which remained attached to the intact edges.

When slabs exhibited large deflections (two to three times the slab thickness), their resistance was almost entirely due to tensile membrane action. In a few cases this tension caused some of the reinforcing bars to fracture in midspan. No primary fragments were obtained in the test series.

Figure 23 SLAB WITH EDGES FIXED AND LATERALLY RESTRAINED/  
DYNAMIC PRESSURE LOAD OF 101 PSI

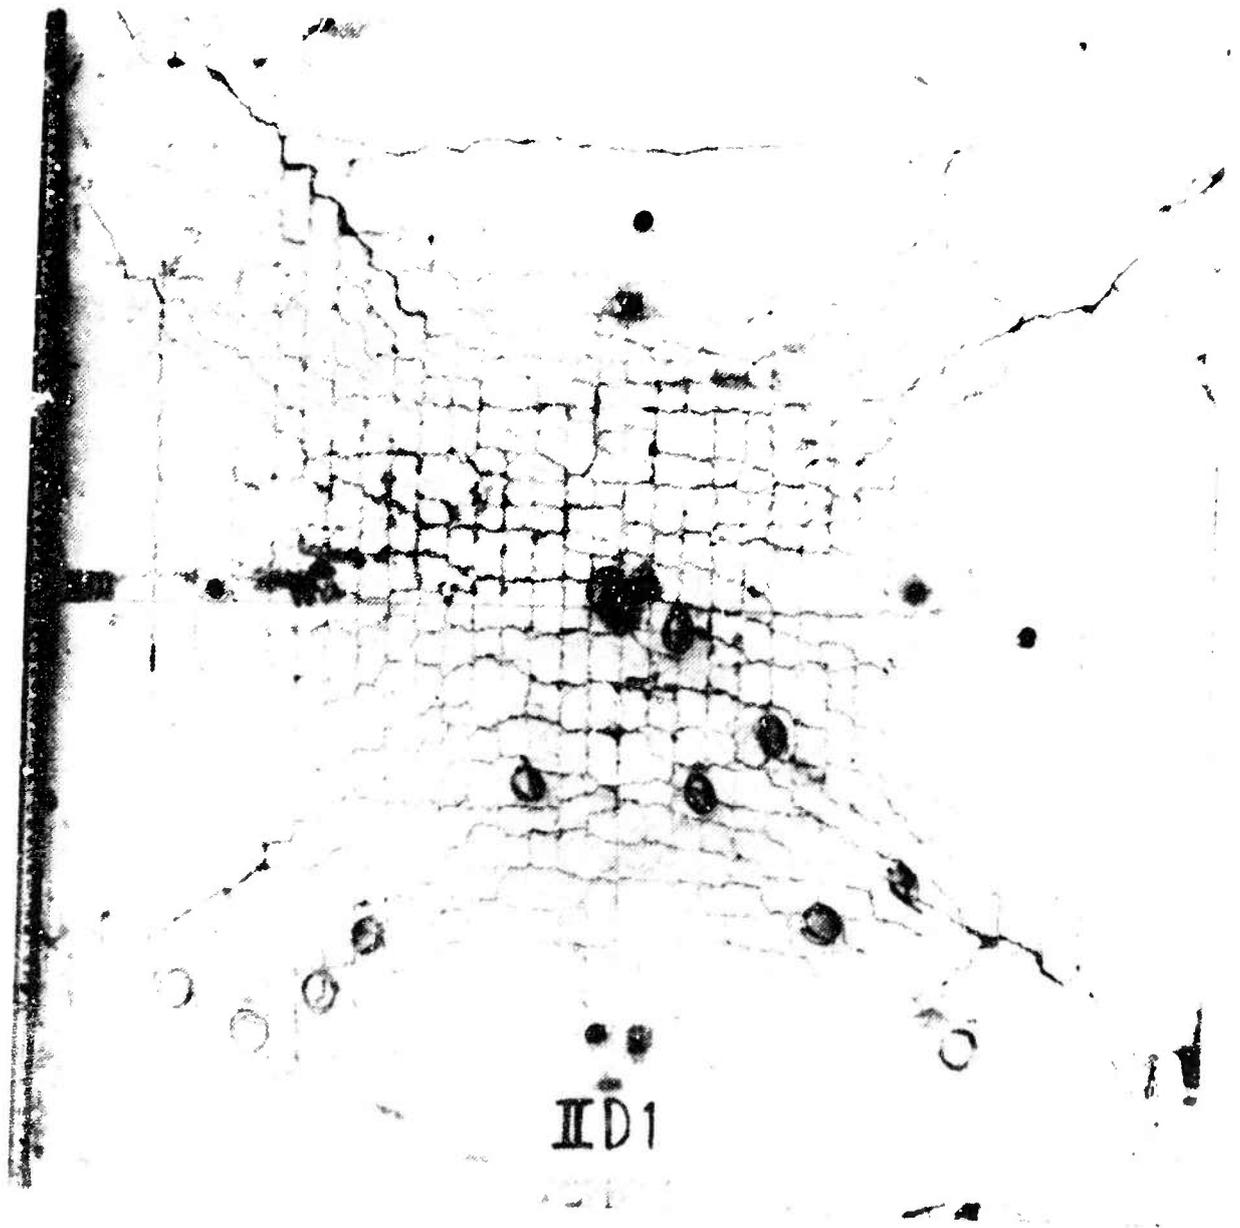
Figure 27 TENSION SURFACE OF R/C SLAB WITH 1.0 PERCENT STEEL  
SUBJECTED TO 12.5 PSI OVERPRESSURE

To complete our account of cracking we recall that a wedging action is associated with the "pull out" motion of a deformed reinforcing bar. Where the steel stress is sufficiently high, this action manifests itself in a surface crack which occurs in the slab face directly above the reinforcing bars. Such cracking is discussed in Case 18 and the resulting crack pattern is clearly illustrated in Figures 27 and 36. This effect was also exhibited in Keevan's Study which is described in Case 10.

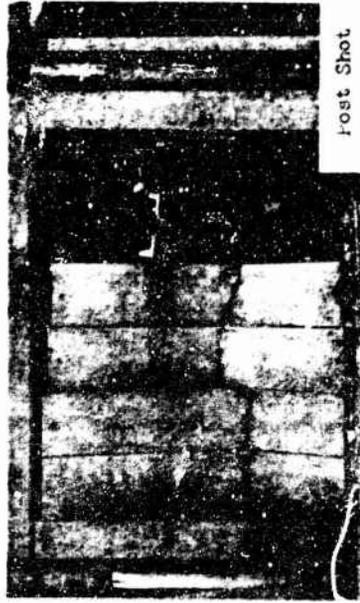
Figure 30 PRESHOT AND POSTSHOT PHOTOGRAPHS OF PRECAST R/C CHANNEL  
SLAB REAR WALL AT 7.5 PSI OVERPRESSURE RANGE

Remark: A rear wall consisting of precast R/C channel slabs was tested at the 7.5 psi overpressure range. Due to construction details, these slabs may be considered to have been simply supported along the top and bottom edges. Figure 30 reveals the extent of the damage sustained by this wall panel. All of the channel slabs were damaged with the maximum severity occurring in the center of the wall panel. The photograph of the interior of the test cell reveals that the flange reinforcing bars were separated from the channel slabs and that the permanent maximum deflections were considerable. This allowed some of the slabs to pull off their supports.

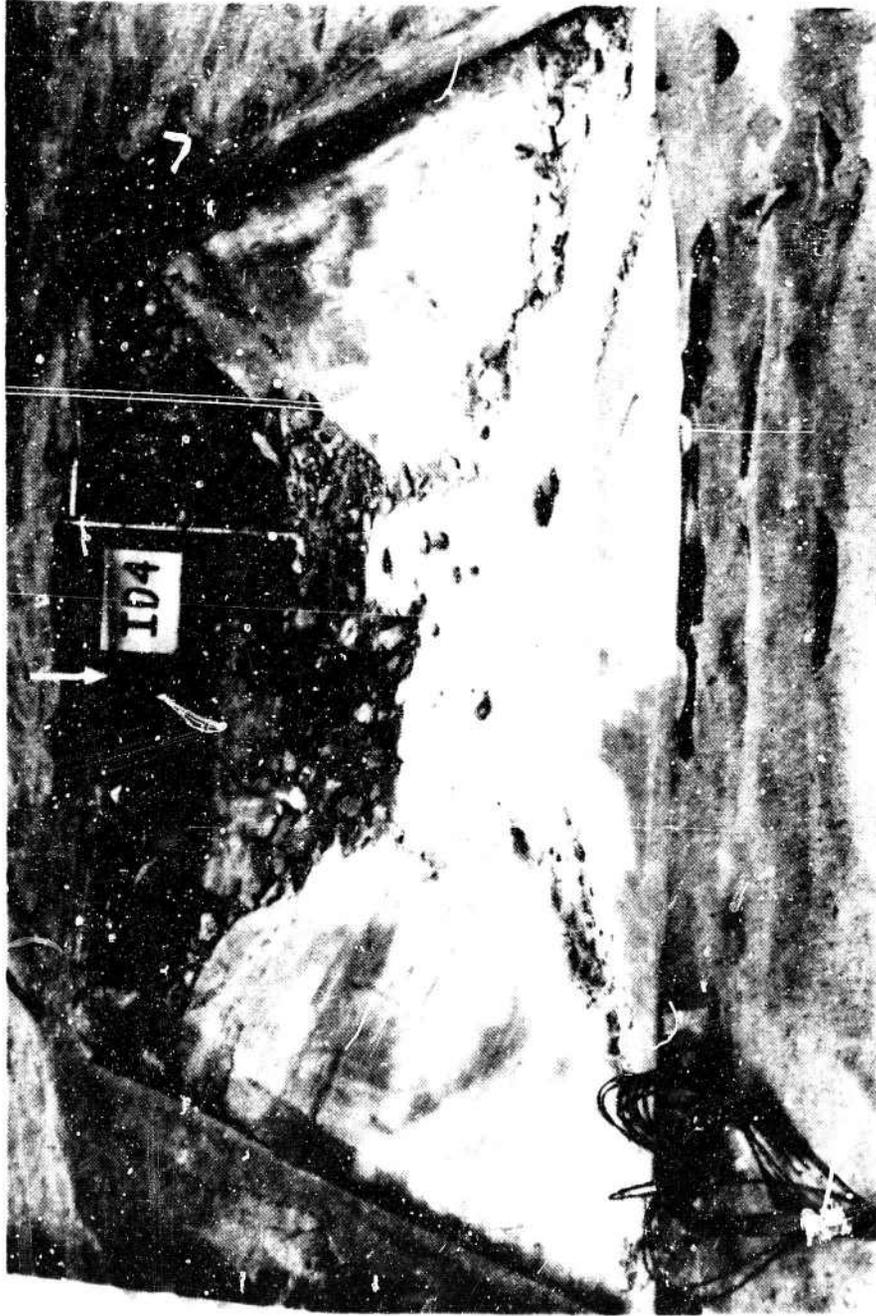
Remark: The simply supported R/C slab shown in Figure 31 has apparently pulled off its support along almost one entire edge. The permanent midpoint deflection for this slab was determined to be 17 in. while the corresponding deflection for all the other slabs tested in the subject reference ranges from 2.0 to 8.8 in.

Figure 31 COMPRESSION SURFACE OF R/C SLAB WITH 0.78 PERCENT STEEL  
SUBJECTED TO 11.0 PSI OVERPRESSURE

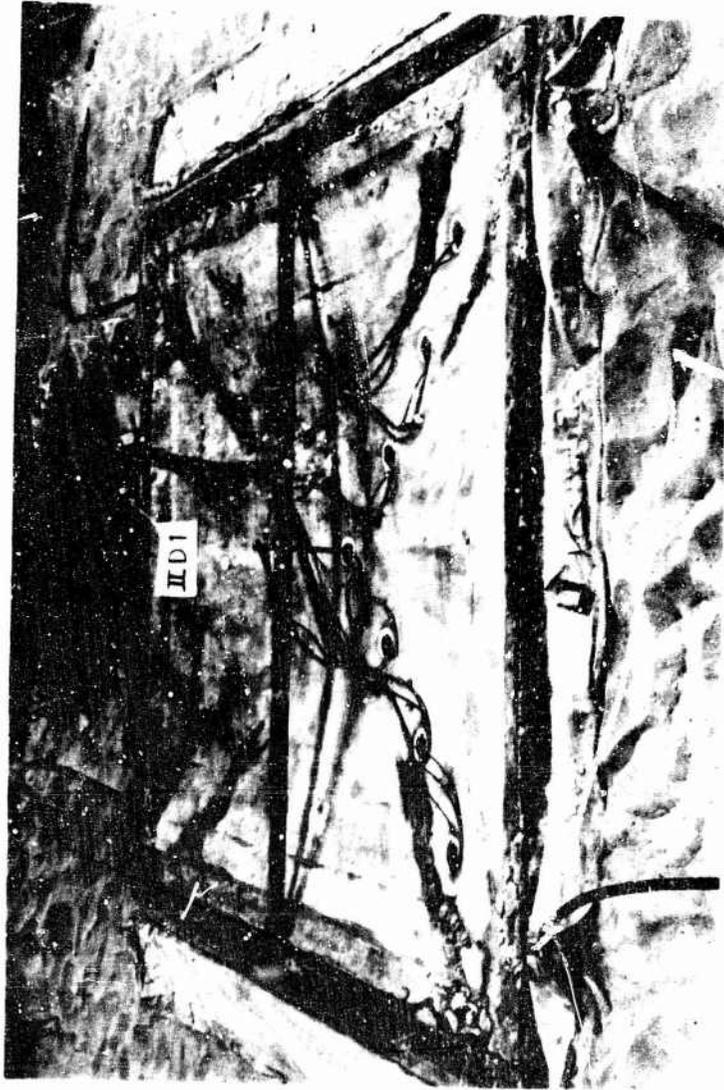
Remark: Typical concrete compression failures are observed along the diagonals near the corners of the R/C slab shown in Figure 38. A detailed view of one of the corners of this slab is shown in Figure 39. It is interesting to observe that the secondary fragments which were produced tended to remain with the slab on the upstream face.

Figure 38 COMPRESSION SURFACE OF R/C SLAB WITH 1.0 PERCENT STEEL  
SUBJECTED TO 12.5 PSI OVERPRESSURE

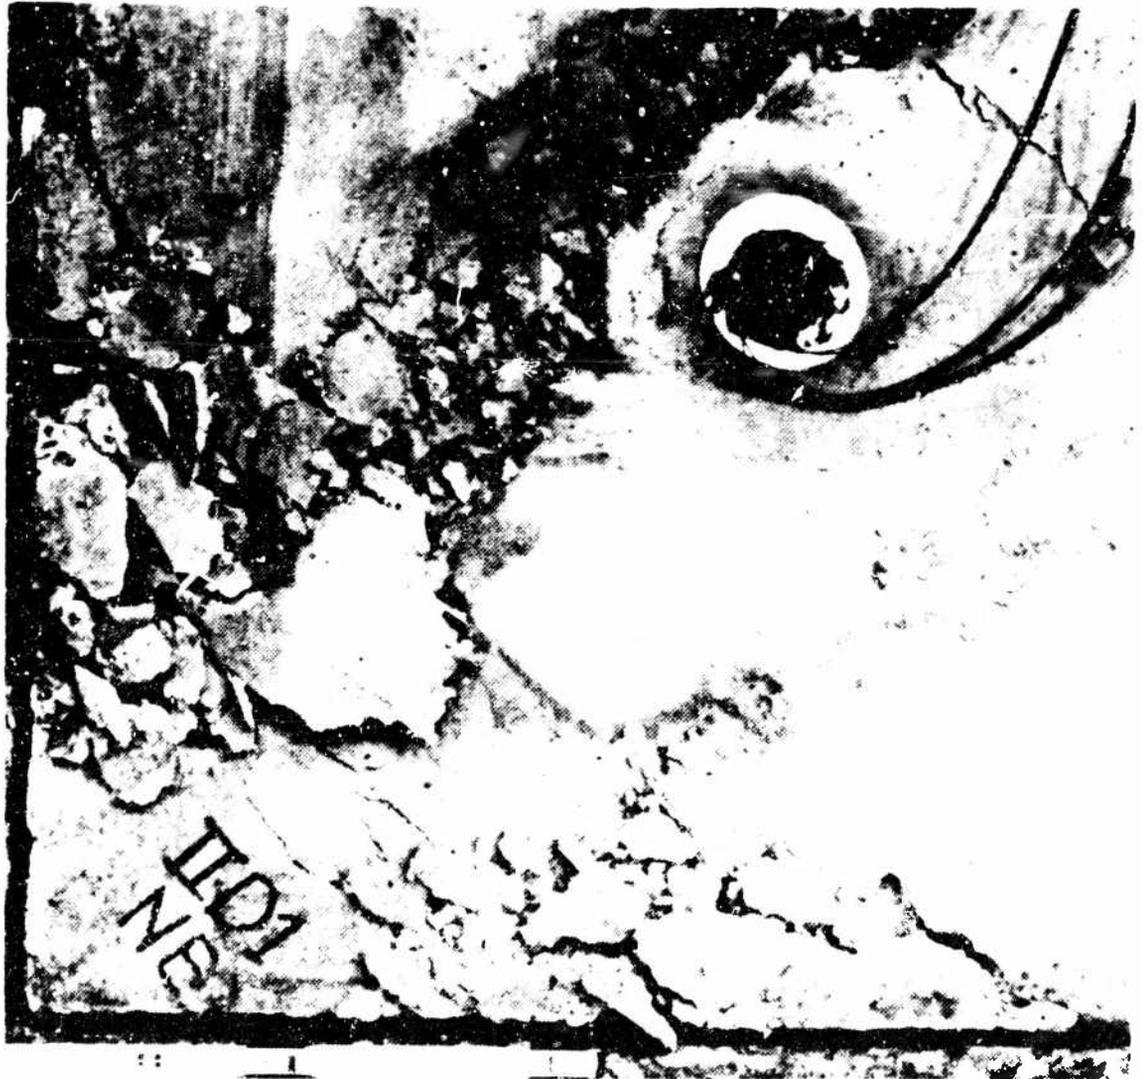
Figure 39 COMPRESSION CHIPPING PRODUCED IN R/C SLAB  
WITH 1.0 PERCENT STEEL SUBJECTED TO 12.5  
PSI OVERPRESSURE

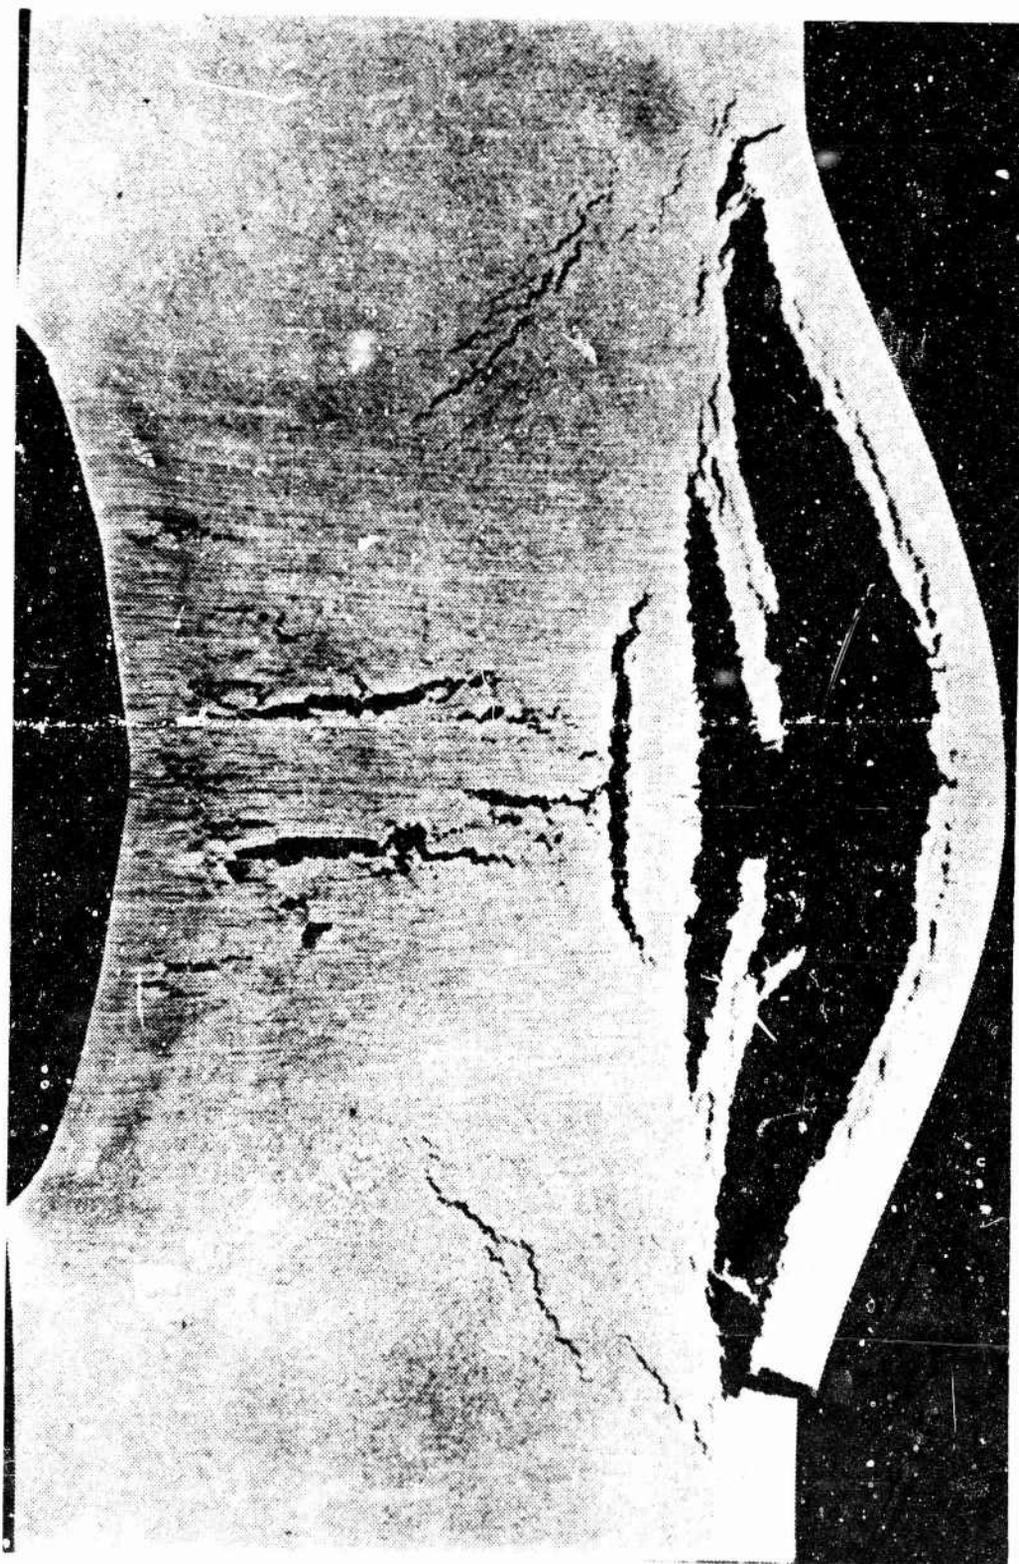
A typical example of a scabbing type of fracture is illustrated in Figure 40. Basically the two most important factors influencing scabbing are: (1) the magnitude of the tensile stress wave with respect to the magnitude of the fracture strength of the material, and (2) the shape of the stress wave. If the magnitude of the tensile stress wave is less than the strength of the material, no scabbing will occur. The present program is concerned with pressure levels below 100 psi. Here, the low level stress waves will help shake stubborn secondary fragments loose from the slab.

Figure 40 CROSS SECTION OF MILD STEEL PLATE SHOWING MULTIPLE SCABBING
