**EVALUATION OF WELDED AND BRAZED  
STAINLESS STEELS AND SUPERALLOYS IN A  
CORROSIVE ENVIRONMENT**

**TECHNICAL REPORT AFML-TR-67-258**

**October 1968**

Air Force Materials Laboratory  
Air Force Systems Command  
Wright-Patterson Air Force Base, Ohio 45433

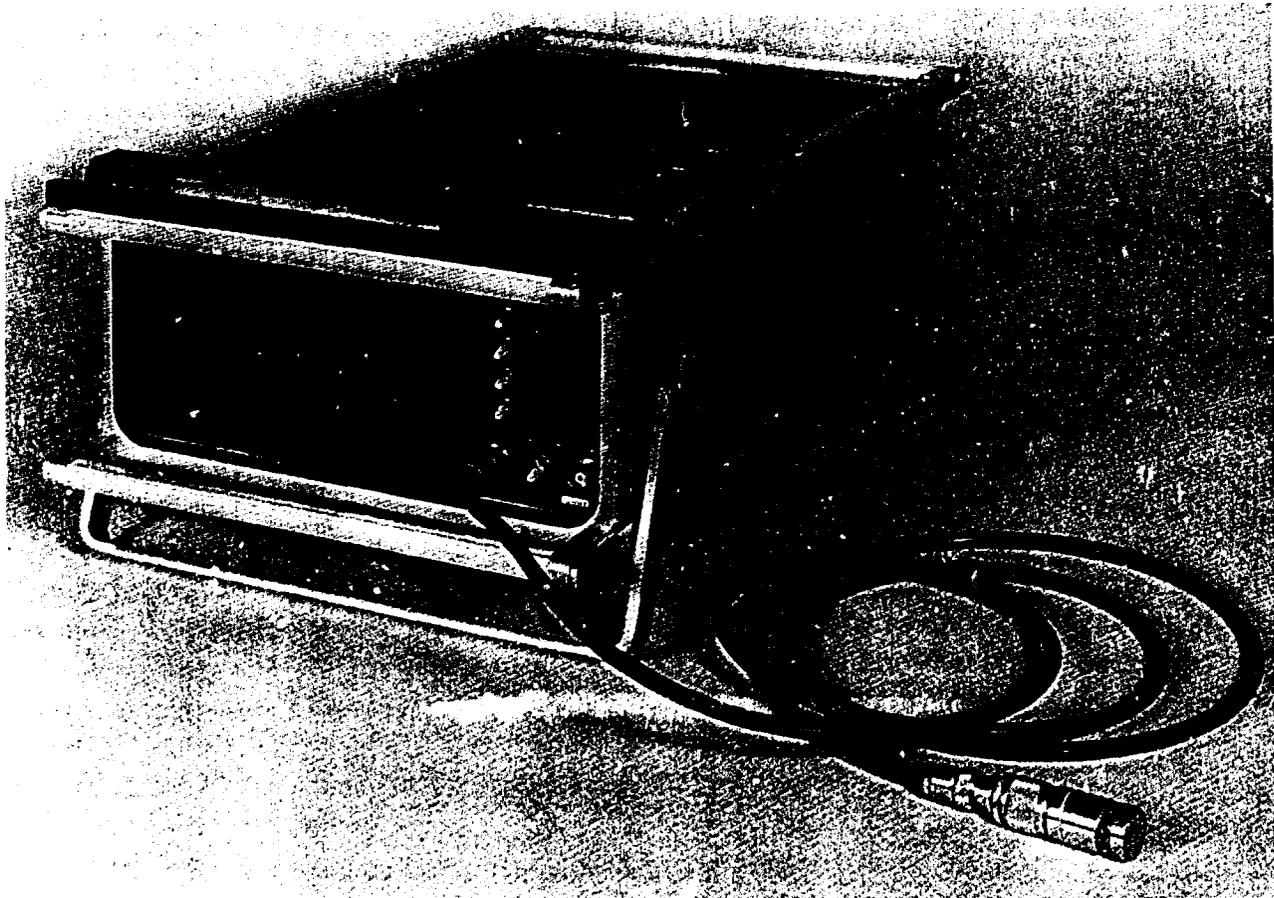
Figure 5 Branson 301 Sonoray Used in Investigation of Non-Destructive-Test Methods (ultrasonic) (XP-60743)

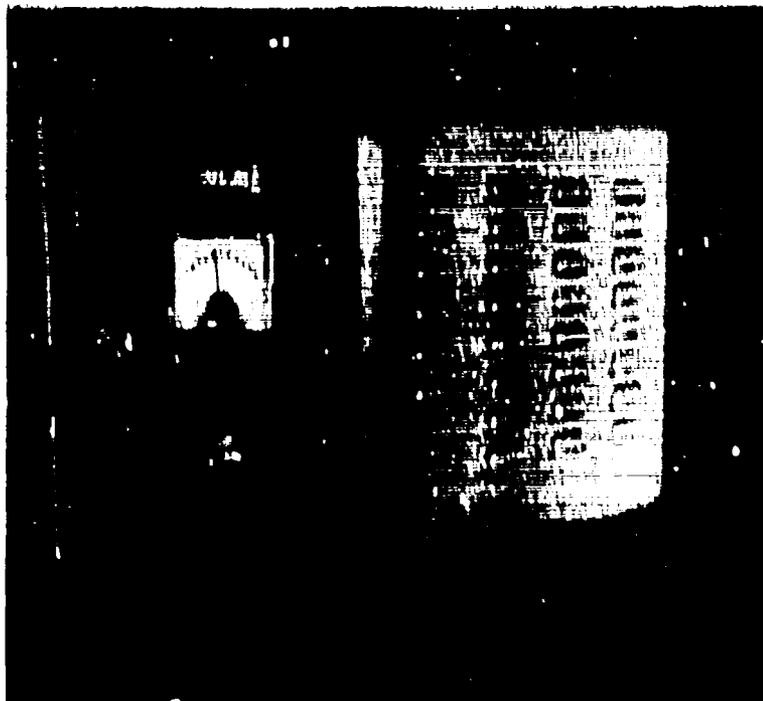
Figure 17 Magnetest Conductivity Meter, FM-100 Series, Used in Investigation of Non-Destructive-Test Methods (conductivity) (XP-77232)

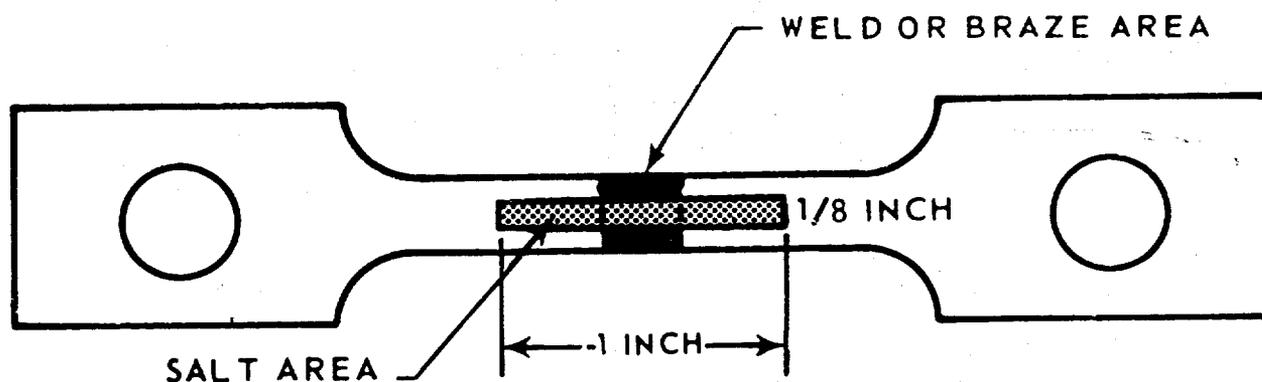
Figure 18 Approximate Location of Salt Patch on Specimen

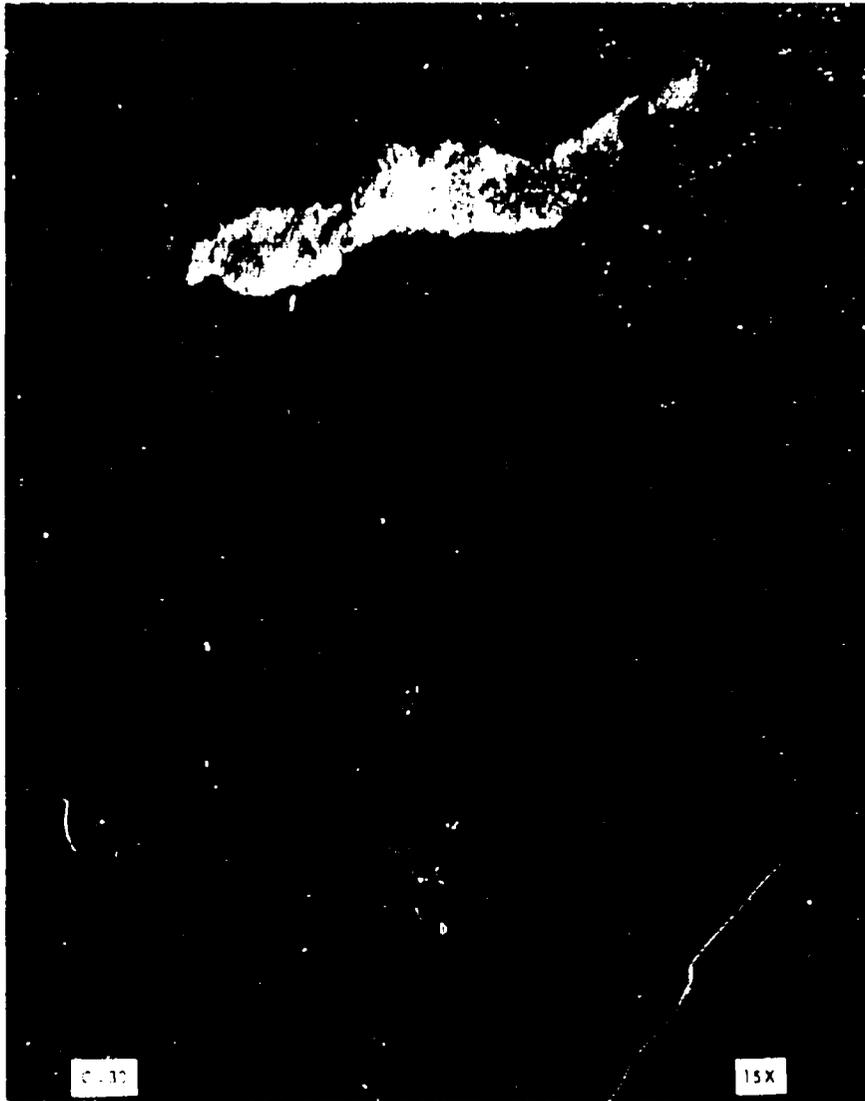
Figure 43 Brazed Specimen C-30. Failed During 55th Cycle. Arrows Point to Cracks in the Stained Area. (Environmental-test conditions: 800F, 130 ksi, no salt; scheduled duration: 63 cycles) (H-64893)  
Mag: 15X

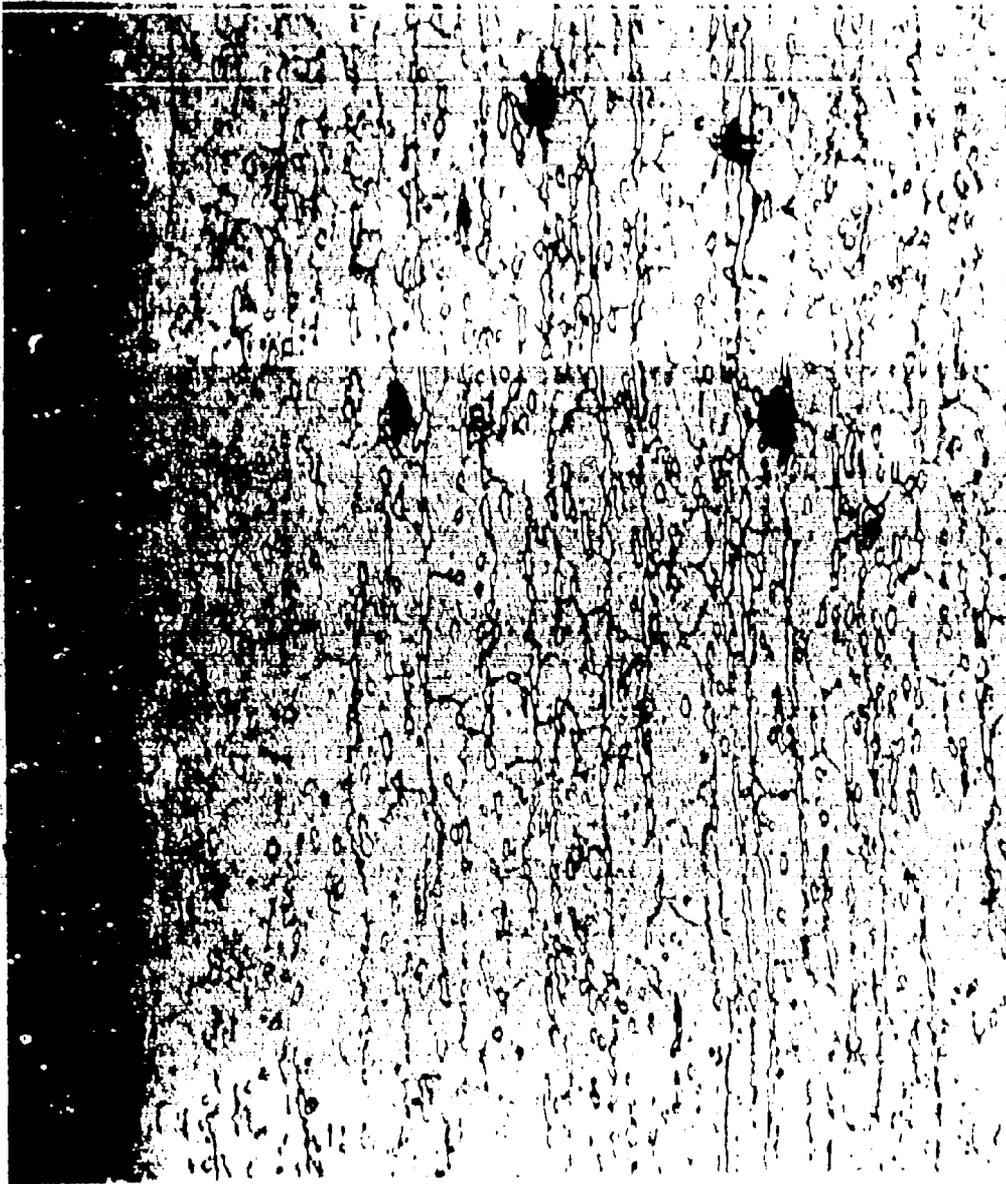
Figure 44 Brazed Specimen C-30. Failed During 85th Cycle. Photomicrograph Through Cracks in Stained Area Shown in Previous Figure. (Environmental-test conditions: 800F, 130 ksi, no salt; scheduled duration: 63 cycles) (EP-2168-7)

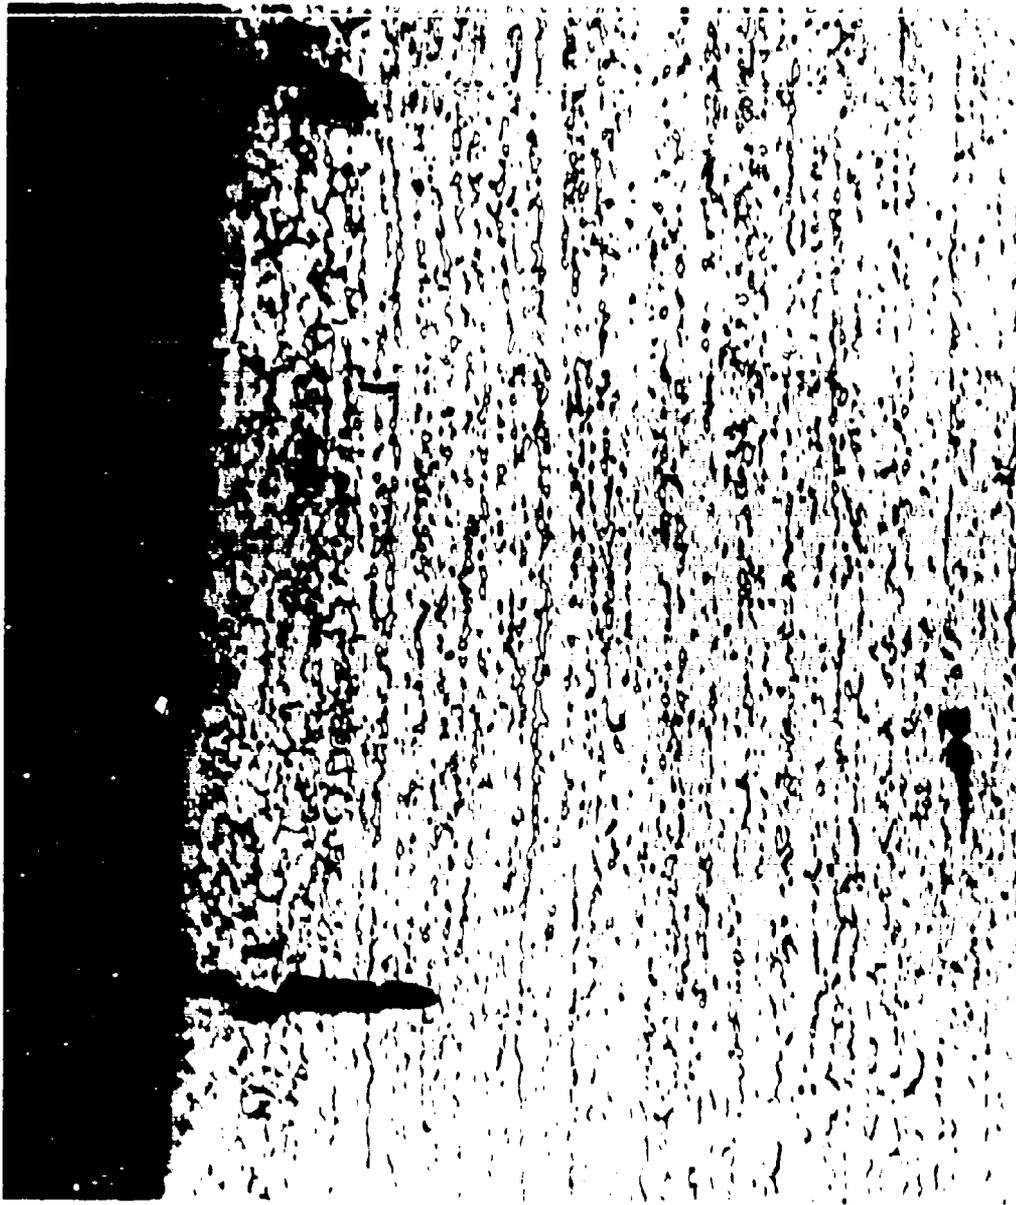
Figure 49 Brazed Specimen D-20. Failed During 2nd Cycle. Photomicrograph Through Cracked Area. (Environmental-test conditions: 800F, 148 ksi, no salt; scheduled duration: 63 cycles)

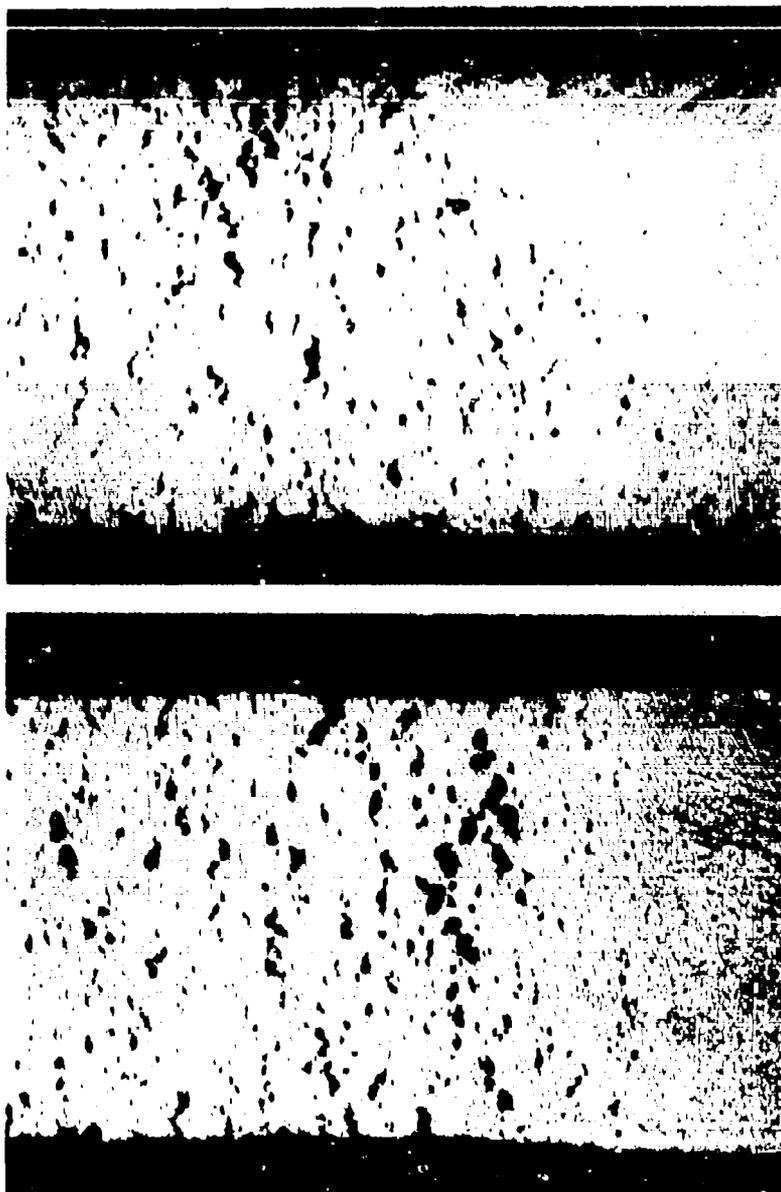
Figure 54 Photomicrographs of Welded Specimens E-1 (top) and E-14 (bottom) Specimen E-1 Ruptured in 50 cycles, E-14 Survived 69-Cycle Exposure. (Environmental-test conditions: 2000F, 1 ksi, E-1 with salt, E-14 without salt; scheduled duration: 88 cycles)

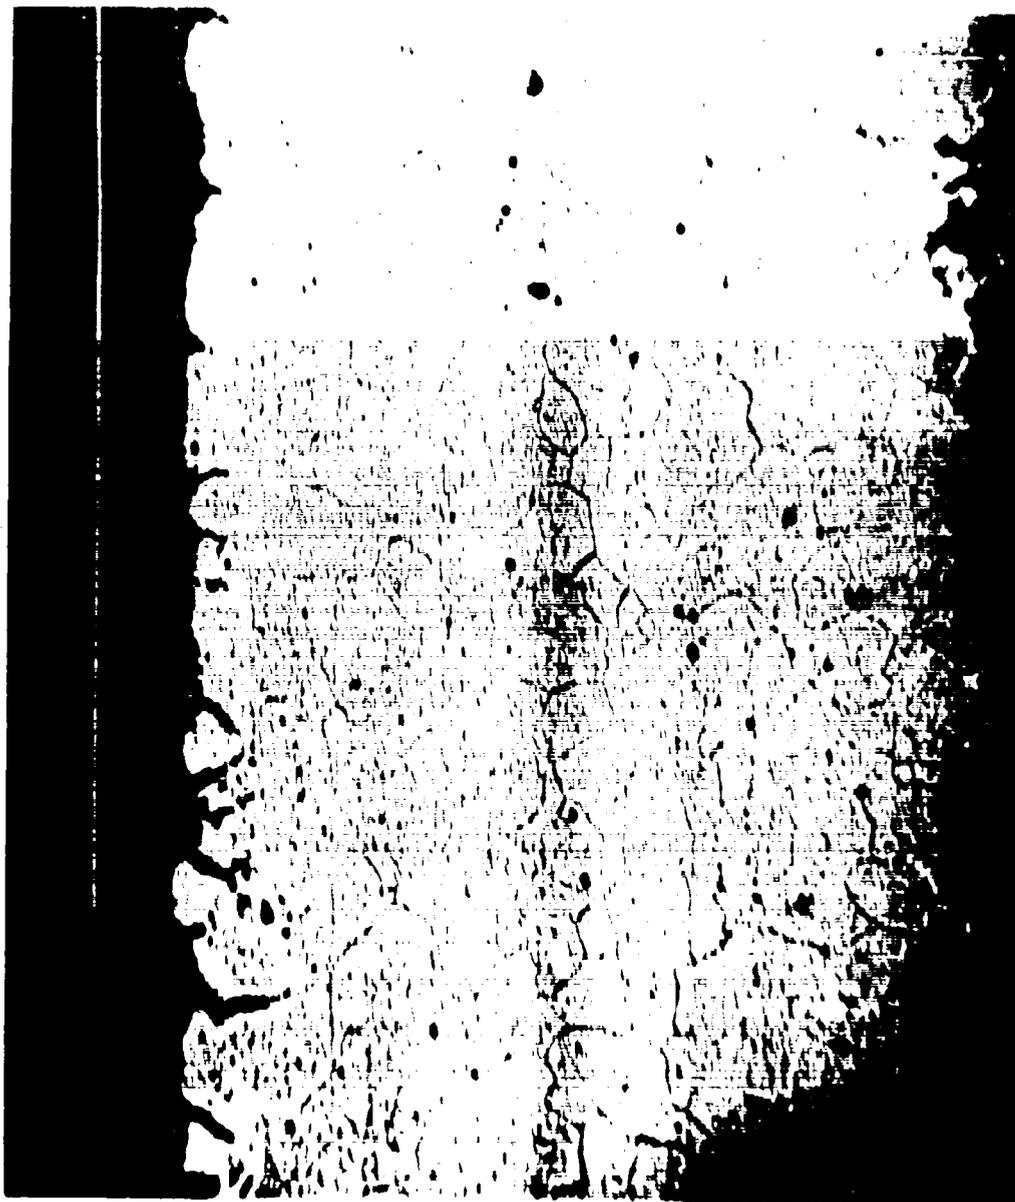
Figure 68 Photomicrograph of Braided Specimen F-26 After Tensile Test, Showing Location of Rupture. (Environmental-test conditions: 1800F, 4 ksi, salt; duration: 10 cycles) (ICP-2210-10)

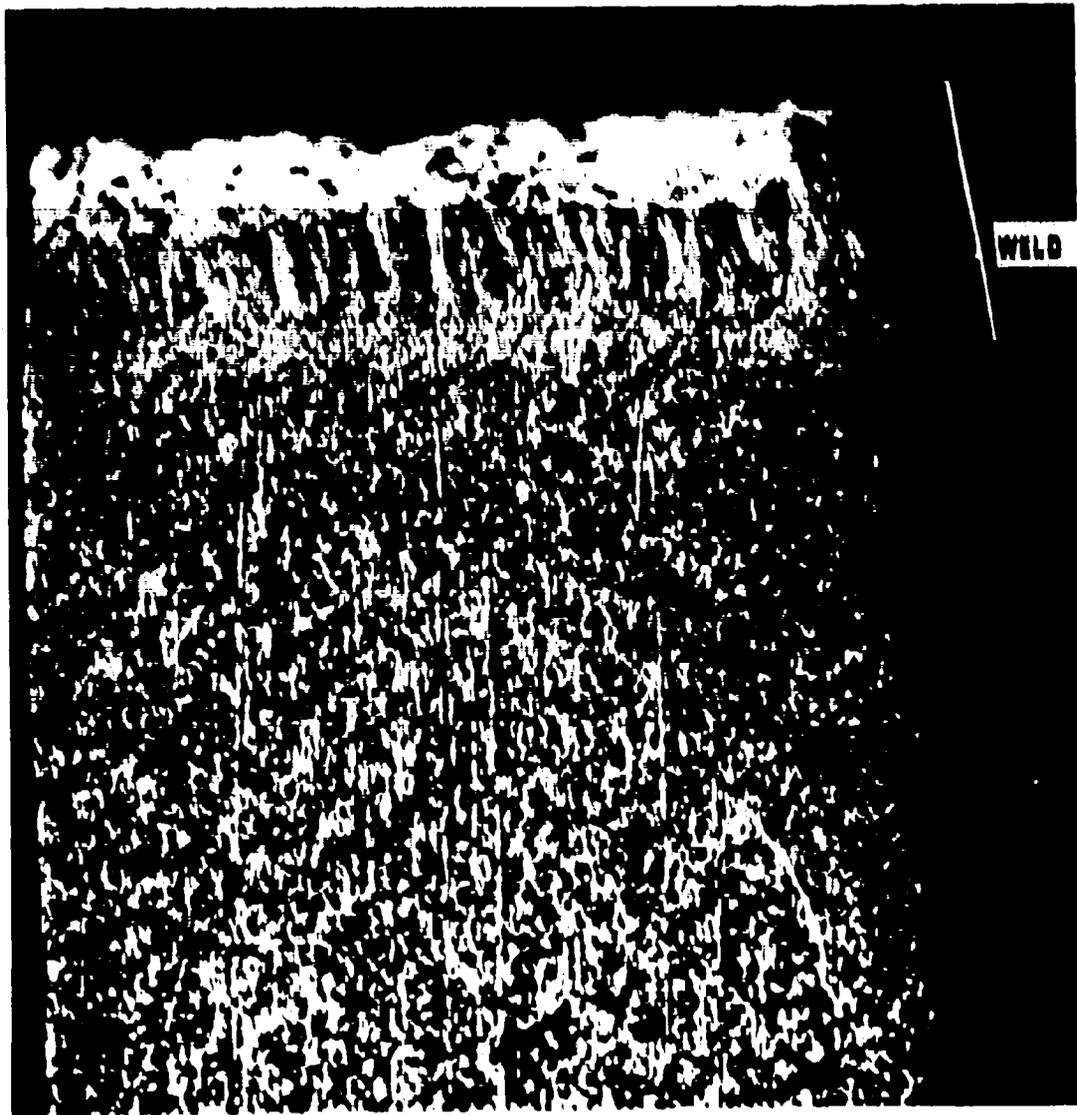
Figure 7b Welded Specimen II-2 After Tensile Test, Showing Rupture Location.  
(Environmental-test conditions: 1200F, 30 ksi, salt; duration:  
03 cycles) (EP-2172-B)  
Mag: 20X

**A 286 (Welded)** - The test history for specimens of this material appears in Table XXIV. No evidence of Type-(1) or Type-(3) corrosion was discovered following environmental testing. Furthermore, there were no failures encountered in the course of such testing. All specimens exposed at 1200F exhibited an increase in tensile strength compared to the tensile strengths of unexposed material (H-11 and H-12). This was due presumably to additional aging. A trend toward increased hardness values was also apparent. The two salted specimens (H-1 and H-2) exposed at 1200F and 30 ksi showed somewhat lower tensile strengths than their unsalted counterparts (H-13 and H-14), although no significant cracking could be attributed to the applied salt (Figure 78). All four specimens failed through the welds or subsequent tensile testing (Figure 79). Salted specimens evaluated at 800F for 63 and 19 cycles had essentially the same tensile properties as unsalted specimens tested at 800F for 63 cycles, and also as unexposed material. Thus, at the lower temperature, salt had no apparent effect on the tensile properties of the alloy. Tables XXIV and XV indicate welding reduces strength after exposure.
