NWC TP 4720

## EVALUATION OF EXPLOSIVES SIMULTANEITY TESTS

URS Research Company  
for the  
Systems Development Department

CHINA LAKE, CALIFORNIA \* MAY 1969

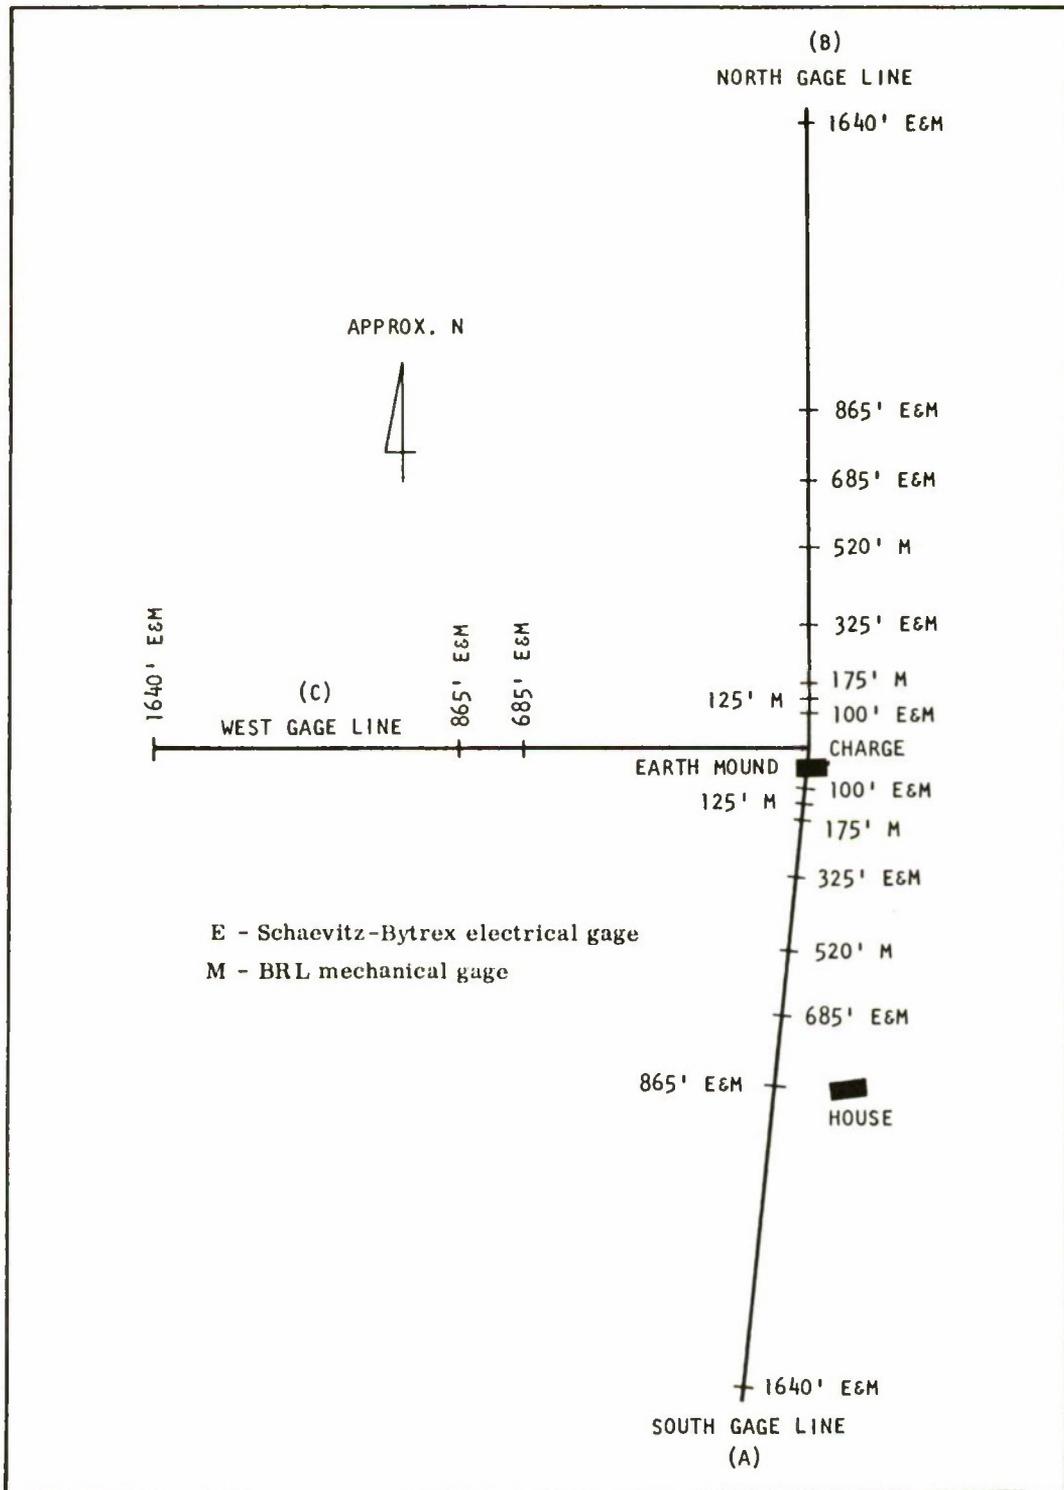
FIG. 1. Layout of Test Site. Gage distances measured from center of charge, house 865 feet from edge of storage bay.

The facilities used for the tests consisted of a conventional two-story frame house, a standard earth barricade, a concrete explosives bay, and 10,000 pounds of TNT arranged as shown in Fig. 1. The front of the house faced the storage bay at ground zero and was 865 feet from the near edge of the bay.

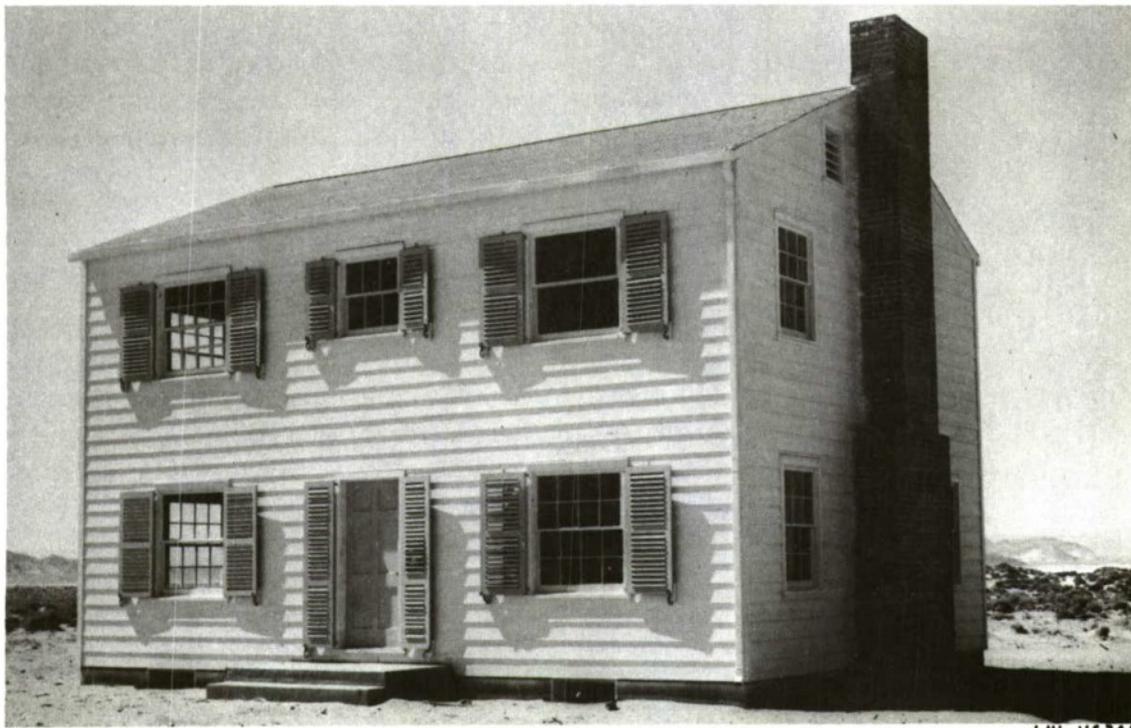
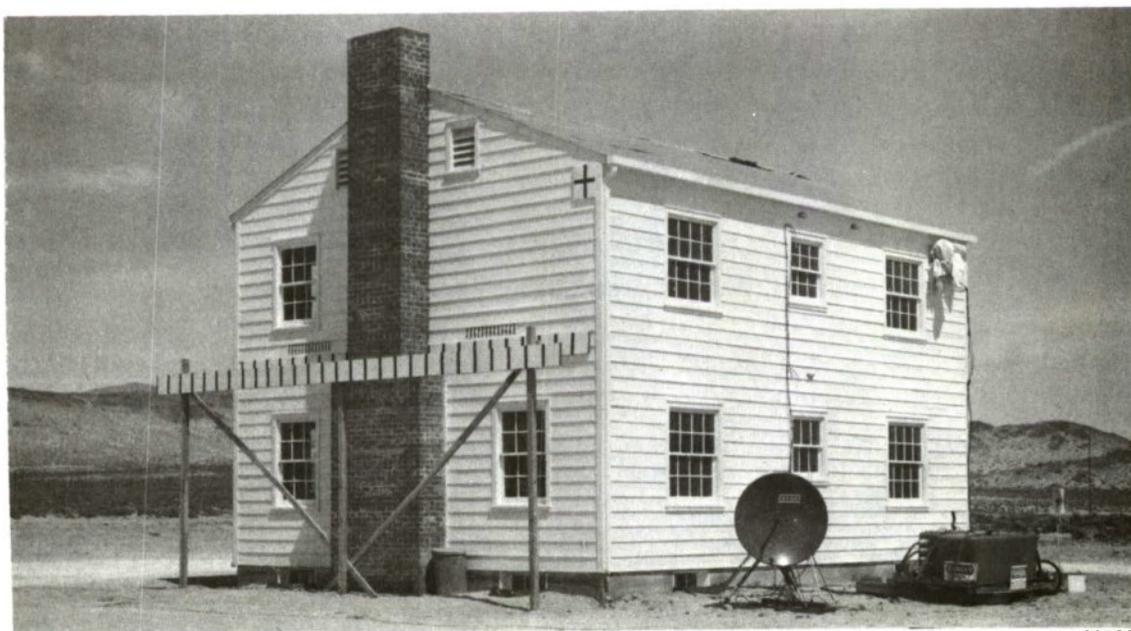
FIG. 2. Exterior Views of Test House.

The house, which was constructed basically in accordance with the Office, Chief of Engineers, D/A Drawing 60-08-45, revised 23 July 1959, was 33 feet 4 inches long by 24 feet 8 inches wide, with full basement and gabled roof (Fig. 2). There were four rooms on each floor, with a brick fireplace in the living room. The walls were plaster but, to reduce cost, the finish coat was eliminated, as were plumbing, electrical, and heating systems. The two large window panes in the front of the house were 1/8-inch thick, the rest of the windows were 3/32-inch thick, and there was a 10-foot 2-inch spacing between the side windows in the kitchen and dining room. For roof sheathing, 3/4-inch plywood was used instead of lumber, and ash and fir 2x4s were used instead of pine for wall studding.

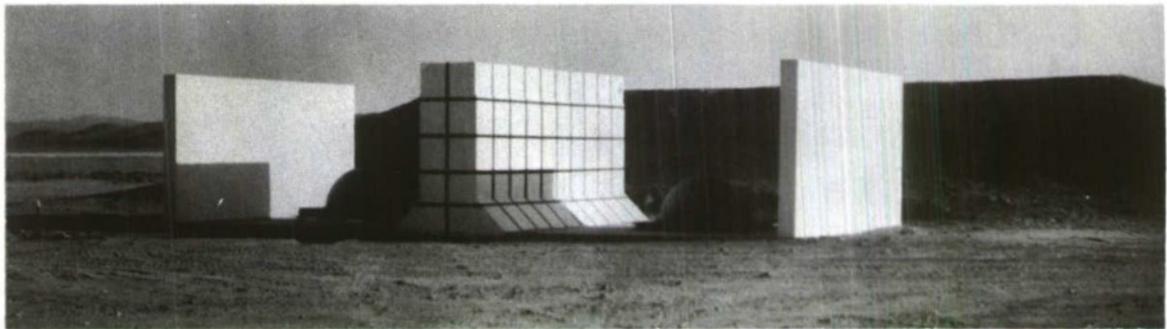
LHL 132509

FIG. 3. Two 5,000-Pound Charges in Place for Test No. 2.

The donor structure for the second test, constructed as above, had 20-foot-long side walls and a floor space of 17 feet by 20 feet for each donor. The two donors were separated by a specially designed nonpropagation wall 10 feet high, 20 feet long, and 4 feet thick (Fig. 3 and 4).

The setup for this test was like that used in Test No. 1, except that two 5,000-pound cast hemispherical charges of TNT, separated by a specially designed heavily reinforced substantial dividing wall (see Fig. 3), were placed in the donor structure and detonated 20 msec apart. Most of the donor structure was destroyed, the special wall between the charges was damaged, and craters approximately 10 feet deep and 20 feet in diameter were formed (Fig. 14).

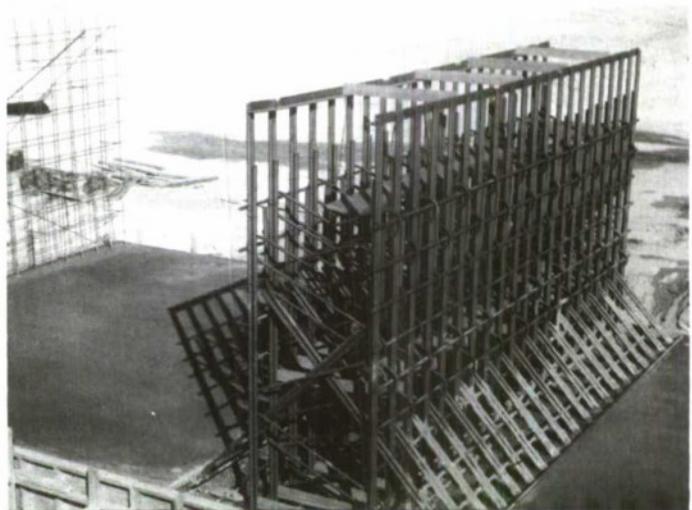
LHL 129410

FIG. 4. Inside Construction of Center Dividing Wall.

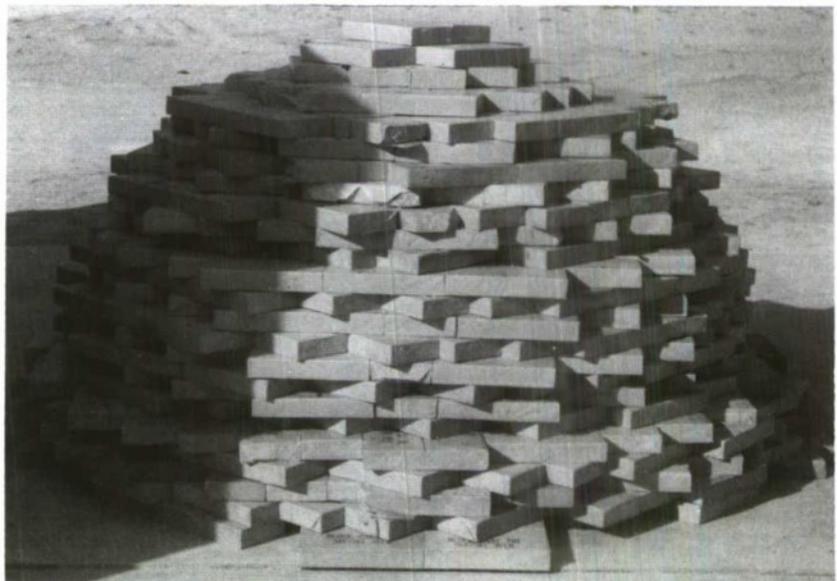
FIG. 5. Configuration of 10,000-Pound Charge for Test No. 1.

The first test was a control test in which a single 10,000-pound charge, built of cast blocks of TNT stacked to approximate a hemisphere (Fig. 5), was placed in the center of the 20-foot-square donor bay and detonated. The bay was completely destroyed by the blast (Fig. 6), and a crater about 38 feet in diameter by 9 feet deep was formed.

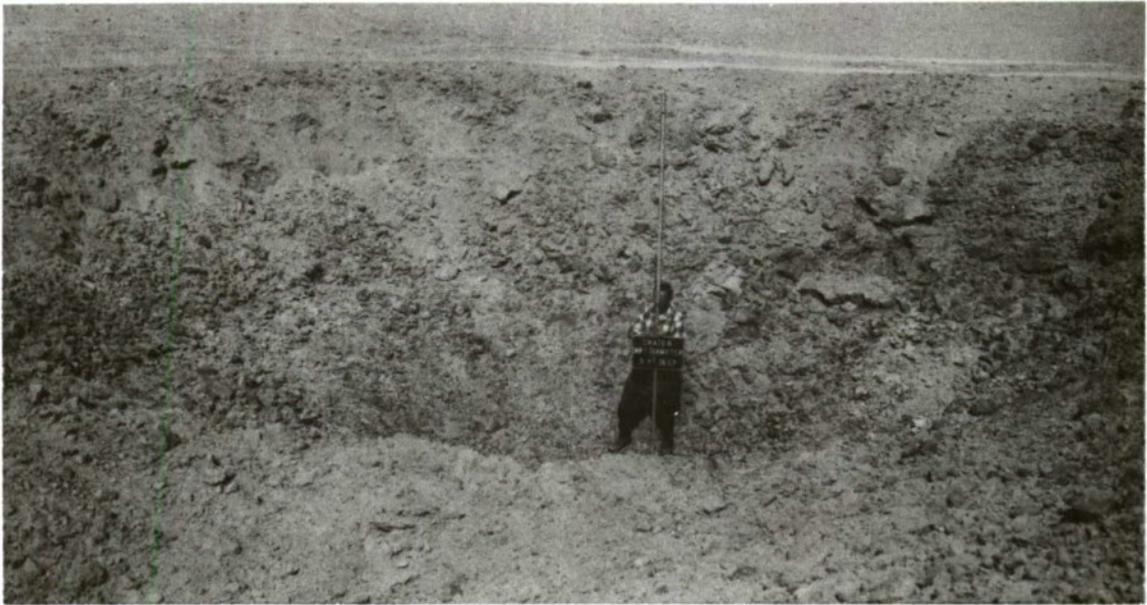
LML 123529

FIG. 6. Crater Formed by Detonation of Single 10,000-Pound Charge.

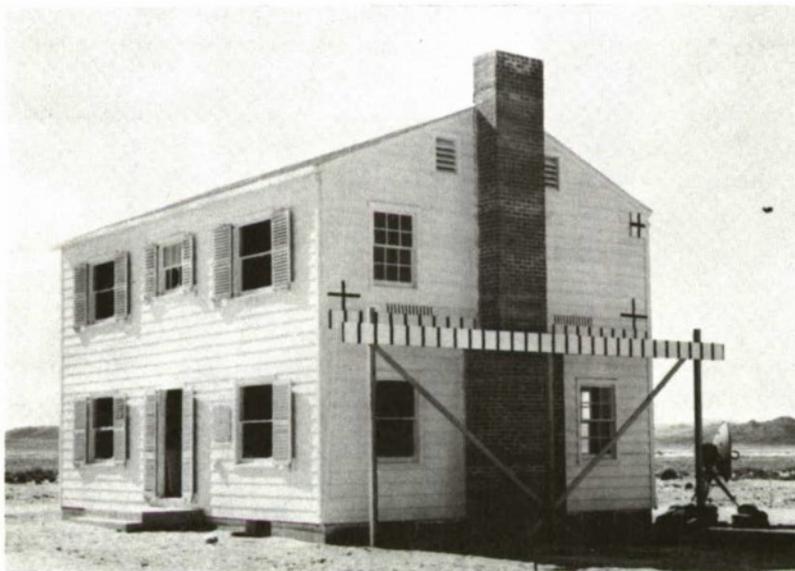
LML 123524

FIG. 7. Front and West Sides of Test House After Test No. 1.

After the blast, all the front windows of the house, except the small one above the front door, were completely removed (Fig. 7). The door was torn off its hinges and blown into the front hall, and all basement windows forward of the centerline of the house were blown in. Figure 8 is a view of the east and south sides of the house. Note the window damage on the east (right side) wall and that only one pane of glass on the back (south) wall was broken. This pane was broken by a wooden fragment from the front window, rather than by the blast. There were also chimney damages, some of which are indicated by the chalk marks in Fig. 9.

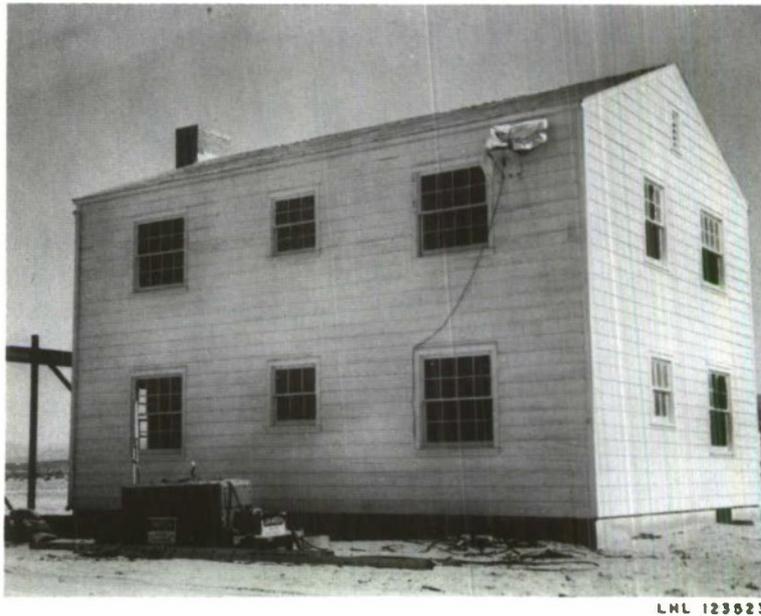
LML 123623

FIG. 8. Back and East Sides of Test House  
After Test No. 1.

Damage to the house, which had been restored after the first test, was similar to that incurred from the single 10,000-pound blast. Note in Fig. 15 that damage to the front windows was slightly more extensive than in the first test and that a shutter at the upper left window was torn loose; whereas, no shutters were torn loose in the first test (compare Fig. 15 with Fig. 7). Figure 16 shows that window damage was substantially greater after the second test than after the first (see Fig. 8), and all windows forward of the centerline of the house were damaged.

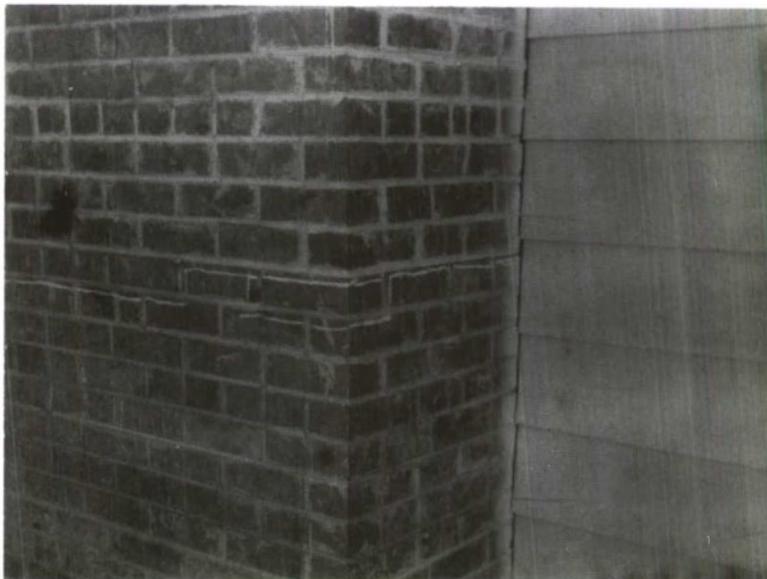
LML 126862

FIG. 9. Chimney Damage Resulting From Detonation  
of Single 10,000-Pound Charge.

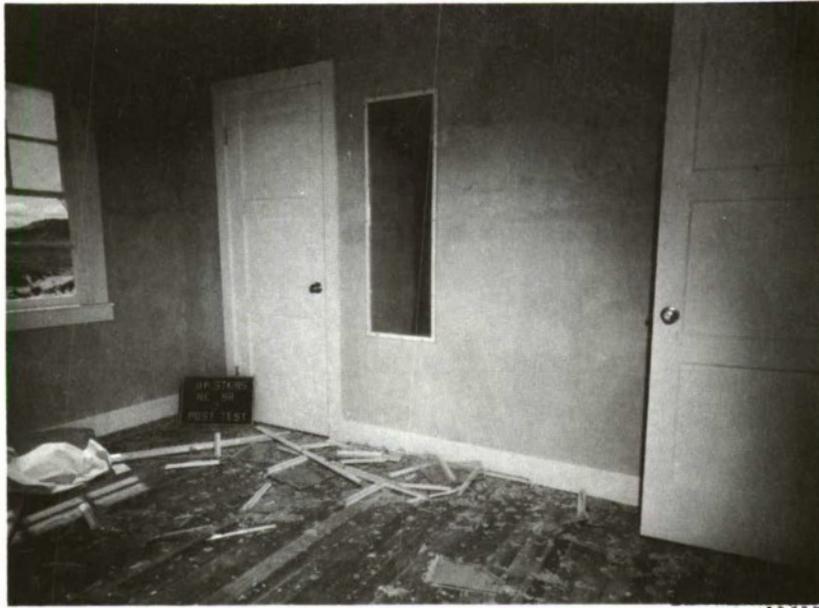
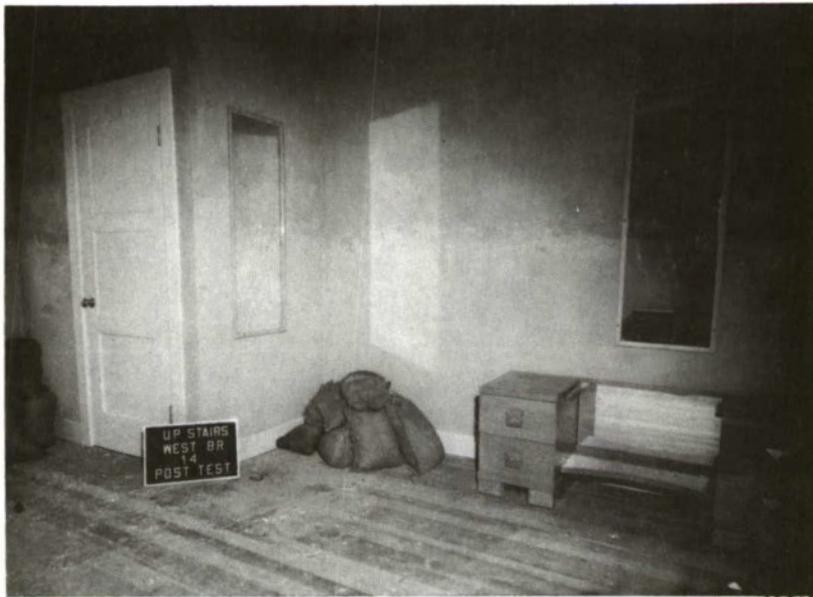
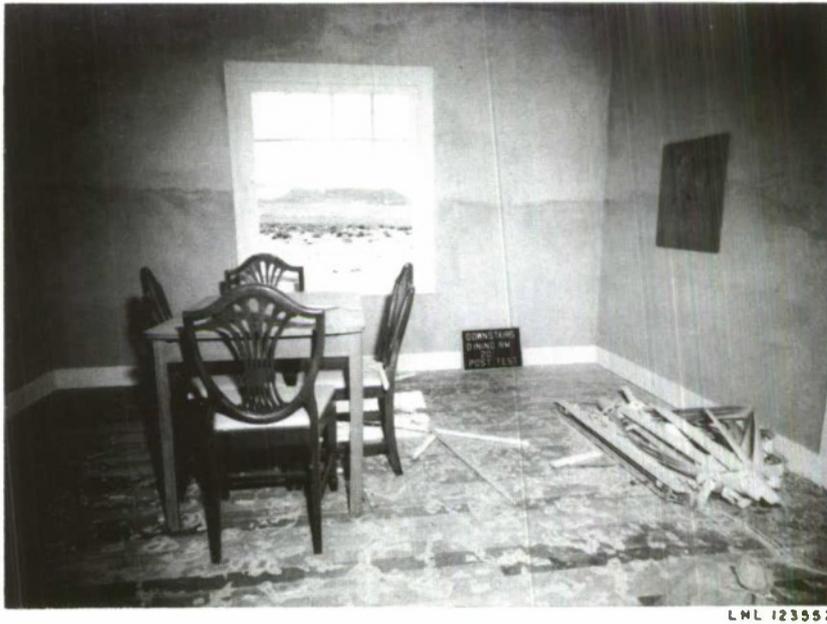
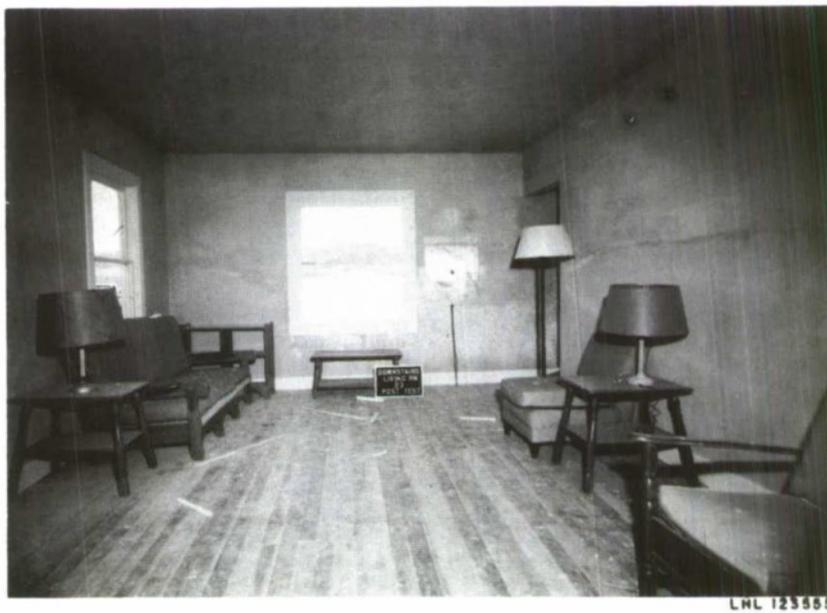
FIG. 10. Damage to Upstairs Northeast Bedroom, Test No. 1.

FIG. 11. Damage to Upstairs West Bedroom, Test No. 1.

FIG. 12. Dining Room Damage, Test No. 1.

FIG. 13. Living Room Damage, Test No. 1.

Large quantities of glass and pieces of window frames and shades were scattered throughout the interior of the house (Fig. 10-13), and some plaster cracking was visible in several of the rooms. Very little furniture movement or damage occurred and, as shown in Fig. 13, even the lampshades were only slightly jarred. None of the wall-mounted mirrors was damaged.

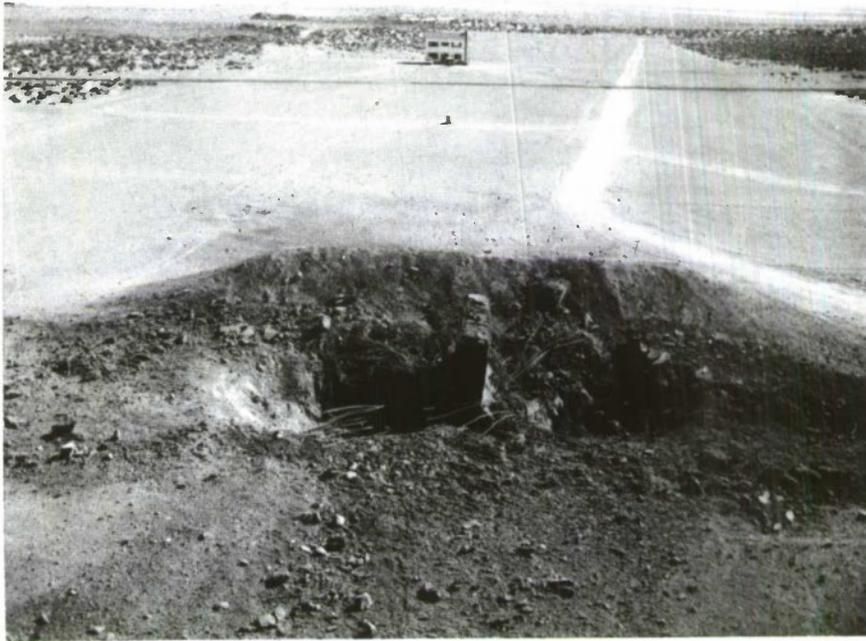
FIG. 14. Views of Dividing Wall and Craters After Programmed Detonation of Two 5,000-Pound Charges, Test No. 2.

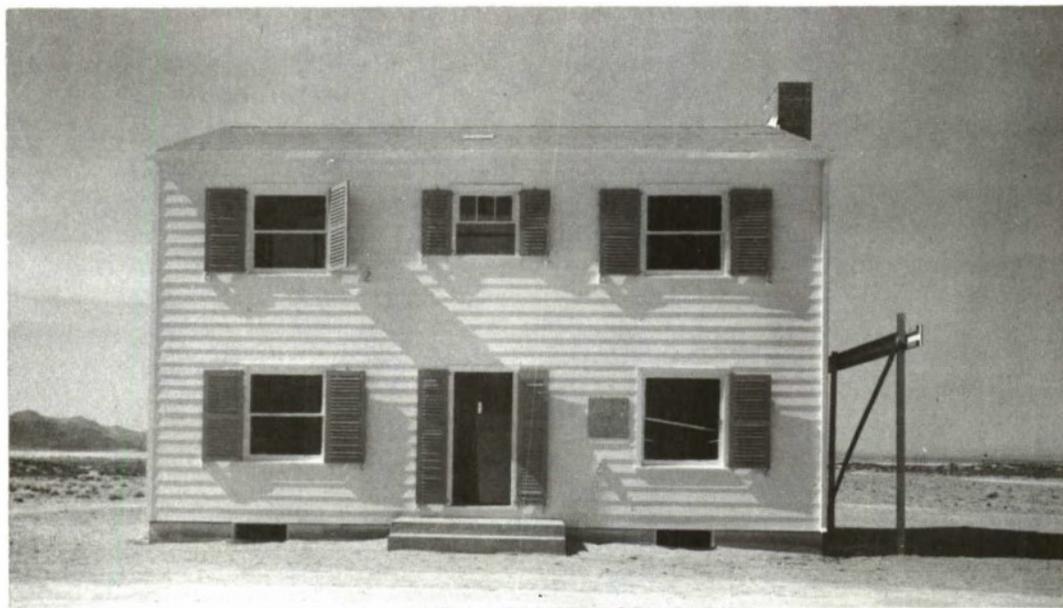
LHL 132536

FIG. 15. Front of House After Test No. 2.

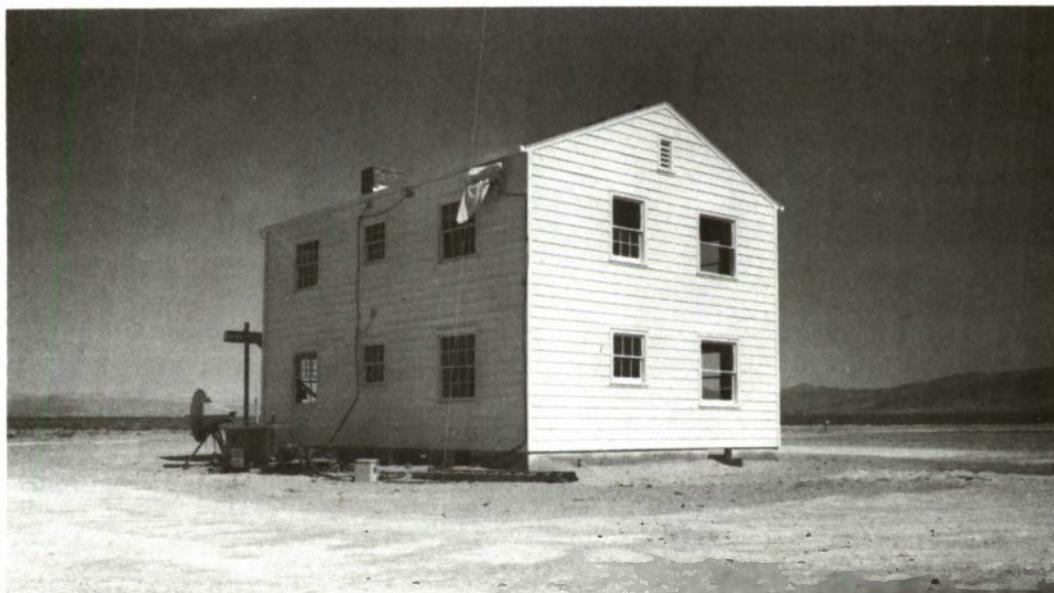
LHL 132535

FIG. 16. Back and East Sides of House After Test No. 2.

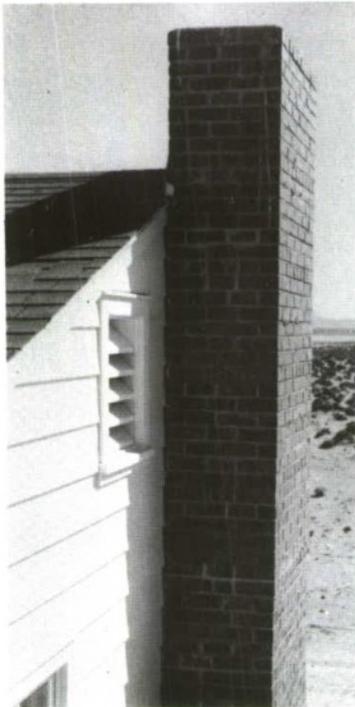
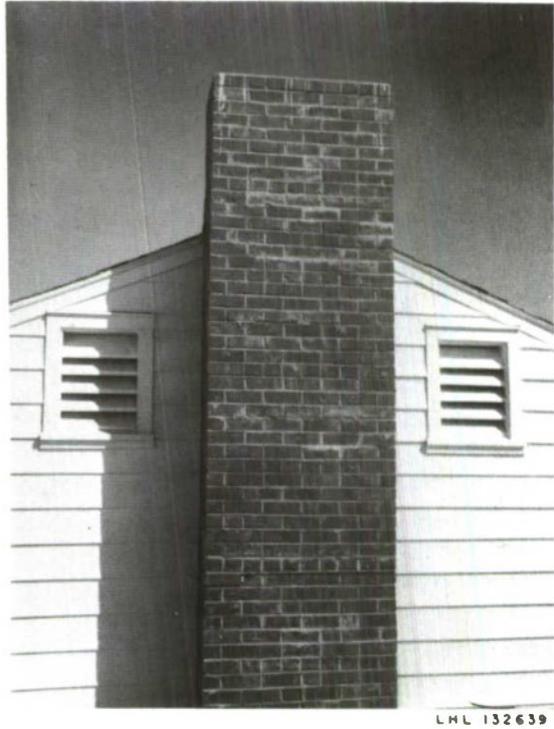
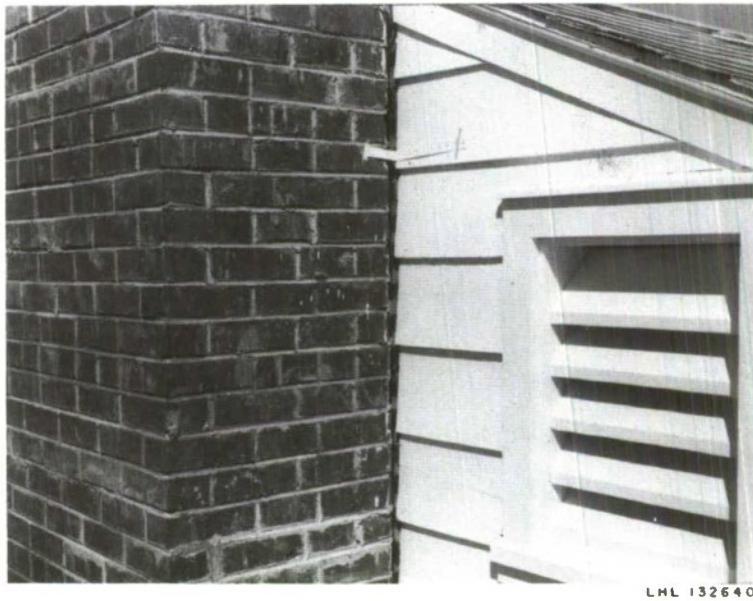
FIG. 17. Views of Chimney Damage, Test No. 2.

Damage to the chimney (Fig. 17) was also more severe after the second test than after the first. Cracks were larger, more spalling occurred, and a large portion of the chimney was separated from the wall by an inch or more.

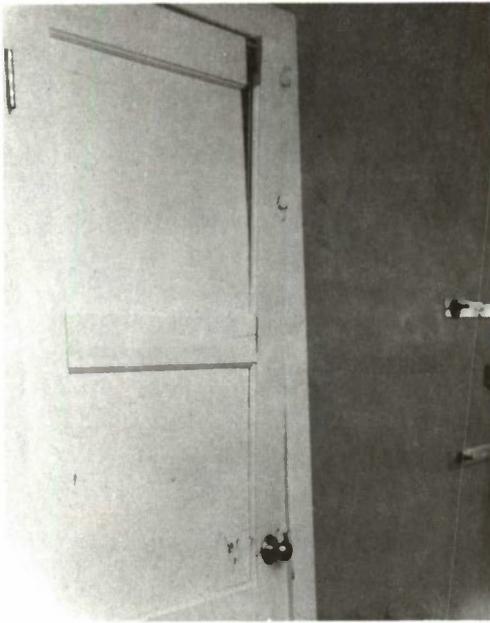
LHL 132644

FIG. 18. Door Between Dining Room and Kitchen After Test No. 2.

Inside the house, plaster cracking was also generally more severe. The door between the dining room and kitchen was badly damaged (Fig. 18), and the rafter damage, shown in Fig. 19, was apparently the most significant damage to a structural element in the house from either test.

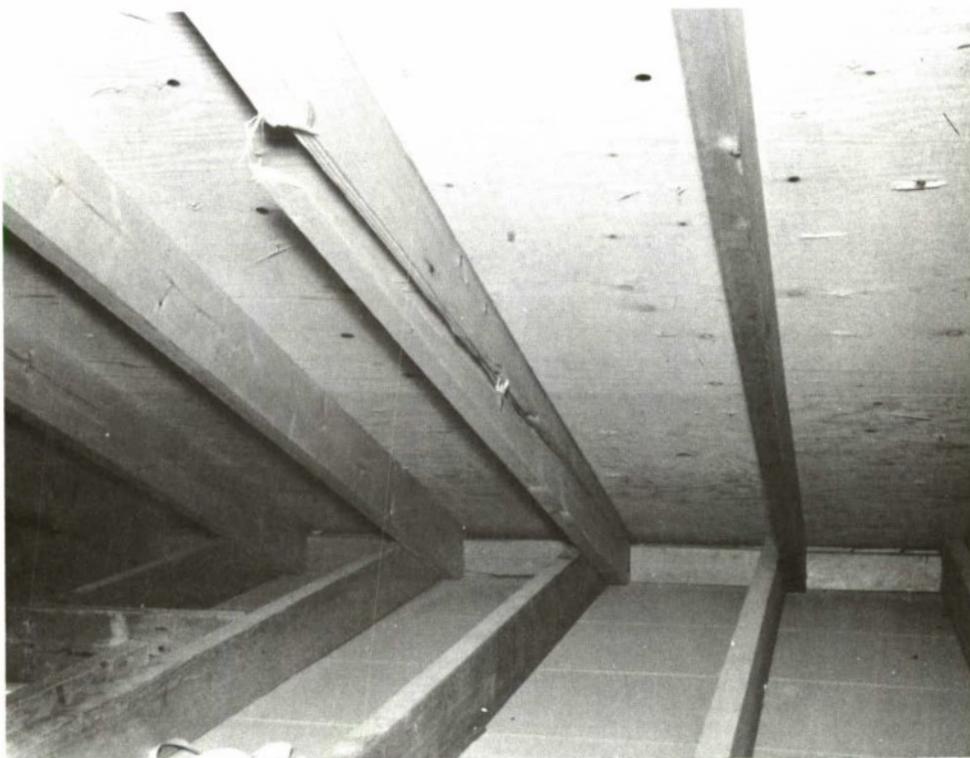
LHL 132647

FIG. 19. Rafter Broken in Test No. 2.

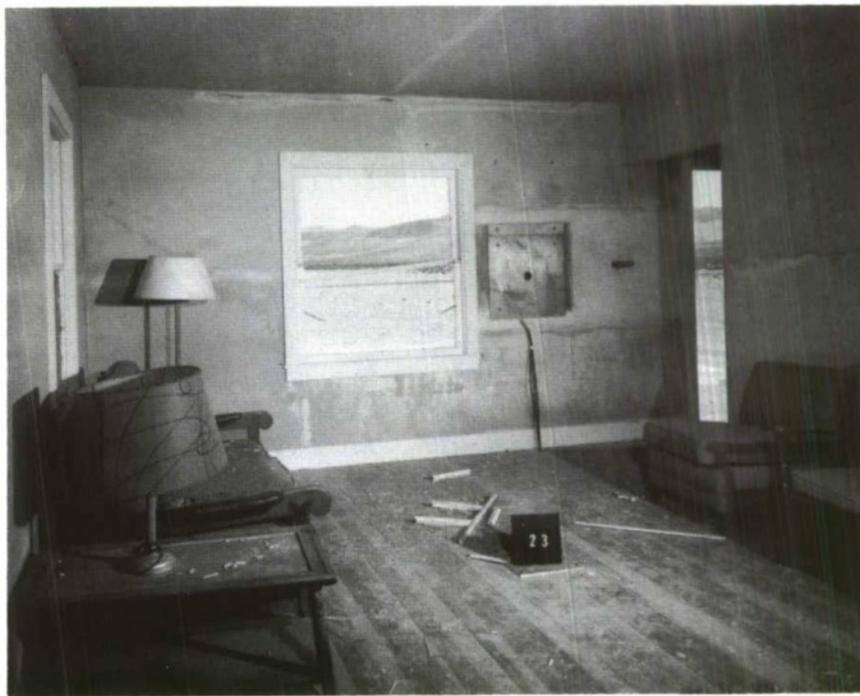
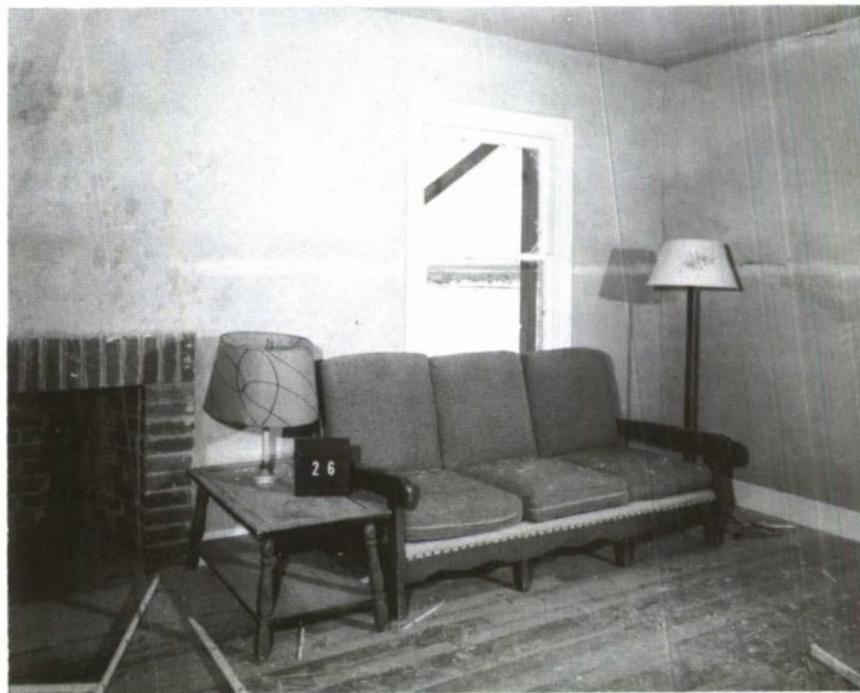
FIG. 20. Views of Living Room Damage, Test No. 2.

Damage to the interior of the upstairs was about the same as that observed in Test No. 1, except that much of the flying glass was intercepted by styrofoam glass-traps and never reached the floor. Again, no mirrors were cracked and no furniture was moved. Damage to the downstairs interior was also comparable to that in the first test, with neither flying glass, pieces of window frame, nor the blast itself significantly disturbing furniture position (Fig. 20).

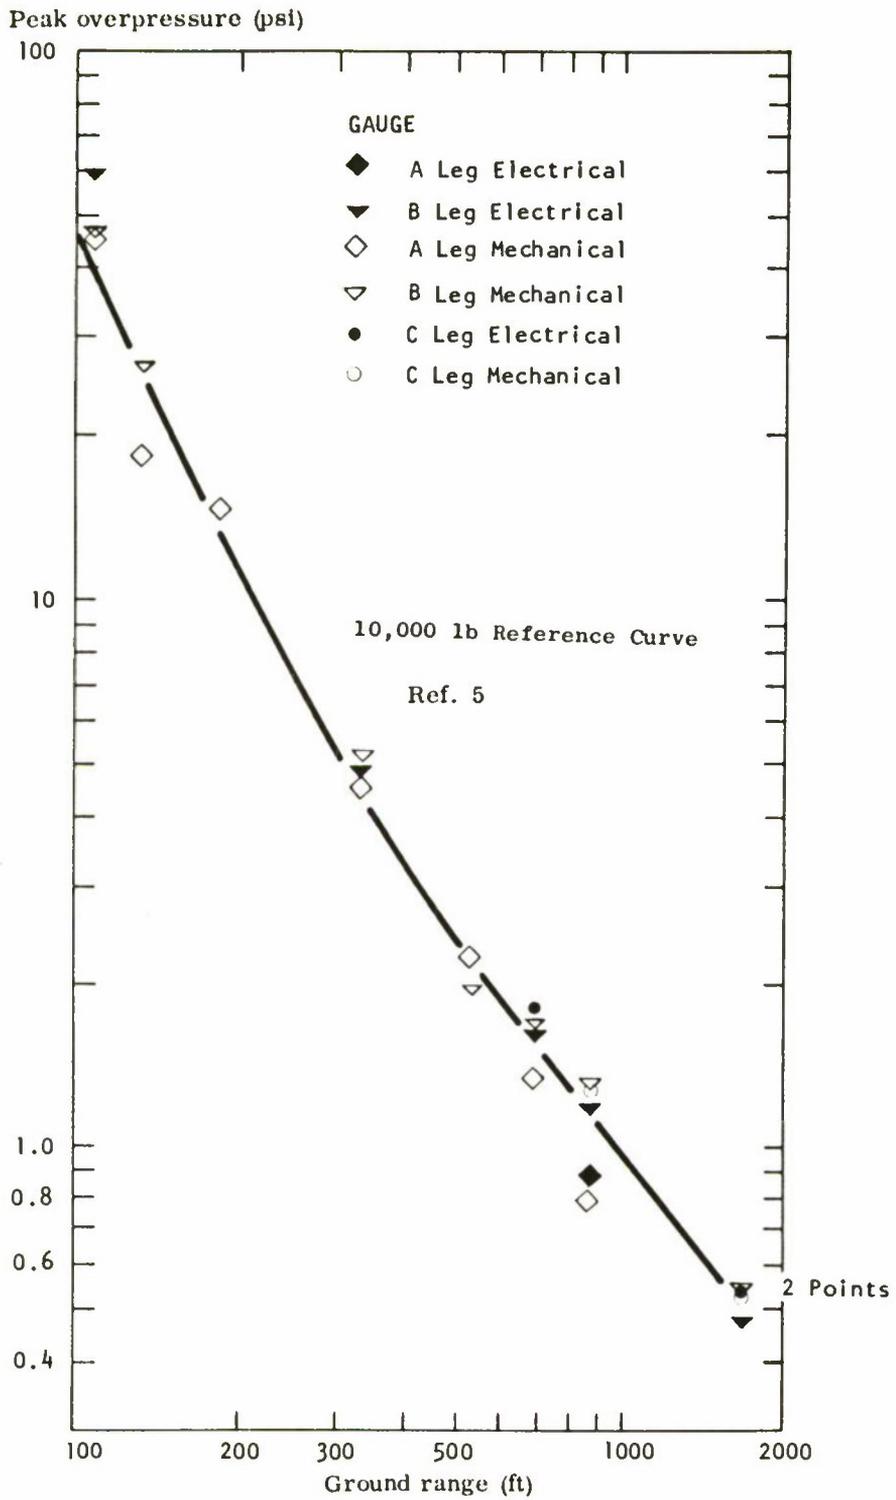
FIG. 21. Peak Overpressure Versus Distance, Test No. 1.

The peak overpressures measured during the tests are plotted as a function of distance in Fig. 21 and 22, and the peak overpressure data recorded for the B and A gage arrays in both tests are shown in Fig. 23 and 24, along with two curves taken from Ref. 5, representing the anticipated TNT falloff curve for the detonation of 5,000 and 10,000 pounds of explosives. In Fig. 23, the data from the unbarricaded array (B) for both tests fit the reference curve for the detonation of 10,000 pounds of HE, but not for the 5,000-pound quantity at any ground range. In Fig. 24, for the delayed ignition of two 5,000-pound charges, Test No. 2, the peak overpressure data recorded by the barricaded gages (A) from the two stations closest to ground zero fit the falloff curve for the 5,000-pound charge, while the data from the remaining stations fit along the 10,000-pound charge falloff curve. Figure 25 shows why this should occur.

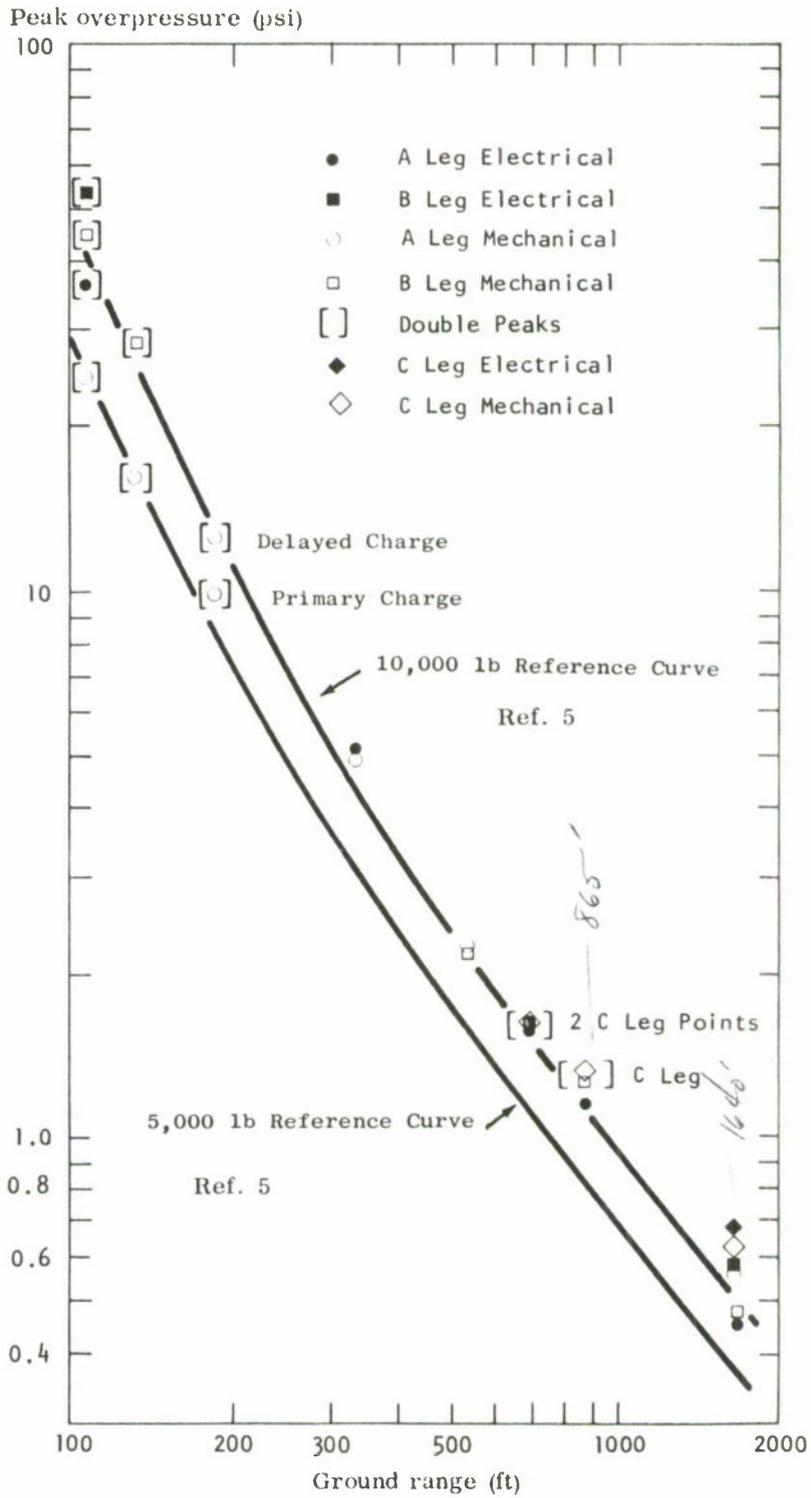
FIG. 22. Peak Overpressure Versus Distance, Test No. 2.

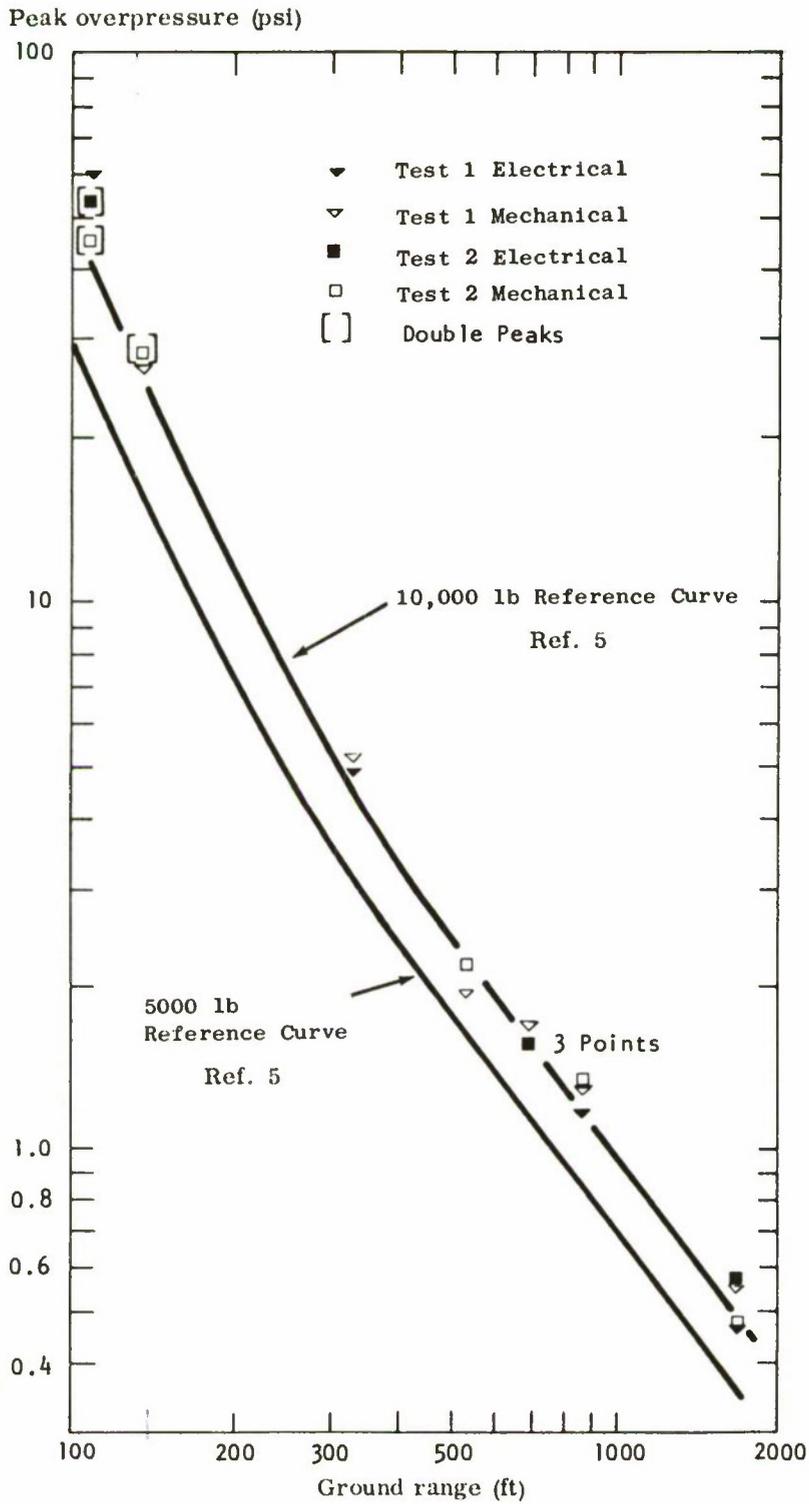
FIG. 23. Peak Overpressure Versus Distance, Unbarricaded Leg (B), Tests 1 and 2.

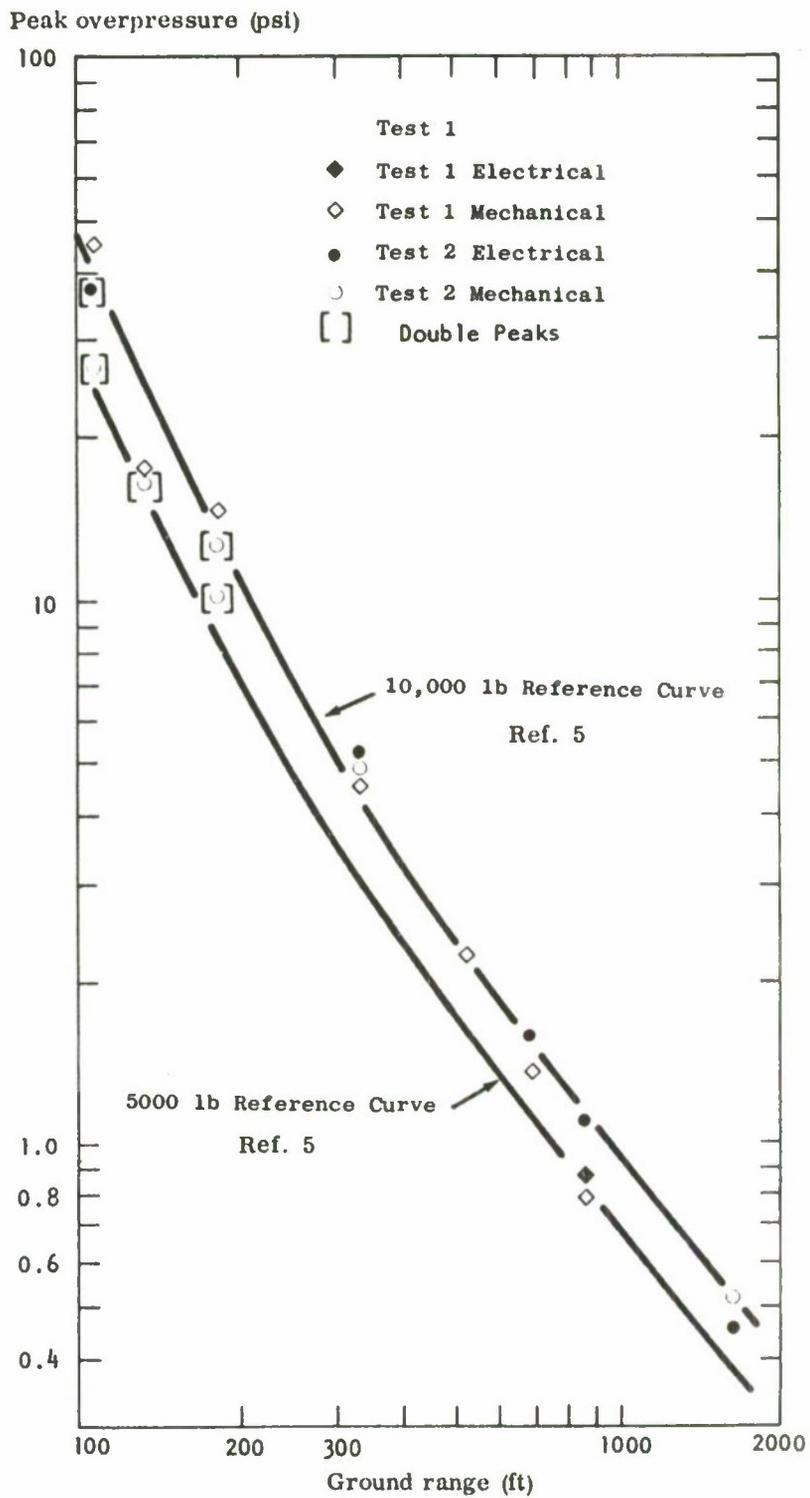
FIG. 24. Peak Overpressure Versus Distance, Barricaded Leg (A), Tests 1 and 2.
