NWC TP 4720

## EVALUATION OF EXPLOSIVES SIMULTANEITY TESTS

URS Research Company  
for the  
Systems Development Department

CHINA LAKE, CALIFORNIA \* MAY 1969

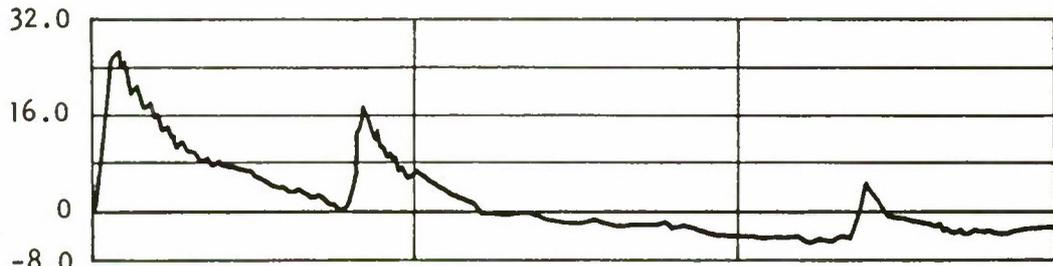
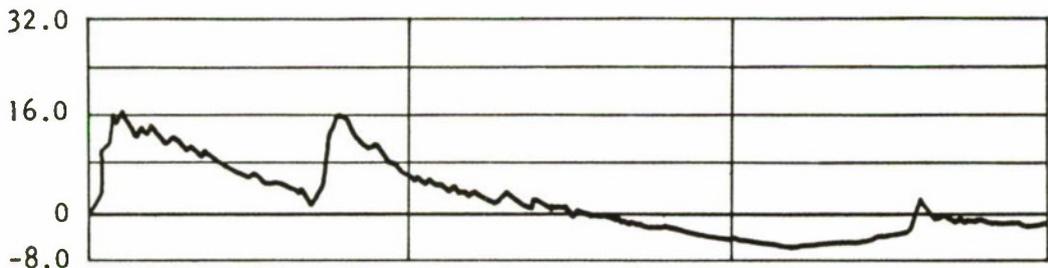
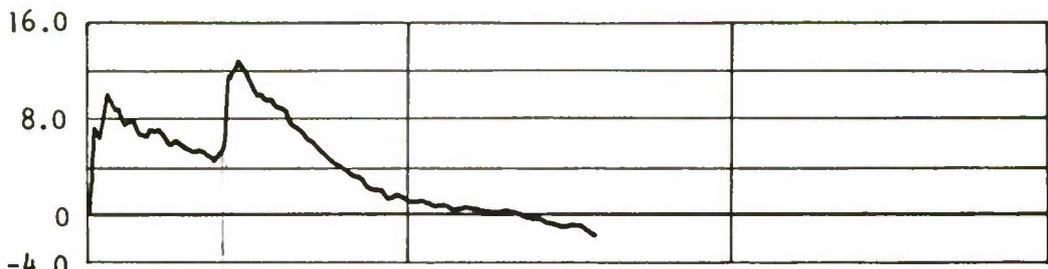
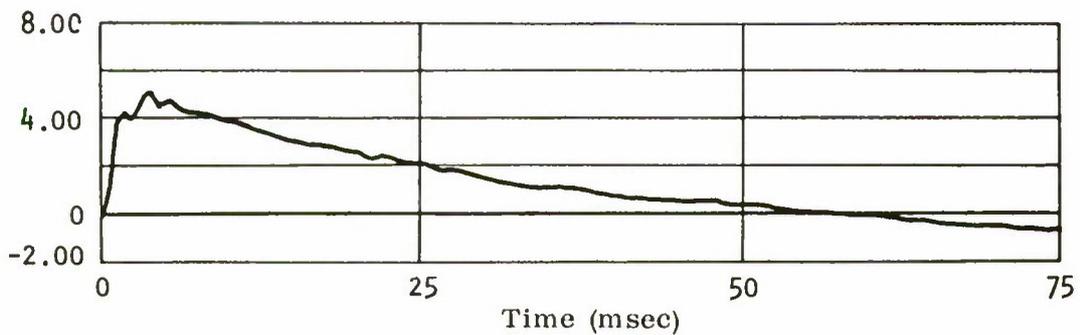
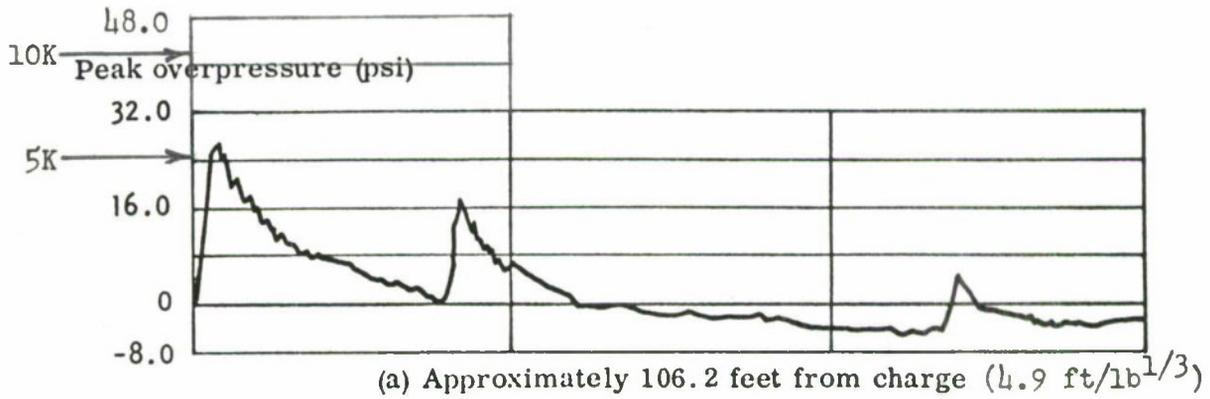
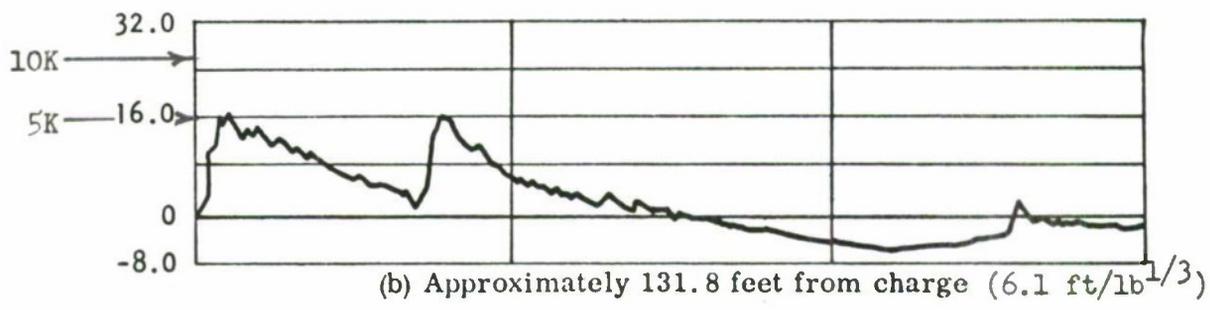
(a) Approximately 106.2 feet from charge

(b) Approximately 131.8 feet from charge

(c) Approximately 182.2 feet from charge

(d) Approximately 331.9 feet from charge

FIG. 25. Gage Recordings on Barricaded Leg (A), Test No. 2.

The peak overpressures measured during the tests are plotted as a function of distance in Fig. 21 and 22, and the peak overpressure data recorded for the B and A gage arrays in both tests are shown in Fig. 23 and 24, along with two curves taken from Ref. 5, representing the anticipated TNT falloff curve for the detonation of 5,000 and 10,000 pounds of explosives. In Fig. 23, the data from the unbarricaded array (B) for both tests fit the reference curve for the detonation of 10,000 pounds of HE, but not for the 5,000-pound quantity at any ground range. In Fig. 24, for the delayed ignition of two 5,000-pound charges, Test No. 2, the peak overpressure data recorded by the barricaded gages (A) from the two stations closest to ground zero fit the falloff curve for the 5,000-pound charge, while the data from the remaining stations fit along the 10,000-pound charge falloff curve. Figure 25 shows why this should occur.

At the two closest ground ranges along the barricaded leg (Fig. 25a and b) the two shocks have not coalesced, and the maximum peak overpressure is at the shock front of the first pulse and is, in fact, from a single 5,000-pound charge detonation. At the third station from ground zero, located at approximately 180 feet from the charge (Fig. 25c), the two shocks have started to coalesce, and the maximum peak overpressure is at the second peak. Of course, the shock front (first peak) is still due to the explosion of one 5,000-pound charge and, consequently, the peak overpressure there still falls (within the experimental limits of error) on the anticipated 5,000-pound charge falloff curve (see this point plotted in Fig. 24), while the second peak corresponds very nearly to that from the explosion of a 10,000-pound charge. Figure 25d of the sequence shows the pulse at the next station after the second shock front has caught the first, and now the shock fronts from the two pulses coincide at a value definitely equivalent to that from a single 10,000-pound charge detonation. Thus, along the barricaded leg at a distance corresponding to somewhere between a K factor (reduced distance, or  $d/w^{1/3}$ ) of 7 and 15, the overpressure data from the two 5,000-pound charges with a programmed delay of approximately 20 msec between ignitions cannot be distinguished from the reference curve. From these

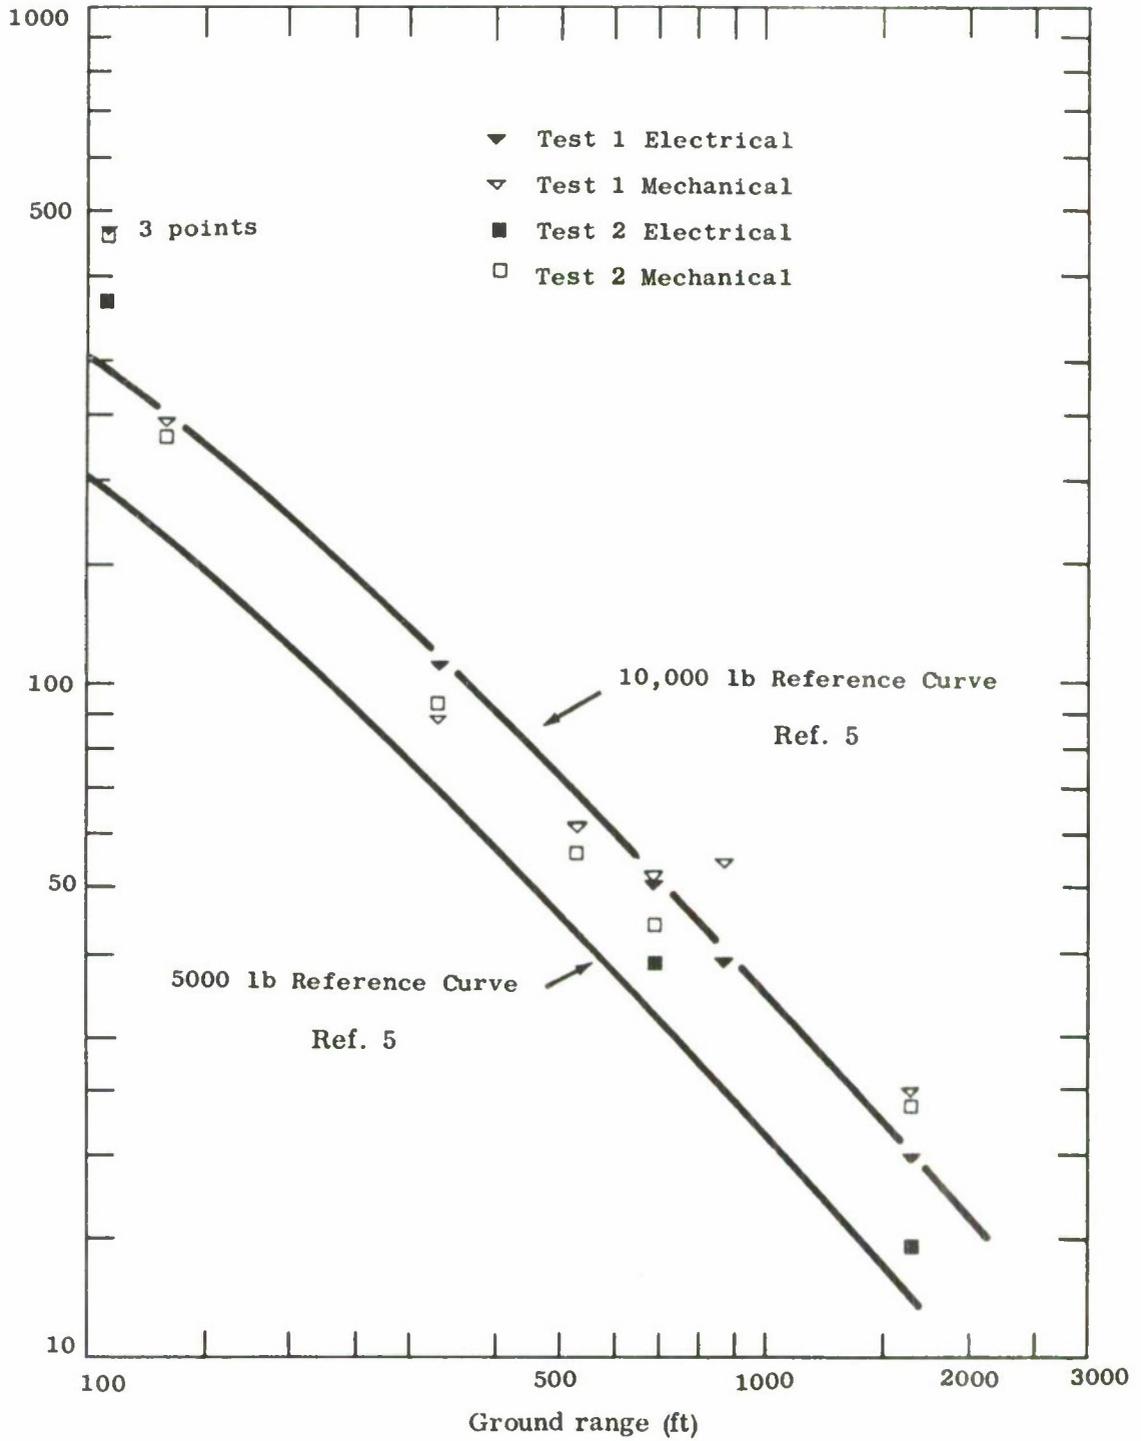
FIG. 26. Positive-Phase Impulse Versus Distance, Unbarricaded Leg (B), Tests 1 and 2.

Figure 26, which is a plot of the positive-phase impulse data from the unbarricaded gage leg for the two tests plus curves from Ref. 5, shows that the electrical gage data from the detonation of the single 10,000-pound charge are a very good fit to the 10,000-pound reference curve, with the exception of the station closest to the charge, where it falls considerably higher. Although the electrical gage data from Test No. 2 are in short supply, the points available fall below those for Test No. 1. Along the unbarricaded gage leg, then, the Test No. 2 data are at the level expected from the detonation of a charge slightly under 7,000 pounds versus 10,000 pounds for the Test No. 1 data. The mechanical gage data along the unbarricaded leg, however, indicate a much smaller positive-phase impulse difference between the two tests. When the electrical and mechanical gage data on the unbarricaded side are averaged for each test and then compared, the disparity between the two tests is a yield of 8,500 pounds of TNT versus a yield of 10,000 pounds, excluding events at the closest station, which seem to disagree radically with all the other stations. The conclusion is that there is some effect on positive-phase impulse when the 10,000 pounds of HE is ignited as two charges with a 20 msec delay, rather than when detonated all in a single charge.

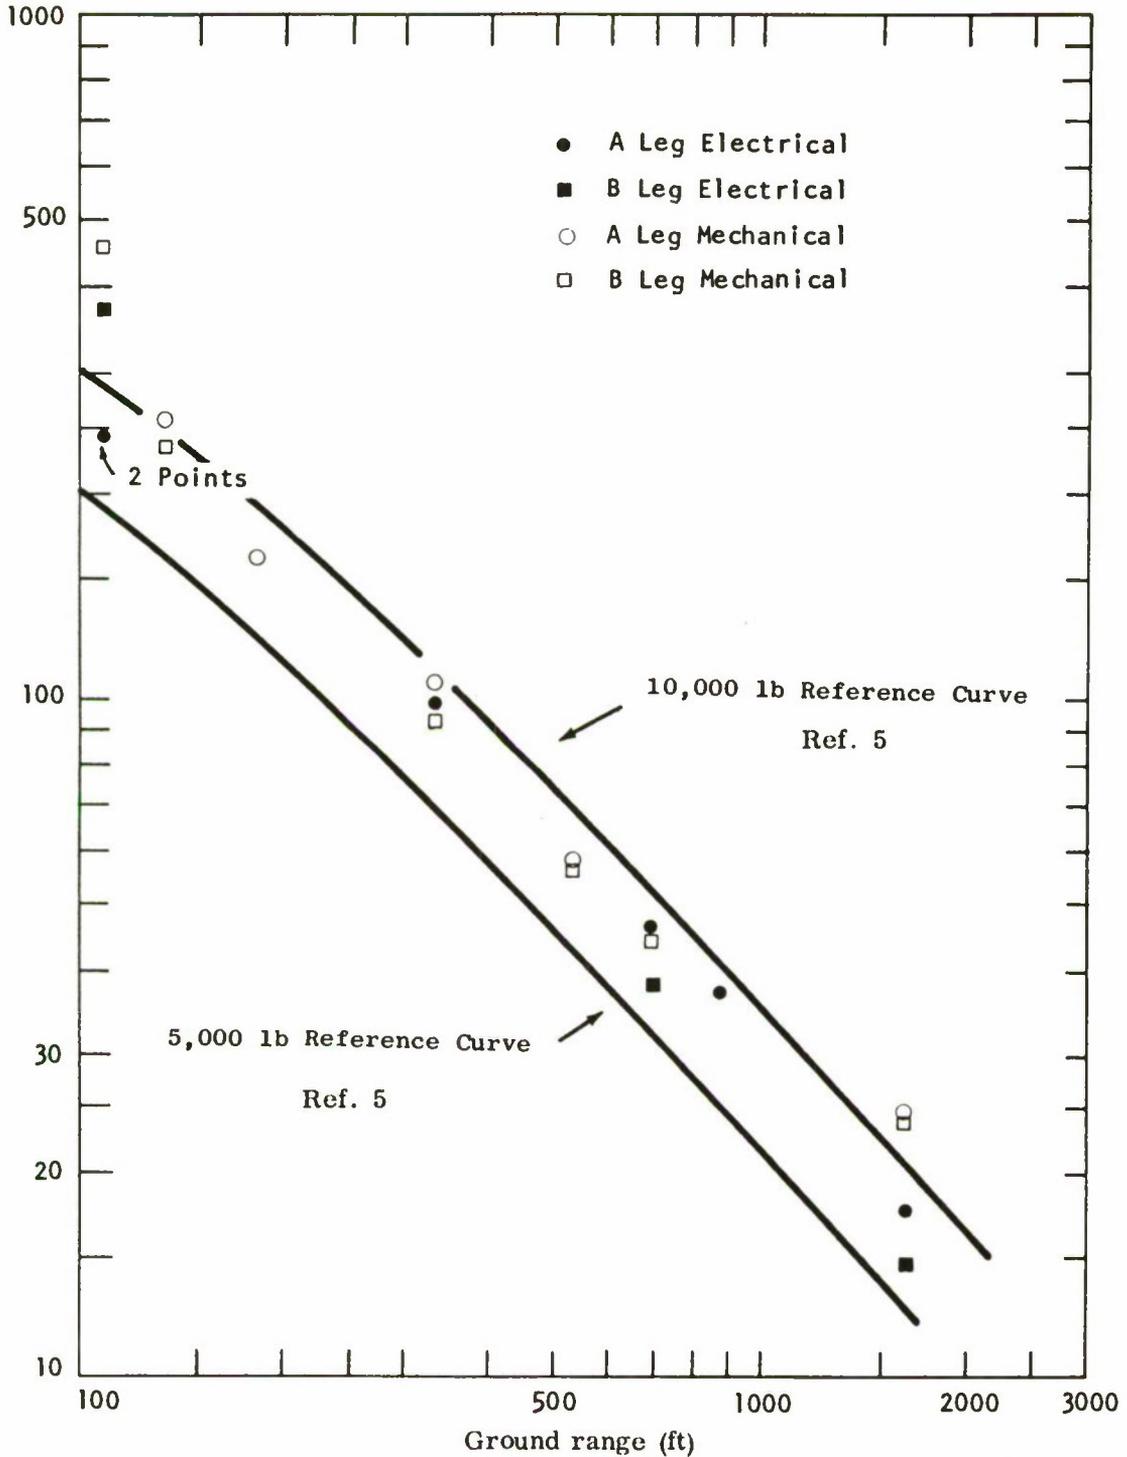
FIG. 27. Positive-Phase Impulse Versus Distance, Barricaded and Unbarricaded Legs, Test No. 2.

Figure 27 shows the graphed positive-phase impulse data from the A and B gages for Test No. 2. The electrical gage data for the barricaded leg fall between a 7,000- and a 10,000-pound yield over the entire range while, along the unbarricaded leg, the data fall between a 5,000- and a 7,000-pound yield in the vicinity of the barricaded inhabited building distance. However, one data point close-in falls considerably above that expected from the detonation of 10,000 pounds of HE. The average of the mechanical gage data falls only slightly below that for 10,000 pounds of HE, ranging from a minimum slightly above a 7,000-pound yield to a maximum of more than a 10,000-pound yield at the station just before, and the one just beyond, the ground range corresponding to the barricaded inhabited building distance. The mechanical gage data taken along the unbarricaded array shows a slightly greater range than for the barricaded array and, in the vicinity of the barricaded inhabited building distance, the average is midway between the 7,000- and the 10,000-pound yield levels.

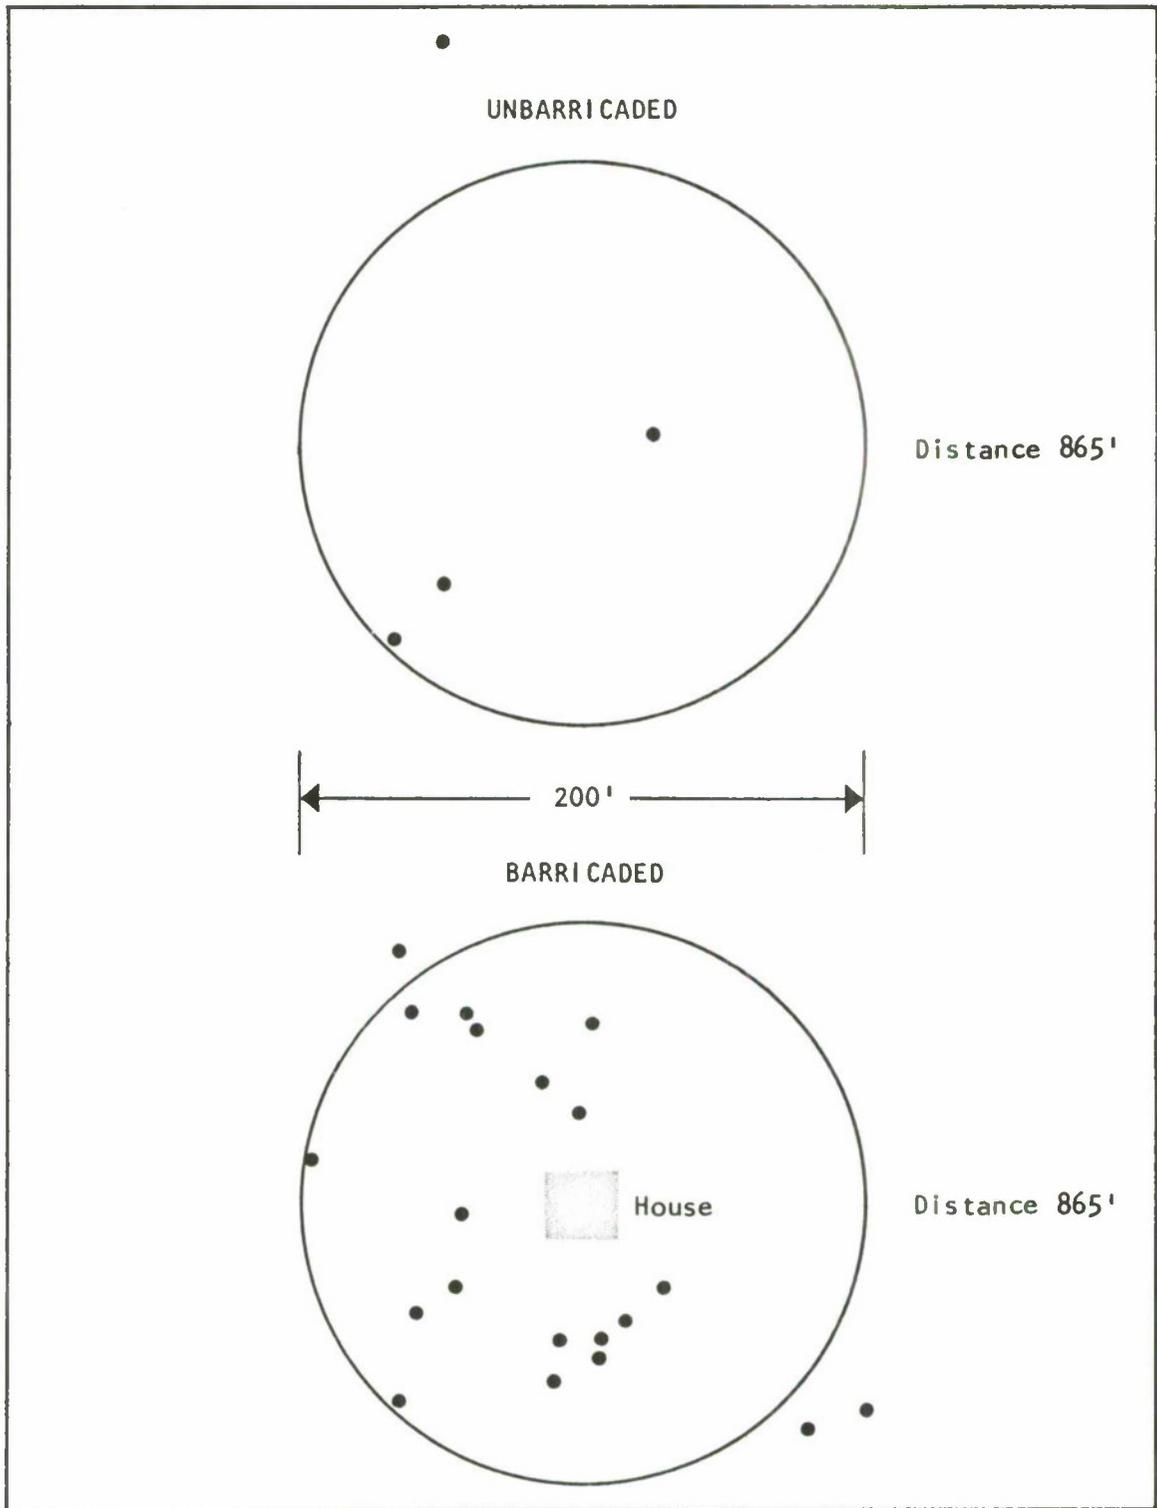
FIG. 28. Search Areas Showing Fragments Found After Test No. 1.

Figure 28 shows the distribution of concrete and steel pieces exceeding either 6 inches in diameter or 4 feet in length that were found after Test No. 1 in the 200-foot-radius search area centered at the house on the barricaded side and a like search area centered at the 865-foot station on the unbarricaded side. It is interesting to note that 17 such fragments were found in the area on the barricaded side, and only three were found in the corresponding area along the unbarricaded side. No fragments were found in the other search areas after this test. In Test No. 2, no fragments were found beyond 600 feet on either the barricaded or unbarricaded side. However, on the unbarricaded west leg (C in Fig. 1), to the side of the charge, approximately 130 fragments were found in a 200-foot-radius circle centered at the 865-foot distance.
