REPORT M72-11-1

A FRACTOGRAPHIC INVESTIGATION OF EXPLOSIVELY FRAGMENTED SILICON-MANGANESE STEELS BY SCANNING ELECTRON MICROSCOPY

May 1972

**DEPARTMENT OF THE ARMY  
FRANKFORD ARSENAL  
Philadelphia, Pa. 19137**

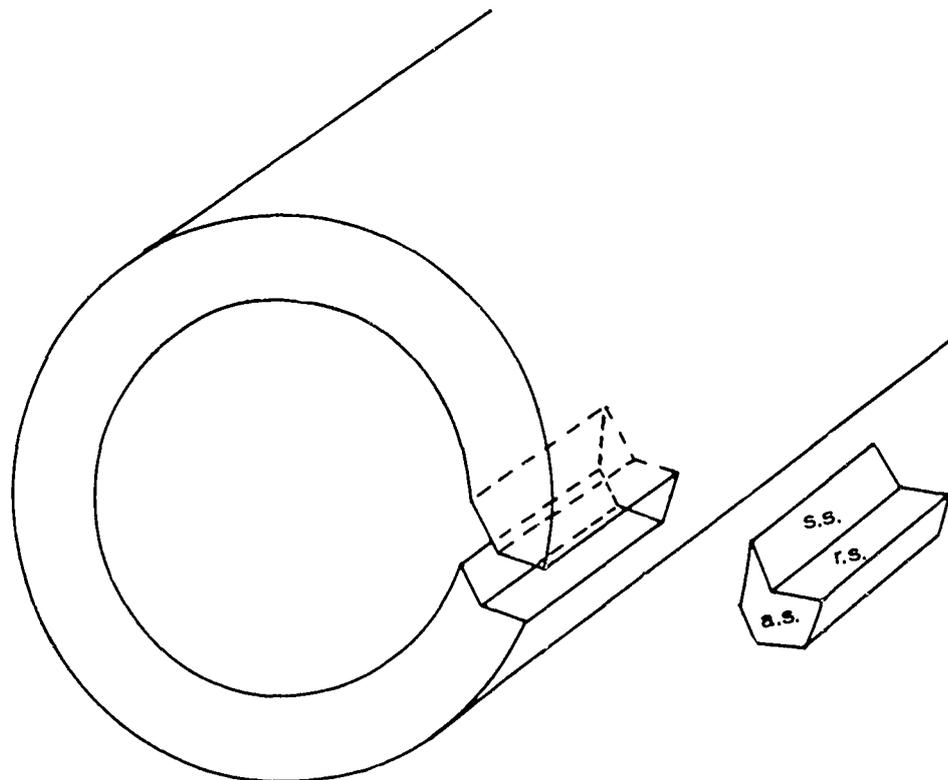
Three fracture surfaces of each fragment were examined wherever possible. A schematic illustrating the fracture surfaces is shown in Figure 1. The figure is intended to be descriptive only and does not necessarily depict a typically shaped fragment. The surface, radially

directed with respect to the cylinder axis, is labeled r.s.; the surface which is inclined at an angle of approximately  $45^\circ$  to the inner surface is essentially a shear surface and is labeled s.s.; and the surface which is normal to the cylinder axis is labeled a.s. Some of the fragments examined exhibited all three surfaces. In many instances, however, radial surfaces were absent and axial surfaces were ill-defined.

Figure 1. Schematic Illustrating Various Surfaces of a Fragment

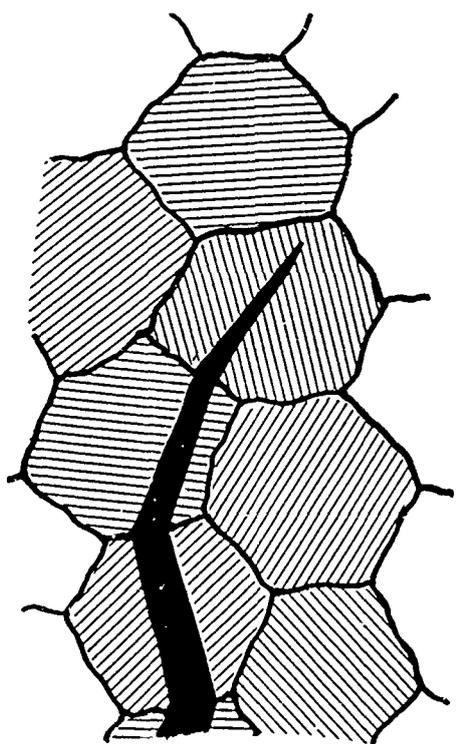
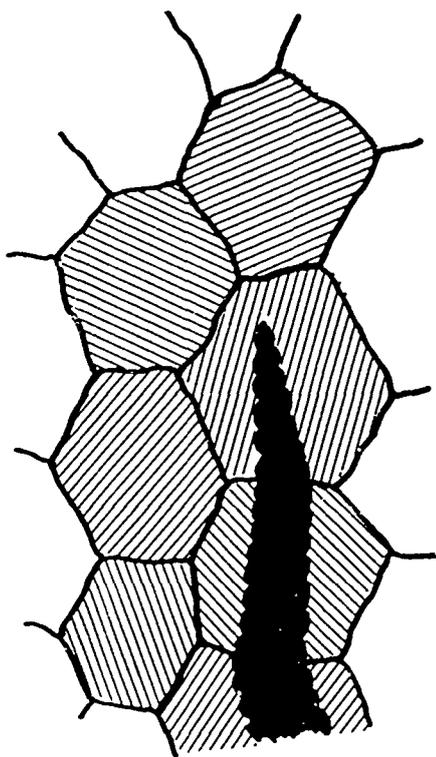
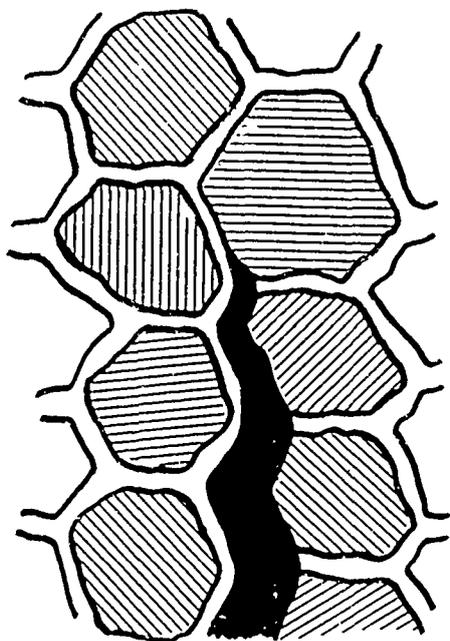
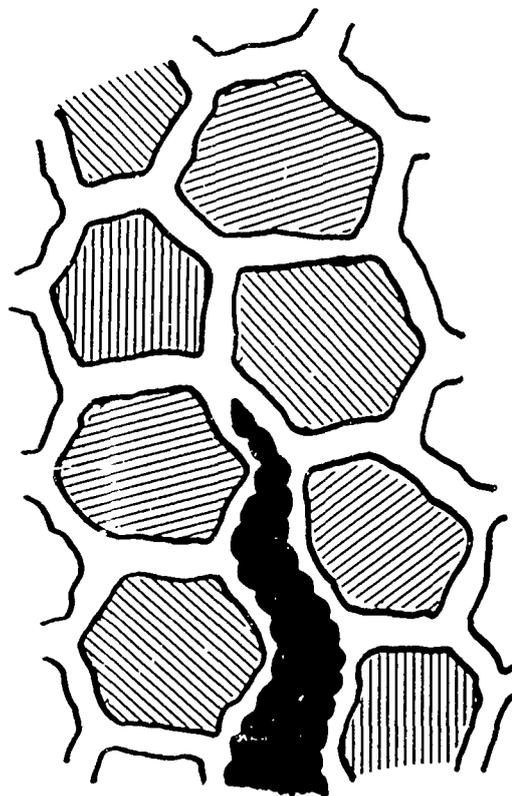
A schematic illustrating various fracture modes often observed in fractographic studies is shown in Figure 2. They are introduced here to provide a basis for the discussion on the fractographs which will be presented for XF-1 and HF-1.

Intergranular separation (upper left) refers to the separation of a grain boundary constituent from the matrix. This is considered to be a relatively brittle fracture mode. Another brittle fracture mode is transgranular cleavage (upper right), in which fracture occurs along certain "cleavage planes" within a grain. The fracture surface exhibited by this fracture mode consists of relatively flat areas whose size corresponds to the grain size of the material, and is characterized by "river patterns" which are related to the direction of crack propagation.

Figure 2. Schematic Illustrating Various Fracture Modes

The dimpled modes of fracture, shown in the lower section of the figure, are generally described as ductile modes. They absorb much more energy than the separation or cleavage modes. The intergranular dimpled mode (lower left) results from the ductile rupture of the grain boundary constituent. The transgranular dimpled mode also occurs by a ductile process but is unaffected by grain boundaries. It is usually associated with precipitates, inclusions, or regions of severe plastic flow.

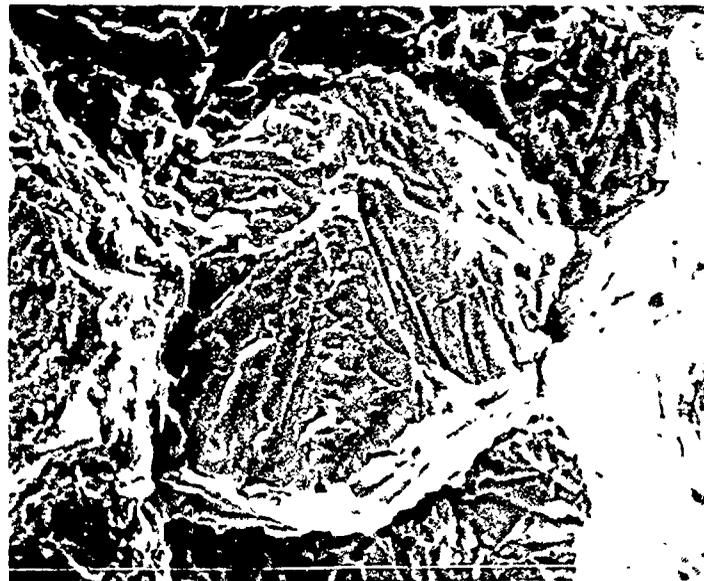
A typical radial fracture surface that was observed on fragments from one of the superior fragmenting conditions (a carbide network and lightly tempered martensite matrix microstructure) is shown in Figures 8 and 9. The fractographs indicate that intergranular separation was the only operable mode of fracture.

Figure 8. HF-1: Carbide Network and Lightly Tempered Martensite Matrix, Radial Surface

Figure 9. HF-1: Carbide Network and Lightly Tempered Martensite Matrix, Radial Surface (Same as Figure 8, but higher magnification.)
